Davis Structure Assessment #1

Collected Date/Time: 8/25/2018 9:24:01 PM, Collected By: Eric J Kurtz STPS Incident Number: MT-KNF-000161

Location: 28933 Yaak River Road (Hwy 508) , Yaak

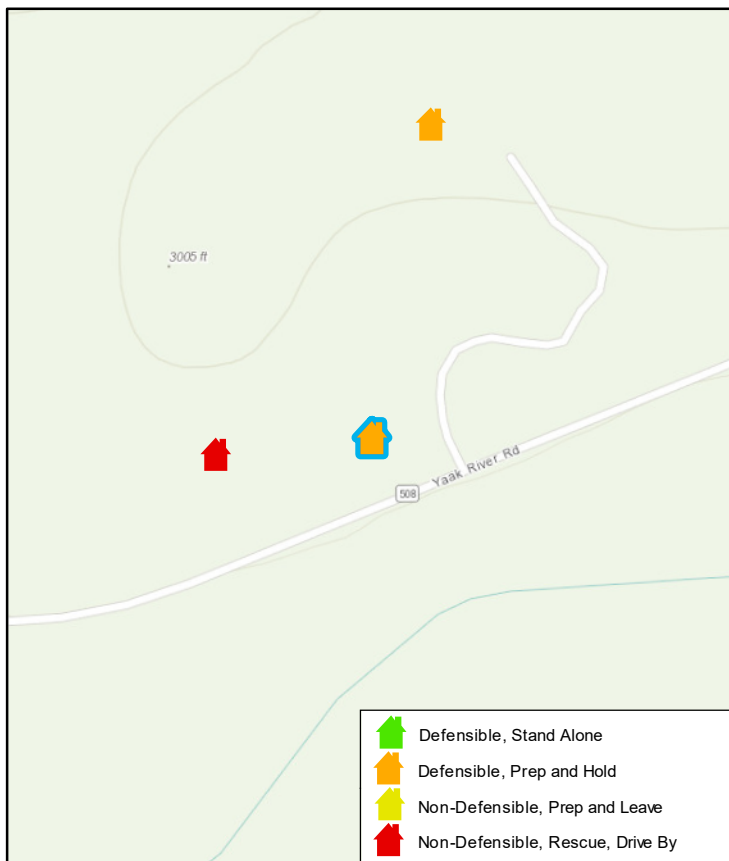
Hazard Notes: Large woodshed 10 feet from shop and house. Wood walk way from house to shop

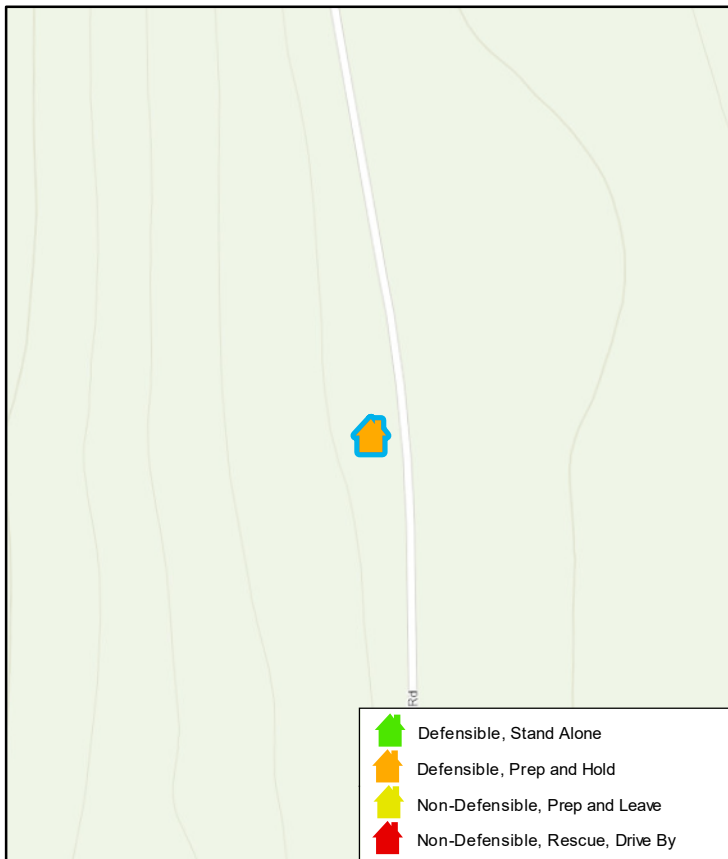
Hazard Notes: Attached rear woodshed full

Notes: Former historic US Forest Service cabin built in 1925 donated the community of Yaak. Type 2 hancrew assigned to create Defensible Space around the Community Hall. Structure locate on US Forest Service land

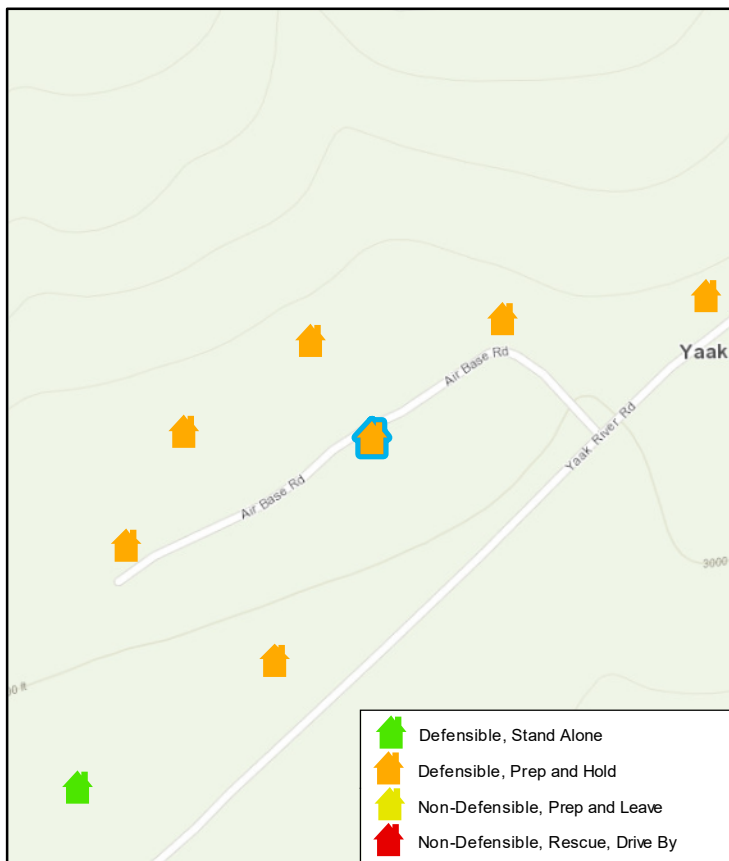
Hazard Notes: Large woodpiles within 30 feet of structure. Combination shop and living quarters under construction. Cluttered yard area

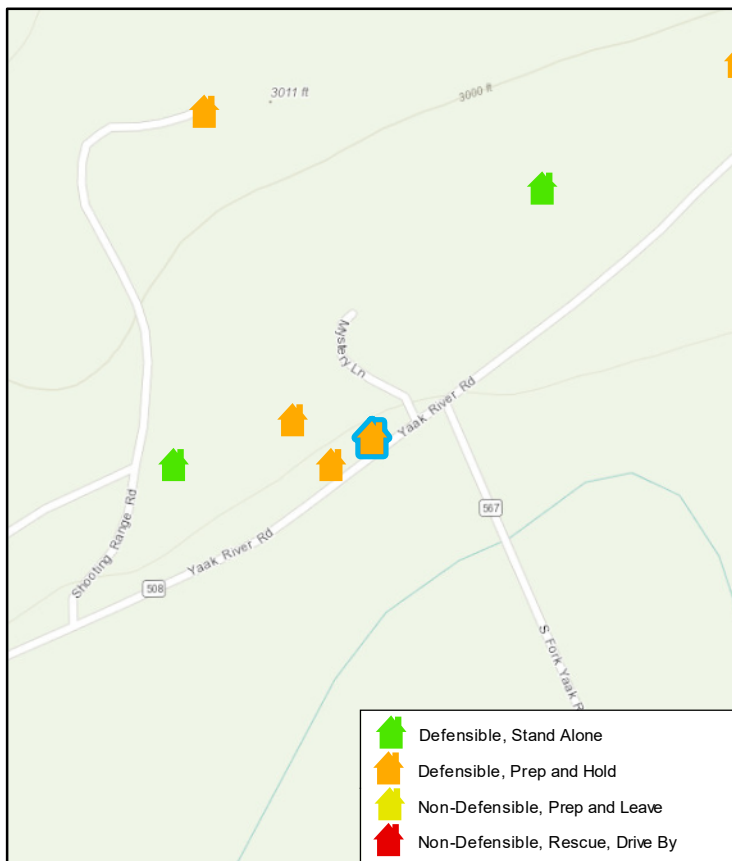
Hazard Notes: Above ground 1500 Unleaded commercial fuel tank. Commercial cage of twenty 5 lb LPG tanks for sale in front of store. Large woodshed within 30 feet of store. Open aired wood band stage and

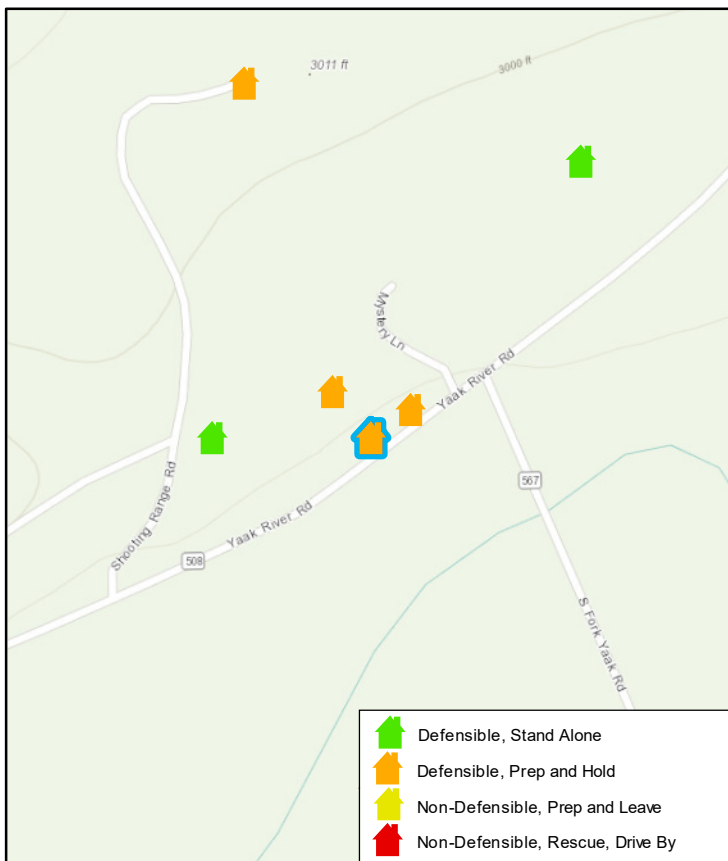
Hazard Notes: 1000 gallon concrete Convault fuel cell empty. Partial shake roof. Yard debris, abandon vehicles and campers. Grassy uncut slope up against rear of buildings. Wild and crazy locals bar!!

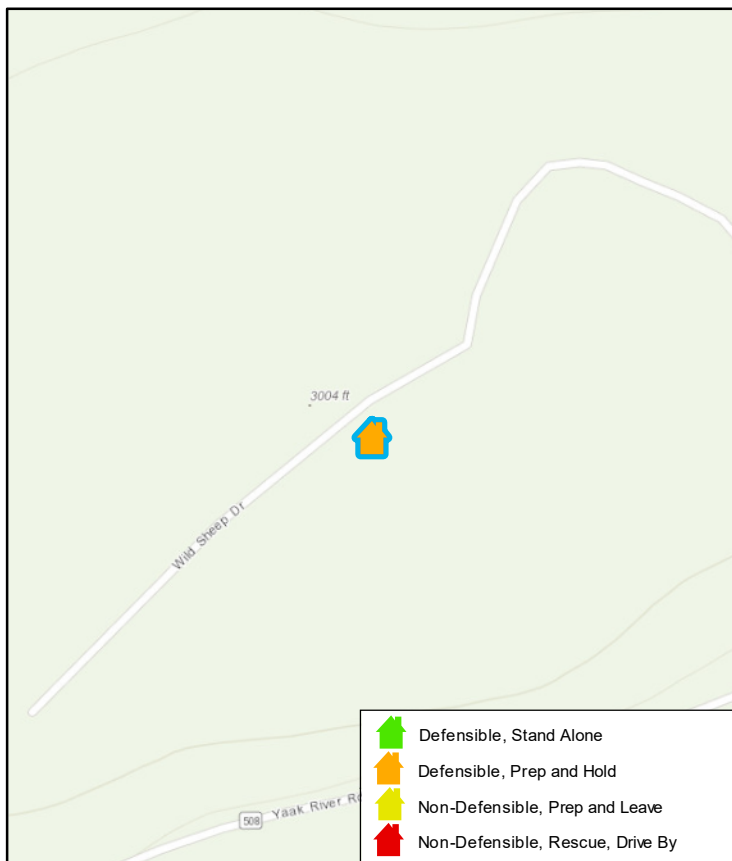
Hazard Notes: Firewood piles stacked in carport, decks and two large wood sheds within 30 feet of residence. Very narrow driveway entrance steel gate

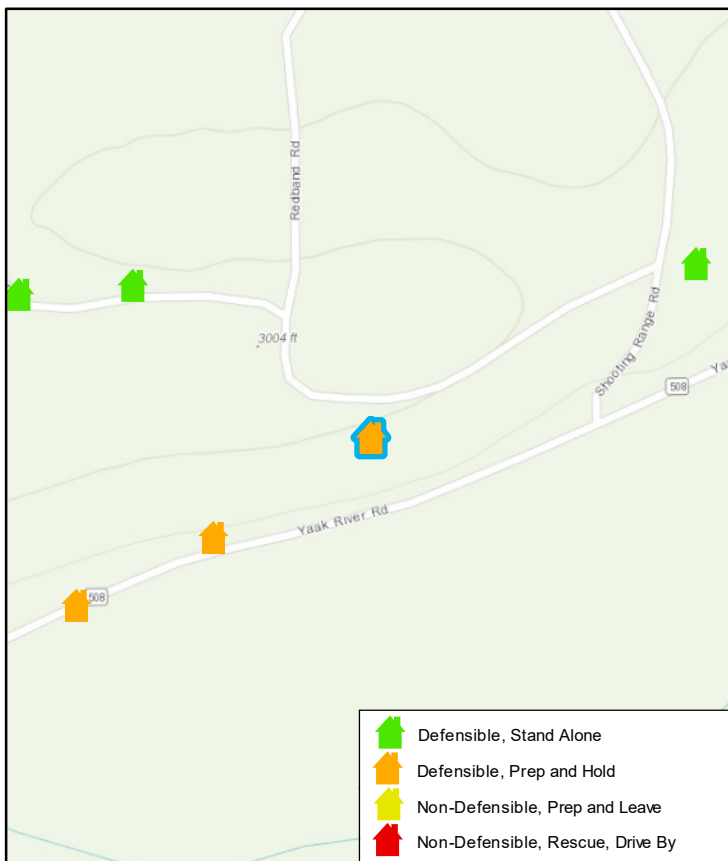
Hazard Notes: Small woodpile below the deck. Woodpile street side of structure 70 percent slope open grass and weed covered leads up to rear deck. Unscreened crawl space vents ember traps

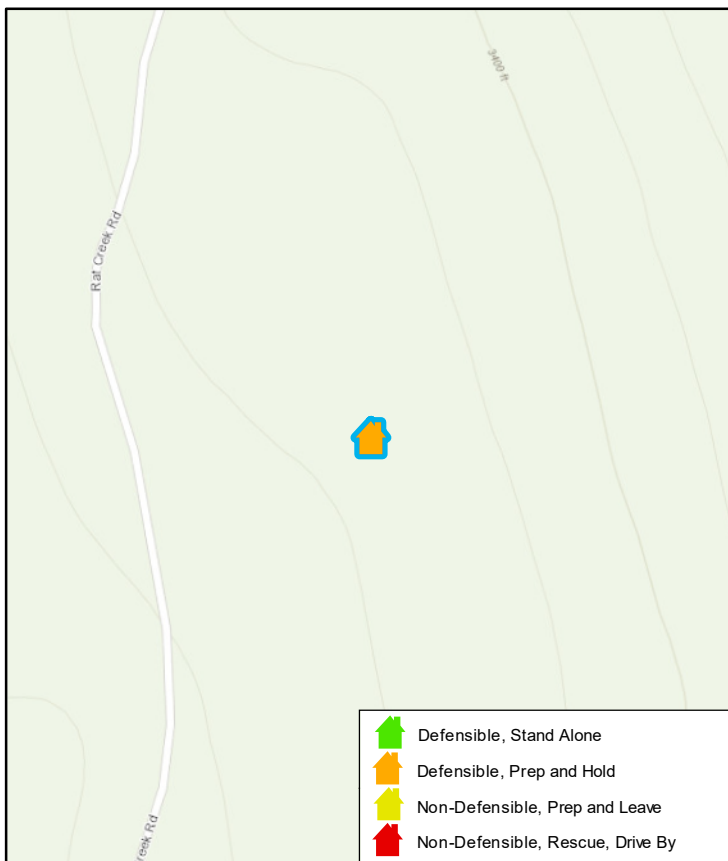
Hazard Notes: Large woodpiles on decks and woodsheds Tractors on site

Notes: Super Defensible Space below and above the primary year round residence. Stock pond feed by artesian well approximately 1000 gallon to draft from or set up Mark 3 Pump kit with Sprinklers. Spend the time to prepare structures to Stand Alone if time allows. Super people

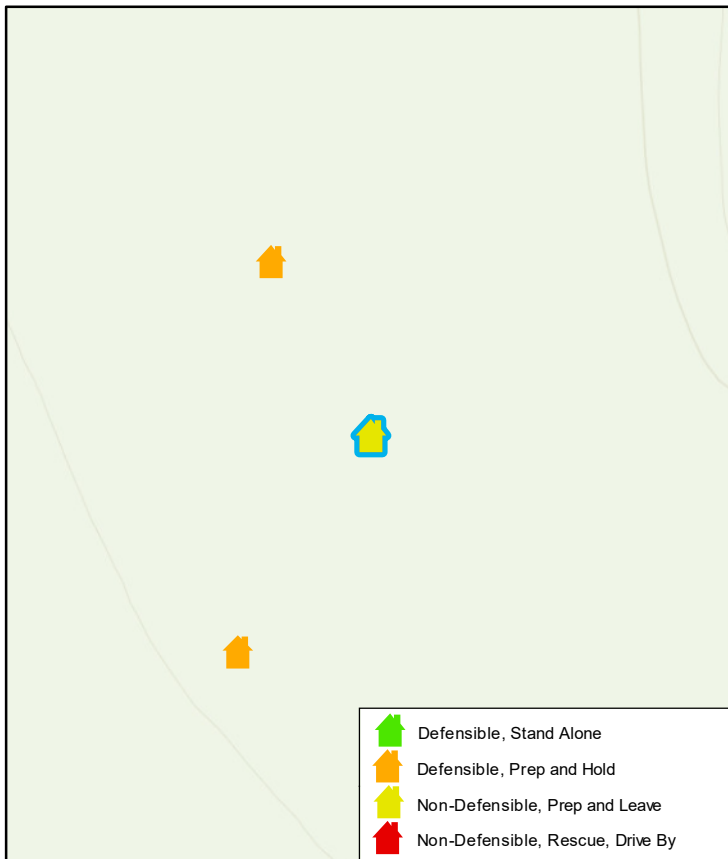
Hazard Notes: Empty newly built garage with loft apartment unoccupied plus unoccupied original cabin. Unknown haz mat inside garage and surrounding structures. Old wood pile with 30 feet of structures.

Notes: Risk vs Gain assessment. Prep only if ample time to do so

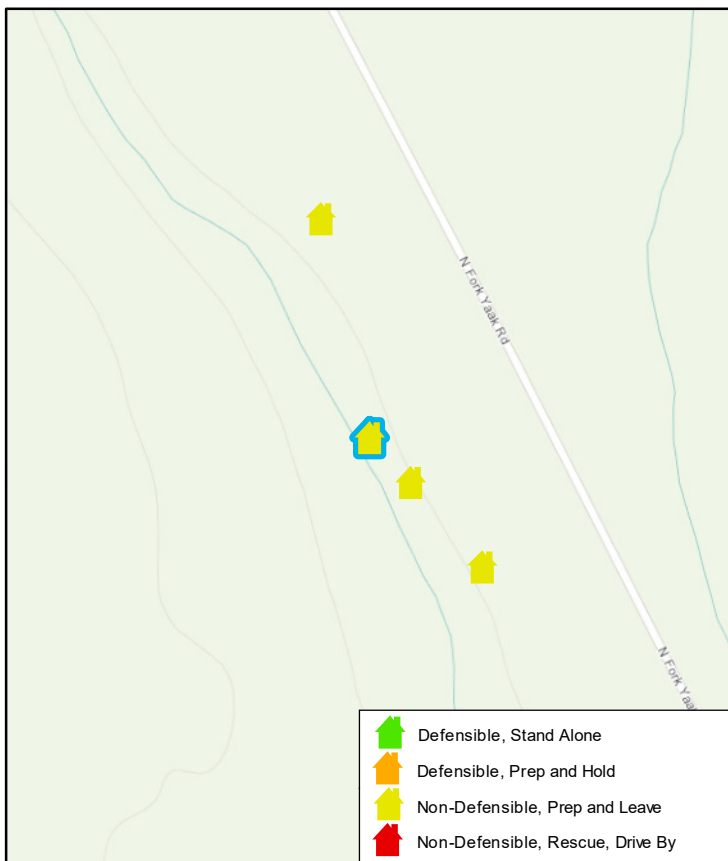
Hazard Notes: No driveable access. Heavy blown down timber on site

Notes: Boarded up abandoned cabin. Low priority for mitigation work. Risk vs Gain based on Current and Expected Fire Behavior
