Structure Number:	169		FED TEAM
Structure Name:	FS #2		2 1-17-10-2
SubDivision:	<b>Cottonwood Guard Station</b>		S. LL VE
GPS Location, Lat.	48 1.25178		
GPS Location, Long.	120 38.45526		ANAGE
Safety Zone Present:	No	Where is Safety Zone: No safety zone present.	
Type of Structure:	Other	Primary Structures: 1	Outbuildings: 4
Other Type of	Government Building		
Surrounding Fuels:	Shrub,Timber,Slash	Defensible Space	e: 50-100 Feet
Structure Triage			
Category:	Non-Defensible, Prep and Le	ave	
Roof Material:	Metal	Siding Materia	I: Wood
Heat Traps:	Wood Deck, Other Receptor		
Electrical Power:	Solar/Wind	Gas to Structure	e: Aboveground
Hazards:	Terrain, Fuels, Haz Mat		
Hazard Notes:	500 gal LPG tank on site, no	safety zone.	
Access to Site:	T3/4 Engine	Best Access From: Located at the end of E	ntiat River Road MP 37.5 on left.
Comm with ICP:	Radio		
Water Source:	Faucet / Hose,Creek		
Mitigation Time:	1-2 Hours

Structure Number:	144		FED TLAN
Structure Name:	PH #4-2		2 000000
SubDivision:	Pope Summer Homes		S. LL P
GPS Location, Lat.	47 58.56648		
GPS Location, Long.	120 33.70884		24NAGE
Safety Zone Present:	No	Where is Safety Zone: Safety zone is located 7	miles south on Entiat Ri

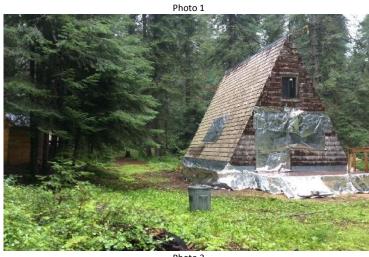
Photo 2

Structure Number: Structure Name:	374 1-1 structure 5100 rd		
SubDivision:	Entiat		
GPS Location, Lat.	47 58.11516		
GPS Location, Long.	120 33.1575		
Safety Zone Present:	No	Where is Safety Zone: Silver Falls parking	
Type of Structure:	Residential	Primary Structures: 1	Outbuildings: 2
Other Type of		-	U
Surrounding Fuels:	Shrub, Timber, Slash	Defensible Space: None	2
Structure Triage			
Category:	Non-Defensible, Prep and	Leave	
Roof Material:	Wood	Siding Material: Woo	d
Heat Traps:	Wood Deck,Other Recepto	or	
Electrical Power:	None	Gas to Structure: Abov	veground
Hazards:	Terrain, Fuels, No Turn Aro	und	
Hazard Notes:	Snags, interconnected cro	wn	
Access to Site:	Handcrew	Best Access From: Access on foot from structure	1-2
Comm with ICP:	Radio		
Water Source:	Creek		
Mitigation Time:	1-2 Hours		
Other Resources			
Needed to Protect:	Sprinkles, pump, foil		
Notes:	Summer cabin with good water	r source, must access by foot from structure 1-2's driveway.

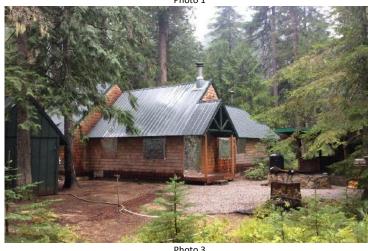
08/17/2014 18:50 Photo 2

Structure Triage Information	NATION
Structure Number:	375		
Structure Name:	1-3 structure 5100 rd		
SubDivision:	Entiat		TEAM
GPS Location, Lat.	47 58.09122		Contract of the second s
GPS Location, Long.	120 33.16032		CNI
Safety Zone Present:	No	Where is Safety Zone: Silver falls parking	
Type of Structure:	Residential	Primary Structures: 1	Outbuildings: 2
Other Type of			
Surrounding Fuels:	Shrub, Timber, Slash	Defensible Spac	e: None
Structure Triage			
Category:	Non-Defensible, Prep ar	nd Leave	
Roof Material:	Metal	Siding Materia	al: Wood
Heat Traps:	Open Eaves,Wood Deck	,Other Receptor	
Electrical Power:	Underground	Gas to Structur	<b>'e:</b> Aboveground
Hazards:	Terrain, Fuels		-
Hazard Notes:	Multiple large wood pile	es less than 30 ft from structure, interconnected ci	rown, propane tank, snags
Access to Site:	T6 Engine	Best Access From: 5100 rd	
Comm with ICP:	None		
Water Source:	Creek		
Mitigation Time:	1-2 Hours

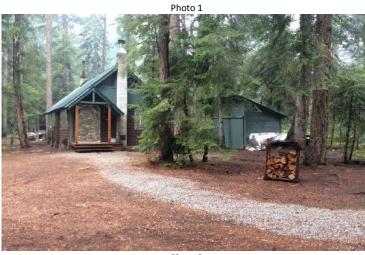
08/17/2014 18:50 Photo 2

Structure Number: Structure Name: SubDivision:	376 Structure 2-1 rd 5100 Entiat		
GPS Location, Lat.	47 58.13922		8
GPS Location, Long.	120 33.18114		
Safety Zone Present:	No	Where is Safety Zone: Silver falls parking	
Type of Structure:	Residential	Primary Structures: 1	Outbuildings: 3
Other Type of			
Surrounding Fuels:	Shrub, Timber, Slash	Defensible Space	e: None
Structure Triage			
Category:	Non-Defensible, Prep an	id Leave	
Roof Material:	Metal	Siding Materia	I: Wood
Heat Traps:	Open Eaves,Wood Deck,	Other Receptor	
Electrical Power:	None	Gas to Structure	e: Aboveground
Hazards:	Terrain, Fuels		-
Hazard Notes:	Interconnected crown, m	nultiple wood piles around structure, propane tank	< c
Access to Site:	T6 Engine	Best Access From: Driveway 2 from 5100 r	ď
Comm with ICP:	None	·	
Water Source:	Creek		
Mitigation Time:	1-2 Hours		
Other Resources			
Needed to Protect:	Sprinklers, pump, foil		
Notes:		ter source, propane tank, interconnected crown
