Structures Map

Bulldog Mountain
WACOF-2348
8/26/2021 Day

Bulldog_Mountain

WACOF-002348

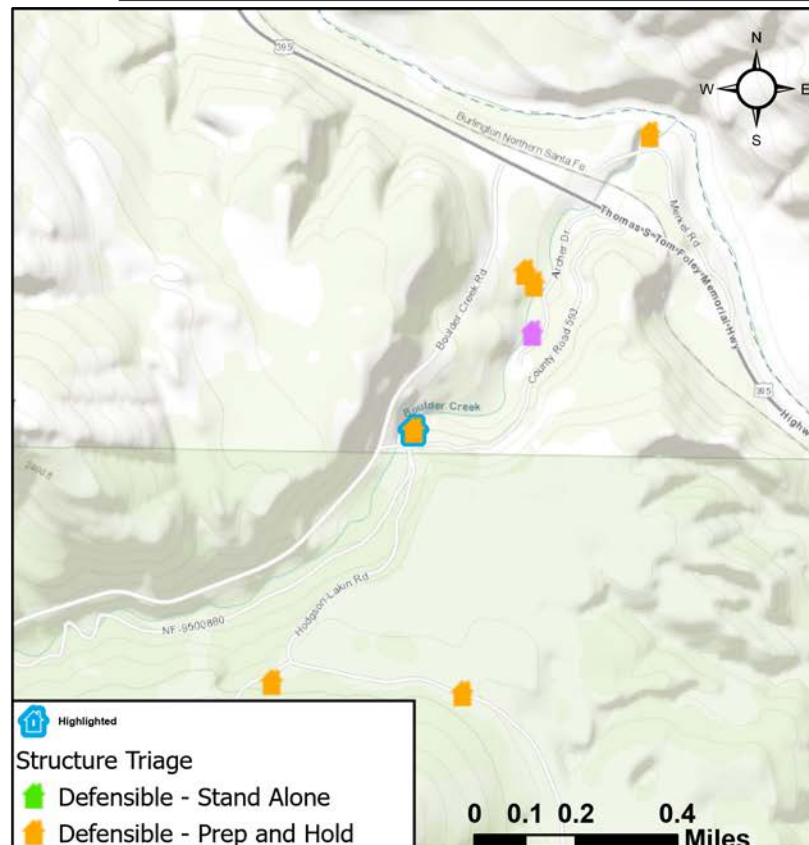
Triage Category: Defensible, Prep and Hold
FIRESCOPE Triage Category:
Structure Number: 1
Collected Date/Time:
Collected By:
Inspector's Position: Division
Type of Structure: Residential
Primary Structures: 1
Is the building Occupied?: Unknown
Outbuildings: 1
Fuel Surrounding Structure: Shrub or timber
Defensible Space: 30 ft treated
Roof Material: Noncombustible or not applicable
Siding Material: Wood or open sided
Electrical Power: Yes
Gas to Structure: Unknown
Hazards: Power lines
Access to Site:
Describe Access:
Comm With ICP: Yes
Water Source: Reliable water source nearby
Safety Zone Present:
Mitigation Time (in hours): 2
Mitigation Description: Brush out, scratch line, porta tanks
Resources Needed to Protect Structure: x1 Type 6 Engine, x1 20 Person Crew
FIRESCOPE Tactics:
Notes: Horse Barn with two horses

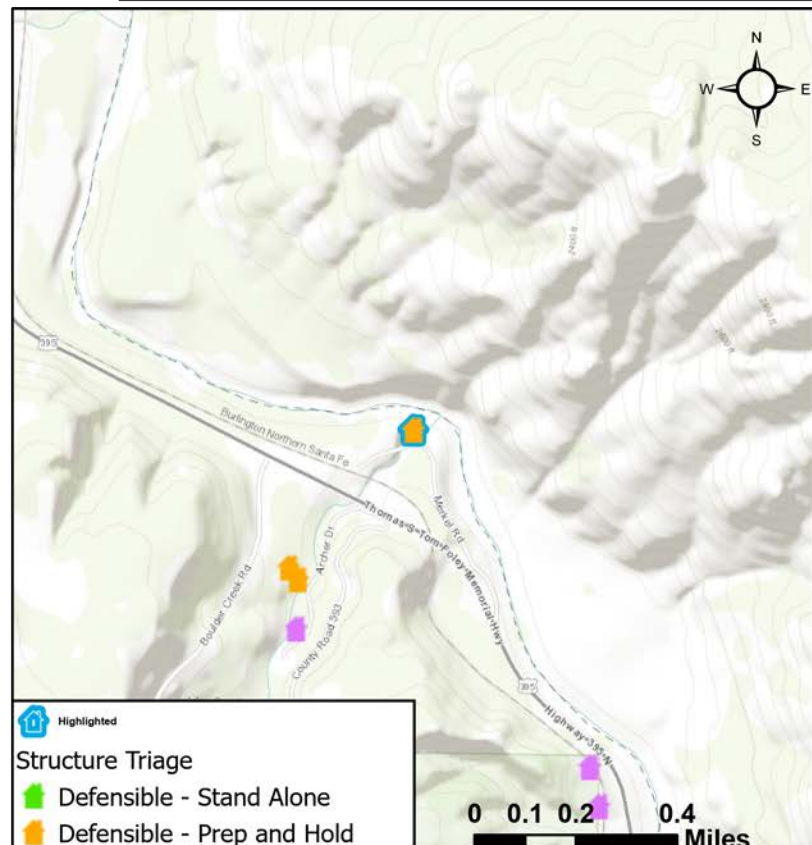
Triage Category: Defensible, Prep and Hold
FIRESCOPE Triage Category:
Structure Number: 10
Collected Date/Time:
Collected By:
Inspector's Position: Division
Type of Structure: Residential
Primary Structures: 1
Is the building Occupied?: Yes
Outbuildings:
Fuel Surrounding Structure: Shrub or timber
Defensible Space: 100 ft treated
Roof Material: Noncombustible or not applicable
Siding Material: Wood or open sided
Electrical Power: Yes
Gas to Structure: Unknown
Hazards:
Access to Site:
Describe Access:
Comm With ICP: Yes
Water Source: Reliable water source nearby
Safety Zone Present:
Mitigation Time (in hours): 2
Mitigation Description: Removal of lateral fuels, Scratch line, possible dozer line, porta tanks
Resources Needed to Protect Structure: x1 Type 6 Engine, x1 20 Person Hand Crew
FIRESCOPE Tactics:
Notes:

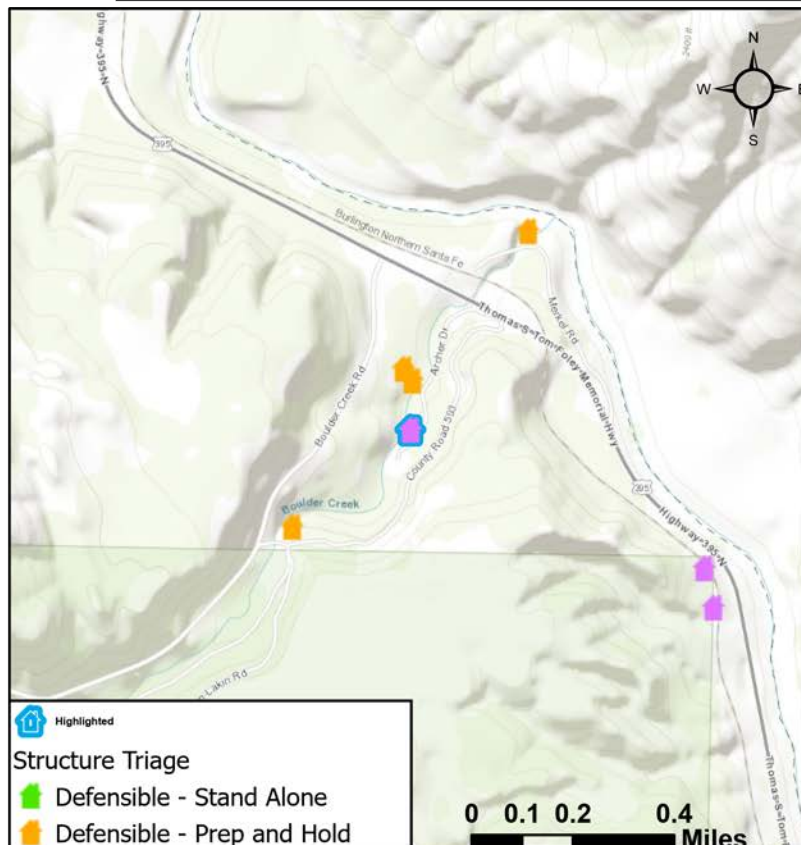
Structure Number: 11

Triage Category: Non-Defensible, Prep and Leave

Defensible Space: 100 ft treated

Siding Material: Wood or open sided

Mitigation Description: Removal of lateral fuels, scratch line, possible dozer line, porta tanks

Resources Needed to Protect Structure: x1 Type 6

Engine, x1 20 Person Crew

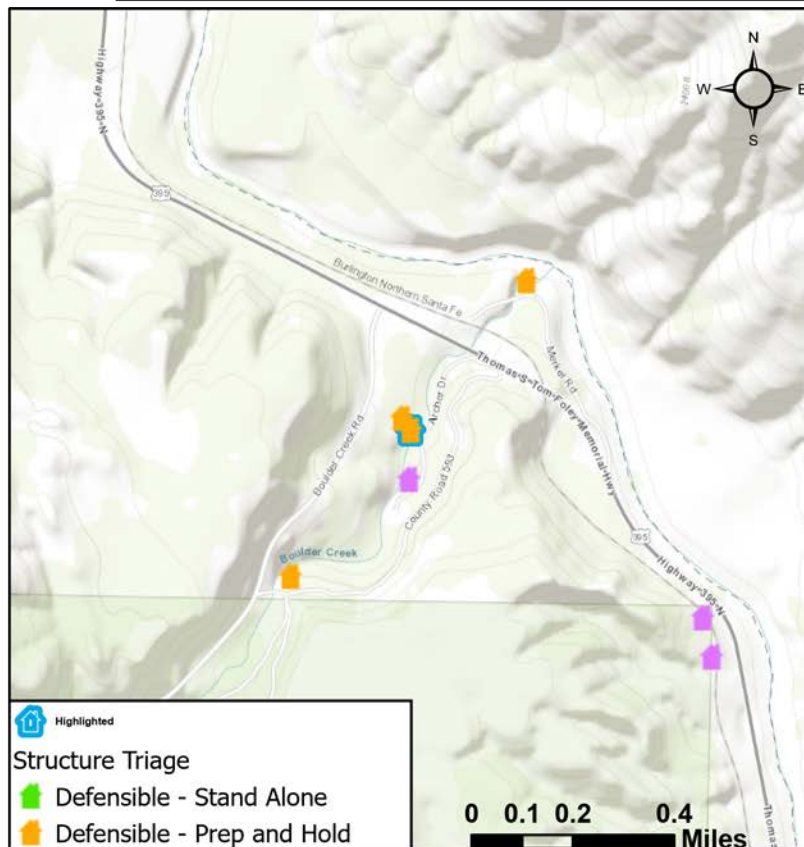
Triage Category: Defensible, Prep and Hold
FIRESCOPE Triage Category:
Structure Number: 12
Collected Date/Time:
Collected By:
Inspector's Position: Division
Type of Structure: Residential
Primary Structures:
Is the building Occupied?: Yes
Outbuildings: 3
Fuel Surrounding Structure: Shrub or timber
Defensible Space: 100 ft treated
Roof Material: Noncombustible or not applicable
Siding Material: Wood or open sided
Electrical Power: Yes
Gas to Structure: Unknown
Hazards:
Access to Site:
Describe Access:
Comm With ICP: Yes
Water Source: Reliable water source nearby
Safety Zone Present:
Mitigation Time (in hours): 4
Mitigation Description: Removal of lateral fuels, Brush out, Scratch Line, porta tanks
Resources Needed to Protect Structure: x1 Type 6 Engine, x1 20 Person Hand Crew
FIRESCOPE Tactics:
Notes:

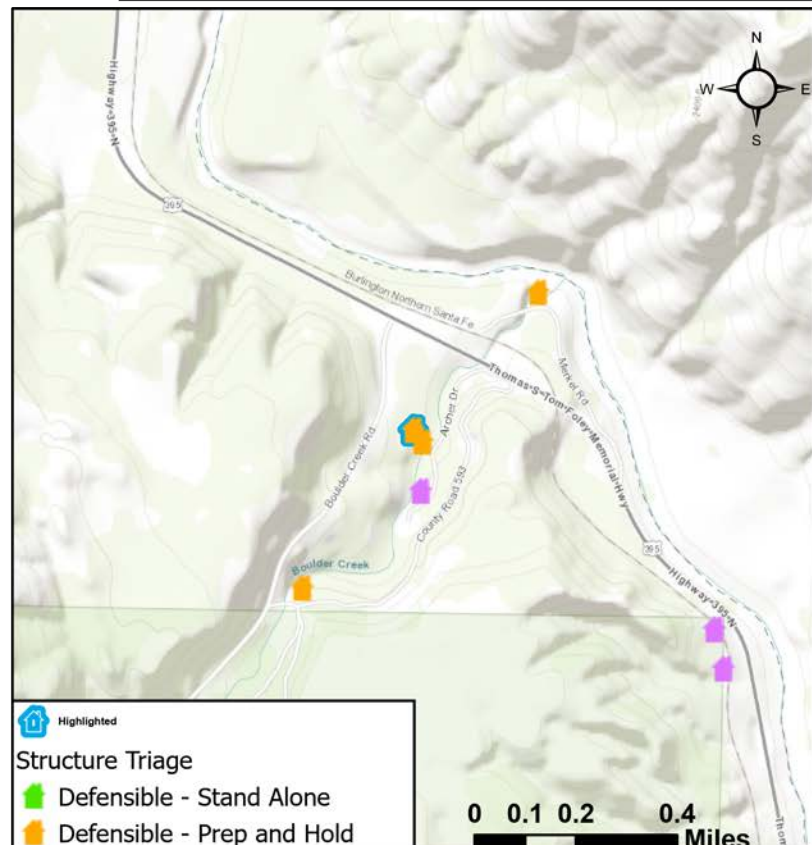
Triage Category: Defensible, Prep and Hold
FIRESCOPE Triage Category:
Structure Number: 13
Collected Date/Time:
Collected By:
Inspector's Position: Division
Type of Structure: Residential
Primary Structures: 1
Is the building Occupied?: Yes
Outbuildings: 3
Fuel Surrounding Structure: Shrub or timber
Defensible Space: 100 ft treated
Roof Material: Noncombustible or not applicable
Siding Material: Wood or open sided
Electrical Power: Yes
Gas to Structure: Unknown
Hazards:
Access to Site:
Describe Access:
Comm With ICP: Yes
Water Source: Reliable water source nearby
Safety Zone Present:
Mitigation Time (in hours): 4
Mitigation Description: Removal of lateral fuels, scratch line, brush out, possible dozer line, porta tanks
Resources Needed to Protect Structure: x1 Type 6 Engine, x1 20 Person Hand Crew
FIRESCOPE Tactics:
Notes:

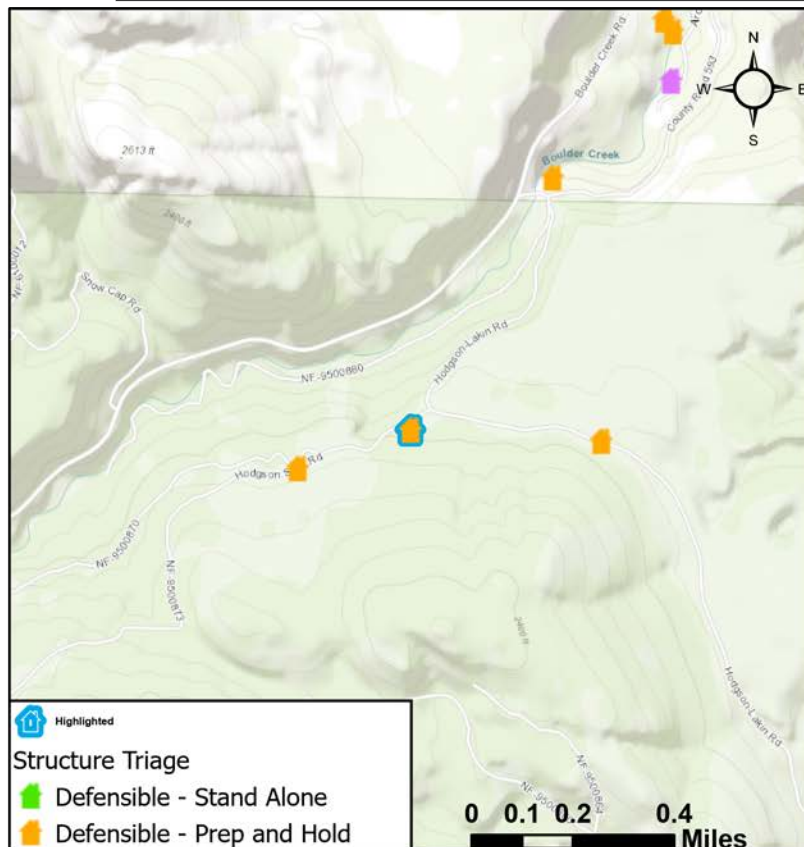
Triage Category: Defensible, Prep and Hold
FIRESCOPE Triage Category:
Structure Number: 2
Collected Date/Time:
Collected By:
Inspector's Position: Division
Type of Structure: Residential
Primary Structures: 2
Is the building Occupied?: Yes
Outbuildings: 3
Fuel Surrounding Structure: Shrub or timber
Defensible Space: 100 ft treated
Roof Material: Noncombustible or not applicable
Siding Material: Log construction
Electrical Power: Yes
Gas to Structure: Unknown
Hazards:
Access to Site: T1 Engine
Describe Access:
Comm With ICP: Yes
Water Source: Reliable water source nearby
Safety Zone Present:
Mitigation Time (in hours): 2
Mitigation Description: Sprinkle system, porta tank, scratch line
Resources Needed to Protect Structure: x2 Type 6 Engine, x1 20 Person Crew
FIRESCOPE Tactics:
Notes:

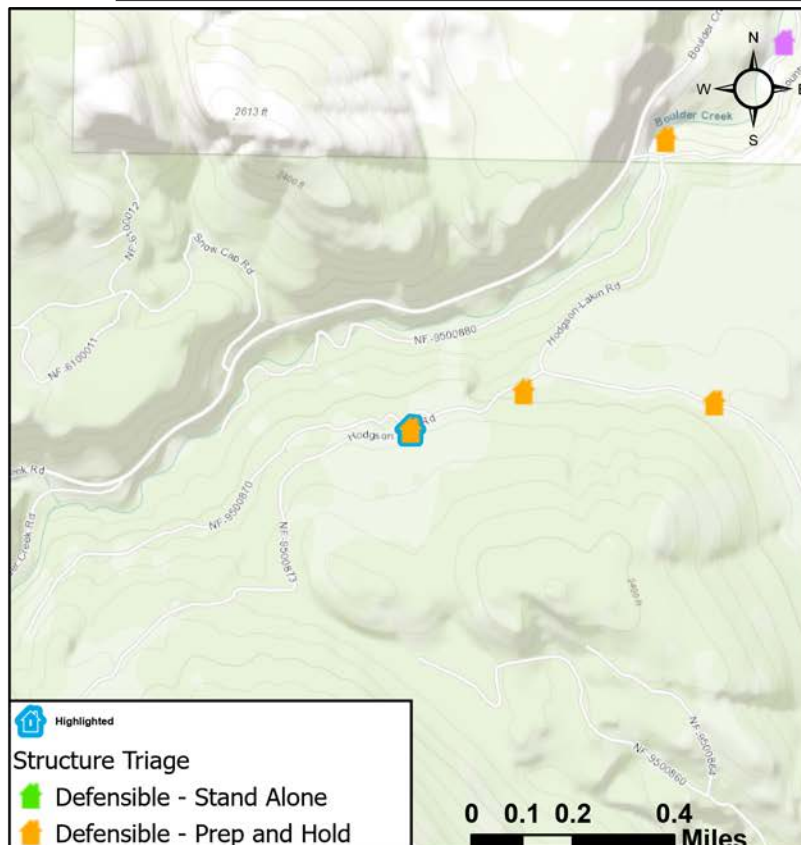
Triage Category: Defensible, Prep and Hold
FIRESCOPE Triage Category:
Structure Number: 3
Collected Date/Time:
Collected By:
Inspector's Position: Division
Type of Structure: Residential
Primary Structures: 1
Is the building Occupied?: Yes
Outbuildings: 4
Fuel Surrounding Structure: Shrub or timber
Defensible Space: 100 ft treated
Roof Material: Noncombustible or not applicable
Siding Material: Wood or open sided
Electrical Power: Yes
Gas to Structure: Unknown
Hazards: Power lines
Access to Site:
Describe Access:
Comm With ICP: Yes
Water Source: Reliable water source nearby
Safety Zone Present:
Mitigation Time (in hours): 2
Mitigation Description: Brush out, tree felling, scratch line, possible dozer line
Resources Needed to Protect Structure: x1 Type 6 Engine, x1 20 Person Hand Crew
FIRESCOPE Tactics:
Notes: Hay Barn across road

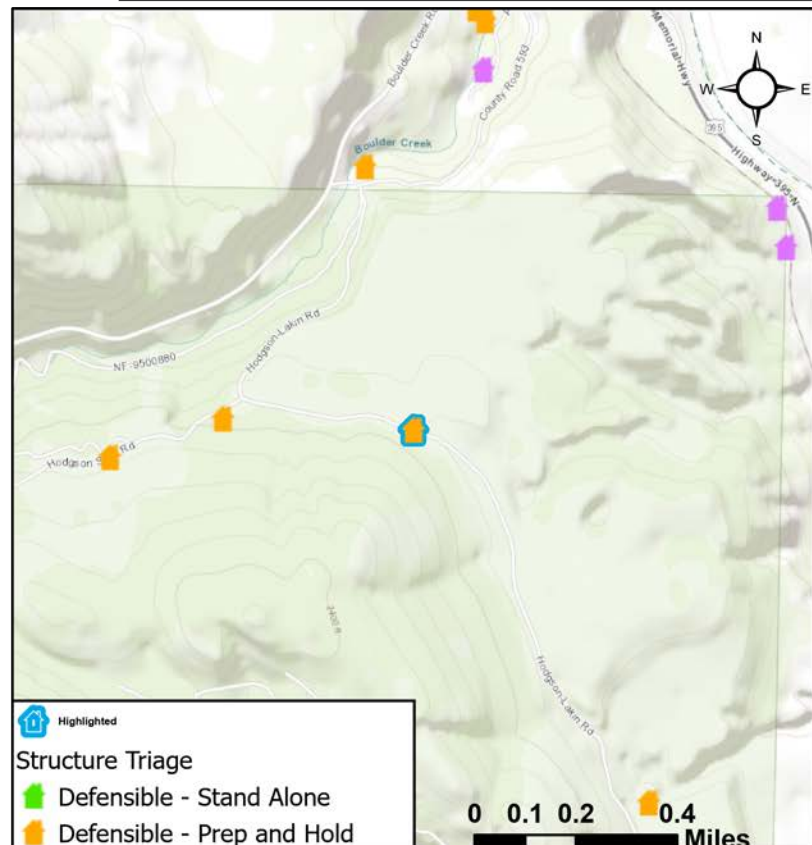
Triage Category: Defensible, Prep and Hold
FIRESCOPE Triage Category:
Structure Number: 4
Collected Date/Time:
Collected By:
Inspector's Position: Division
Type of Structure: Residential
Primary Structures: 1
Is the building Occupied?: Yes
Outbuildings: 4
Fuel Surrounding Structure: Shrub or timber
Defensible Space: 30 ft treated
Roof Material: Noncombustible or not applicable
Siding Material: Wood or open sided
Electrical Power: Yes
Gas to Structure: Unknown
Hazards: Power lines
Access to Site:
Describe Access:
Comm With ICP: Yes
Water Source: Reliable water source nearby
Safety Zone Present:
Mitigation Time (in hours): 4
Mitigation Description: Brush out, lateral fuels, possible dozer line, scratch line, porta tanks
Resources Needed to Protect Structure: x2 Type 6 Engines, x1 20 Person Crew
FIRESCOPE Tactics:
Notes:

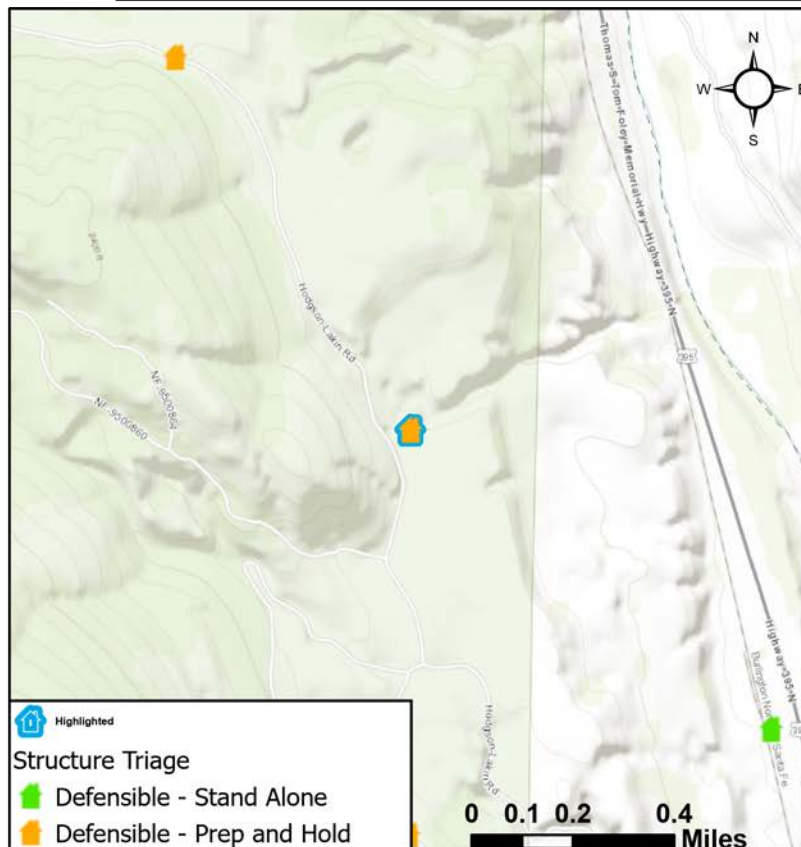
Triage Category: Defensible, Prep and Hold
FIRESCOPE Triage Category:
Structure Number: 5
Collected Date/Time: 8/25/2021 12:38:12 AM
Collected By:
Inspector's Position: Division
Type of Structure: Residential
Primary Structures: 1
Is the building Occupied?: Yes
Outbuildings: 3
Fuel Surrounding Structure: Shrub or timber
Defensible Space: 100 ft treated
Roof Material: Noncombustible or not applicable
Siding Material: Wood or open sided
Electrical Power: Yes
Gas to Structure: Unknown
Hazards: Power Lines
Access to Site:
Describe Access:
Comm With ICP: Yes
Water Source: Reliable water source nearby
Safety Zone Present:
Mitigation Time (in hours): 2
Mitigation Description: Removal of lateral fuels, Brush Out, Scratch Line, Possible dozer line, Porta tanks
Resources Needed to Protect Structure: x2 Type 6 Engine, x2 20 Person Hand Crew
FIRESCOPE Tactics:
Notes:

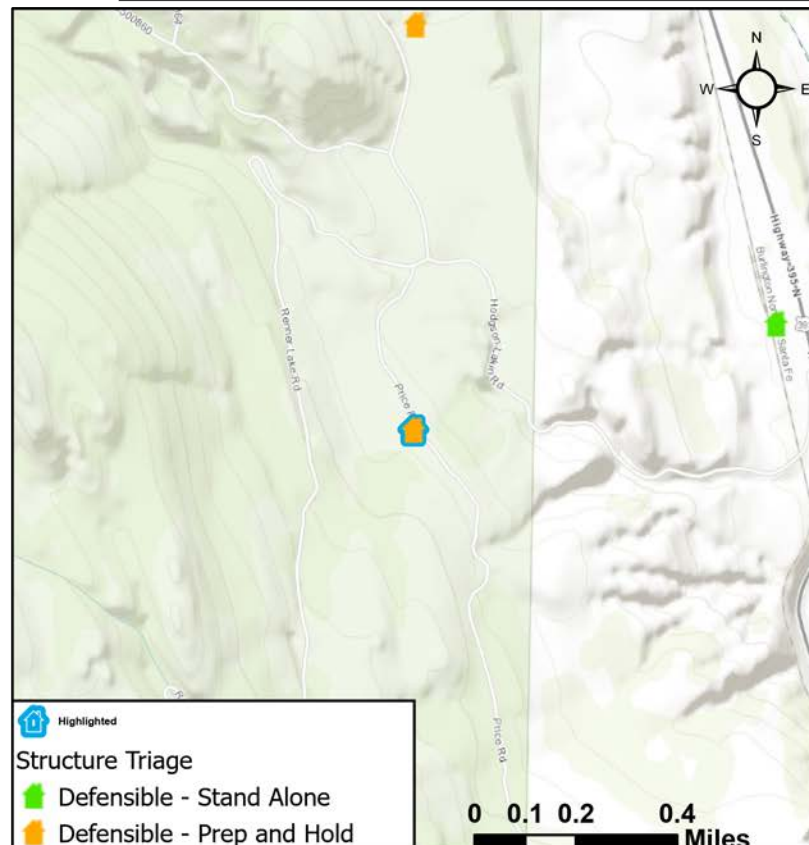
Triage Category: Defensible, Prep and Hold
FIRESCOPE Triage Category:
Structure Number: 6
Collected Date/Time: 8/23/2021 10:22:10 PM
Collected By:
Inspector's Position: Division
Type of Structure: Residential
Primary Structures:
Is the building Occupied?: No
Outbuildings: 2
Fuel Surrounding Structure: Shrub or timber
Defensible Space: Less than 30 ft treated
Roof Material: Noncombustible or not applicable
Siding Material: Wood or open sided
Electrical Power: Yes
Gas to Structure: Unknown
Hazards: Power lines
Access to Site:
Describe Access:
Comm With ICP: Yes
Water Source: No reliable water source nearby
Safety Zone Present:
Mitigation Time (in hours): 2
Mitigation Description: Brush out, scratch line, possible dozer line
Resources Needed to Protect Structure: Engine
FIRESCOPE Tactics:
Notes:

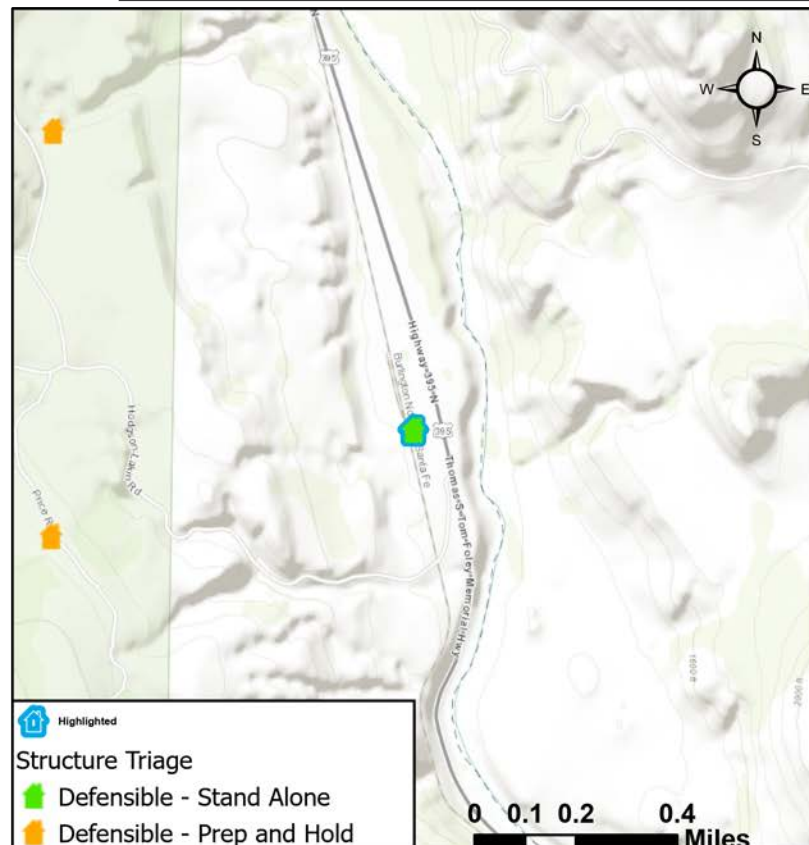
Triage Category: Defensible, Stand Alone
FIRESCOPE Triage Category:
Structure Number: 7
Collected Date/Time:
Collected By:
Inspector's Position: Division
Type of Structure: Residential
Primary Structures:
Is the building Occupied?: No
Outbuildings:
Fuel Surrounding Structure: Shrub or timber
Defensible Space: More than 100ft treated
Roof Material: Noncombustible or not applicable
Siding Material:
Electrical Power: Unknown
Gas to Structure:
Hazards: Rail Line
Access to Site:
Describe Access:
Comm With ICP: Yes
Water Source: Reliable water source nearby
Safety Zone Present:
Mitigation Time (in hours):
Mitigation Description:
Resources Needed to Protect Structure:
FIRESCOPE Tactics:
Notes:

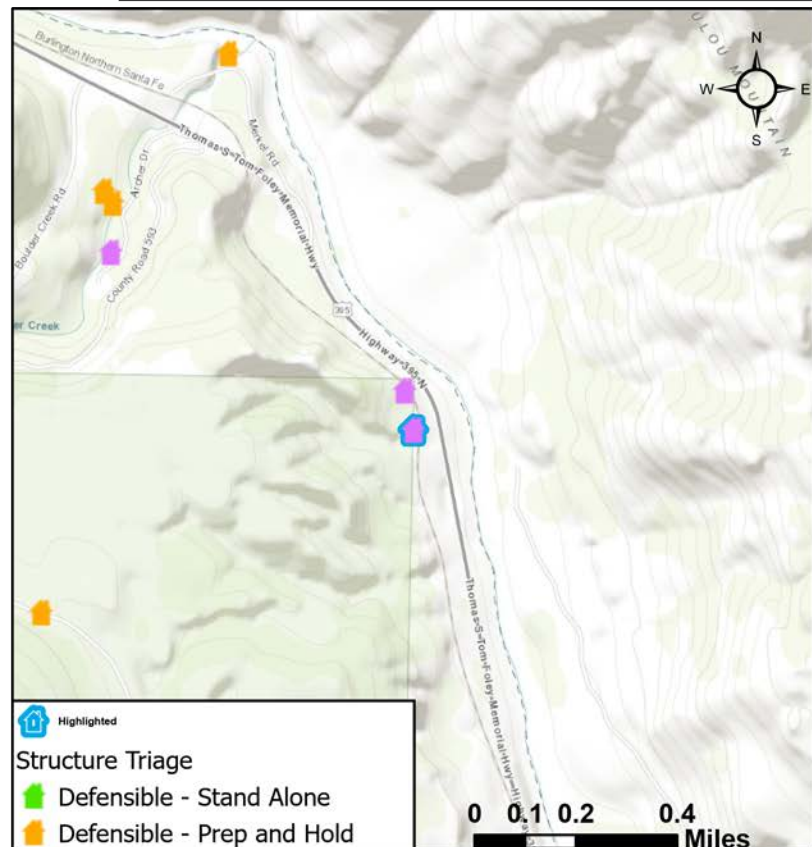
Structure Number: 8

Triage Category: Non-Defensible, Prep and Leave

Defensible Space: Less than 30 ft treated

Siding Material: Wood or open sided

Mitigation Description: Removal of lateral fuels, Brush out, Scratch Line, Possible dozer line, porta tanks

Resources Needed to Protect Structure: x1 Type 6 Engine, x1 20 Person Hand Crew

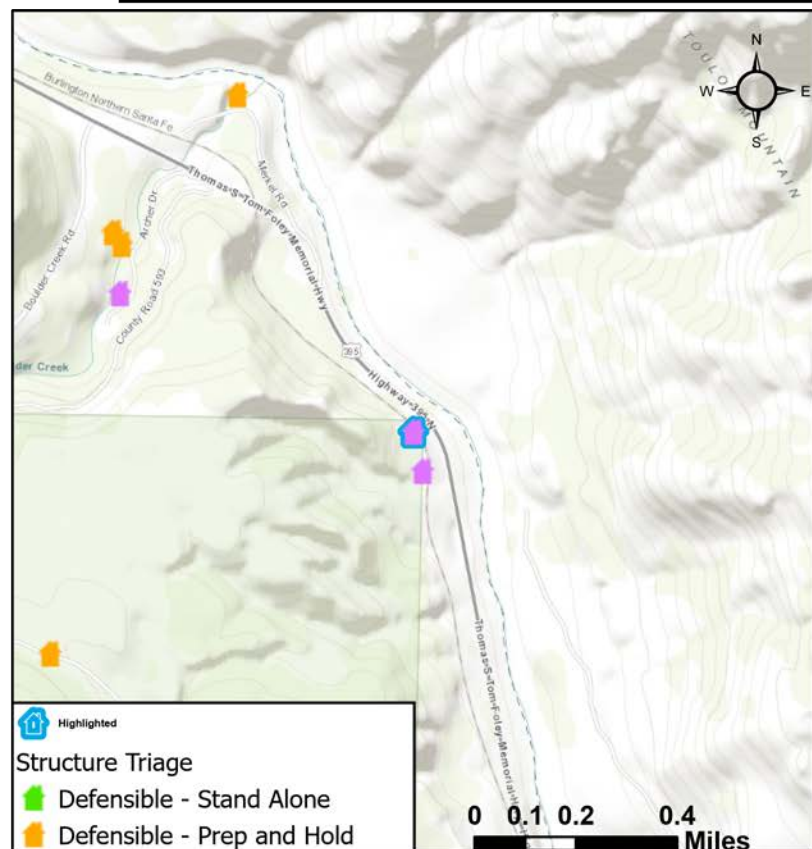
Structure Number: 9

Triage Category: Non-Defensible, Prep and Leave

Defensible Space: 100 ft treated

Siding Material: Wood or open sided

Mitigation Description: Removal of lateral fuels, Brush out, Scratch line, possible dozer line, porta tanks

Resources Needed to Protect Structure: x1 Type 6 Engine, x1 20 Person Hand Crew
