Incident: Cow Canyon

Subdivision: Wenas Road

Triage Category

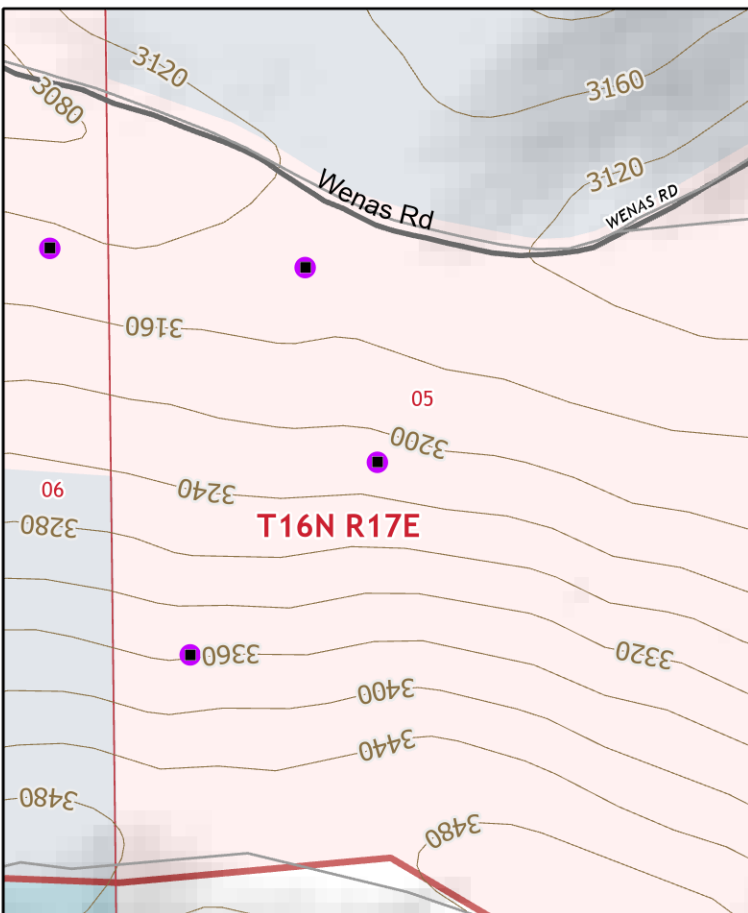
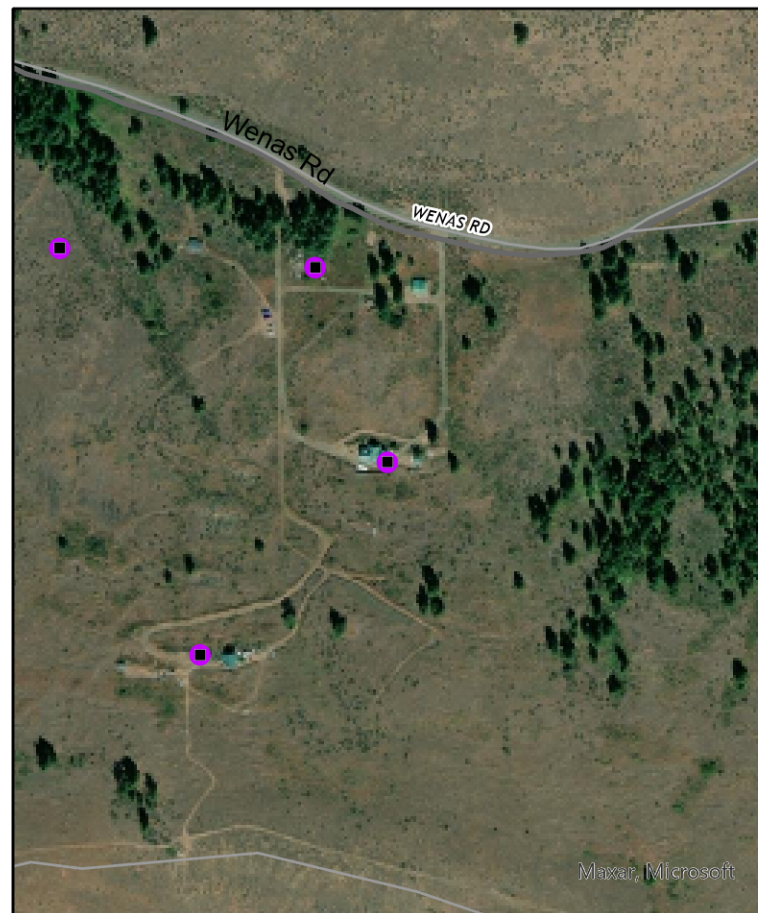
Address: 26200

Non-Defensible, Prep and Leave

Structure comments: Data taken by various strike team engines and consolidated by DIVS.

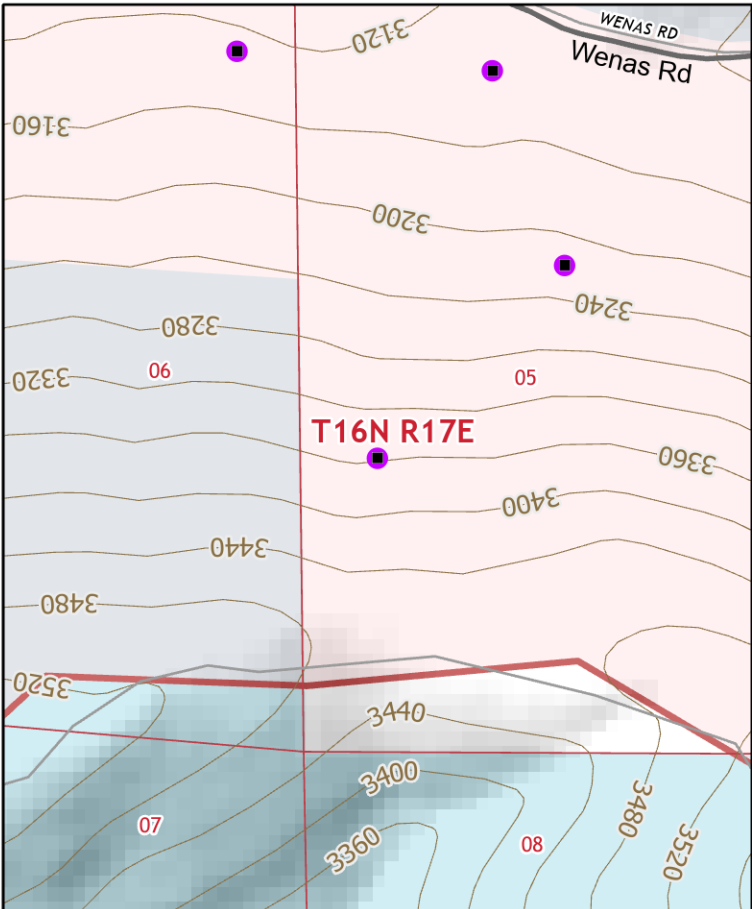
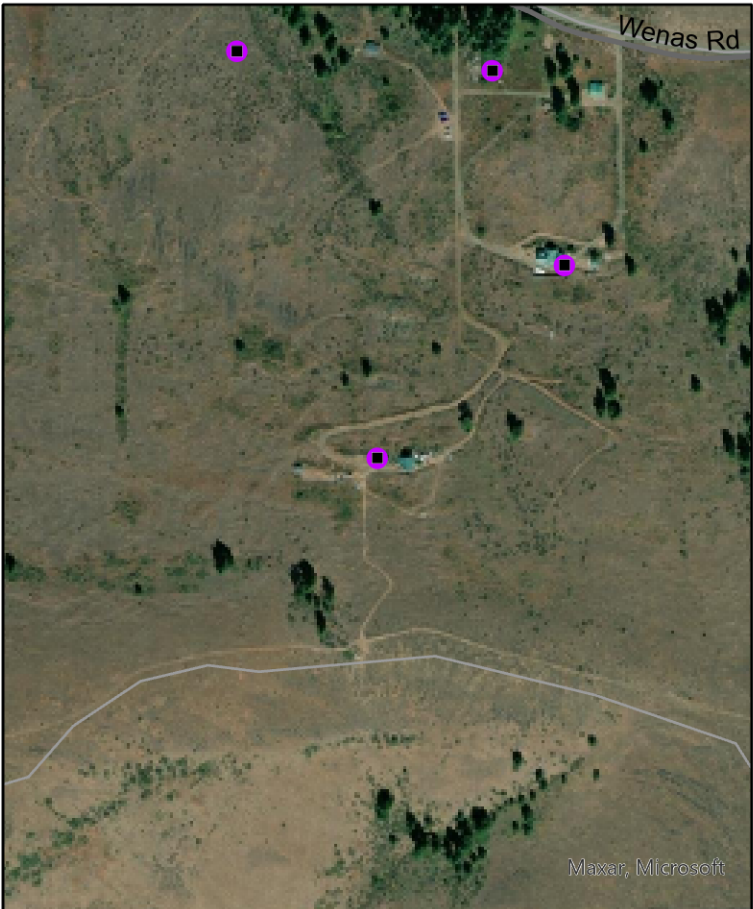
Address: 26204

Triage Category
Non-Defensible, Prep and Leave

Description of access: Too steep for engines

Structure comments: Data taken by various strike team engines and consolidated by DIVS.

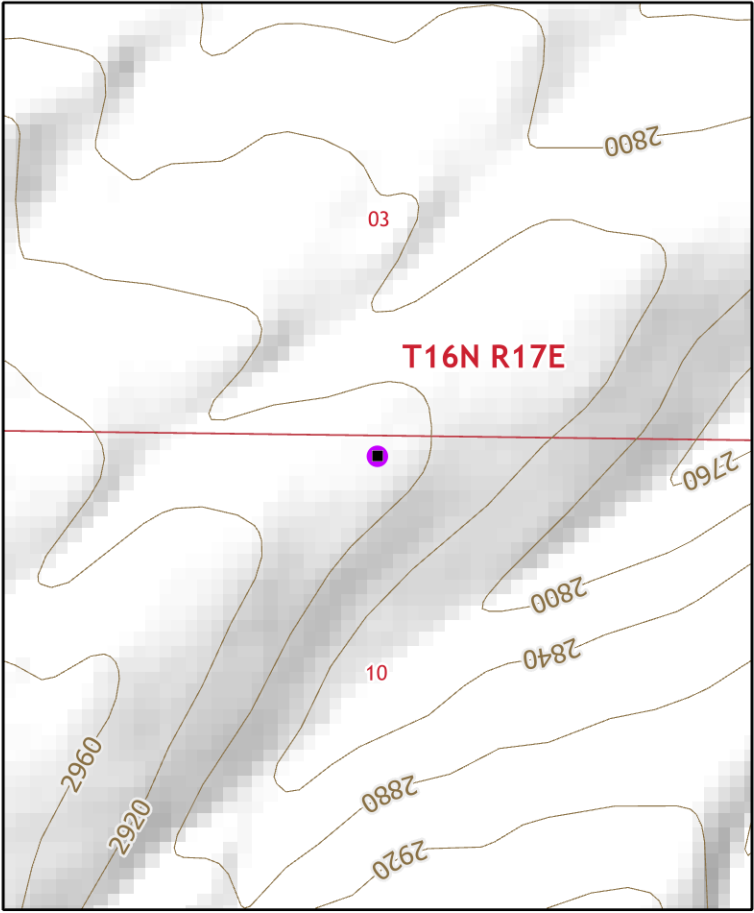
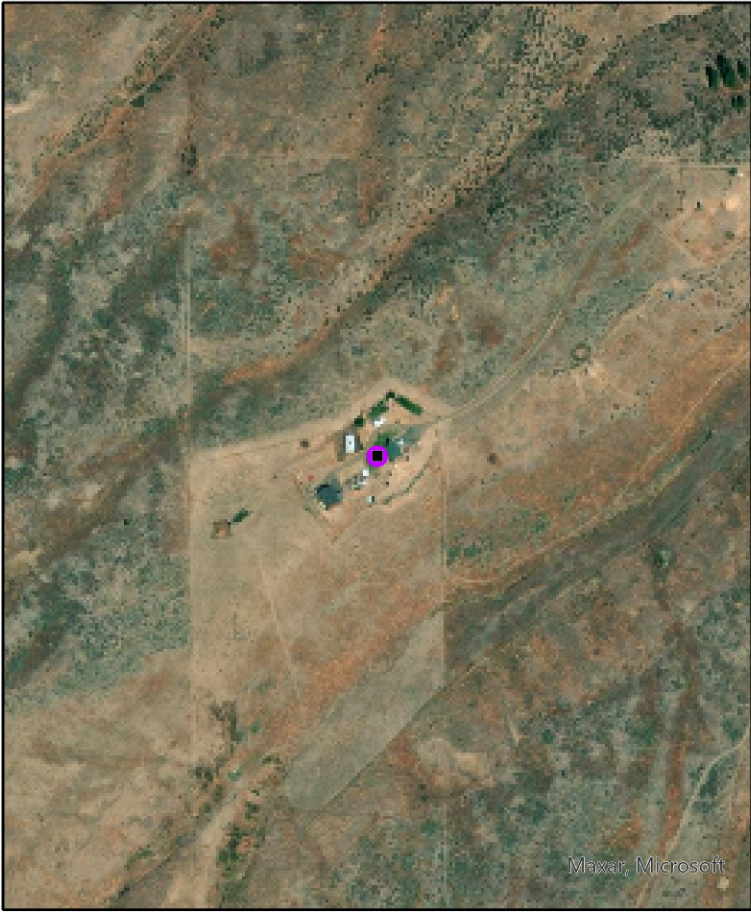
Address: 28201 Wenas Roaf

Triage Category
Non-Defensible, Prep and Leave

Description of access: Long driveway from Wenas Rd with 3 address.

Structure comments: Keep left on driveways/roads.

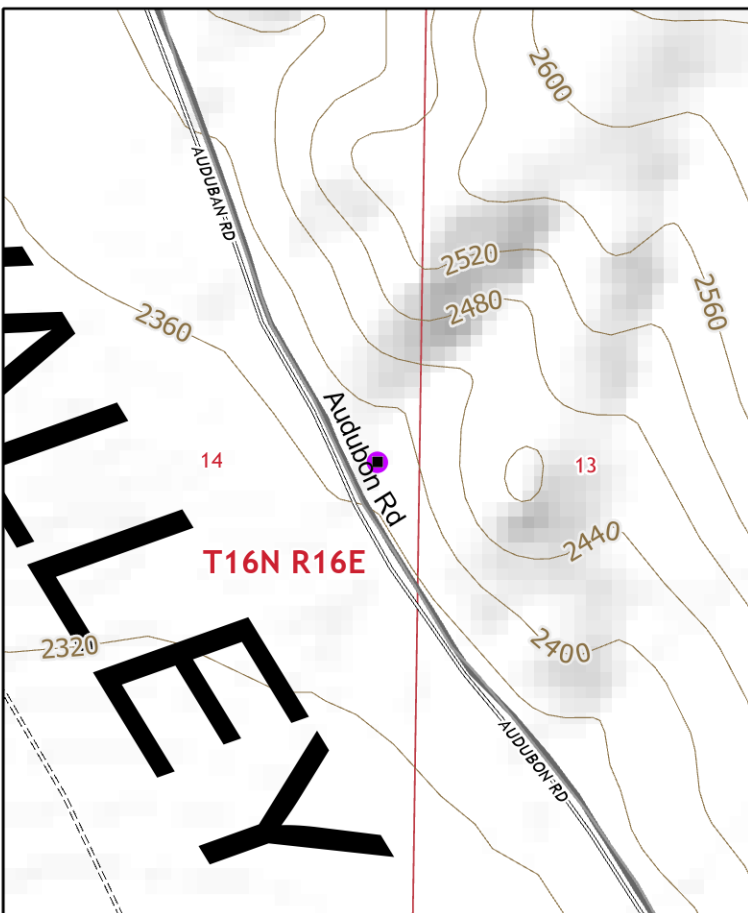
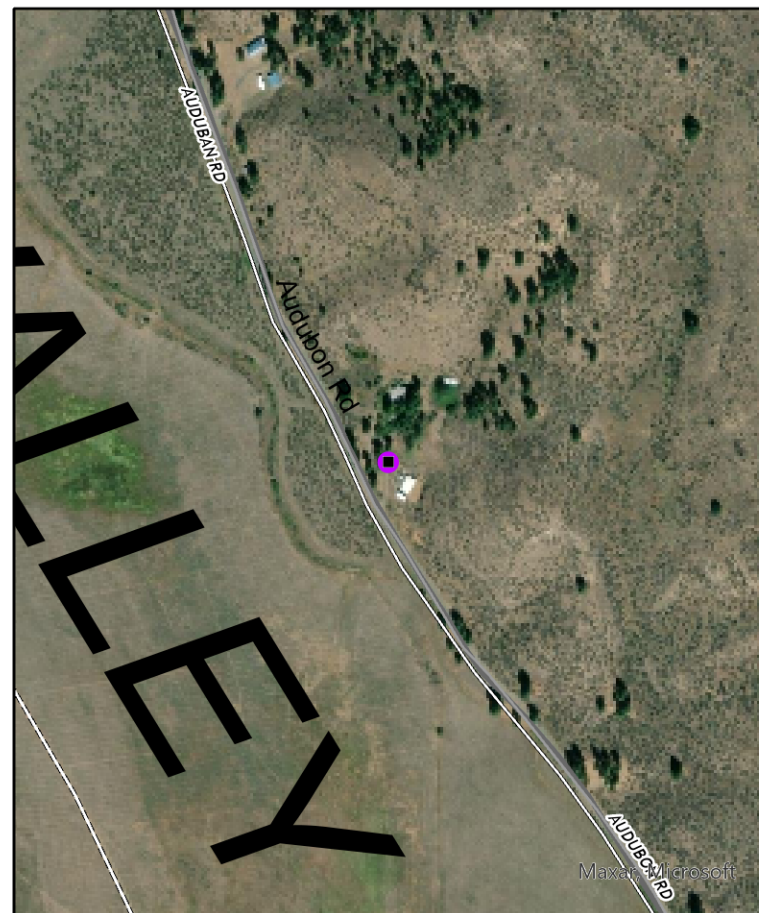
Address: 571 Audubon
Lat: 46°52.736'N Long: 120°46.922'W
Collected Date: 8/8/2022 9:21:00 PM

Hazards: Large propane and fuel tanks 25' from house

Defensible space: No defensible space
Fuel type: Shrub or timber
Water supply: No reliable water source nearby
Mitigation time: 3 Hr(s)
Mitigation resource: 1 Type 1 engine. Sprinkler kits can be used with porta tanks.

Non-Defensible, Prep and Leave

Mitigation description: Remove ground fuels from around house and out buildings.
