Methodist East Structure Assessment

Structure ID: 30

Collected Date/Time: 9/26/2019 12:08:00 AM
Collected By: Chris Masson
Inspector's Position: Divs

Location: 5210 east highway 50,

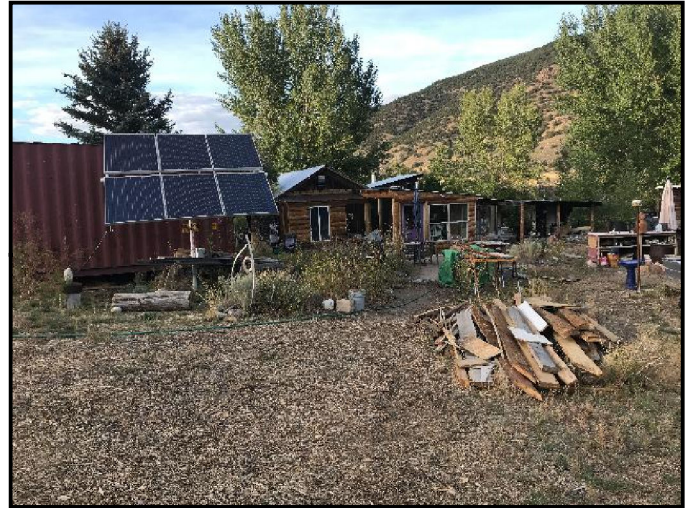
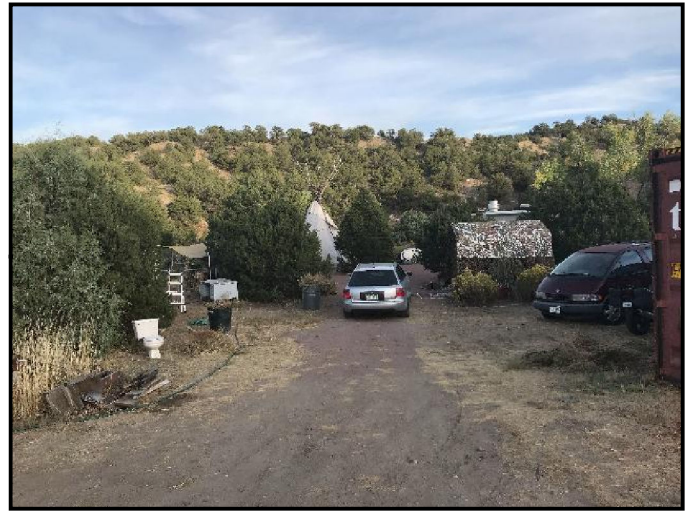
Fuel Surrounding Structure: Shrub or timber

Defensible Space: Less Than 30 ft treated

Siding Material: Wood or open sided

Hazards: Fuels above structures and fuel loading adjacent to structures

Notes: Multiple structures, small main wood structure, teepee, and travel home, lots of debris

Mitigation Description: Weed whacking, some thinning, debris removal

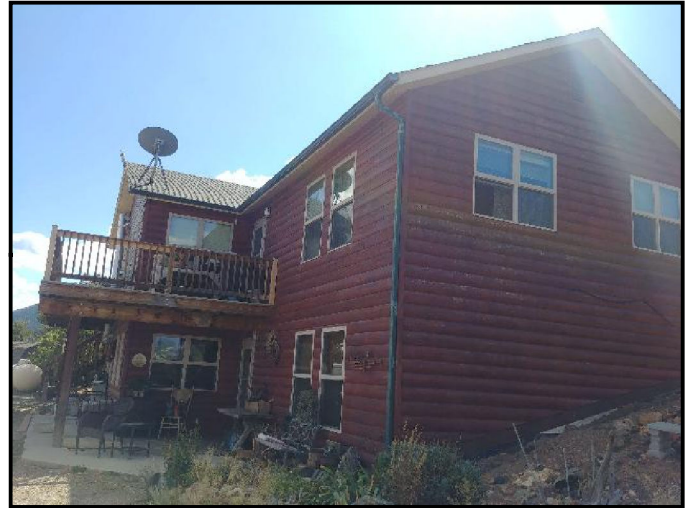
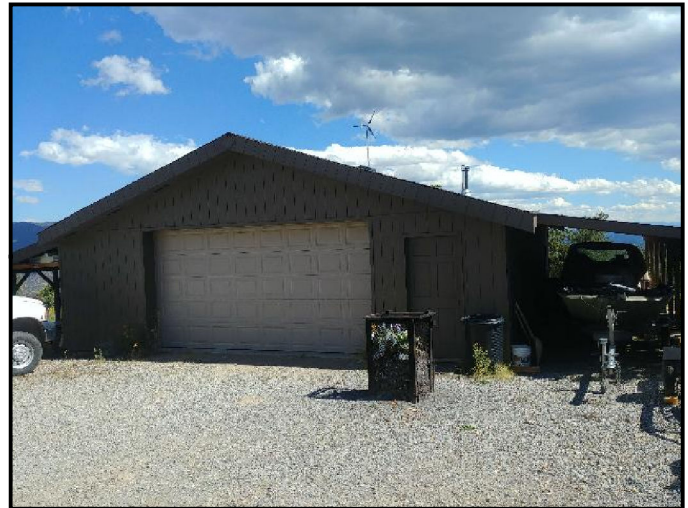
Hazards: Long one way access road on top of a ridge steep slopes 3 sides

Notes: Lots of fuel at or near structure with overhanging deck and steep slopes

Mitigation Description: Lots of saw and weed eater work

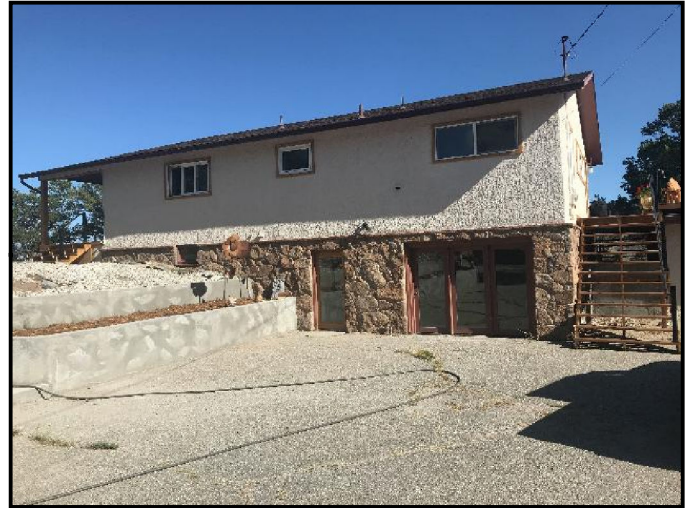
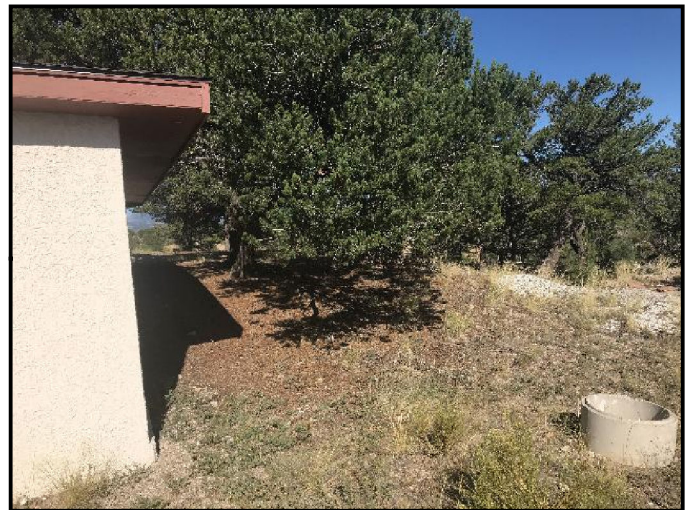
Hazards: Fuels below structure

Notes: Fuel loading below residence, wooden deck on roof. Asphalt driveway, rock landscaping.

Mitigation Description: Thinning and weed whacking

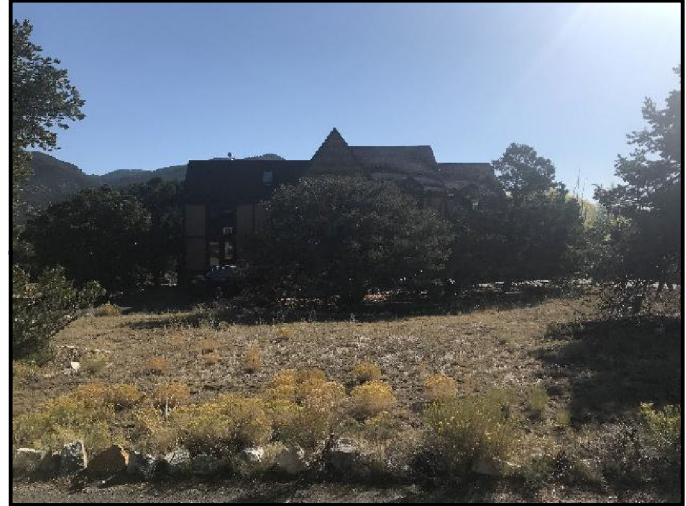
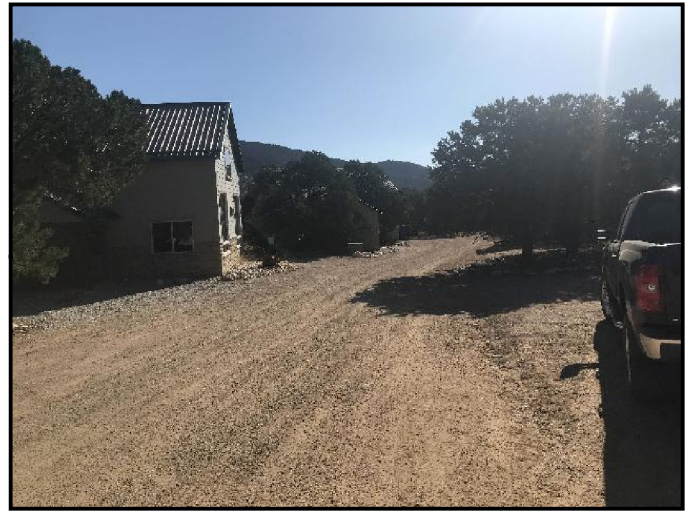
Structure ID: 34

Hazards: Fuels

Notes: Multiple structures on compound, fuels below some structures, gravel road to each individual structure, some turn around, no reliable water source

Mitigation Description: Thinning

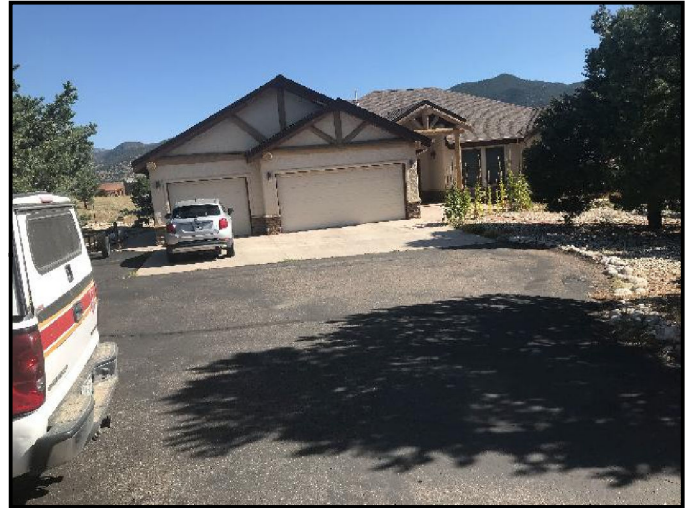
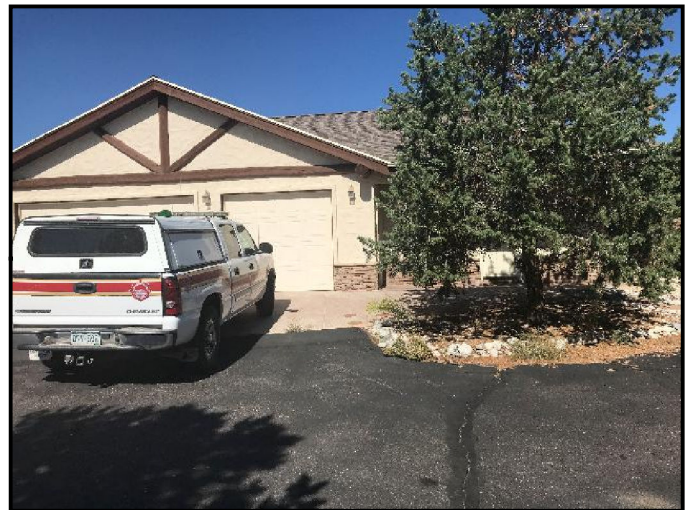
Hazards: Fuels next to structure

Notes: Fuel around structures, grass and shrubs

Mitigation Description: Thinning and weed whacking

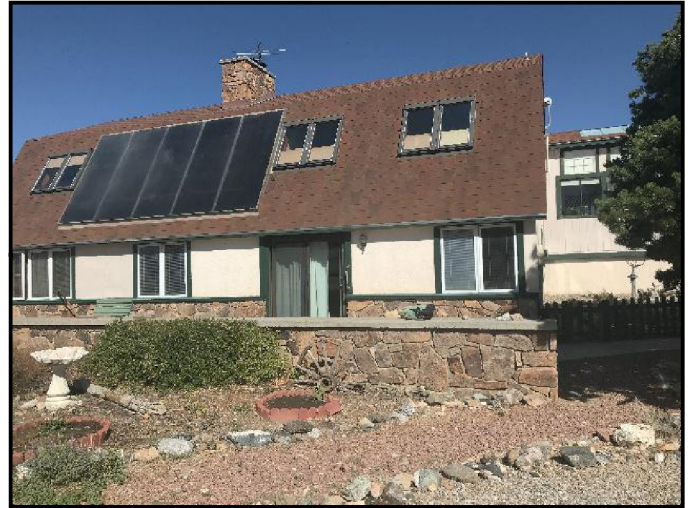
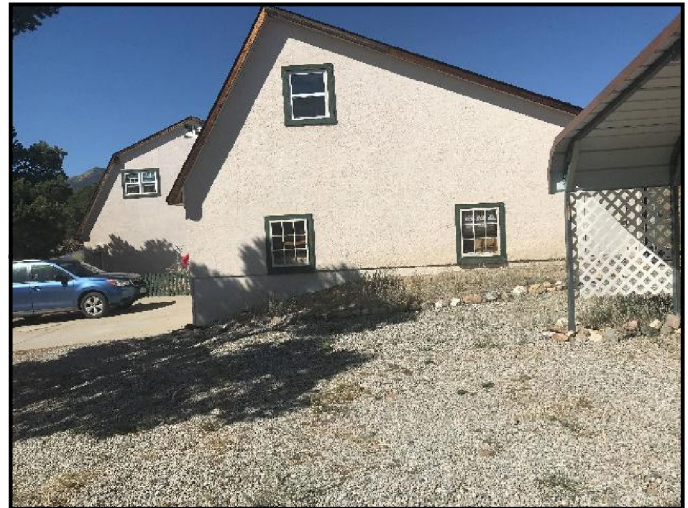
Structure ID: 39

Hazards: Fuels

Notes: Structure has gravel perimeter. Fuel loading in some areas. Wood piles. Wooden deck.

Mitigation Description: Thinning and weed whacking

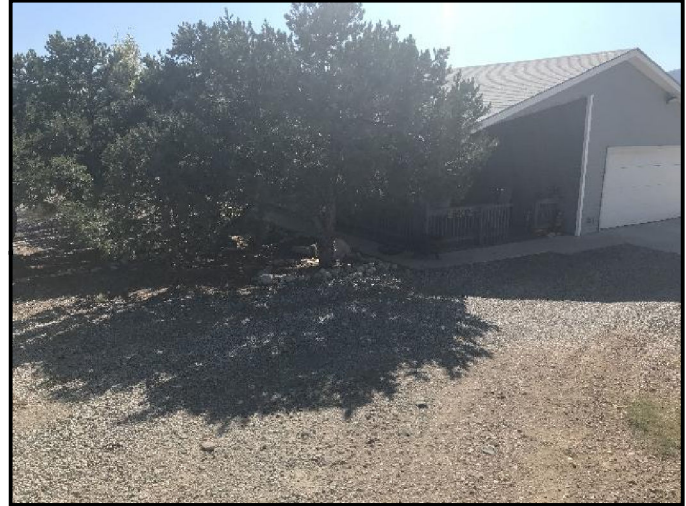
Structure ID: 40

Notes: Structure has gravel perimeter. Fuel loading below residence

Mitigation Description: Thinning

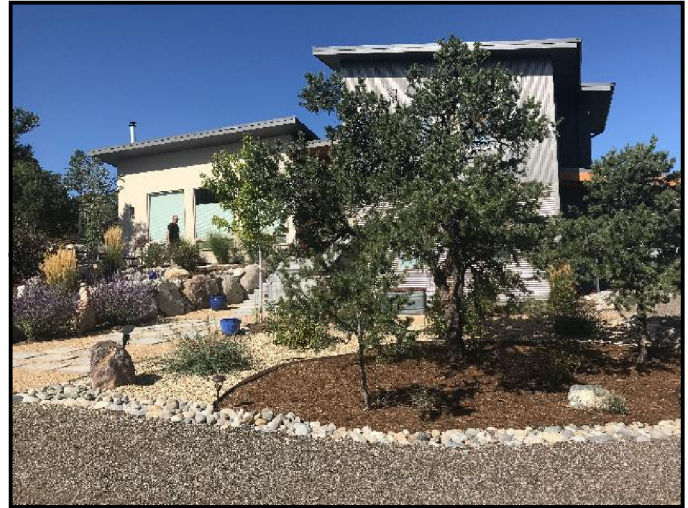
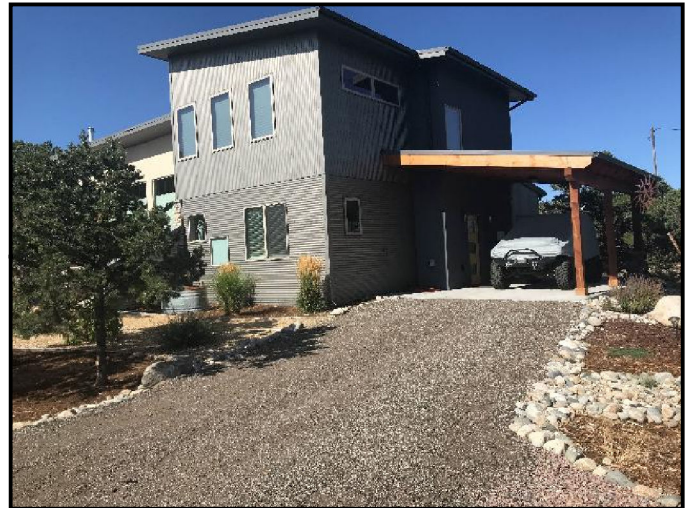
Hazards: Fuels below structure

Notes: Structure has gravel perimeter 1/2
Fuel loading below residence, wooden deck

Mitigation Description: Thinning

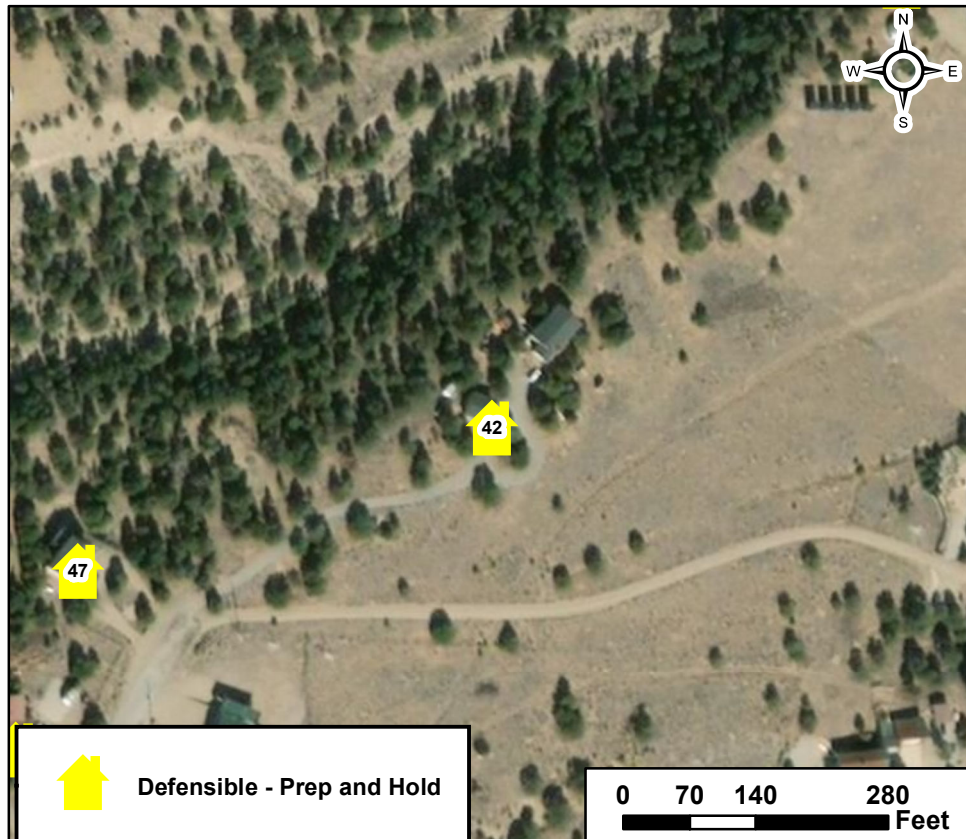
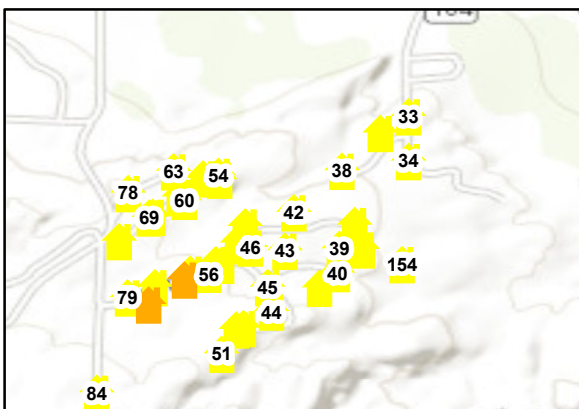
Notes: Structure has gravel driveway. Fuel loading below residence, trex deck

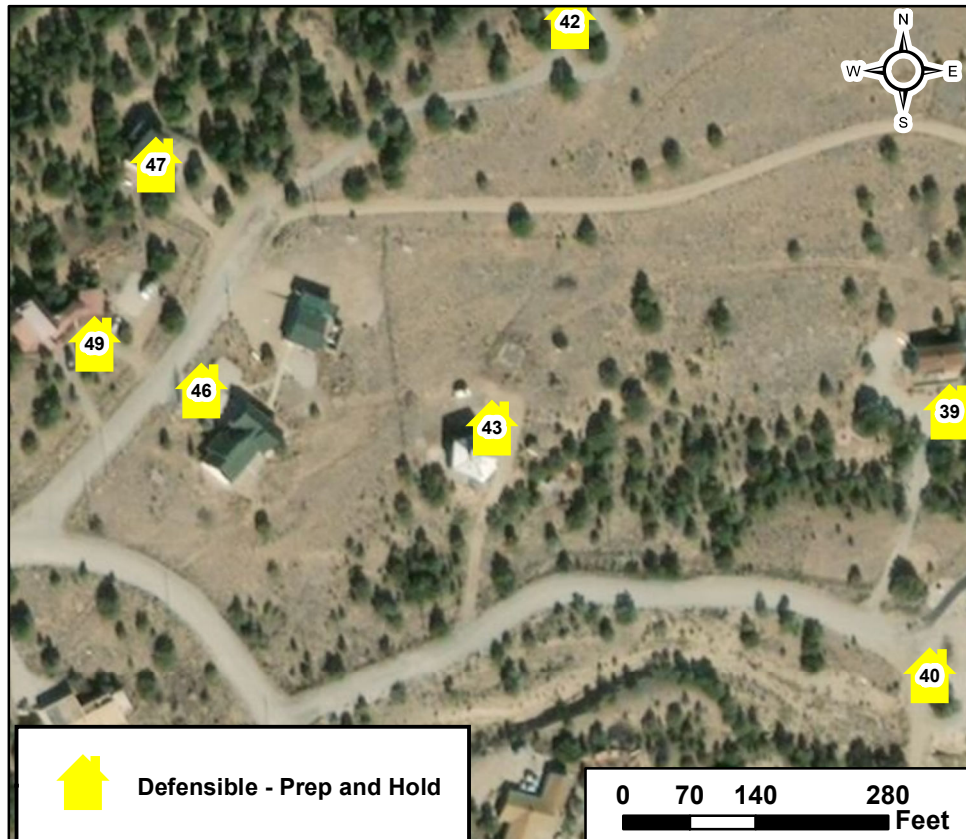
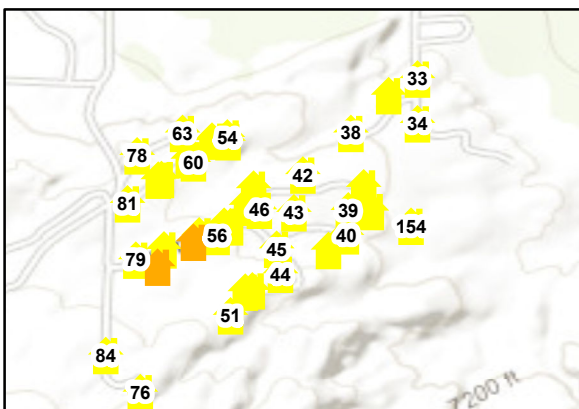
Notes: Structure has gravel/dirt perimeter

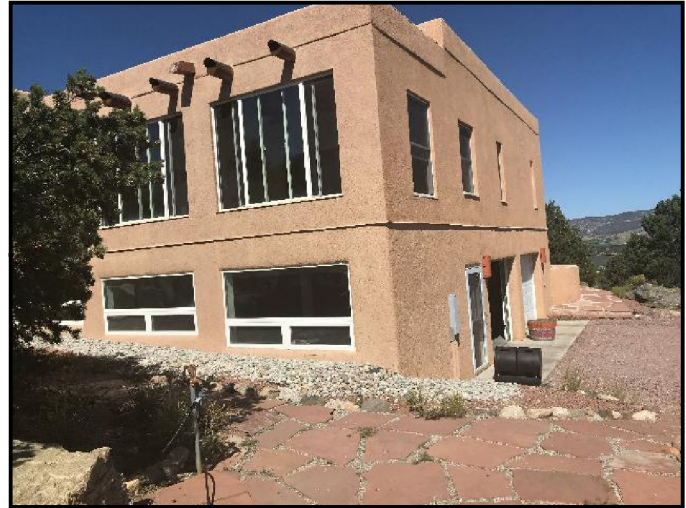
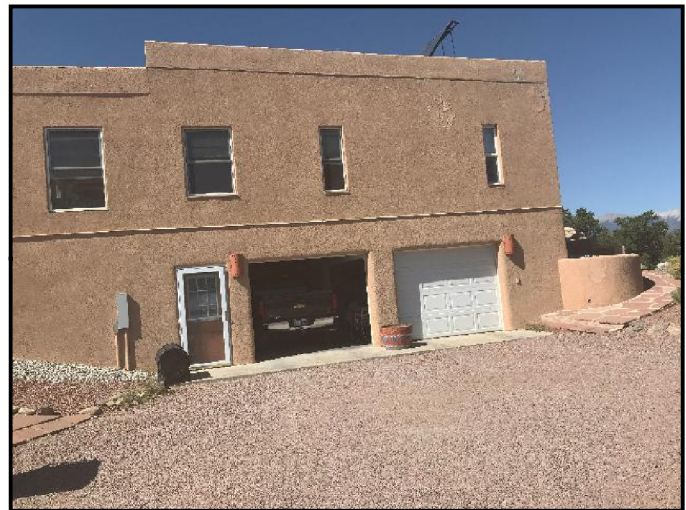
Hazards: Fuels below structure

Mitigation Time (in hours): 6

Mitigation Description: Thinning

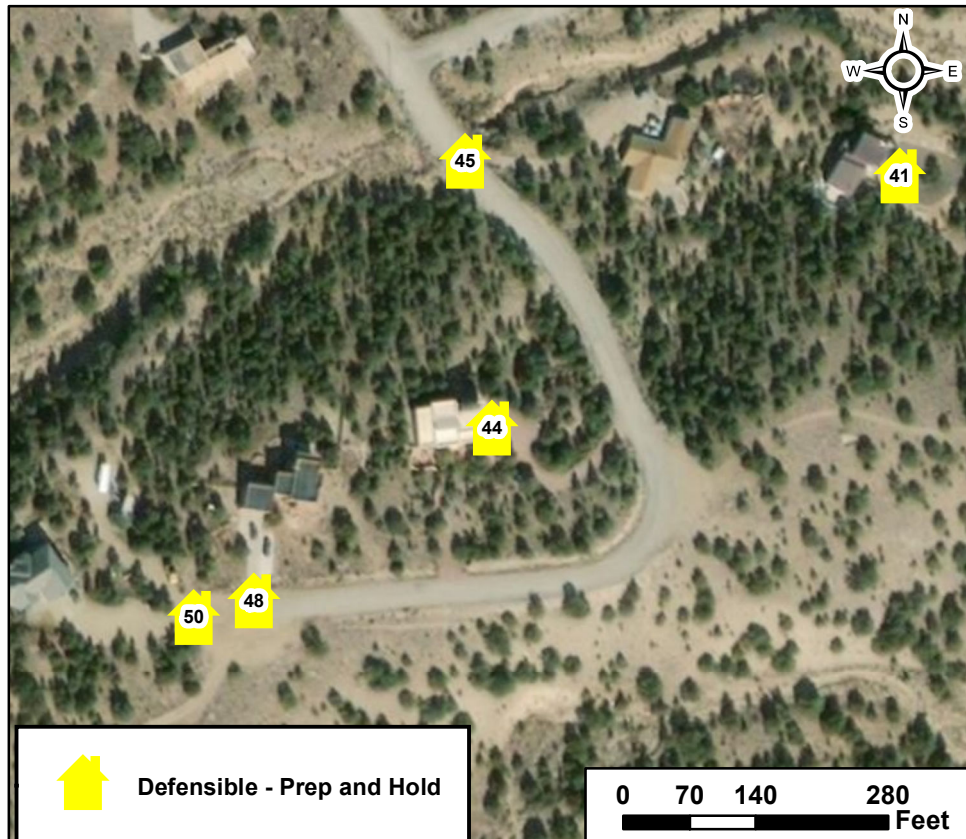
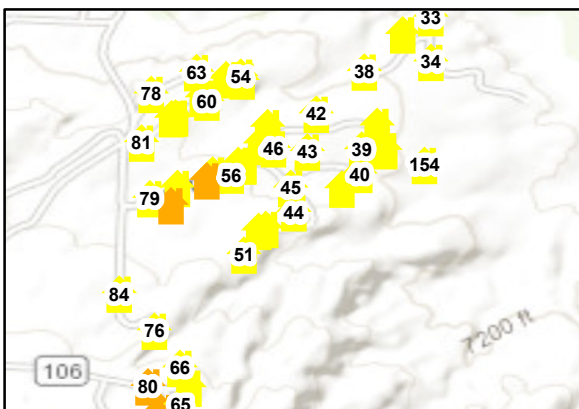
Notes: Structure has some gravel perimeter. Fuel loading below residence. Slate patio area.

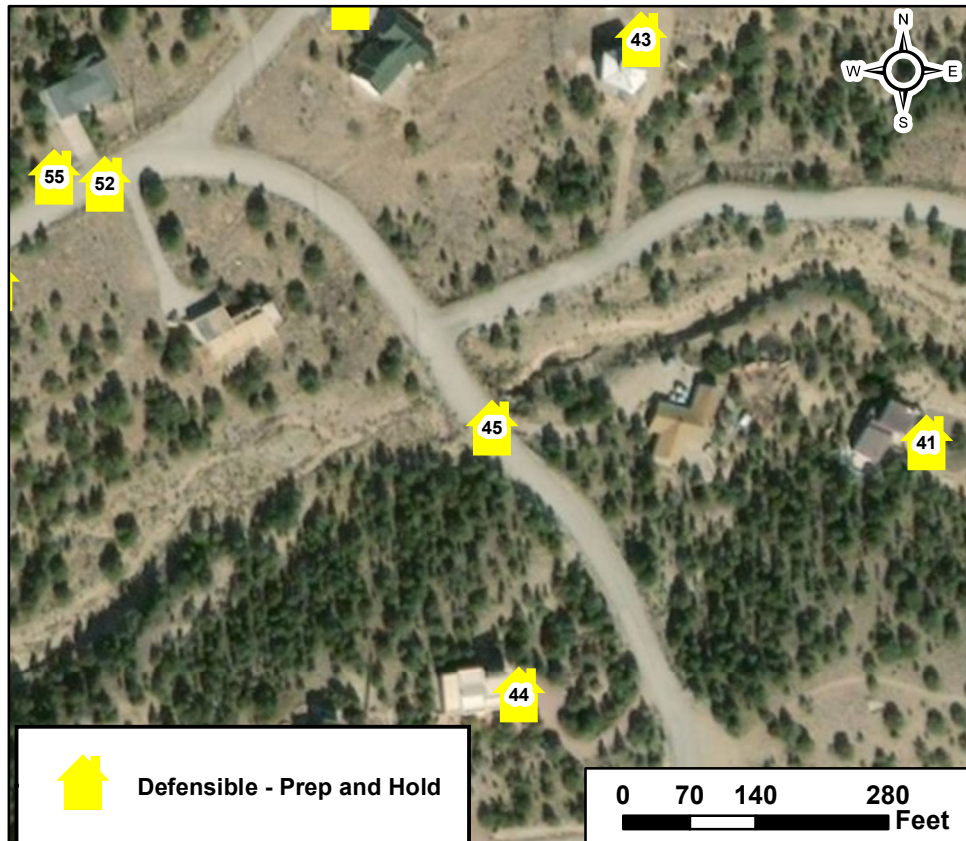
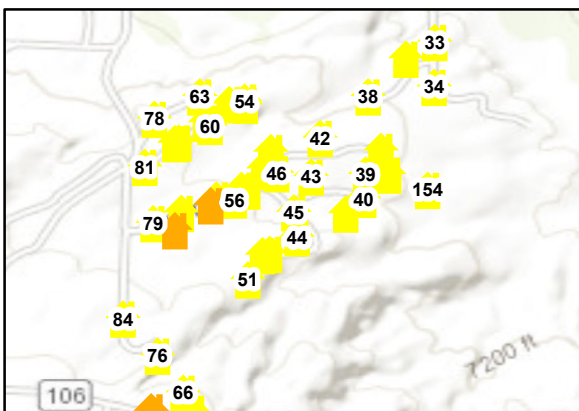
Notes: Structure has some gravel perimeter, deck in back, fuel above and side of structure, wood piles

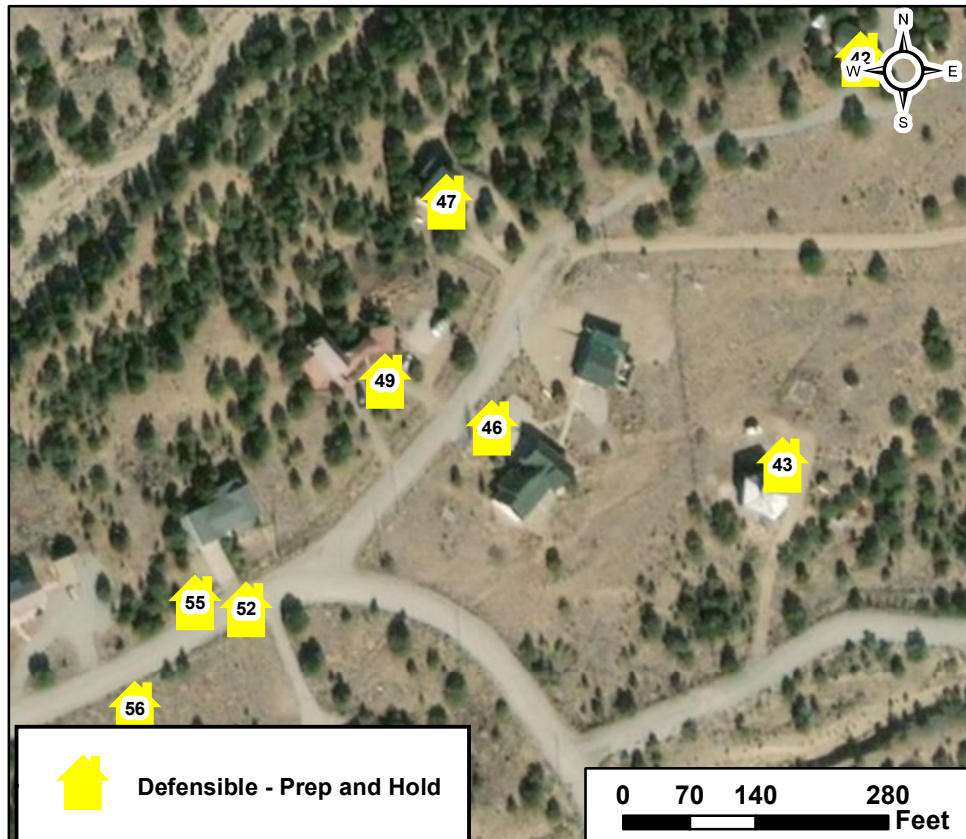
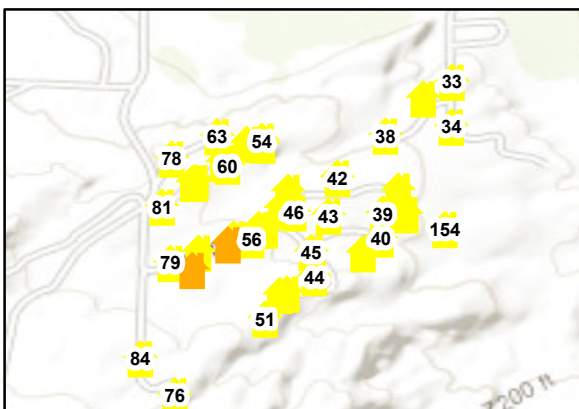
Notes: Structure has gravel perimeter 3/4.

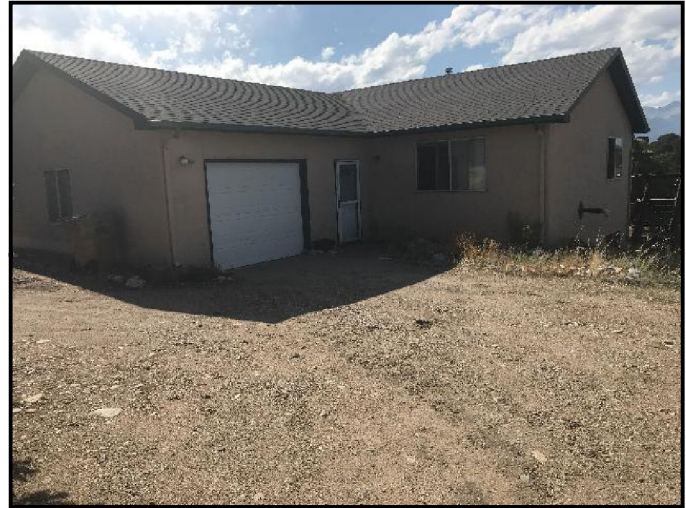
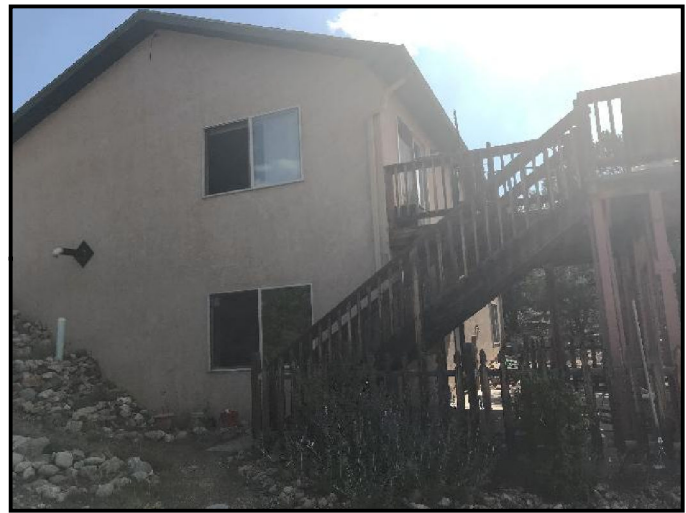
Hazards: Fuels below structure

Mitigation Time (in hours): 6

Mitigation Description: Thinning

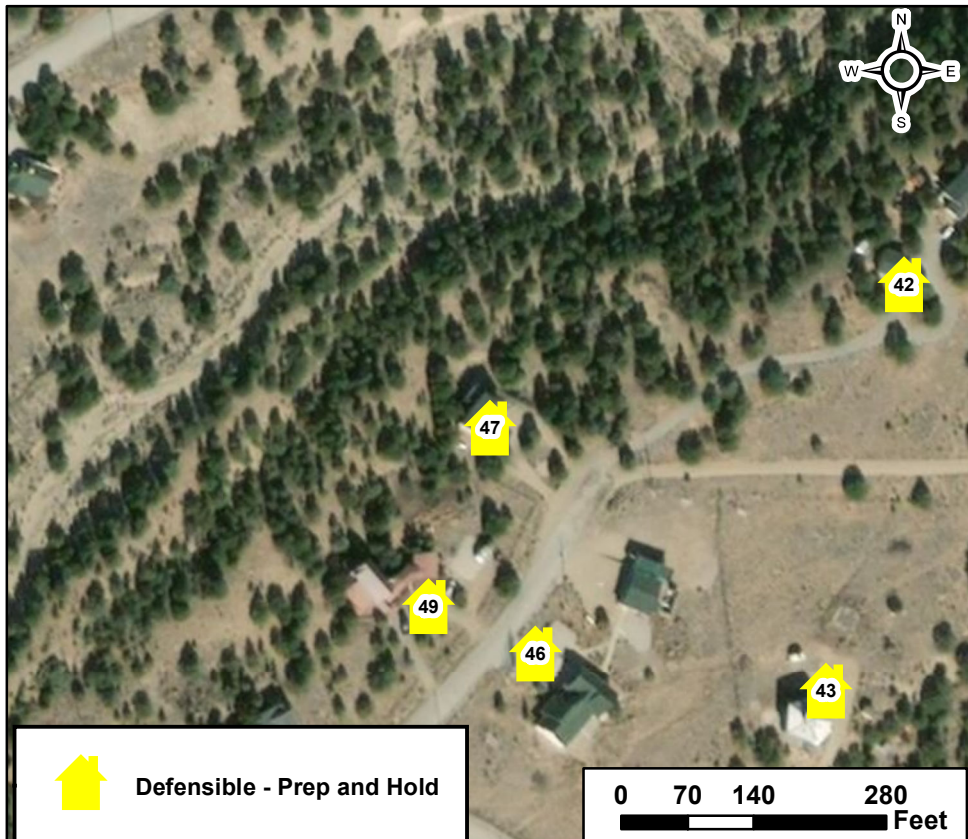
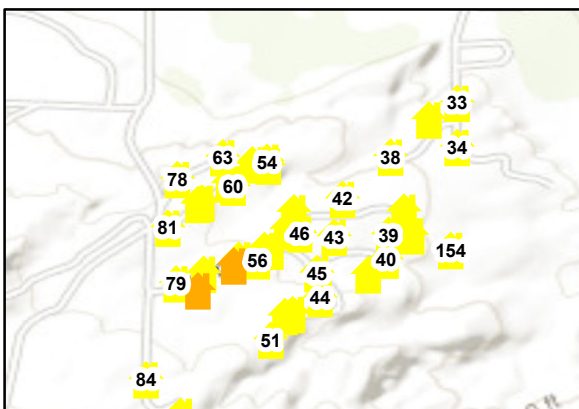
Notes: Fuel loading below residence, wooden deck

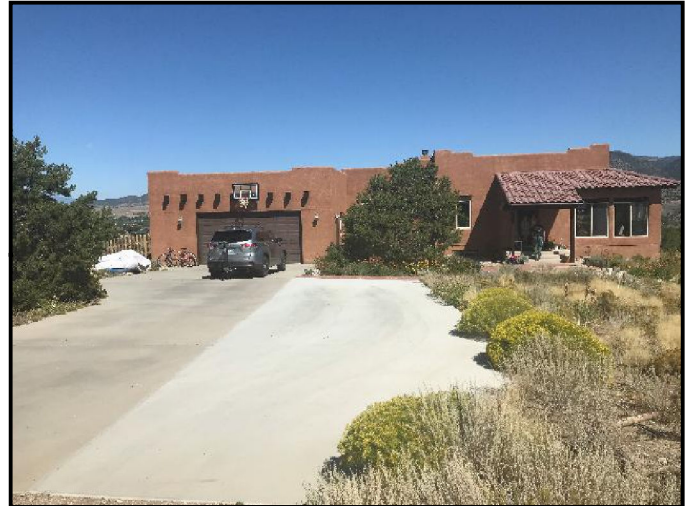
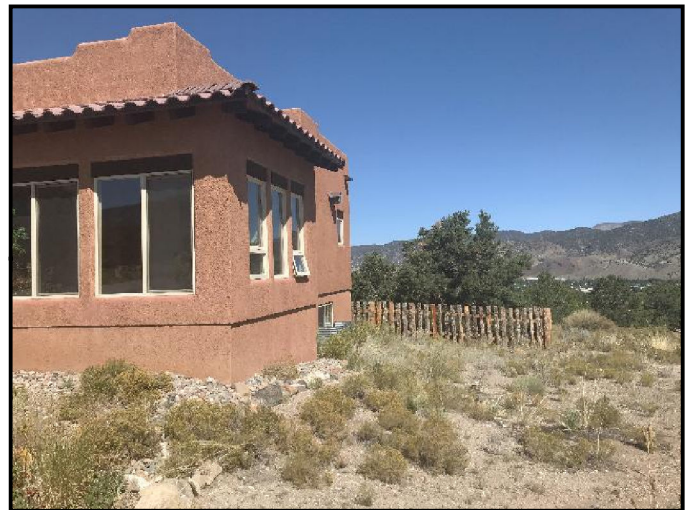
Hazards: Fuels below structure

Mitigation Time (in hours): 6

Mitigation Description: Thinning and weed whacking

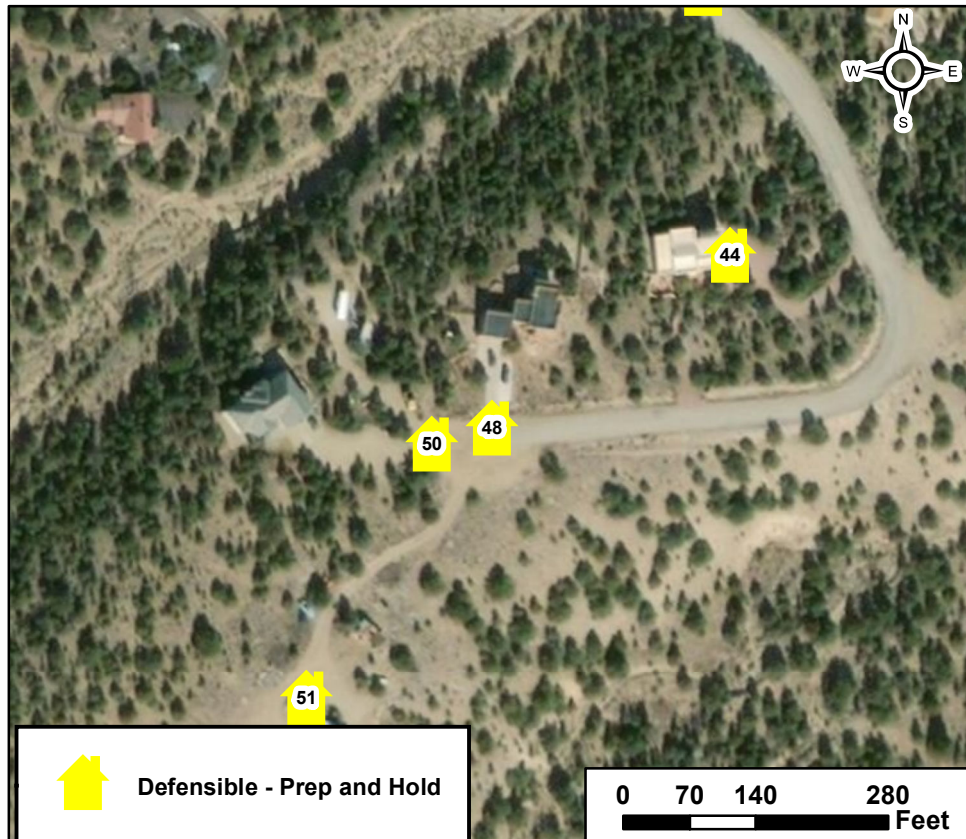
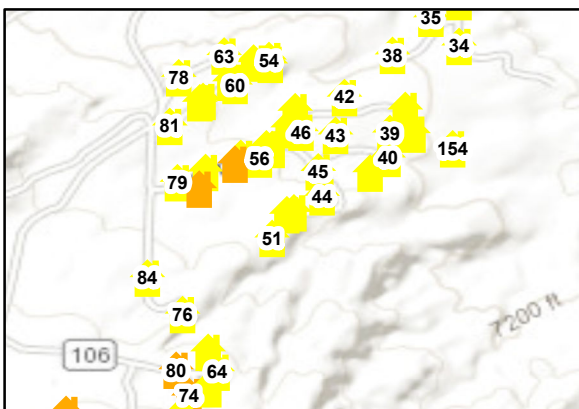
Notes: Structure has some landscaping/garden in front. Fuel loading below/ behind residence, wooden deck

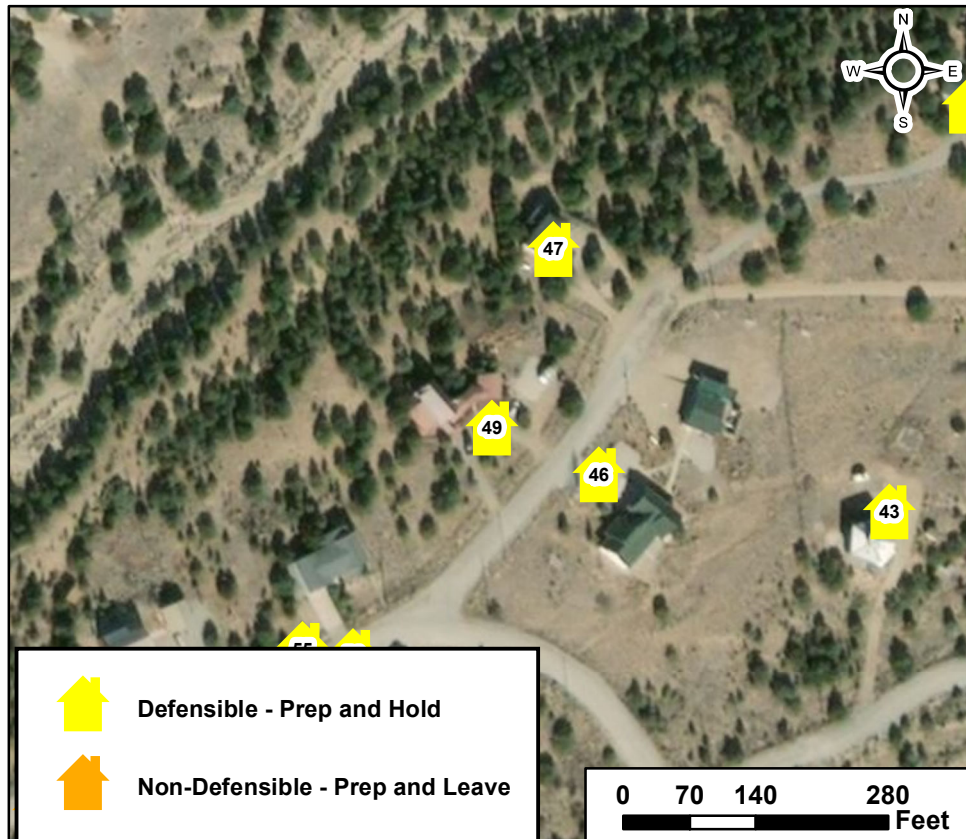
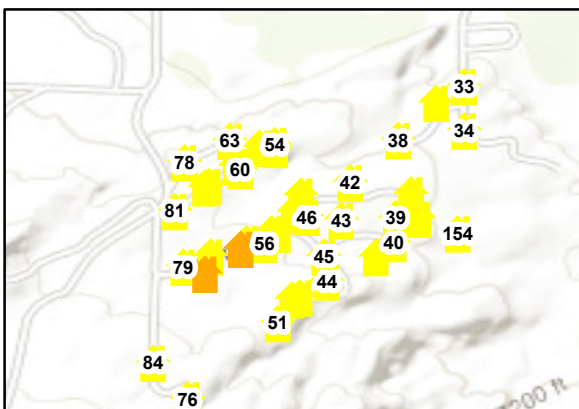
Notes: Fuel loading below residence, wood pile, wood piles, some debris, wooden deck

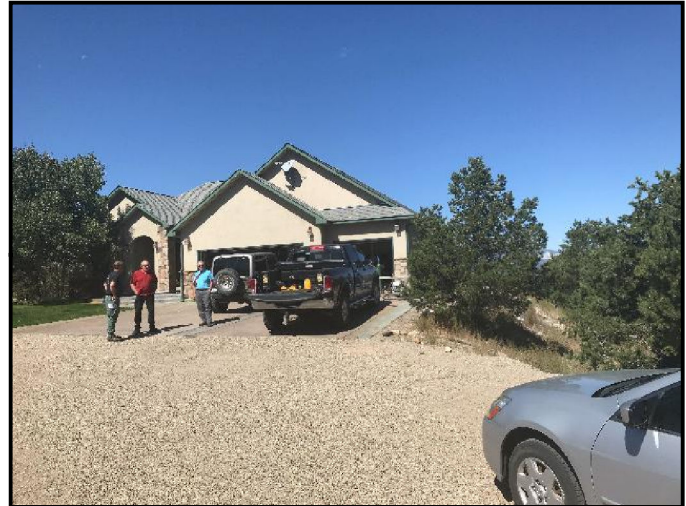
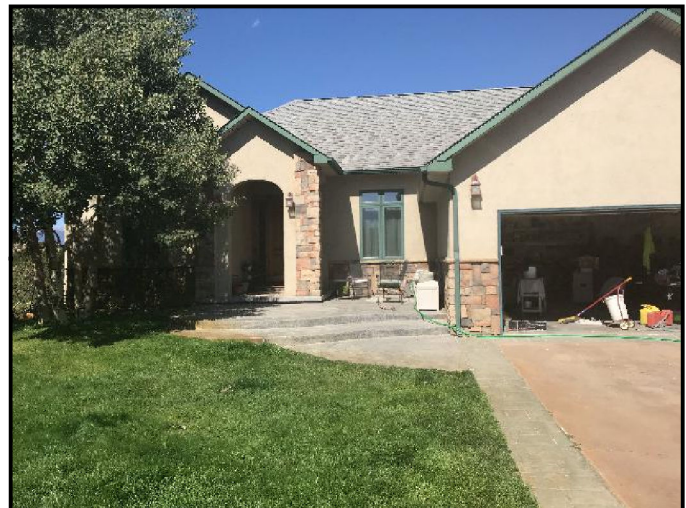
Hazards: Fuels below structure

Mitigation Time (in hours): 6

Mitigation Description: Thinning

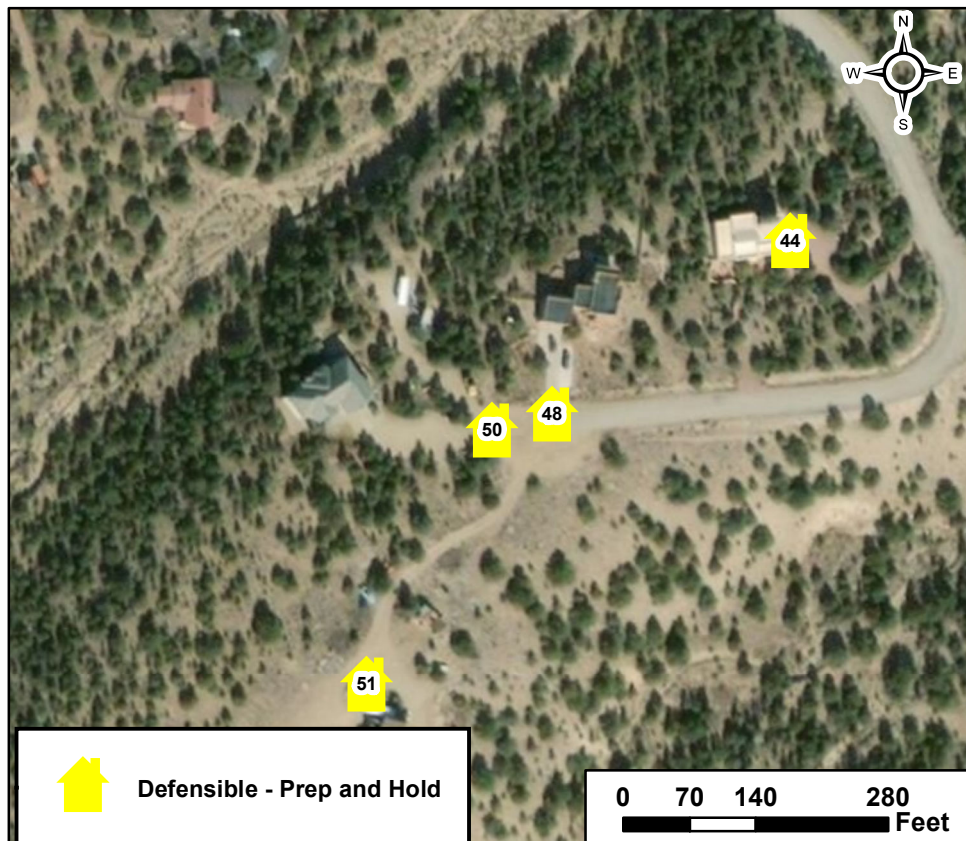
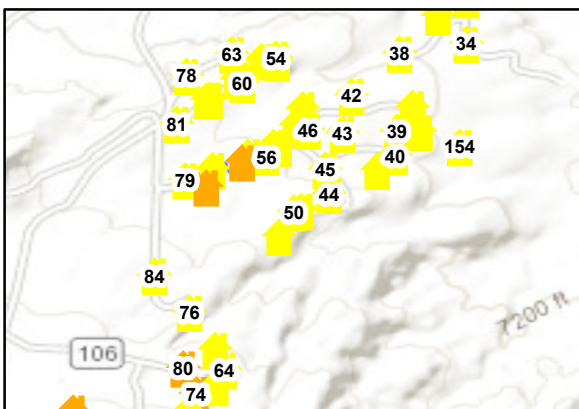
Notes: Structure has wide gravel drive. Fuel loading below residence, metal deck

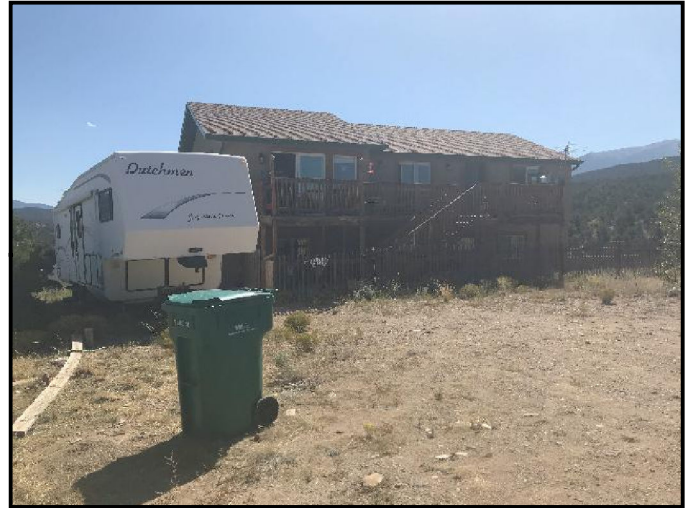
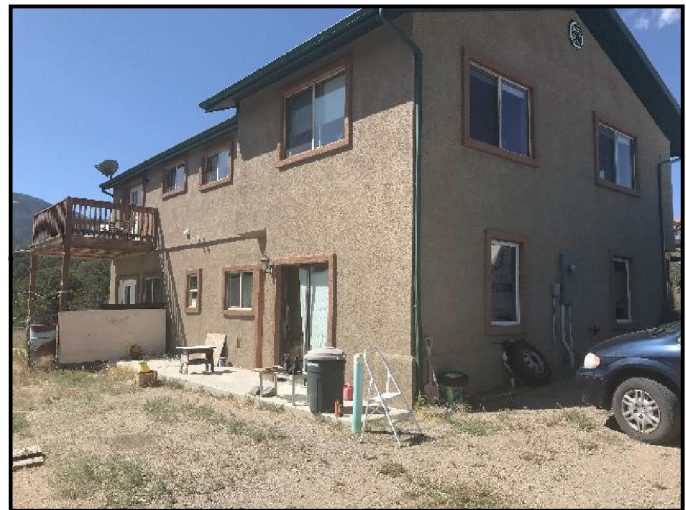
Hazards: Fuels below structure and sides of structure

Mitigation Time (in hours): 6

Mitigation Description: Thinning

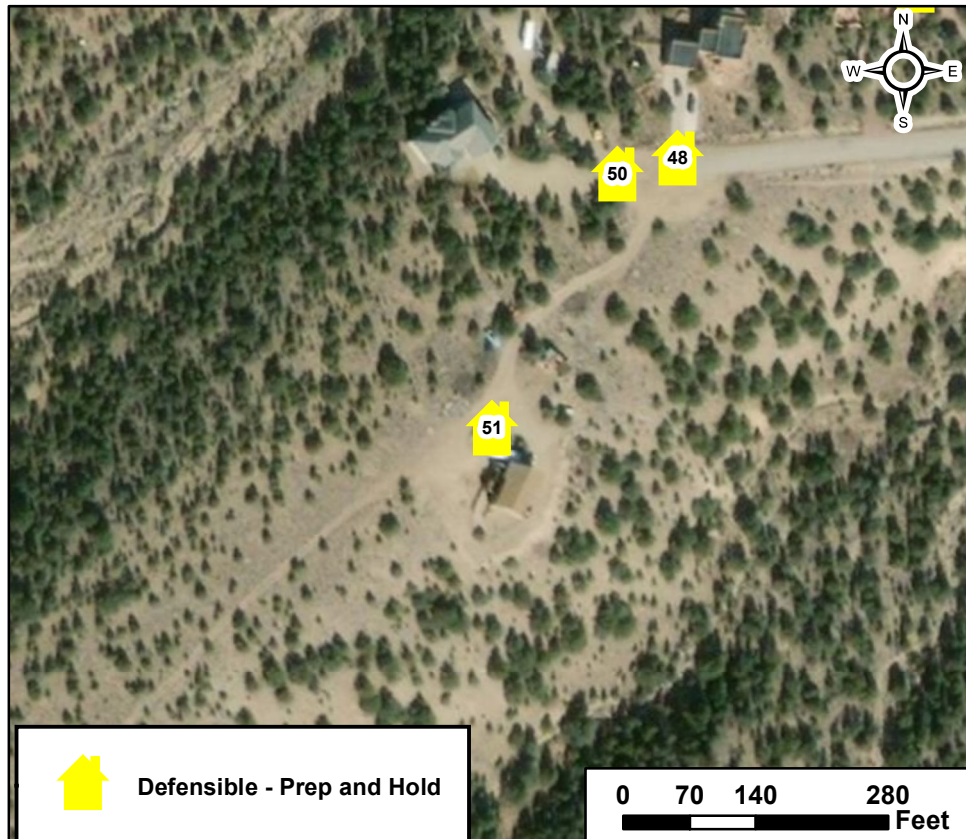
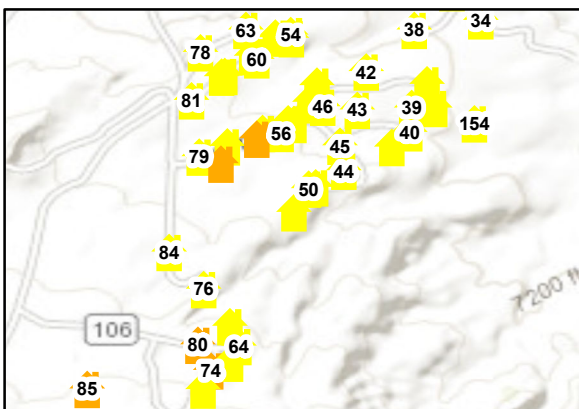
Notes: Fuel loading below/side of residence, wooden deck, yard debris and some old vehicles

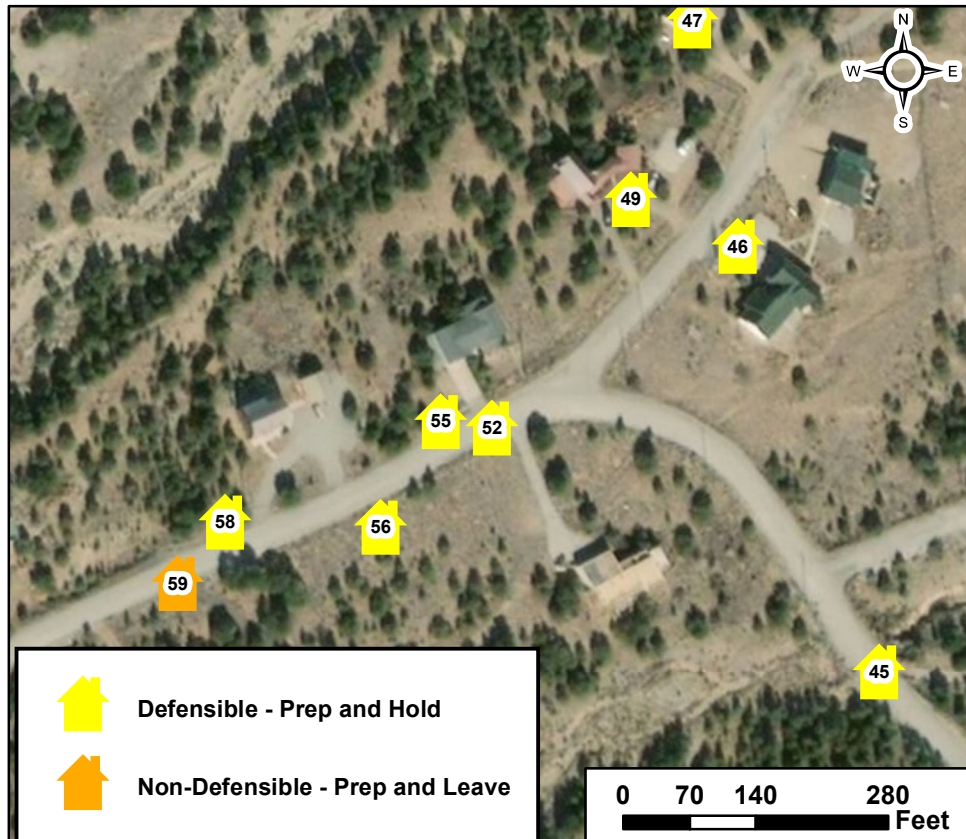
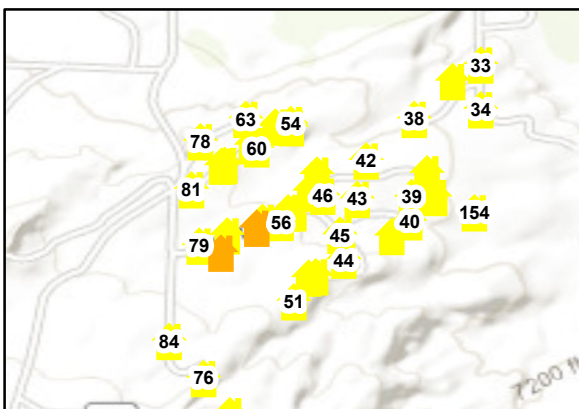
Resources Needed to Protect Structure:
Type 6 engine
Notes: Fuel loading below residence

Mitigation Time (in hours): 6
Mitigation Description: Thinning and weed whacking

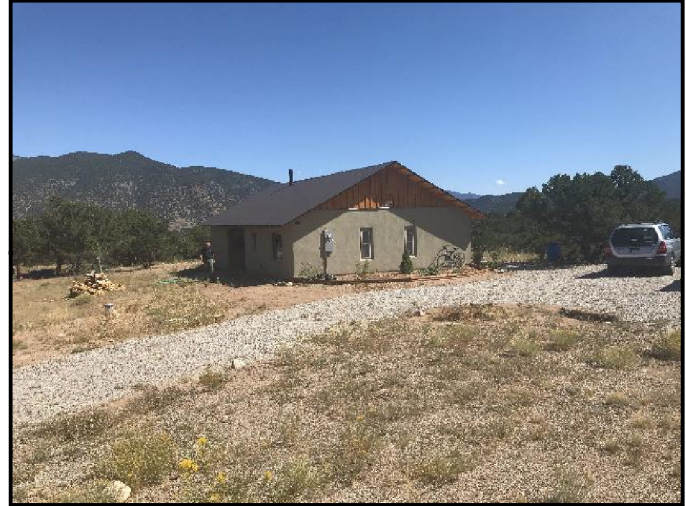
Triage Category: Defensible, Prep and Hold
Type of Structure: Residential
Primary Structures:
Is the building Occupied?: Yes
Outbuildings: 0
Fuel Surrounding Structure: Shrub or timber
Defensible Space: Less Than 30 ft treated
Roof Material: Noncombustible or not applicable
Siding Material: Rock, concrete, metal
Electrical Power: Yes
Gas to Structure: Yes
Hazards: Fuels below structure
Access to Site: T6 Engine
Describe Access: One way in and out
Comm With ICP: No
Water Source: Limited or dependent on electricity
Safety Zone Present: Potential safety zone(s) in area

Mitigation Time (in hours): 6

Mitigation Description: Thinning

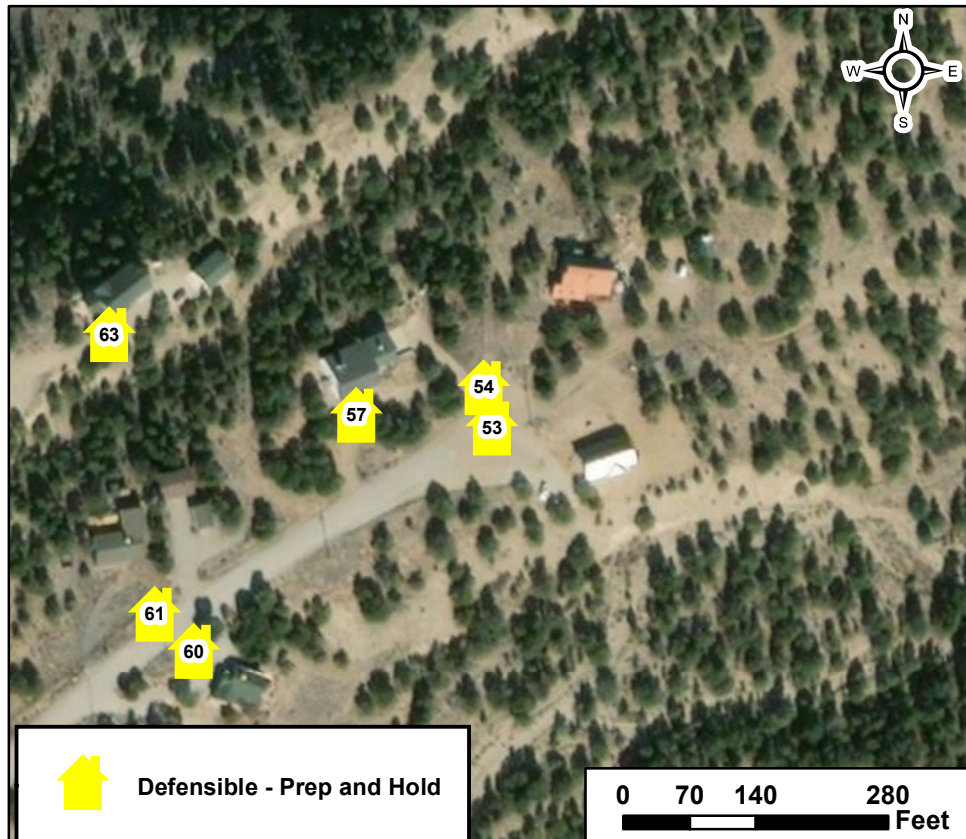
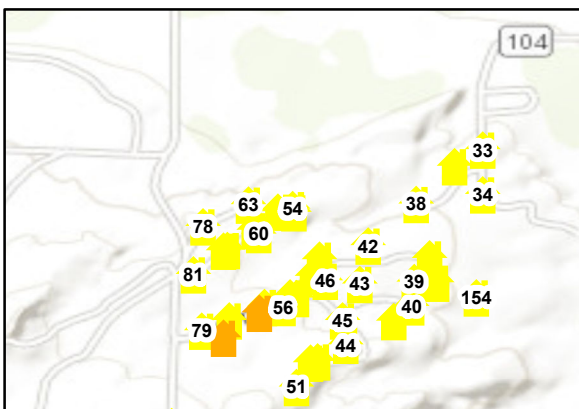
Notes: Structure has gravel drive. Fuel loading below residence, wood pile/debris
