Methodist East Structure Assessment

Structure ID: 30

Collected Date/Time: 9/26/2019 12:08:00 AM
Collected By: Chris Masson
Inspector's Position: Divs

Location: 5210 east highway 50,

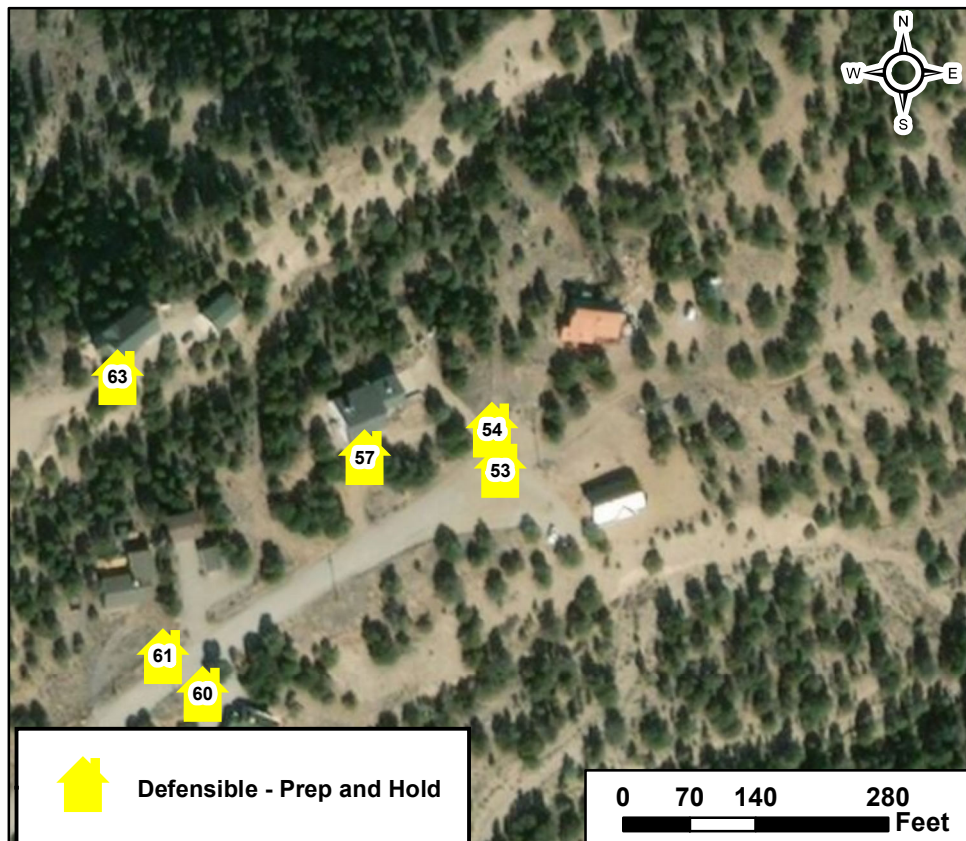
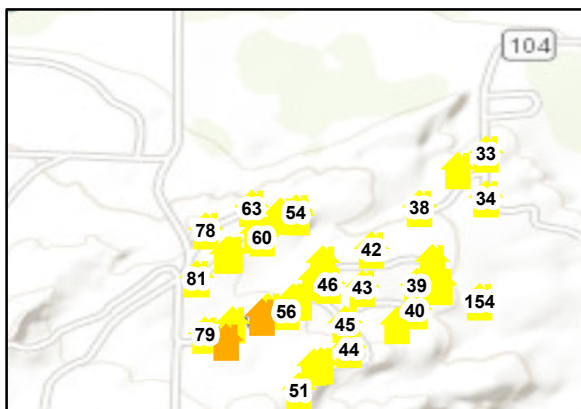
Notes: Structure has gravel perimeter 3/4. Fuel loading below residence, wooden deck on two sides, wood pile

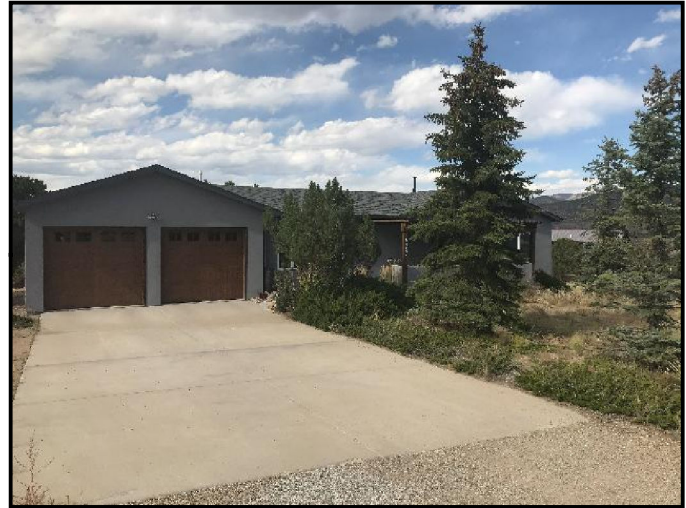
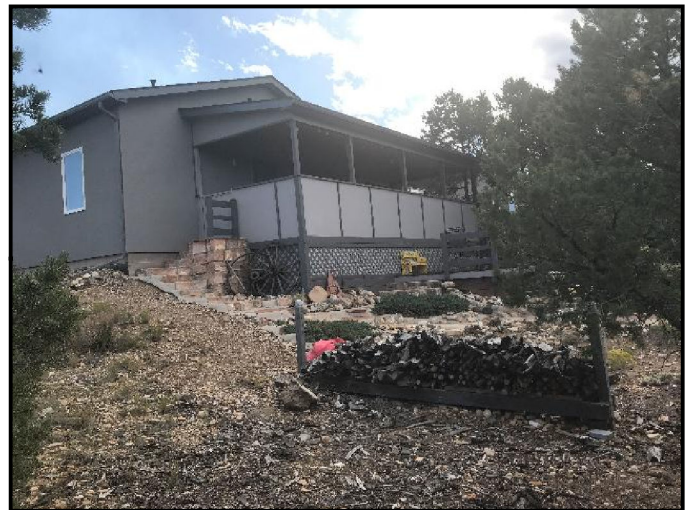
Triage Category: Defensible, Prep and Hold
Type of Structure: Residential
Primary Structures:
Is the building Occupied?: Yes
Outbuildings: 0
Fuel Surrounding Structure: Shrub or timber
Defensible Space: Less Than 30 ft treated
Roof Material: Fire resistant- tar, rubberized
Siding Material: Rock, concrete, metal
Electrical Power: Yes
Gas to Structure: Yes
Hazards: Fuels below structure, fm 1 in front yard
Access to Site: T6 Engine
Describe Access: One way in and out
Comm With ICP: No
Water Source: Limited or dependent on electricity
Safety Zone Present: Potential safety zone(s) in area

Mitigation Time (in hours): 6

Mitigation Description: Thinning

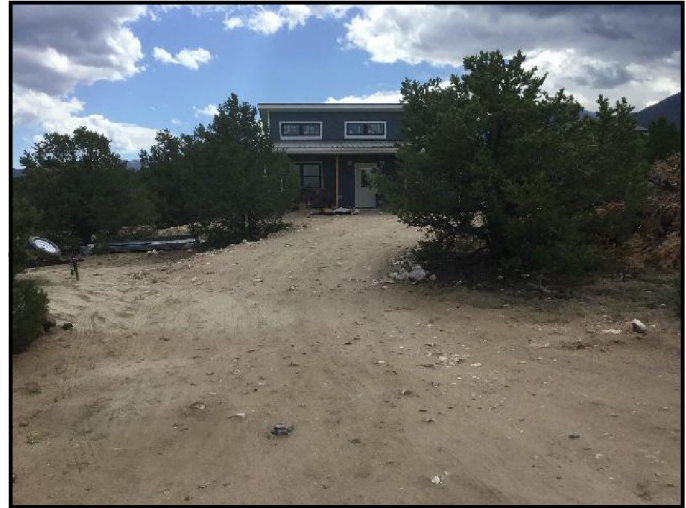
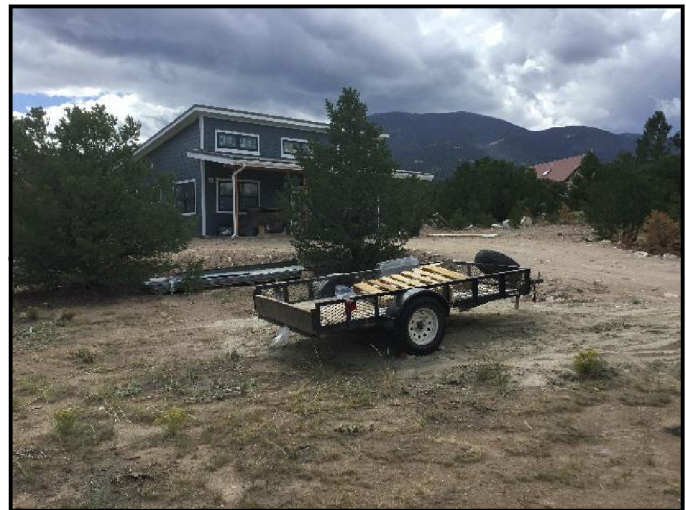
Structure ID: 56

Hazards: One way in and out. Neighbors propane tank adjacent to NE corner.

Notes: No landscaping at present. Adjacent residence close. Propane tank buried.

Mitigation Description: Saw work, brushing around structure

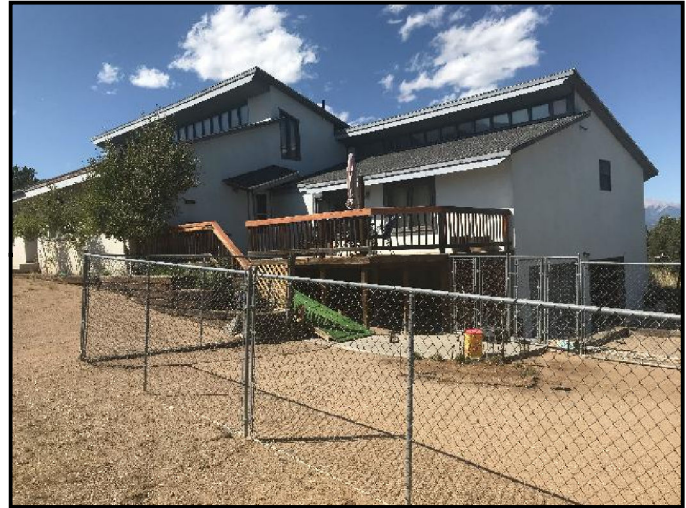
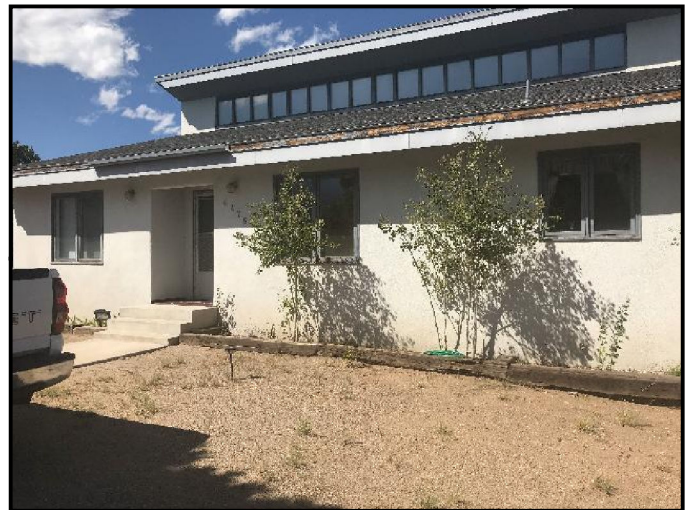
Structure ID: 57

Triage Category: Defensible, Prep and Hold
Type of Structure: Residential
Primary Structures:
Is the building Occupied?: Yes
Outbuildings: 0
Fuel Surrounding Structure: Shrub or timber
Defensible Space: Less Than 30 ft treated
Roof Material: Fire resistant- tar, rubberized
Siding Material: Rock, concrete, metal
Electrical Power: Yes
Gas to Structure: Yes
Hazards: Fuels below structure
Access to Site: T6 Engine
Describe Access: One way in and out
Comm With ICP: No
Water Source: Limited or dependent on electricity
Safety Zone Present: Potential safety zone(s) in area

Notes: Structure has gravel drive. Fuel loading below residence, wooden deck on two sides, wood pile

Mitigation Description: Thinning

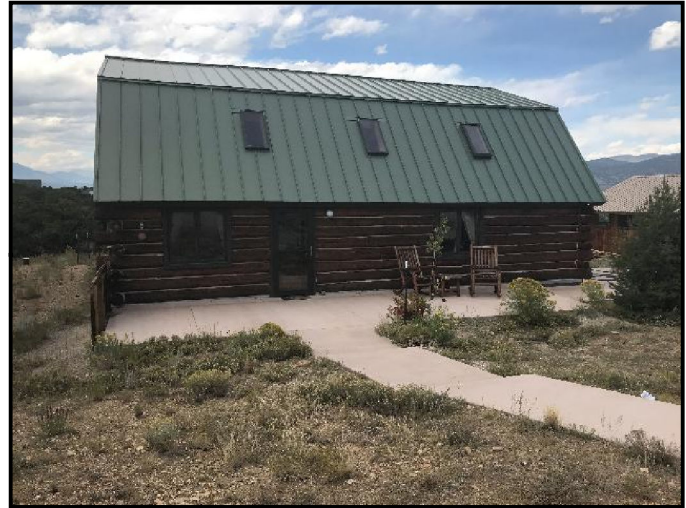
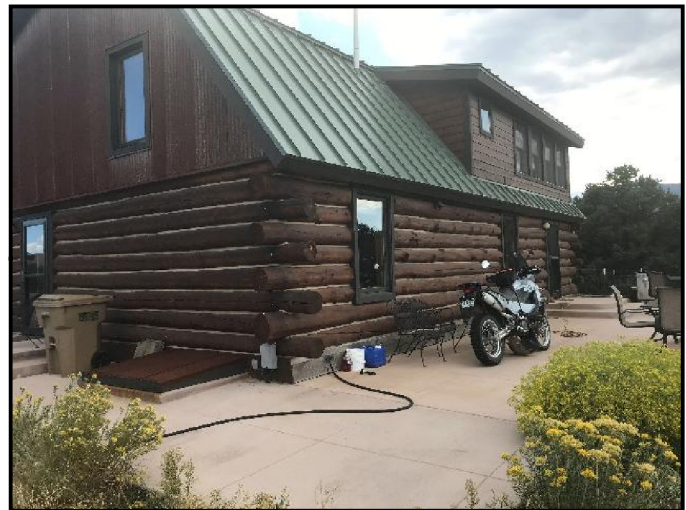
Structure ID: 58

Triage Category: Defensible, Prep and Hold
Type of Structure: Residential
Primary Structures:
Is the building Occupied?: Yes
Outbuildings: 2
Fuel Surrounding Structure: Shrub or timber
Defensible Space: Less Than 30 ft treated
Roof Material: Noncombustible or not applicable
Siding Material: Log construction
Electrical Power: Yes
Gas to Structure: Yes
Hazards: Fuels below structure and side
Access to Site: T6 Engine
Describe Access: One way in and out
Comm With ICP: No
Water Source: Limited or dependent on electricity
Safety Zone Present: Potential safety zone(s) in area

Notes: Structure has gravel/cement perimeter 3/4. Fuel loading below residence, some debris

Mitigation Description: Thinning

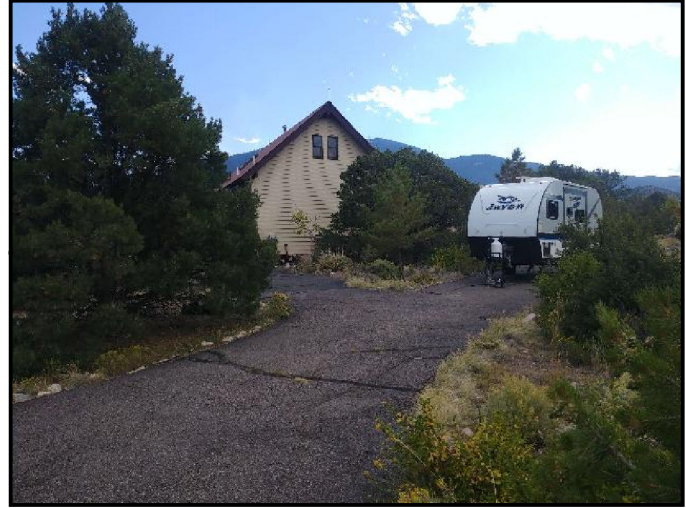
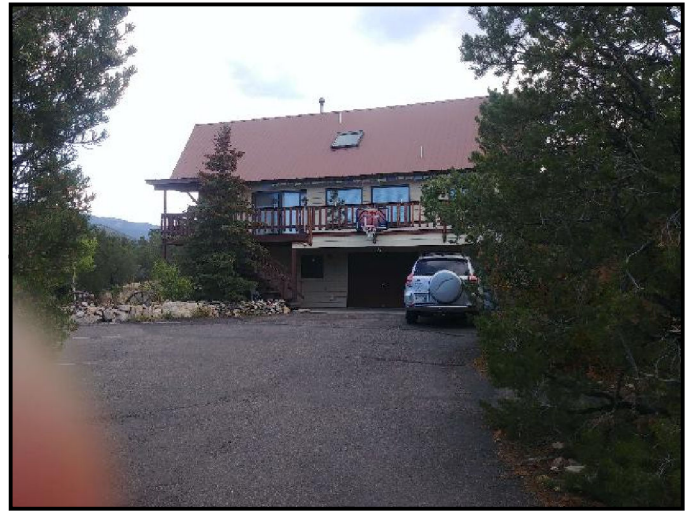
Structure ID: 59

Hazards: 1 way access

Notes: Fuels close , decks with fuels under

Mitigation Description: Brush and grass removal

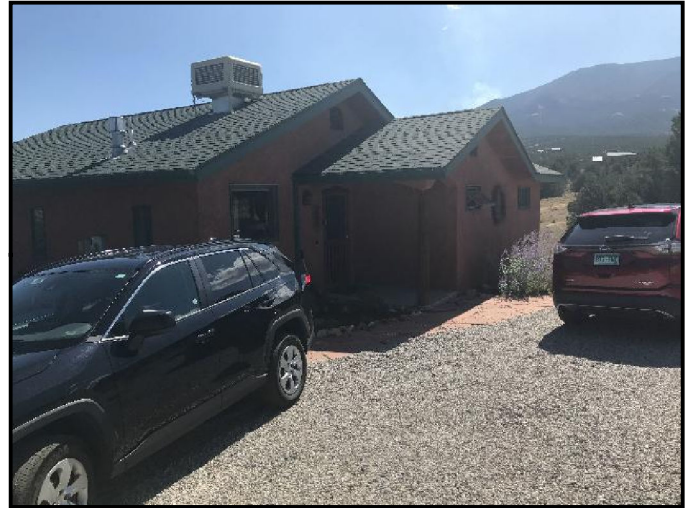
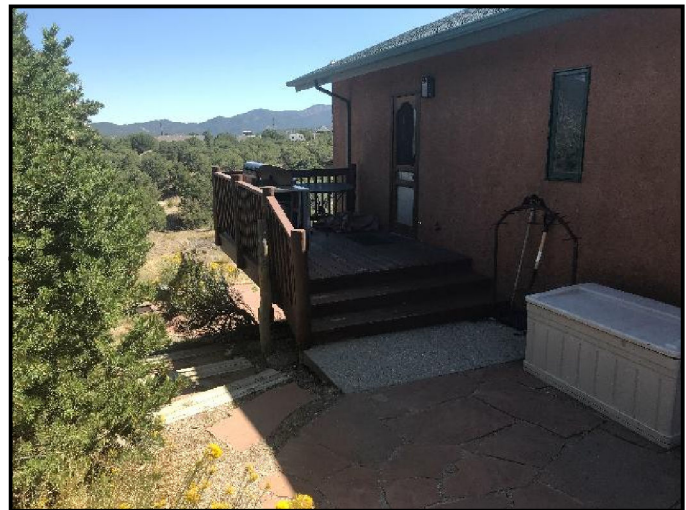
Structure ID: 60

Hazards: Fuels below structure

Notes: Structure has gravel drive. Fuel loading on side of residence, small wooden deck

Mitigation Description: Thinning

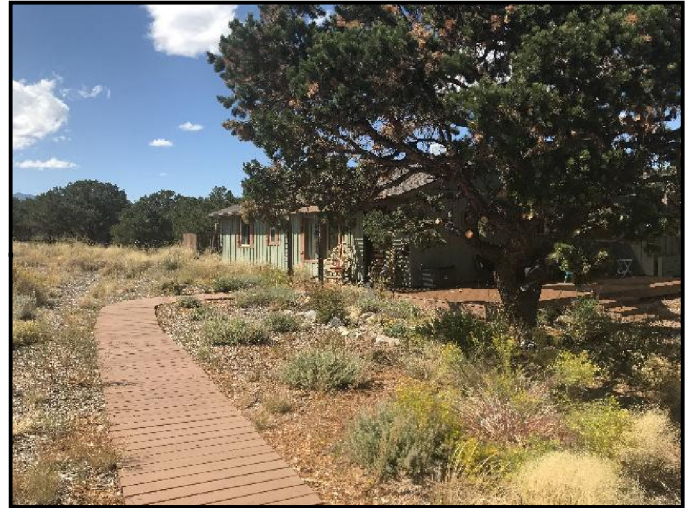
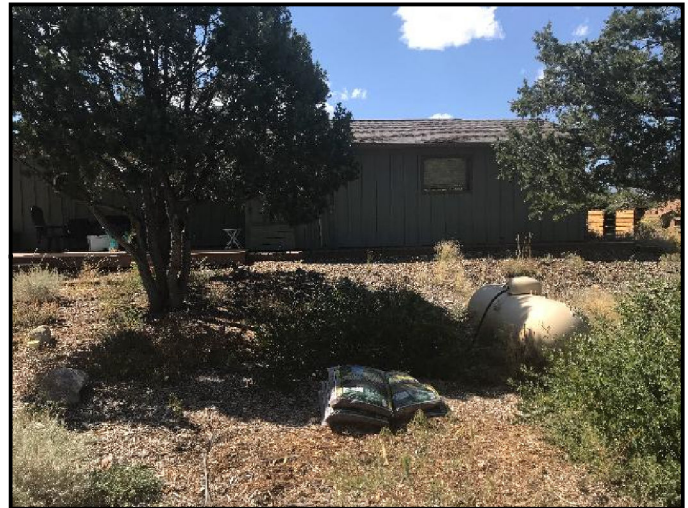
Structure ID: 61

Triage Category: Defensible, Prep and Hold
Type of Structure: Residential
Primary Structures:
Is the building Occupied?: Yes
Outbuildings: 3
Fuel Surrounding Structure: Shrub or timber
Defensible Space: Less Than 30 ft treated
Roof Material: Fire resistant- tar, rubberized
Siding Material: Wood or open sided
Electrical Power: Yes
Gas to Structure: Yes
Hazards: Fuels below structure
Access to Site: T6 Engine
Describe Access: One way in and out
Comm With ICP: No
Water Source: Limited or dependent on electricity
Safety Zone Present: Potential safety zone(s) in area

Notes: Structure has gravel drive. Fuel loading below residence, taller grasses in front of house

Mitigation Time (in hours): 6
Mitigation Description: Thinning and weed whacking

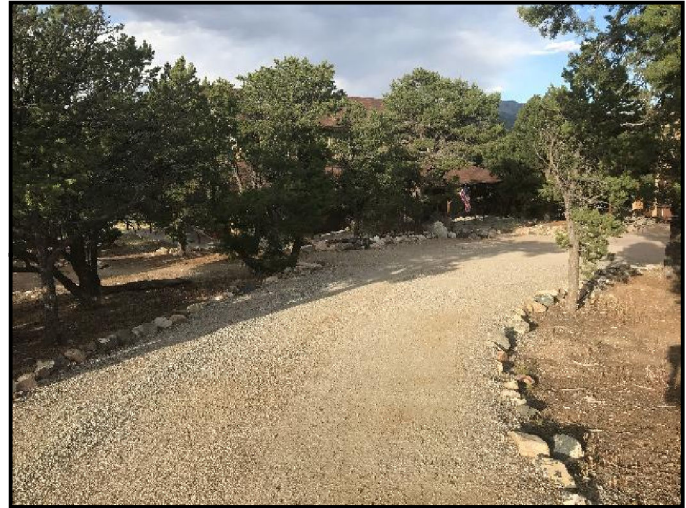
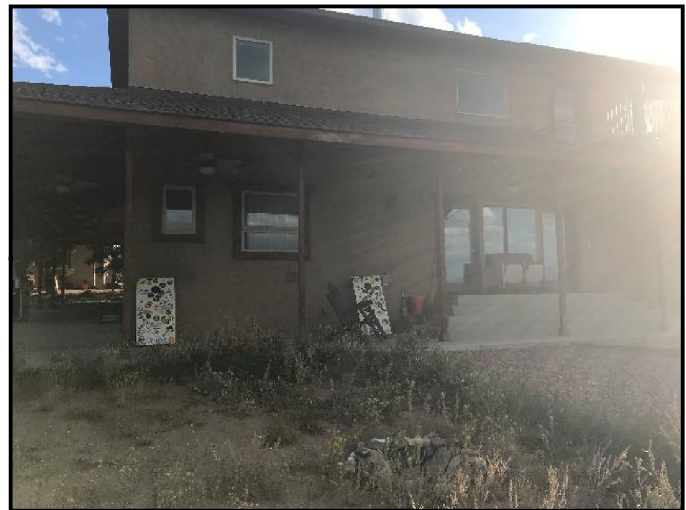
Structure ID: 62

Triage Category: Defensible, Prep and Hold
Type of Structure: Residential
Primary Structures:
Is the building Occupied?: Yes
Outbuildings: 1
Fuel Surrounding Structure: Shrub or timber
Defensible Space: Less Than 30 ft treated
Roof Material: Fire resistant- tar, rubberized
Siding Material: Rock, concrete, metal
Electrical Power: Yes
Gas to Structure: Yes
Hazards: Fuels below structure
Access to Site: T6 Engine
Describe Access: One way in and out
Comm With ICP: No
Water Source: Limited or dependent on electricity
Safety Zone Present: Potential safety zone(s) in area

Notes: Cement surrounding base of structure, wooden overhangs, large wood pile, wood/trex deck

Mitigation Time (in hours): 6
Mitigation Description: Thinning and weed whacking

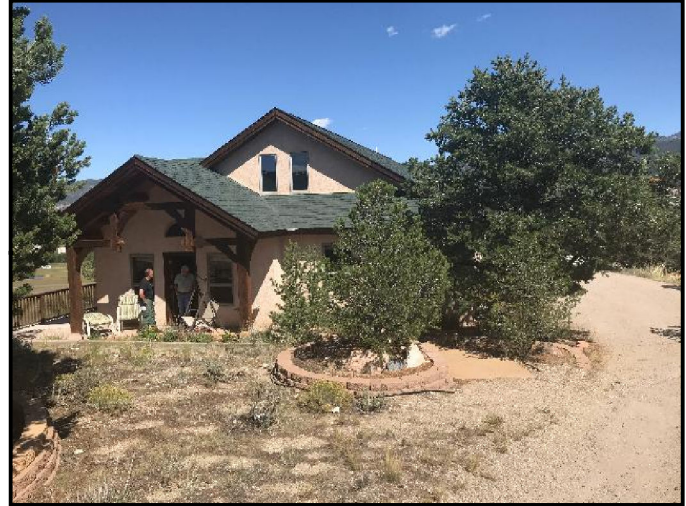
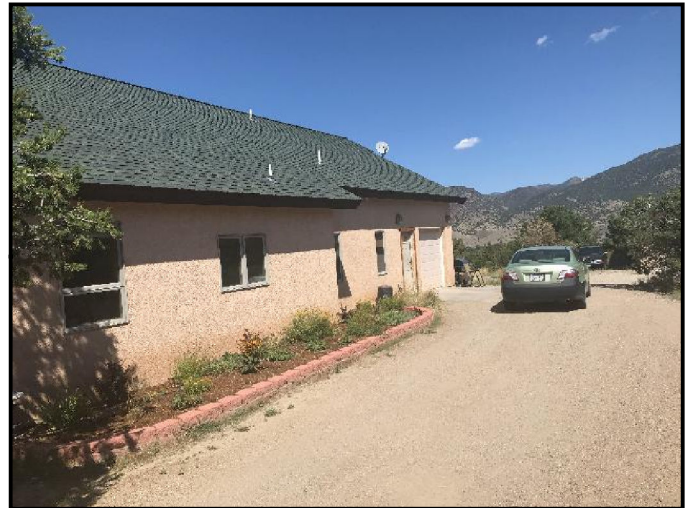
Structure ID: 63

Triage Category: Defensible, Prep and Hold
Type of Structure: Residential
Primary Structures:
Is the building Occupied?: Yes
Outbuildings: 1
Fuel Surrounding Structure: Shrub or timber
Defensible Space: Less Than 30 ft treated
Roof Material: Fire resistant- tar, rubberized
Siding Material: Rock, concrete, metal
Electrical Power: Yes
Gas to Structure: Yes
Hazards: Fuels below structure and side
Access to Site: T6 Engine
Describe Access: One way in and out
Comm With ICP: No
Water Source: Limited or dependent on electricity
Safety Zone Present: Potential safety zone(s) in area

Notes: Structure has gravel perimeter 3/4.

Fuel loading below residence, wooden deck

Mitigation Description: Thinning

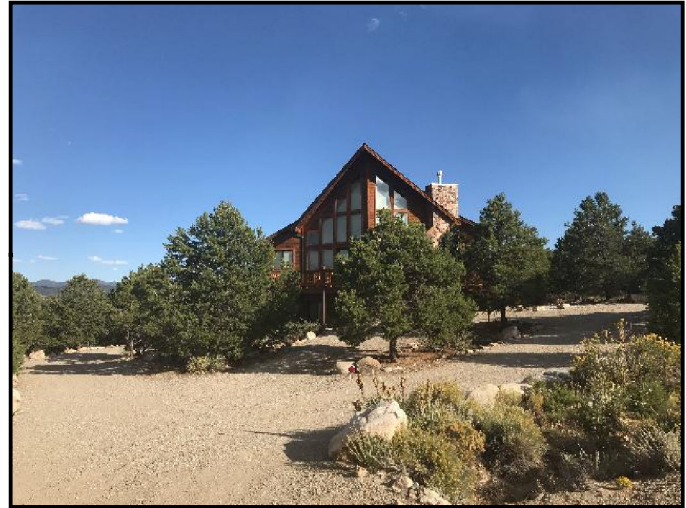
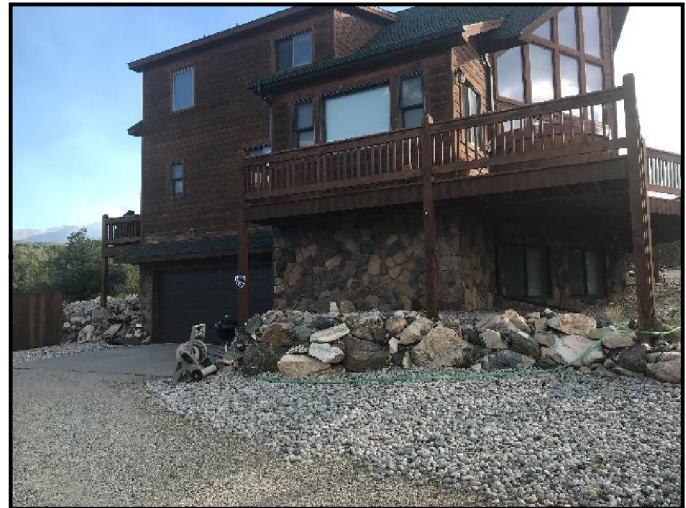
Structure ID: 65

Triage Category: Defensible, Prep and Hold
Type of Structure: Residential
Primary Structures:
Is the building Occupied?: Yes
Outbuildings: 0
Fuel Surrounding Structure: Shrub or timber
Defensible Space: Less Than 30 ft treated
Roof Material: Fire resistant- tar,rubberized
Siding Material: Wood or open sided
Electrical Power: Yes
Gas to Structure: Yes
Hazards: Fuels below structure and on flanks
Access to Site: T6 Engine
Describe Access: One way in and out
Comm With ICP: No
Water Source: Limited or dependent on electricity
Safety Zone Present: Potential safety zone(s) in area

Notes: Structure has gravel perimeter 3/4.
Fuel loading below residence, wooden deck on three sides

Mitigation Description: Thinning

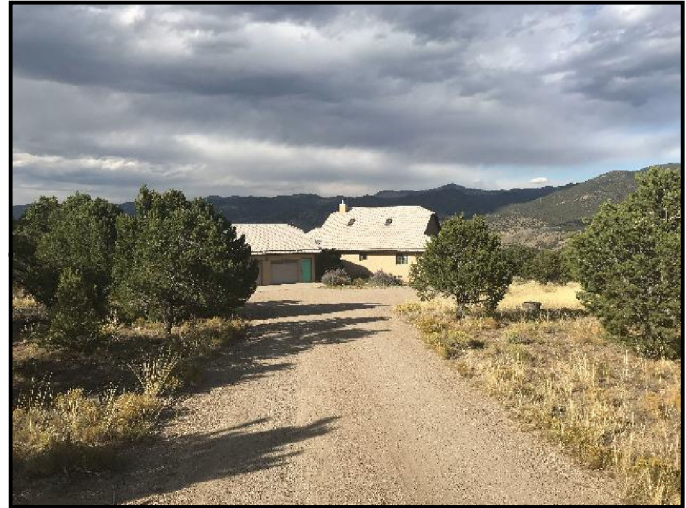
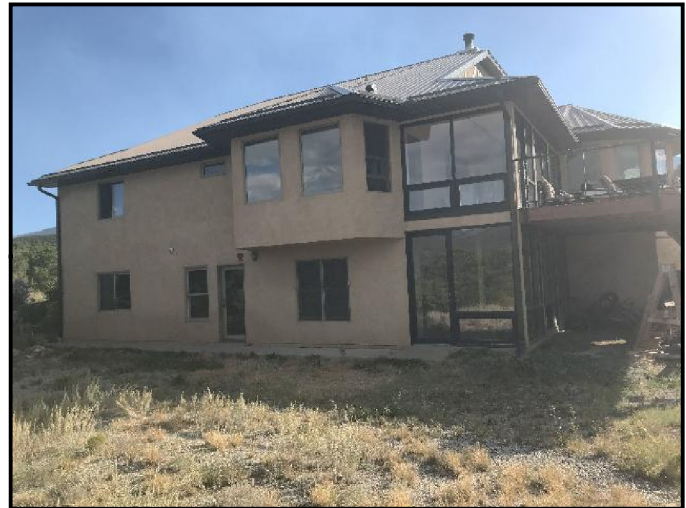
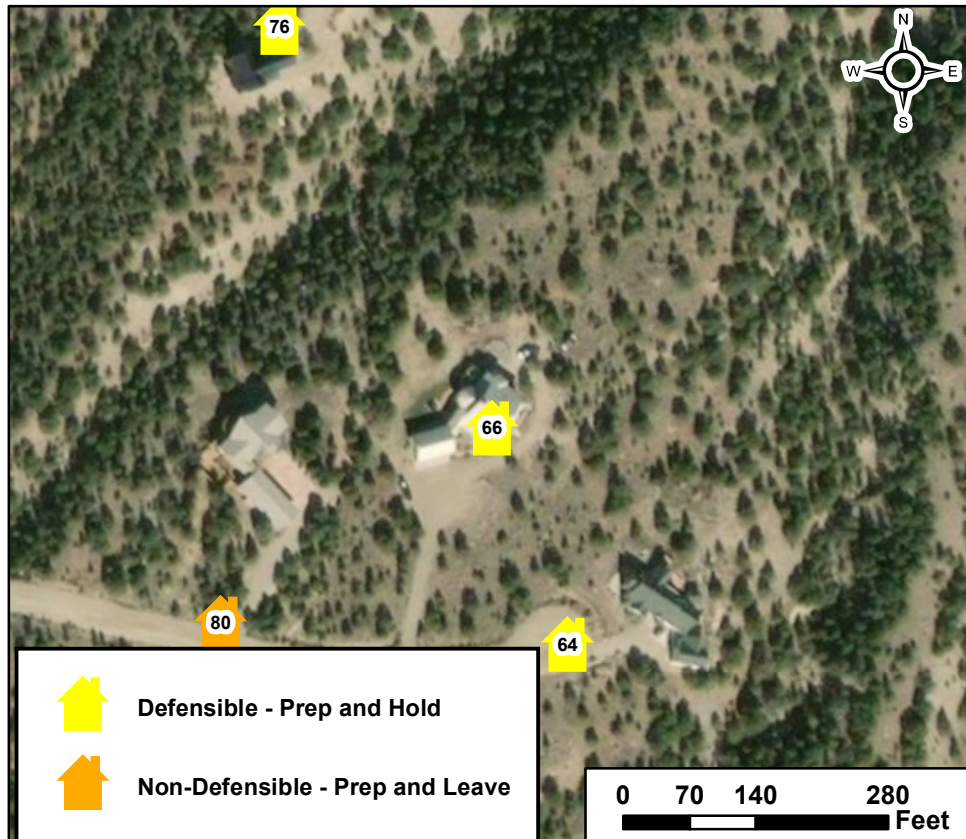
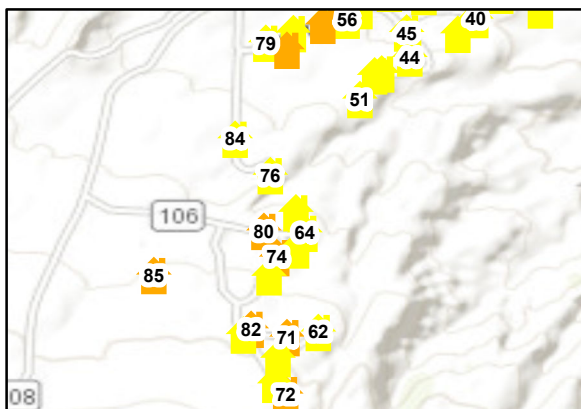
Triage Category: Defensible, Prep and Hold
Type of Structure: Residential
Primary Structures:
Is the building Occupied?: Yes
Outbuildings: 0
Fuel Surrounding Structure: Shrub or timber
Defensible Space: Less Than 30 ft treated
Roof Material: Noncombustible or not applicable
Siding Material: Rock, concrete, metal
Electrical Power: Yes
Gas to Structure: Yes
Hazards: Fuels below structure and on sides, slope
Access to Site: T6 Engine
Describe Access: One way in and out
Comm With ICP: No
Water Source: Limited or dependent on electricity
Safety Zone Present: Potential safety zone(s) in area

Notes: Fuel loading below residence, wooden deck, wood pile, trex front porch

Mitigation Time (in hours): 6
Mitigation Description: Thinning and weed whacking

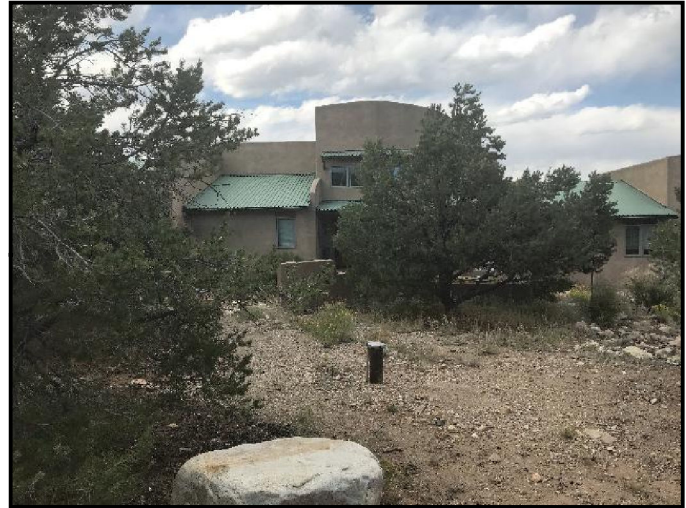
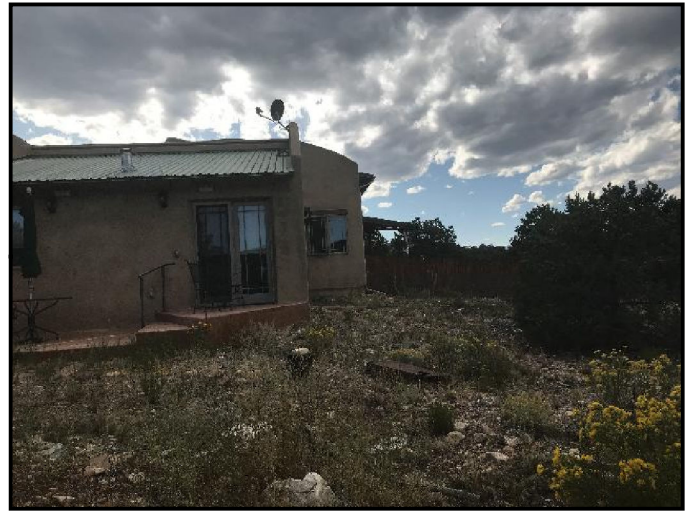
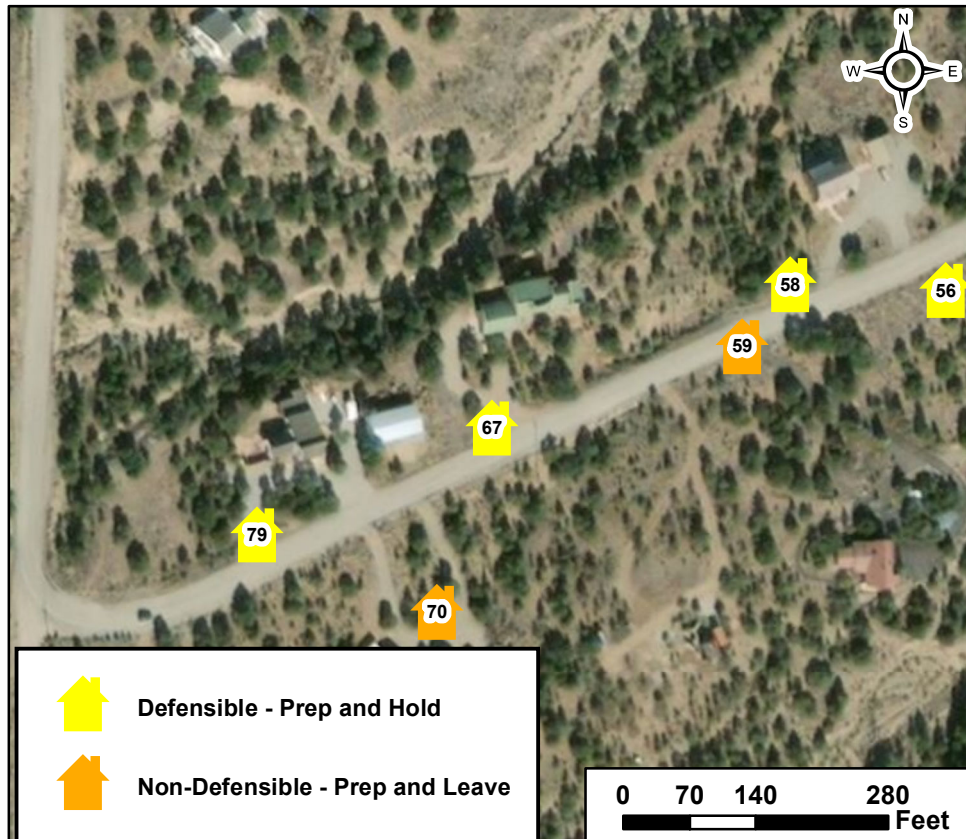
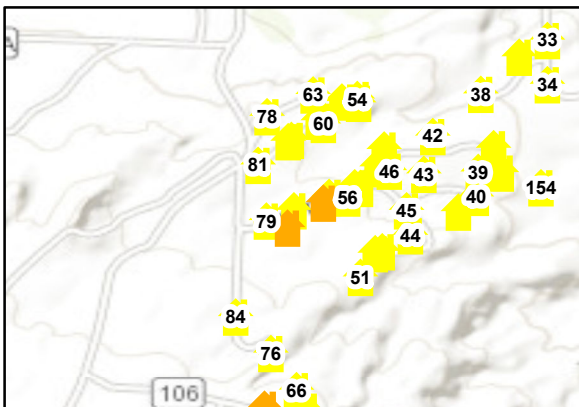
Structure ID: 67

Triage Category: Defensible, Prep and Hold
Type of Structure: Residential
Primary Structures:
Is the building Occupied?: Yes
Outbuildings: 0
Fuel Surrounding Structure: Shrub or timber
Defensible Space: Less Than 30 ft treated
Roof Material: Noncombustible or not applicable
Siding Material: Rock, concrete, metal
Electrical Power: Yes
Gas to Structure: Yes
Hazards: Fuels around structure
Access to Site: T6 Engine
Describe Access: One way in and out
Comm With ICP: No
Water Source: Limited or dependent on electricity
Safety Zone Present: Potential safety zone(s) in area

Notes: Fuel loading below residence, wooden fence, fuels in front of house

Mitigation Time (in hours): 6

Mitigation Description: Thinning

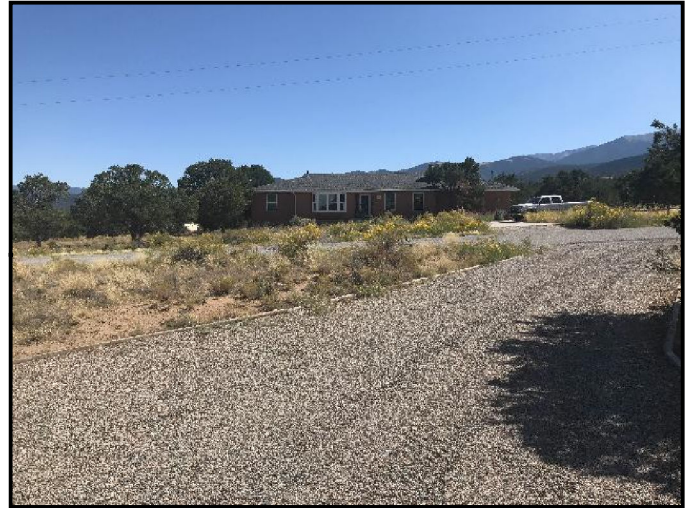
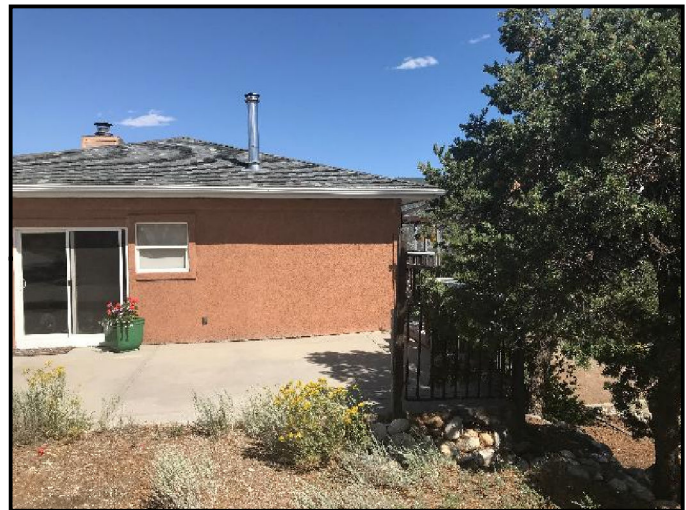
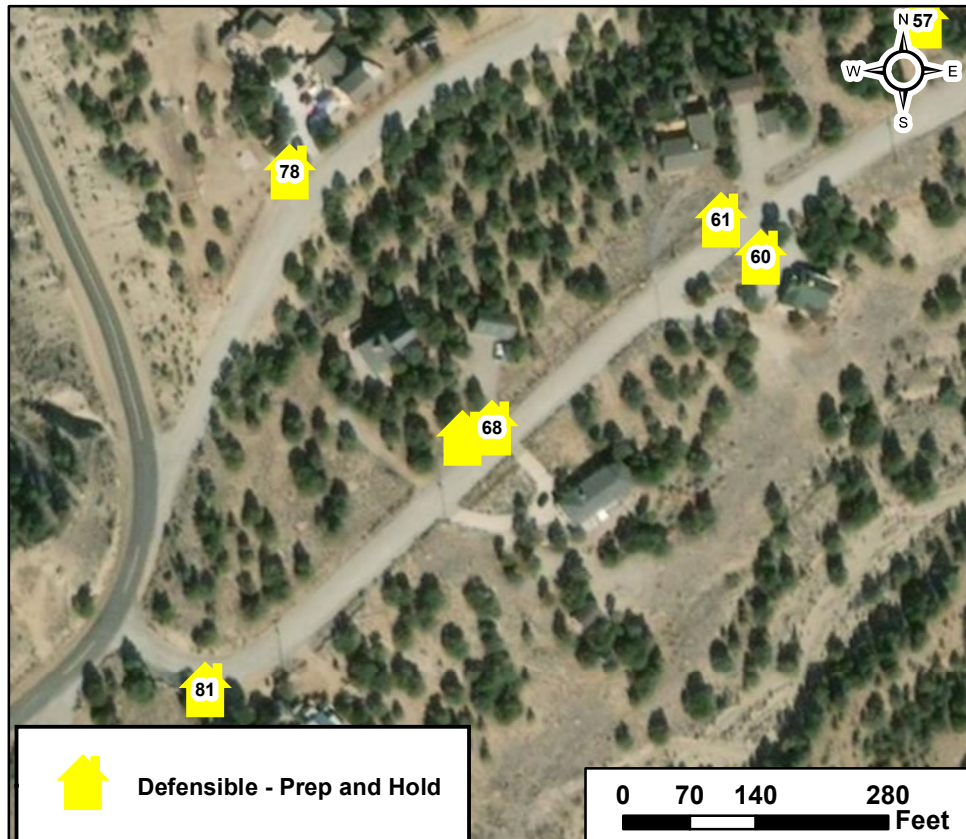
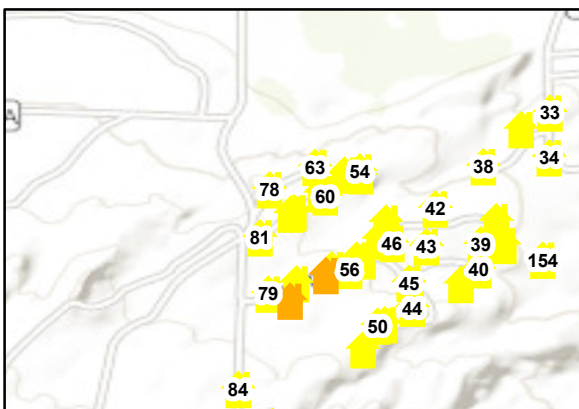
Structure ID: 68

Triage Category: Defensible, Prep and Hold
Type of Structure: Residential
Primary Structures:
Is the building Occupied?: Yes
Outbuildings: 1
Fuel Surrounding Structure: Shrub or timber
Defensible Space: Less Than 30 ft treated
Roof Material: Fire resistant- tar, rubberized
Siding Material: Rock, concrete, metal
Electrical Power: Yes
Gas to Structure: Yes
Hazards: Fuels below structure
Access to Site: T6 Engine
Describe Access: One way in and out
Comm With ICP: No
Water Source: Limited or dependent on electricity
Safety Zone Present: Potential safety zone(s) in area

Notes: Fuel loading below residence, wooden deck, fm1 in front

Mitigation Time (in hours): 6
Mitigation Description: Thinning weed whacking

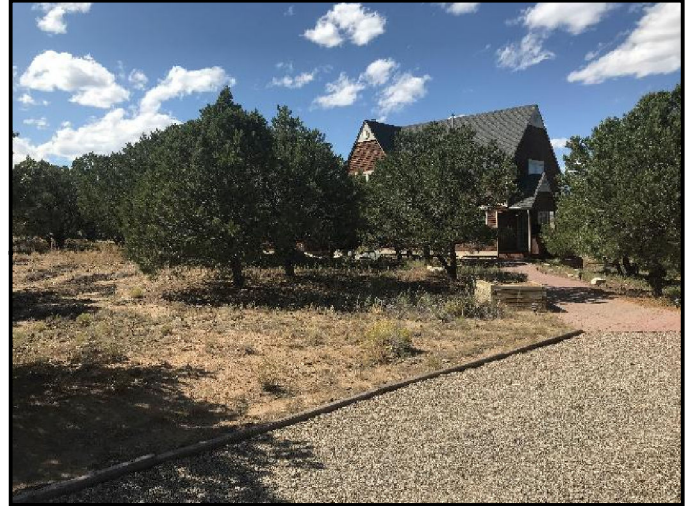
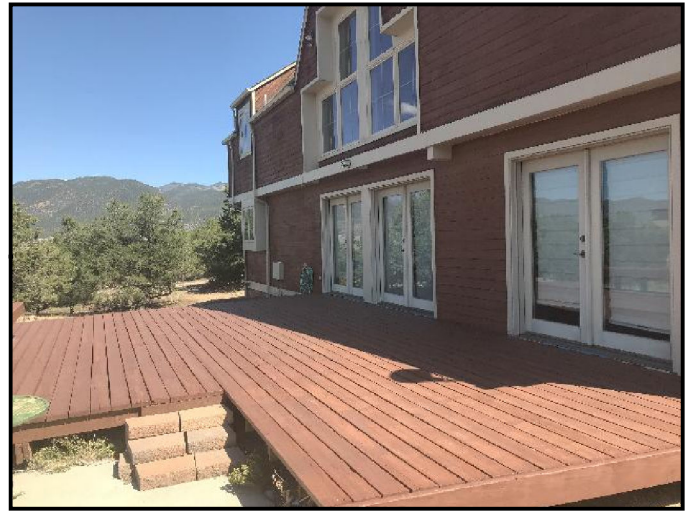
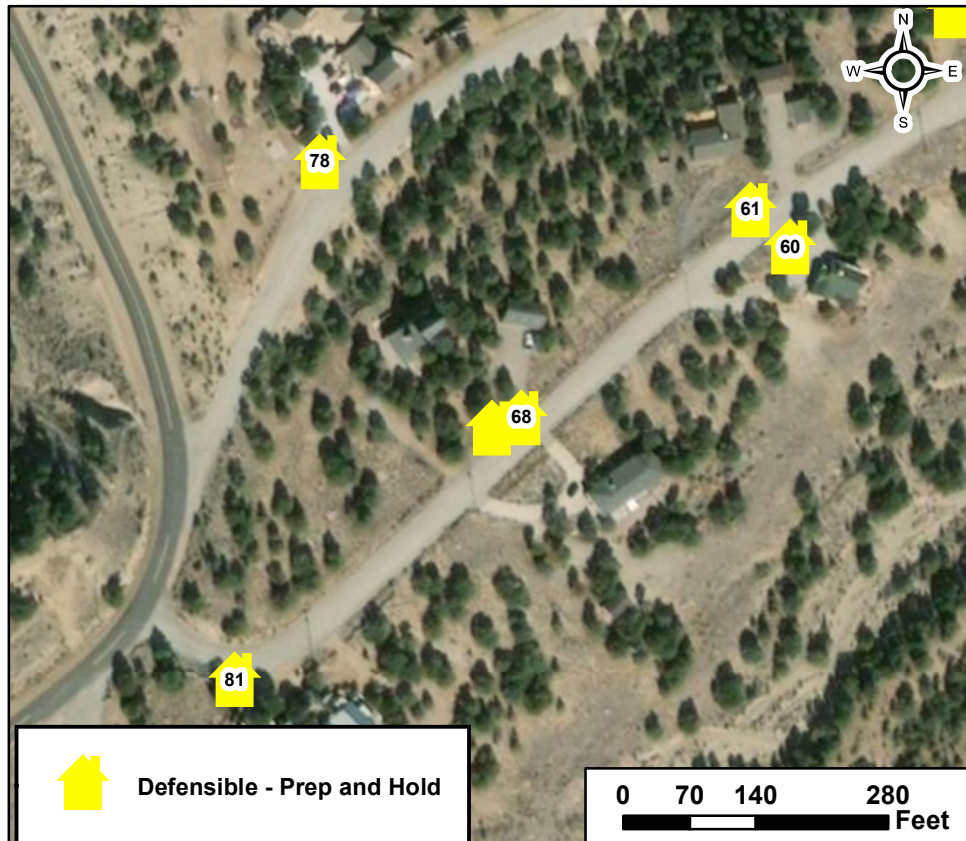
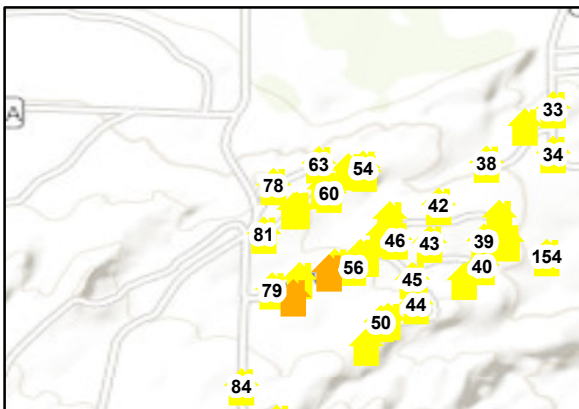
Structure ID: 69

Hazards: Fuels below structure

Notes: Fuel loading below residence, wooden deck, fuels in side yards

Mitigation Time (in hours): 7

Mitigation Description: Thinning

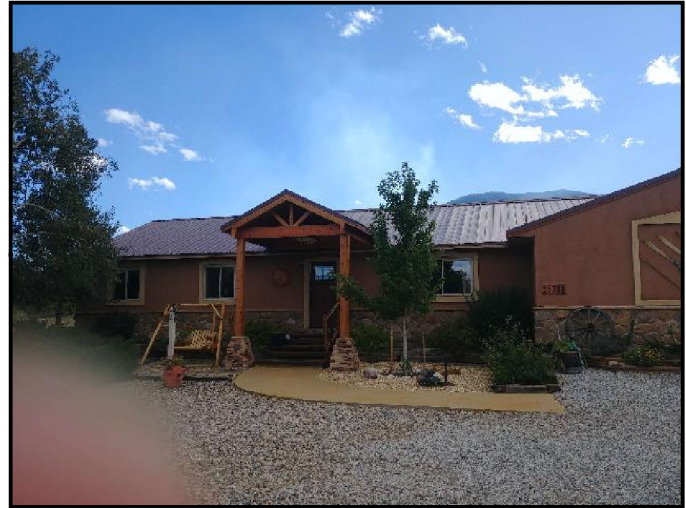
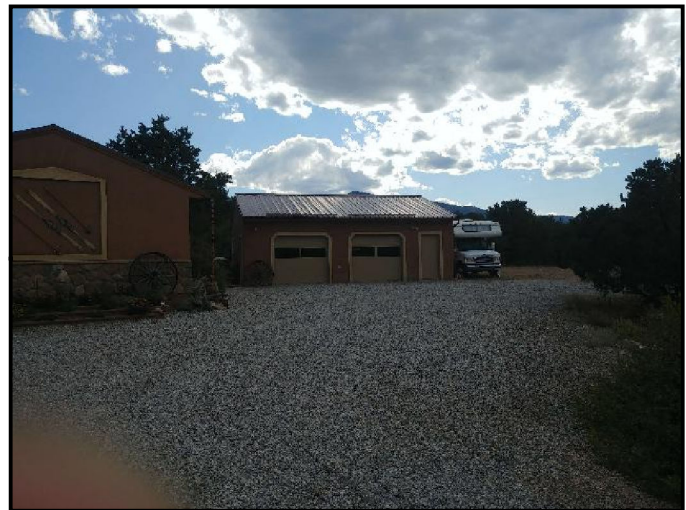
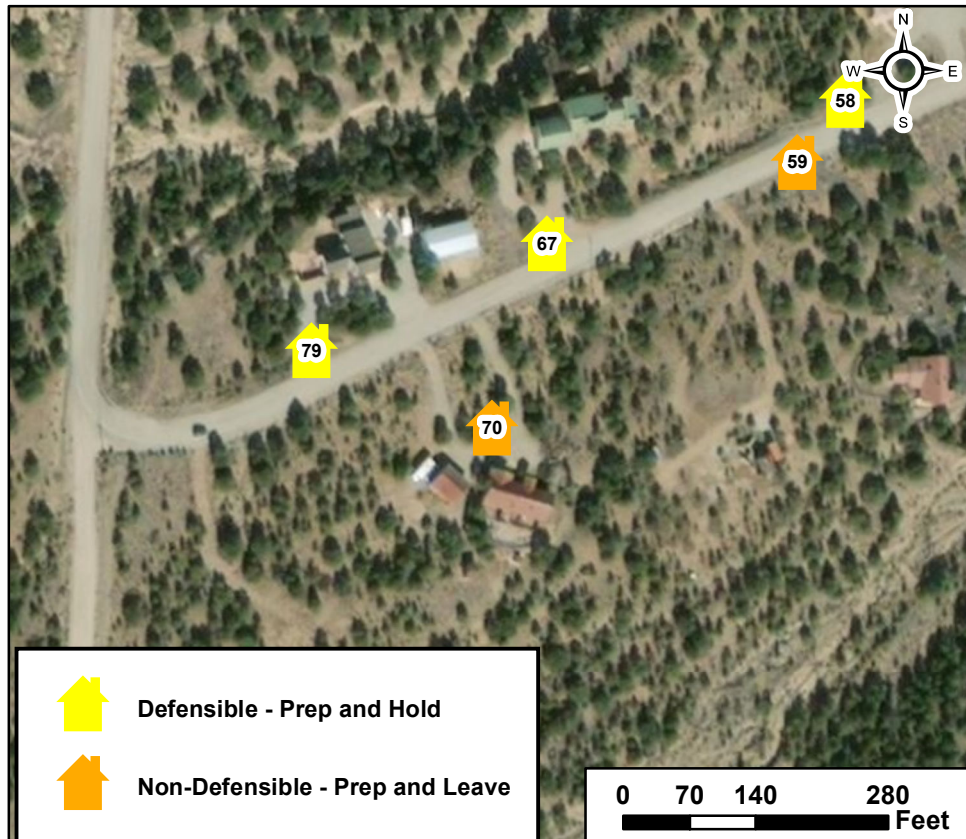
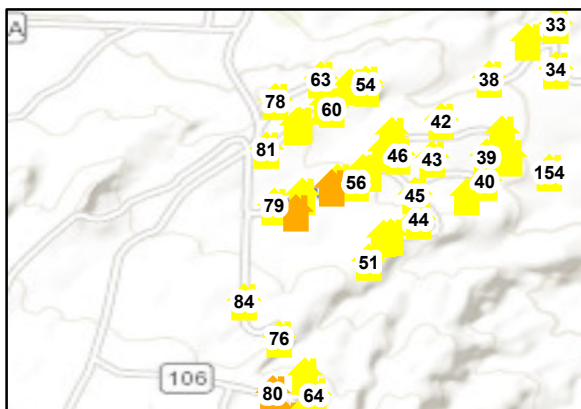
Hazards: 1 way access

Notes: Fuels close to structure

Mitigation Time (in hours): 2

Mitigation Description: Brush and grass removal

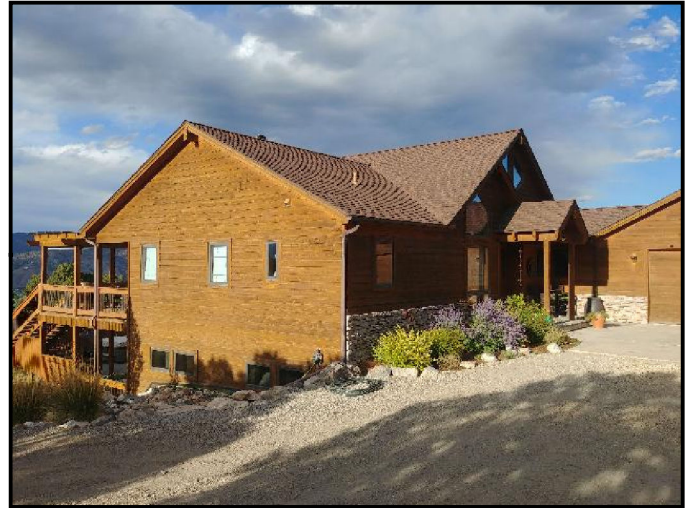
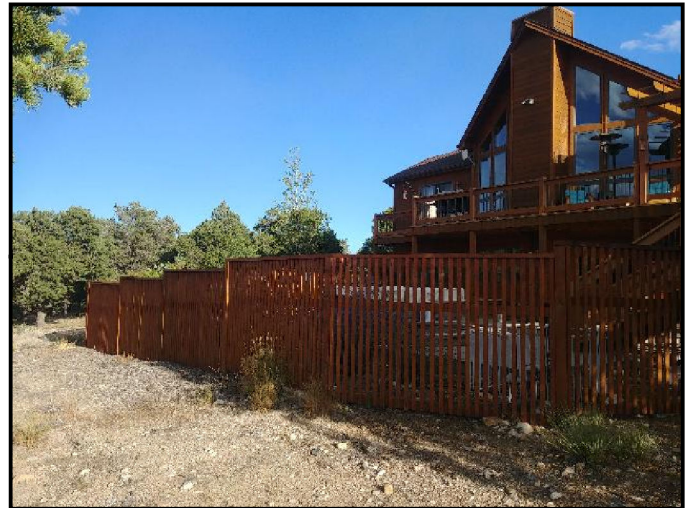
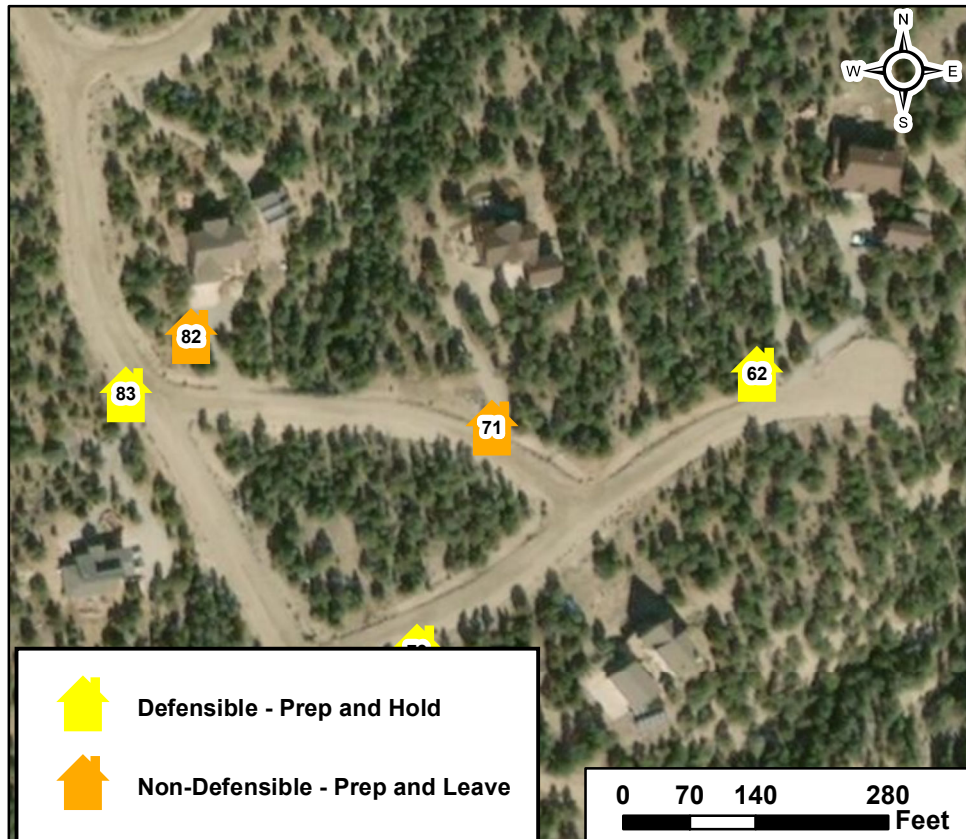
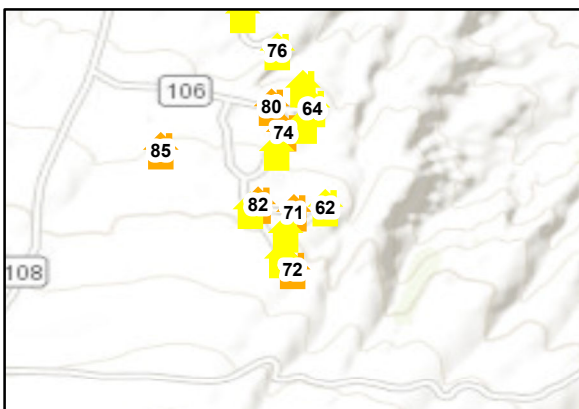
Structure ID: 71

Hazards: 1 way access

Notes: Light Fuels close to decks and fences

Mitigation Time (in hours): 4

Mitigation Description: Brush and grass removal

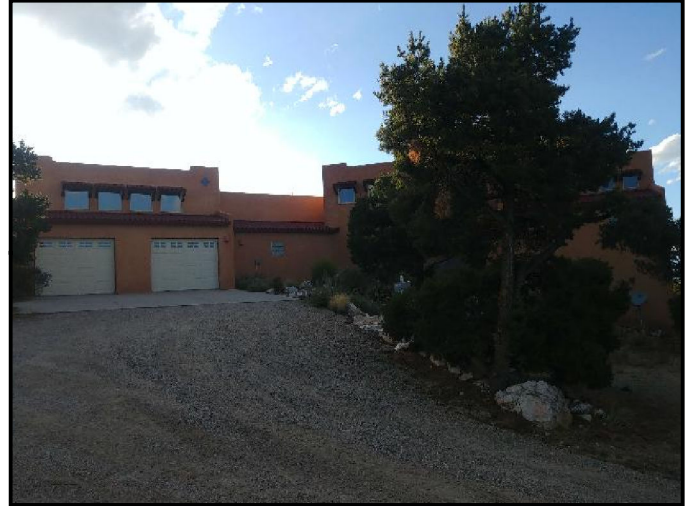
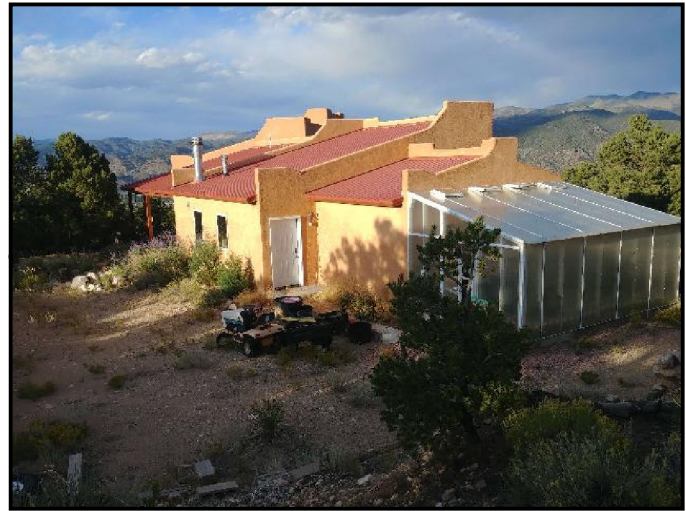
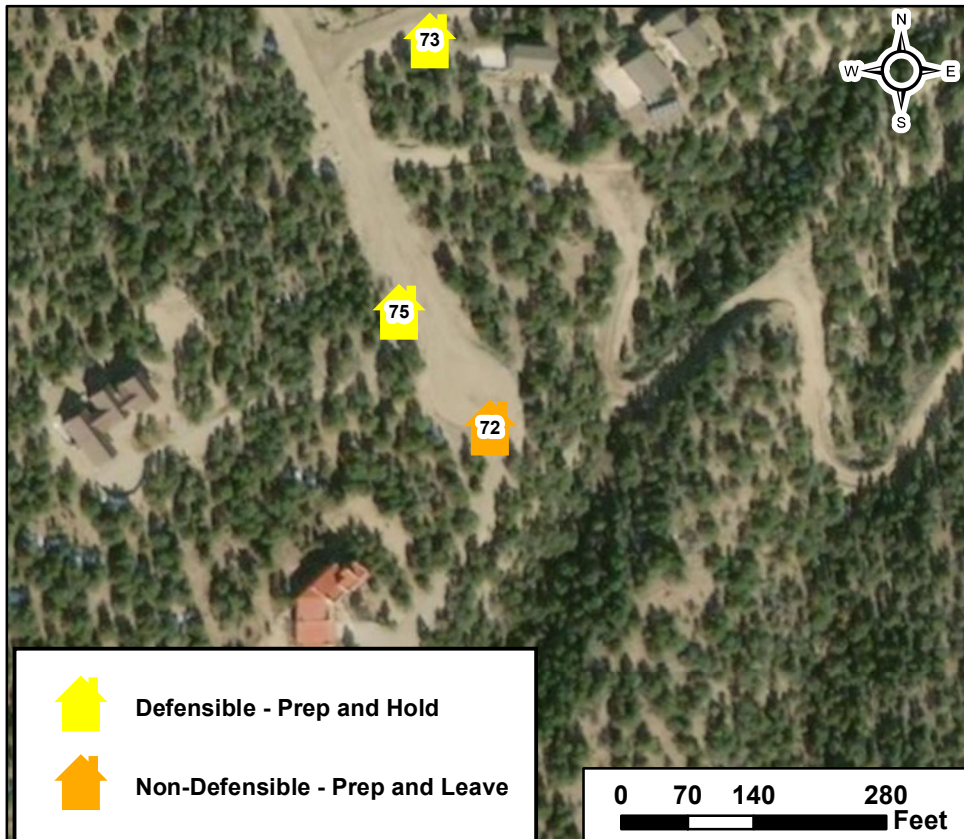
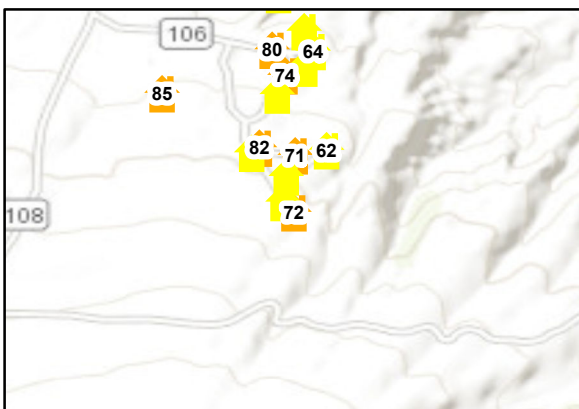
Structure ID: 72

Hazards: 1 way access

Notes: Heavy fuels inside of 30 feet from structure

Mitigation Time (in hours): 4

Mitigation Description: Brush and grass removal
