Methodist East Structure Assessment

Structure ID: 30

Collected Date/Time: 9/26/2019 12:08:00 AM
Collected By: Chris Masson
Inspector's Position: Divs

Location: 5210 east highway 50,

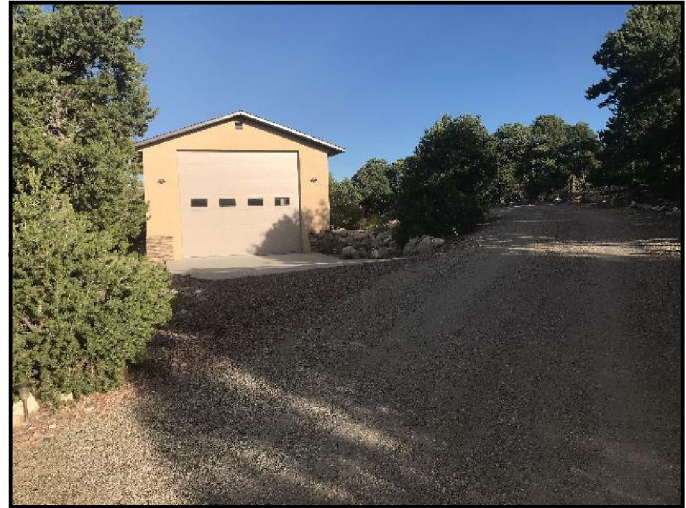
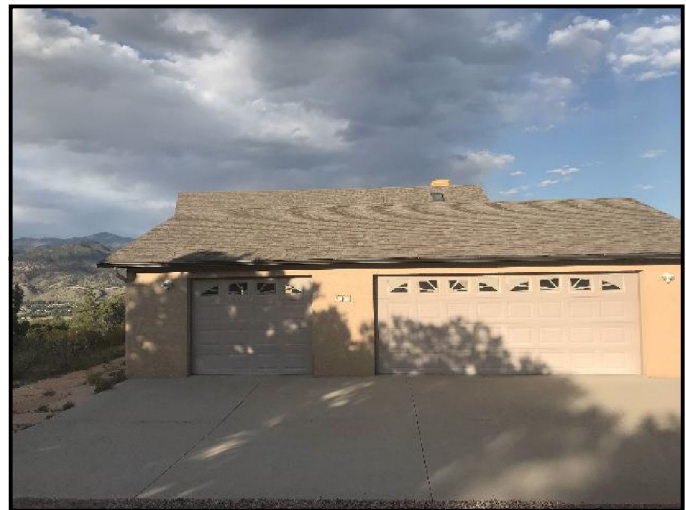
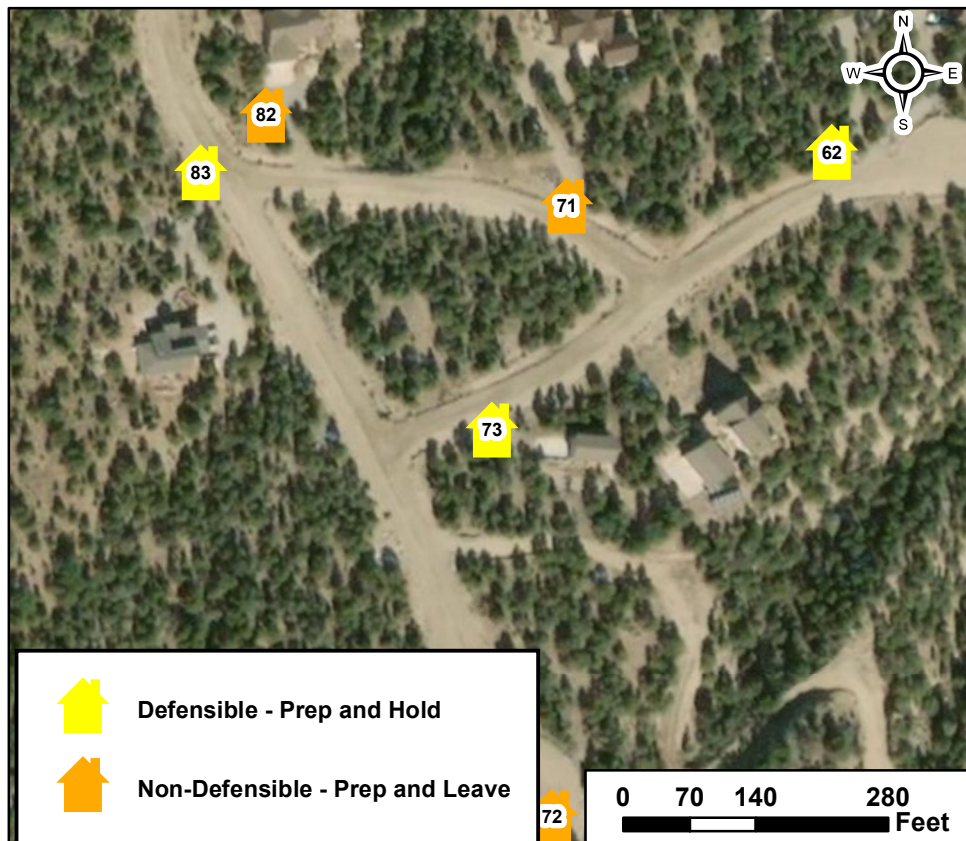
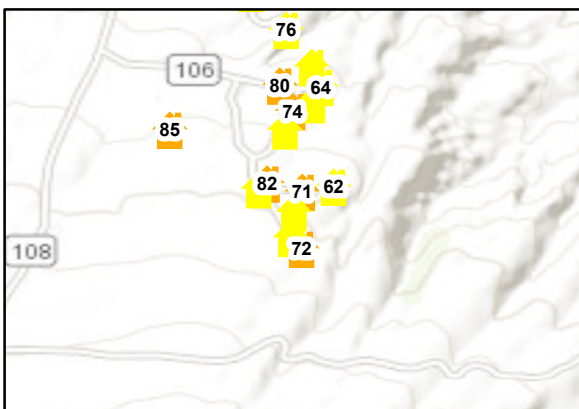
Structure ID: 73

Hazards: Fuels below structure, slope some fuels on side hill

Notes: Trex decks, multiple buildings, some fuels touching deck, traveled drive

Mitigation Time (in hours): 6

Mitigation Description: Thinning and weed whacking

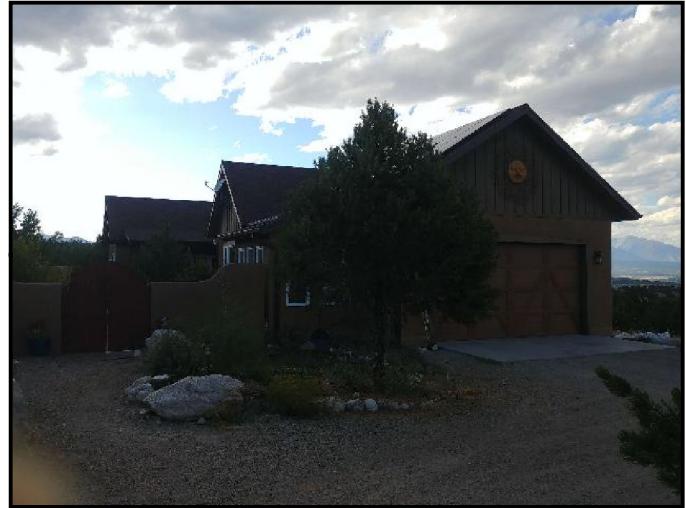
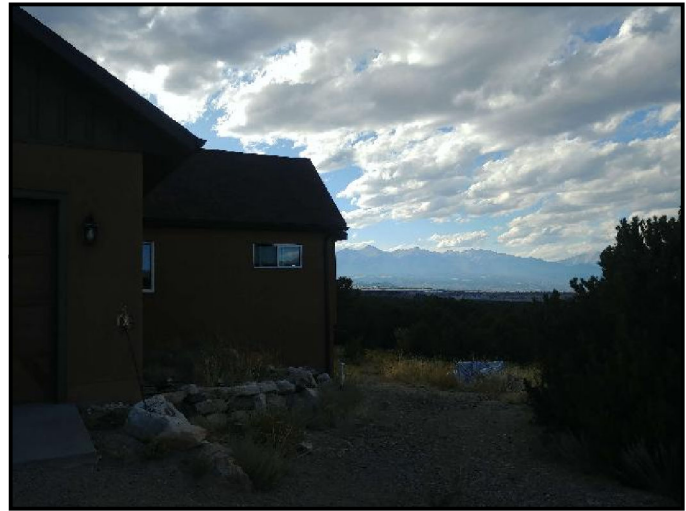
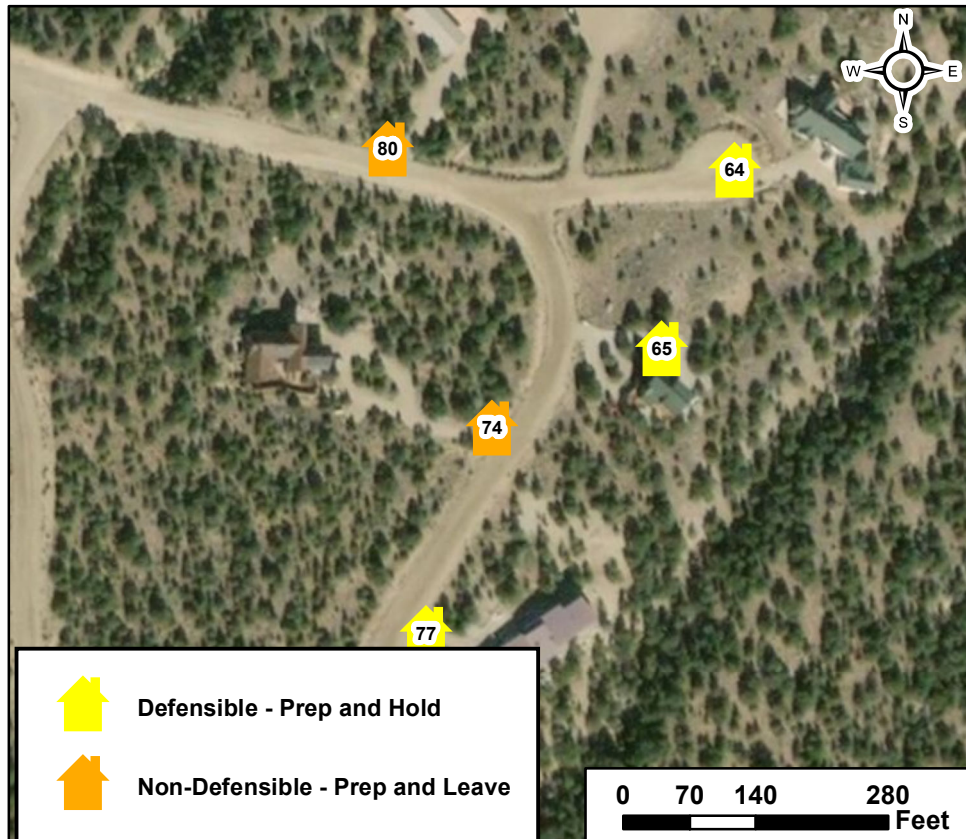
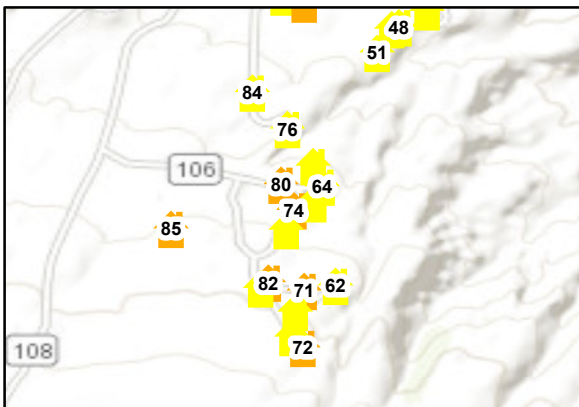
Structure ID: 74

Hazards: 1 way access

Notes: Fuels close , decks with fuels under

Mitigation Time (in hours): 4

Mitigation Description: Brush and grass removal

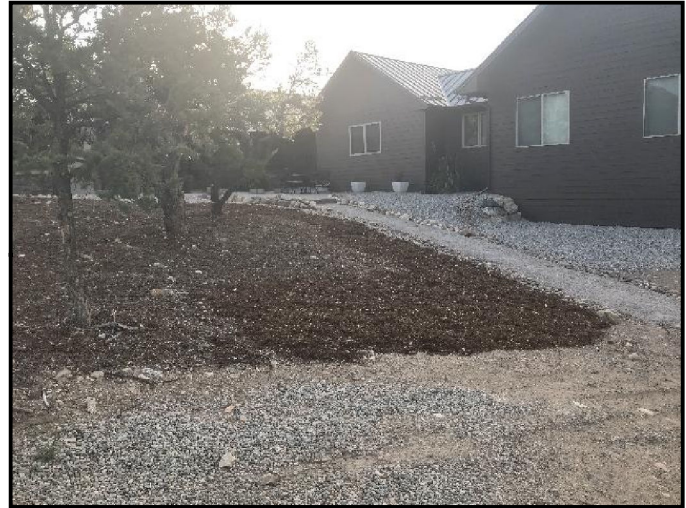
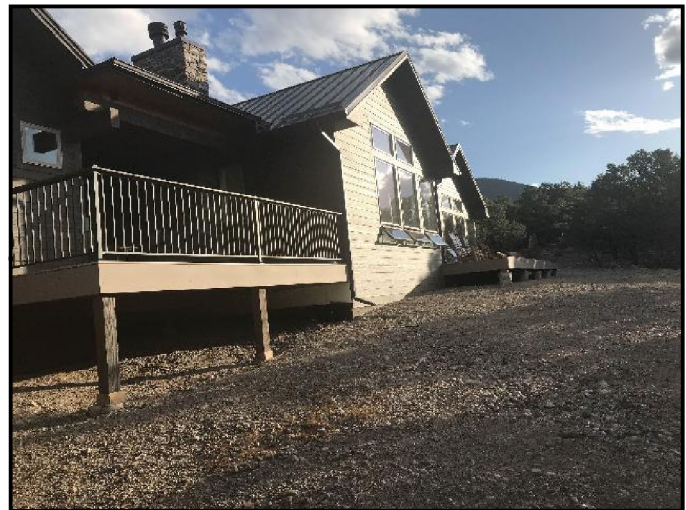
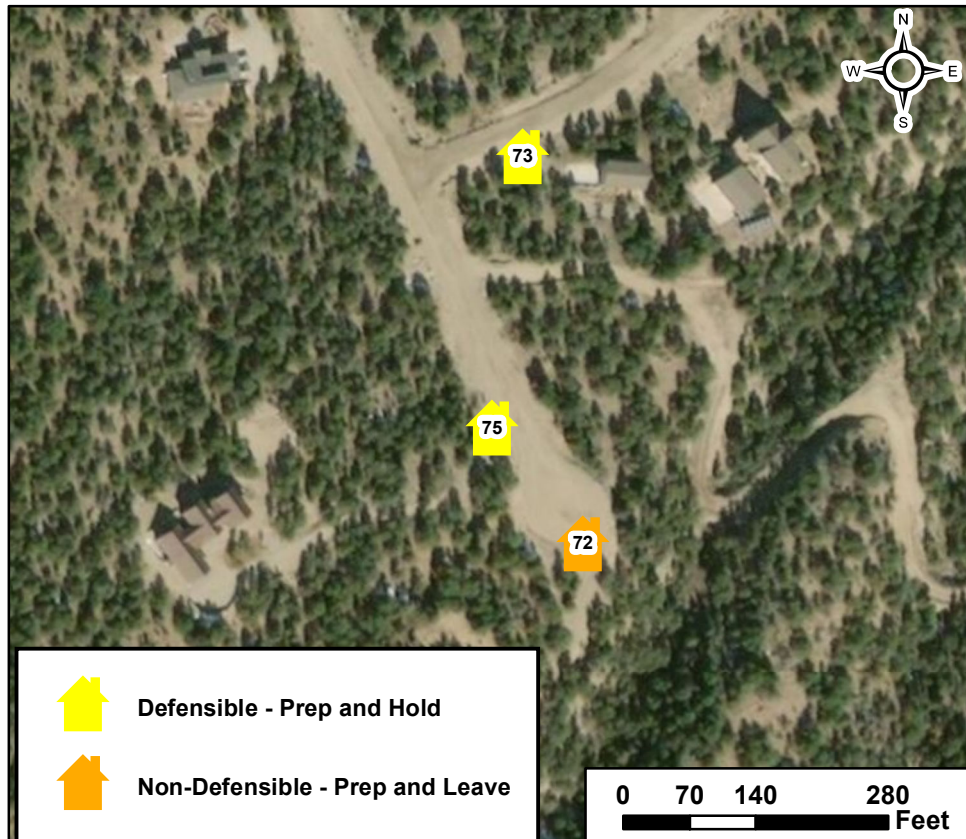
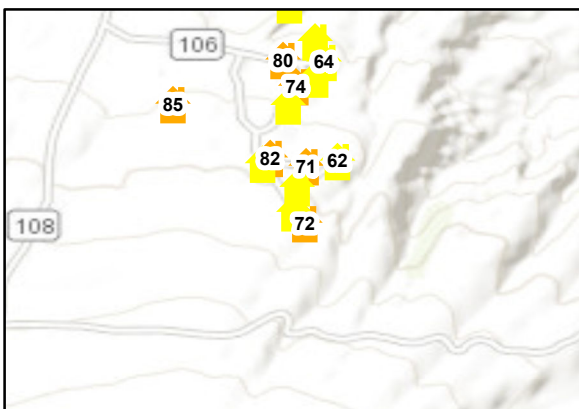
Structure ID: 75

Hazards: Fuels below structure

Notes: Gravel in drive, trex constructed decks, fuels below and on sides of structure

Mitigation Time (in hours): 6

Mitigation Description: Thinning

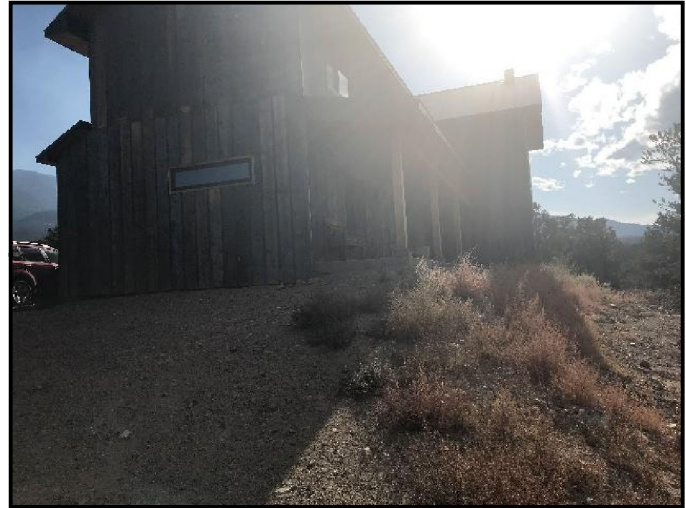
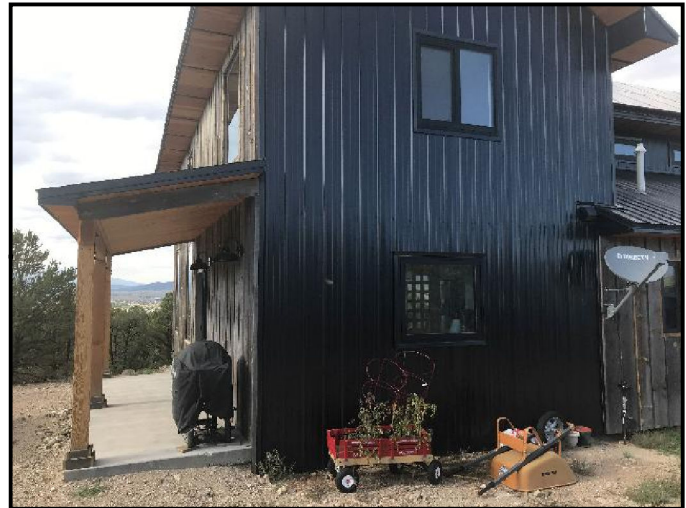
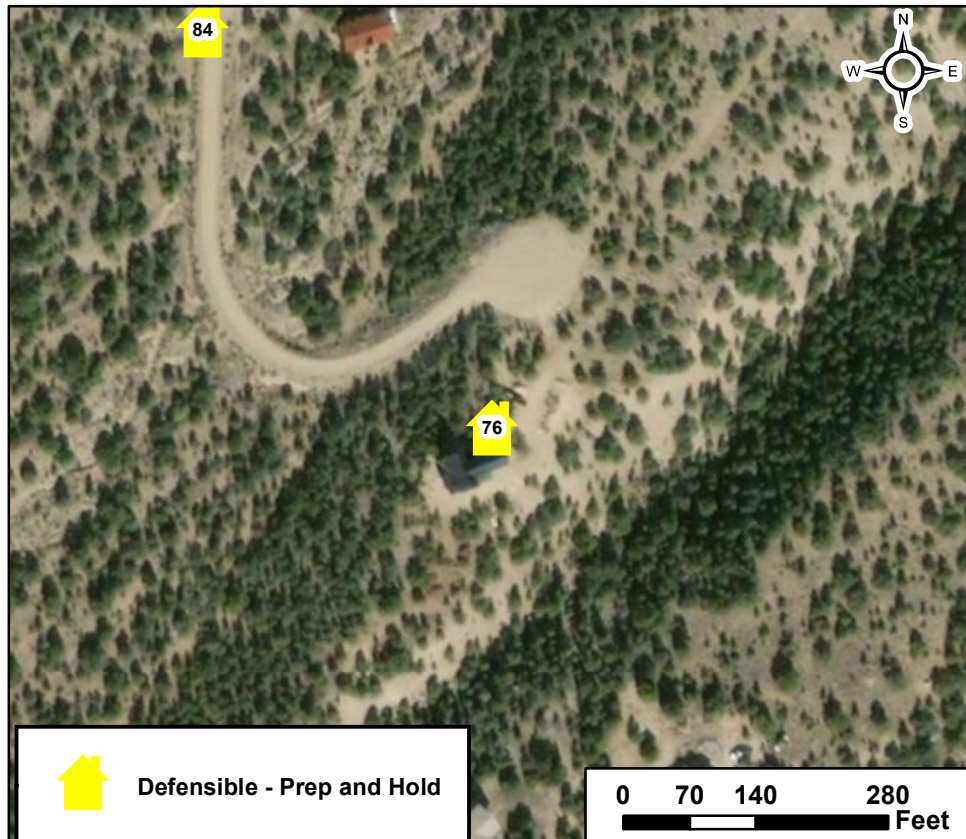
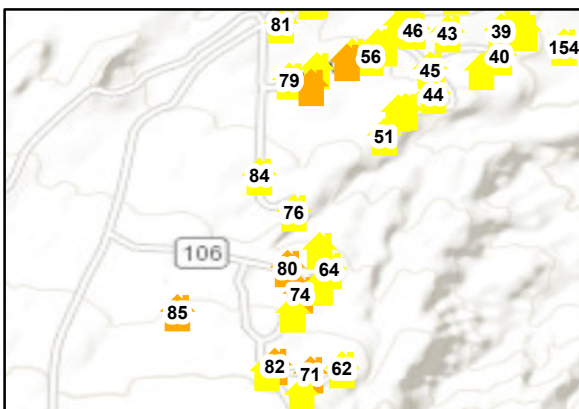
Triage Category: Defensible, Prep and Hold
Type of Structure: Residential
Primary Structures:
Is the building Occupied?: Yes
Outbuildings: 0
Fuel Surrounding Structure: Shrub or timber
Defensible Space: Less Than 30 ft treated
Roof Material: Noncombustible or not applicable
Siding Material: Wood or open sided
Electrical Power: Yes
Gas to Structure: Yes
Hazards: Fuels below structure, slope
Access to Site: T6 Engine
Describe Access: One way in and out
Comm With ICP: No
Water Source: Limited or dependent on electricity
Safety Zone Present: Potential safety zone(s) in area

Notes: Fuel loading below residence and behind

Mitigation Time (in hours): 6

Mitigation Description: Thinning

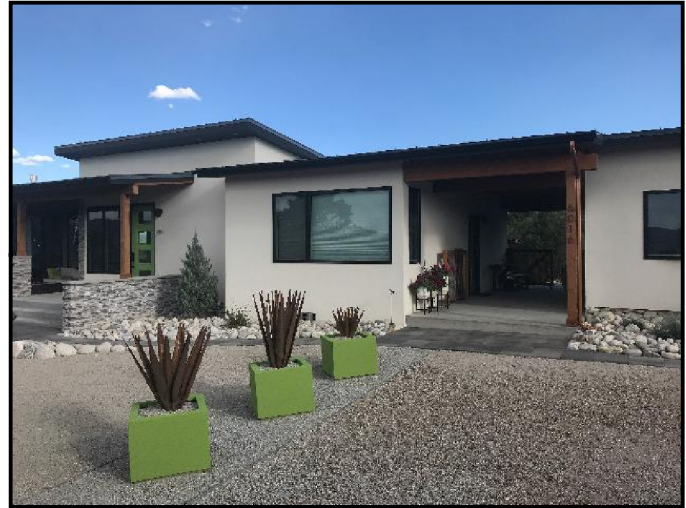
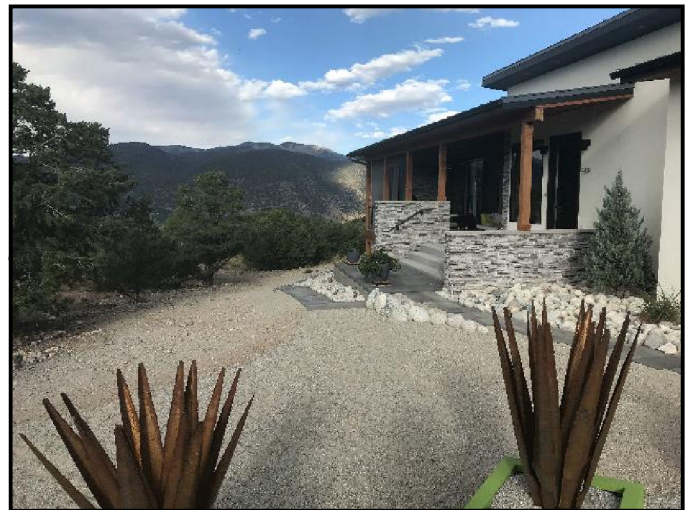
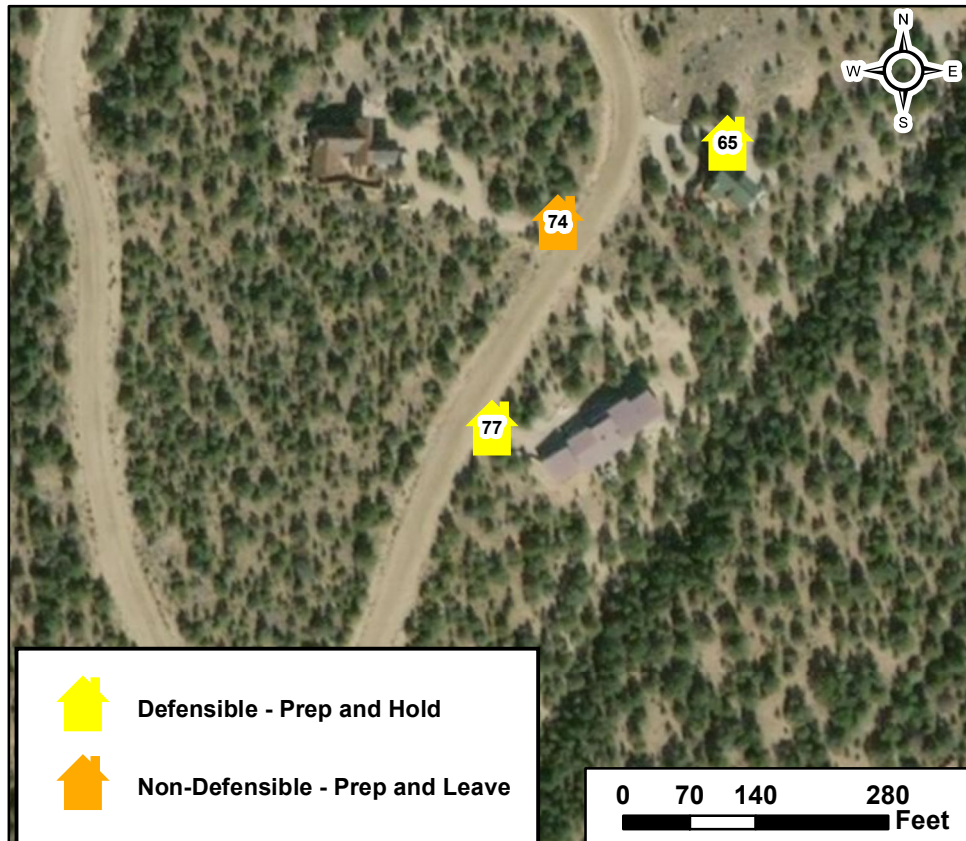
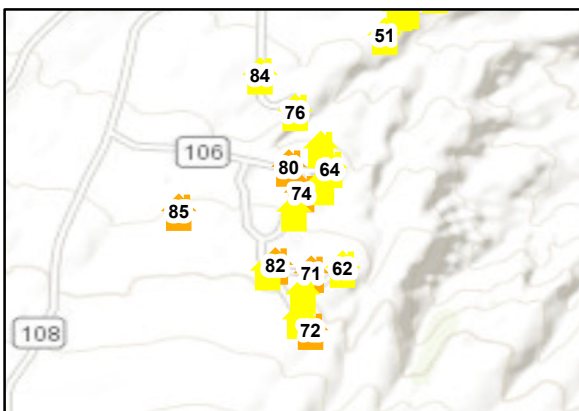
Structure ID: 77

Triage Category: Defensible, Prep and Hold
Type of Structure: Residential
Primary Structures:
Is the building Occupied?: Yes
Outbuildings: 0
Fuel Surrounding Structure: Shrub or timber
Defensible Space: Less Than 30 ft treated
Roof Material: Noncombustible or not applicable
Siding Material: Rock, concrete, metal
Electrical Power: Yes
Gas to Structure: Yes
Hazards: Fuels below structure and on flanks
Access to Site: T6 Engine
Describe Access: One way in and out
Comm With ICP: No
Water Source: Limited or dependent on electricity
Safety Zone Present: Potential safety zone(s) in area

Notes: Structure has gravel perimeter 3/4.

Fuel loading below residence, trex deck

Mitigation Time (in hours): 6

Mitigation Description: Thinning

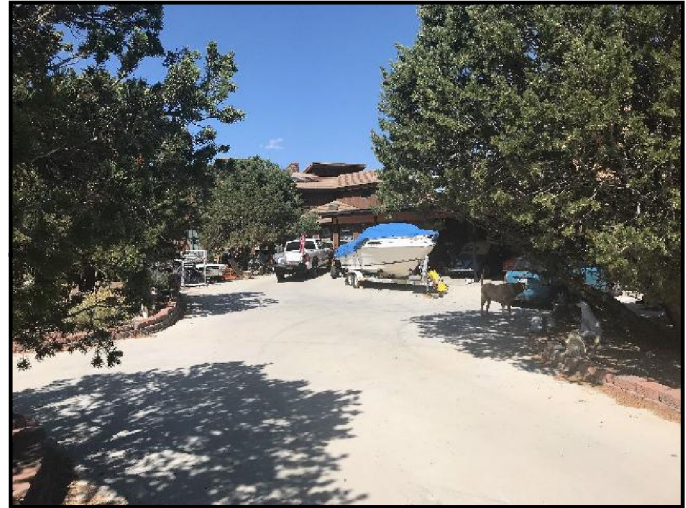
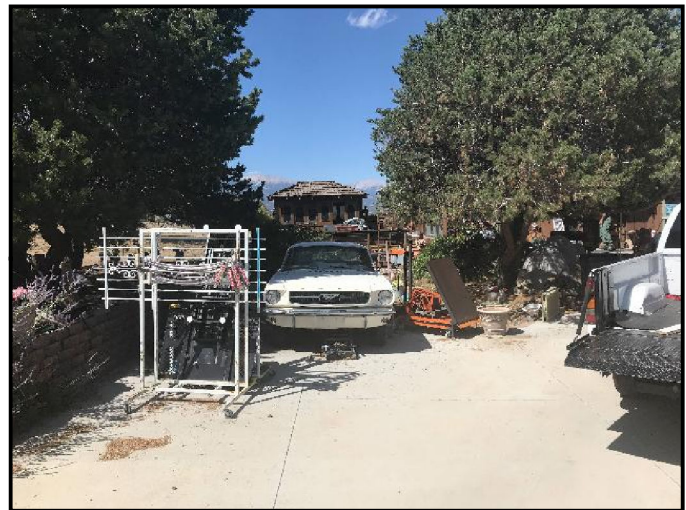
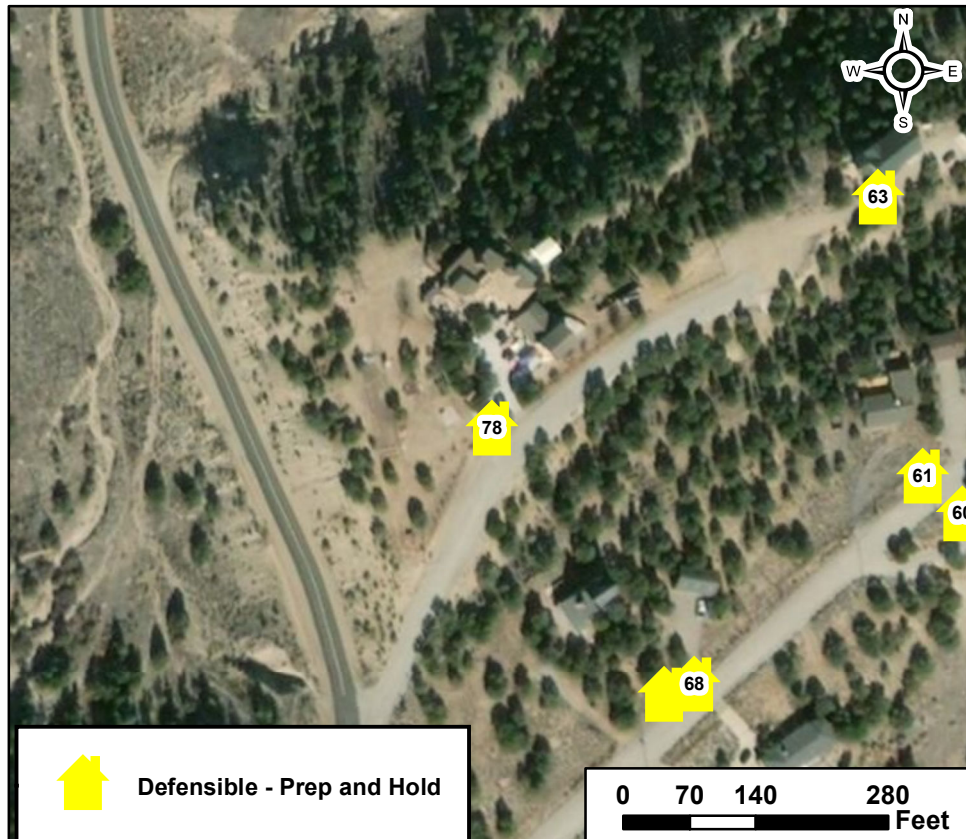
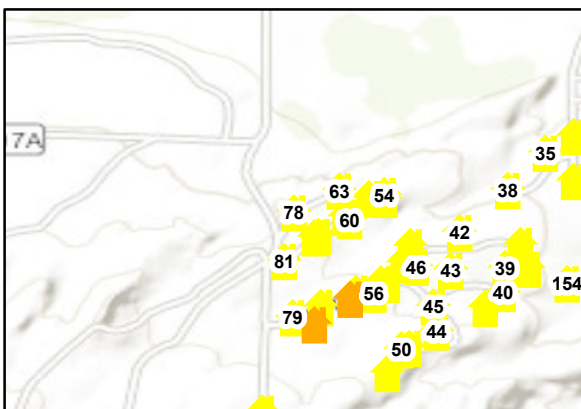
Structure ID: 78

Triage Category: Defensible, Prep and Hold
Type of Structure: Residential
Primary Structures:
Is the building Occupied?: Yes
Outbuildings: 2
Fuel Surrounding Structure: Shrub or timber
Defensible Space: Less Than 30 ft treated
Roof Material: Combustible or no roof
Siding Material: Wood or open sided
Electrical Power: Yes
Gas to Structure: Yes
Hazards: Fuels below structure
Access to Site: T6 Engine
Describe Access: One way in and out
Comm With ICP: No
Water Source: Limited or dependent on electricity
Safety Zone Present: Potential safety zone(s) in area

Notes: Structure has cement driveway. Fuel loading below residence, shake shingles, multiple vehicles, debris, wooden fence w/ fuels touching

Mitigation Time (in hours): 6

Mitigation Description: Thinning

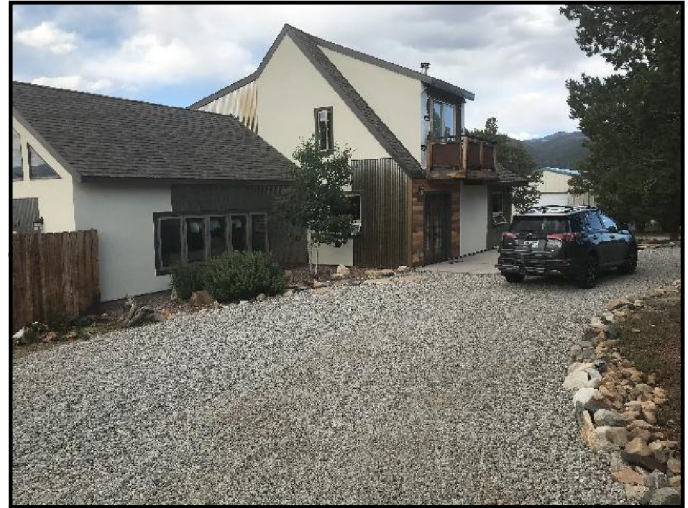
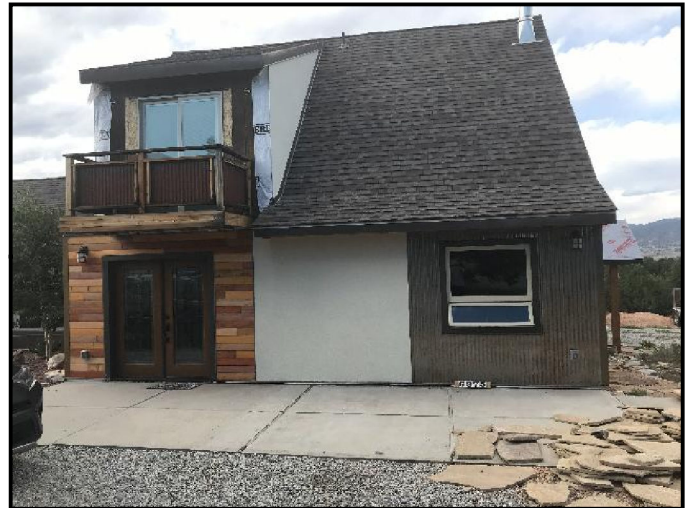
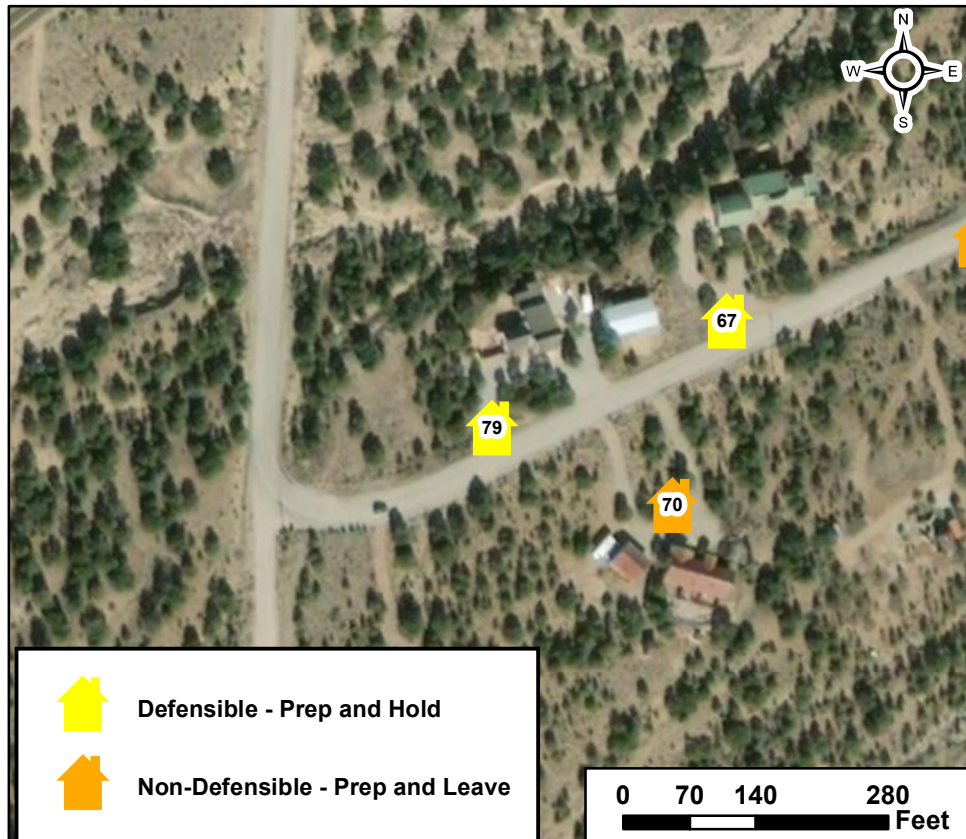
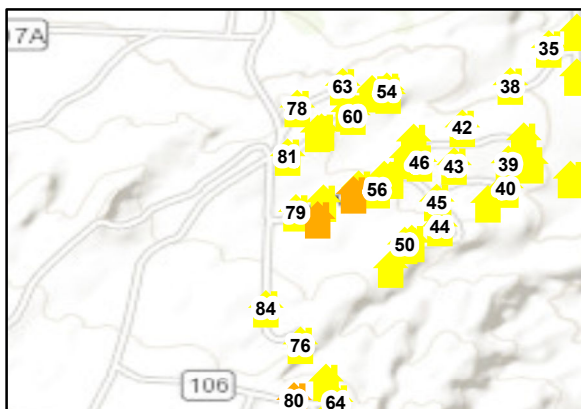
Structure ID: 79

Triage Category: Defensible, Prep and Hold
Type of Structure: Residential
Primary Structures:
Is the building Occupied?: Yes
Outbuildings: 1
Fuel Surrounding Structure: Shrub or timber
Defensible Space: Less Than 30 ft treated
Roof Material: Fire resistant- tar,rubberized
Siding Material: Rock, concrete, metal
Electrical Power: Yes
Gas to Structure: Yes
Hazards: Fuels below structure, some slope
Access to Site: T6 Engine
Describe Access: One way in and out
Comm With ICP: No
Water Source: Limited or dependent on electricity
Safety Zone Present: Potential safety zone(s) in area

Notes: Structure has gravel perimeter 3/4.

Mitigation Time (in hours): 6

Mitigation Description: Thinning

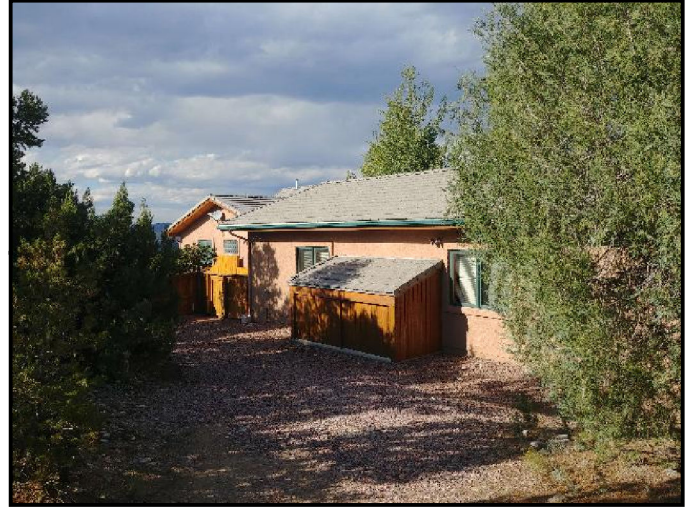
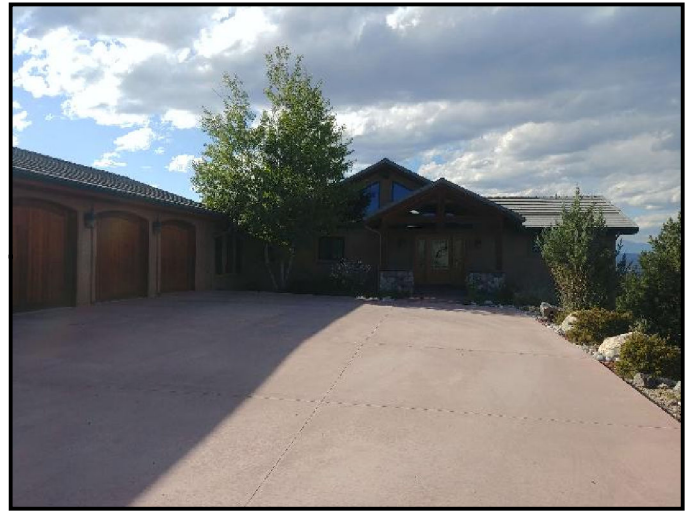
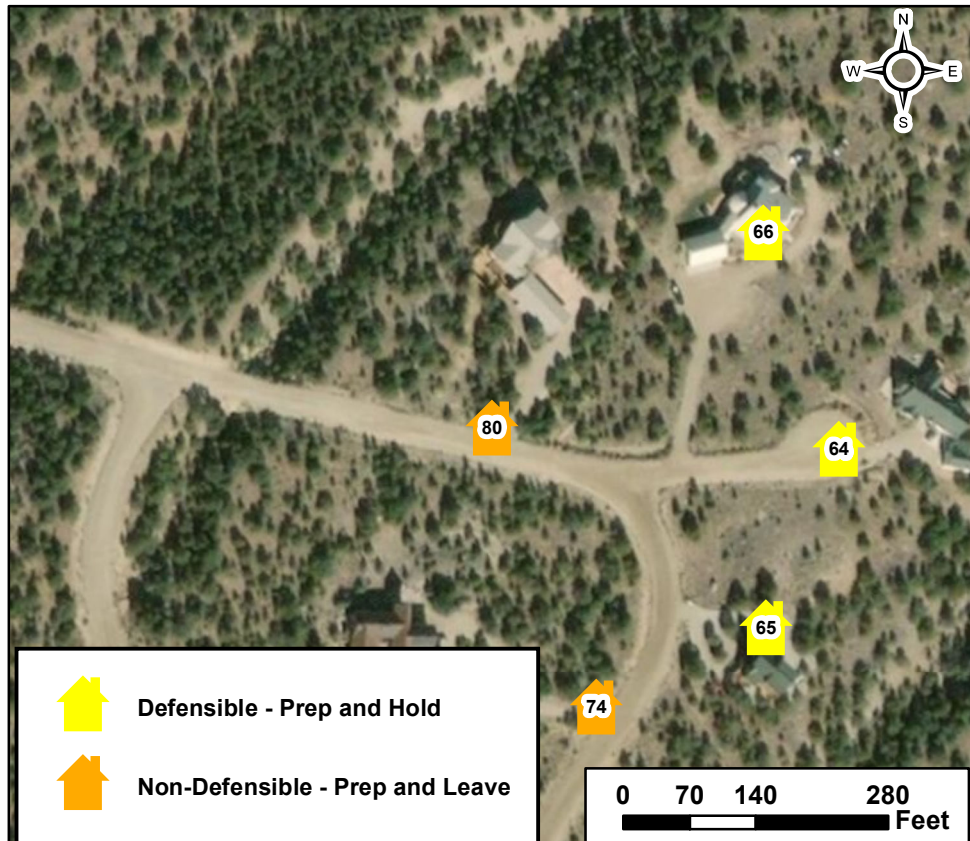
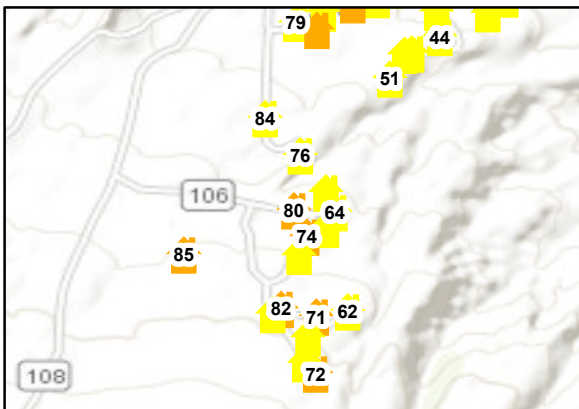
Structure ID: 80

Hazards: 1 way access

Notes: Fuels close, decks with fuels under deck and fences touching timber and brush

Mitigation Time (in hours): 6

Mitigation Description: Brush and grass removal

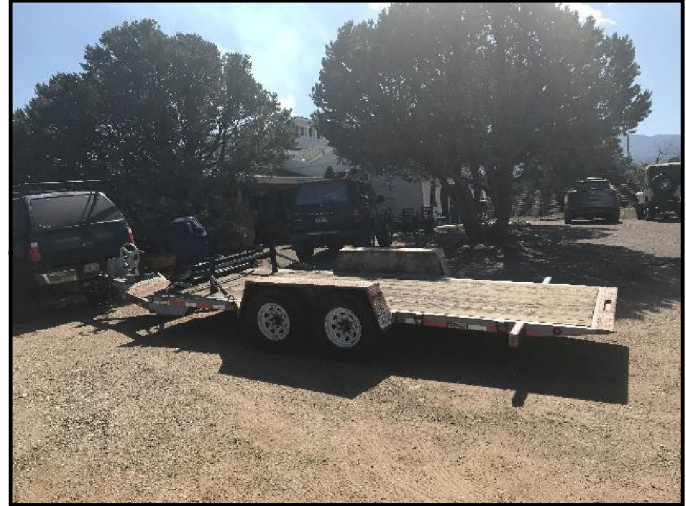
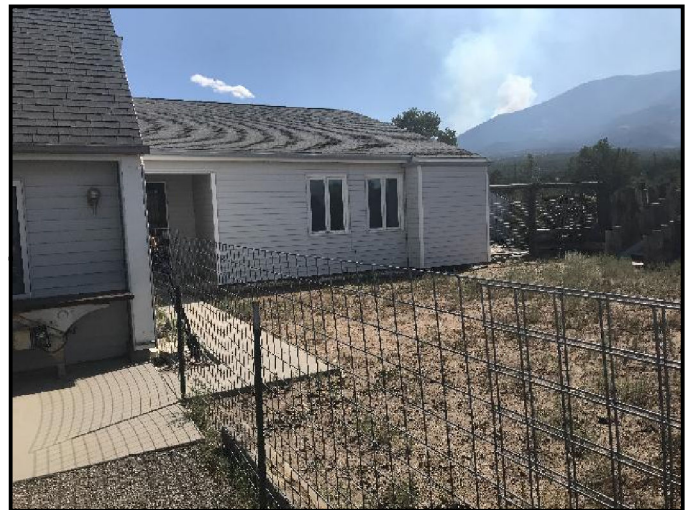
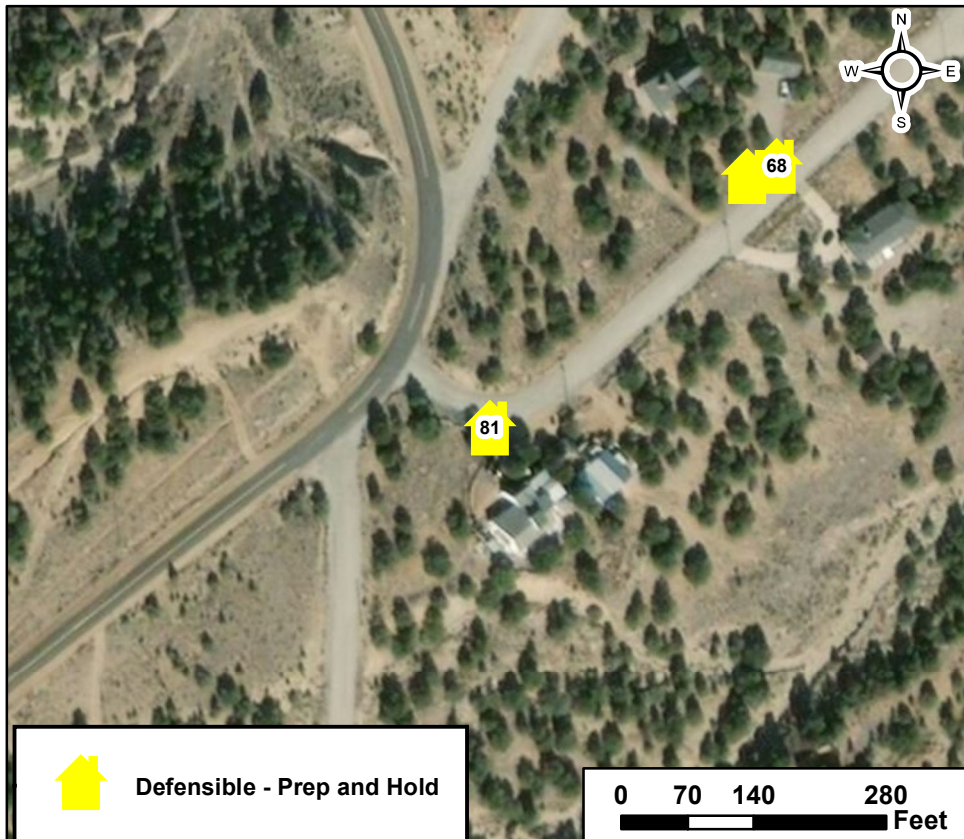
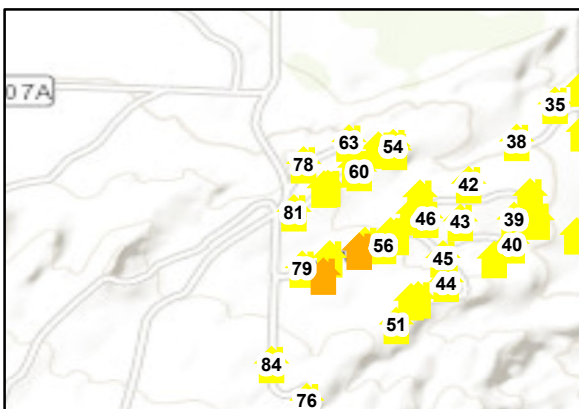
Structure ID: 81

Hazards: Fuels below structure

Notes: Fuel loading below residence, wooden fence, debris

Mitigation Time (in hours): 6

Mitigation Description: Thinning

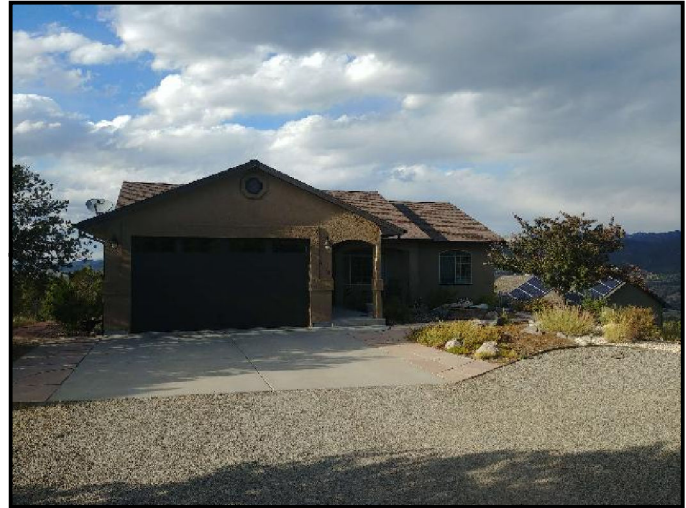
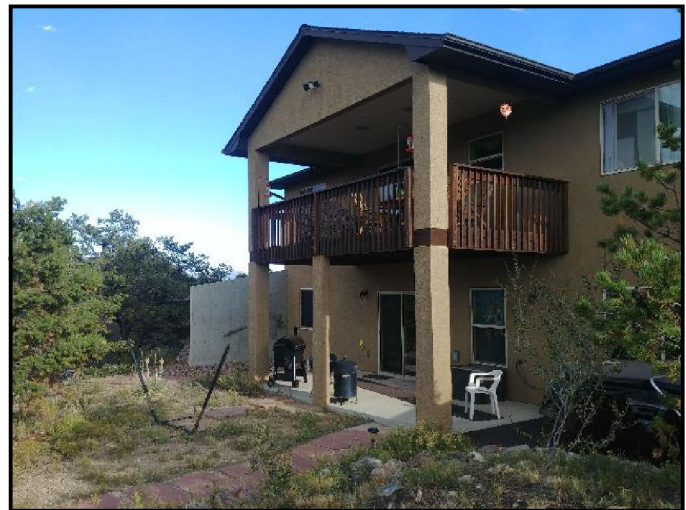
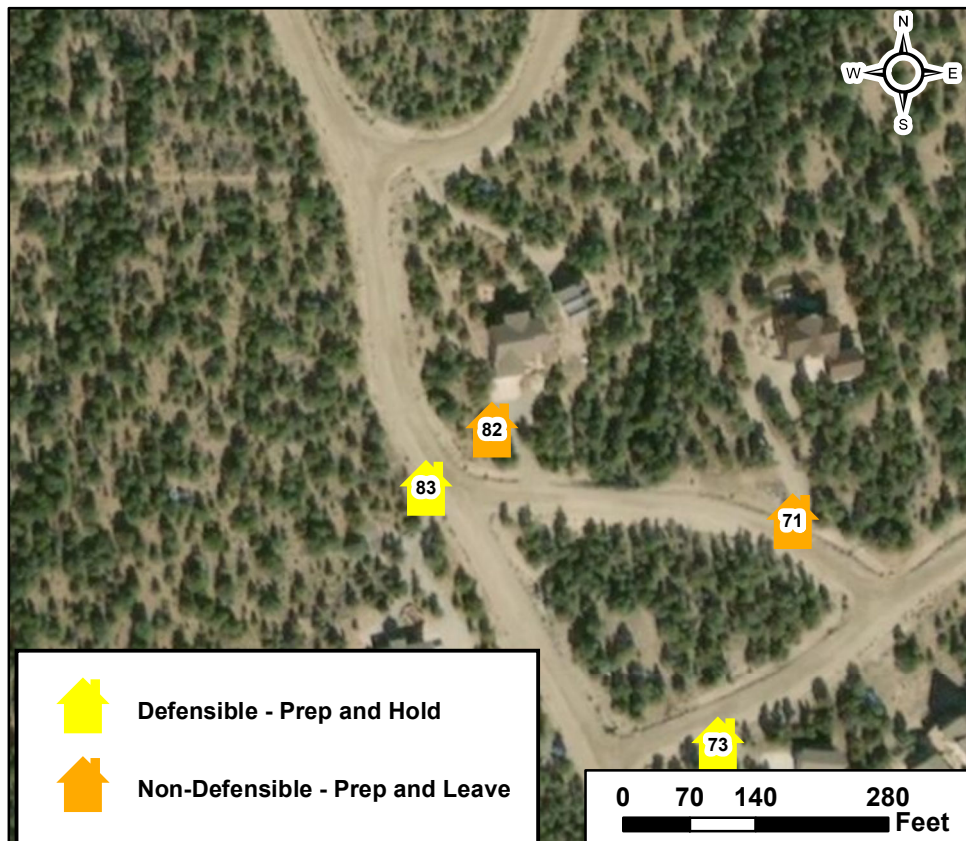
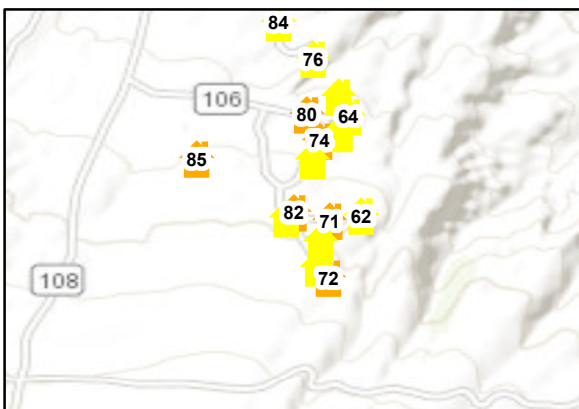
Hazards: 1 way access

Notes: Heavy fuels with in 30 feet of structure

Mitigation Time (in hours): 6

Mitigation Description: Brush and grass removal

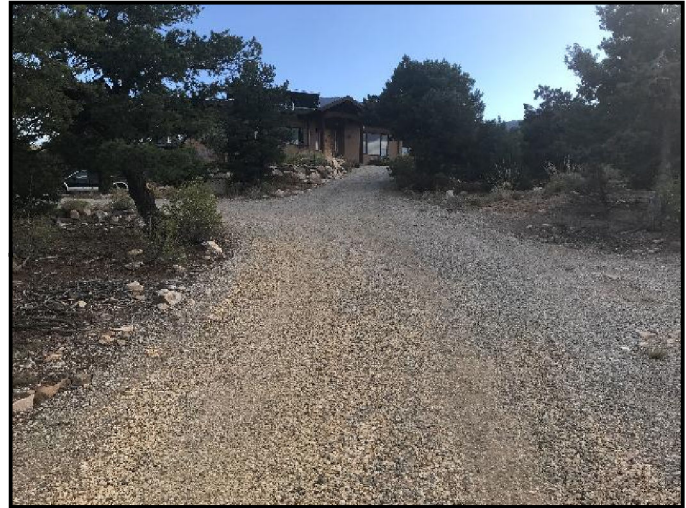
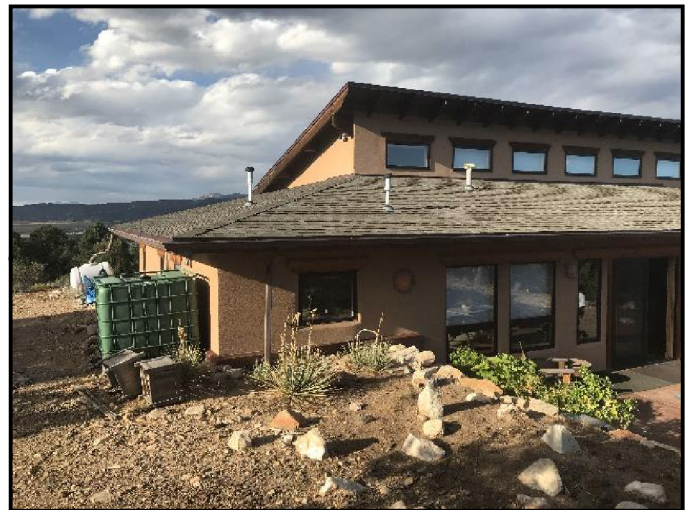
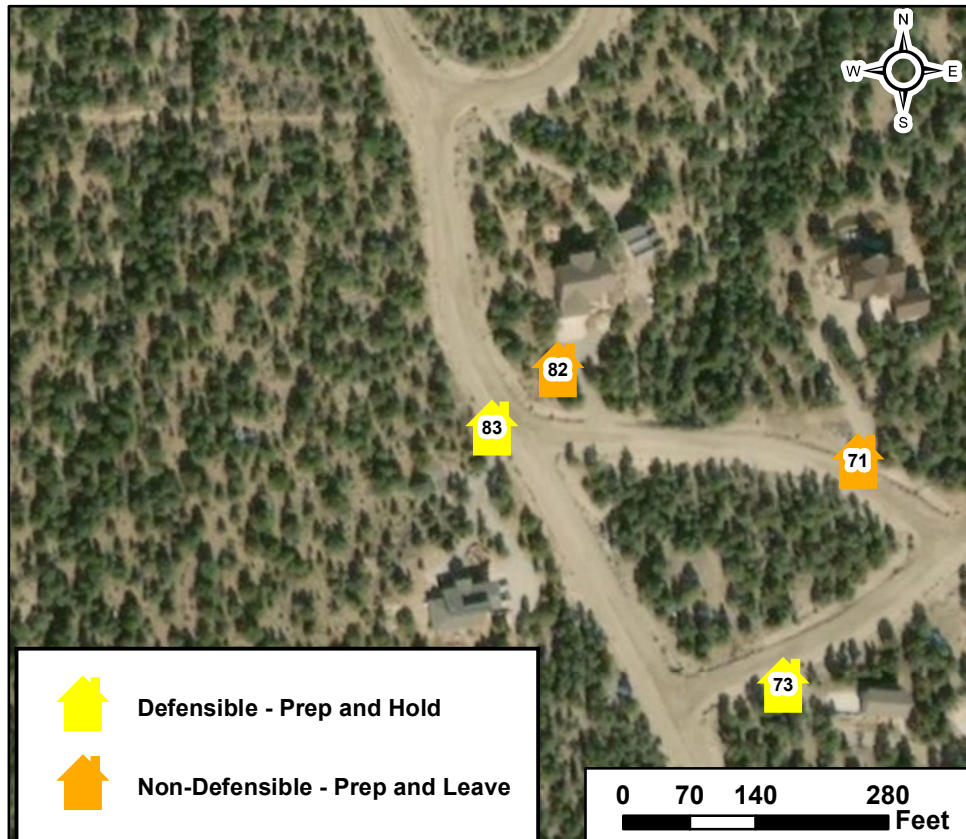
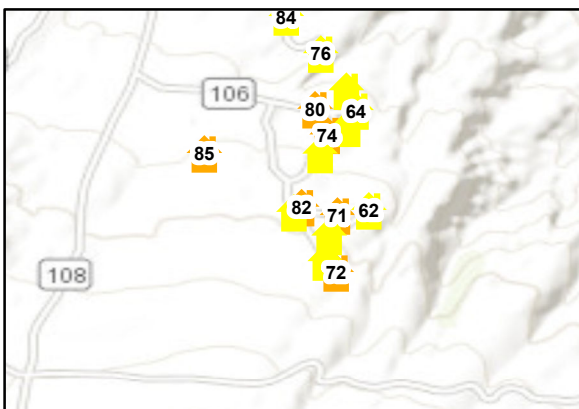
Structure ID: 83

Hazards: Fuels below structure and below.

Notes: Water available at structure 400 gallons with pump. Patio made of concrete, gravel driveway. Some thinning completed.

Mitigation Time (in hours): 6

Mitigation Description: Thinning

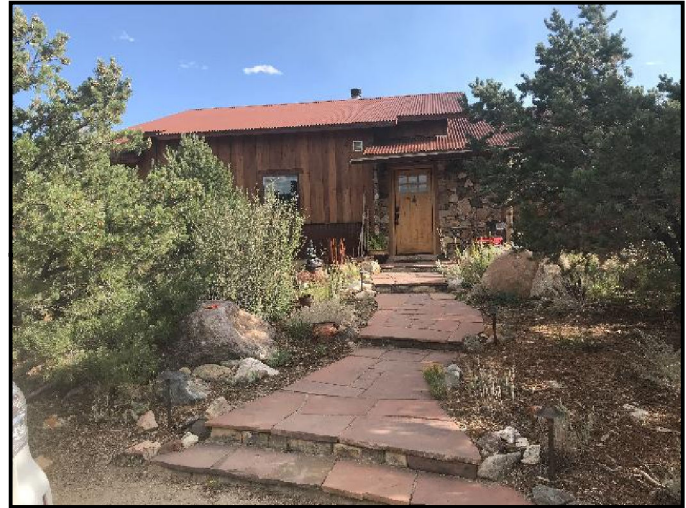
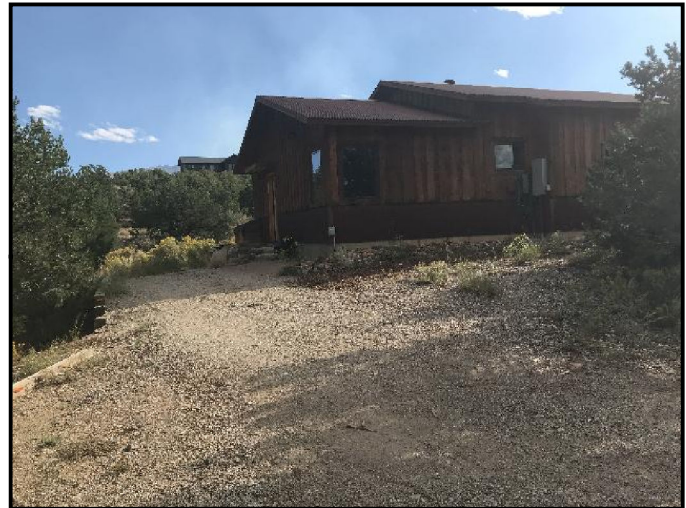
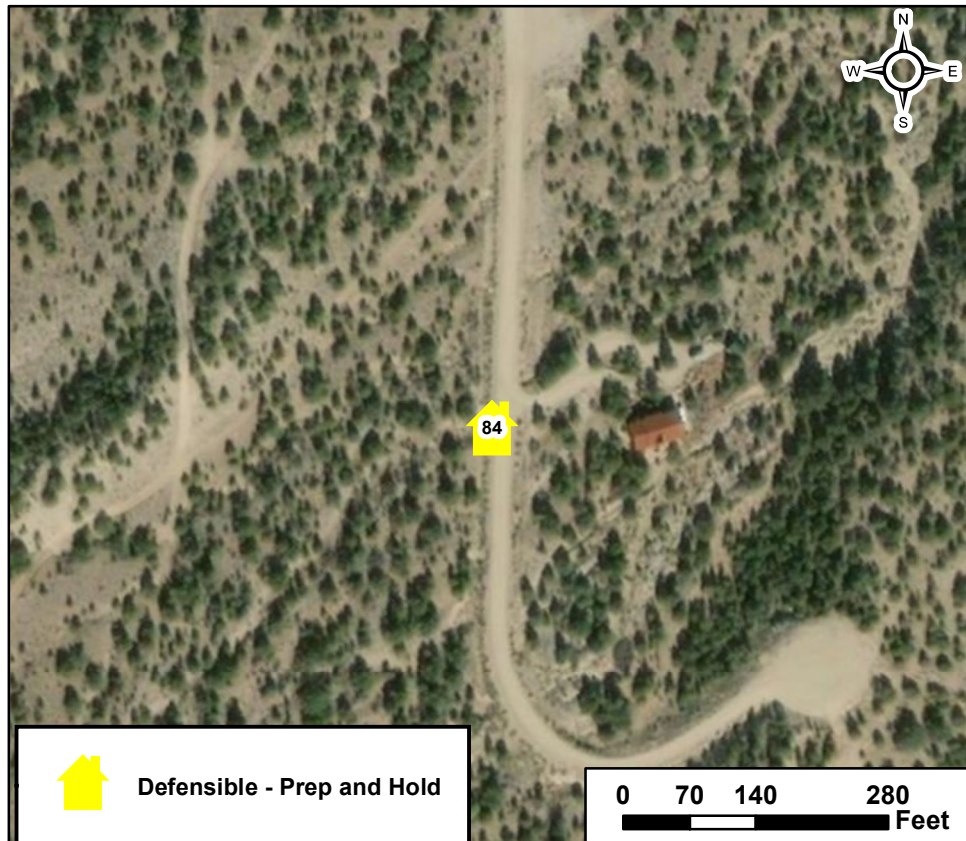
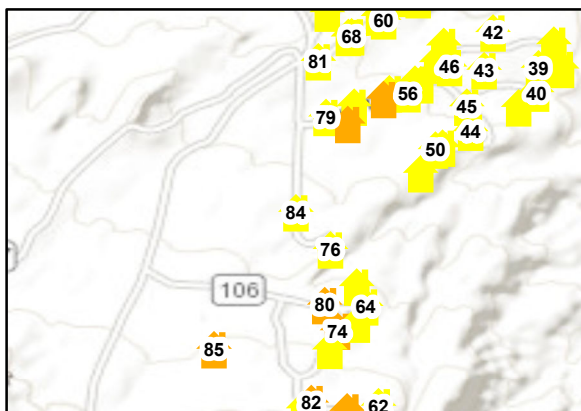
Structure ID: 84

Triage Category: Defensible, Prep and Hold
Type of Structure: Residential
Primary Structures:
Is the building Occupied?: Yes
Outbuildings: 0
Fuel Surrounding Structure: Shrub or timber
Defensible Space: Less Than 30 ft treated
Roof Material: Noncombustible or not applicable
Siding Material: Log construction
Electrical Power: Yes
Gas to Structure: Yes
Hazards: Fuels below/around structure
Access to Site: T6 Engine
Describe Access: One way in and out
Comm With ICP: No
Water Source: Limited or dependent on electricity
Safety Zone Present: Potential safety zone(s) in area

Notes: Structure has gravel perimeter 2/3.
Fuel loading below residence and on flanks

Mitigation Time (in hours): 6

Mitigation Description: Thinning
