Methodist East Structure Assessment

Structure ID: 30

Collected Date/Time: 9/26/2019 12:08:00 AM
Collected By: Chris Masson
Inspector's Position: Divs

Location: 5210 east highway 50,

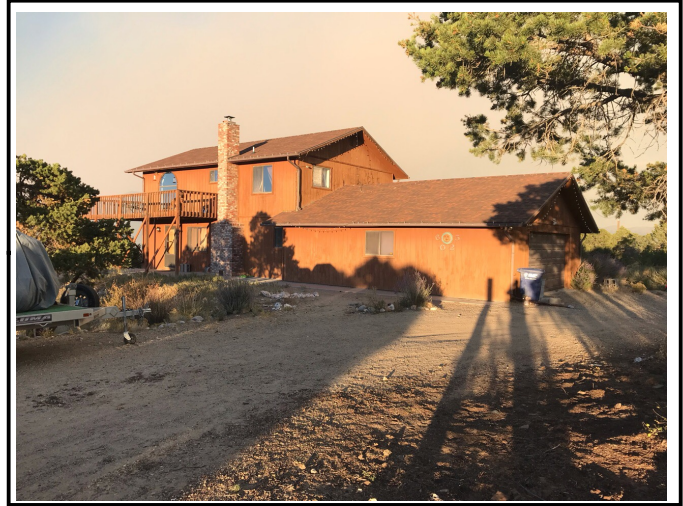
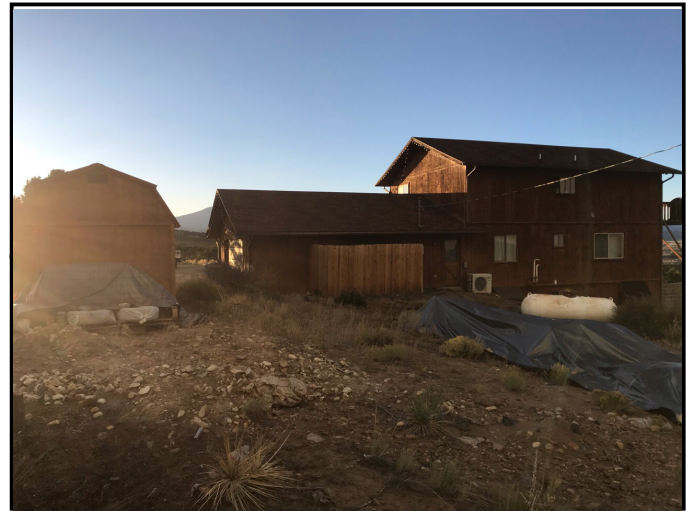
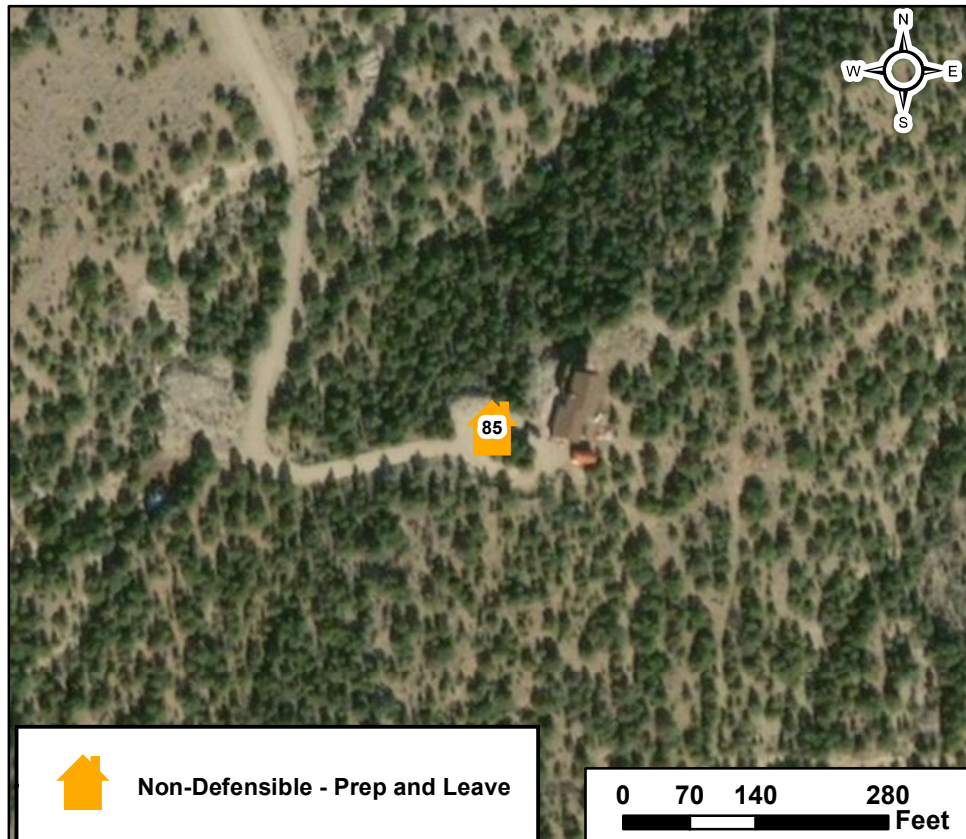
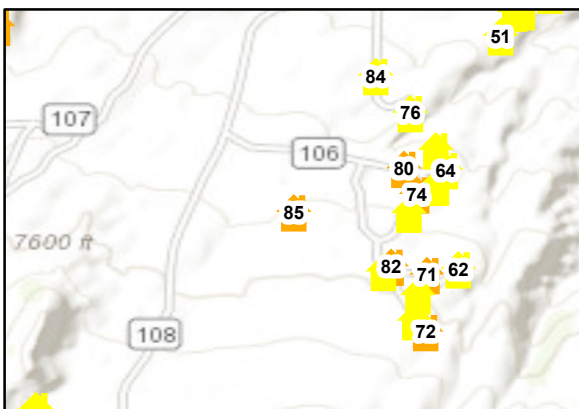
Hazards: One way in one way out

Notes: Structure is well maintained

Mitigation Description: Mitigation has been completed. Brushed 30 ft. Around

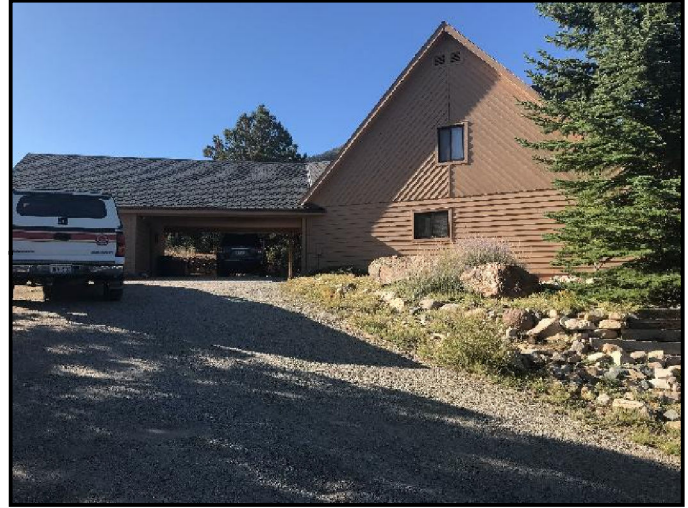
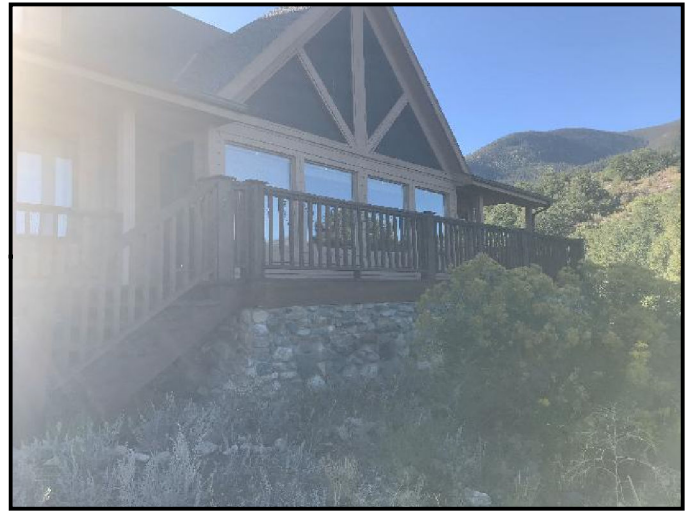
Notes: Structure has some gravel perimeter. Fuel loading below residence, wooden deck

Mitigation Description: Thinning and weed whacking

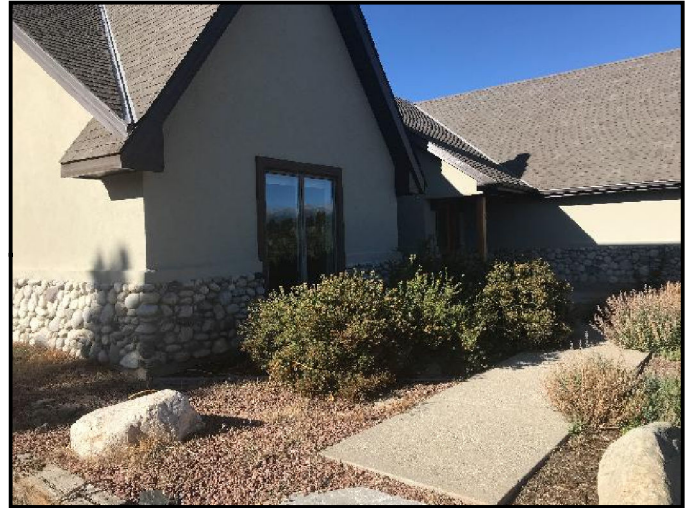
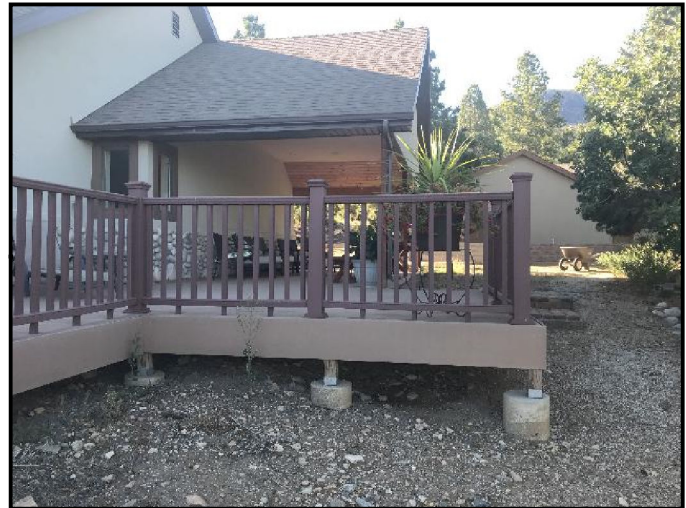
Notes: Fuel loading below residence and above, trex deck

Mitigation Time (in hours): 6
Mitigation Description: Thinning and weed whacking

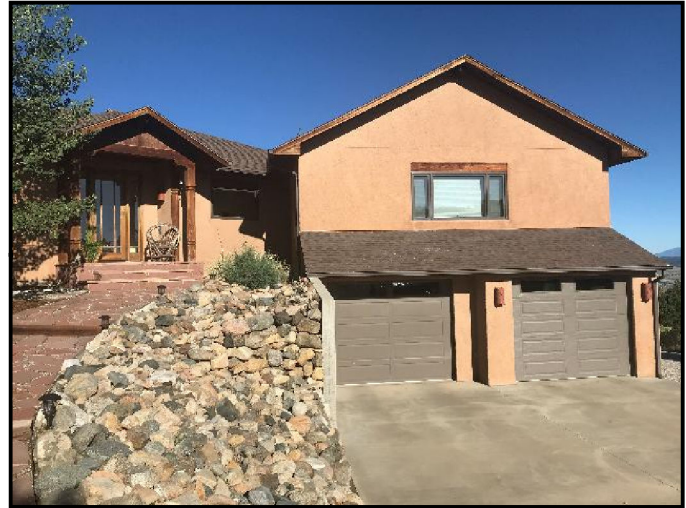
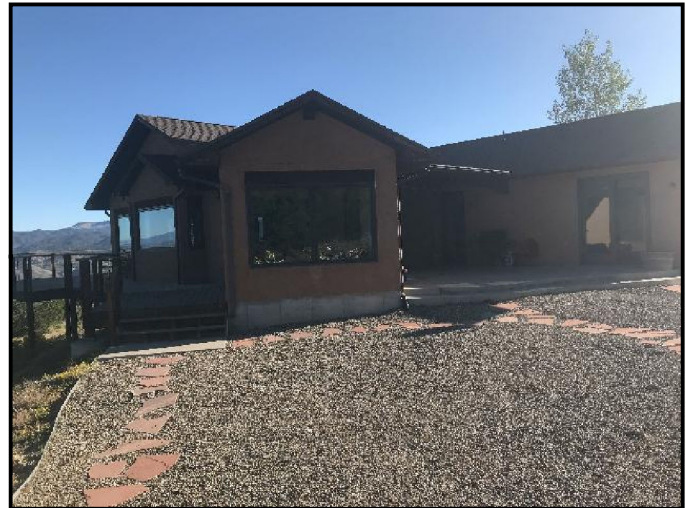
Structure ID: 88

Hazards: Fuels below structure

Notes: Structure has gravel perimeter. Fuel loading below residence, wrap around wooden deck, some thinning around property

Mitigation Description: Thinning and weed whacking

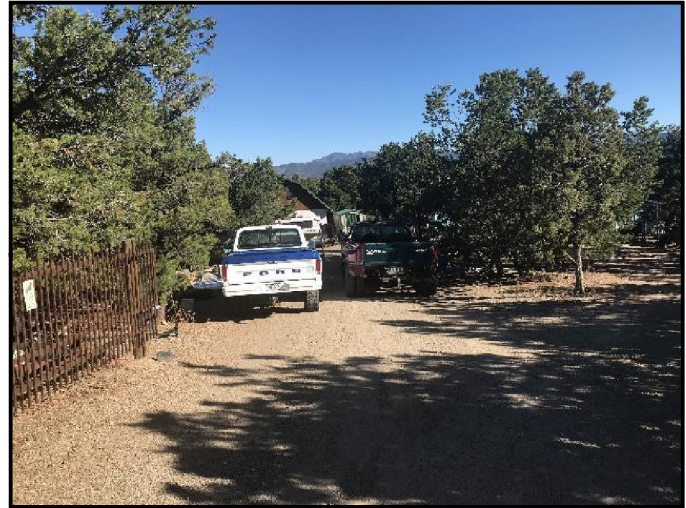
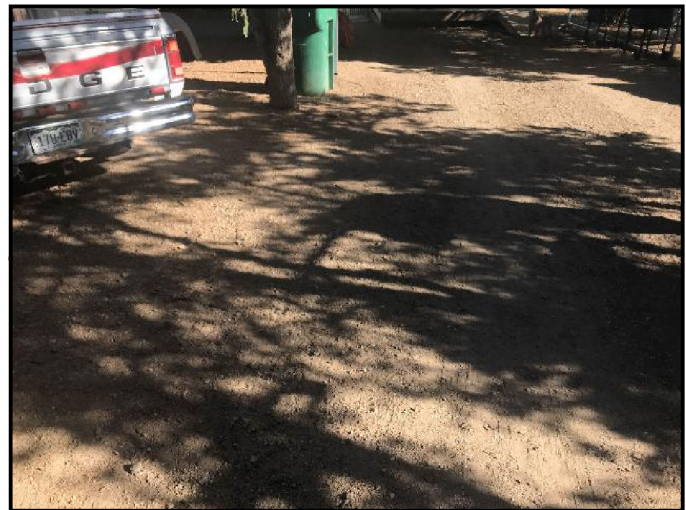
Hazards: Dense fuels, some slope

Notes: Bunched up structures, some debris, vehicles

Mitigation Description: Thinning and weed whacking

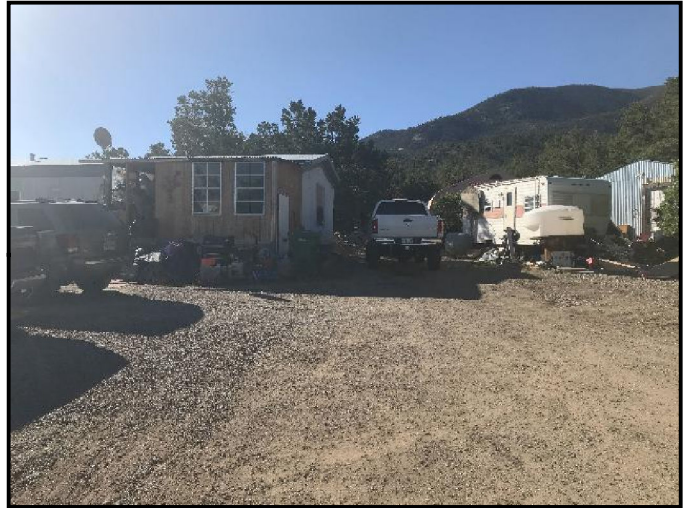
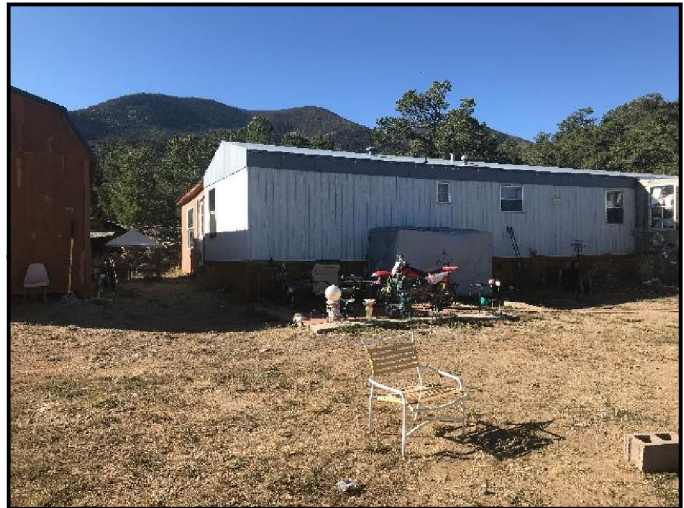
Structure ID: 90

Hazards: Fuels surrounding structures are dense, slope, possible hazmat

Notes: Large amounts of debris, modular home, multiple out buildings

Mitigation Description: Thinning and weed whacking

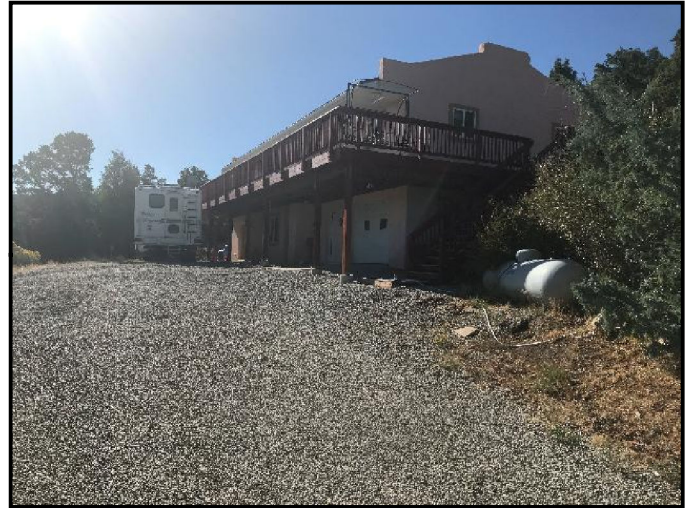
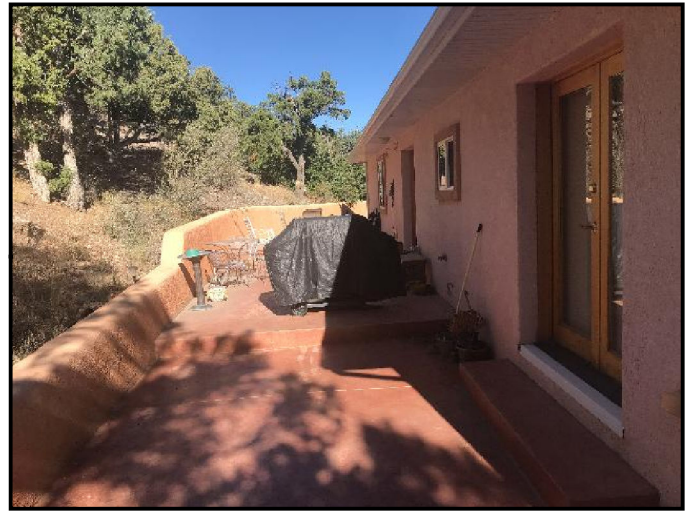
Structure ID: 91

Notes: Structure has some gravel perimeter. Fuel loading below residence, wooden/trex deck, propane tank near structure, some patio area

Mitigation Time (in hours): 6
Mitigation Description: Thinning and weed whacking

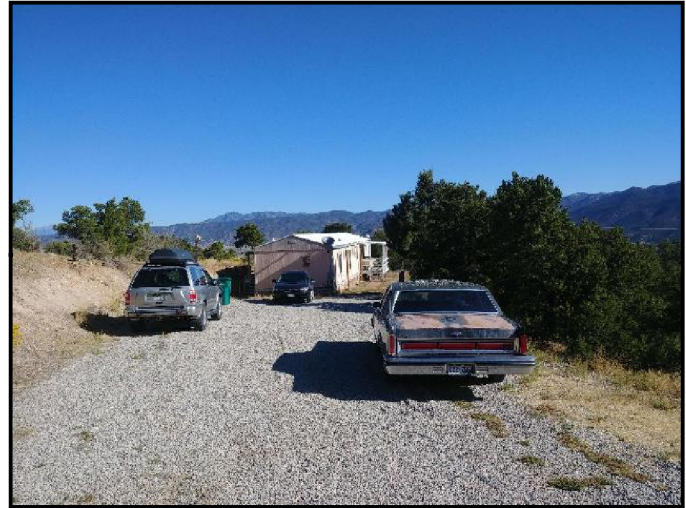
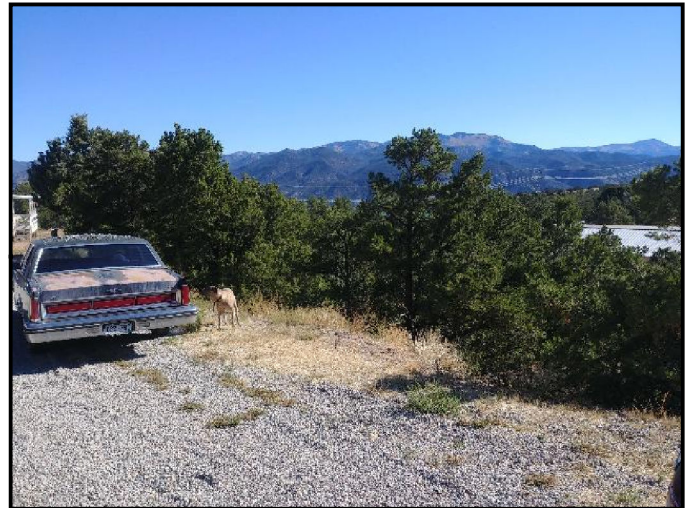
Structure ID: 92

Hazards: 1 way access

Notes: Fuels close, some clearance mobile home skirted

Mitigation Description: Brush and grass removal

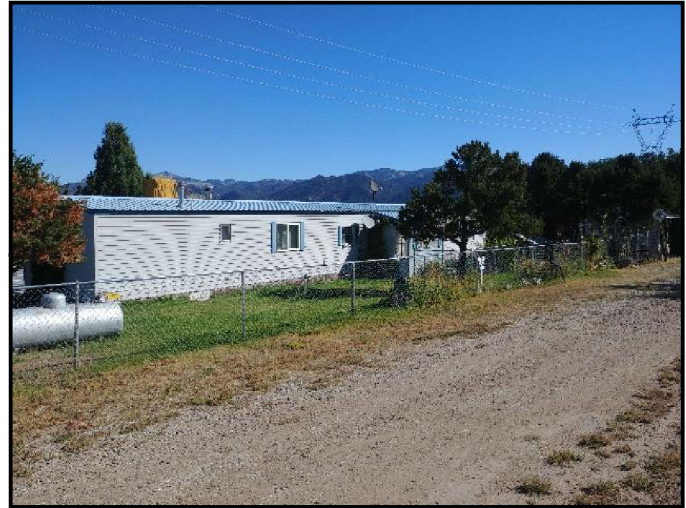
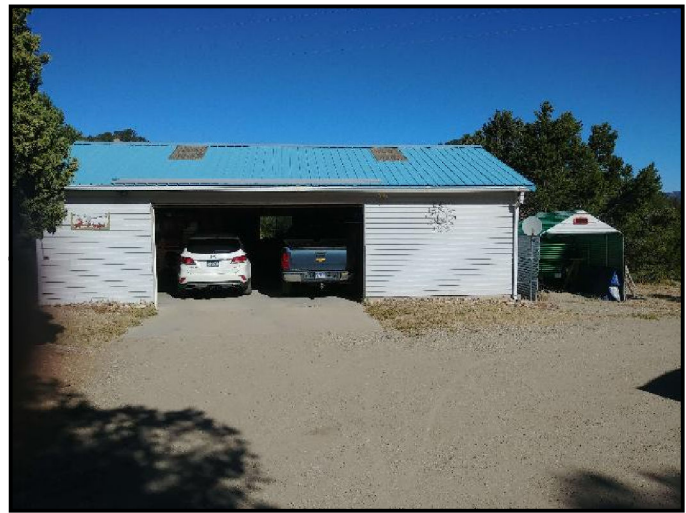
Structure ID: 93

Hazards: 1 way access

Notes: Numerous outbuildings some fuels close to structure

Mitigation Description: Brush and grass removal

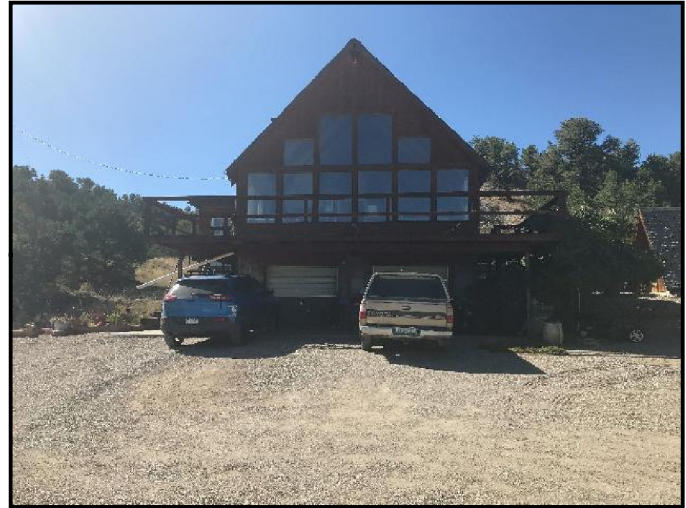
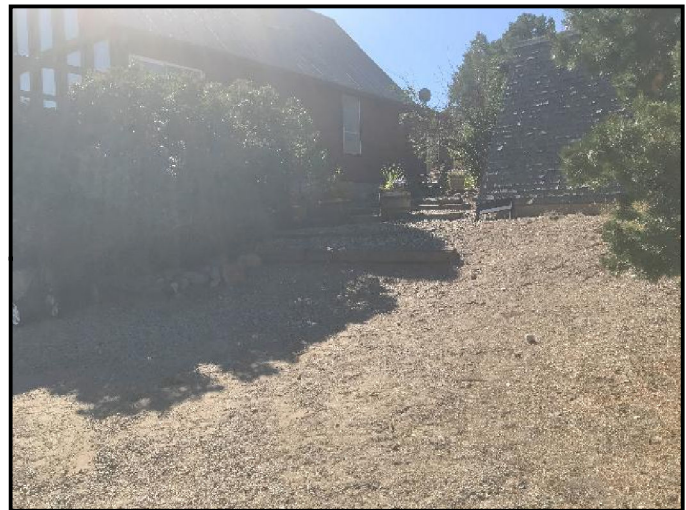
Structure ID: 94

Resources Needed to Protect Structure:
Type 6 engine
Notes: Wooden deck, large driveway area, A-frame, some debris

Mitigation Time (in hours): 6
Mitigation Description: Thinning and weed whacking

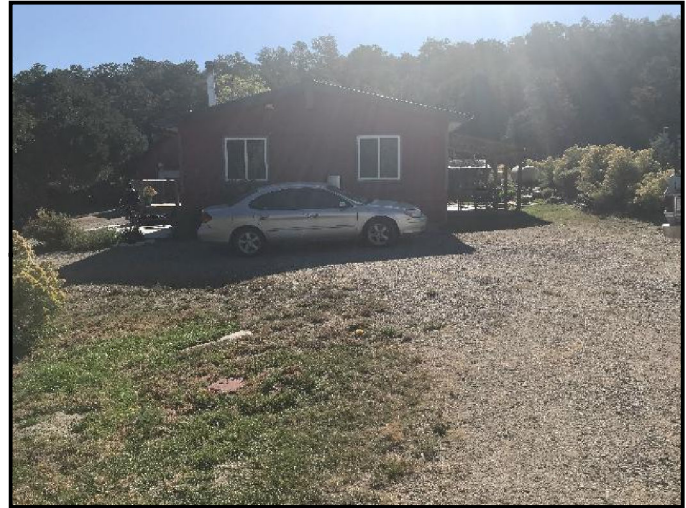
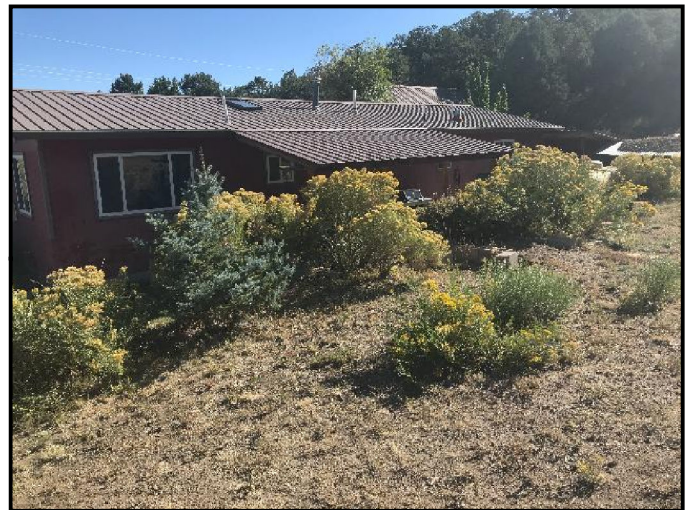
Hazards: Fuels above structure

Notes: Modular home with add on, wood shed connected to structure, some fuel loading above structure, some gravel pathways.

Mitigation Description: Thinning and weed whacking, porta tank and sprinklers

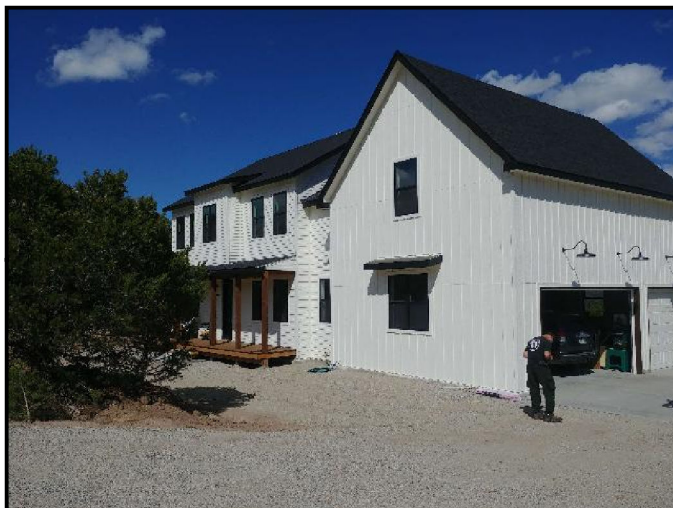
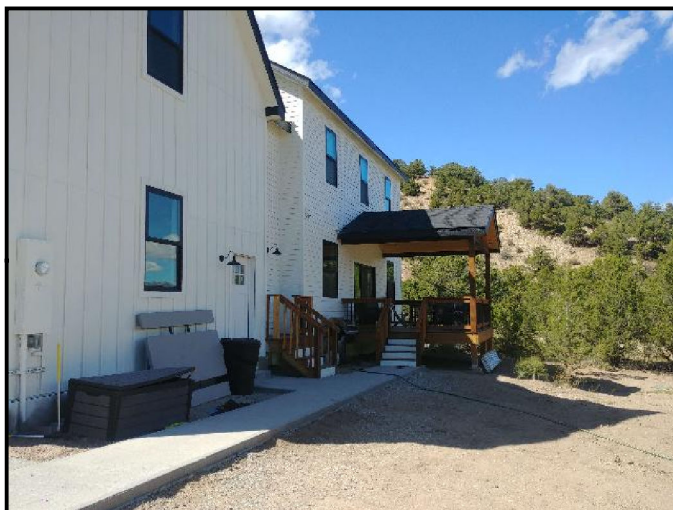
New construction no surface fuels

Notes: Well maintained structure and landscaping New construction

Mitigation Time (in hours): 0

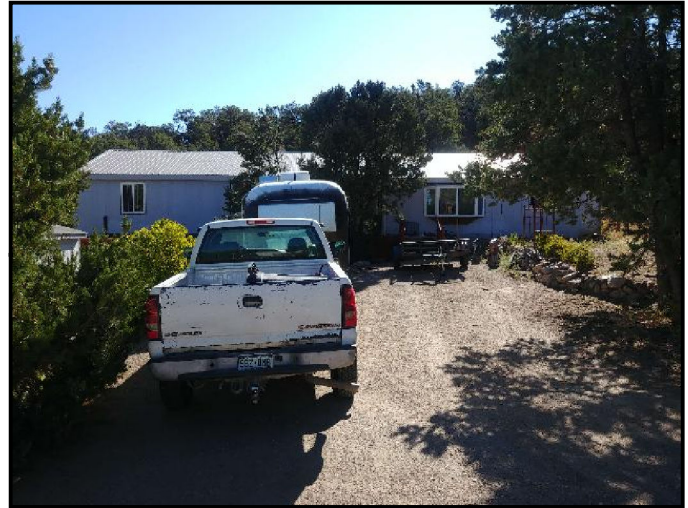
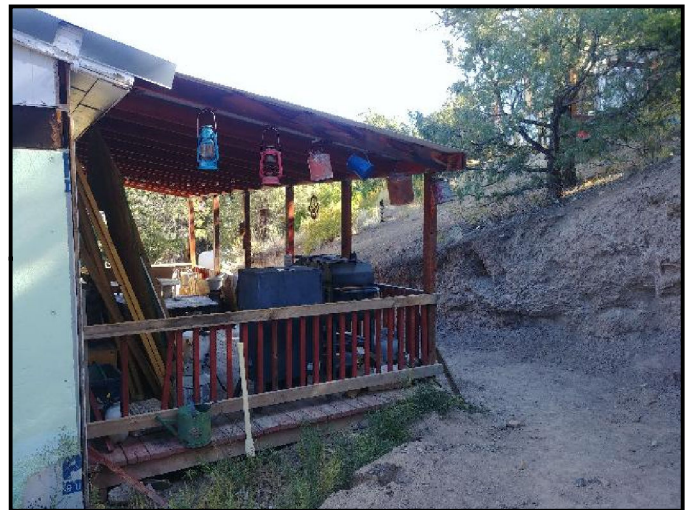
Structure ID: 97

Hazards: 1 way access, lots of yard debris

Notes: Fuels close, decks with fuels under, lots of uard debris and closely space budings

Mitigation Description: Brush and grass removal and yard debris

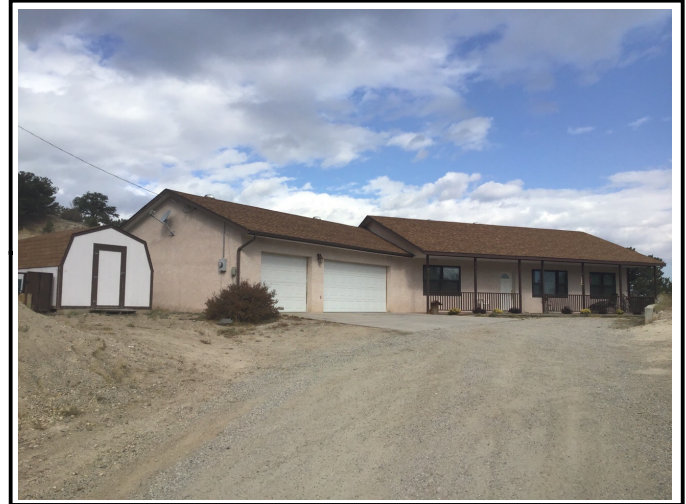
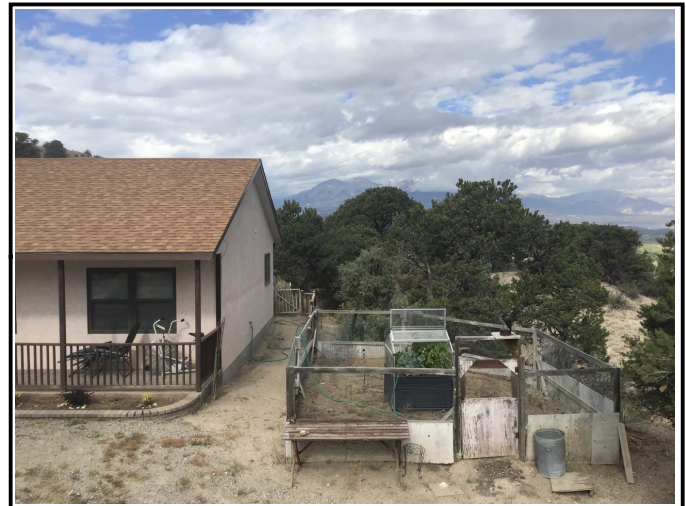
Structure ID: 98

Hazards: One way in and out

Notes: Well maintained around the house. North side of house could use more clearing.

Mitigation Description: Brush and limb up along north side of house on north facing slope in drainage leading up to the house

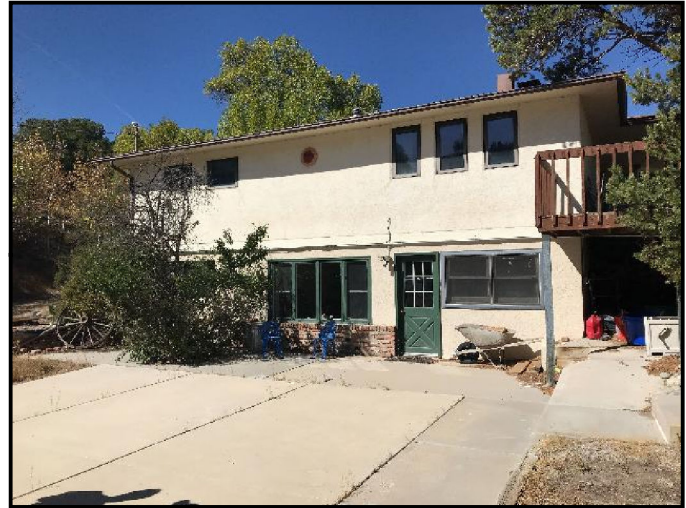
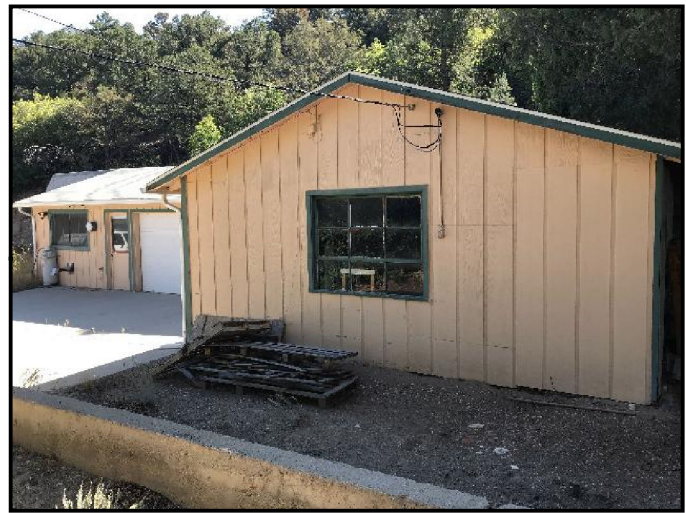
Hazards: Tight turns on roads, fuels above and below, slope

Notes: Modular shop below tucked into hillside, propane in front, paved drive, residence above

Mitigation Description: Thinning and weed whacking

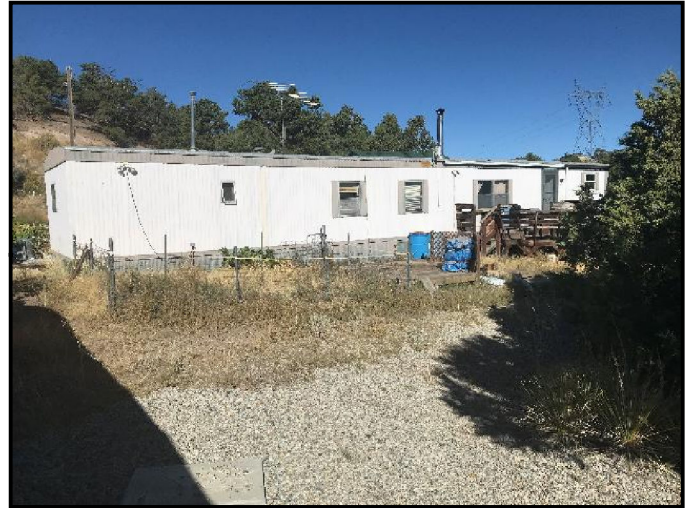
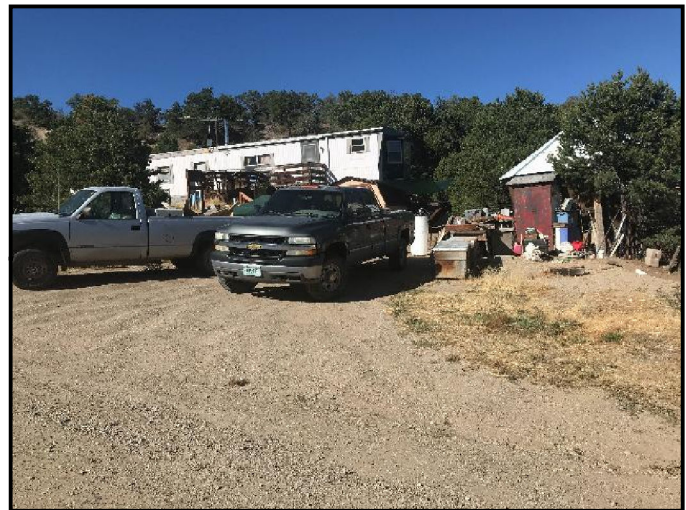
Hazards: Some fuels, possible fuel containers

Notes: Modular home, debris, wooden deck

Mitigation Description: Debris removal

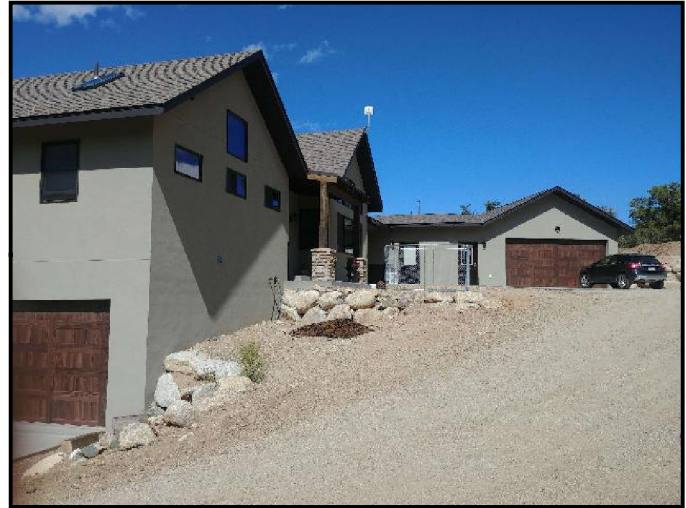
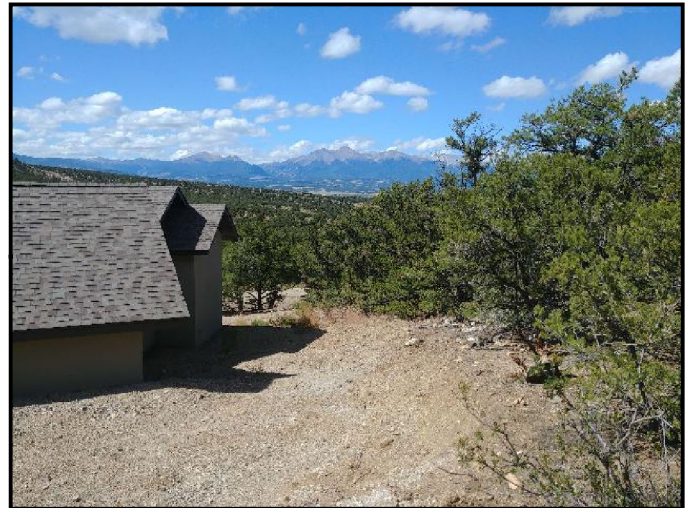
Structure ID: 101

Hazards: Long access road one way in and out

Notes: Well maintained new construction. PJ with no surface fuels if the fire is wind driven there is no safety zone

Mitigation Description: Nothing to do no fuels at structure

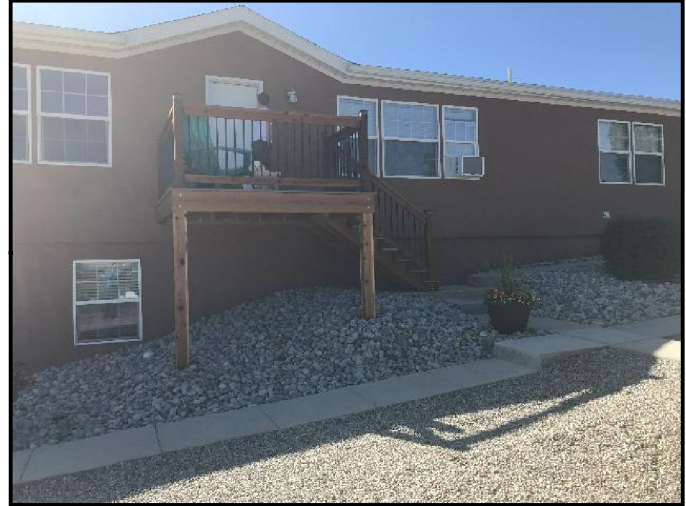
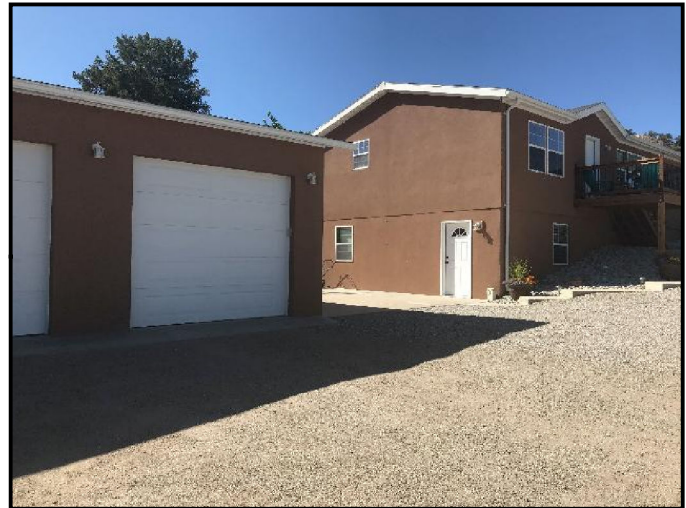
Structure ID: 102

Notes: Structure has some gravel perimeter. Small wooden deck.

Mitigation Time (in hours): 6
Mitigation Description: Thinning

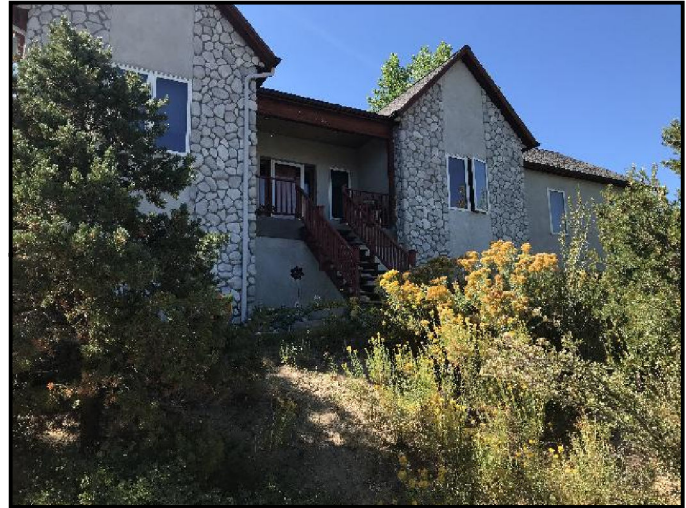
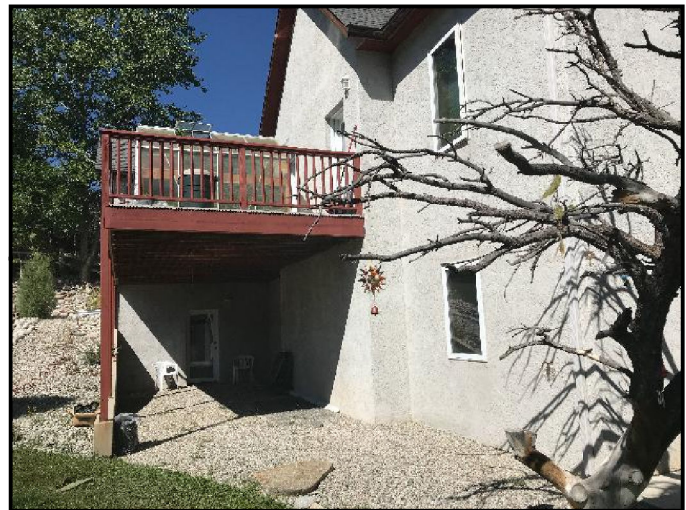
Hazards: Tight turns on roads, fuels above and below, slope

Notes: Wooden stairs to entrance, green lawn, wood/trex deck, some gravel landscaping

Mitigation Description: Thinning

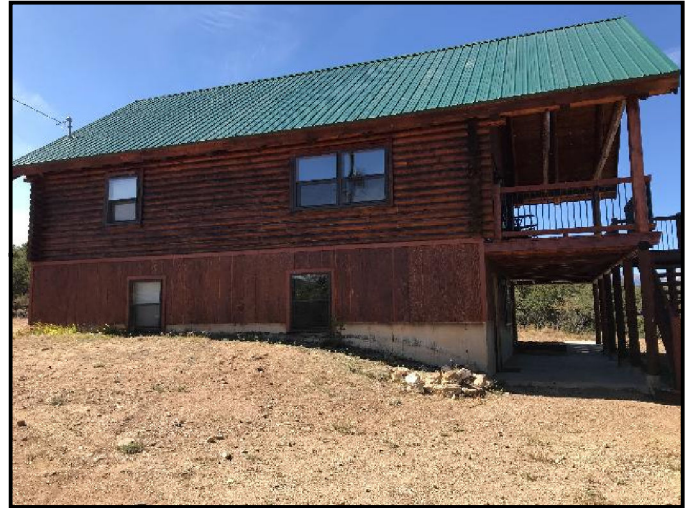
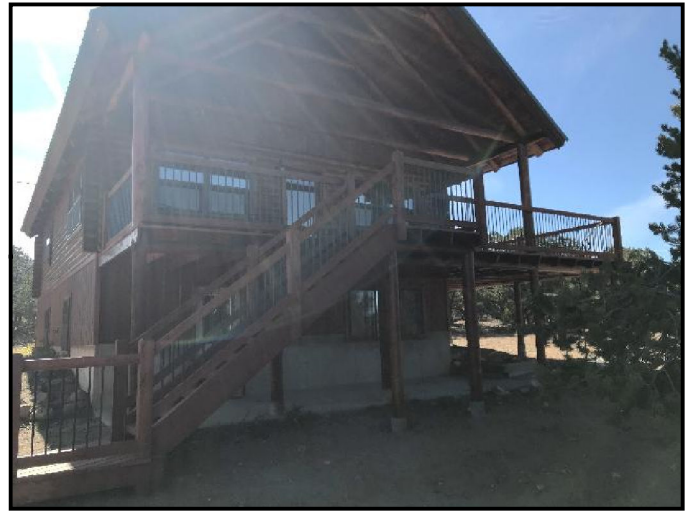
Hazards: fuels above and below, slope

Notes: Wood wrap around deck, gravel drive

Mitigation Description: Thinning and weed whacking

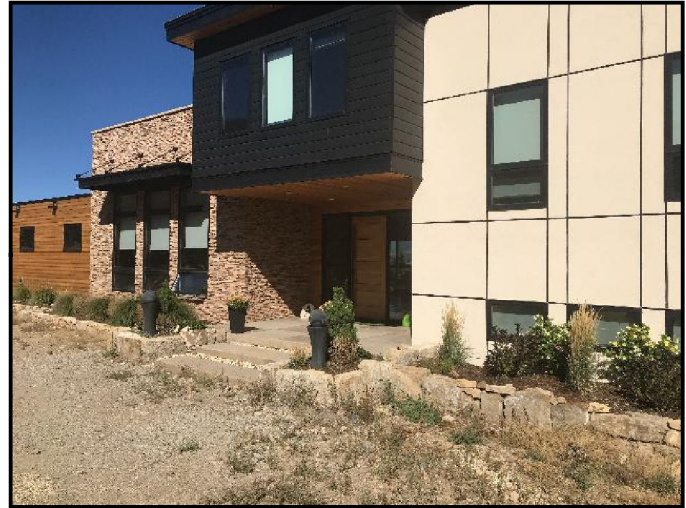
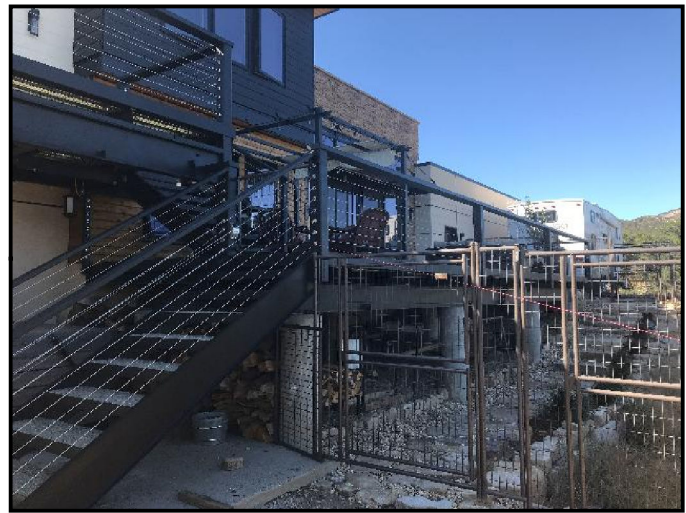
Structure ID: 105

Notes: Structure has some gravel perimeter. Fuel loading below residence, metal deck, wood pile under deck next to residence, deck chairs with cushions

Mitigation Time (in hours): 6
Mitigation Description: Thinning and weed whacking

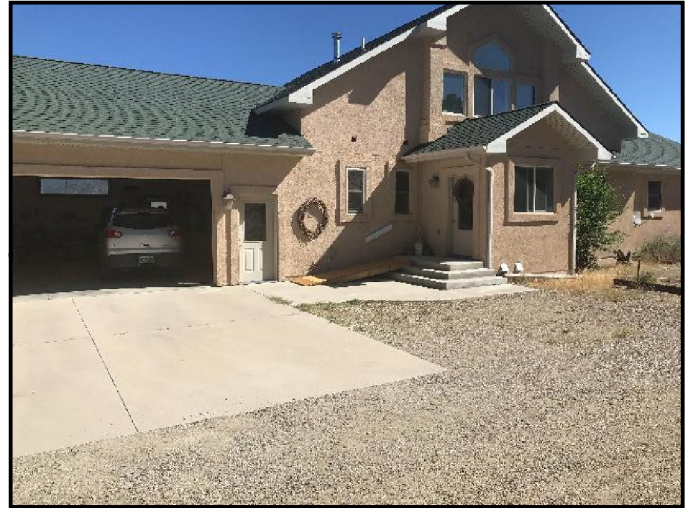
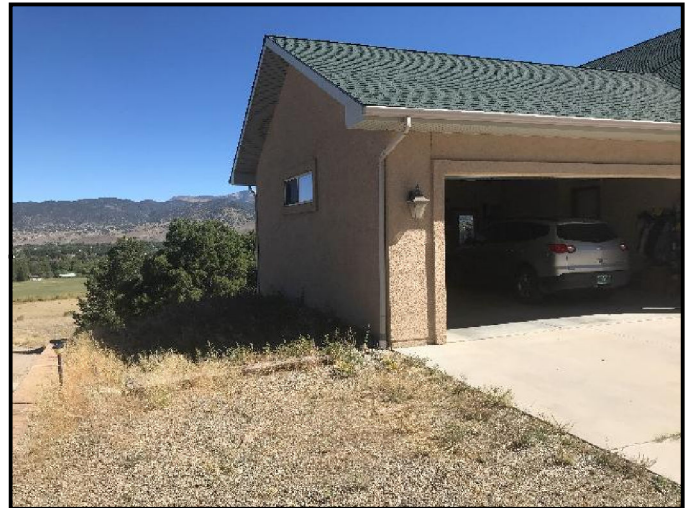
Triage Category: Defensible, Prep and Hold
Type of Structure: Residential
Primary Structures:
Is the building Occupied?: Yes
Outbuildings: 1
Fuel Surrounding Structure: Shrub or timber
Defensible Space: Less Than 30 ft treated
Roof Material: Fire resistant- tar, rubberized
Siding Material: Rock, concrete, metal
Electrical Power: Yes
Gas to Structure: Yes
Hazards: Fuels above structure, slope
Access to Site: T6 Engine
Describe Access: One way in and out
Comm With ICP: No
Water Source: Limited or dependent on electricity
Safety Zone Present: Potential safety zone(s) in area

Notes: Structure has some gravel perimeter. Fuel loading above residence, wooden deck

Mitigation Time (in hours): 6
Mitigation Description: Thinning and weed whacking

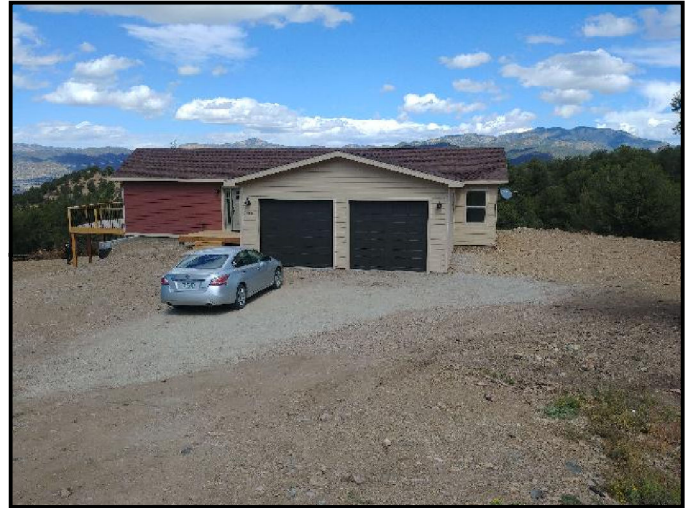
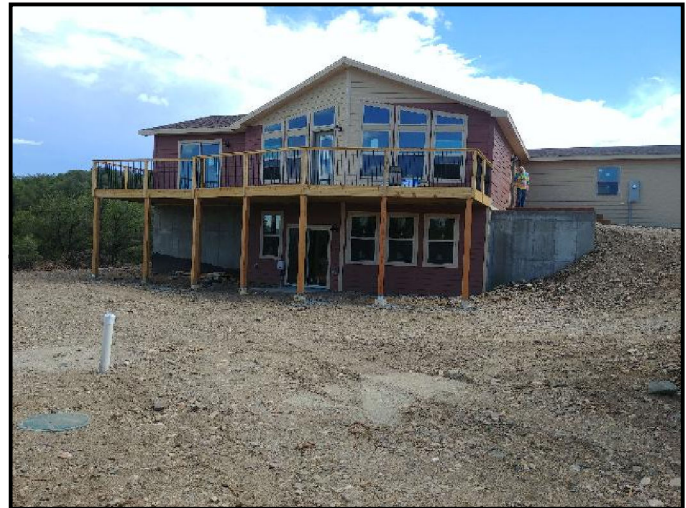
Hazards: One way in and out, Some slash, debris less then 100 feet from residence

Notes: Well maintained structure and landscaping

Mitigation Description: Moderate to some pockets of heavy brush needs to be removed

Porta tank and sprinklers. pump# RMK-0148-309

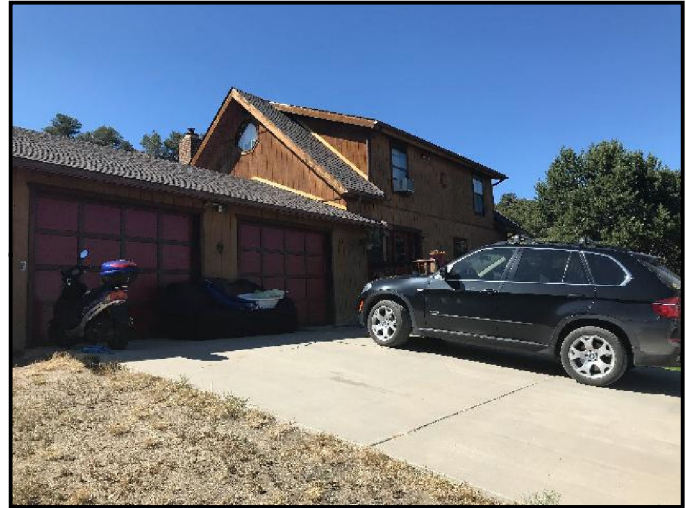
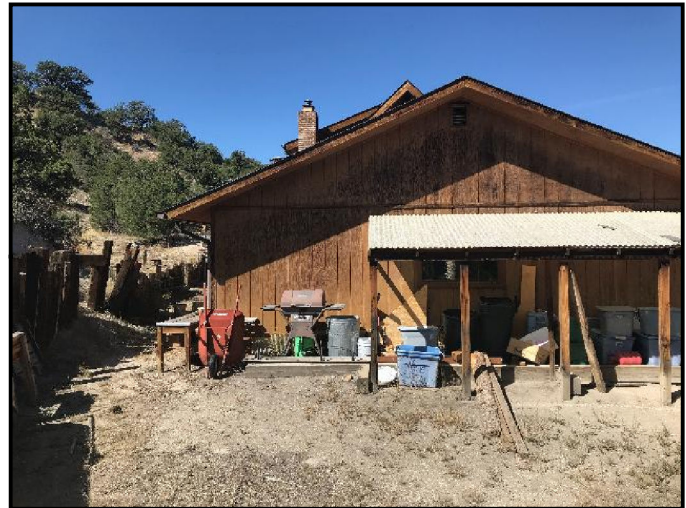
Hazards: Fuels above, slope

Notes: Wood wrap around deck, some debris, wood pile

Mitigation Description: Thinning and weed whacking

Type 6 engine, porta tank and sprinklers

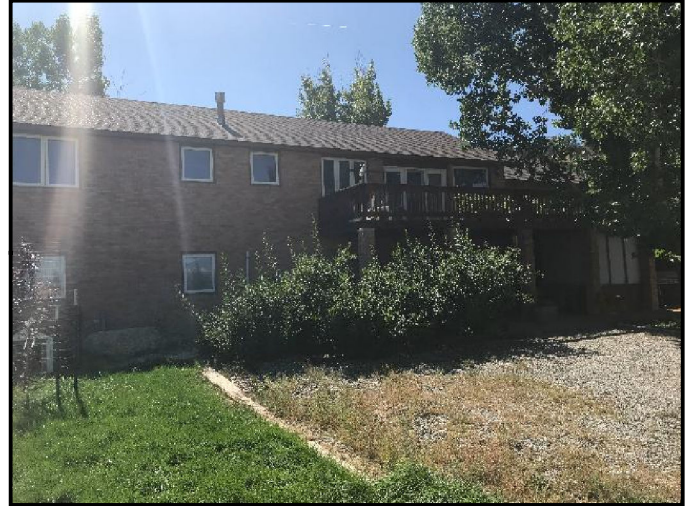
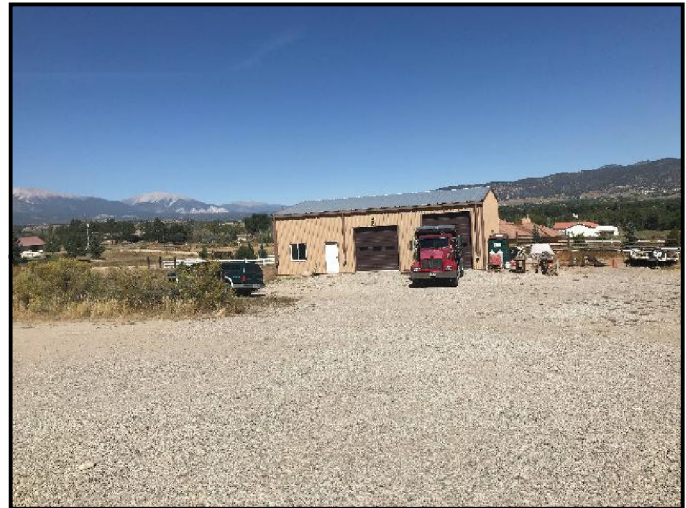
Triage Category: Defensible, Prep and Hold
Type of Structure: Residential
Primary Structures:
Is the building Occupied?: Yes
Outbuildings: 1
Fuel Surrounding Structure: Shrub or timber
Defensible Space: Less Than 30 ft treated
Roof Material: Fire resistant- tar,rubberized
Siding Material: Rock, concrete, metal
Electrical Power: Yes
Gas to Structure: Yes
Hazards:
Access to Site: T3/4 Engine
Describe Access: Off cr 110
Comm With ICP: No
Water Source: Limited or dependent on electricity
Safety Zone Present: Potential safety zone(s) in area

Resources Needed to Protect Structure:
Type 3/4 engine
Notes: Wooden deck, debris, sprinkler for deck provided by owner

Mitigation Time (in hours): 2
Mitigation Description: Weed whacking

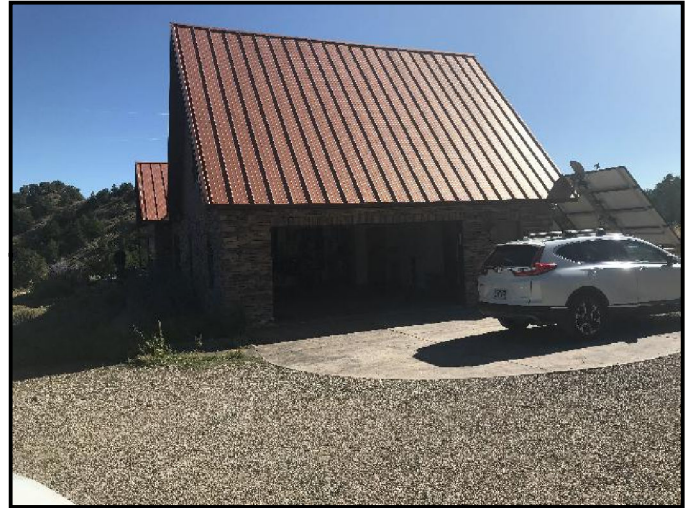
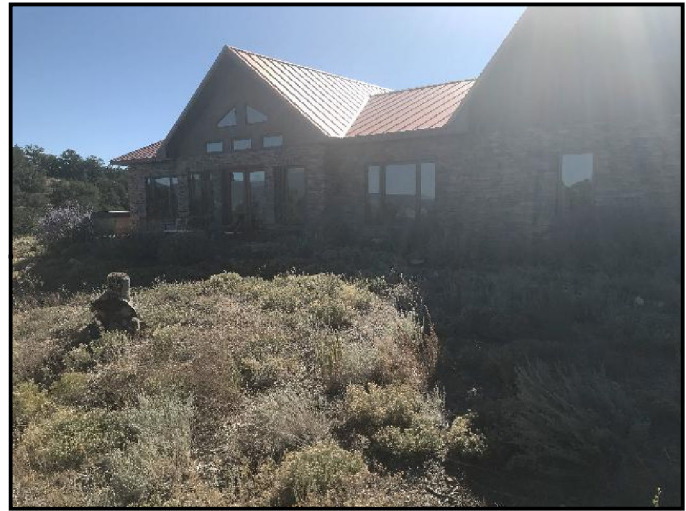
Hazards: Fuels, some slope

Notes: Structure has some gravel perimeter. Fuel loading below residence, grasses up against structure

Mitigation Description: Thinning and weed whacking

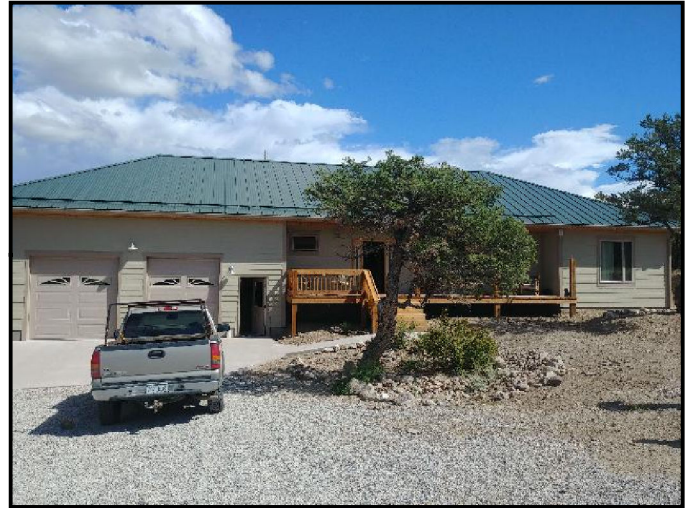
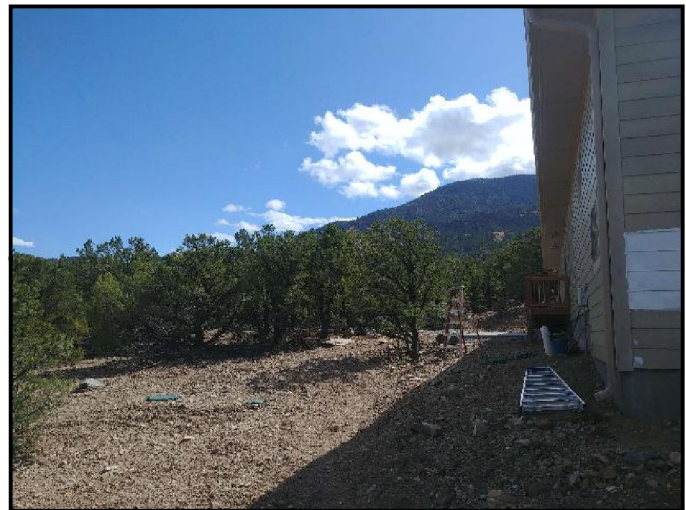
Hazards: One way in and out

Notes: New construction with no surface fuels well maintained structure and landscaping

Mitigation Description: If wind driven no safety zone Light brush and weed eater

Porta tank and sprinklers. Pump# RMK-0148-230. Located between structures 109 and 110 alongside road.

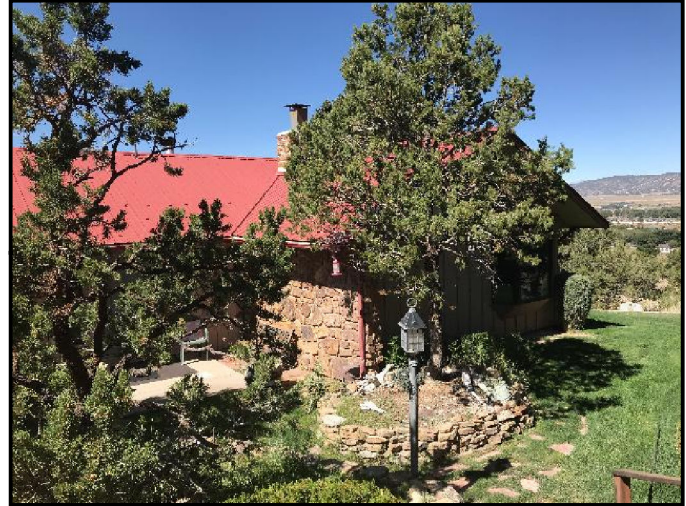
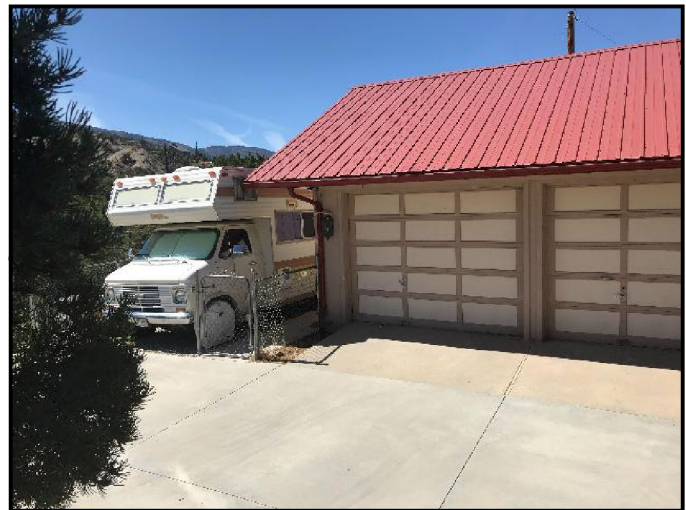
Hazards: Heavy fuels above and below, slope

Notes: Wood deck, asphalt driveway, house set back, green grass, wood piles

Mitigation Description: Thinning and weed whacking

Type 6 engine

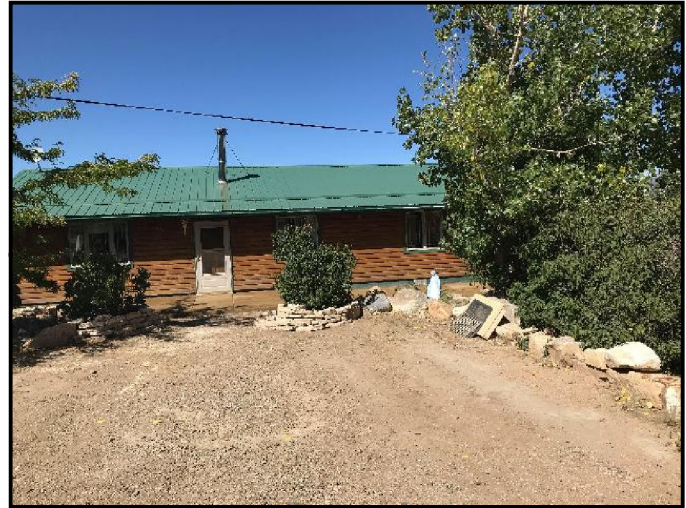
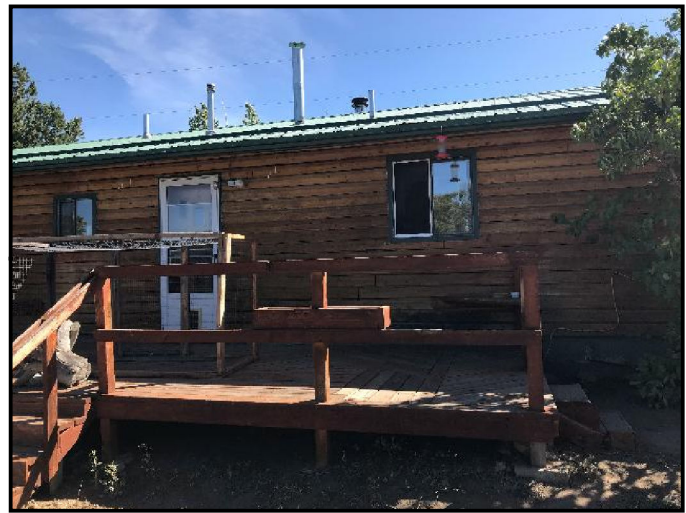
Hazards: fuels above and below, slope

Notes: Gravel driveway, wood deck

Mitigation Description: Thinning and weed whacking

Type 6 engine, porta tank and sprinklers
