Methodist East Structure Assessment

Structure ID: 30

Collected Date/Time: 9/26/2019 12:08:00 AM
Collected By: Chris Masson
Inspector's Position: Divs

Location: 5210 east highway 50,

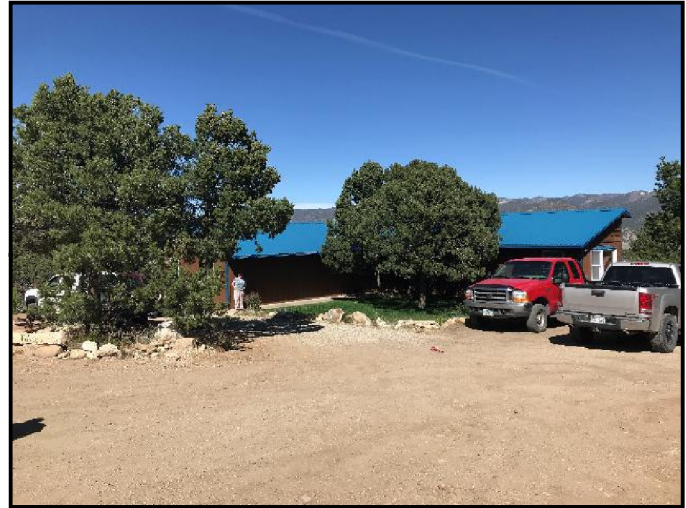
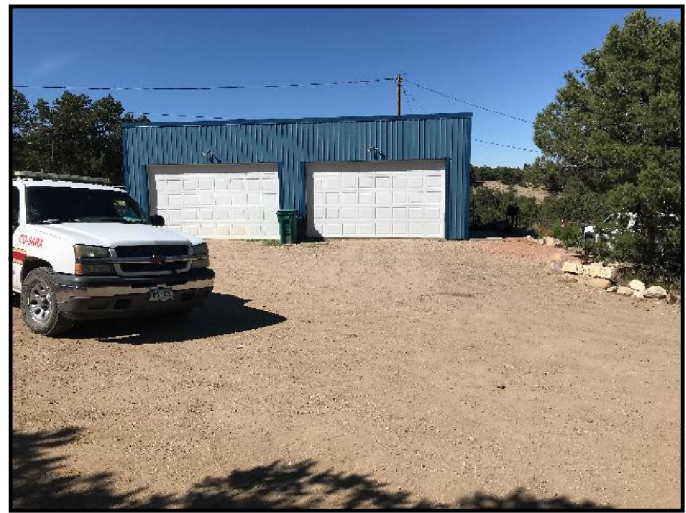
Hazards: fuels above and below, slope

Notes: Wood deck, gravel drive, multiple vehicles, green lawn, debris

Mitigation Description: Thinning

Type 6 engine, porta tank and sprinklers

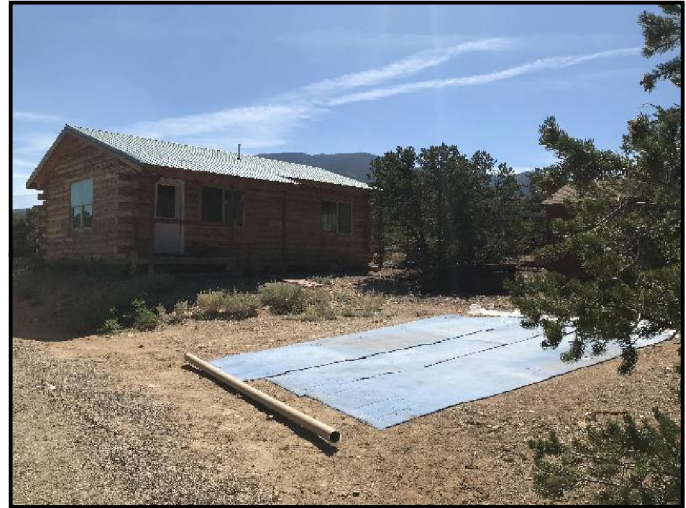
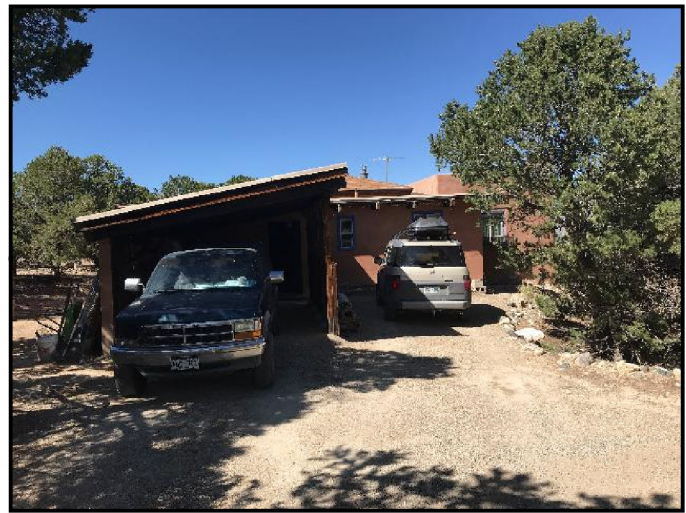
Hazards: fuels above and below, slope

Notes: 2 homes, 1 is log construction, 1 is adobe construction

Mitigation Description: Thinning and weed whacking

Type 3/4 engine

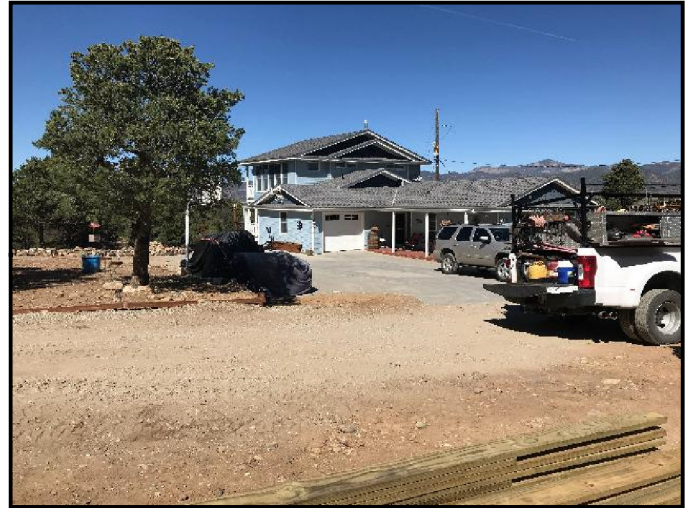
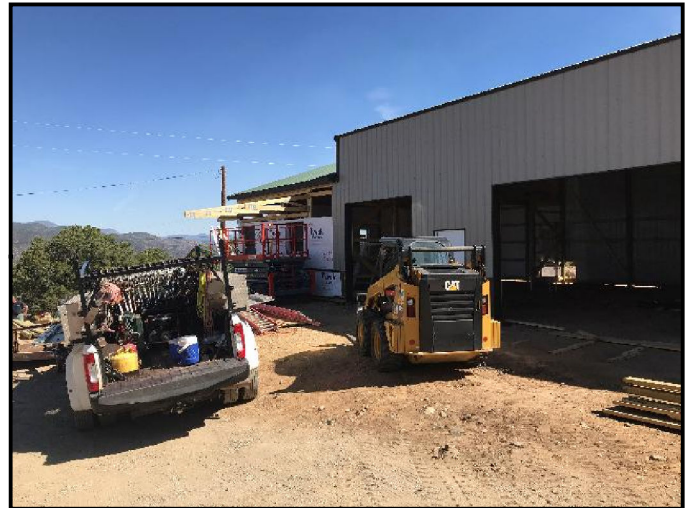
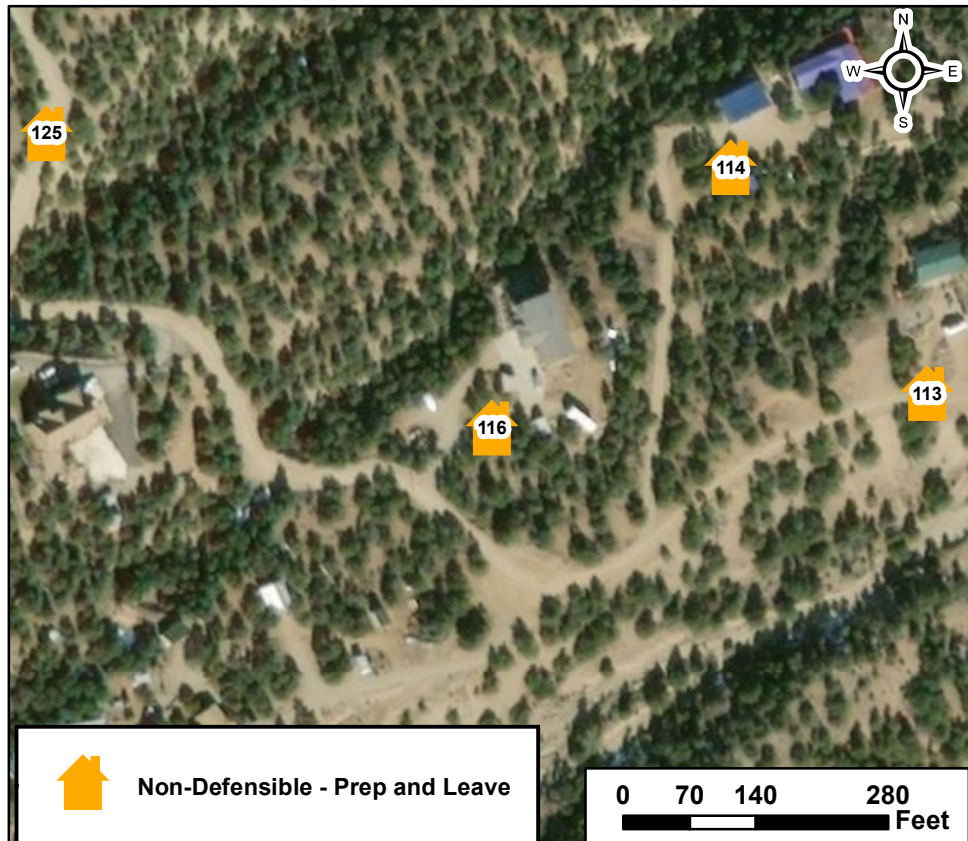
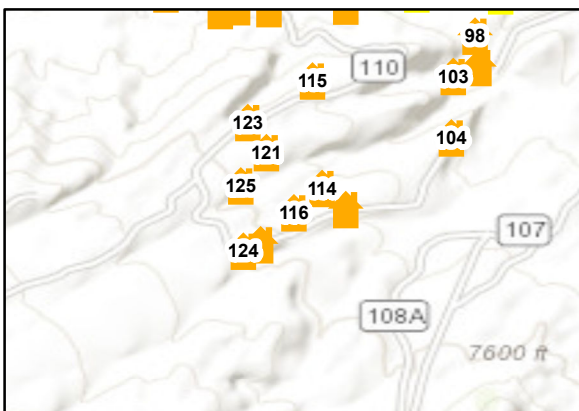
Hazards: Fuels above and below, slope

Water Source: Limited or dependent on electricity

Safety Zone Present: No safety zone(s) in area

Notes: Wood decks, gravel drive, building under construction adjacent to residence, some debris, some mitigation

Mitigation Time (in hours): 6

Mitigation Description: Thinning

Type 6 engine porta tank and sprinklers

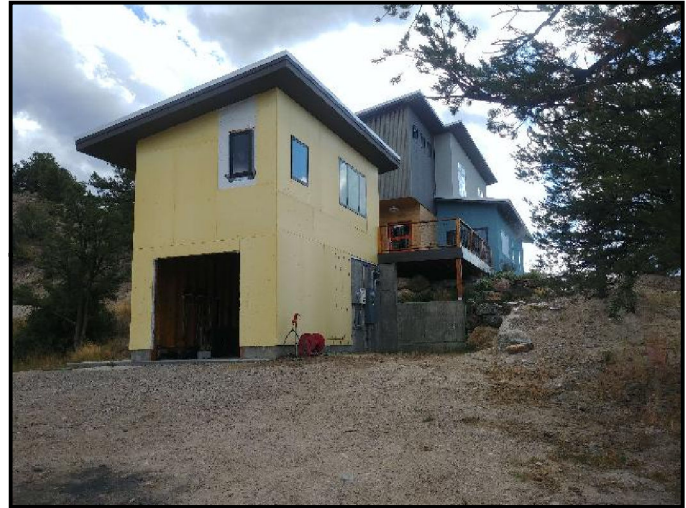
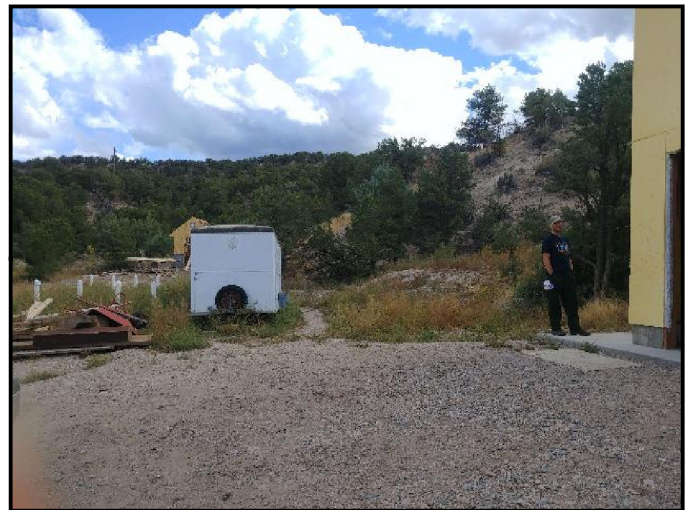
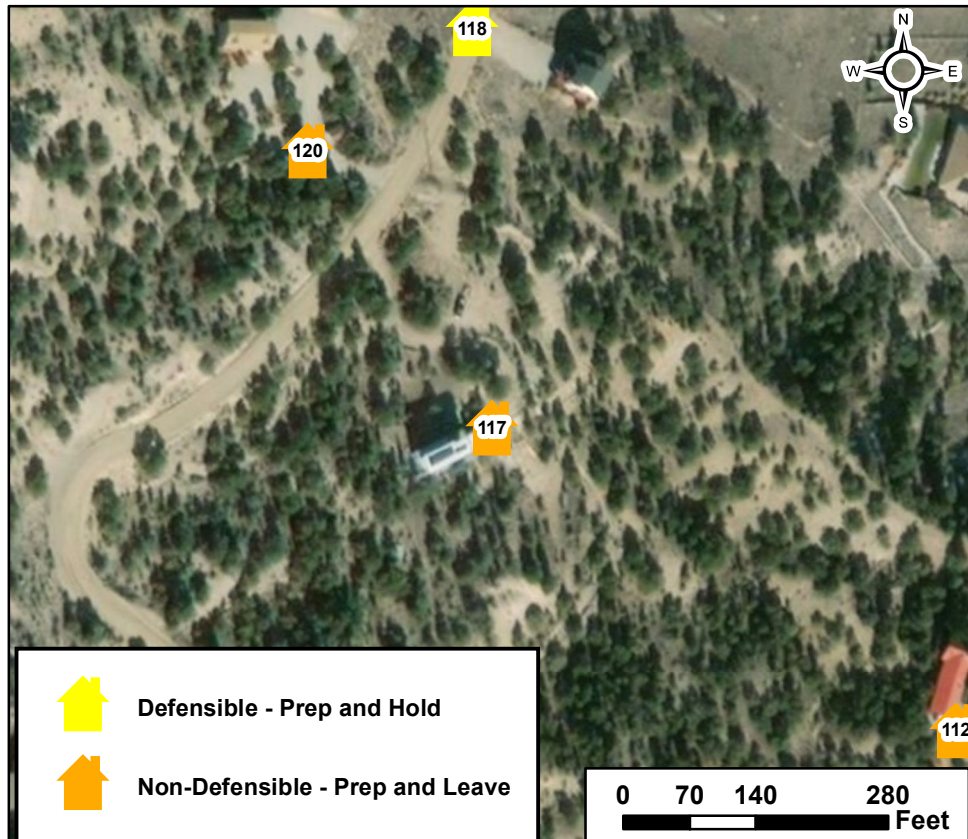
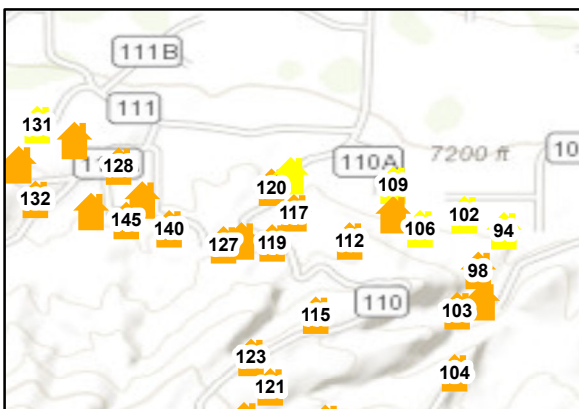
Structure ID: 117

Hazards: One way in and out, on slope fuels surrounding

Notes: Under construction no garage door

Mitigation Time (in hours): 4

Mitigation Description: Light brush and weed eater

Porta tank and sprinklers

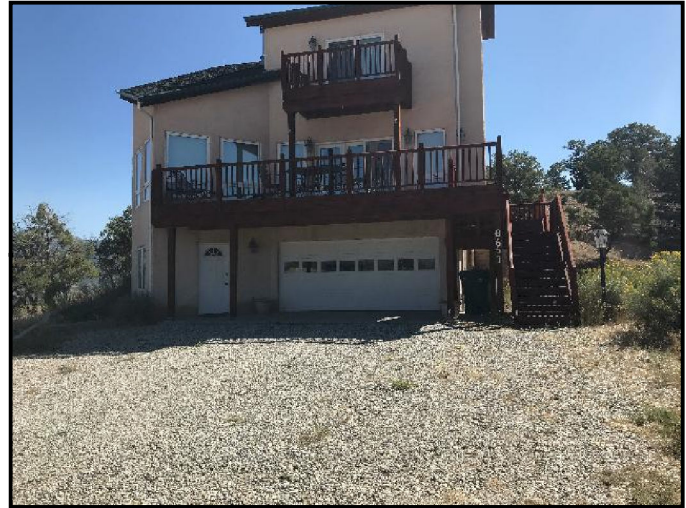
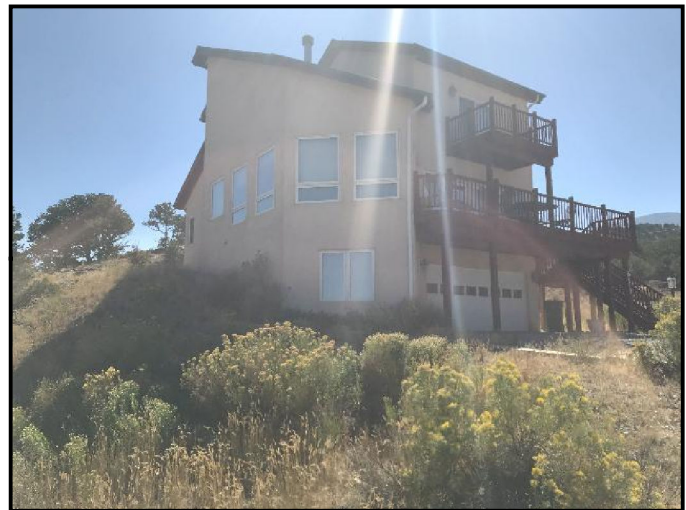
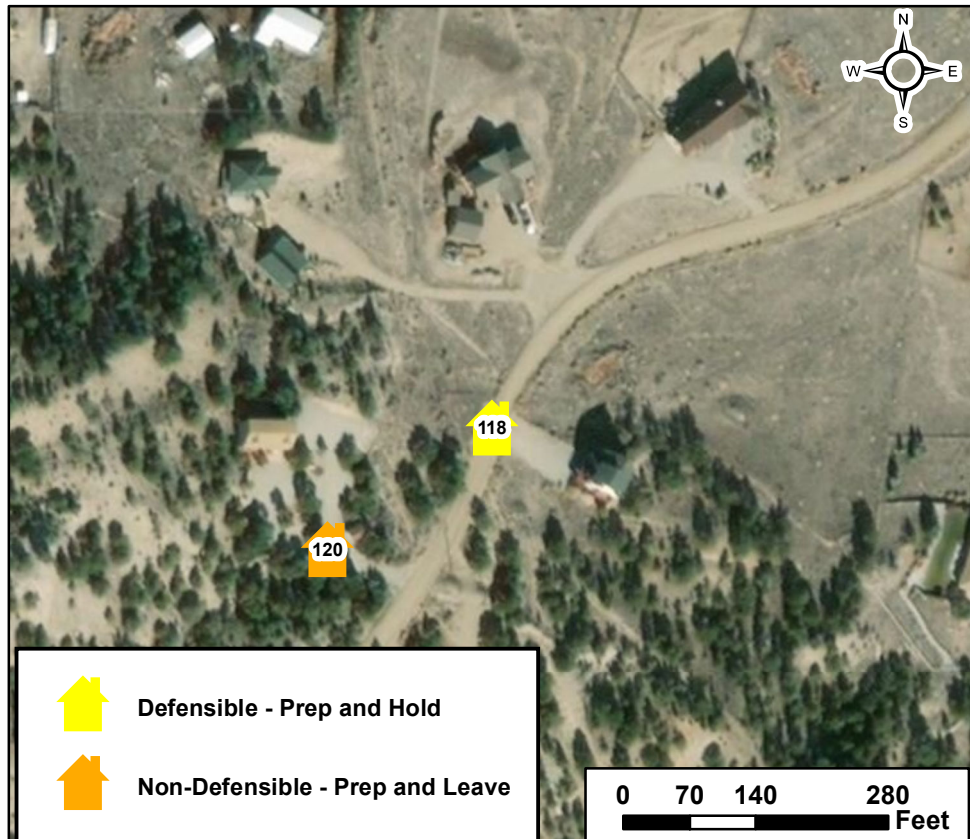
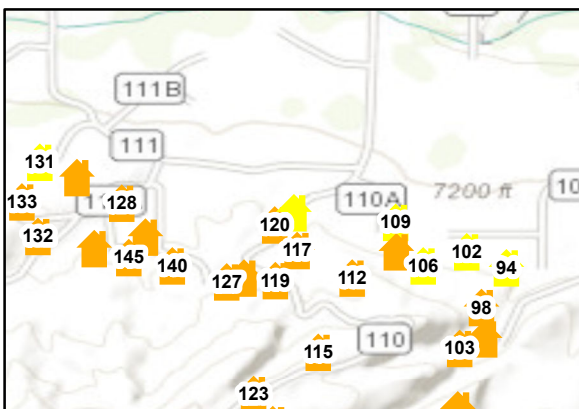
Structure ID: 118

Hazards: fuels above and below, slope

Water Source: Limited or dependent on electricity

Safety Zone Present: Potential safety zone(s) in area

Notes: Wood decks, gravel drive

Mitigation Time (in hours): 6

Mitigation Description: Thinning and weed whacking

Type 3/4 engine

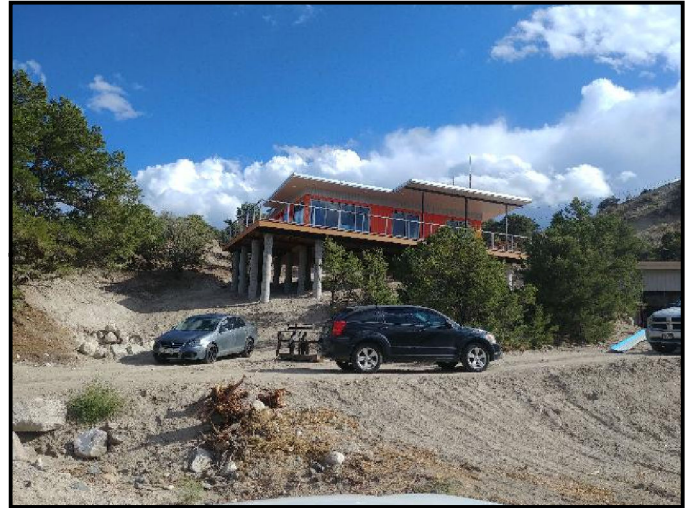
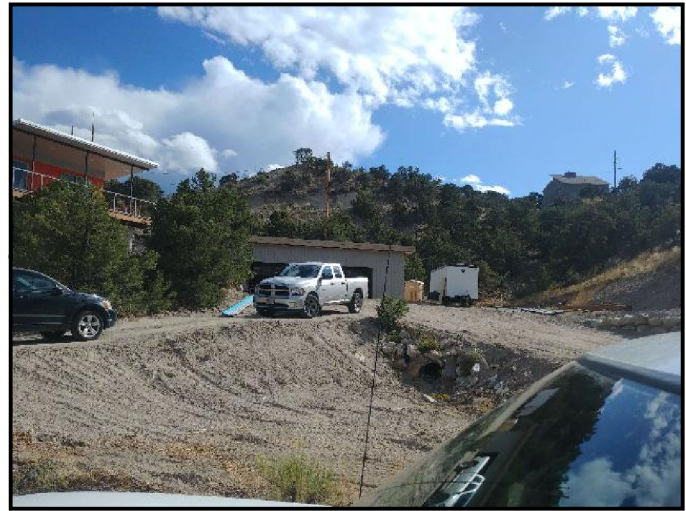
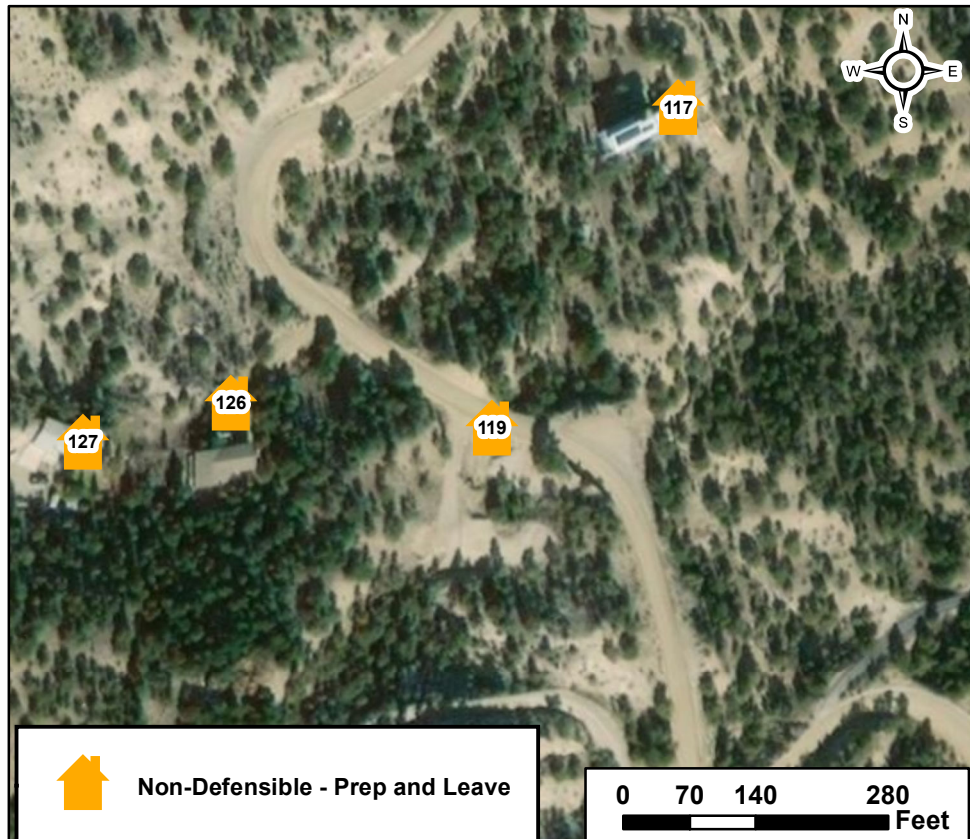
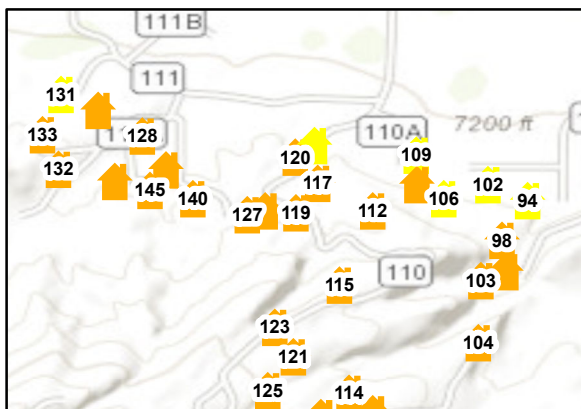
Hazards: One way in and out, on slope fuels surrounding

Notes: Under construction no garage door

Mitigation Time (in hours): 4

Mitigation Description: Light brush and weed eater

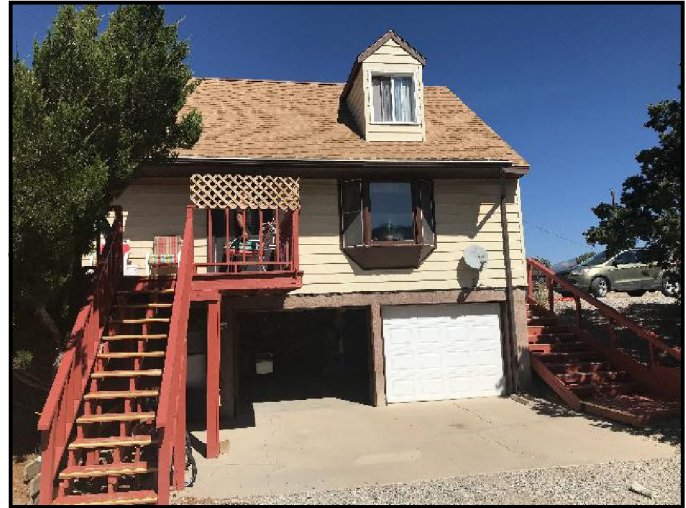
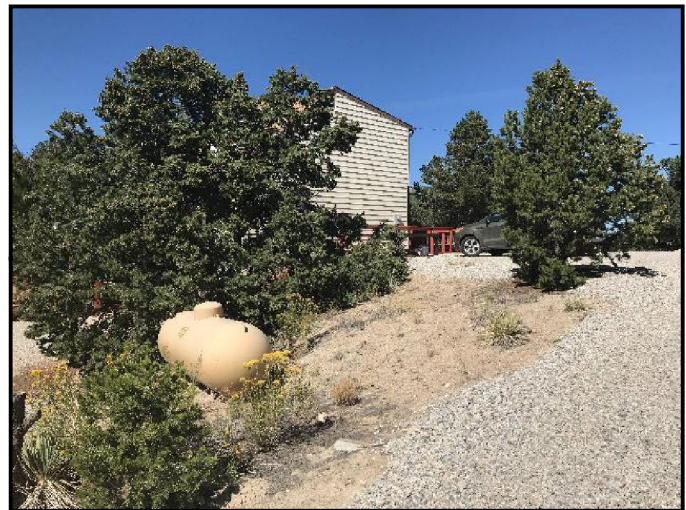
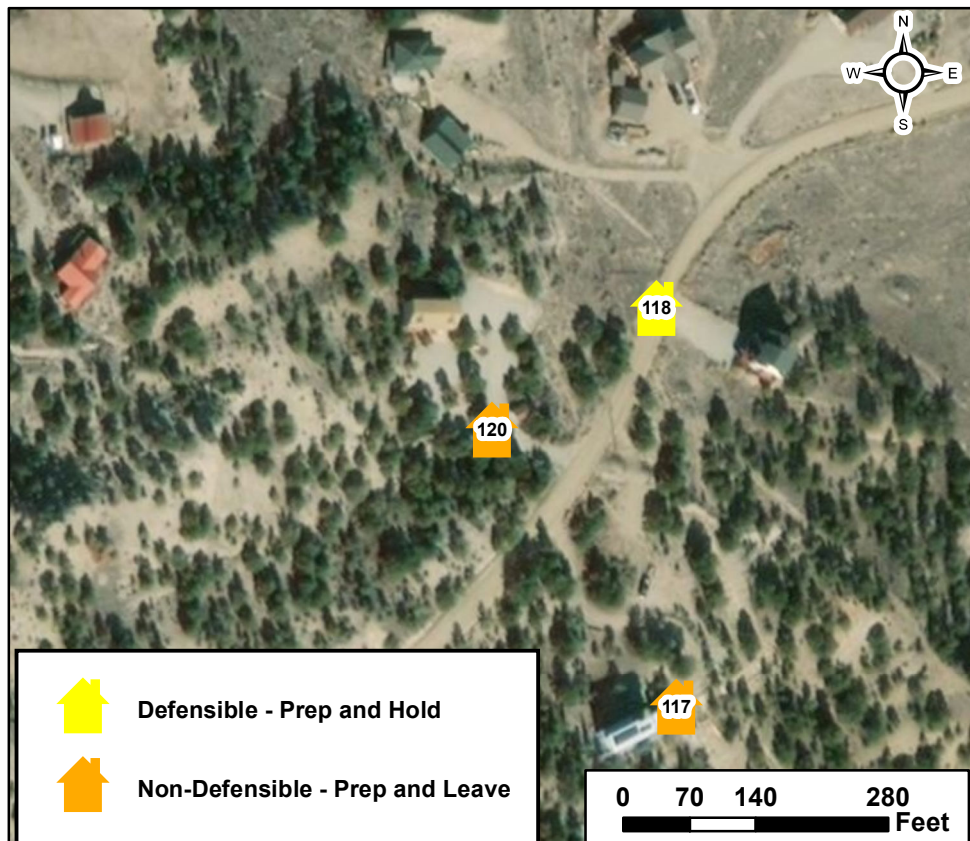
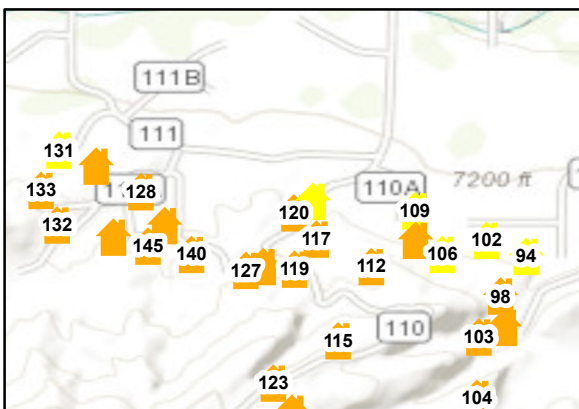
Structure ID: 120

Hazards: Fuels above and below, slope

Water Source: Limited or dependent on electricity

Safety Zone Present: Potential safety zone(s) in area

Notes: Wood decks, gravel drive

Mitigation Time (in hours): 4

Mitigation Description: Thinning and weed whacking

Type 3/4 engine

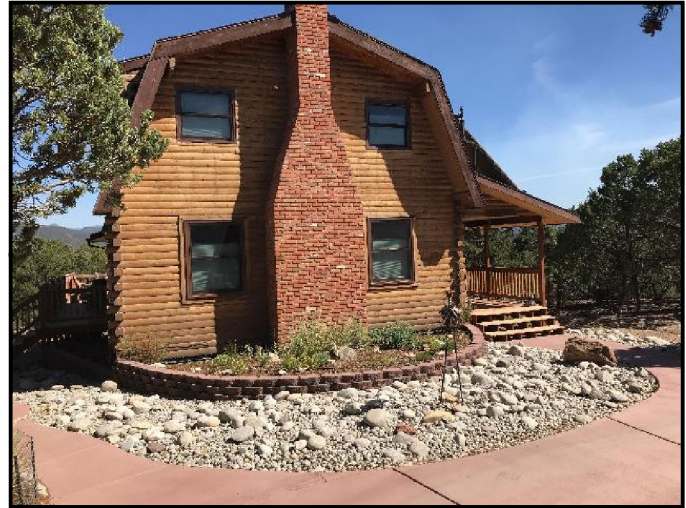
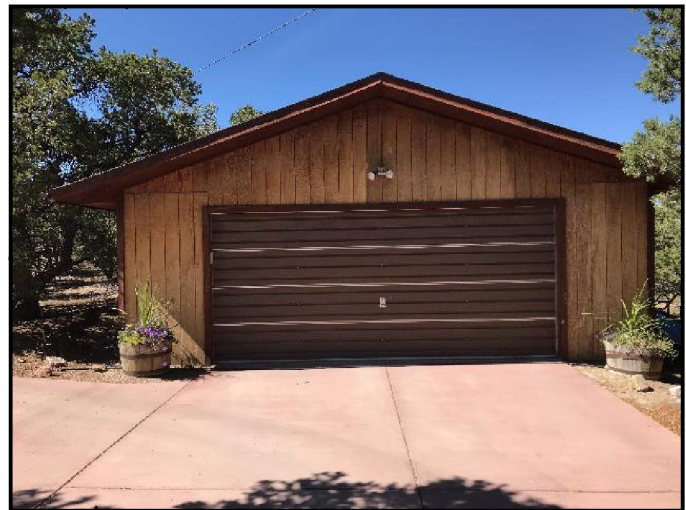
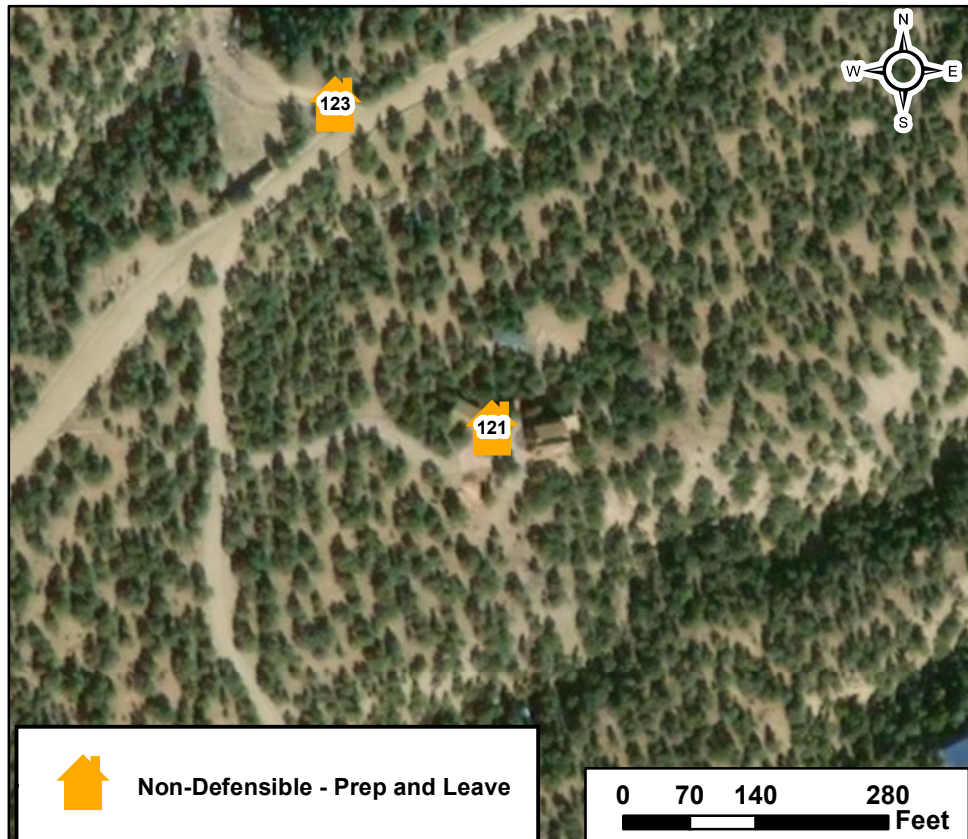
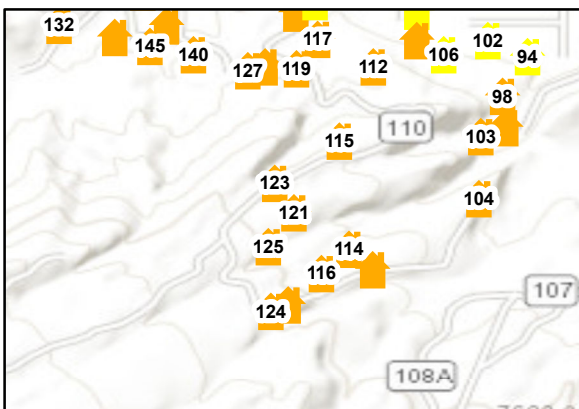
Structure ID: 121

Hazards: fuels above and below, slope

Water Source: Limited or dependent on electricity

Safety Zone Present: No safety zone(s) in area

Notes: Wood/trex decks, paved drive, wood pile

Mitigation Time (in hours): 4

Mitigation Description: Thinning

Type 6 engine, porta tank and sprinklers

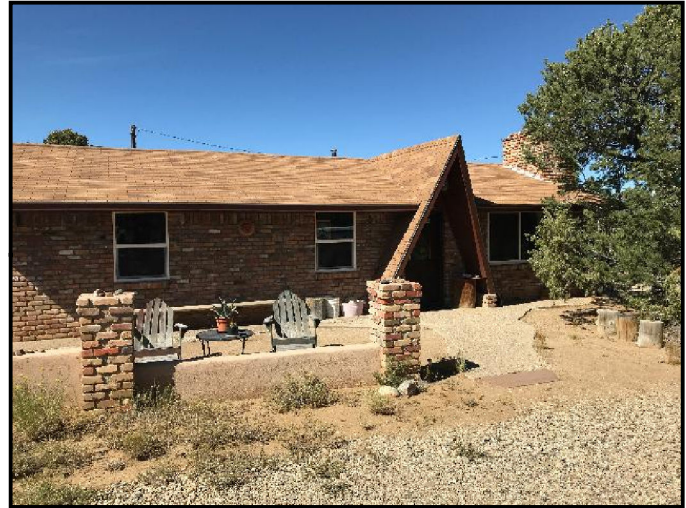
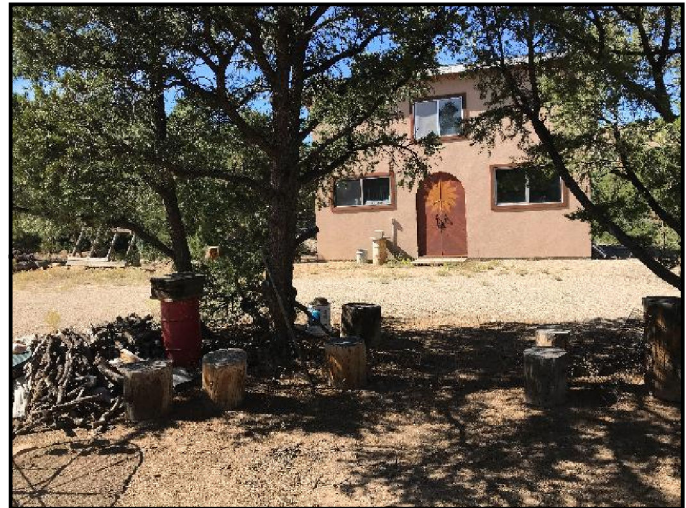
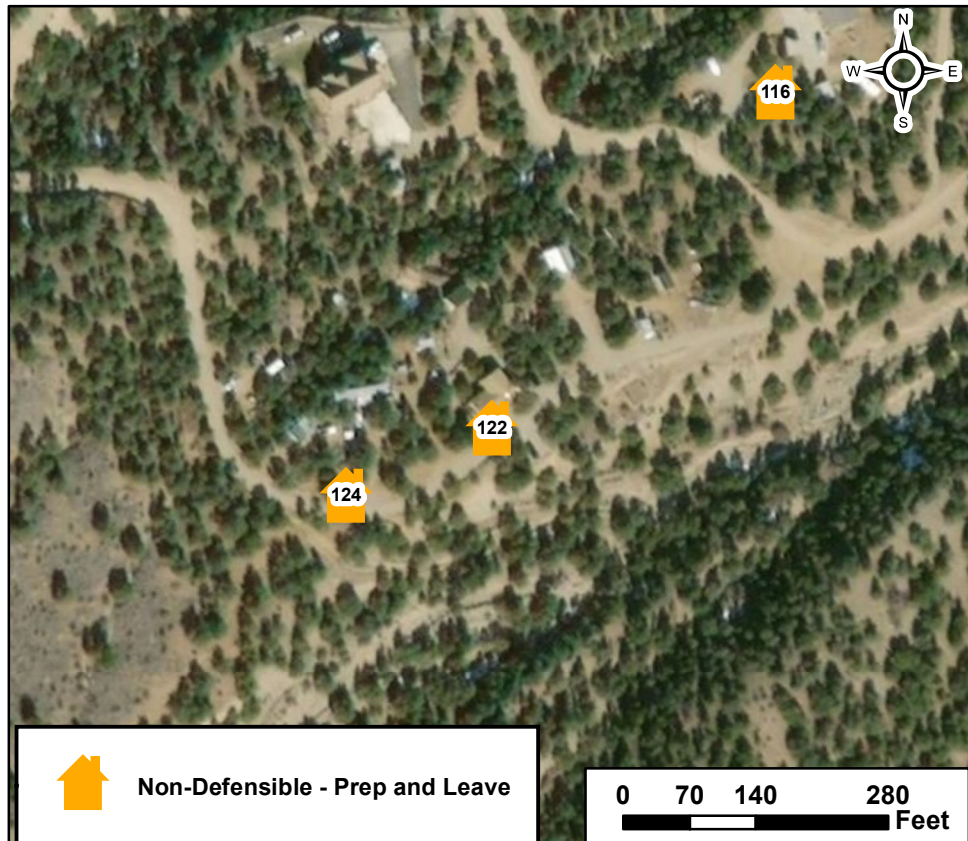
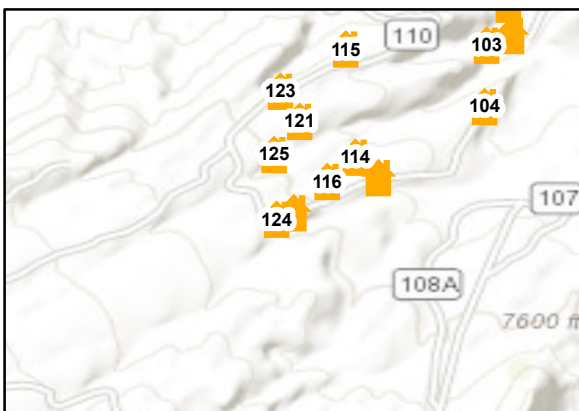
Structure ID: 122

Hazards: fuels above and below, slope

Notes: Wood/trex deck, modular home out building, multiple vehicles, debris

Mitigation Time (in hours): 6

Mitigation Description: Thinning and weed whacking

Type 6 engine, porta tank and sprinklers

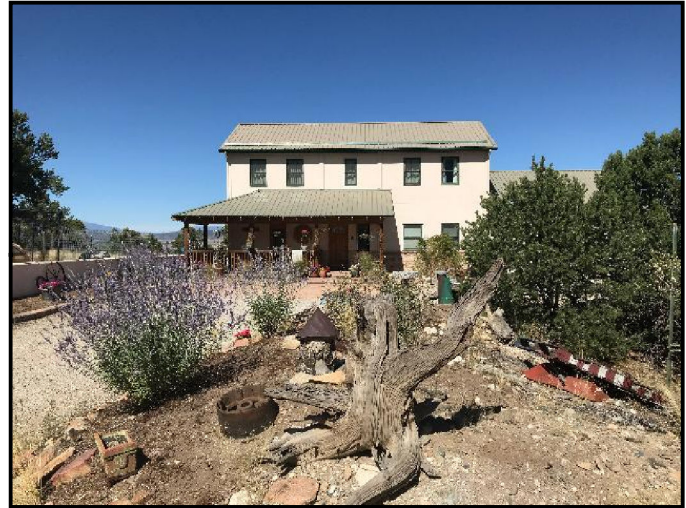
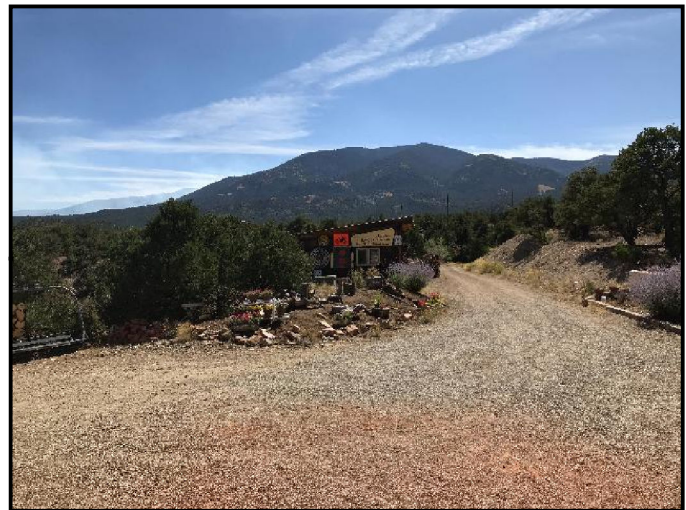
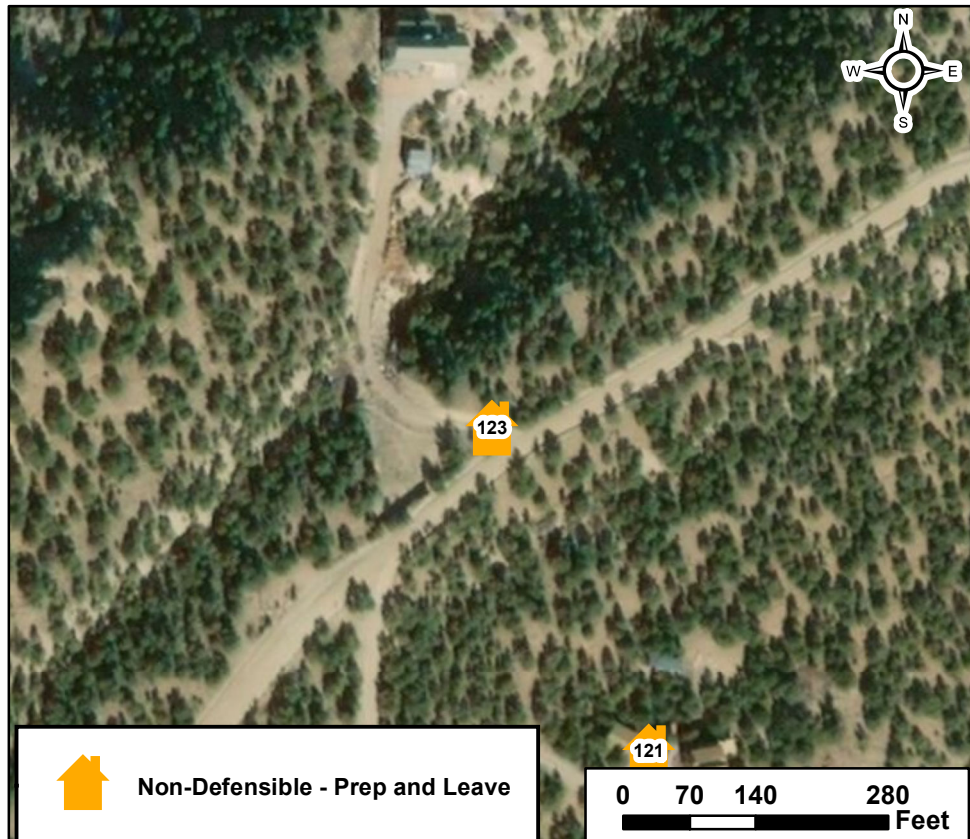
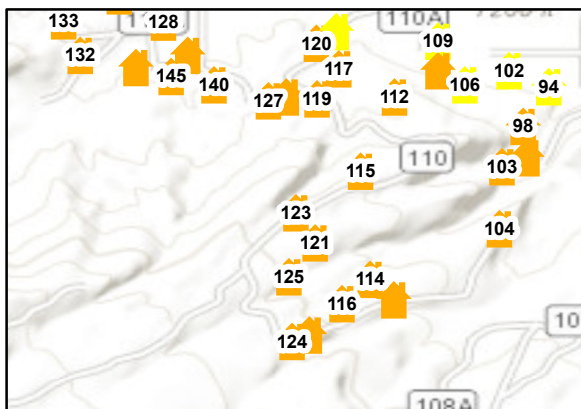
Structure ID: 123

Hazards: Fuels below, slope

Water Source: Limited or dependent on electricity

Safety Zone Present: No safety zone(s) in area

Notes: Wood decks, gravel drive, gated drive, large wood pile

Mitigation Time (in hours): 6

Mitigation Description: Thinning

Type 6 engine, porta tank and sprinklers

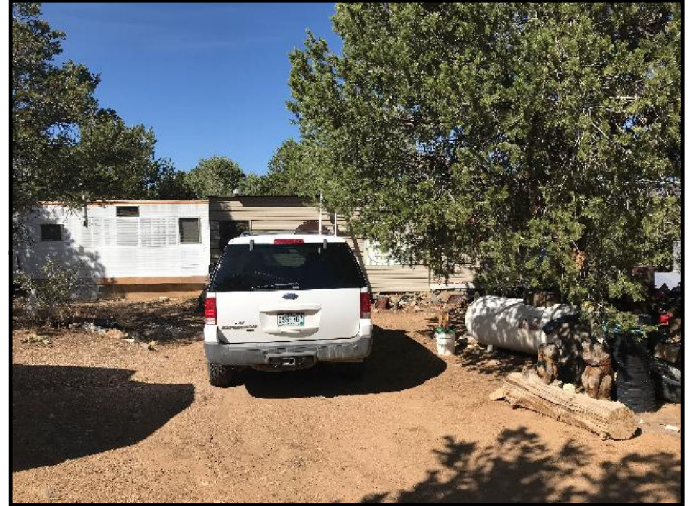
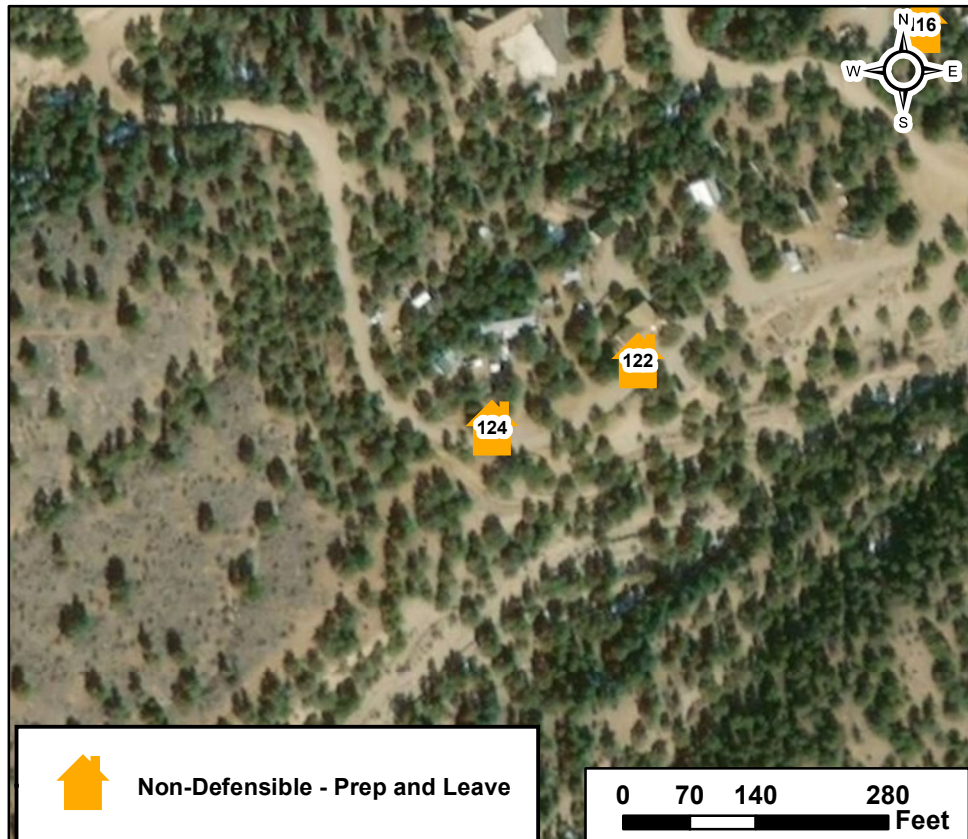
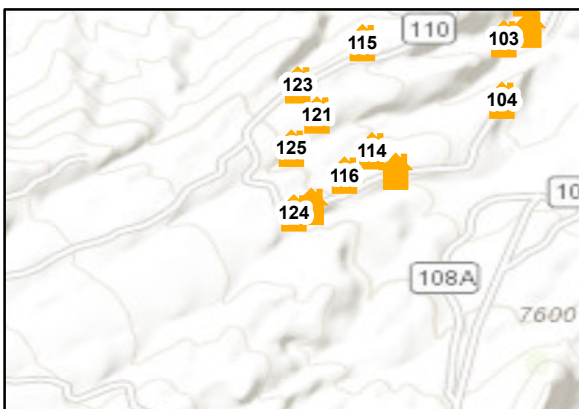
Structure ID: 124

Hazards: fuels above and below, slope

Water Source: Limited or dependent on electricity

Safety Zone Present: No safety zone(s) in area

Notes: Modular home in disrepair, wood pile, debris

Mitigation Time (in hours): 6

Mitigation Description: Thinning

Type 6 engine, porta tank and sprinklers

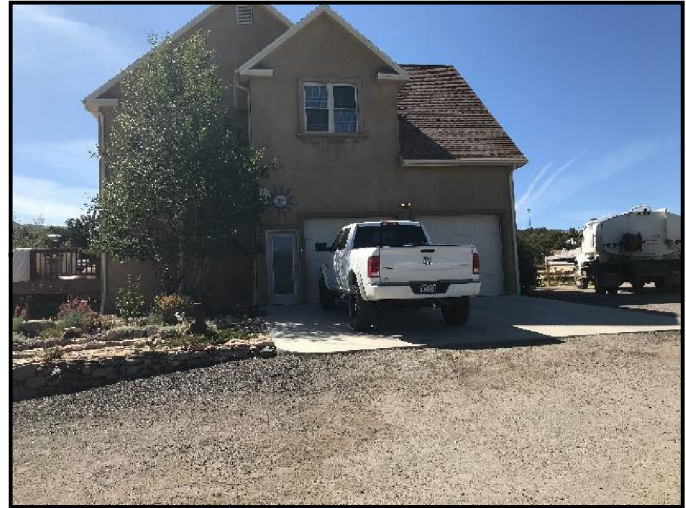
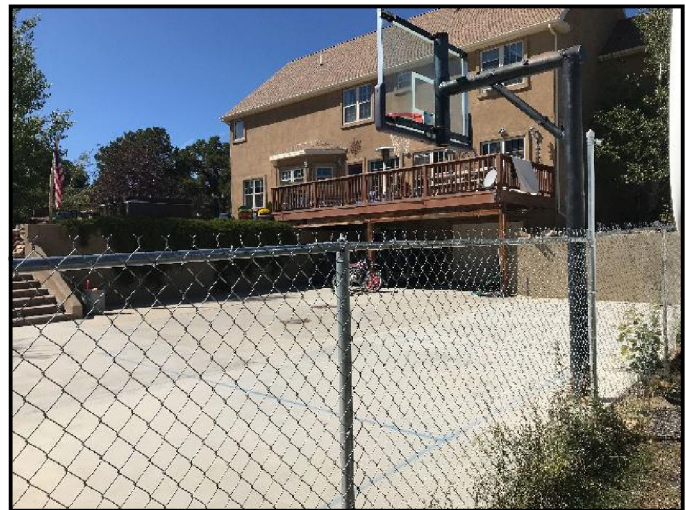
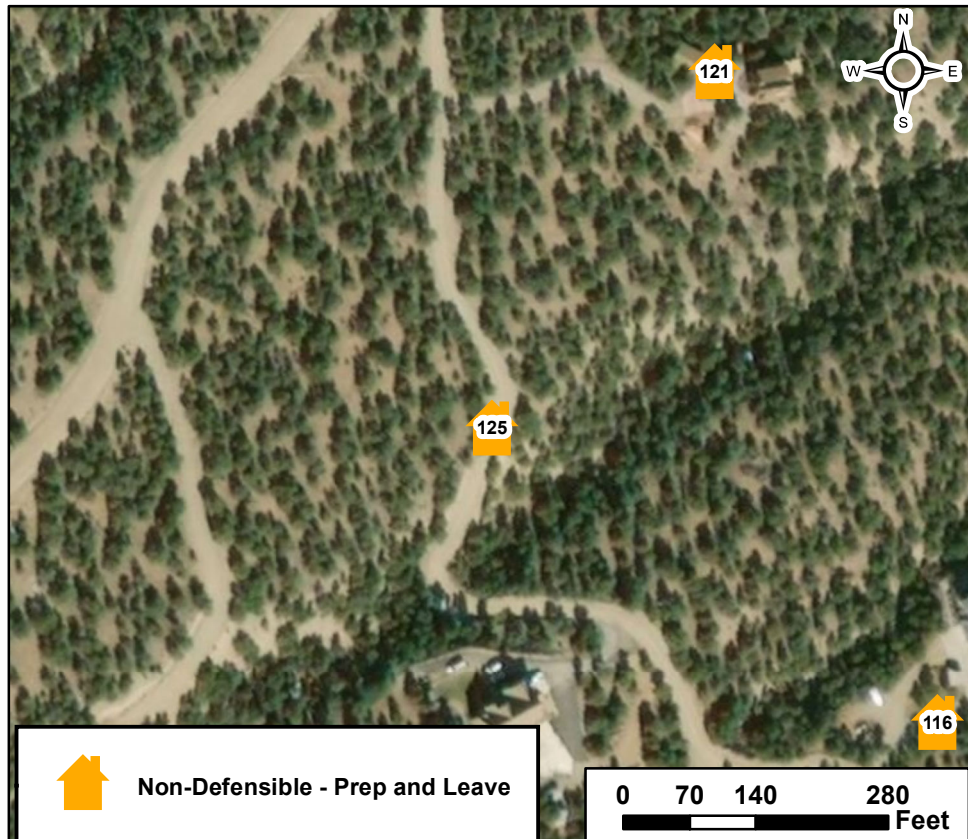
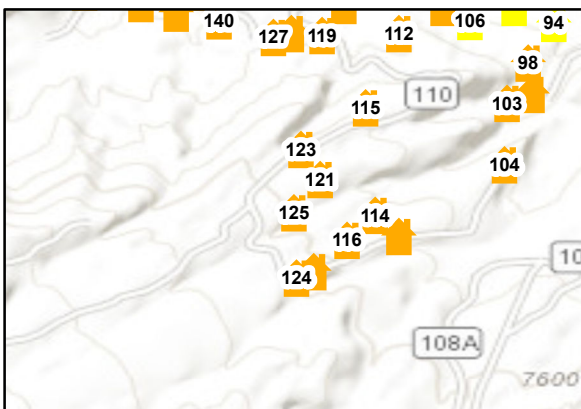
Hazards: fuels above and below, slope

Water Source: Limited or dependent on electricity

Safety Zone Present: Potential safety zone(s) in area

Notes: Wood decks, gravel drive, green lawn, some gravel paths

Mitigation Time (in hours): 6

Mitigation Description: Thinning

Type 6 engine, porta tank and sprinklers

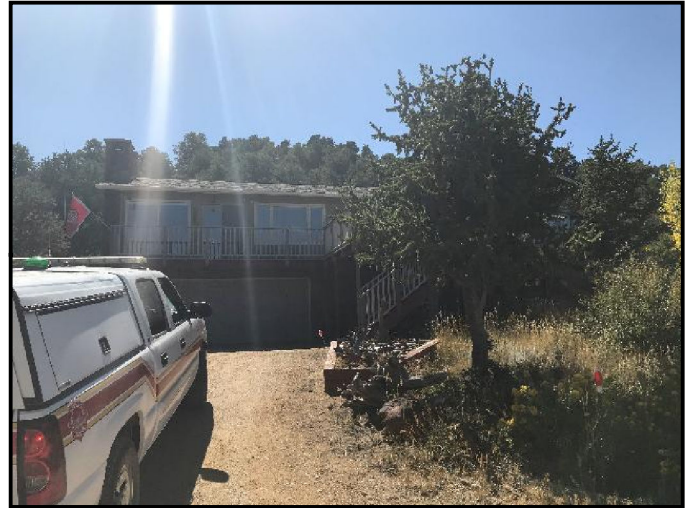
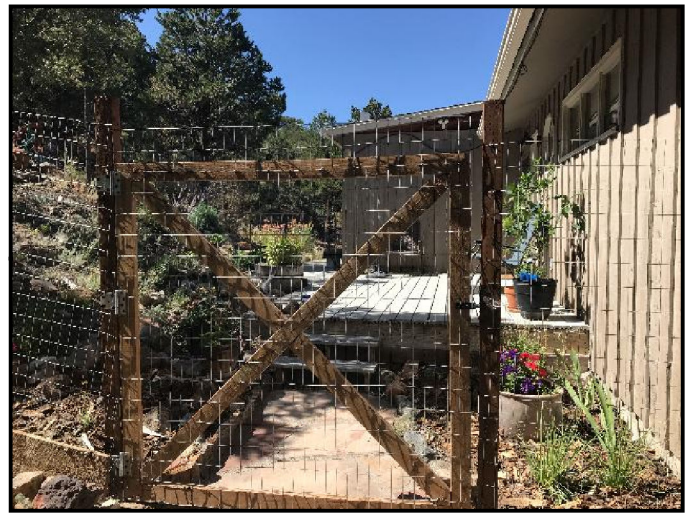
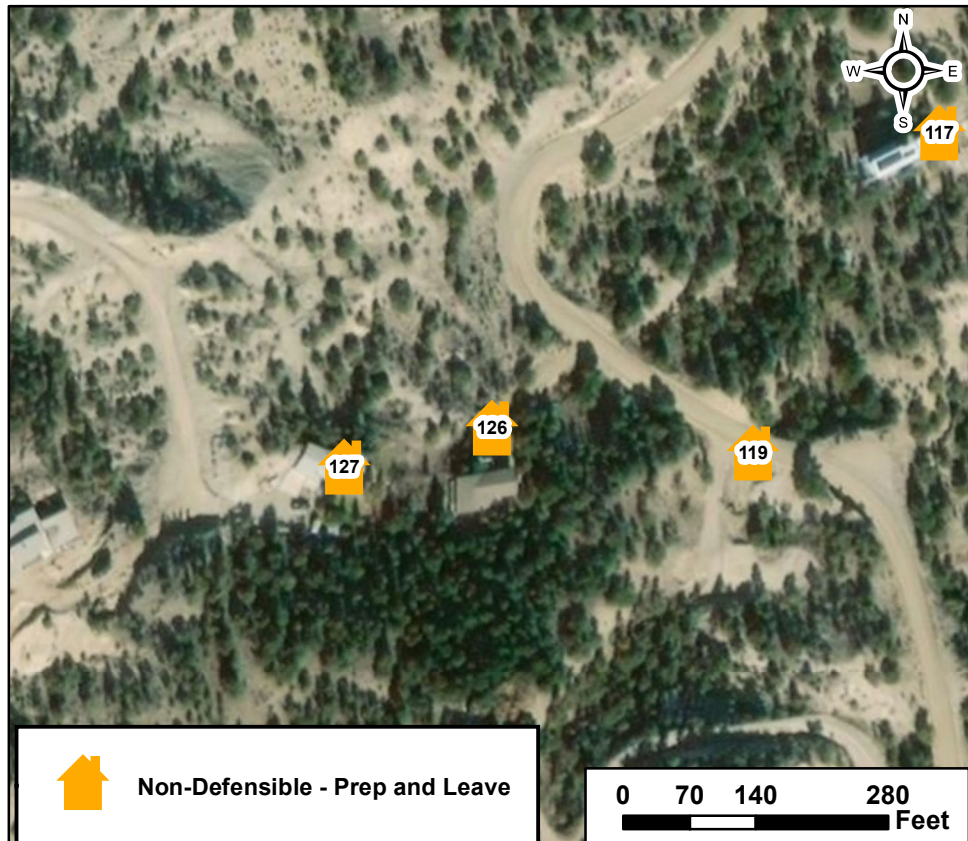
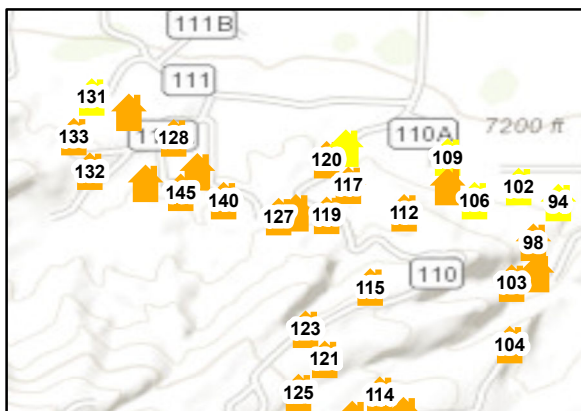
Hazards: fuels above and below, slope

Water Source: Limited or dependent on electricity

Safety Zone Present: No safety zone(s) in area

Notes: Wood decks, gravel drive, trex deck in backyard, wood pile under front deck

Mitigation Time (in hours): 4

Mitigation Description: Thinning and weed whacking

Type 3/4 engine

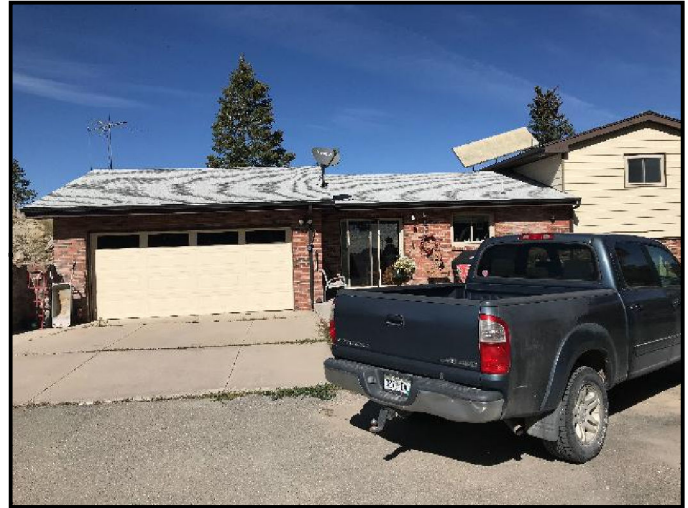
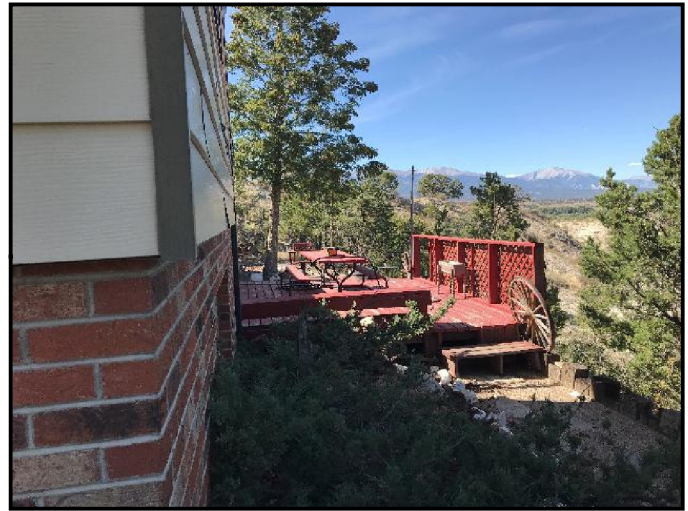
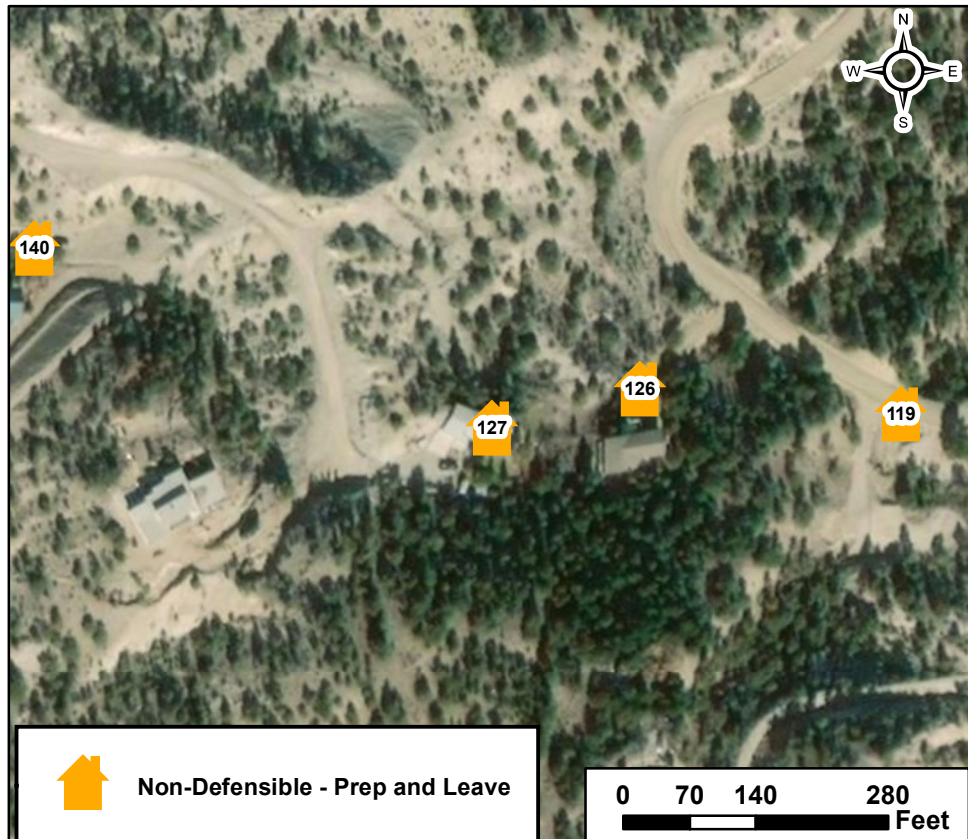
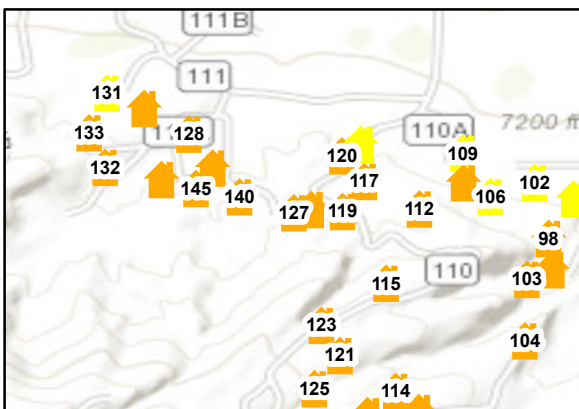
Structure ID: 127

Hazards: fuels above and below, slope

Water Source: Limited or dependent on electricity

Safety Zone Present: No safety zone(s) in area

Notes: Wood deck, some debris

Mitigation Time (in hours): 4

Mitigation Description: Saw work

Type 6 engine, porta tank and sprinklers
