Methodist East Structure Assessment

Structure ID: 30

Collected Date/Time: 9/26/2019 12:08:00 AM
Collected By: Chris Masson
Inspector's Position: Divs

Location: 5210 east highway 50,

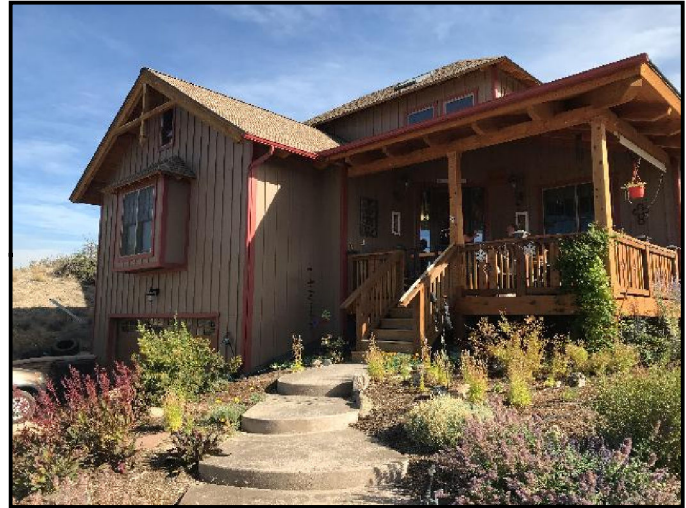
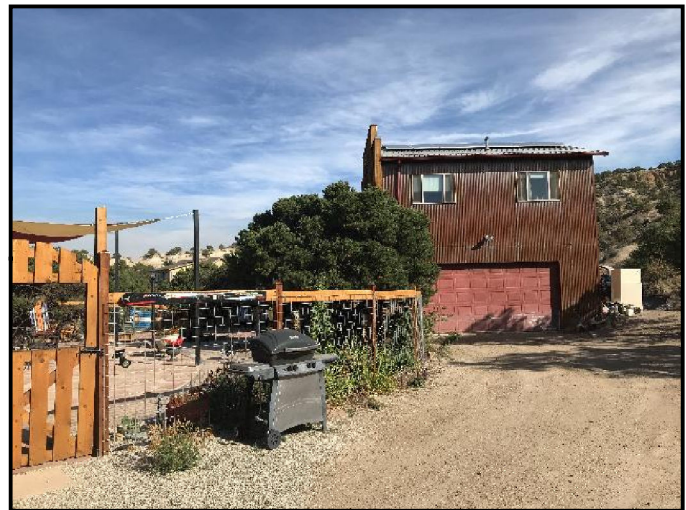
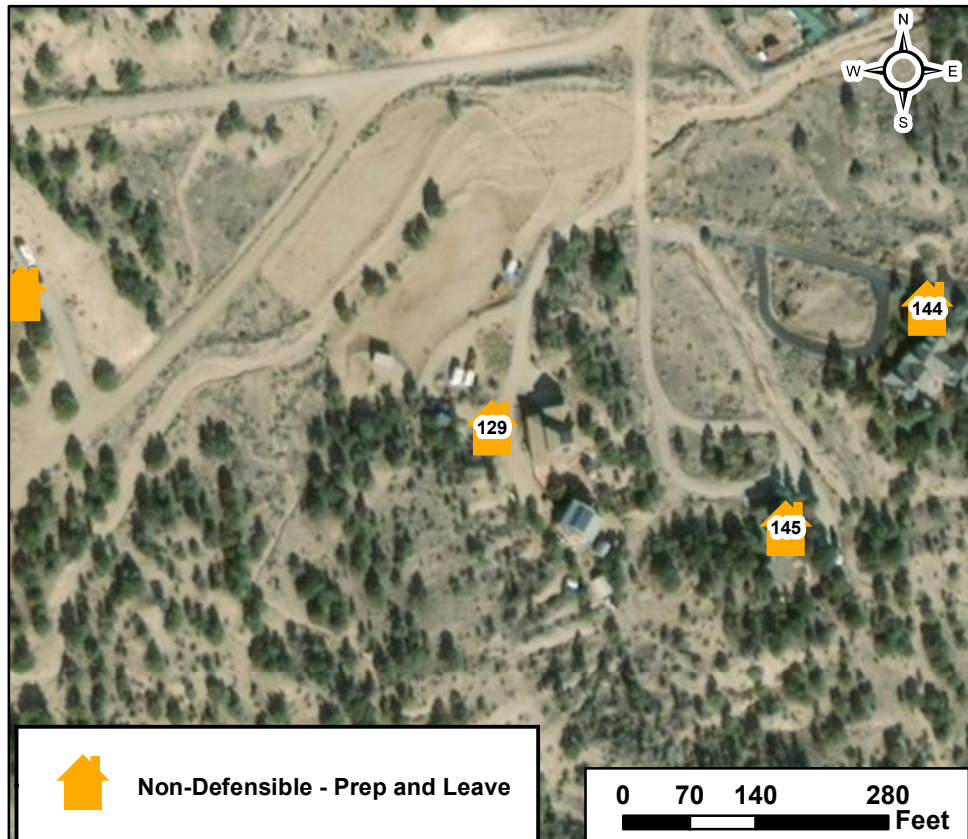
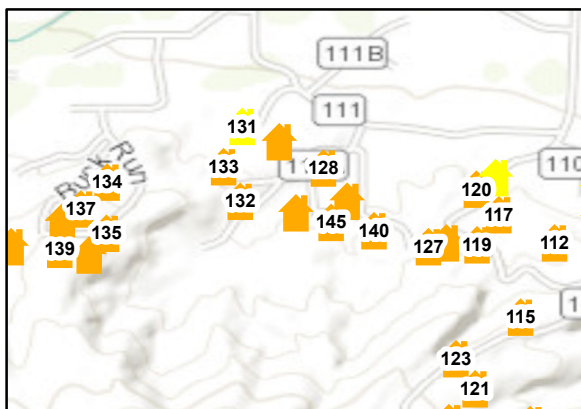
Hazards: fuels above, slope, scabby landscape

Water Source: Limited or dependent on electricity

Safety Zone Present: No safety zone(s) in area

Notes: Wood decks, gravel drive, shrubs touching structure

Mitigation Time (in hours): 4

Mitigation Description: Thinning and weed whacking

Type 3 engine

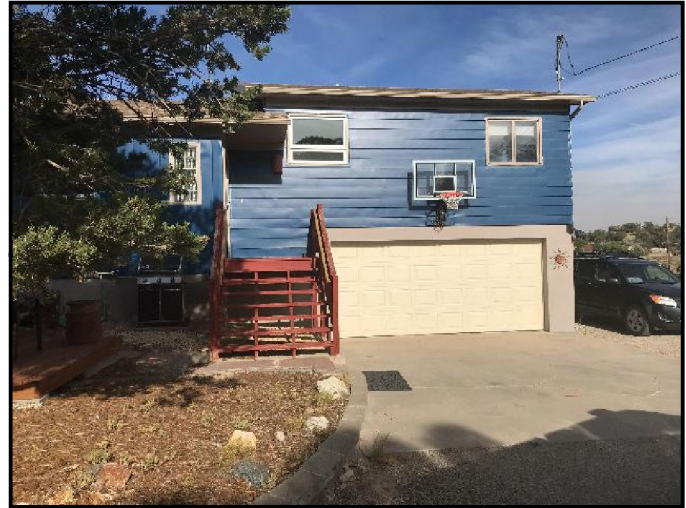
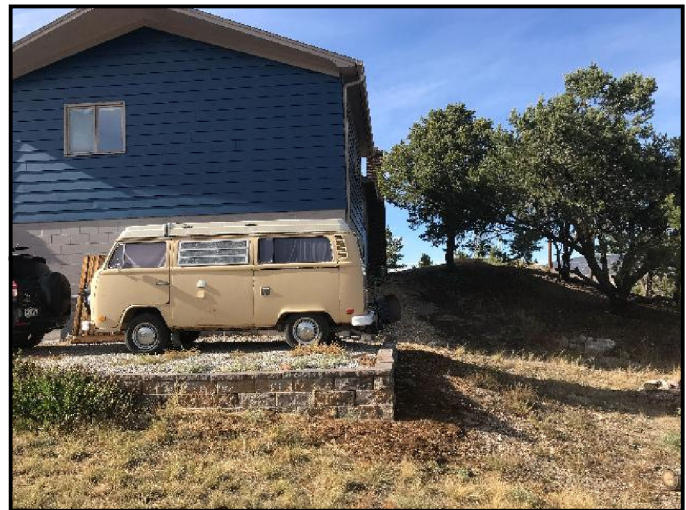
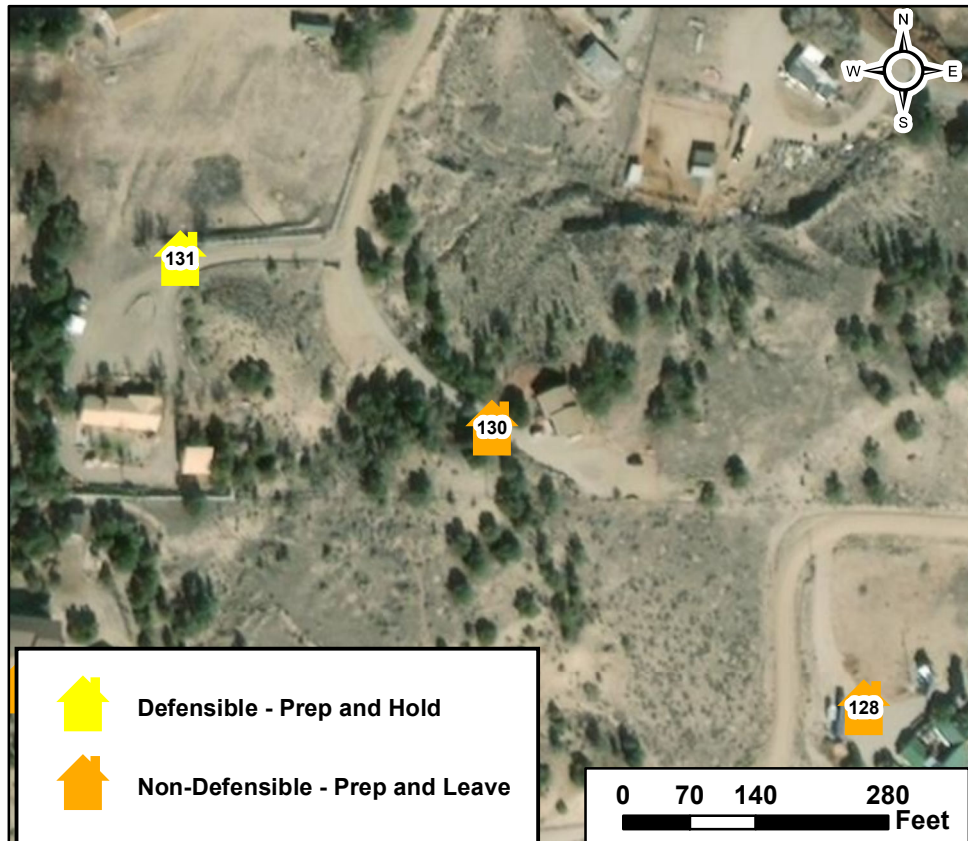
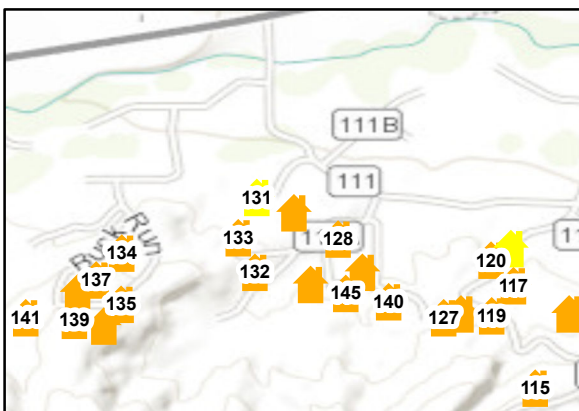
Structure ID: 130

Hazards: Fuels, slope

Water Source: Limited or dependent on electricity

Safety Zone Present: No safety zone(s) in area

Notes: Wood pile, wood deck, some debris

Mitigation Time (in hours): 4

Mitigation Description: Saw work and weed whacking

Type 6 engine, porta tank and sprinklers

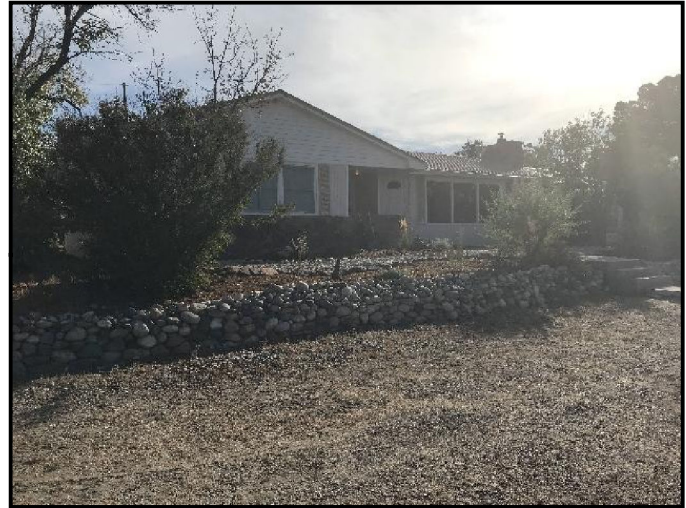
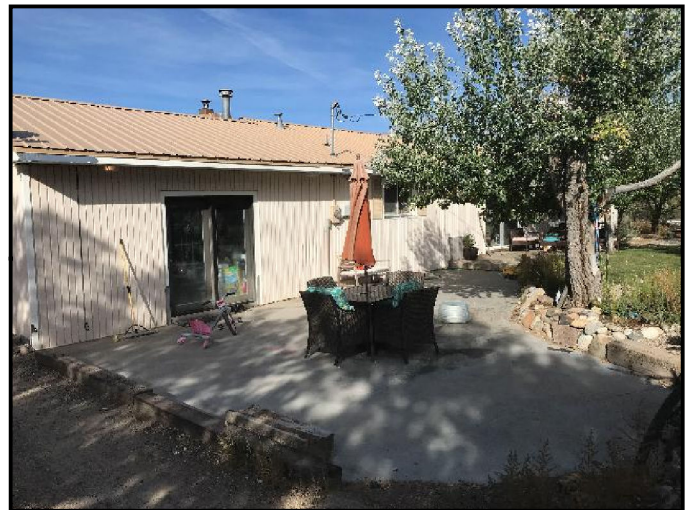
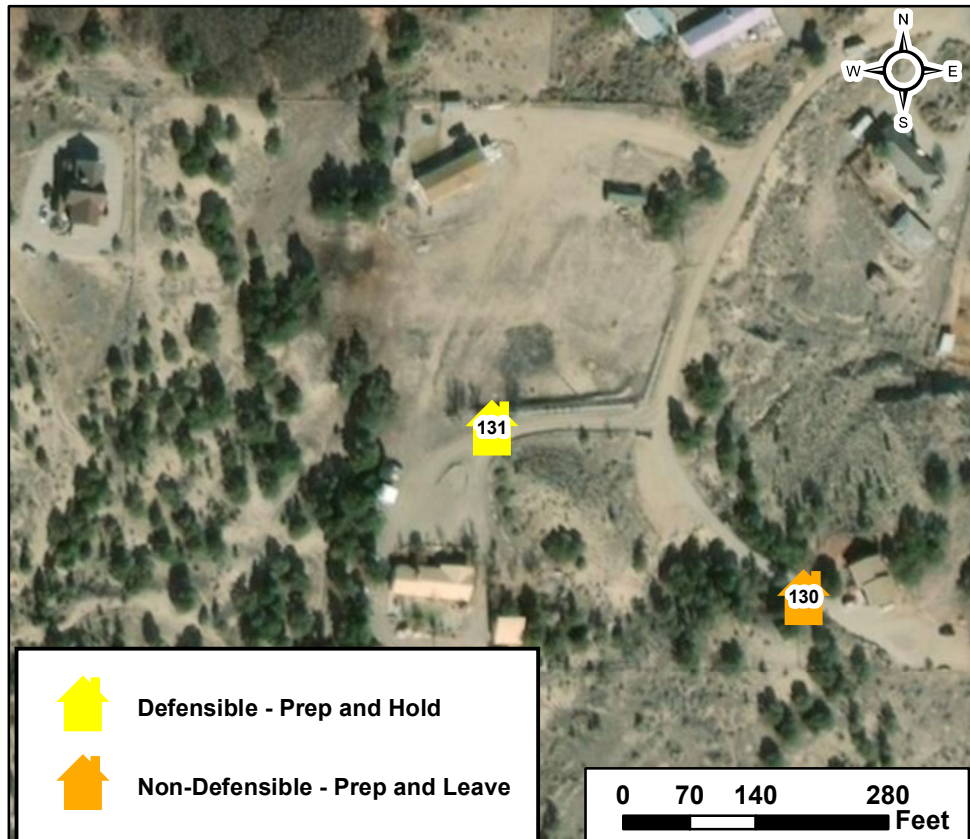
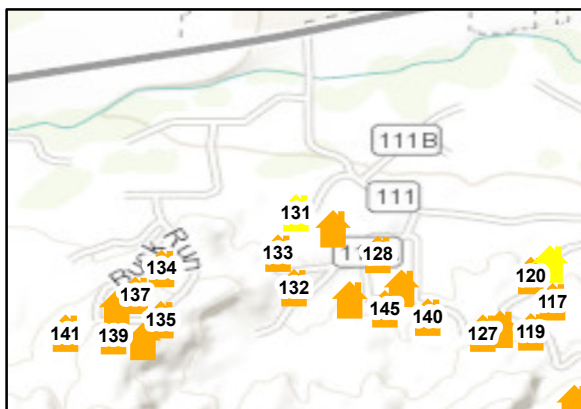
Structure ID: 131

Triage Category: Defensible, Prep and Hold
Type of Structure: Residential
Primary Structures:
Is the building Occupied?: Yes
Outbuildings: 2
Fuel Surrounding Structure: Shrub or timber
Defensible Space: Less Than 30 ft treated
Roof Material: Fire resistant- tar, rubberized
Siding Material: Rock, concrete, metal
Electrical Power: Yes
Gas to Structure: Yes
Hazards: Fuels, slope
Access to Site: T6 Engine
Describe Access: One way in and out
Comm With ICP: No
Water Source: Limited or dependent on electricity
Safety Zone Present: Potential safety zone(s) in area

Notes: Gravel drive around structure, shrubs in backyard, some debris, fence, bark dust pile in front drive

Mitigation Time (in hours): 4
Mitigation Description: Saw work and weed whacking

Type 6 engine, porta tank and sprinklers

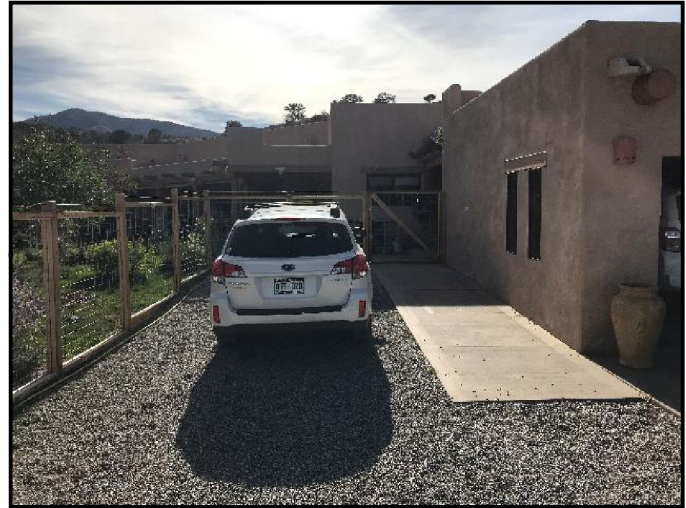
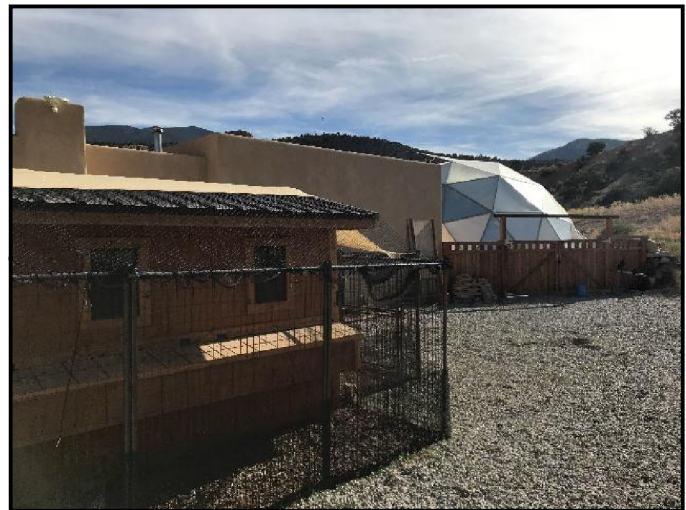
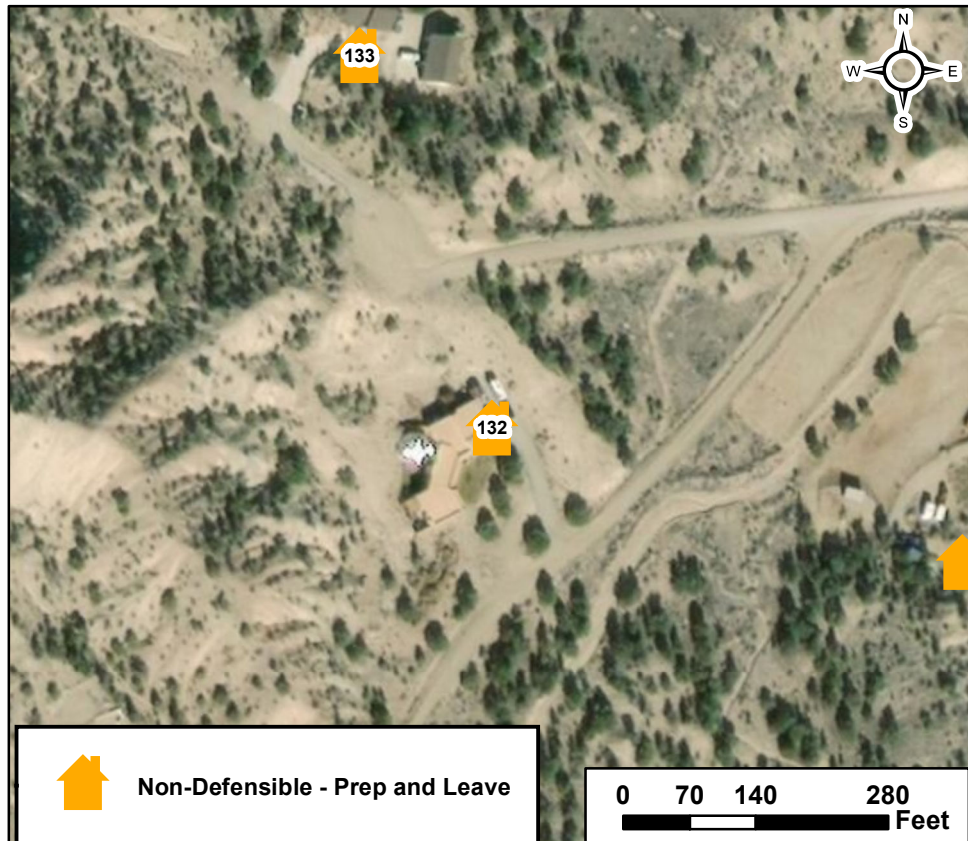
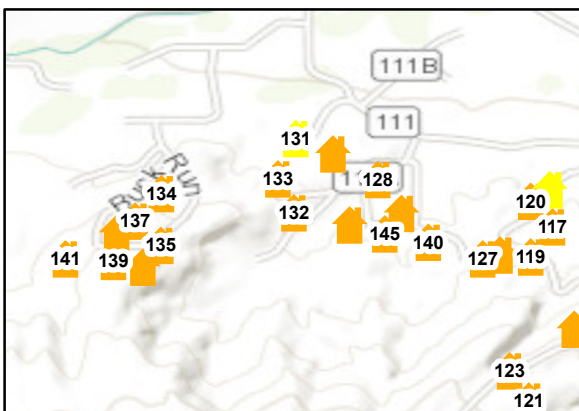
Hazards: fuels above, slope, scabby landscape

Water Source: Limited or dependent on electricity

Safety Zone Present: No safety zone(s) in area

Notes: Fenced yard/garden, gravel drive, geodesic dome in backyard

Mitigation Time (in hours): 4

Mitigation Description: Thinning and weed whacking

Type 3/4 engine

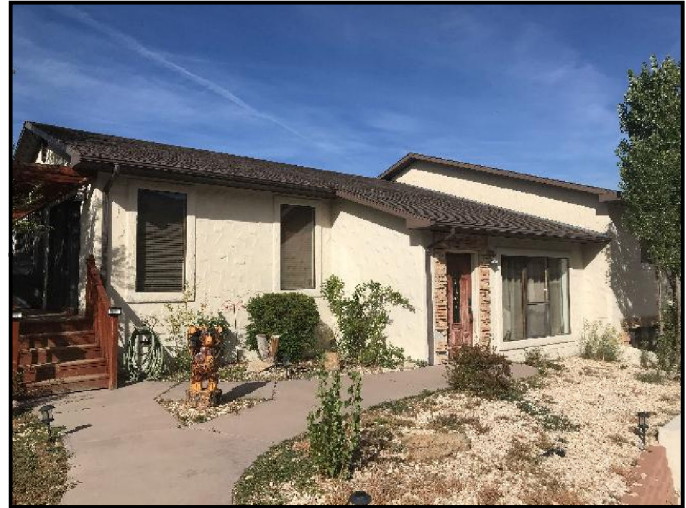
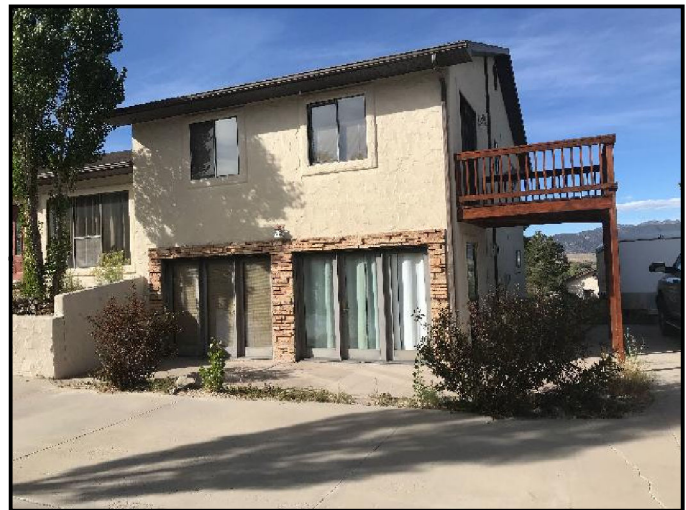
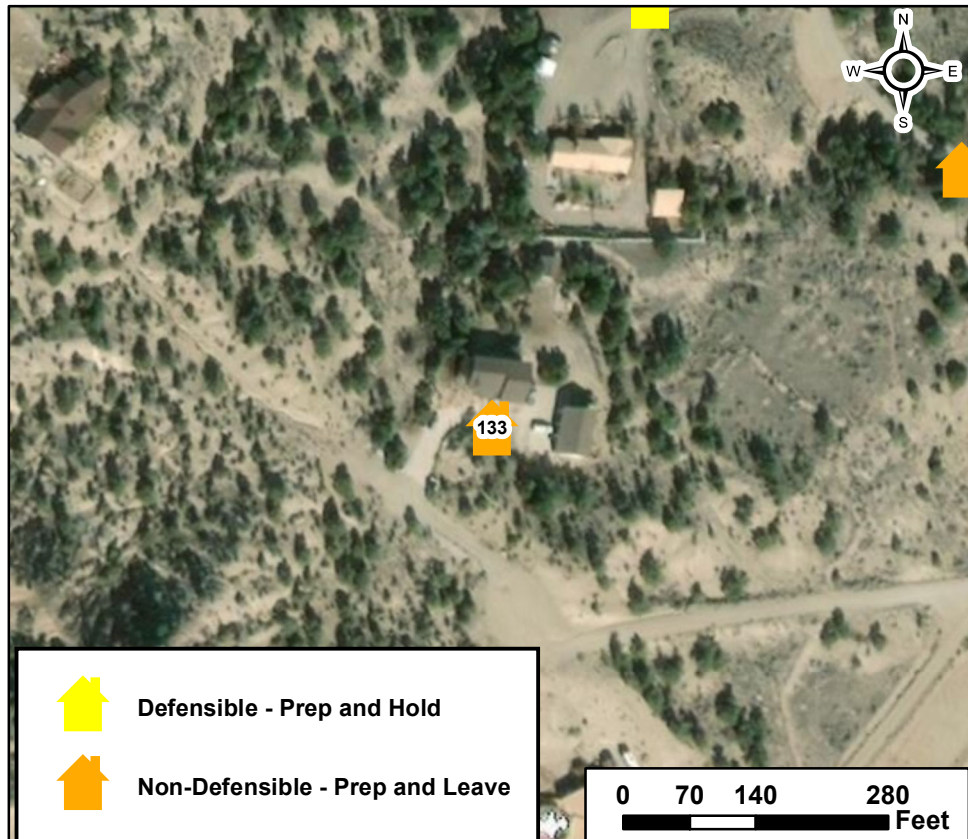
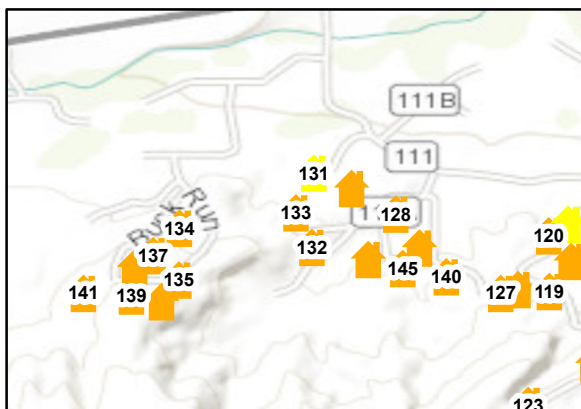
Structure ID: 133

Hazards: Fuels, slope

Water Source: Limited or dependent on electricity

Safety Zone Present: No safety zone(s) in area

Notes: Wood decks, fuels touching structure, paved driveway, yard debris, wood pile

Mitigation Time (in hours): 6

Mitigation Description: Saw work

Type 6 engine, porta tank and sprinklers

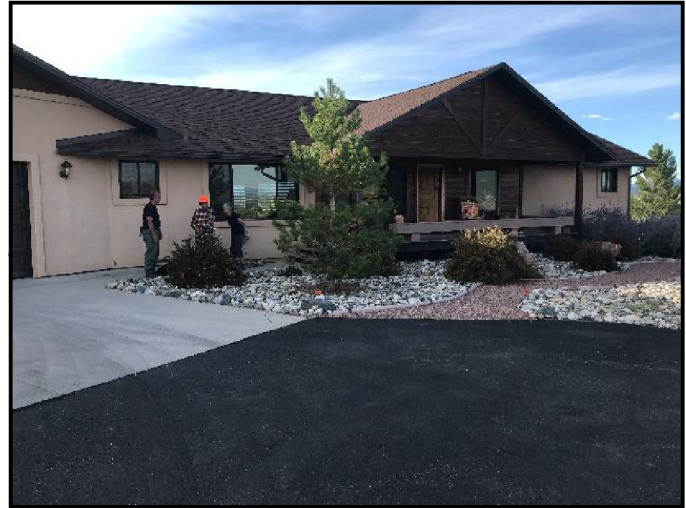
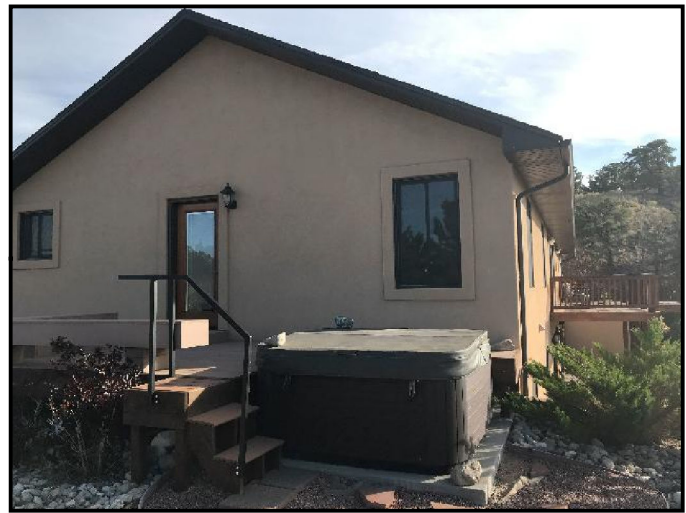
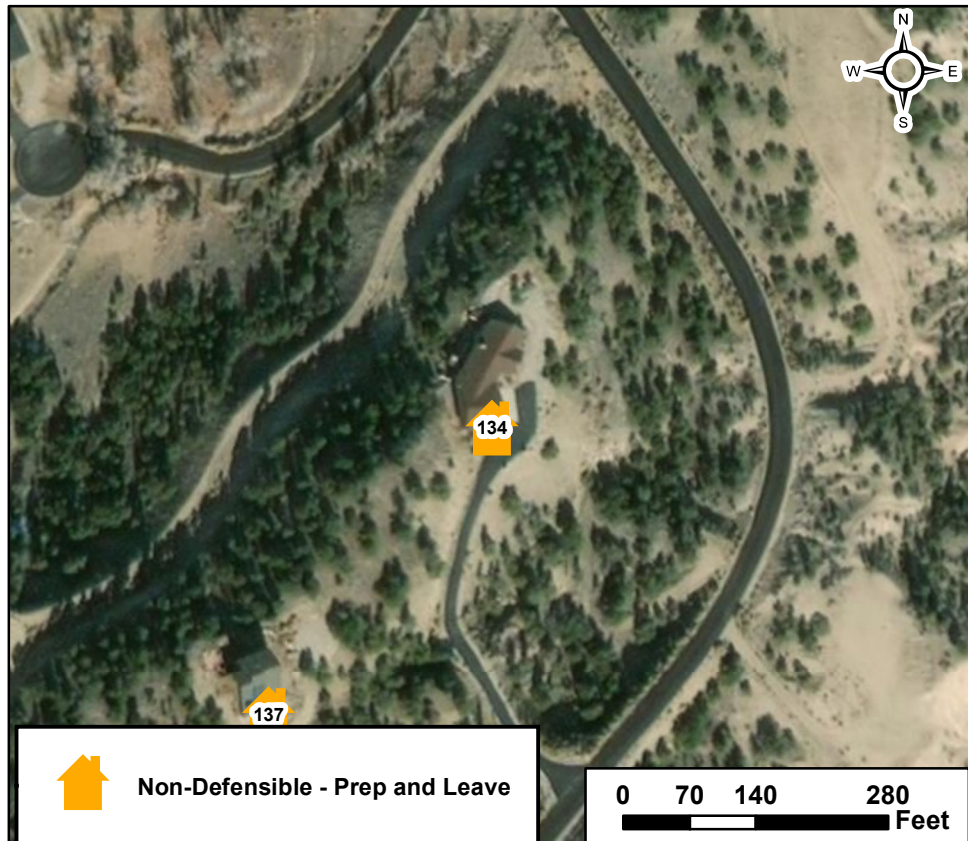
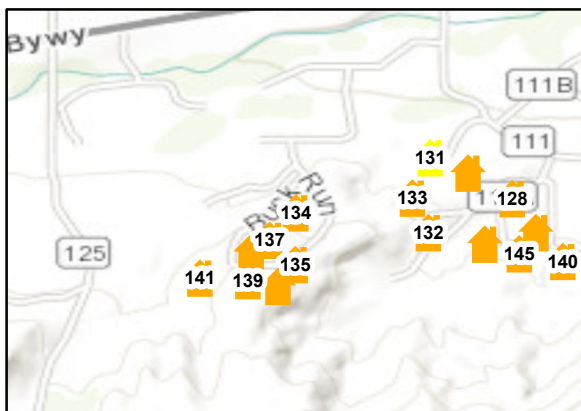
Hazards: Fuels above and below, slope

Water Source: Limited or dependent on electricity

Safety Zone Present: No safety zone(s) in area

Notes: Wood/trex decks, extensive rock landscaping

Mitigation Time (in hours): 4

Mitigation Description: Saw work and weed whacking

Type 6 engine, porta tank and sprinklers

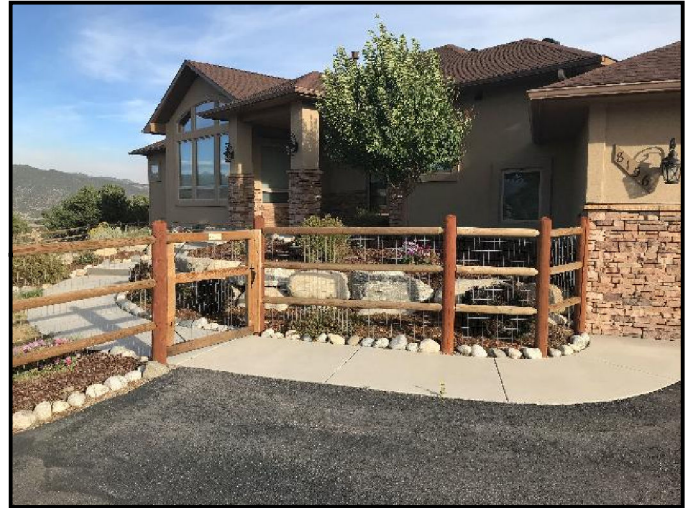
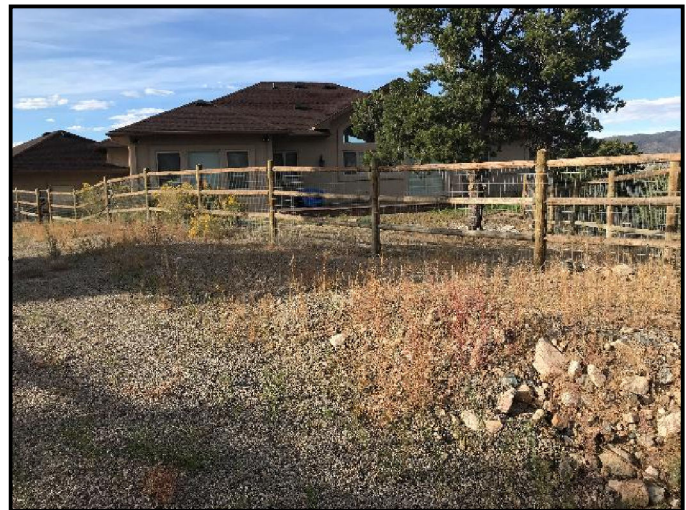
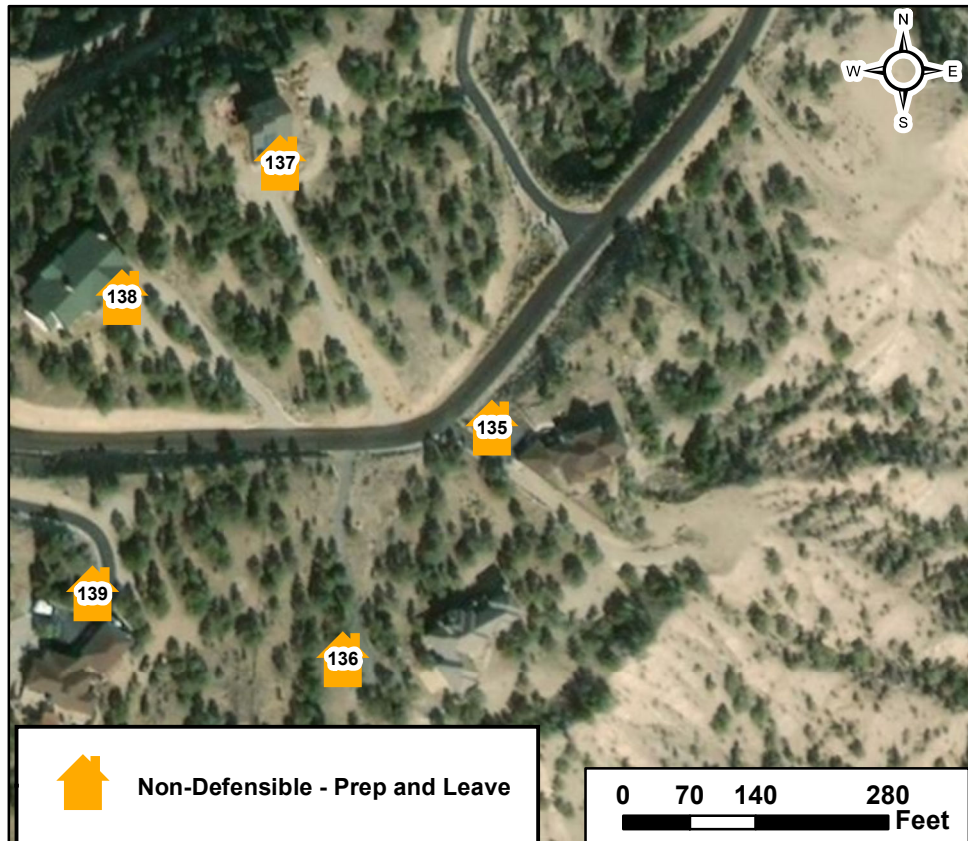
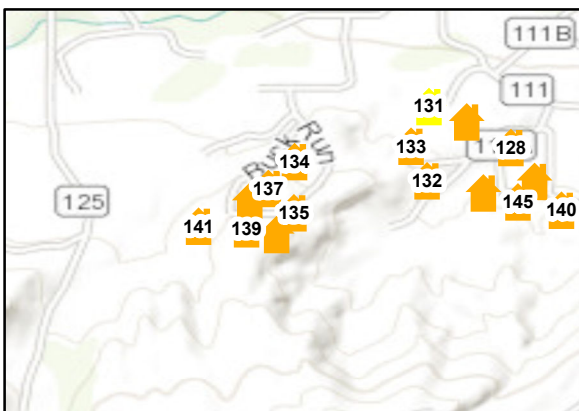
Hazards: Fuels, slope

Water Source: Limited or dependent on electricity

Safety Zone Present: No safety zone(s) in area

Notes: Wood deck, large flat area behind/below structure, landscaping with bark dust

Mitigation Time (in hours): 5

Mitigation Description: Saw work and weed whacking

Type 6 engine, porta tank and sprinklers

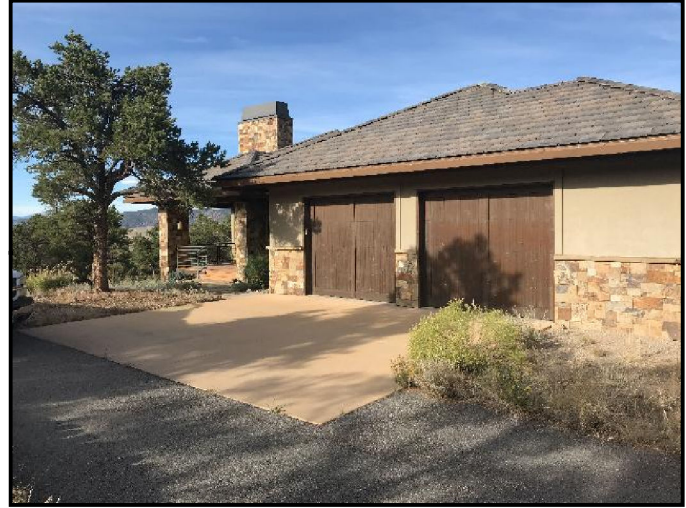
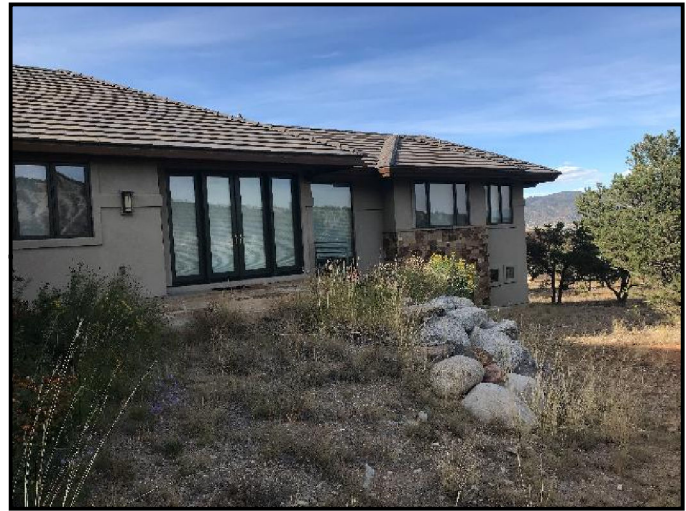
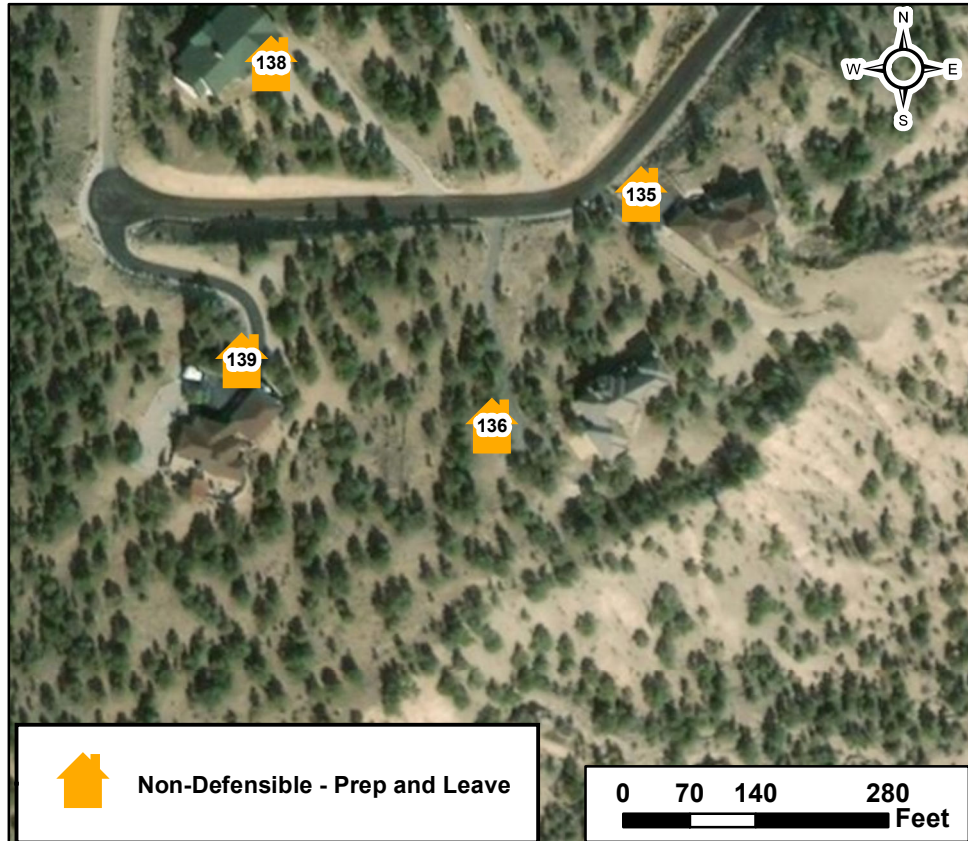
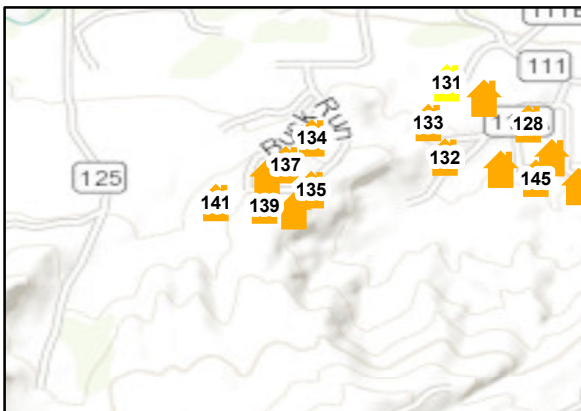
Hazards: Fuels, slope

Water Source: Limited or dependent on electricity

Safety Zone Present: No safety zone(s) in area

Notes: Wood/trex deck, asphalt driveway

Mitigation Time (in hours): 4

Mitigation Description: Saw work and weed whacking

Type 6 engine, porta tank and sprinklers

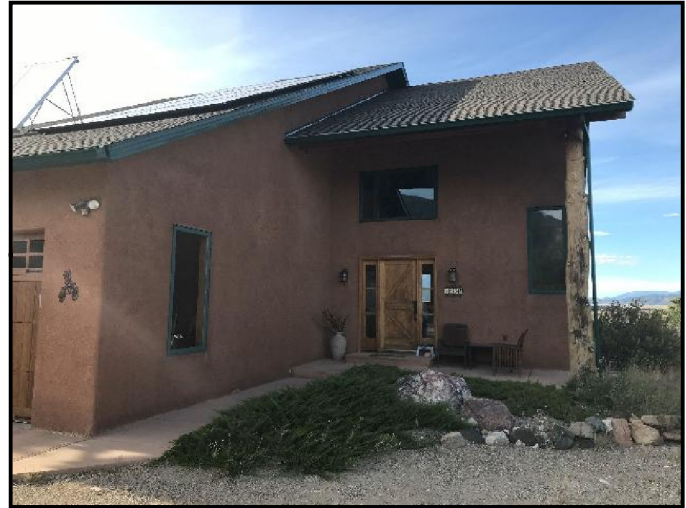
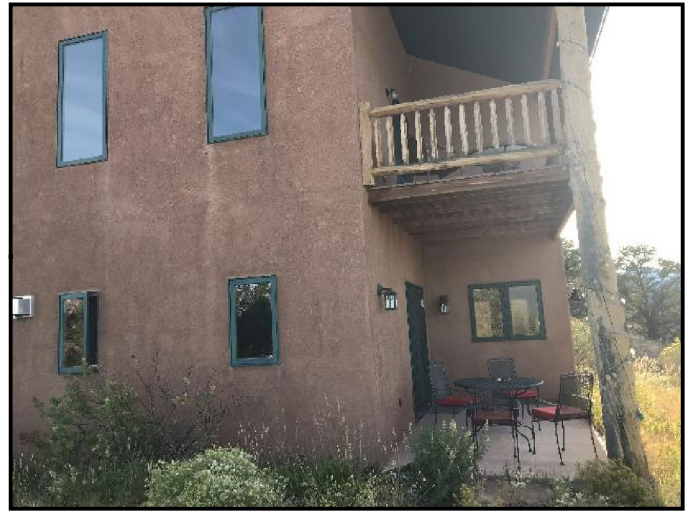
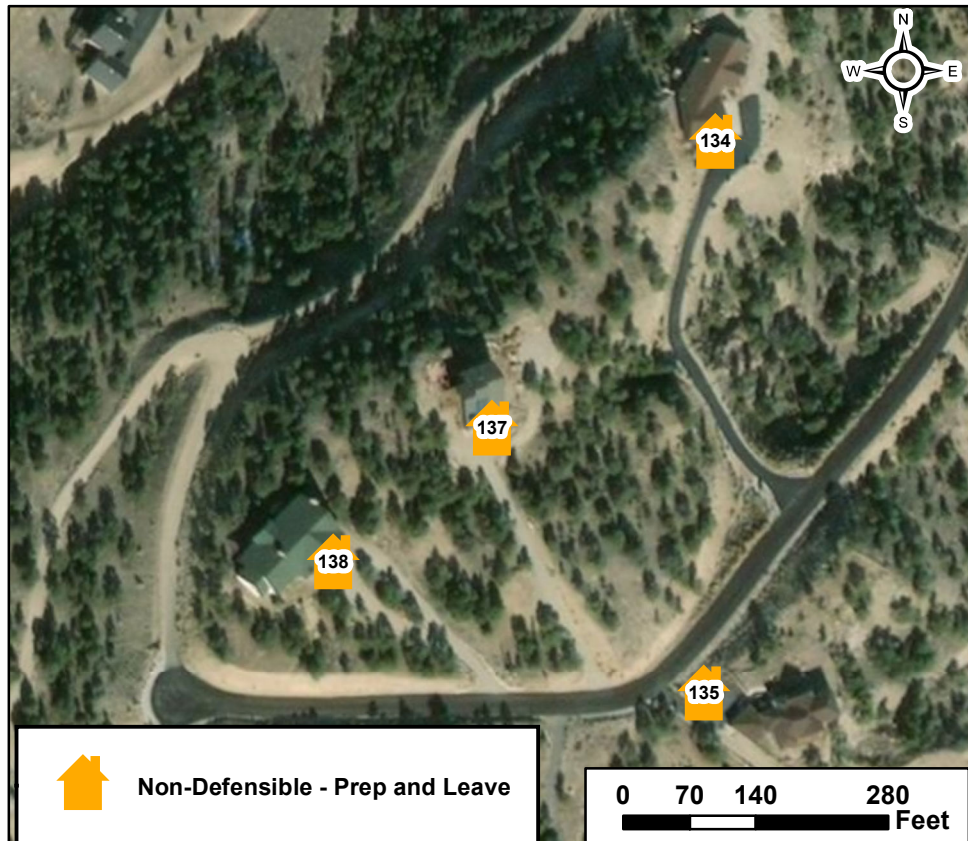
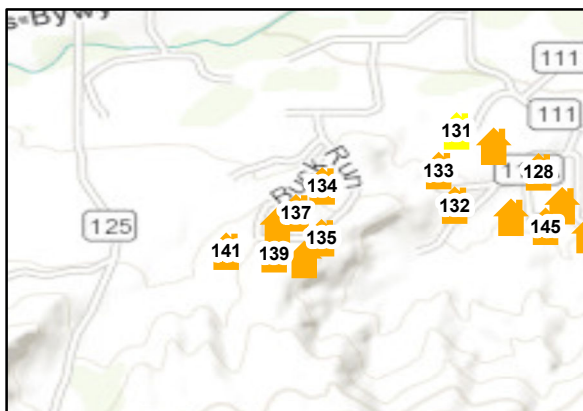
Triage Category: Non-Defensible, Prep and Leave
Type of Structure: Residential
Primary Structures:
Is the building Occupied?: Yes
Outbuildings:
Fuel Surrounding Structure: Shrub or timber
Defensible Space: Less Than 30 ft treated
Roof Material: Fire resistant- tar, rubberized
Siding Material: Rock, concrete, metal
Electrical Power: Yes
Gas to Structure: Yes
Hazards: Fuels, slope
Access to Site: T6 Engine
Describe Access: One way in and out, fat tire neon sign
Comm With ICP: No
Water Source: Limited or dependent on electricity
Safety Zone Present: No safety zone(s) in area

Resources Needed to Protect Structure:
Type 6 engine, porta tank and sprinklers
Notes: Wood/trex deck, fuels up to structure

Mitigation Time (in hours): 5
Mitigation Description: Saw work and weed whacking

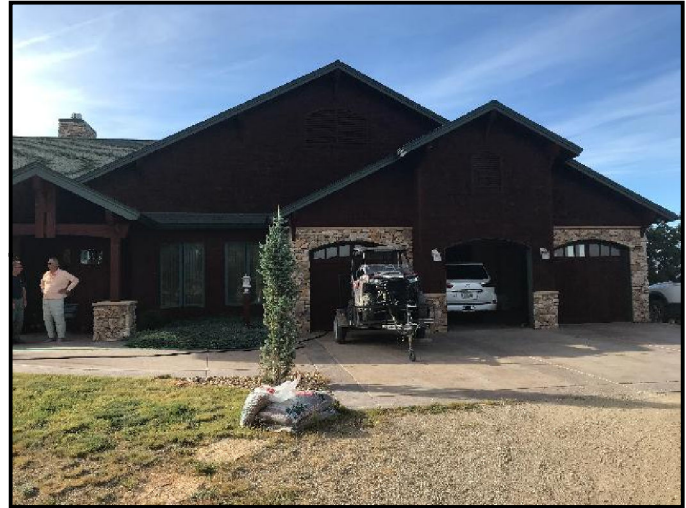
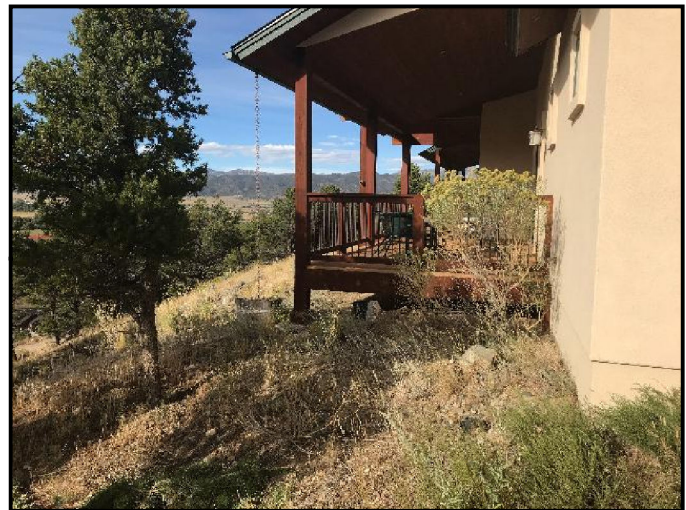
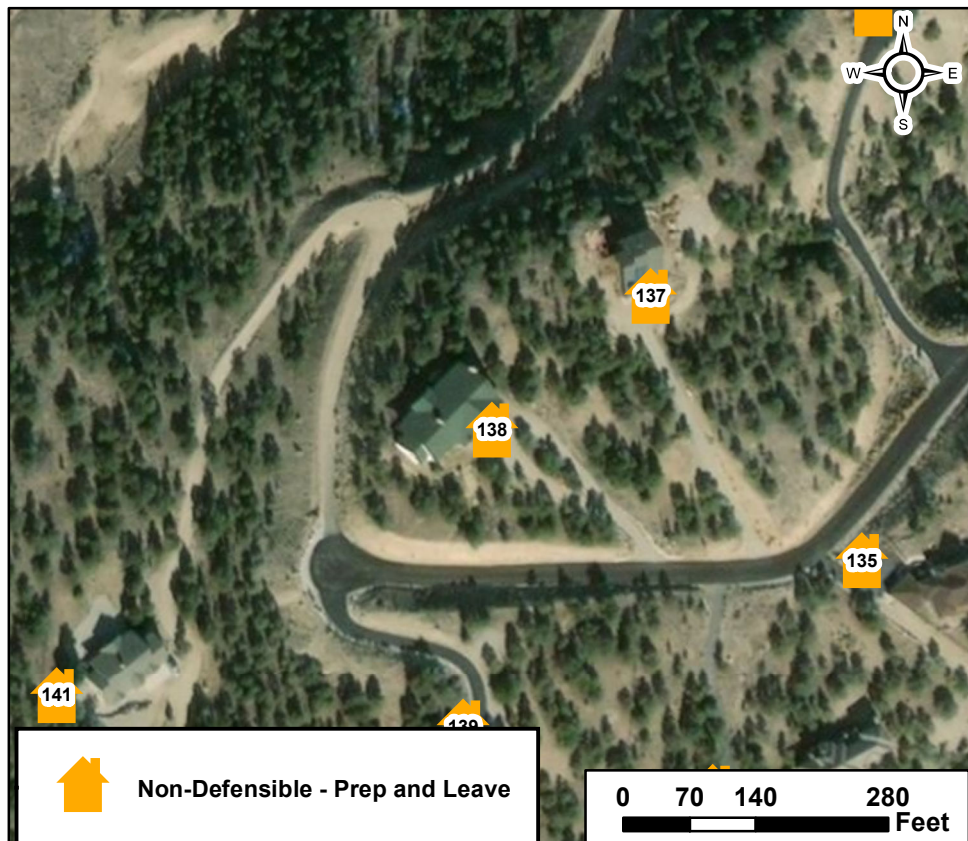
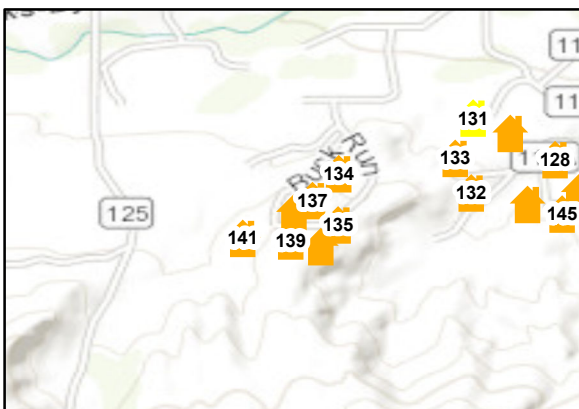
Hazards: Fuels, slope

Safety Zone Present: No safety zone(s) in area

Notes: Wood/trex deck, some landscaping, green grass, emergency road below structure

Mitigation Time (in hours): 4

Mitigation Description: Saw work and weed whacking

Type 6 engine, porta tank and sprinklers

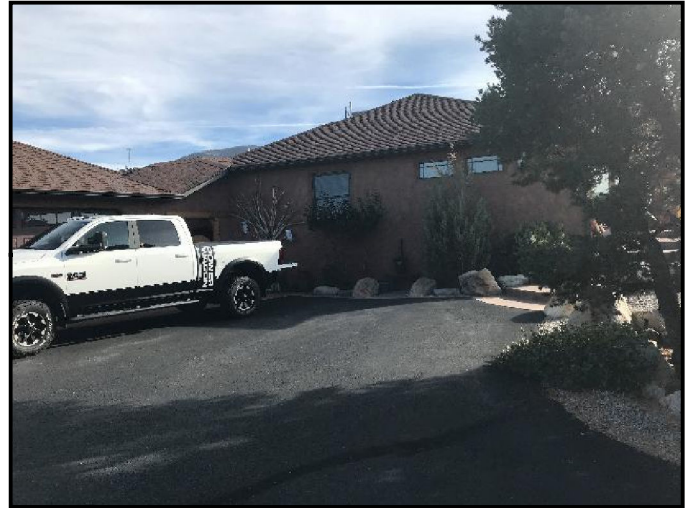
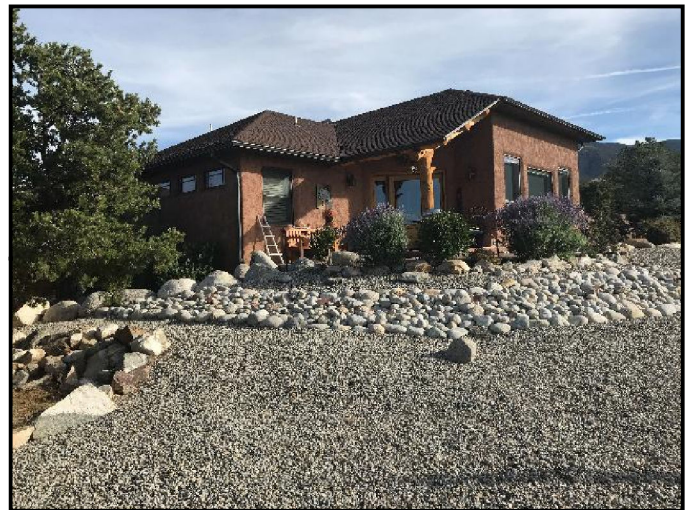
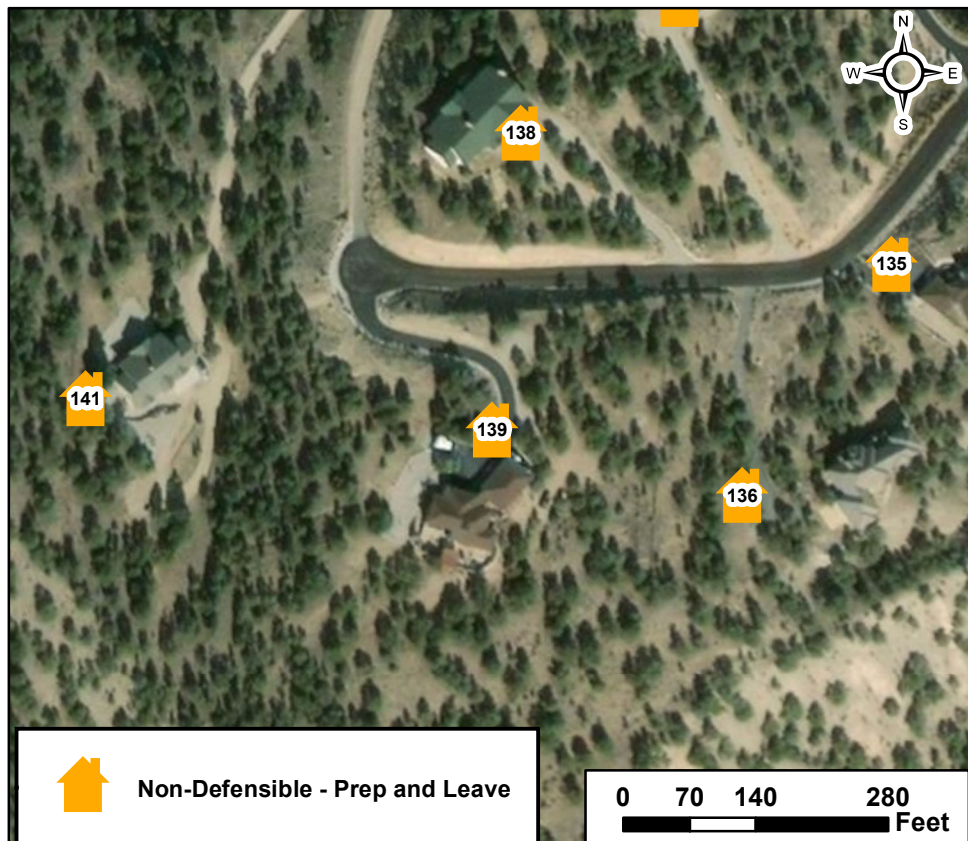
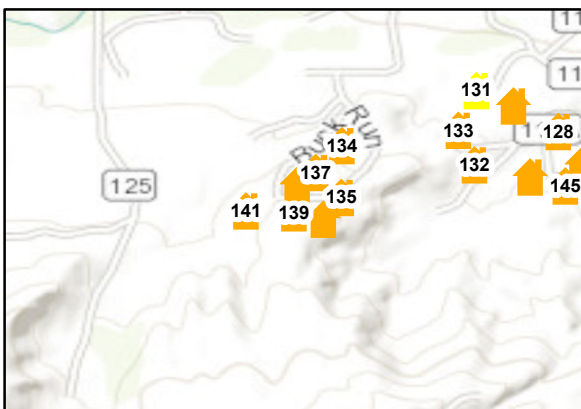
Hazards: Fuels, slope

Safety Zone Present: No safety zone(s) in area

Notes: Gravel landscaping, wood/ brick gazebo

Mitigation Time (in hours): 4

Mitigation Description: Saw work and weed whacking

Type 6 engine, porta tank and sprinklers

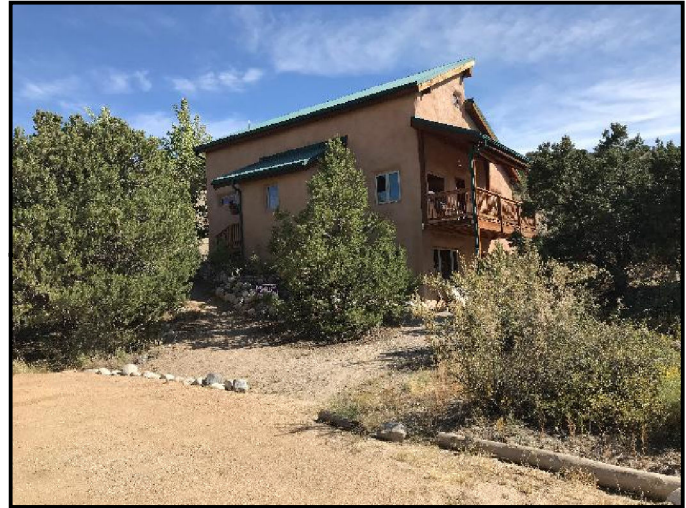
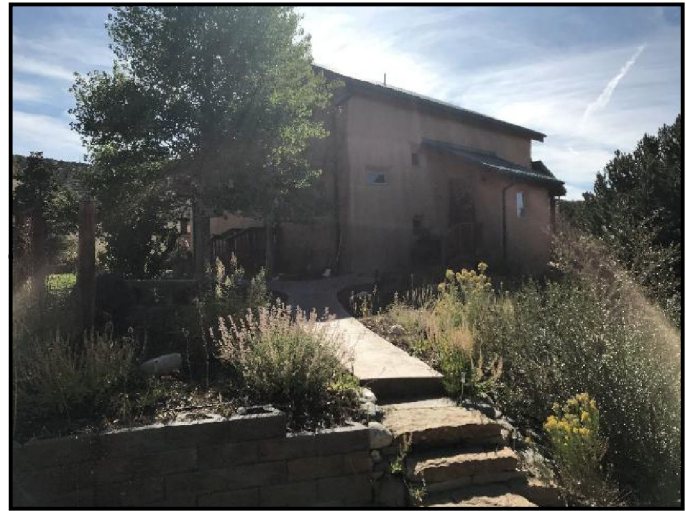
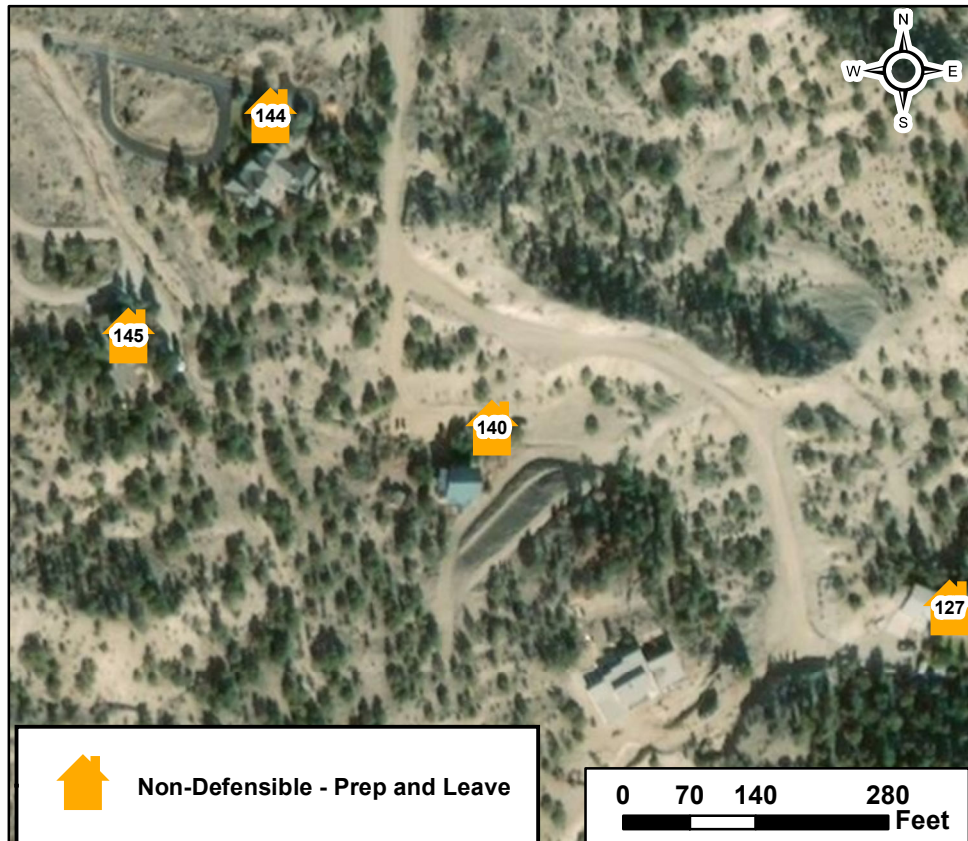
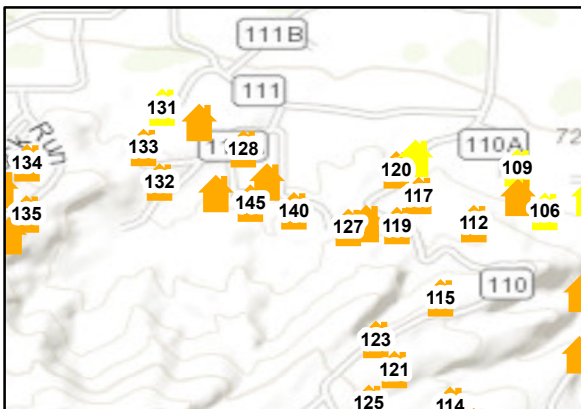
Triage Category: Non-Defensible, Prep and Leave
Type of Structure: Residential
Primary Structures:
Is the building Occupied?: Yes
Outbuildings: 1
Fuel Surrounding Structure: Shrub or timber
Defensible Space: Less Than 30 ft treated
Roof Material: Noncombustible or not applicable
Siding Material: Rock, concrete, metal
Electrical Power: Yes
Gas to Structure: Yes
Hazards: fuels above and below, slope, scabby landscape
Access to Site: T6 Engine
Describe Access: Off Clark hill
Comm With ICP: No
Water Source: Limited or dependent on electricity
Safety Zone Present: No safety zone(s) in area

Resources Needed to Protect Structure:
Type 6 engine, porta tank and sprinklers
Notes: Wood decks, gravel drive, shrubs touching structure

Mitigation Time (in hours): 2
Mitigation Description: Thinning and weed whacking
