Methodist East Structure Assessment

Structure ID: 30

Collected Date/Time: 9/26/2019 12:08:00 AM
Collected By: Chris Masson
Inspector's Position: Divs

Location: 5210 east highway 50,

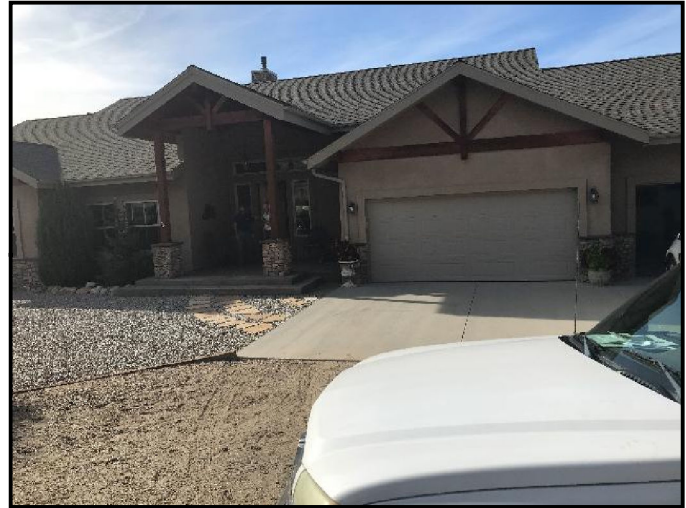
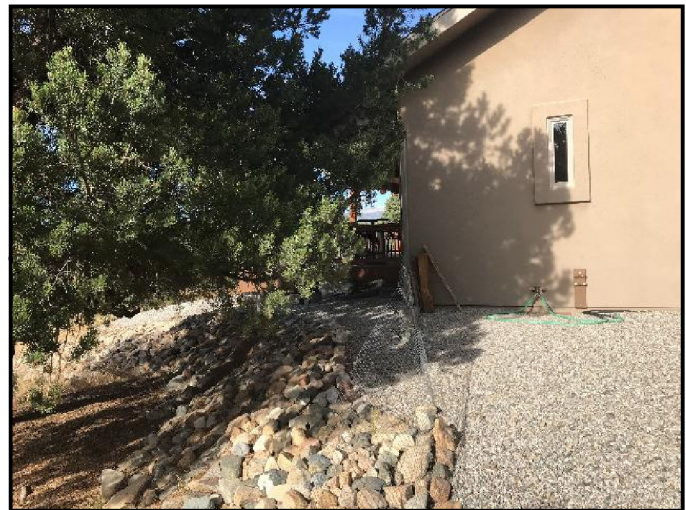
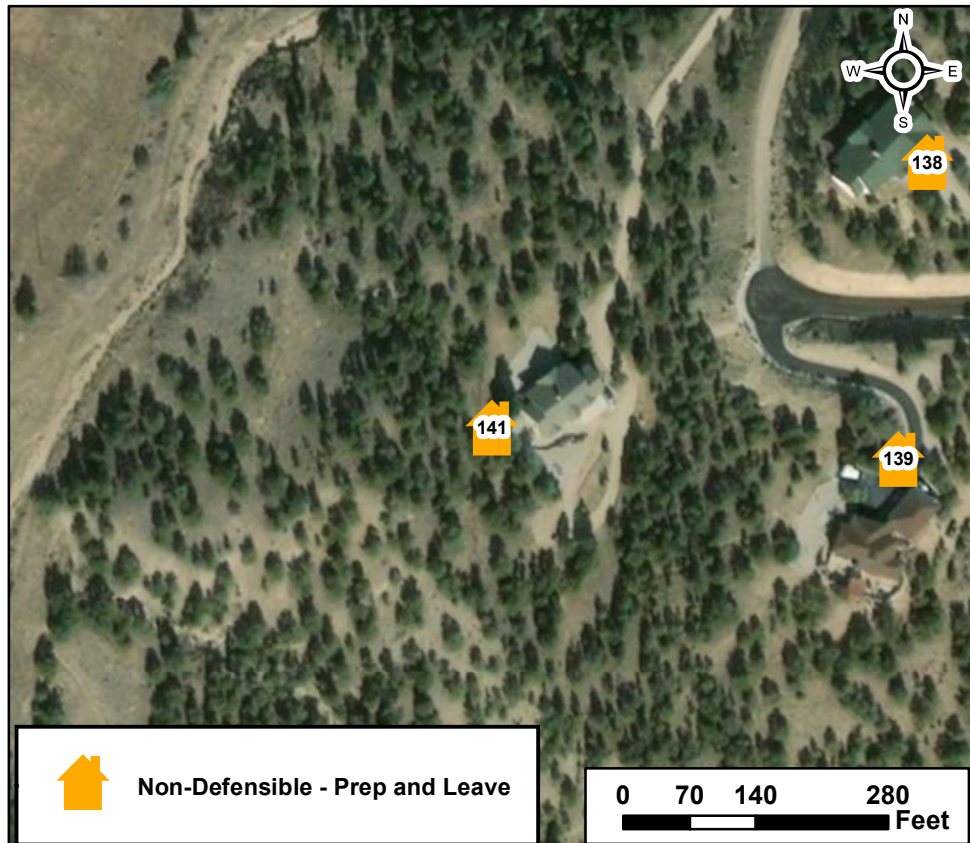
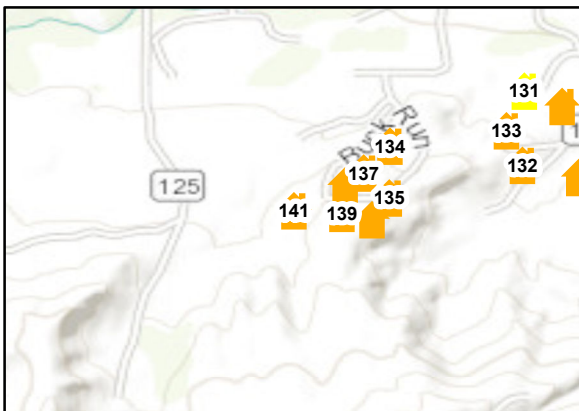
Hazards: Fuels, slope

Safety Zone Present: No safety zone(s) in area

Notes: Gravel landscaping, wood/trex deck

Mitigation Time (in hours): 4

Mitigation Description: Saw work and weed whacking

Type 6 engine, porta tank and sprinklers

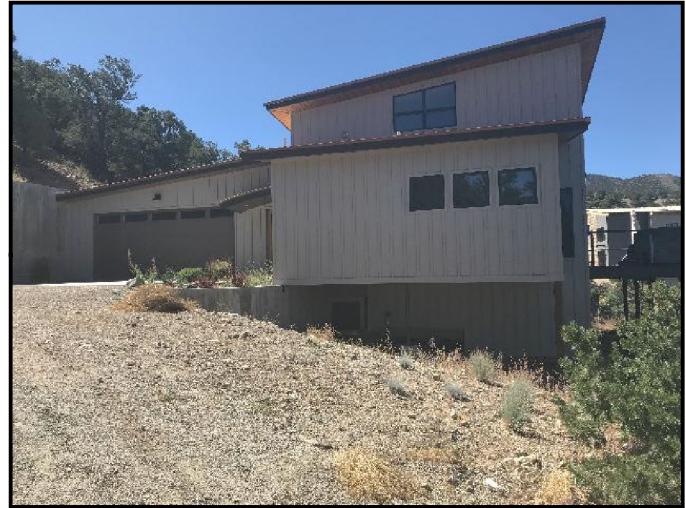
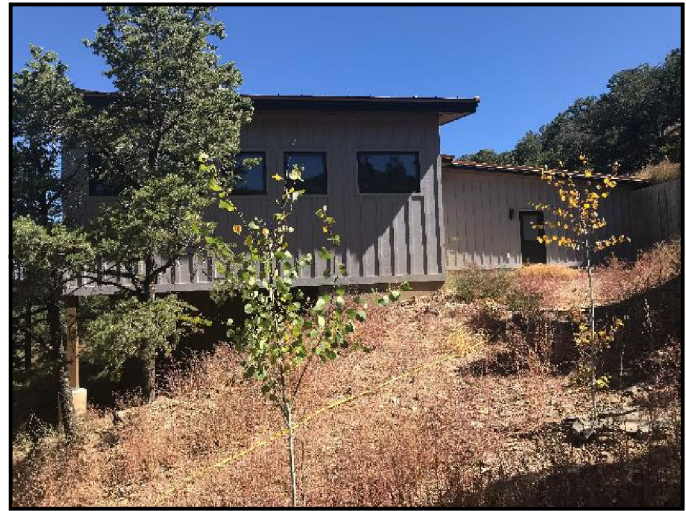
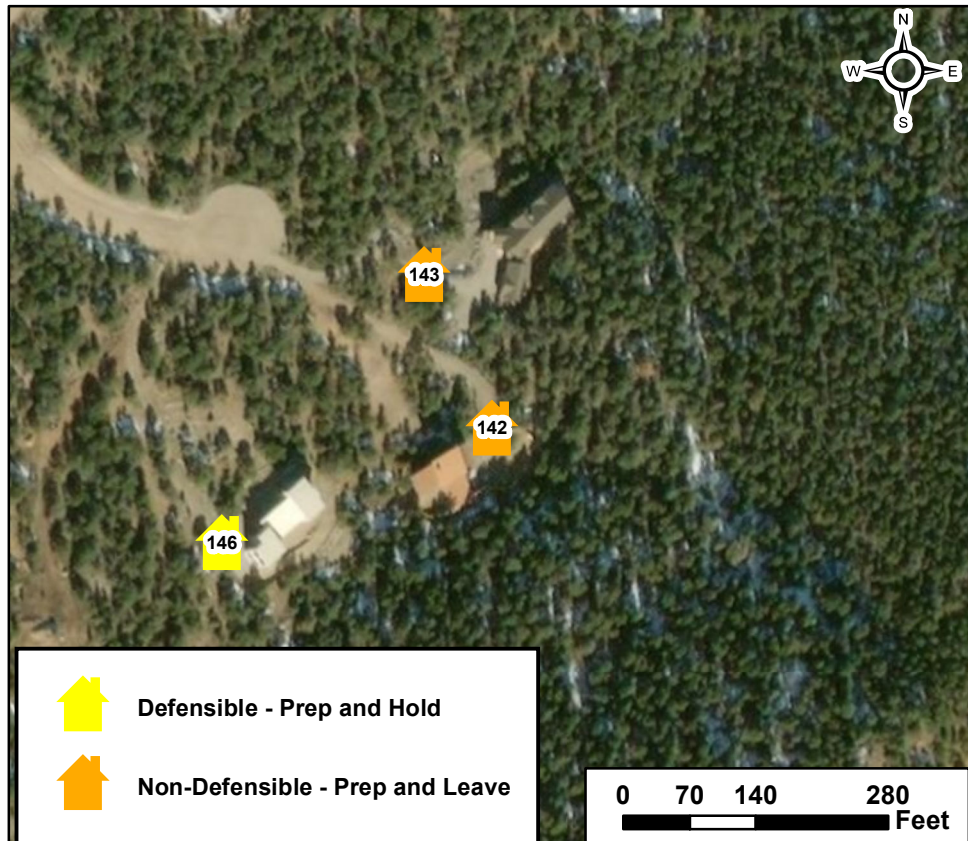
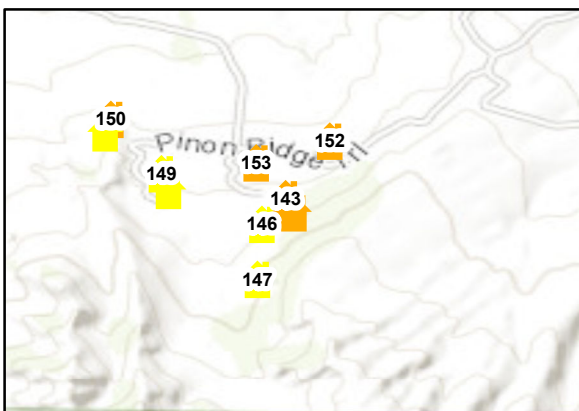
Hazards: Fuels below and above structure, slope

Safety Zone Present: No safety zone(s) in area

Notes: Fuel loading below residence, wooden/trex deck

Mitigation Time (in hours): 6

Mitigation Description: Thinning and weed whacking

Type 6 engine, porta tank and sprinklers

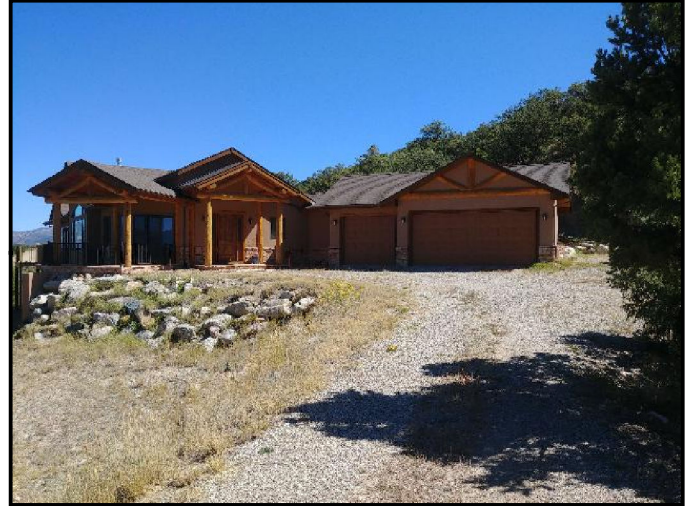
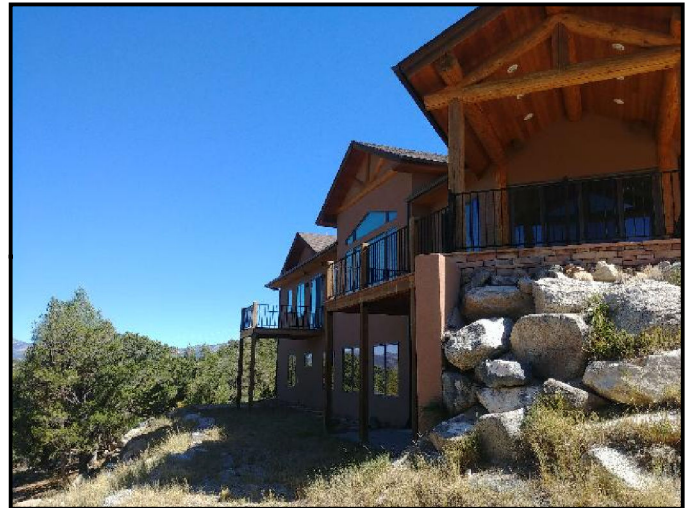
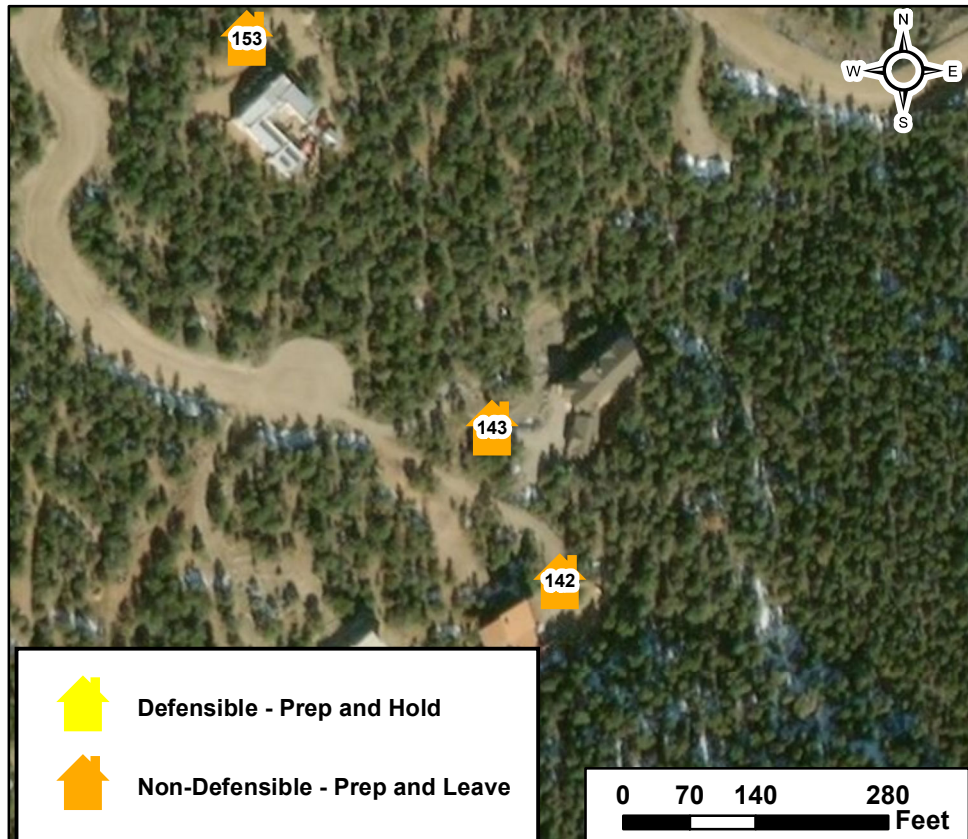
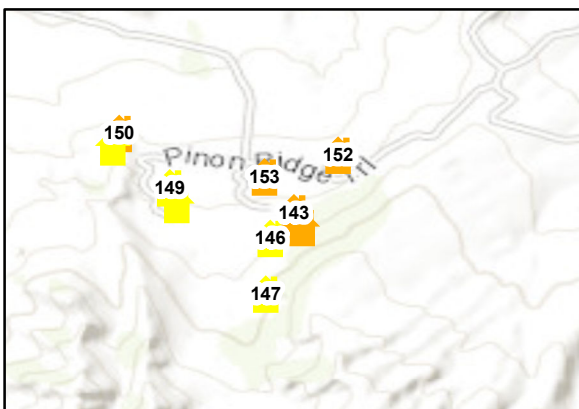
Hazards: 1 way access

Safety Zone Present: No safety zone(s) in area

Notes: Well maintained, midslope with heavy fuels up and down slope

Mitigation Time (in hours): 4

Mitigation Description: Brush and grass removal

Sprinkler

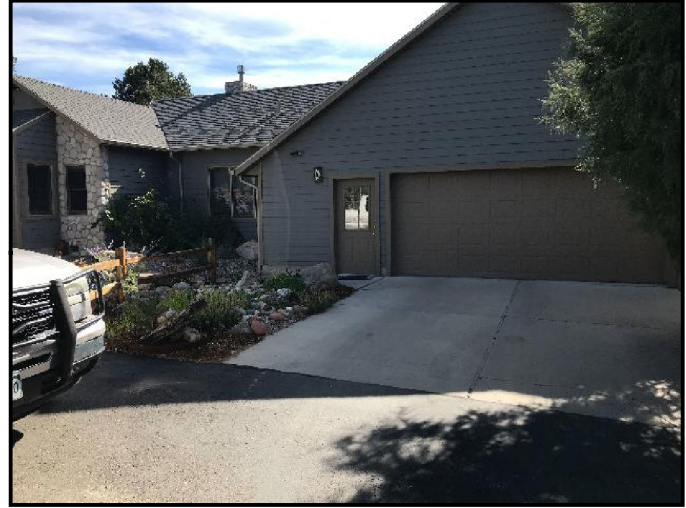
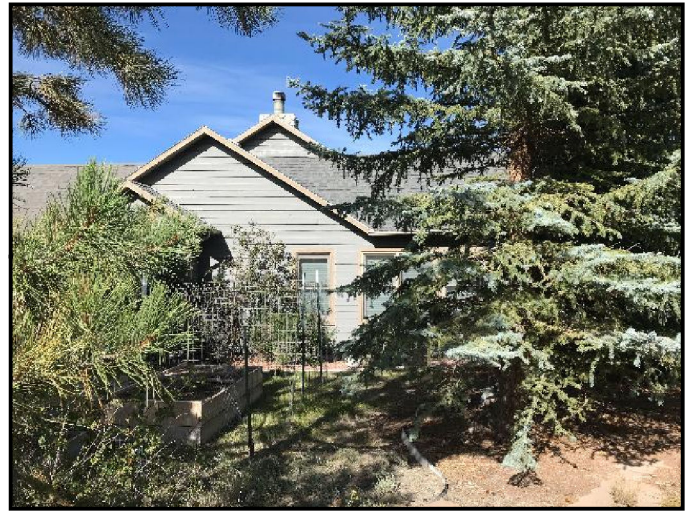
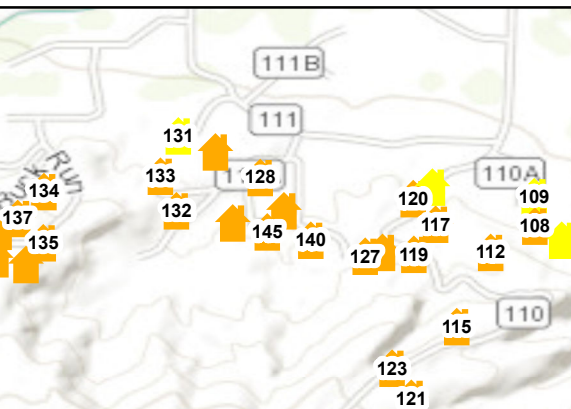
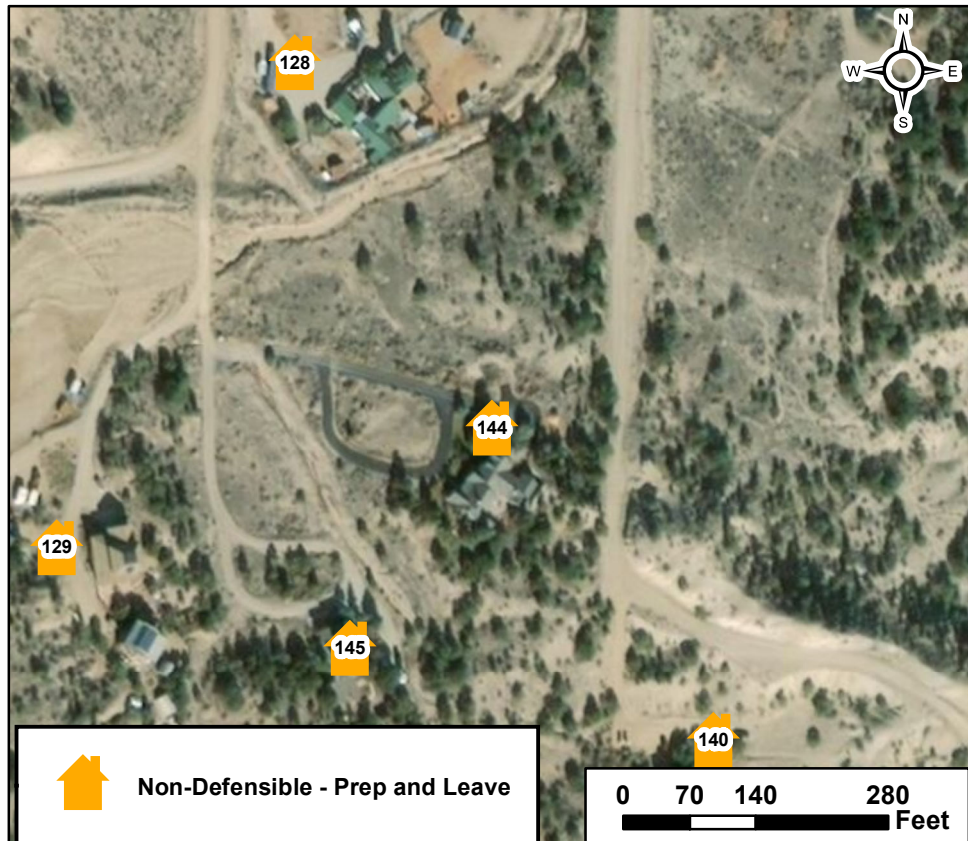
Hazards: fuels above, slope, scabby landscape above structure, paved driveway

Notes: Brick retaining wall, green lawn, big trees in back yard, wood pile, landscaping

Mitigation Time (in hours): 4

Mitigation Description: Thinning and weed whacking

Type 3 engine

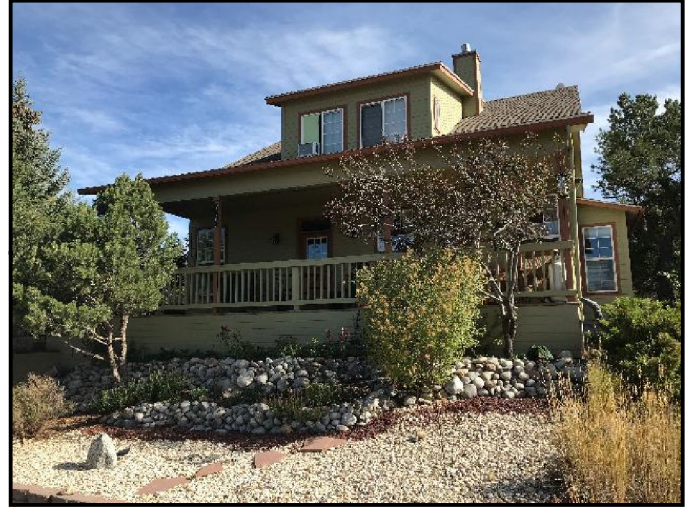
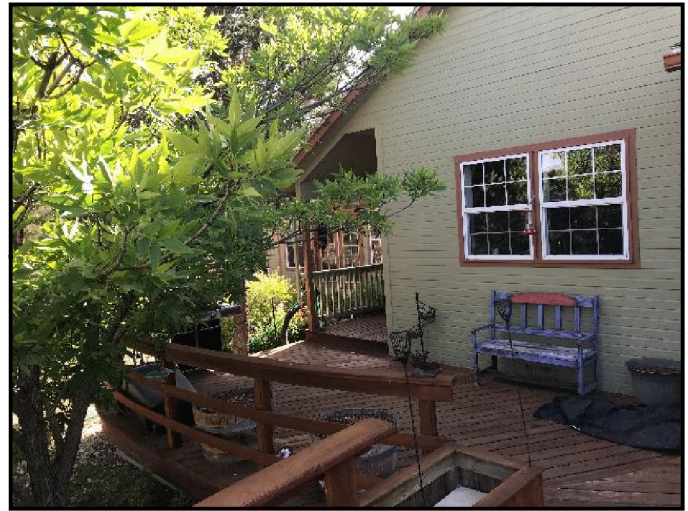
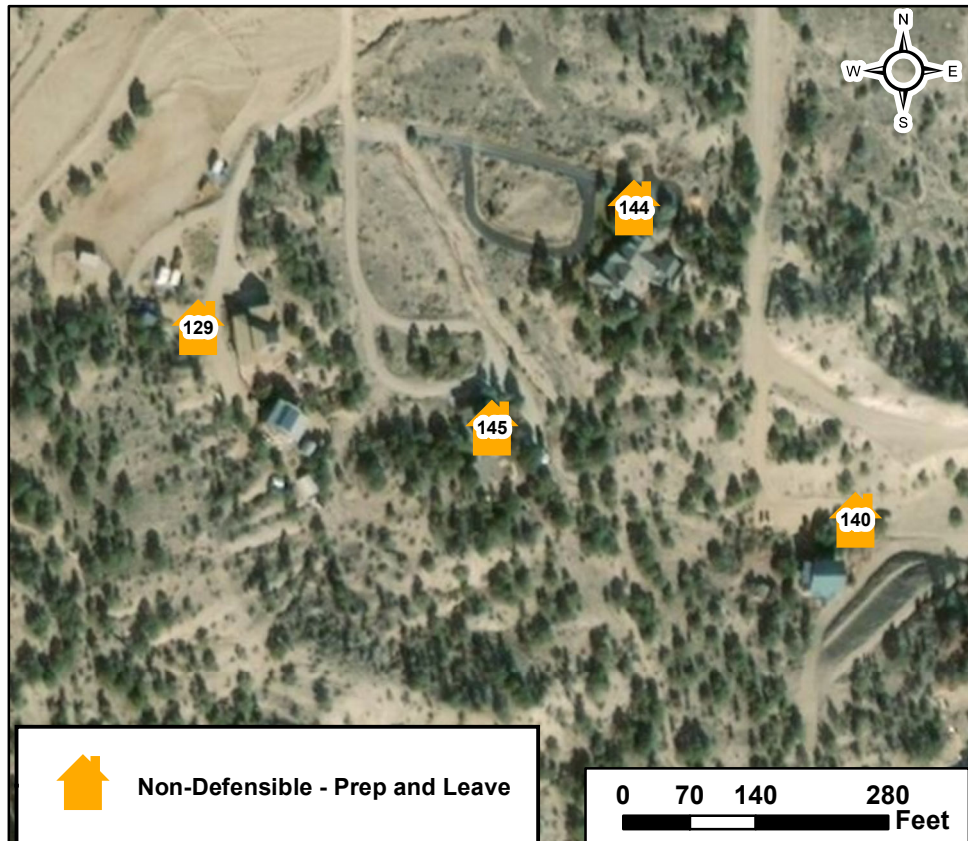
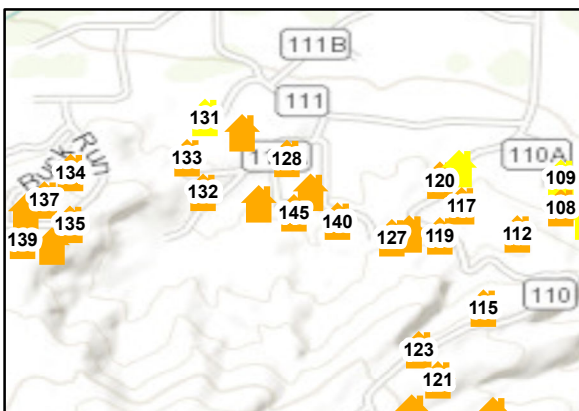
Hazards: fuels above and below, slope, scabby landscape

Safety Zone Present: No safety zone(s) in area

Notes: Wood decks, gravel drive, shrubs touching structure, bark dust bins on deck

Mitigation Time (in hours): 6

Mitigation Description: Thinning and weed whacking

Type 3 engine

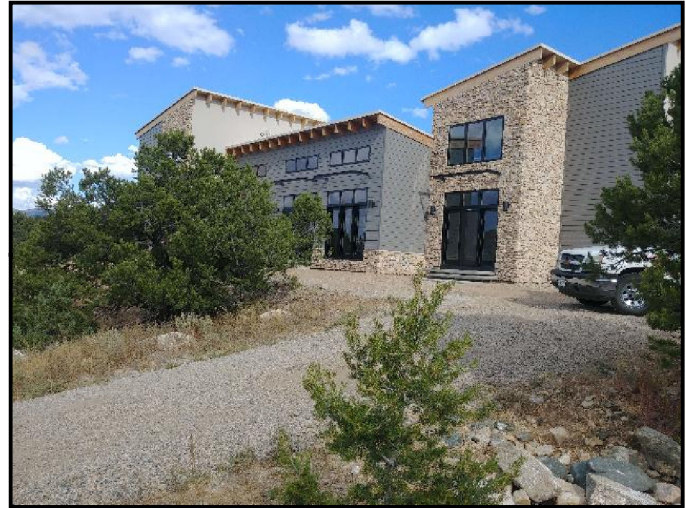
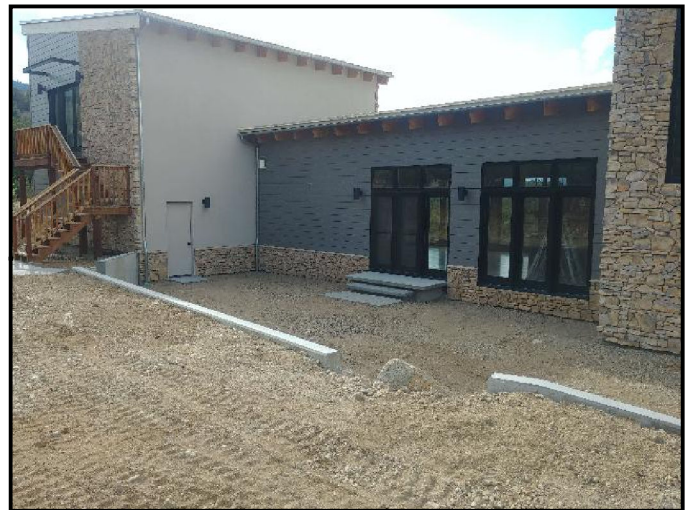
Hazards: One way in and out, on slope fuel 7s surrounding

Notes: Unfinished inside

Mitigation Description: Moderate brush

Porta tank and sprinklers

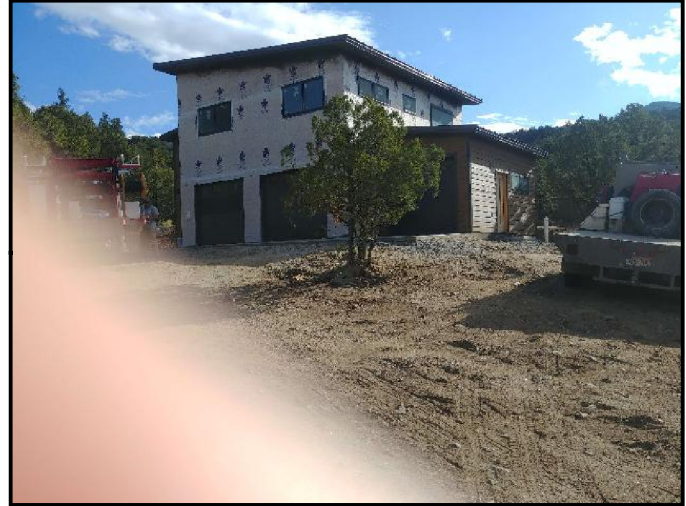
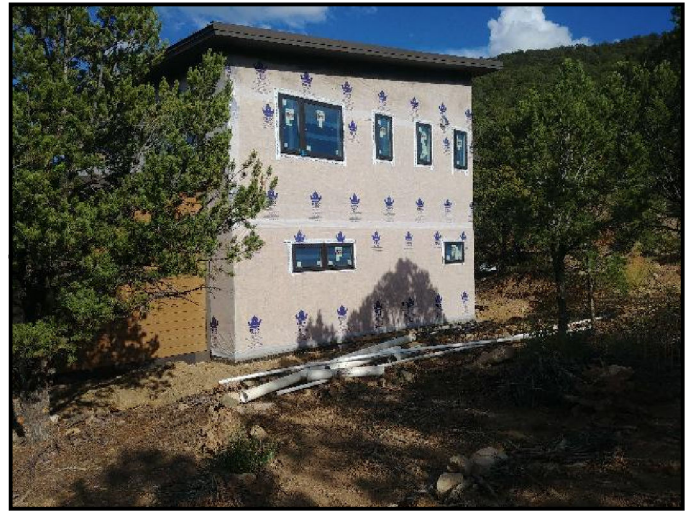
Hazards: Heavy shrub/brush loading

Notes: Under construction

Mitigation Description: Heavy brush removal

Porta tank and sprinklers

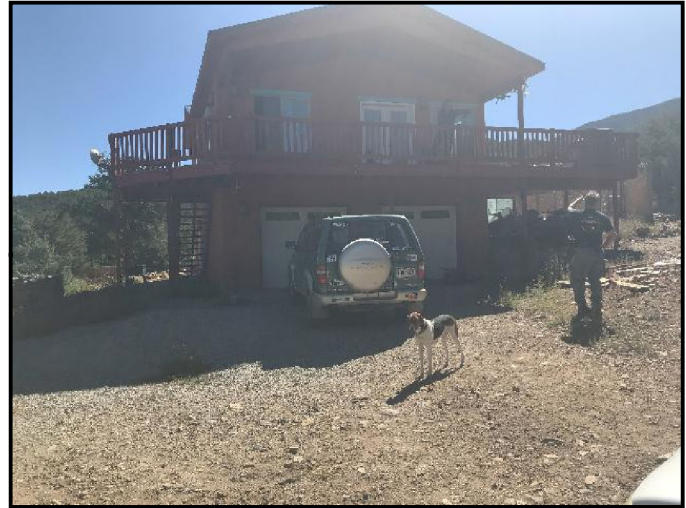
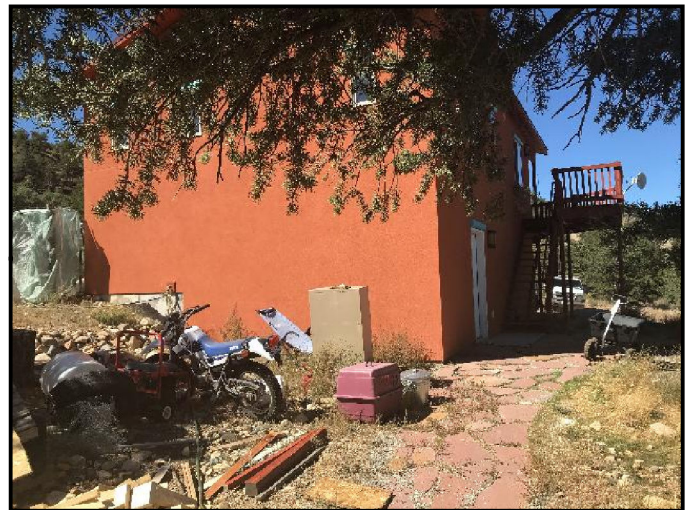
Hazards: Fuels below structure, slope

Notes: Fuel loading below residence, wooden deck, debris, wood pile

Mitigation Description: Thinning and weed whacking

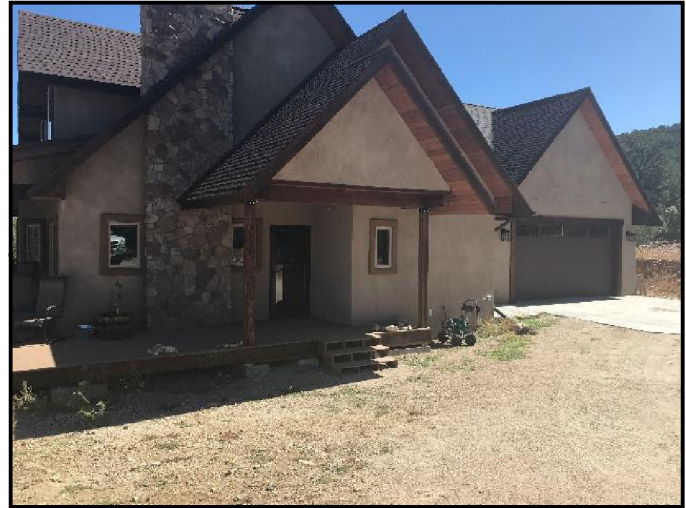
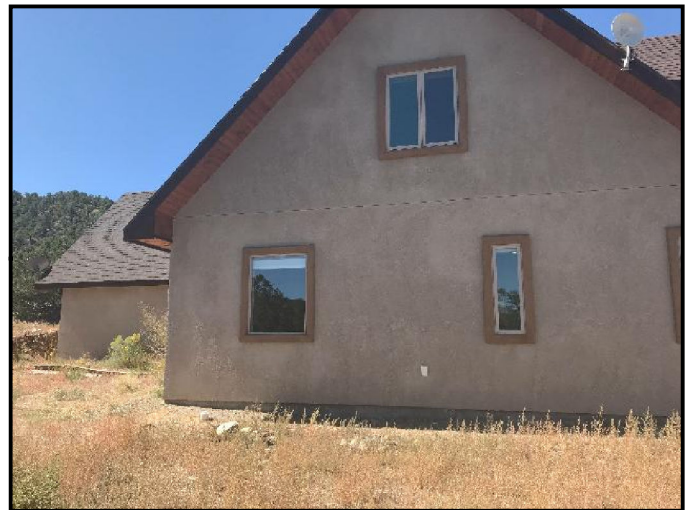
Resources Needed to Protect Structure:
Type 6 engine
Notes: Trex deck, limited clearance

Mitigation Time (in hours): 6
Mitigation Description: Thinning and weed whacking

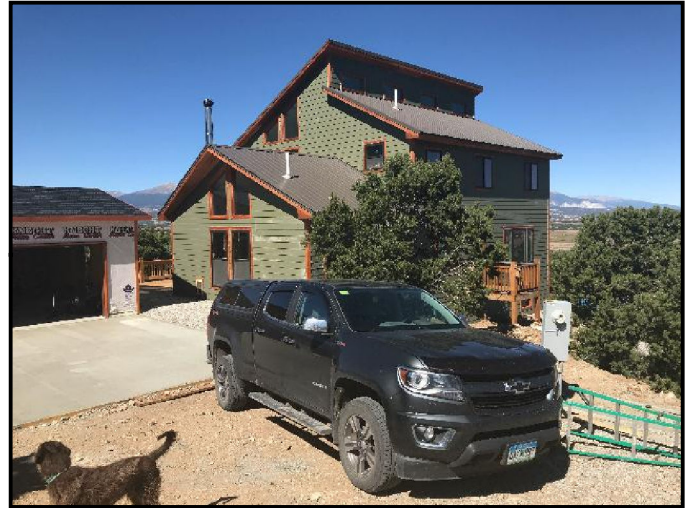
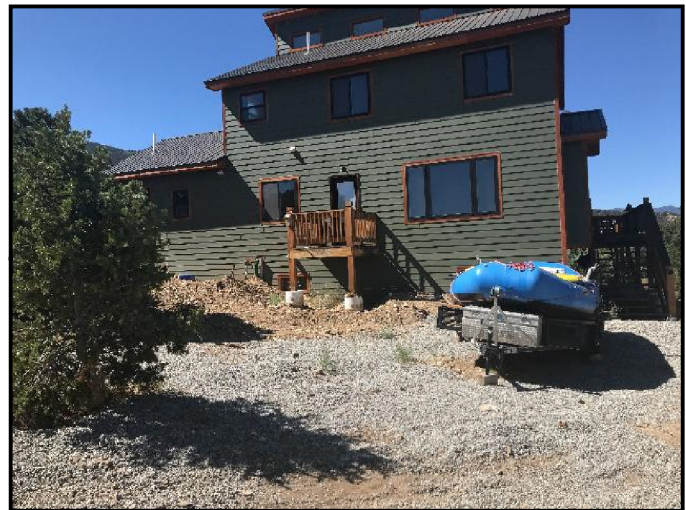
Hazards: Fuels below structure, slope

Notes: Structure has some gravel perimeter. Fuel loading below residence, wooden deck, garage under construction

Mitigation Description: Thinning and weed whacking, porta tank and sprinklers

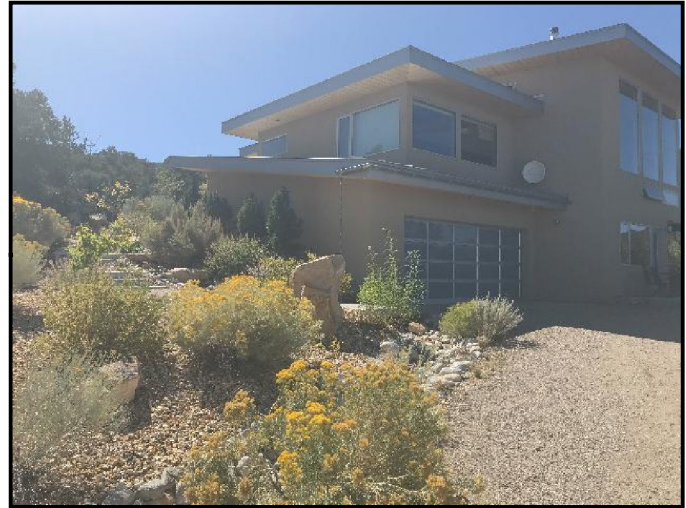
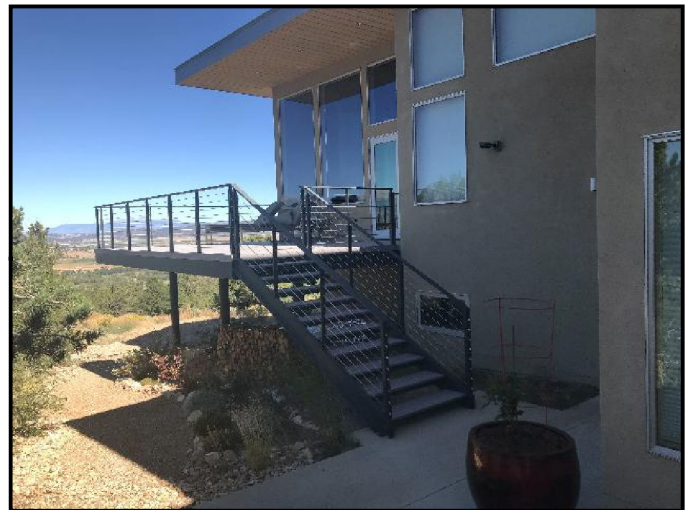
Notes: Structure has some gravel perimeter. Fuel loading below residence and sides, wood/trex deck, wood pile under deck.

Mitigation Time (in hours): 6
Mitigation Description: Thinning and weed whacking

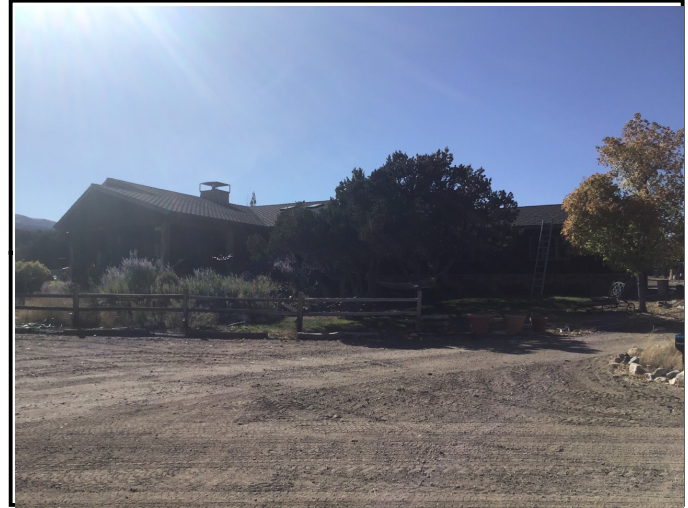
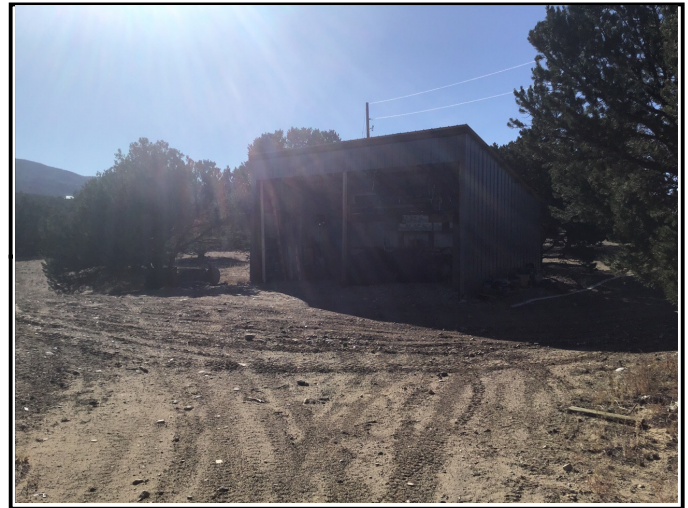
Hazards: One way in one way out

Notes: Well maintained property

Mitigation Description: Set up sprinklers on south side of house and small island on north side

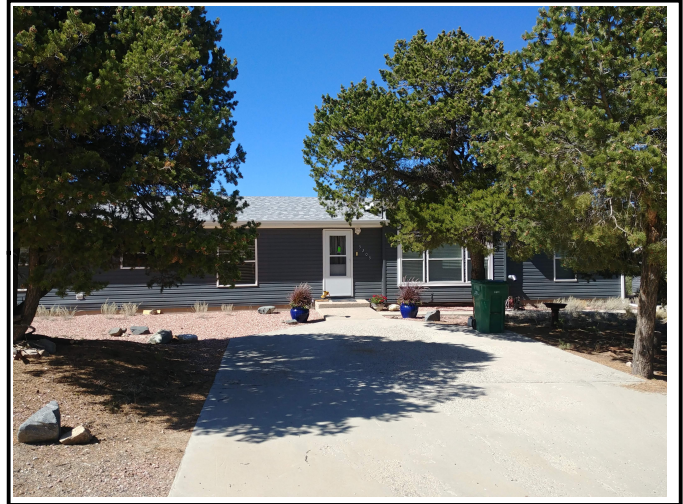
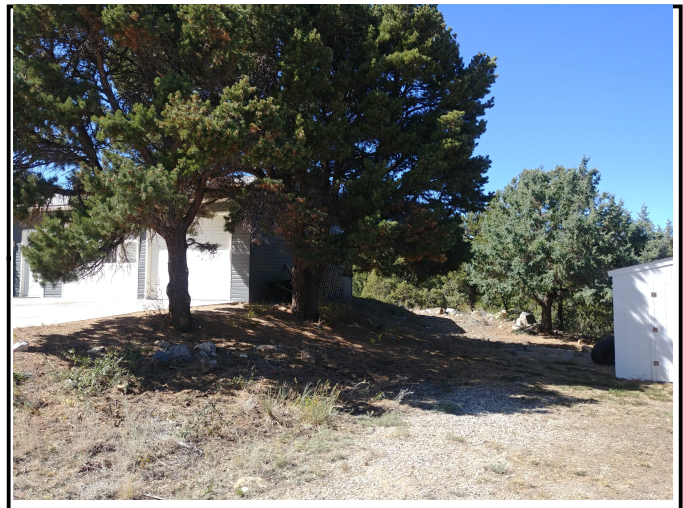
Hazards: Propane behind, steep surround slopes

Notes: deck over drainage, well maintained some gravel surrounding

Mitigation Description: light prep and sprinklers
