# Bear Creek & Silver Heels Structure Assessment

Structure ID: 1

**Location:** 1612 CR 101/49, Bear creek

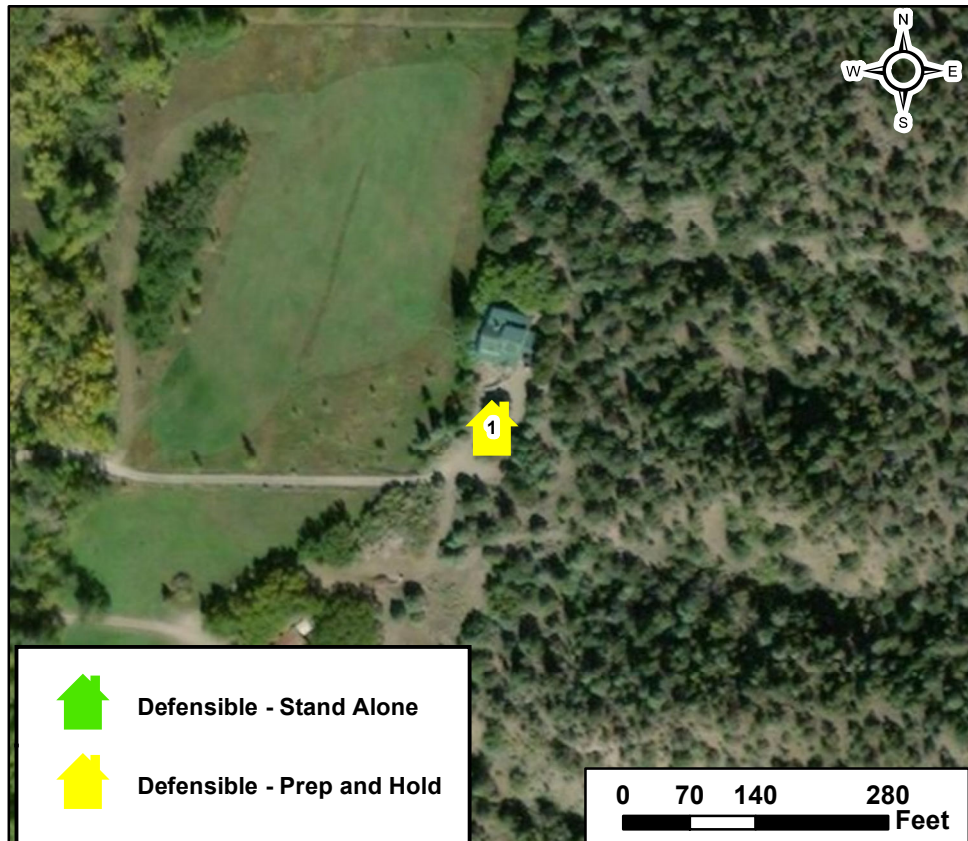
**Triage Category:** Defensible, Prep and Hold

**Defensible Space:** Less Than 30 ft treated

**Notes:** Well maintained structure and landscaping, need trash and lumber removed from around structure

**Mitigation Description:** Light brush and weed eater sprinkler. Pumpkin, pump# RMK-0148-92

1 engine during fire front or check afterwards

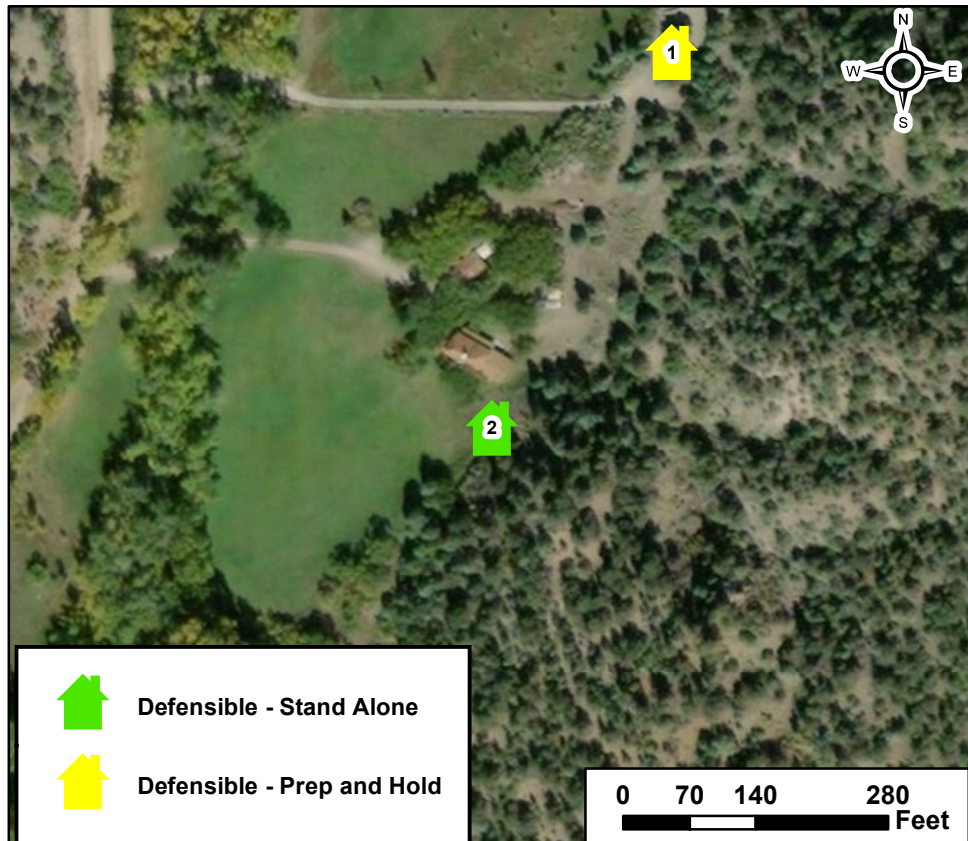
Structure ID: 2

**Triage Category:** Defensible, Stand Alone

**Notes:** Well maintained structure and landscaping

**Mitigation Description:** Light brush and weed eater

1 engine during fire front or check afterwards

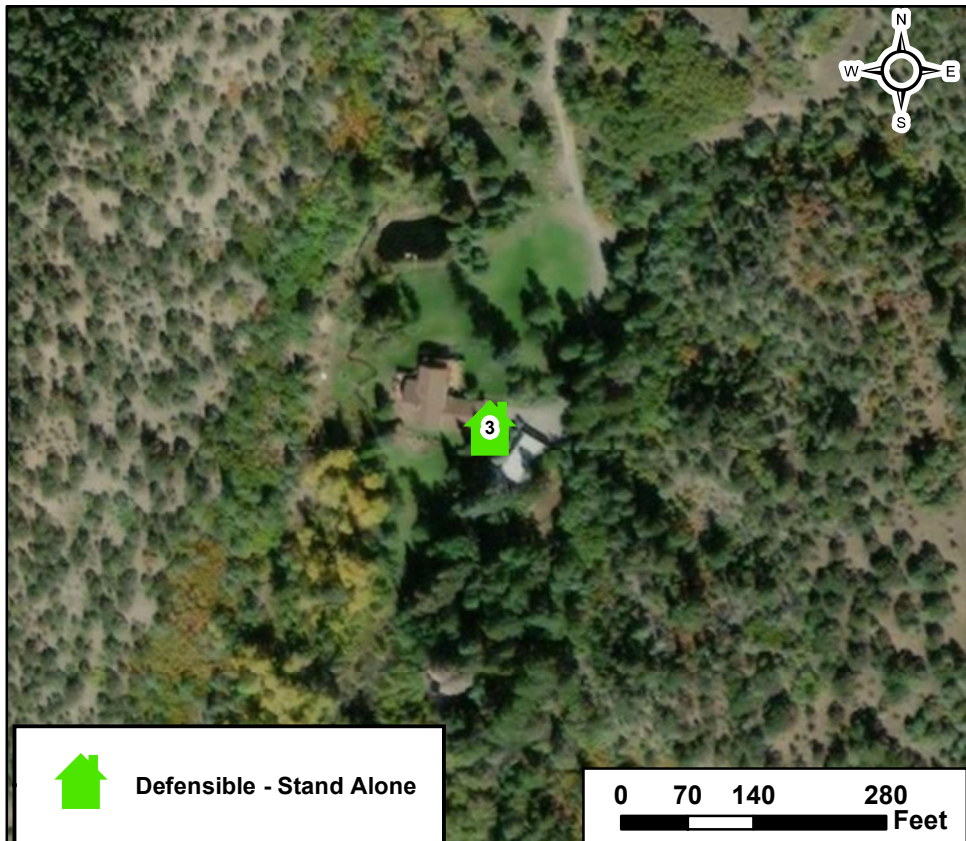
Structure ID: 3

**Triage Category:** Defensible, Stand Alone

**Notes:** Well maintained structure and landscaping

**Mitigation Description:** Light brush and weed eater

1 engine during fire front or check afterwards

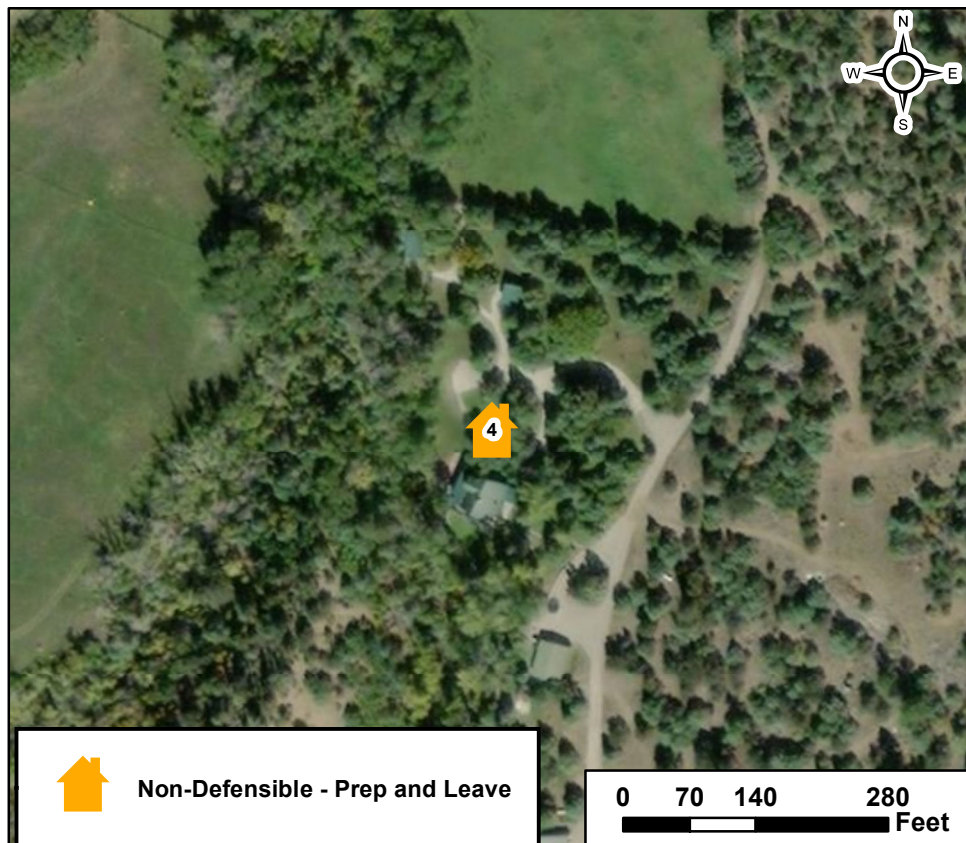
Structure ID: 4

**Triage Category:** Non-Defensible, Prep and Leave

**Defensible Space:** Less Than 30 ft treated

**Hazards:** Egress one way one lane road, fuels well maintained but to close to structure, bridge of unknown capacity

**Notes:** Well maintained structure and landscaping heavy fuels to close to structure

**Mitigation Description:** Heavy brush removal from surrounding area

Sprinklers along with homeowners monitor system Pump# RMK-0148-287

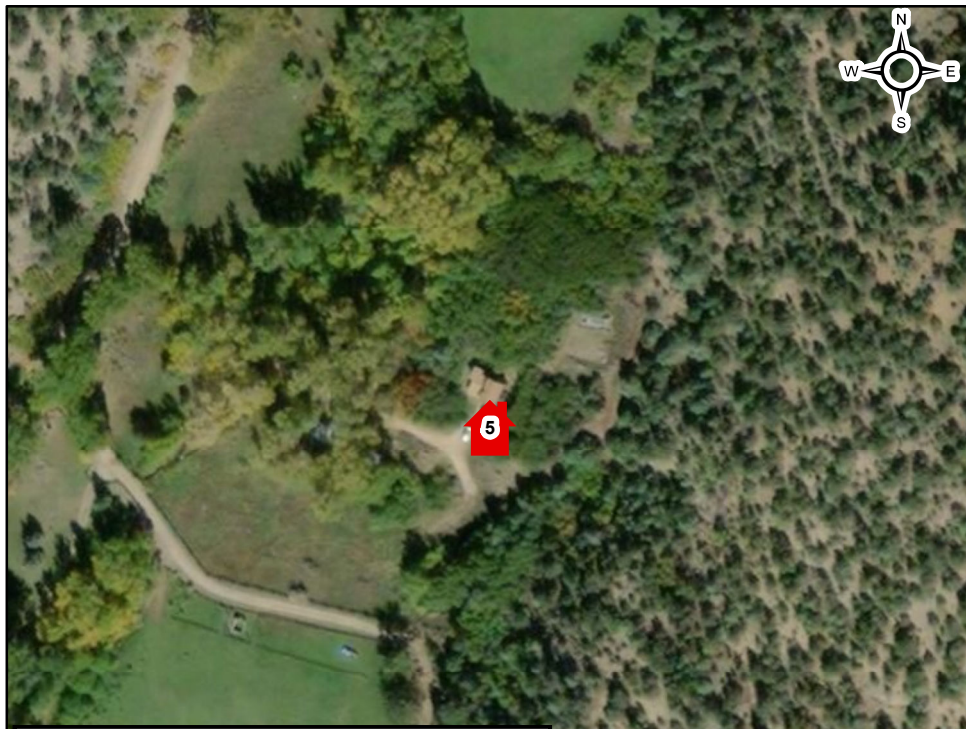
Structure ID: 5

**Notes:** Shake single sided structure, light and heavy fuels at structure

Sprinklers from creek Pump# RMK-0148-278

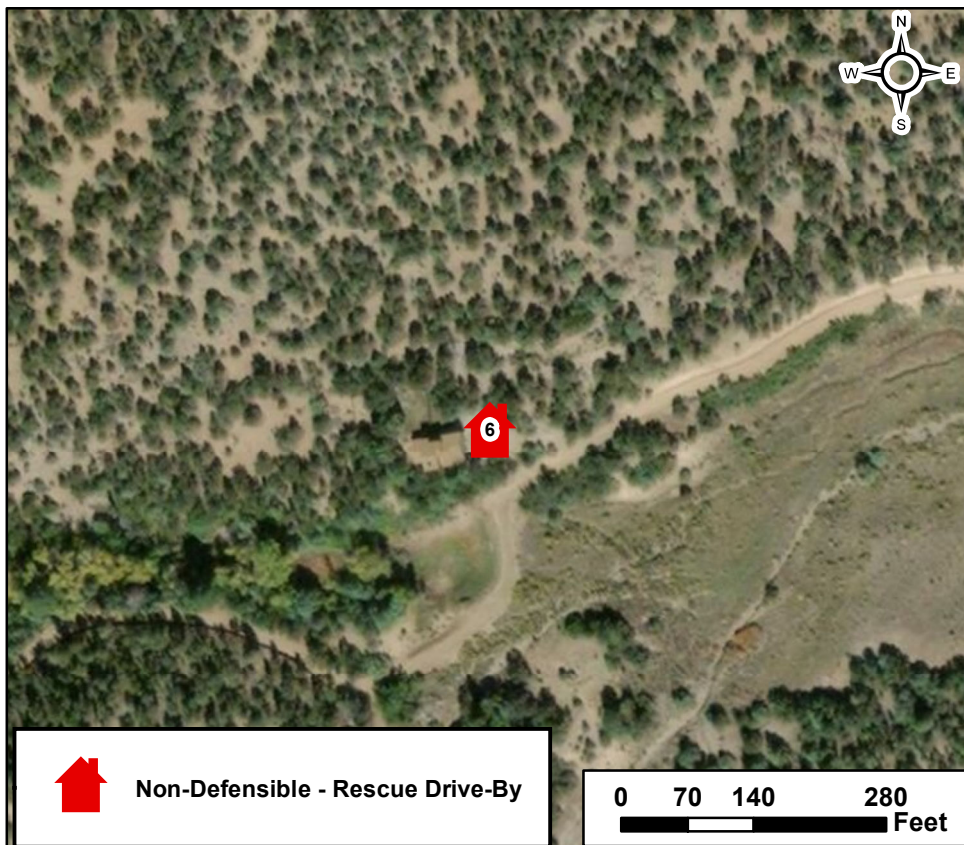
**Notes:** Heavy fuels upto structure, steep slope on south side

prep and install sprinkler, check after fire front passage

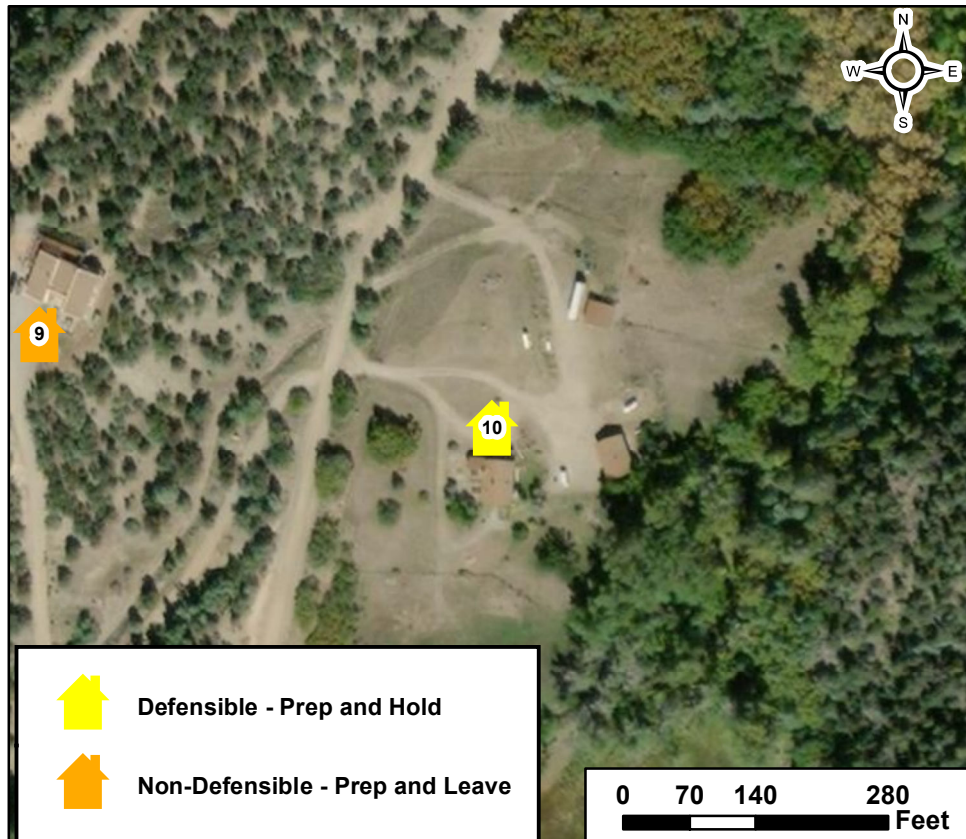
Structure ID: 10

**Notes:** Under construction, shake siding

1 engine during fire front or check afterwards. pump# RNK-0148-210

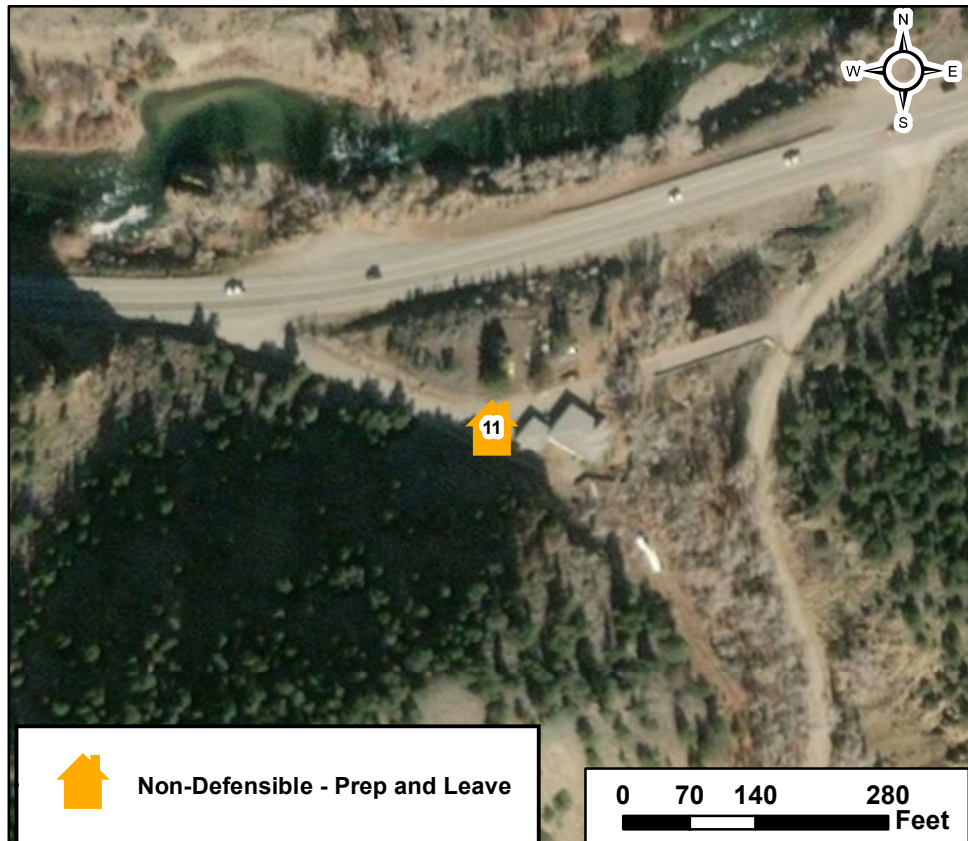
**Notes:** Heavy grass and brush up to structure, lots of yard debris

Sprinklers off creek Pump# RMK-0148-98

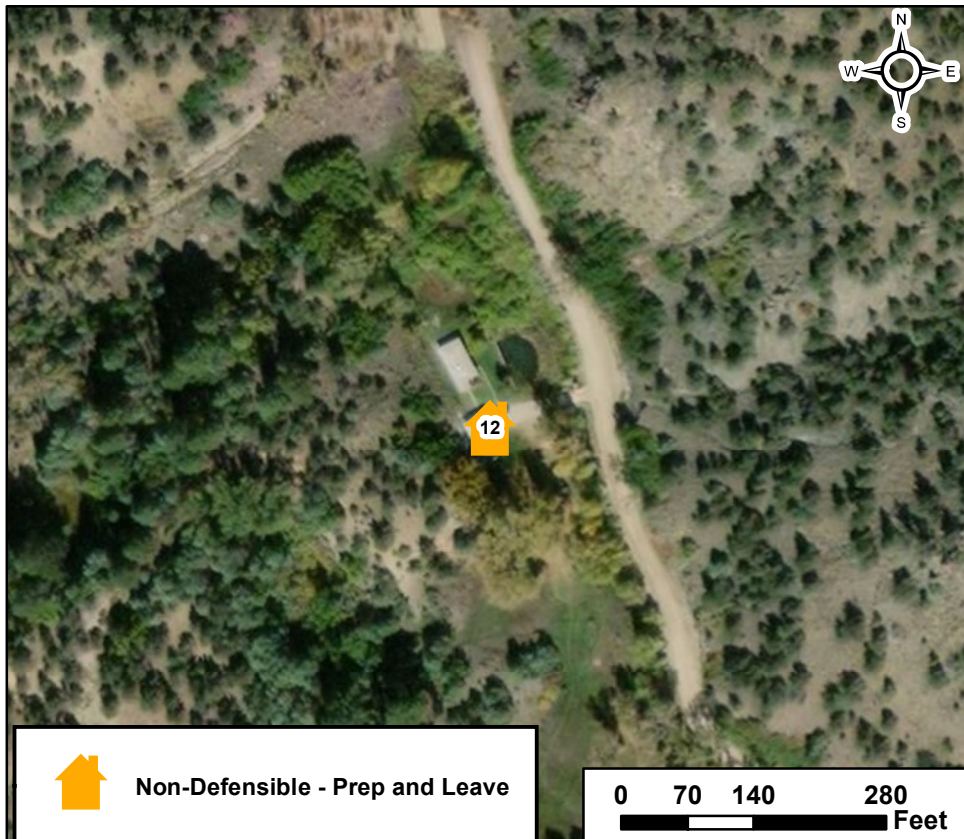
Structure ID: 12

**Notes:** Grass and brush within 10' on west and south side of house and garage

Sprinklers from pond Pump# RMK-0148-113

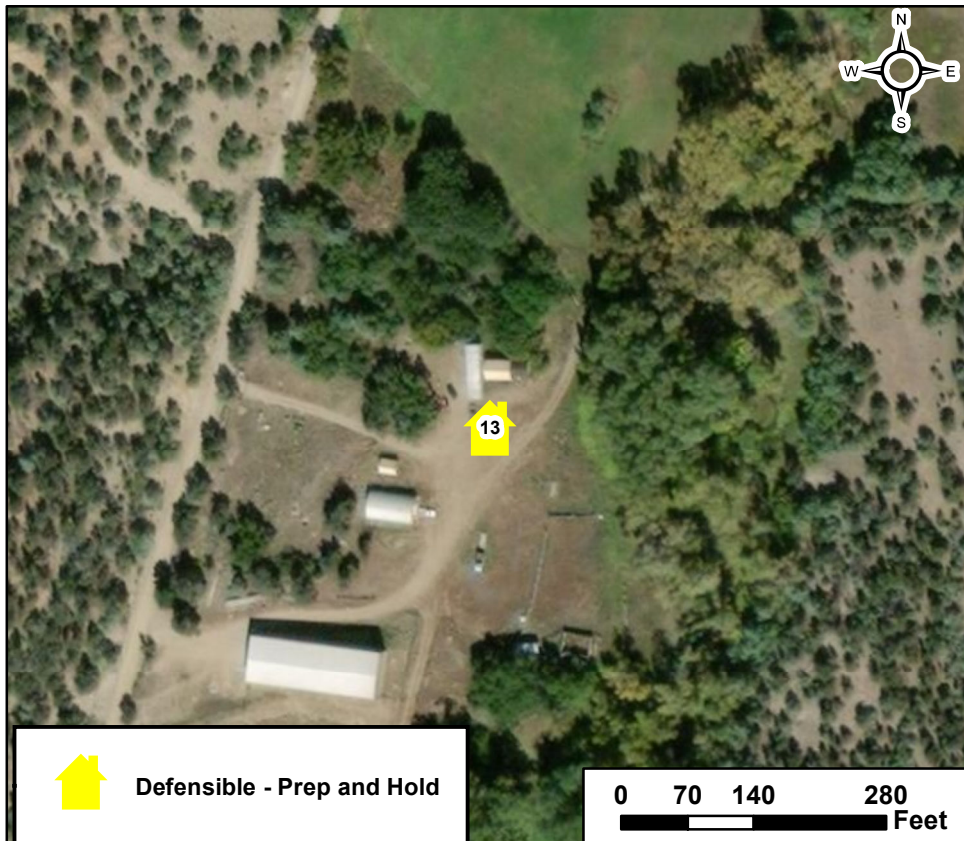
**Hazards:** Historic cabin with mobile home next door

**Notes:** Skirted mobile home next to very flammable historic cabin

1 engine during fire front or check afterwards. pumpkin, Pump# RMK-0148-317

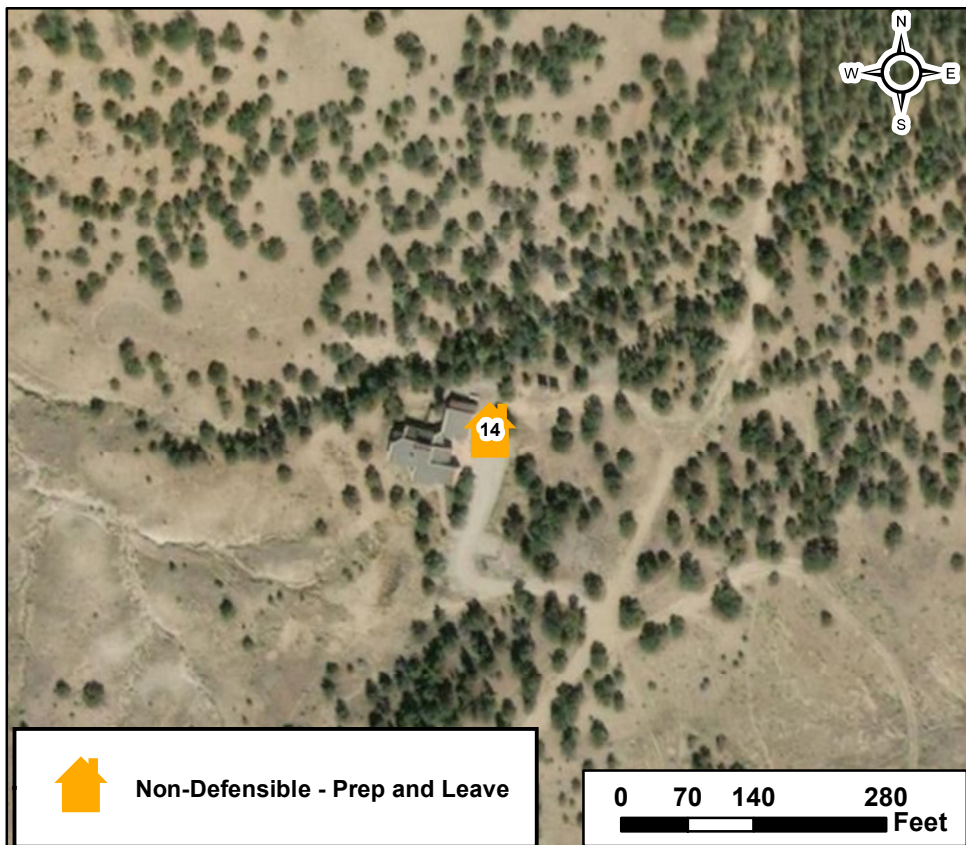
**Notes:** Stucco with both light and heavy fuels at structure

Porta tank and sprinklers Pump# RMK-0148-318

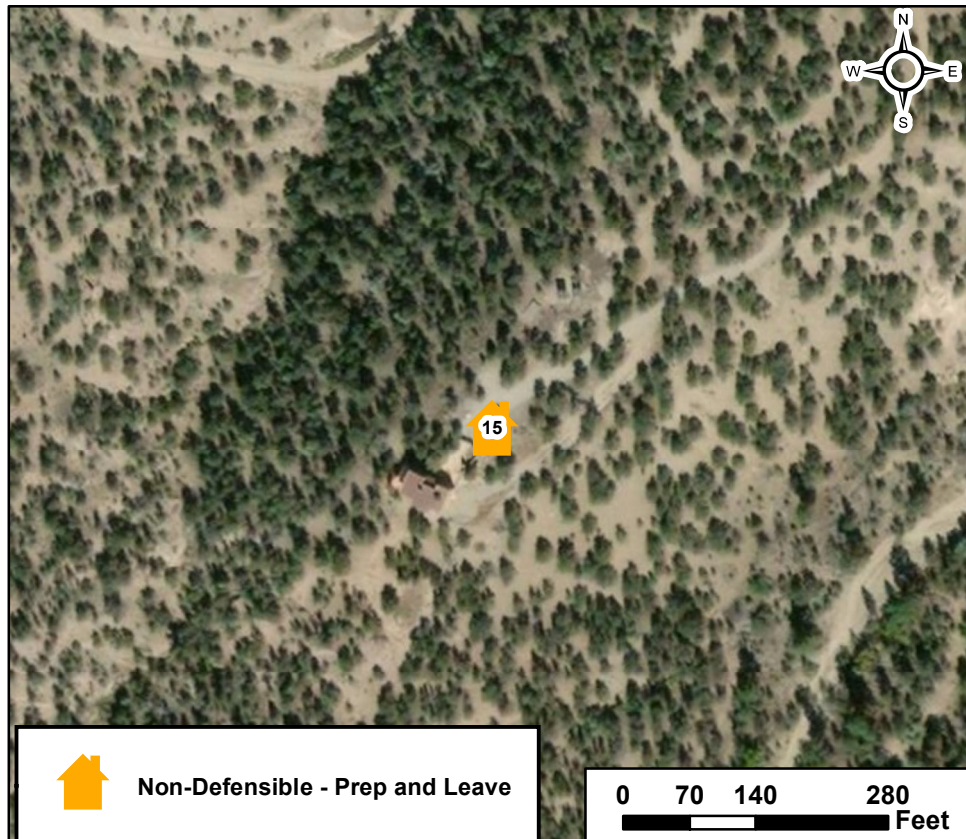
Structure ID: 15

**Notes:** Lots of flammable heavies attached to or adjacent to the structure

Porta tank and sprinklers pump # rmk-0148-120

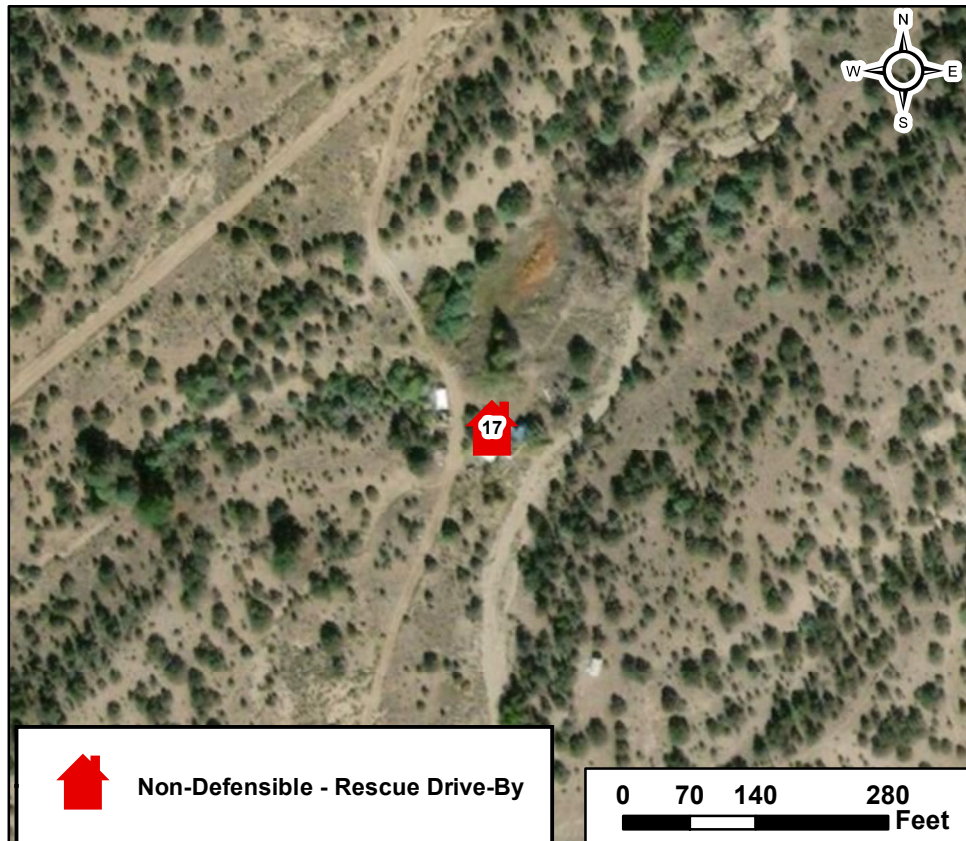
**Notes:** Fuels upto structure and lots of yard debris

Porta tank and sprinklers Pump# RMK-0148-14

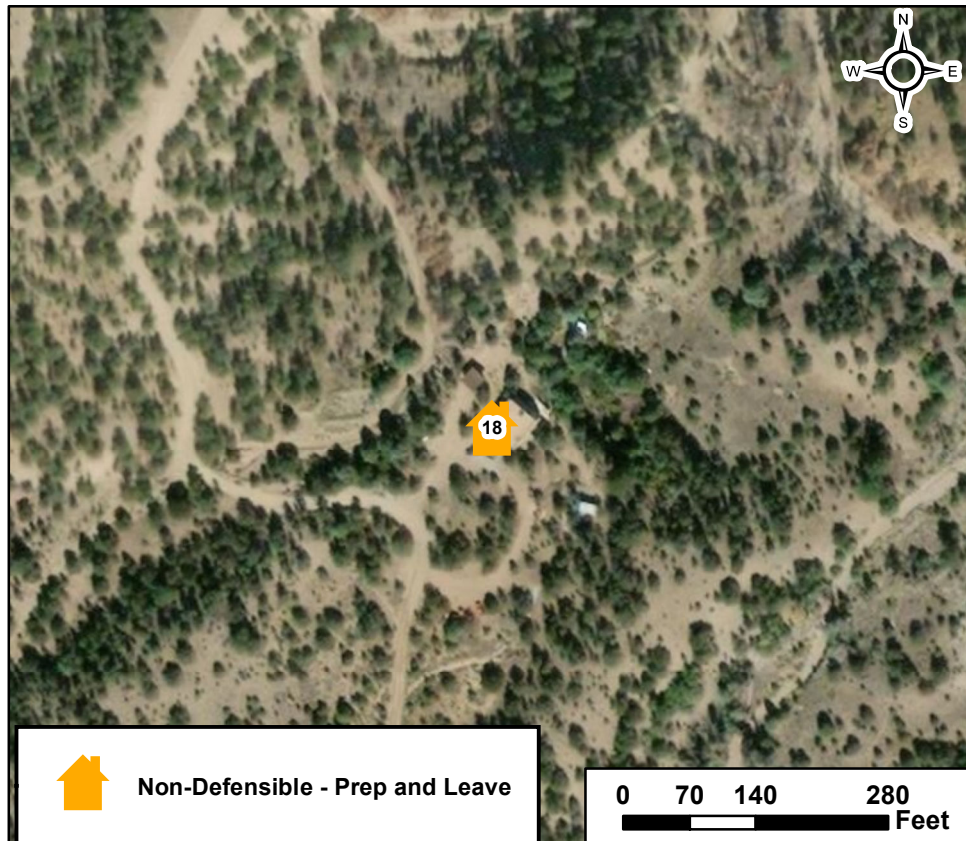
**Notes:** Stucco with brush right up to structure

Porta tank and sprinklers Pump# RMK-0138-318

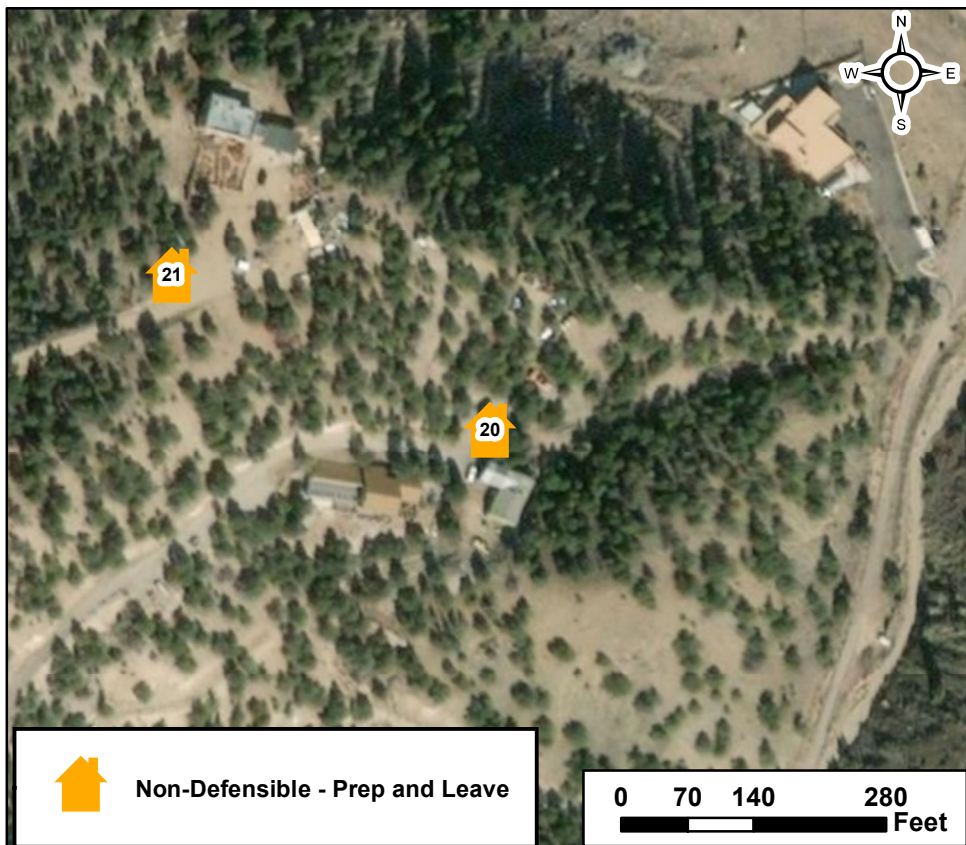
Structure ID: 20

**Hazards:** Hazards include the following: moderate to high fuel loading surrounding structure, tar base shingles on 2/3 of roof main residence, mid slope, steep terrain.

**Notes:** Structure tucked into hillside w/ abundant fuels present.

Sprinkler set up with dedicated water source. Heavy fuels removal would require 10 to 20 person crew. Type 4/3 engine. Pump #RMK-0148-313

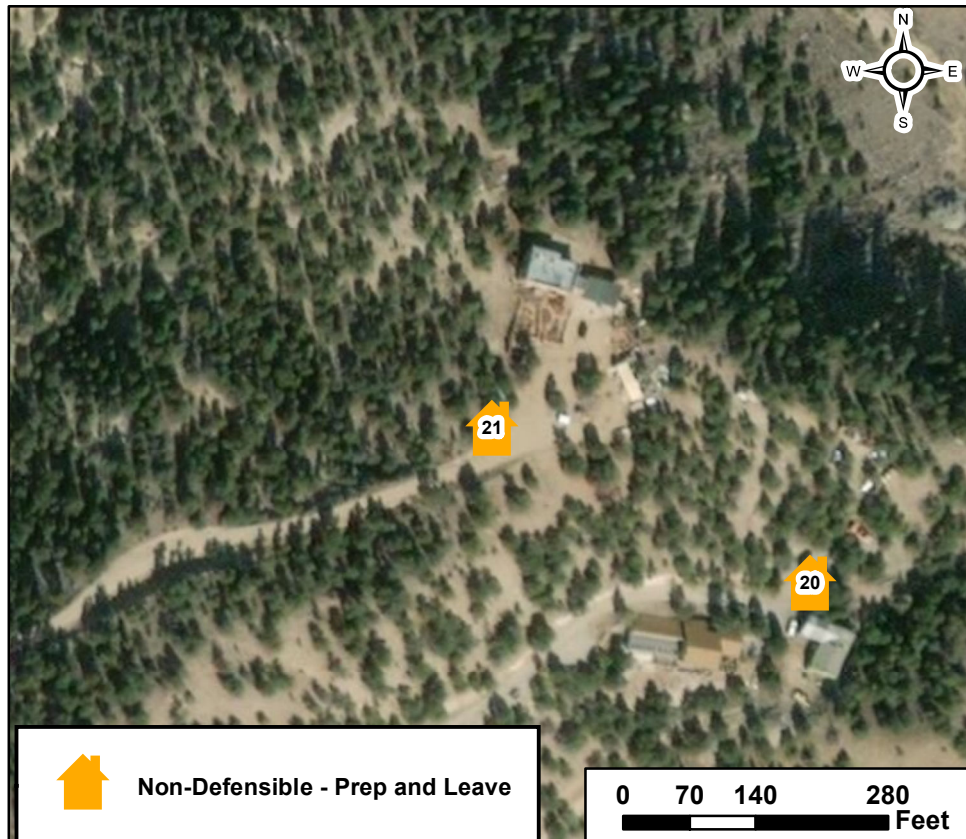
**Notes:** stucco home flat roof attached wood deck.

sprinklers, tank and pump

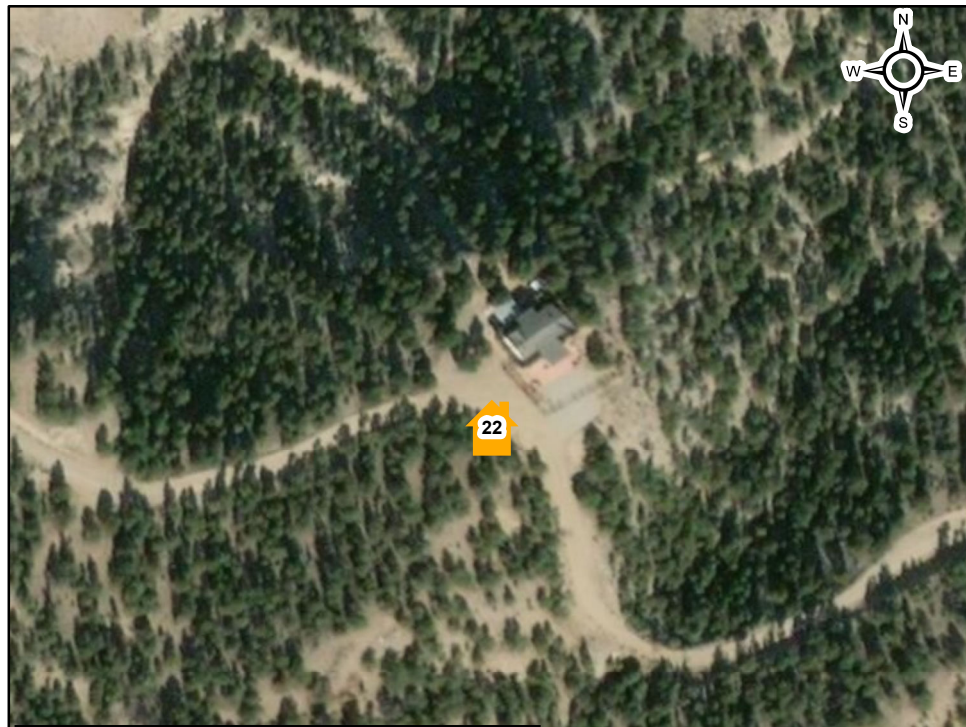
Structure ID: 22

**Triage Category:** Non-Defensible, Prep and Leave

**Hazards:** access road, steep slopes north of house

**Notes:** well maintained, good mitigation, wooden deck

**Mitigation Description:** limbing and brushing

sprinklers
