Howard West Structure Assessment

Structure ID: 281

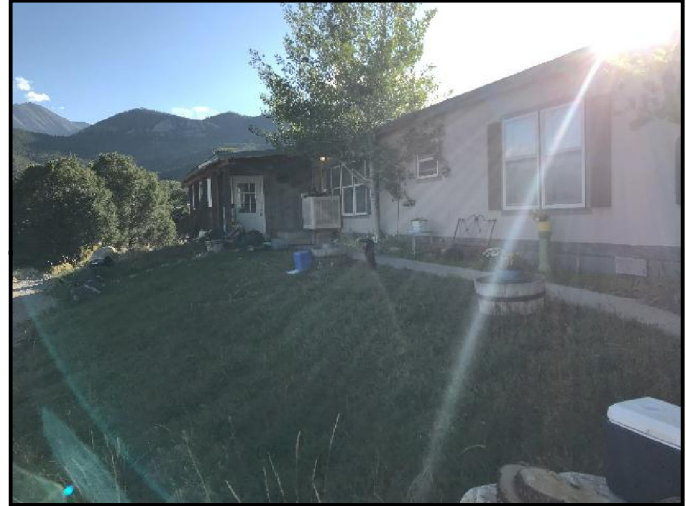
Hazards: Some surrounding fuels including shrubs and grass

Notes: Double wide type structure, lots of debris and misc. equipment

Mitigation Description: Weed whacking and general clean -up

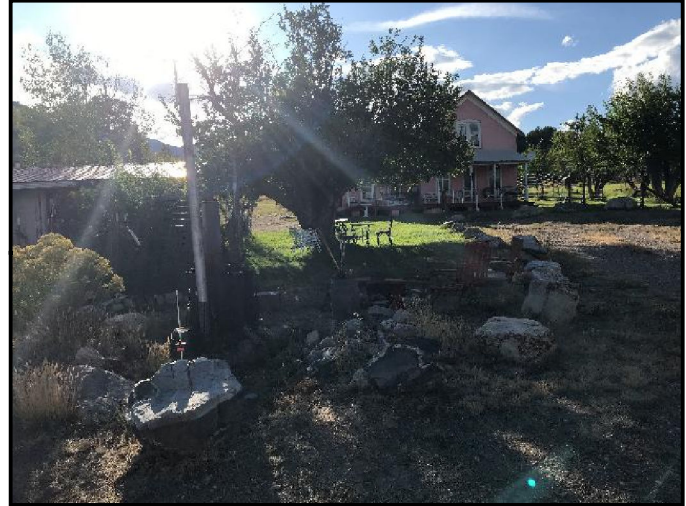
Hazards: Grass fuel models against residence

Notes: Multiple structures, yard debris and wood piles, equipment and abandon vehicles present

Mitigation Description: Weed whacking and general clean-up

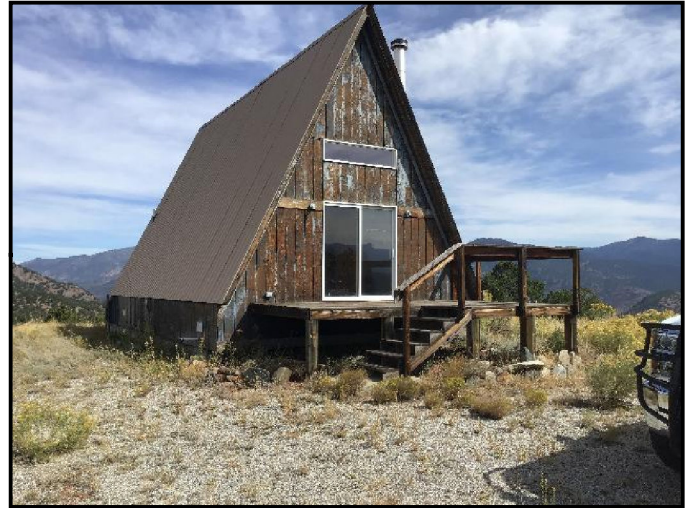
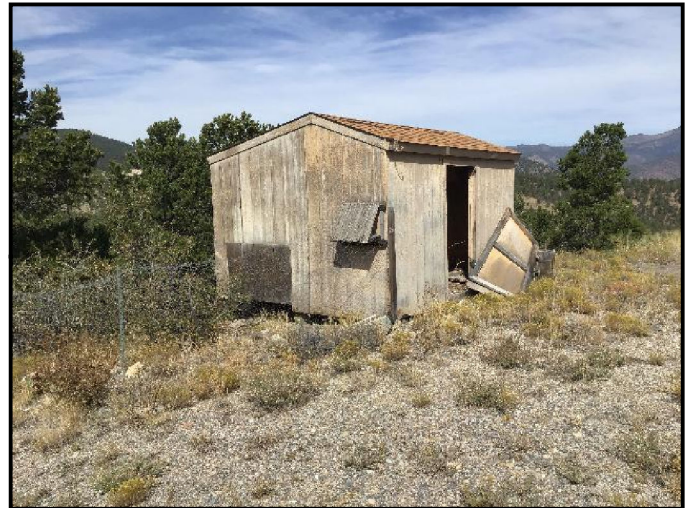
Hazards: House has tall grass growing right up to it

Mitigation Description: Weedeat the grass going up to the house and cut back some trees to increase defensible space

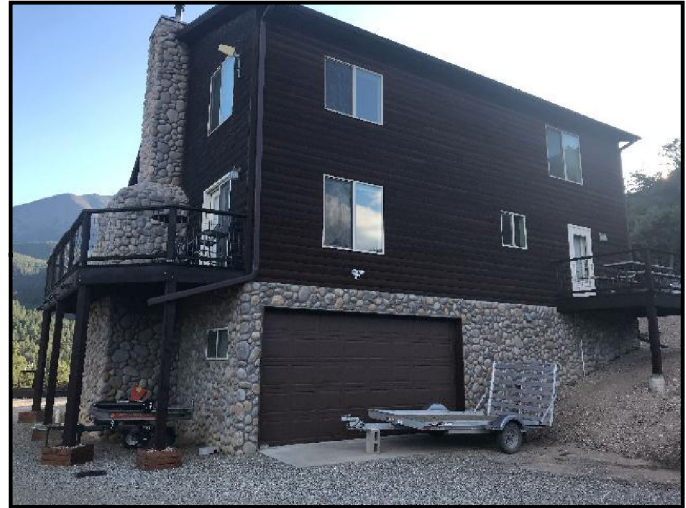
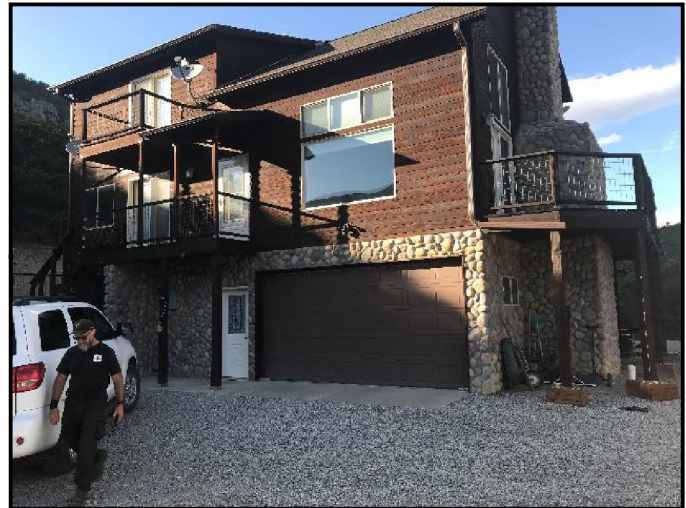
Hazards: Some fuel heavy loading on downhill side east and heavy fuel loading west up slope

Notes: Great gravel perimeter around structure, stone on lower portion of house, small decks, no debris underneath, looks well constructed

Mitigation Description: Some brushing and thinning

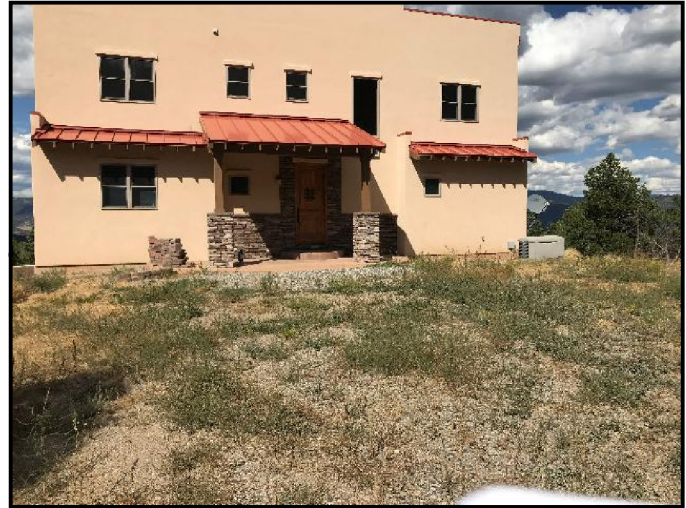
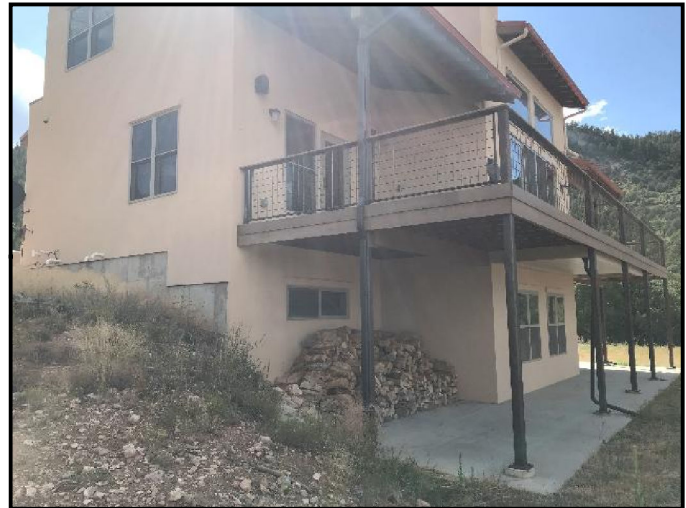
Hazards: Slope, fuel loading, grasses near structure

Notes: Deck w/ wood stacked underneath.

Mitigation Description: Weed whacking and some brush/tree removal

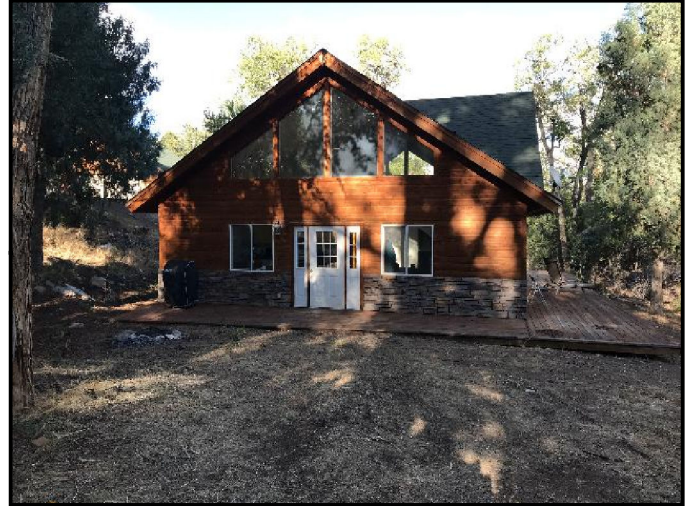
Hazards: Fuel loading adjacent

Notes: Structure well maintained, some clearance with adjacent creek.

Mitigation Description: Brushing and weed whacking

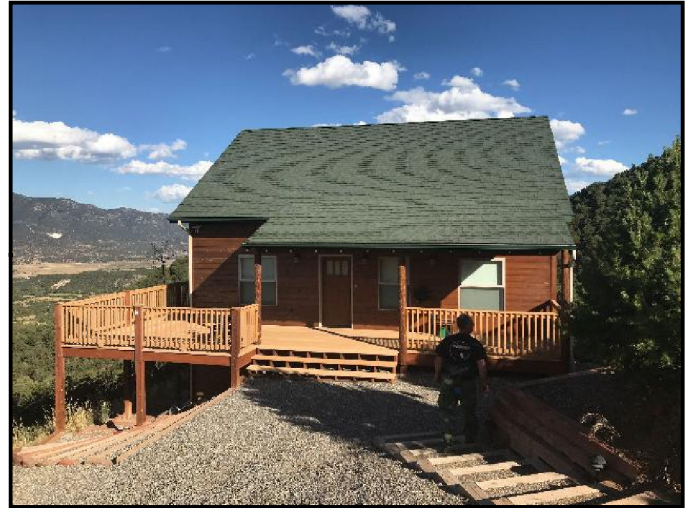
Hazards: Fuels near structure, steep slope below house, gravel around entire perimeter of house

Notes: Wood deck

Mitigation Description: Thinning and brushing around house needed

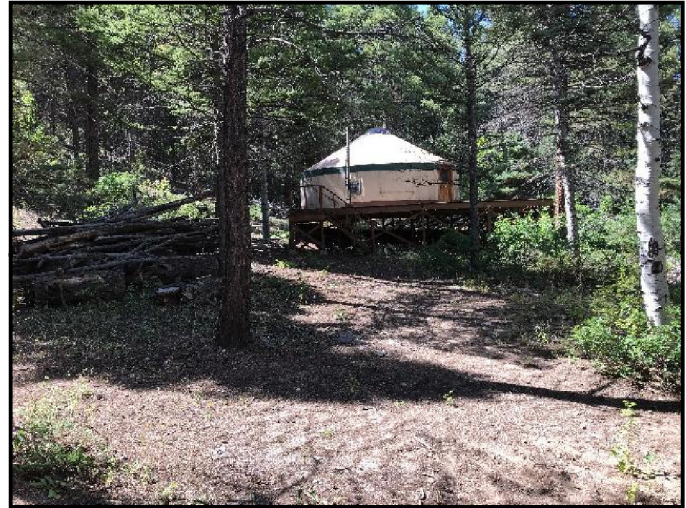
Hazards: Yurt construction of flammable material, large amount of horizontal piles of timber

Notes: Yurt construction, large deck w/ material underneath

Mitigation Description: Removal of large wood piles and thinning of brush

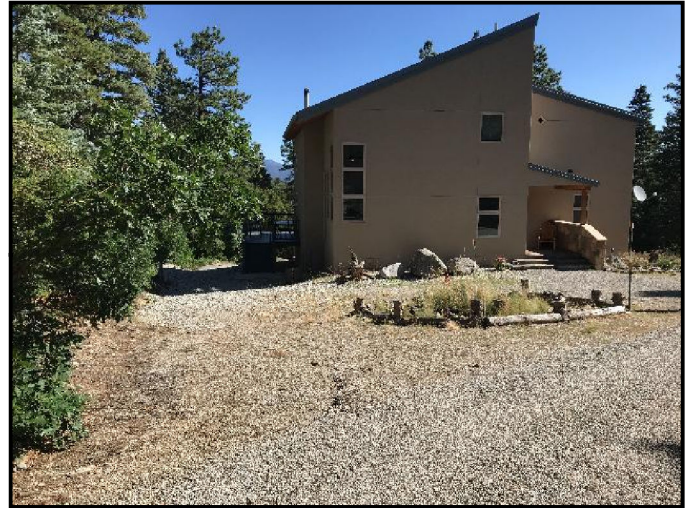
Hazards: Fuel loading, semi canyon

Notes: Stucco, some clearance around structure with gravel in driveway.

Mitigation Description: Tree thinning and brush removal

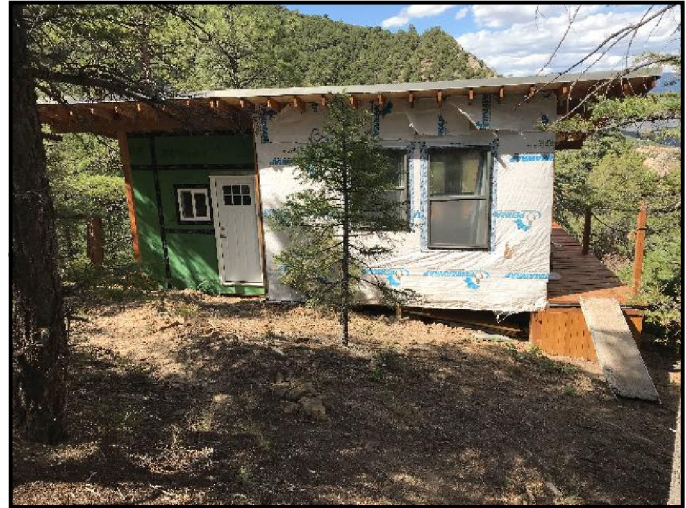
Hazards: Heavy fuel loading around residence , some slope

Notes: Still under construction but livable .
Wood deck

Mitigation Description: Tree and brush removal

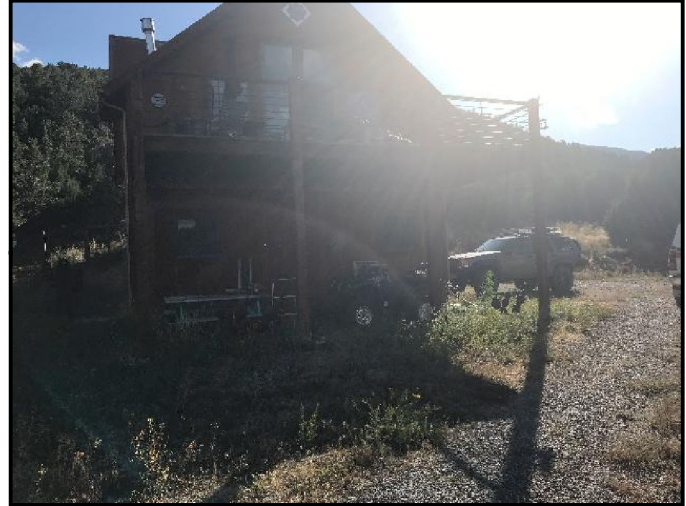
Hazards: Fuels around structure

Notes: All wood w/ wood deck limited turn around area in driveway

Mitigation Description: Brushing and weed whacking

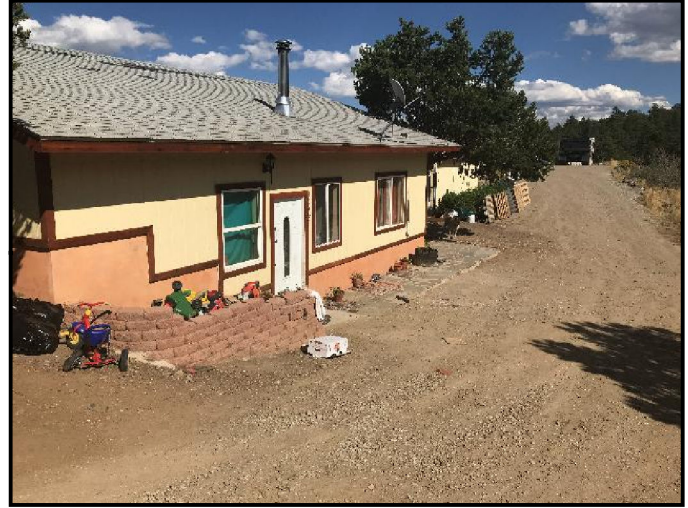
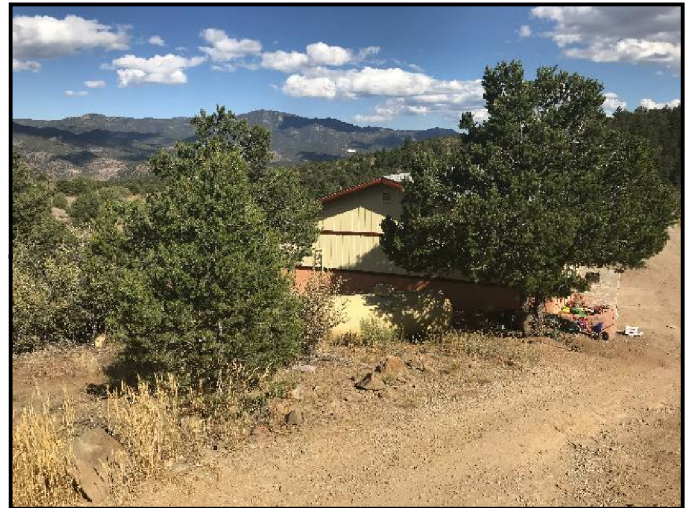
Hazards: Propane tank next to residence

Notes: Top of slope yard debris fuels

Mitigation Description: Brushing and tree removal

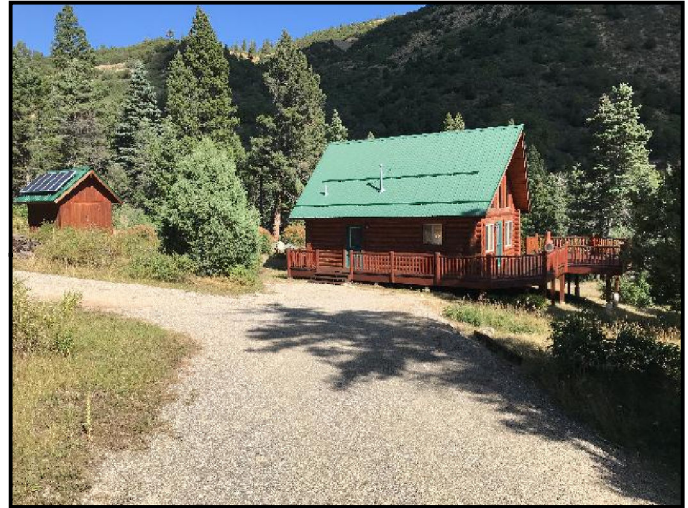
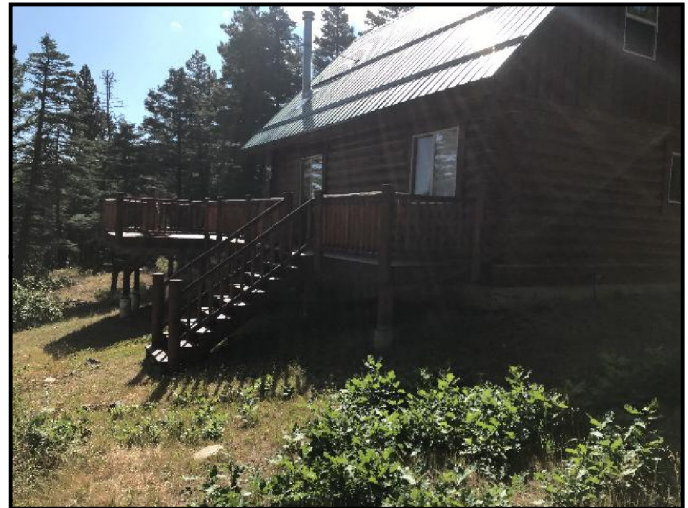
Hazards: Heavy fuel loading, grasses up to structure

Notes: Large wrap around deck, log construction with staining

Mitigation Time (in hours): 8

Mitigation Description: Weed whacking, thinning and tree removal

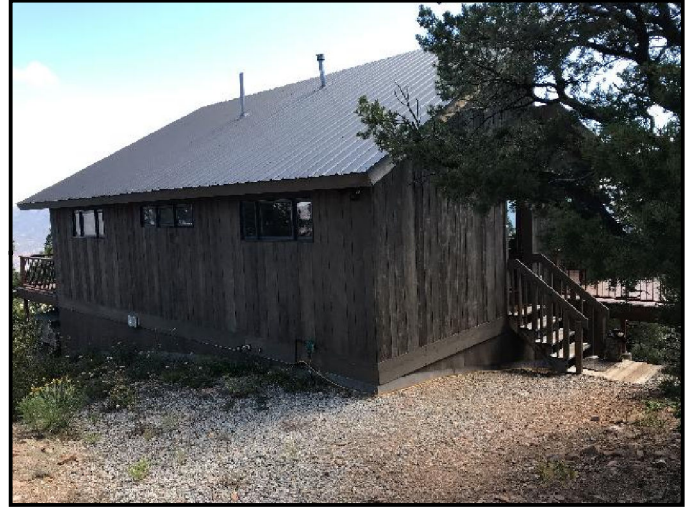
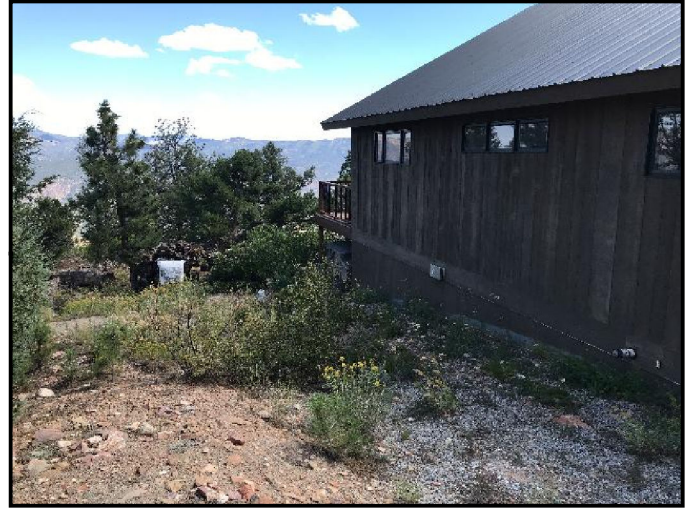
Structure ID: 295

Hazards: Fuels close to structure

Notes: Wrap around deck, wood piles near structure, fuels touching deck.

Mitigation Time (in hours): 10

Mitigation Description: Tree/brush removal

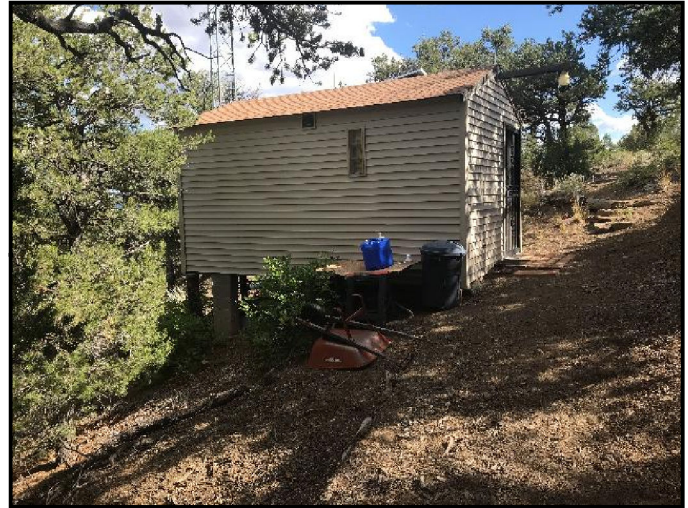
Structure ID: 296

Hazards: Surrounded by fuels and stacked wood under structure

Notes: Small shed like structure

Mitigation Time (in hours): 12

Mitigation Description: Tree removal and brushing around structure

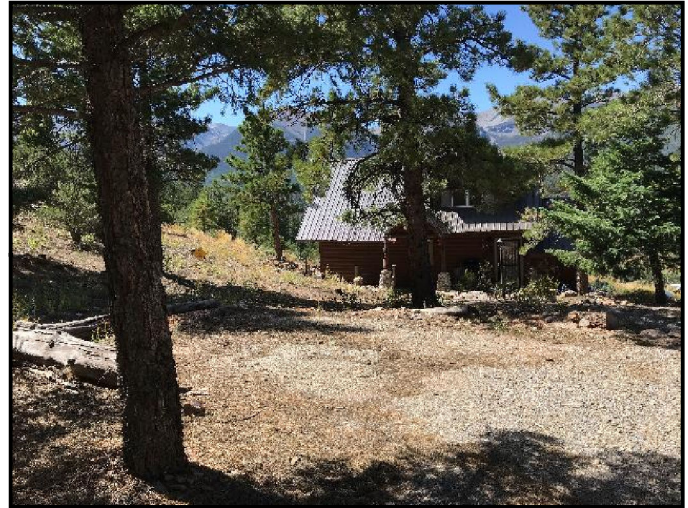
Structure ID: 297

Hazards: Position on slope and fuel loading adjacent

Notes: Decks, portable propane, yard debris

Mitigation Time (in hours): 12

Mitigation Description: Tree felling and brushing, some weed whacking around structure.

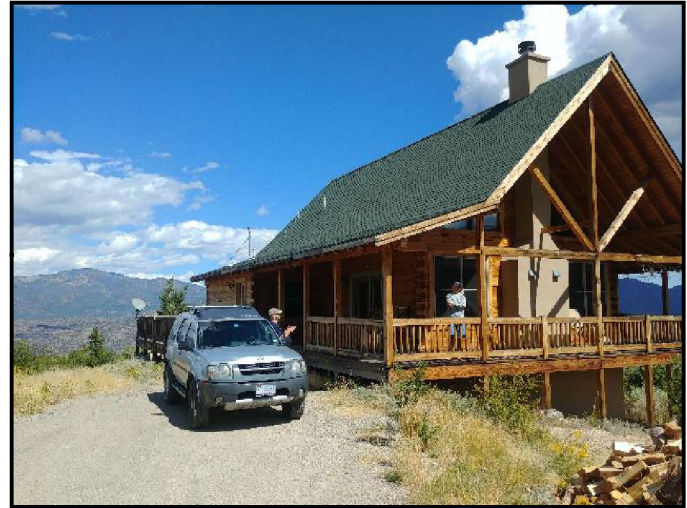
Structure ID: 298

Hazards: Long one way access road on top of a ridge steep slopes 3 sides

Notes: Lots of fuel at or near structure with overhanging deck and steep slopes

Mitigation Time (in hours): 6

Mitigation Description: Lots of saw and weed eater work

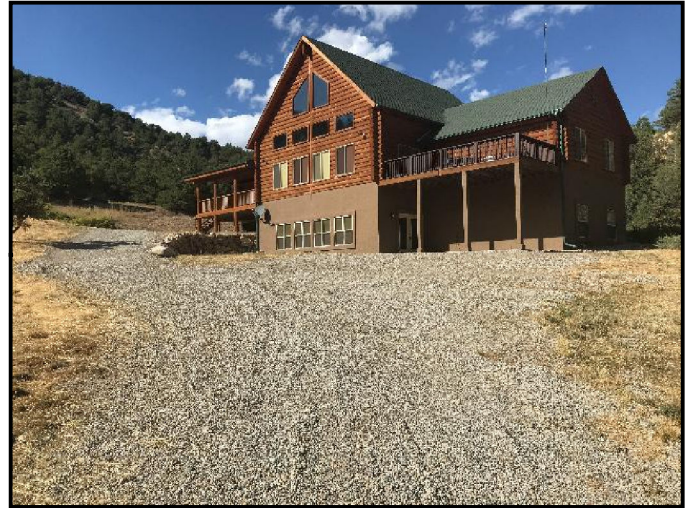
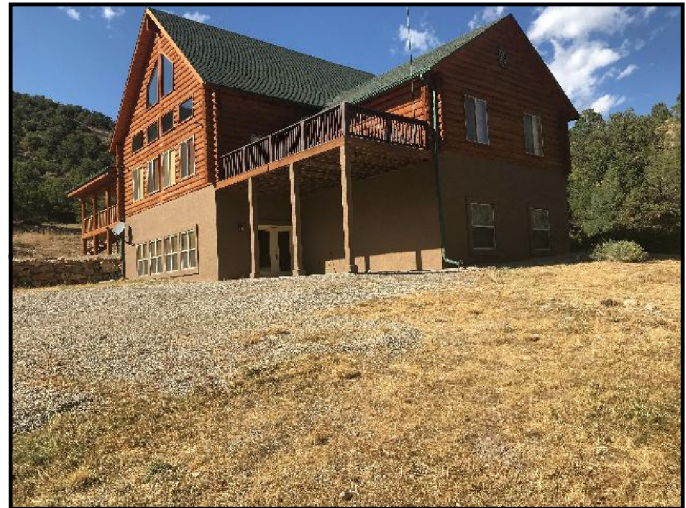
Hazards: Propane tank near residence

Notes: Wood timbers and stucco, large wood deck

Mitigation Time (in hours): 6

Mitigation Description: Weed whacking
and some brushing

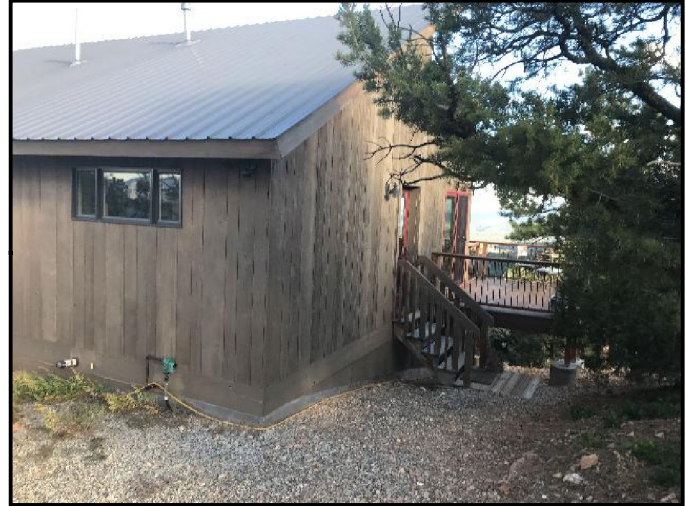
Hazards: Fuels, slope

Notes: Wooden decks front and back, wood pile, fuels close to structure

Mitigation Time (in hours): 4

Mitigation Description: Saw work, weed whacking

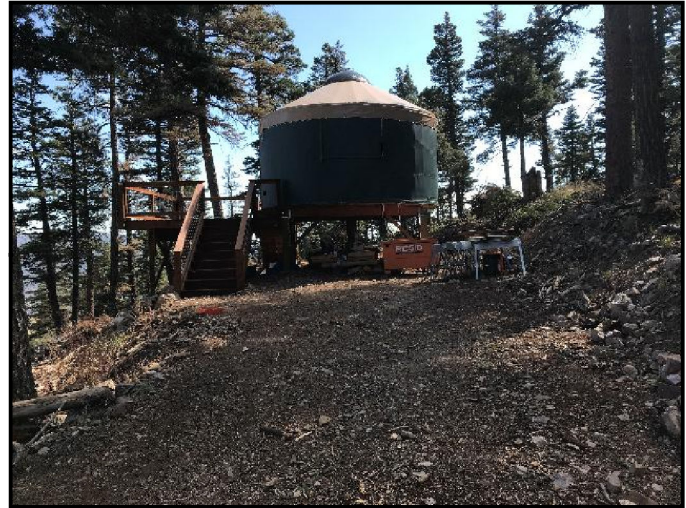
Hazards: Fuel loading surrounding structure.

Notes: Yurt construction, plastic materials on sides and roof. Materials under structure. Deck.

Mitigation Time (in hours): 8

Mitigation Description: Tree felling and removal brush removal

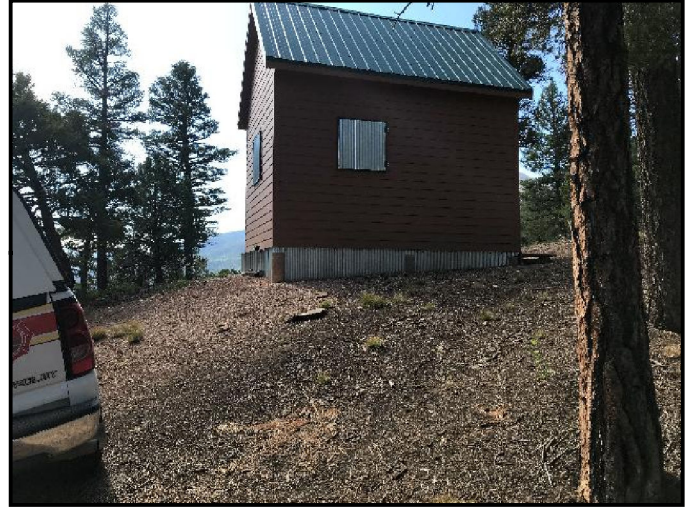
Hazards: Surrounding slope

Notes: Well constructed w/ fire resistant materials

Mitigation Time (in hours): 5

Mitigation Description: Some tree work/removal

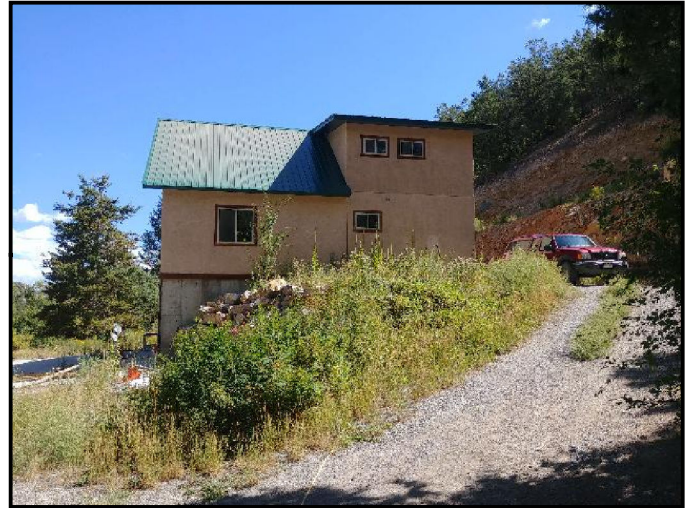
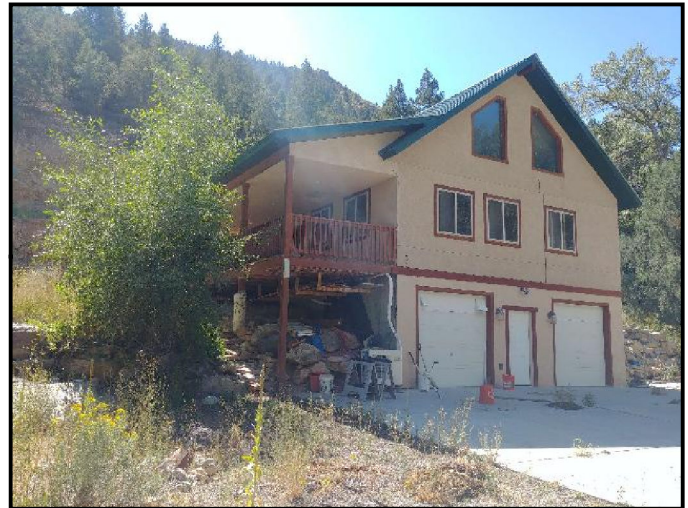
Structure ID: 304

Hazards: Long one way access road

Notes: Lots of fine fuels at or near structure grow operation in attached garage

Mitigation Time (in hours): 6

Mitigation Description: Heavy brush removal

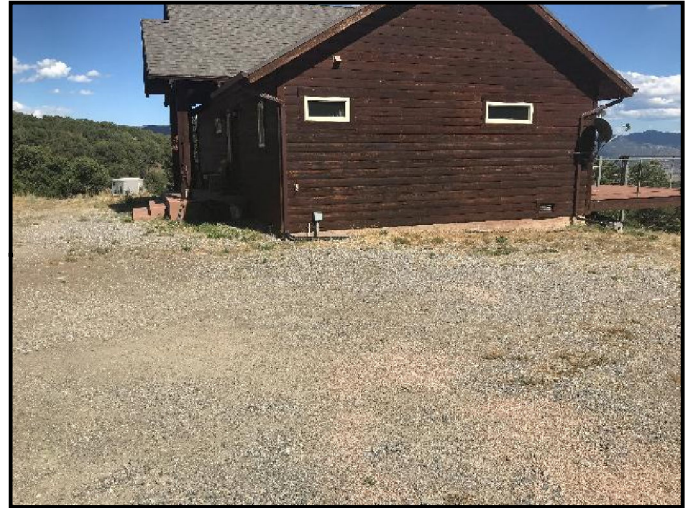
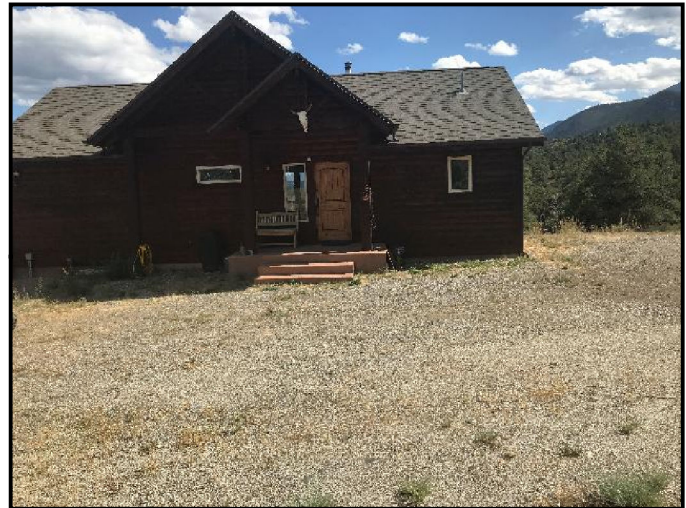
Hazards: Wood construction

Notes: Surrounded by fuels

Mitigation Time (in hours): 12

Mitigation Description: Brushing work around structure

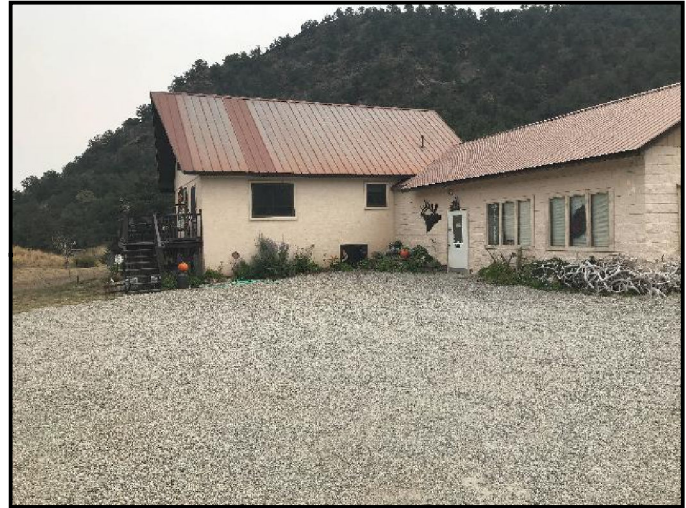
Hazards: Fuels, slope behind structures

Notes: Wooden deck, large gravel driveway, wood piles

Mitigation Time (in hours): 4

Mitigation Description: Weed whacking

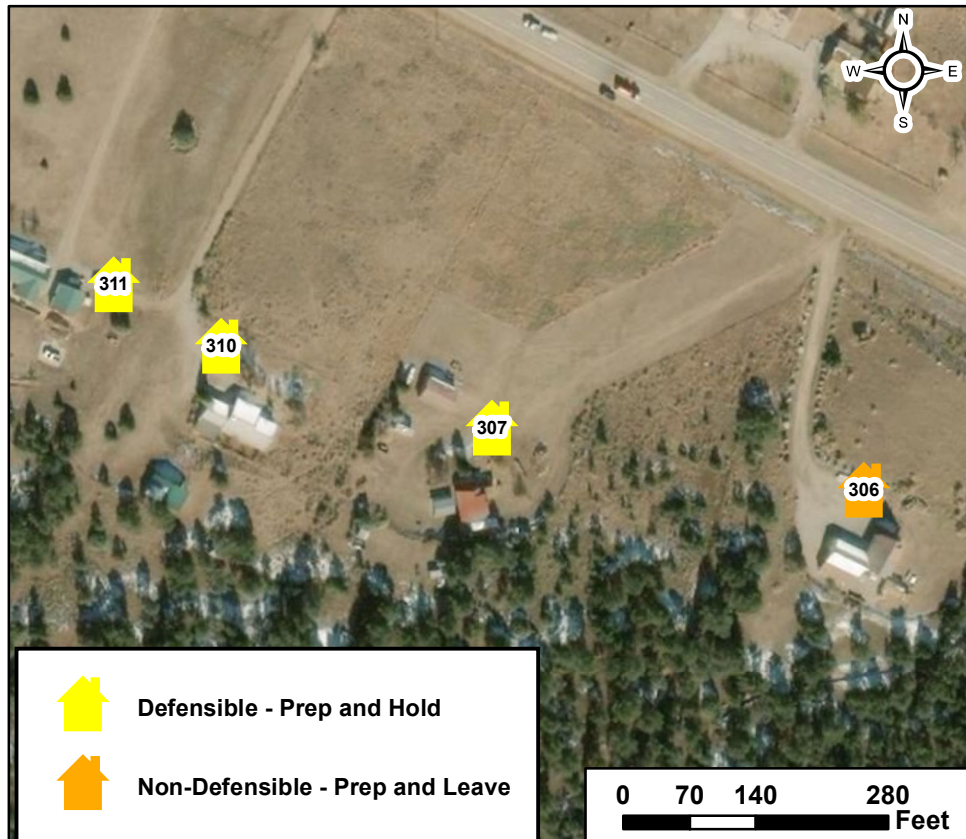
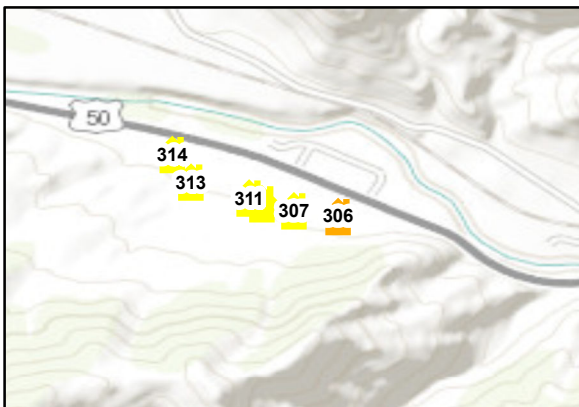
Structure ID: 307

Notes: Wooden decks, large wood pile, some debris, vehicles

Mitigation Time (in hours): 6
Mitigation Description: Tree thinning and brushing, weed whacking

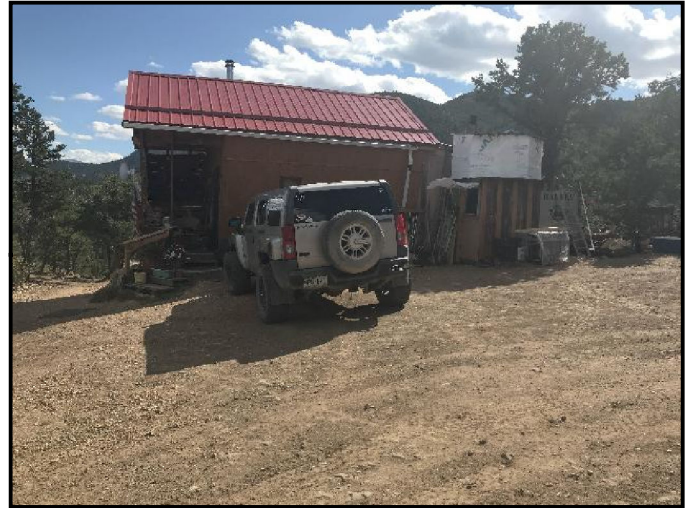
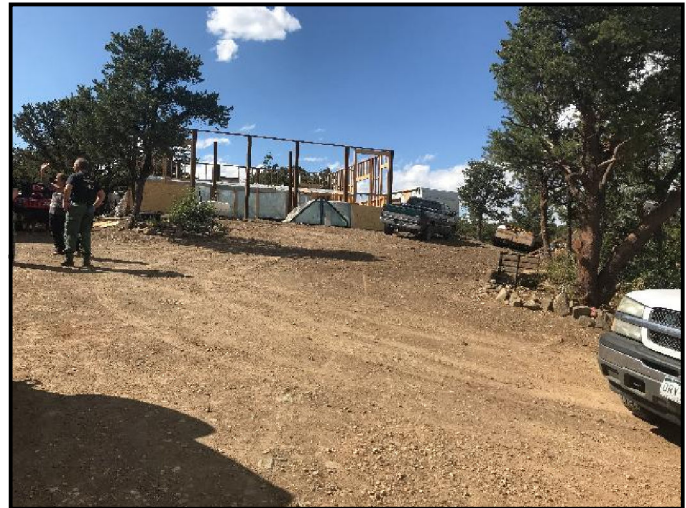
Structure ID: 308

Hazards: Top of ridge, several outbuildings under construction
heavy pinyon/ juniper on all sides surrounding structures

Notes: Primitive structures, some under construction. Difficult to protect.

Mitigation Time (in hours): 12

Mitigation Description: Tree and brush
removal

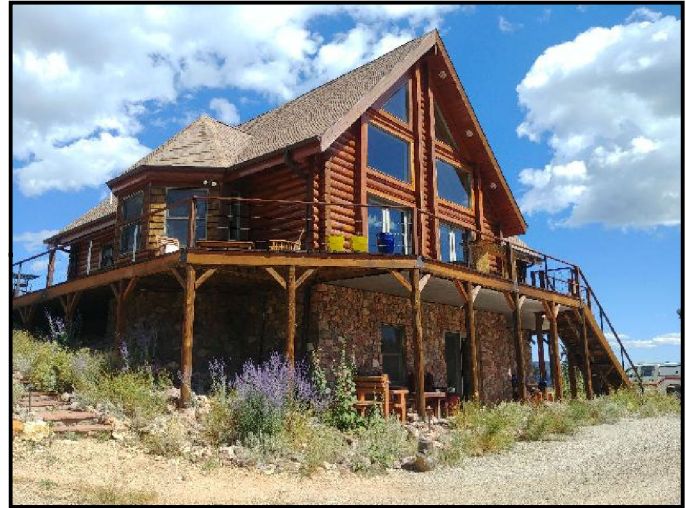
Structure ID: 309

Hazards: Long one way access road on top of a ridge steep slopes 3 sides

Notes: Lots of fuel at or near structure with overhanging deck and steep slopes

Mitigation Time (in hours): 6

Mitigation Description: Lots of saw and weed eater work

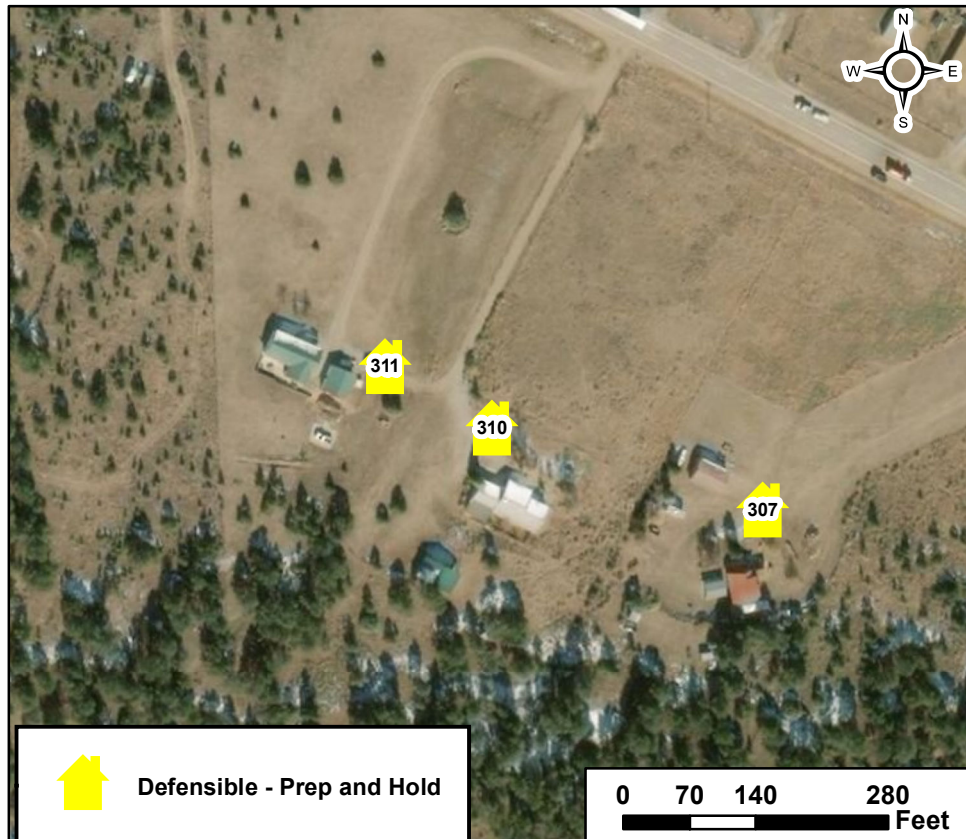
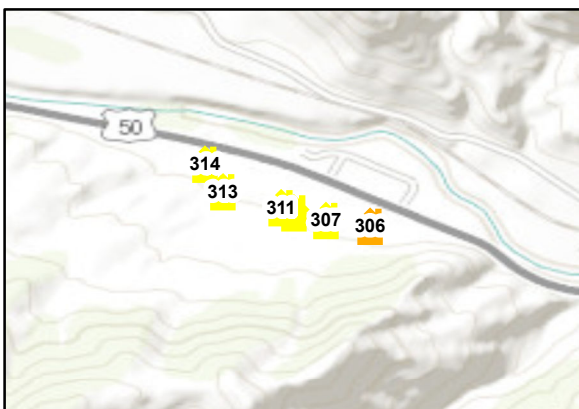
Notes: Grass fuel model in front of house, shrub model behind house, fuels up to house perimeter

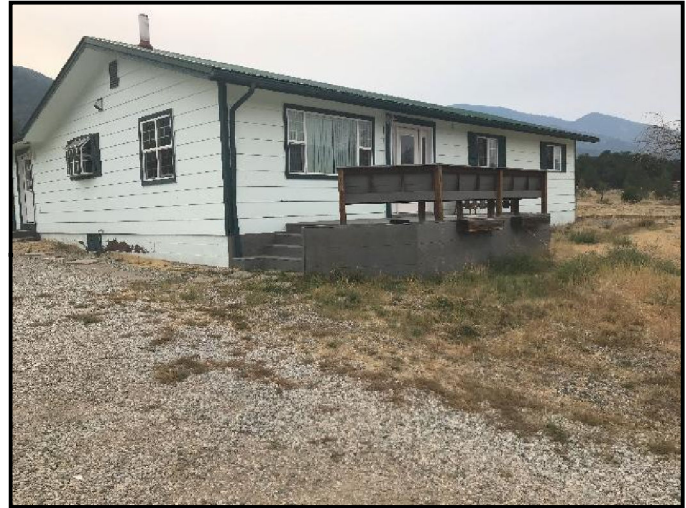
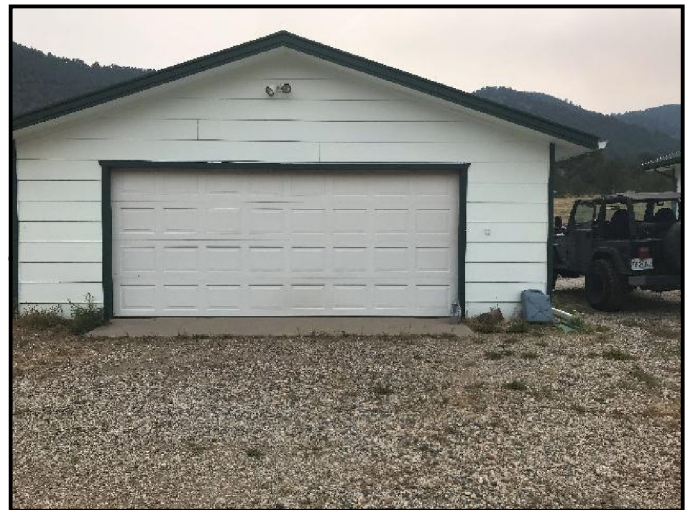
Hazards: Fuels, slope behind structure

Notes: Wooden decks, gravel driveway, wood pile

Mitigation Time (in hours): 6

Mitigation Description: Weed whacking

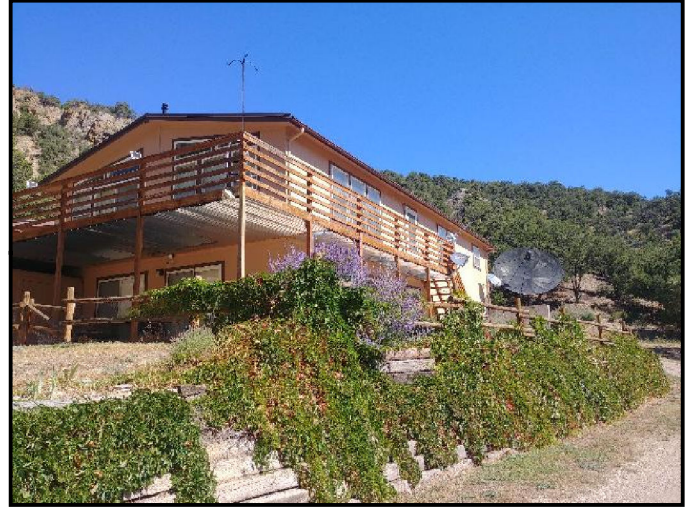
Structure ID: 312

Hazards: Long one way access road

Notes: Single family home with 3 garages
good clearances

Mitigation Time (in hours): 2

Mitigation Description: Very little

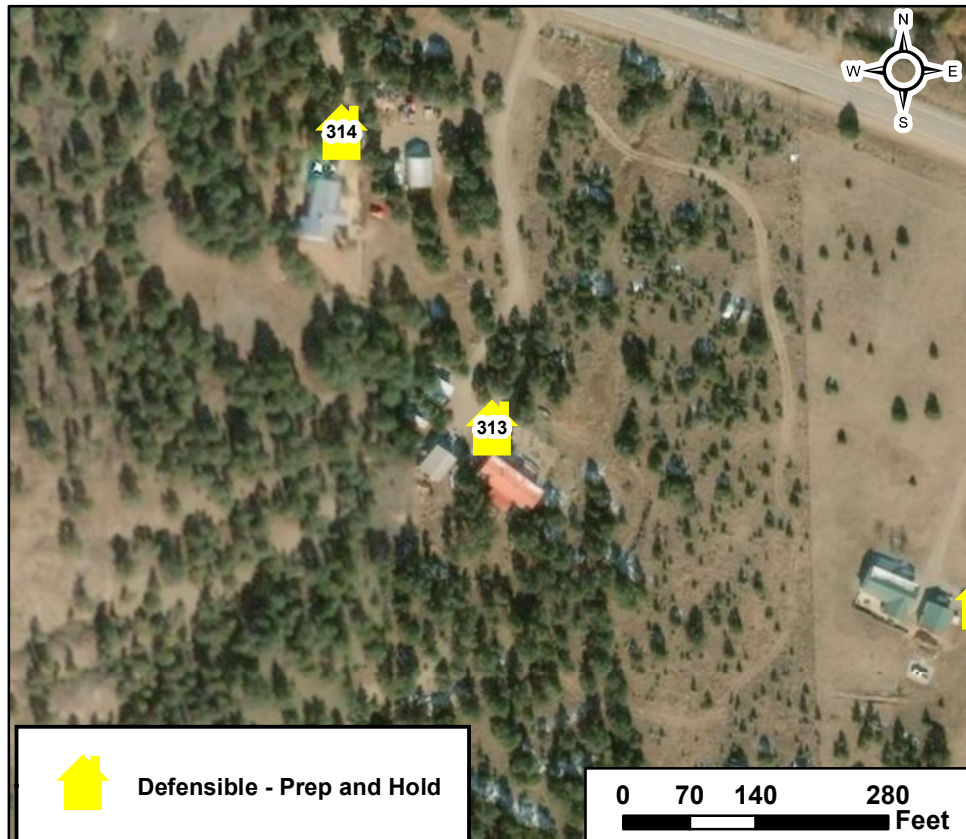
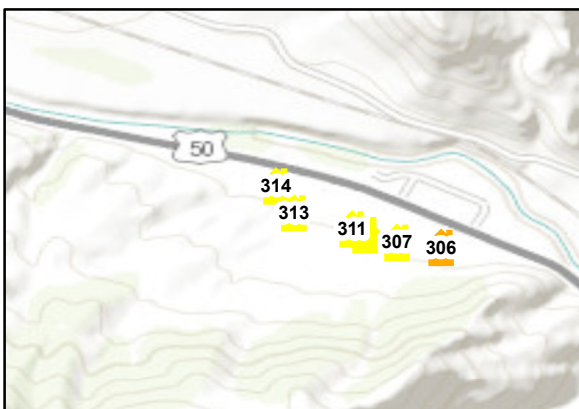
Notes: Wooden decks, gravel driveway, wood piles near structure

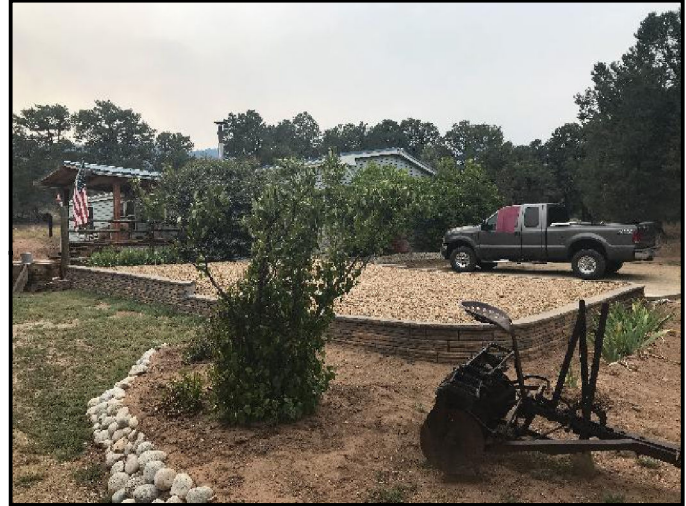
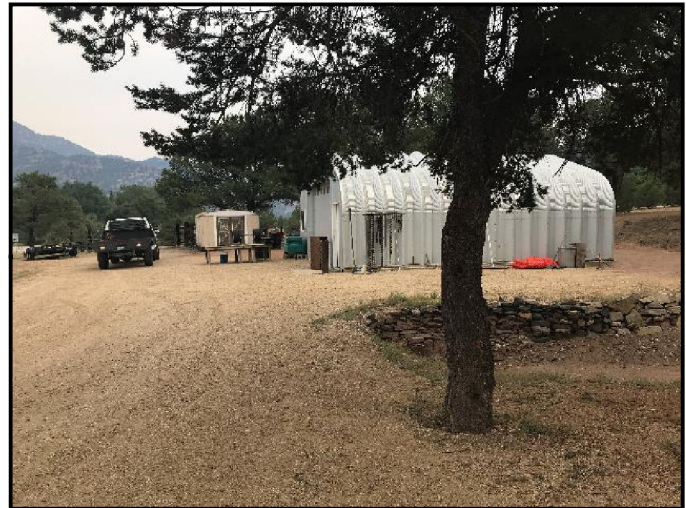
Structure ID: 314

Hazards: Fuels, slope behind structures

Notes: Wooden decks, gravel landscaping in back of residence, large wood pile

Mitigation Time (in hours): 6

Mitigation Description: Tree thinning and brushing

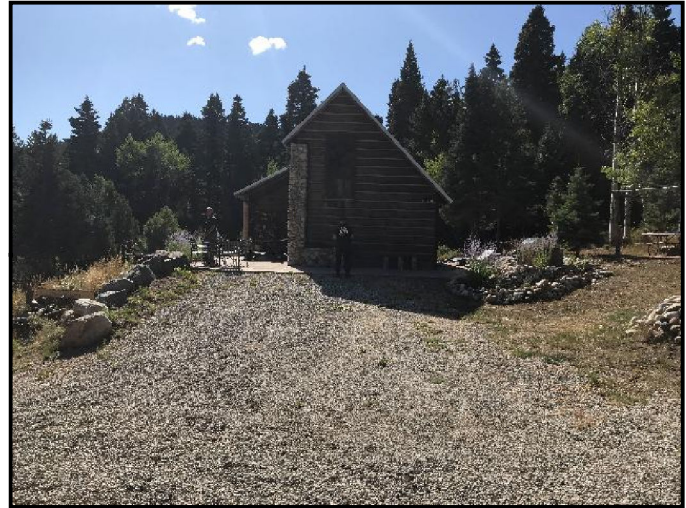
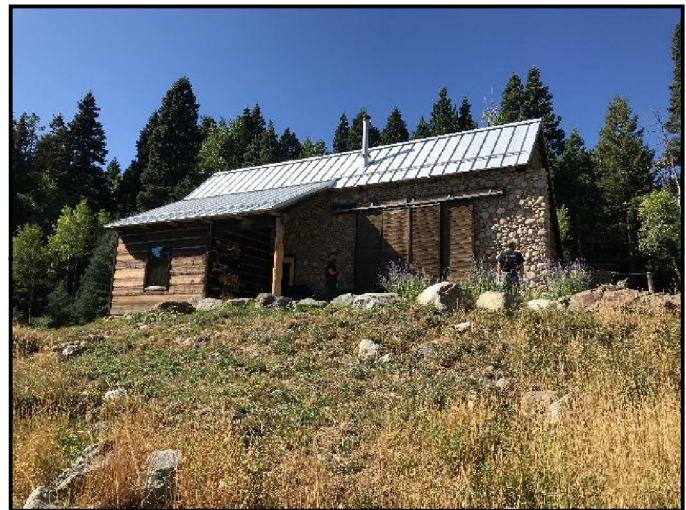
Structure ID: 315

Hazards: Large cache of dead and down logs, fuel loading on all sides

Notes: Wood construction, needs more clearance around structure.

Mitigation Time (in hours): 12

Mitigation Description: Tree thinning and removal, weed whacking

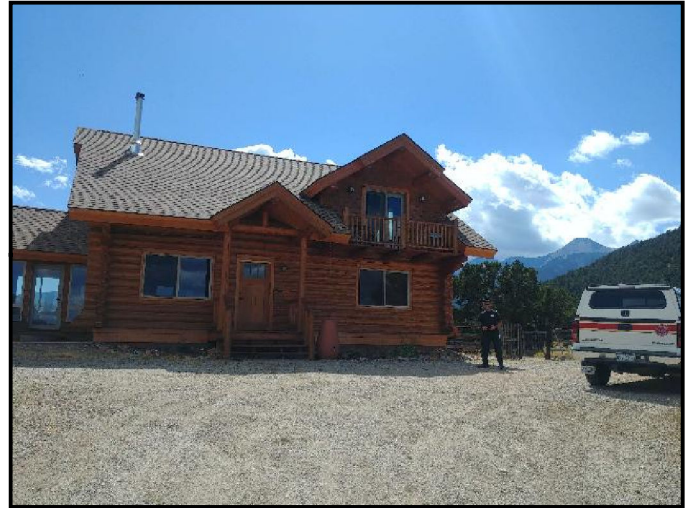
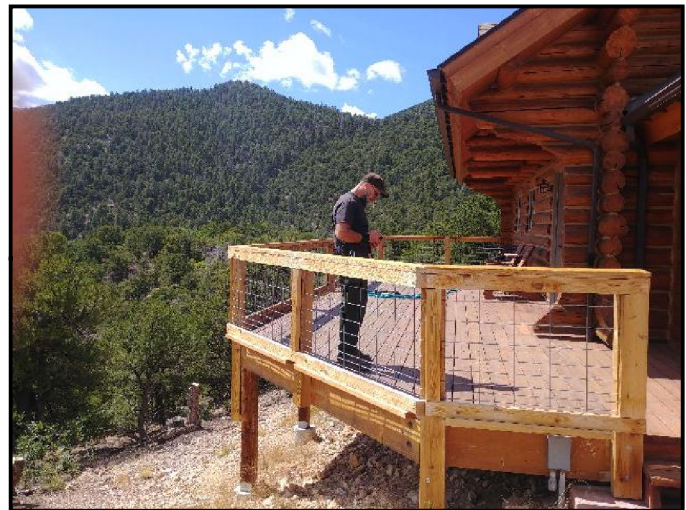
Hazards: Long one way access road on top of a ridge steep slopes 3 sides

Notes: Lots of fuel at or near structure with overhanging deck and steep slopes

Mitigation Time (in hours): 6

Mitigation Description: Lots of saw and weed eater work

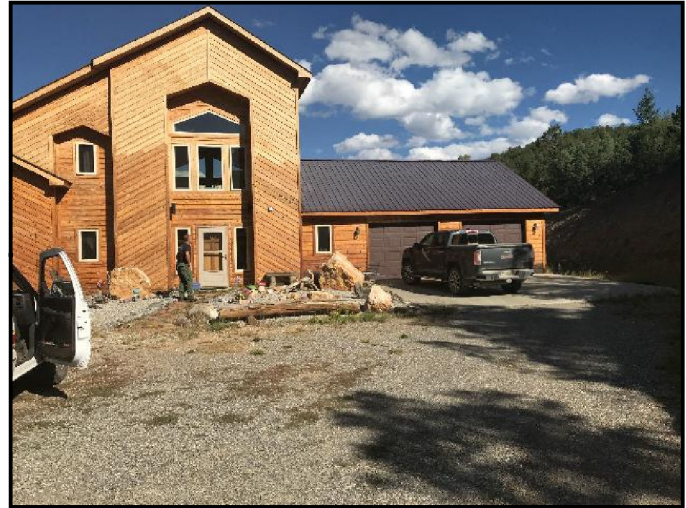
Hazards: Brush around structure, yard debris

Notes: All wood structure w/ treated stain.
Wood deck.

Mitigation Time (in hours): 6

Mitigation Description: Brushing

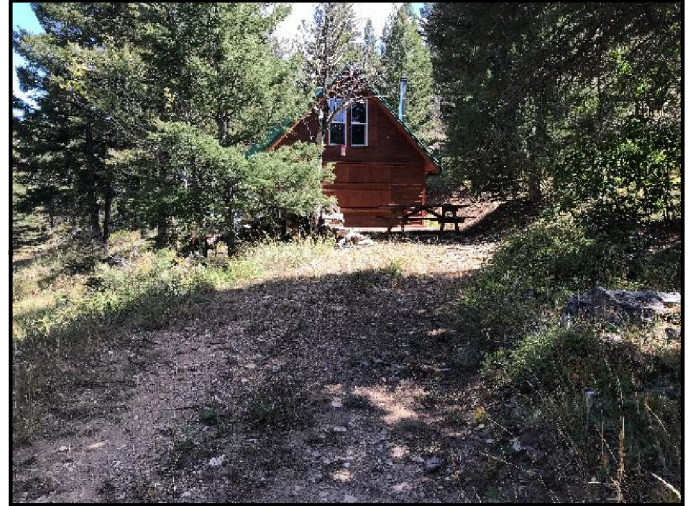
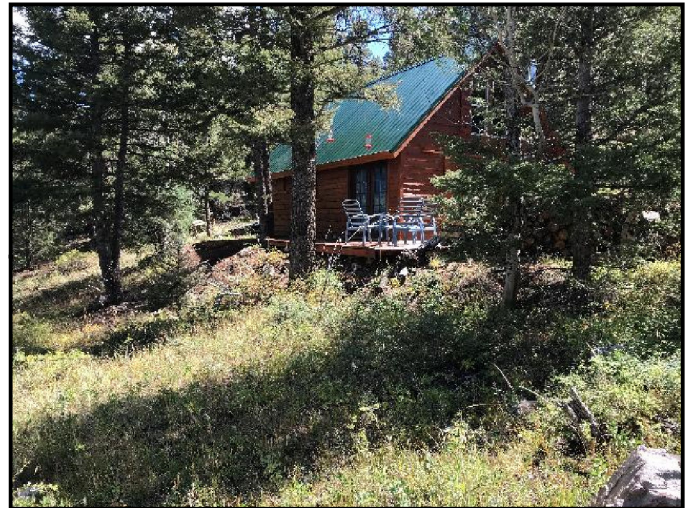
Structure ID: 318

Hazards: Fuel loading around structure, wood piles, etc.

Mitigation Time (in hours): 8

Mitigation Description: Tree and brush thinning, some weed whacking

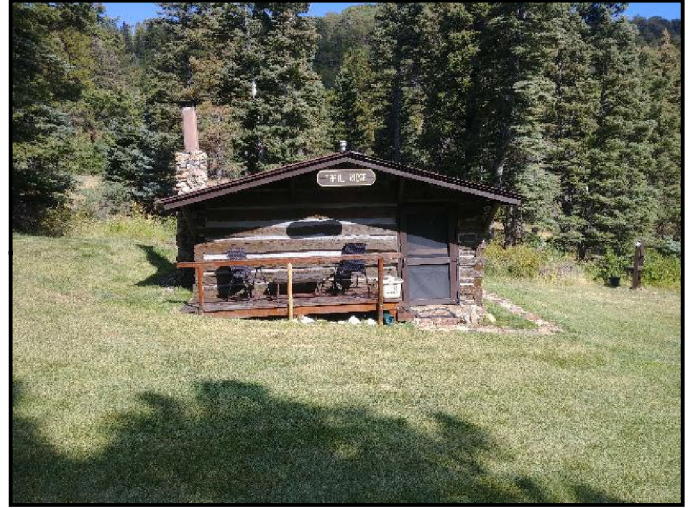
Hazards: Long one way access road

Notes: Historic livable log cabin surrounded by green lawn

Mitigation Description: Very little

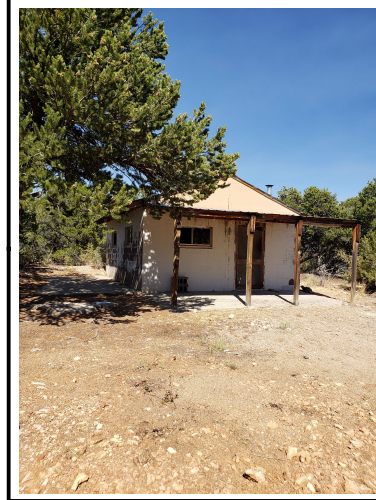
Hazards: access, egress

Notes: cinder block and metal roof very defensible

Mitigation Description: Lynn surrounding pinion pumpkin sprinklers. Bringing pump and water to this remote area not advised

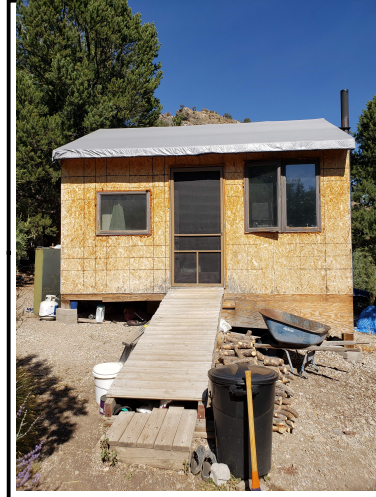
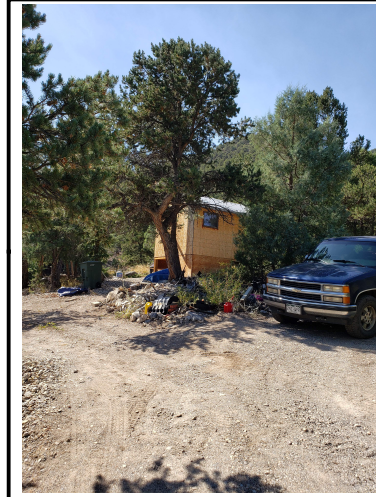
Hazards: egress

Mitigation Description: Lynn pinyon
Juniper and put in pumpkin sprinklers and
pump
