Poncha Pass Structure Assessment

Structure ID: 255

Collected Date/Time: 9/24/2019 10:15:00 PM
Collected By: Chris Masson
Inspector's Position: Divs

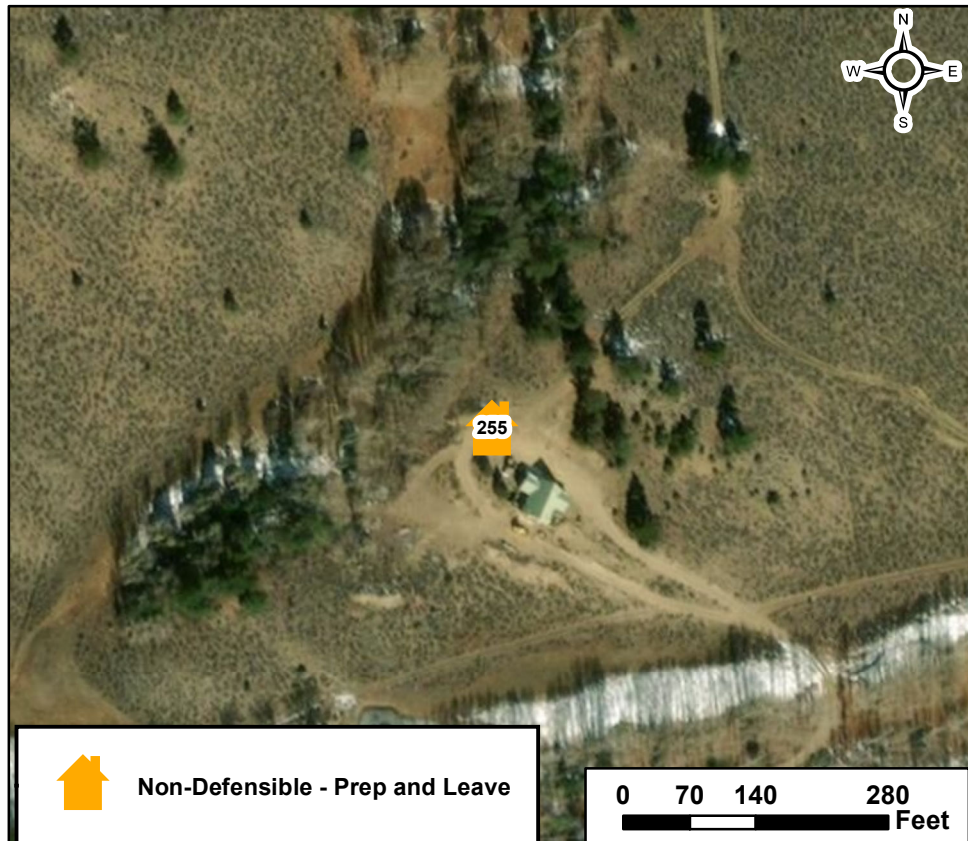
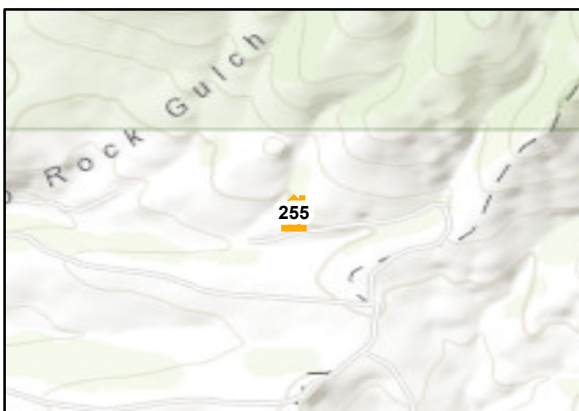
Triage Category: Non-Defensible, Prep and Leave

Fuel Surrounding Structure: Shrub or timber

Defensible Space: Less Than 30 ft treated

Hazards: Fuels, slope

Notes: Wood deck, small pond below structure, some debris around structure

Mitigation Description: Weed whacking and saw work

Type 6 engine, porta tank and sprinklers

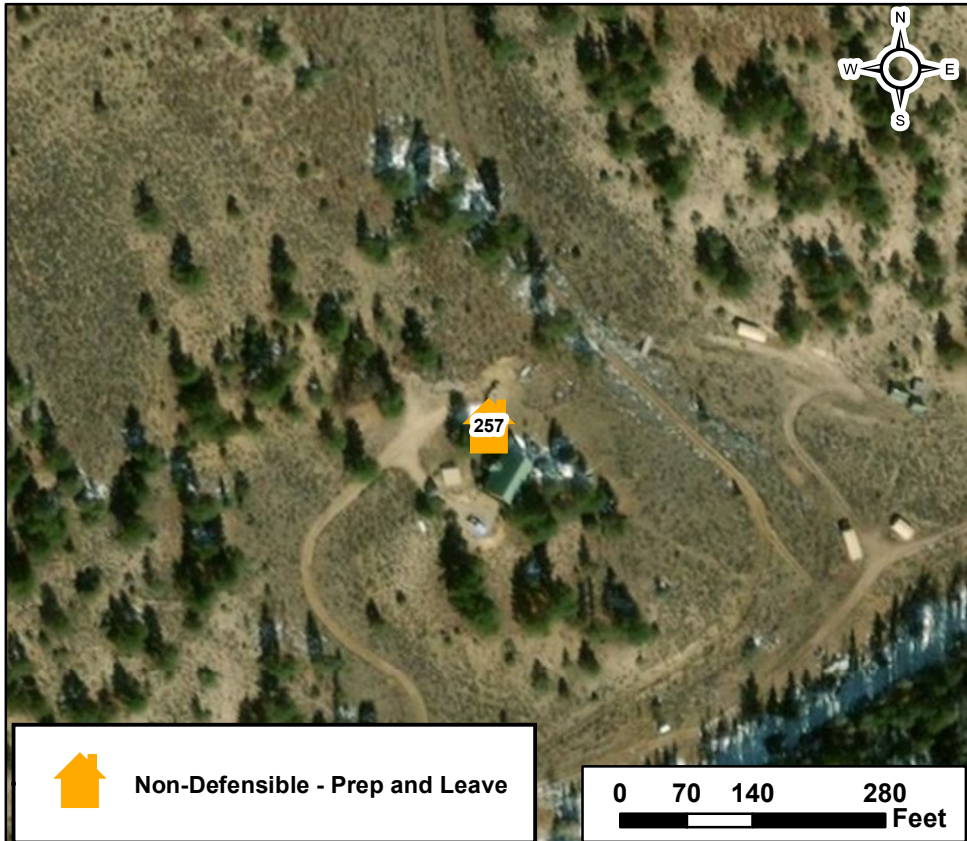
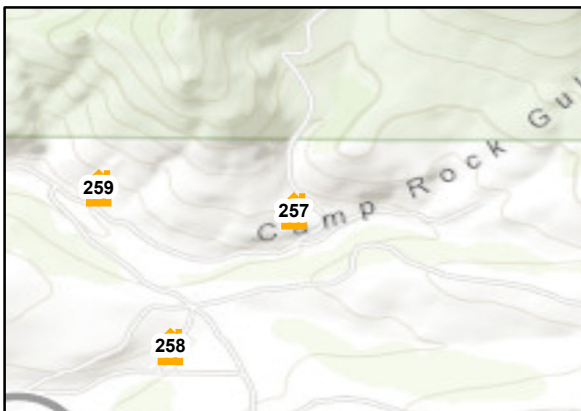
Structure ID: 257

Triage Category: Non-Defensible, Prep and Leave

Defensible Space: Less Than 30 ft treated

Hazards: Fuels, slope, long stretch of road from highway 285

Notes: Cabin construction, wood deck, wood stairs, out buildings are constructed from wood, debris

Mitigation Description: Saw work and weed whacking

Type 6 engine, porta tank and sprinklers

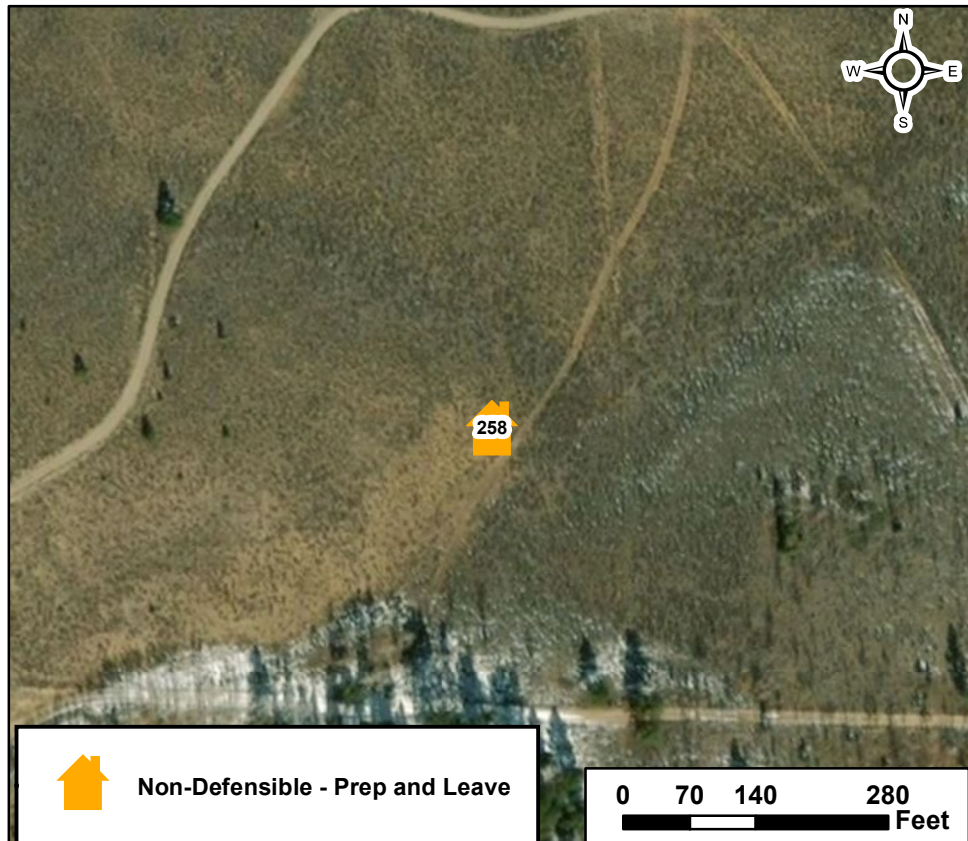
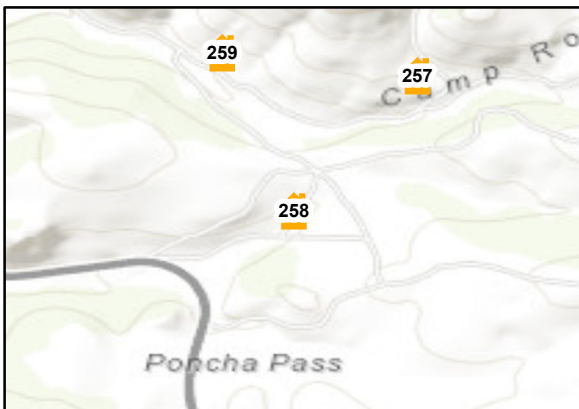
Structure ID: 258

Triage Category: Non-Defensible, Prep and Leave

Defensible Space: Less Than 30 ft treated

Hazards: Fuel, abundance of grass/sage around structure, slope

Notes: Gravel and rock path around structure, fuels below structure, wood pile on deck

Mitigation Description: Weed whacking and thinning

Type 6 engine porta tank with sprinklers

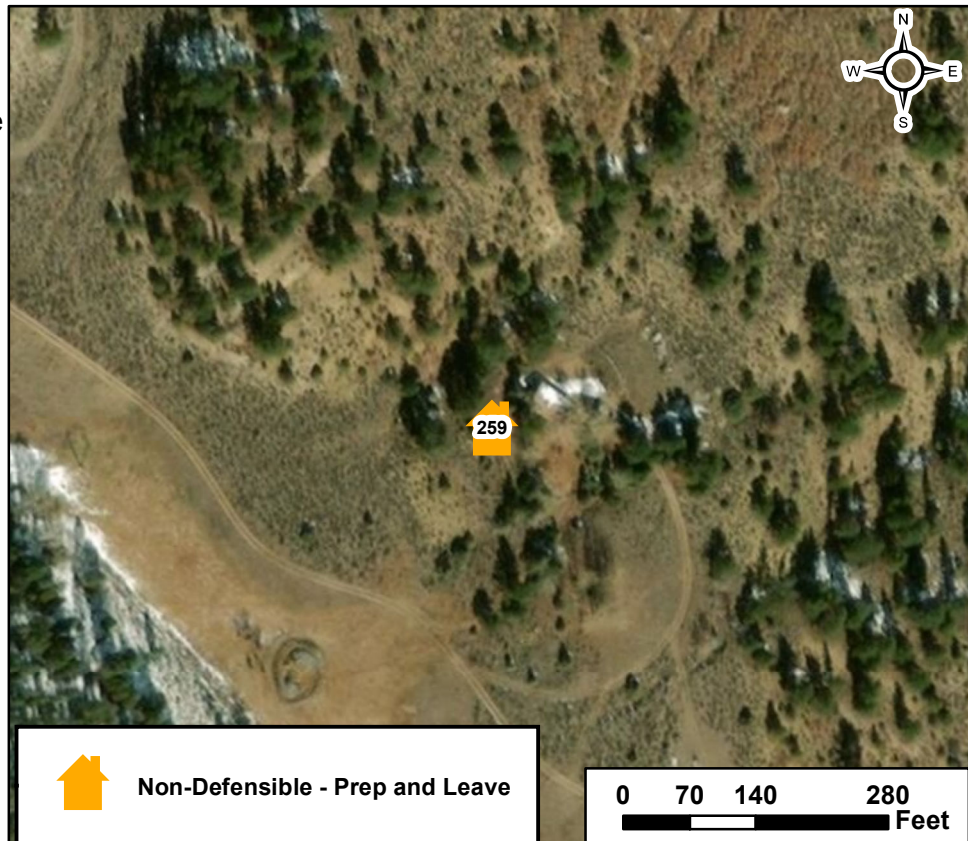
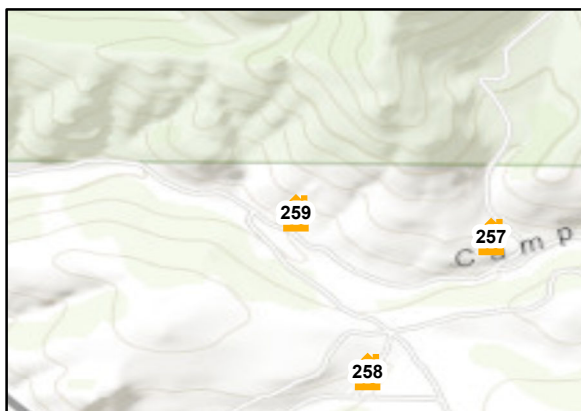
Structure ID: 259

Triage Category: Non-Defensible, Prep and Leave

Defensible Space: No defensible space

Hazards: Fuels, slope, access, debris

Notes: Structure tucked into the trees, some clearance behind, mid-slope

Mitigation Description: Saw work and weed whacking

Type 6 engine, porta tank and sprinklers

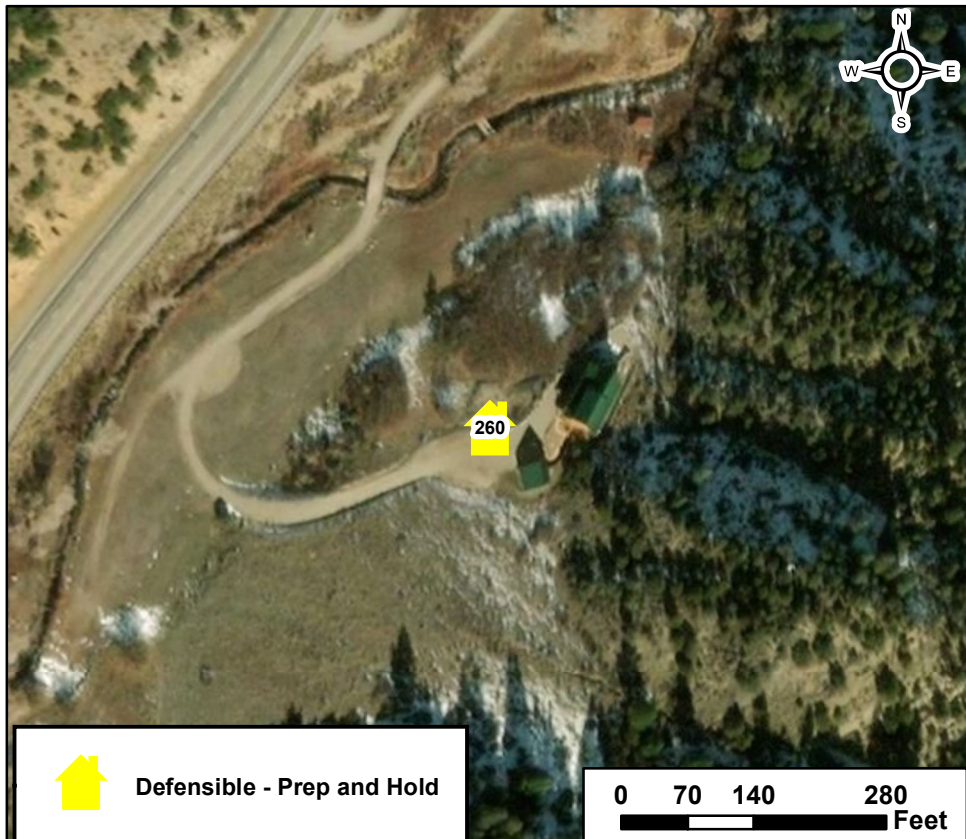
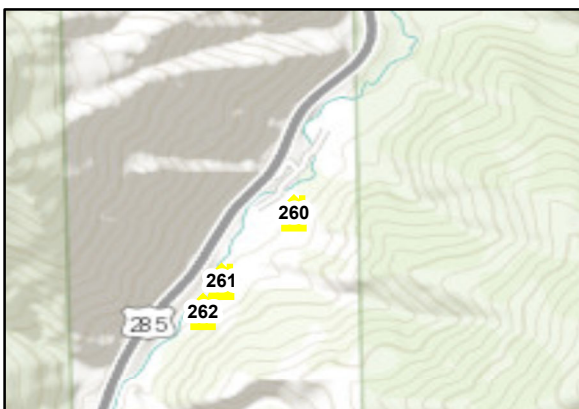
Structure ID: 260

Triage Category: Defensible, Prep and Hold

Defensible Space: Less Than 30 ft treated

Hazards: Fuels above structure, mid-slope

Notes: Multiple level wood decking, some gravel terracing, retaining walls, clean around structure

Mitigation Description: Thinning and brushing, weed whacking

Type 3/4 engine

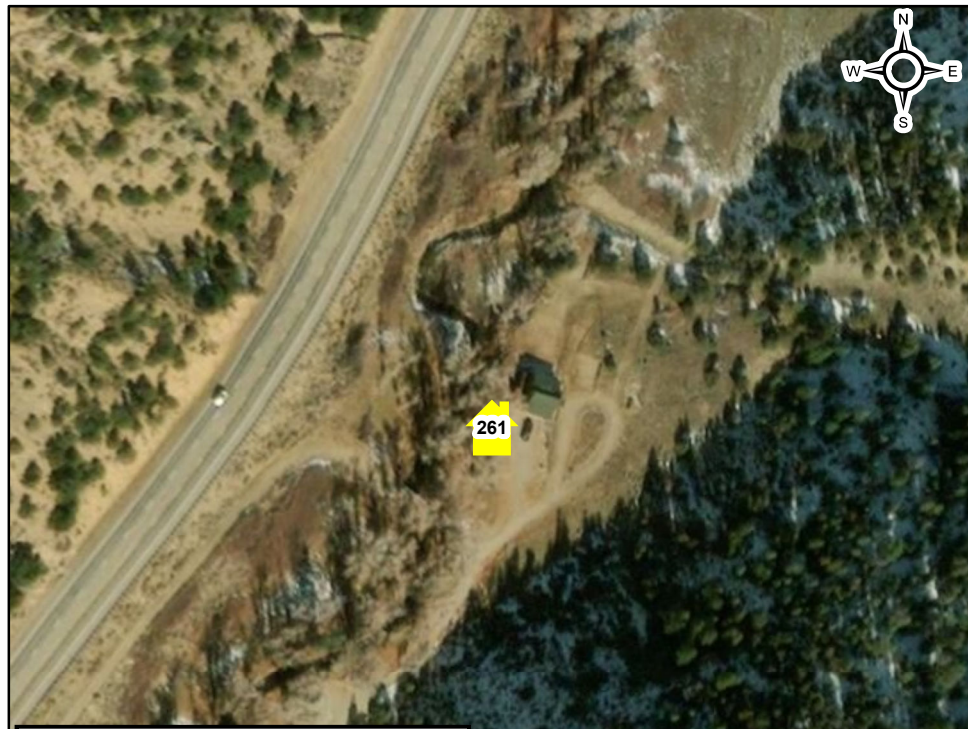
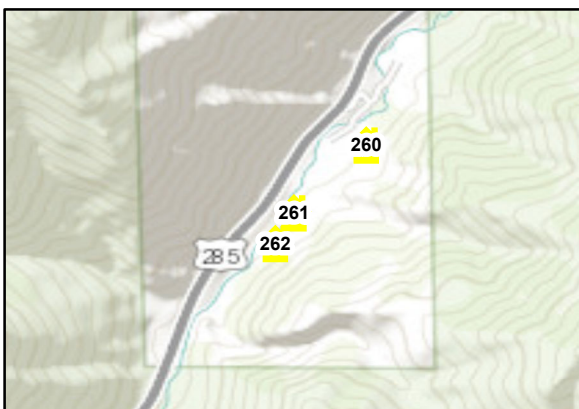
Hazards: Fuels above structure

Notes: Wood deck, weeds up to some portions of structure, River directly below structure

Type 3 engine or pump and hose lay

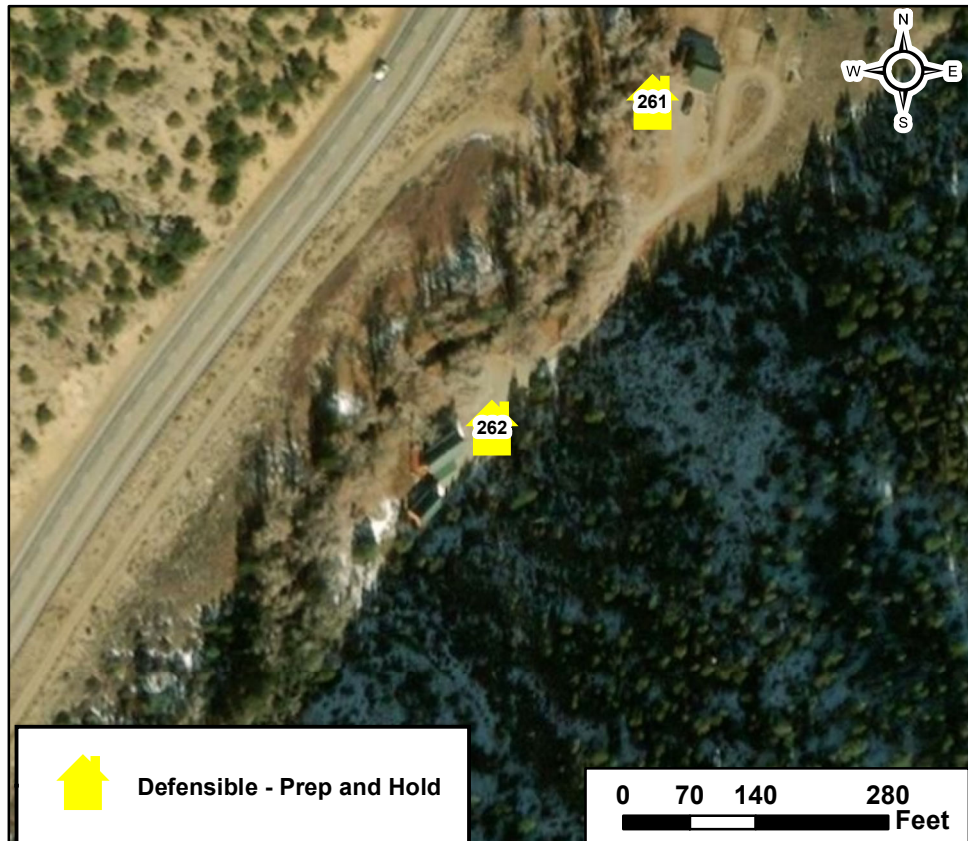
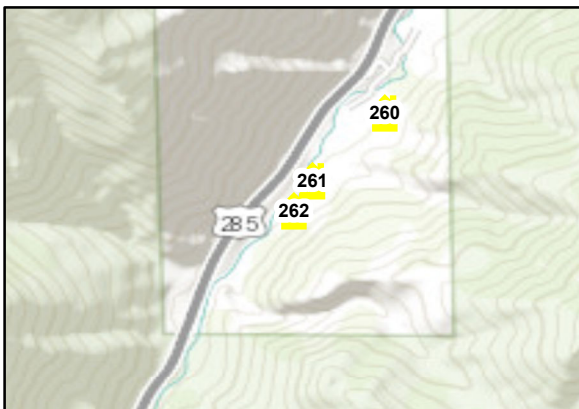
Hazards: Slope, fuels behind structure

Notes: Well maintained, gravel/ cement path around portions of structure, wood deck, River below structure

Type 3/4 engine or pump w/ hose lay

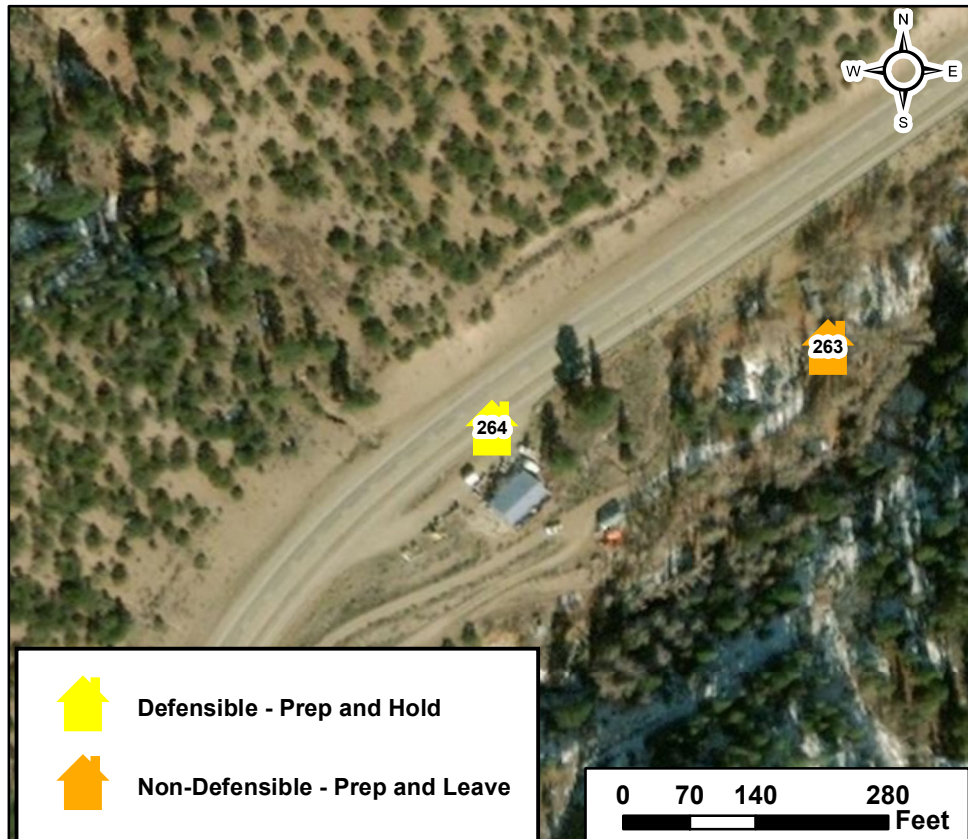
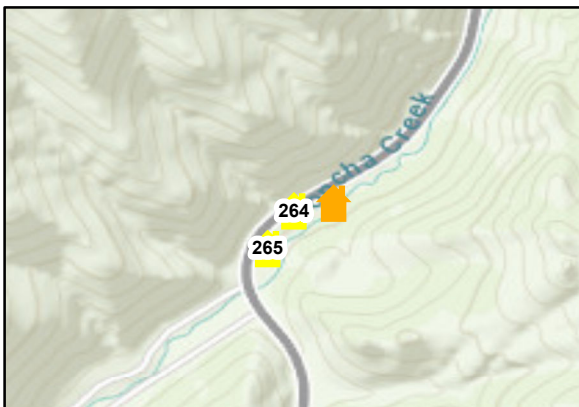
Structure ID: 264

Notes: Ramshackle structure, large amounts of debris surrounding

Type 3/4 engine

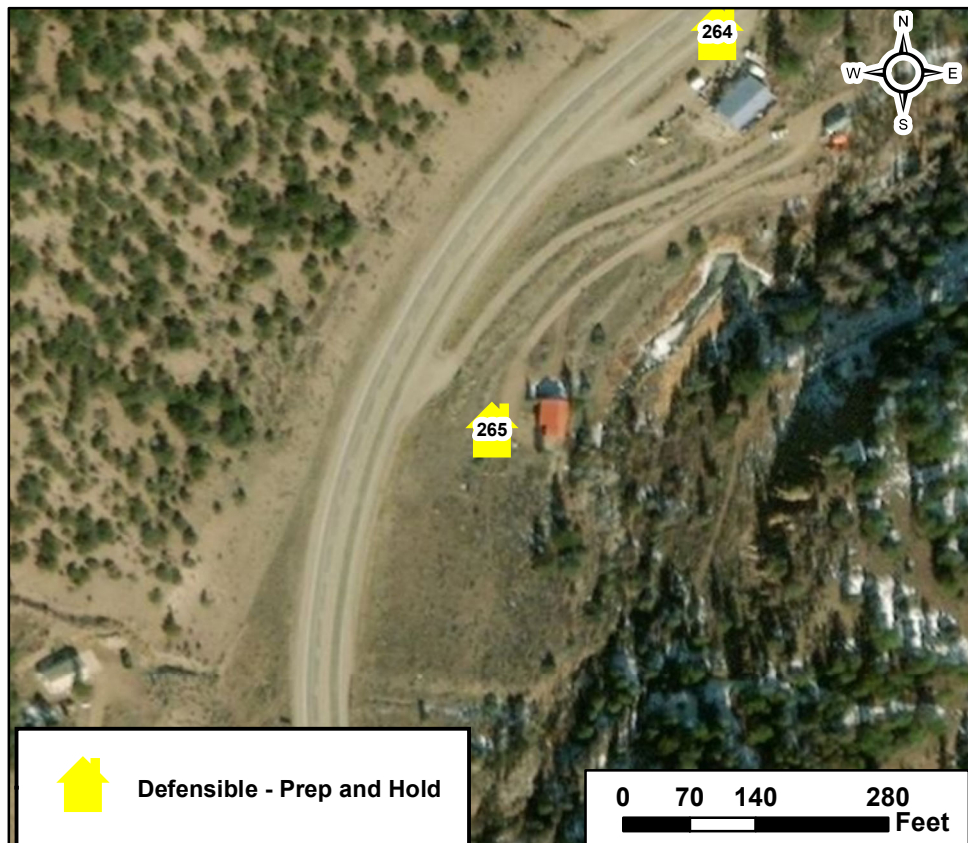
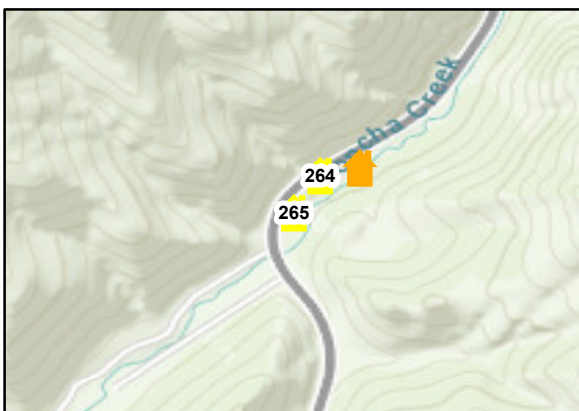
Structure ID: 265

Hazards: Busy highway access, slope, fuels, heavy grass and sage

Notes: Log cabin, small wood deck, River directly below structure

Type 3 engine, pump w/ hose lay from River

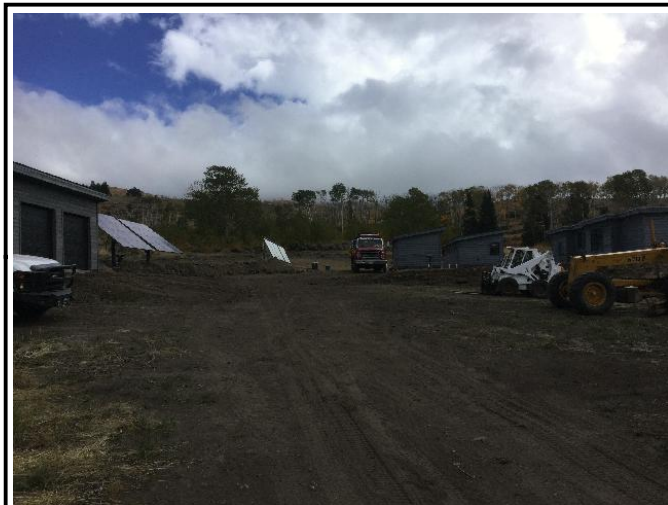
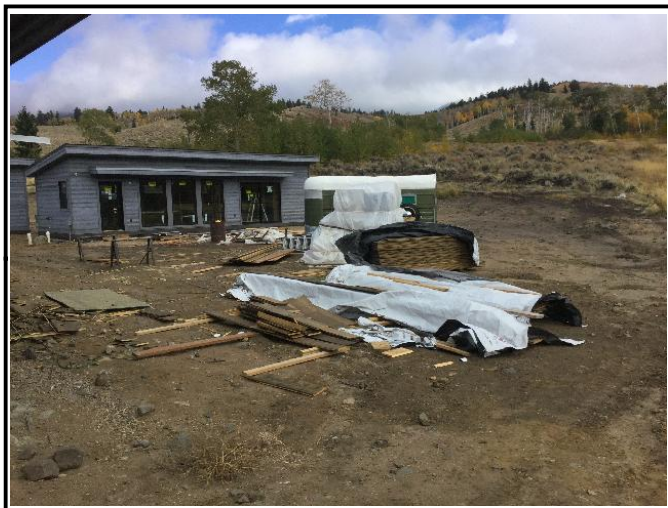
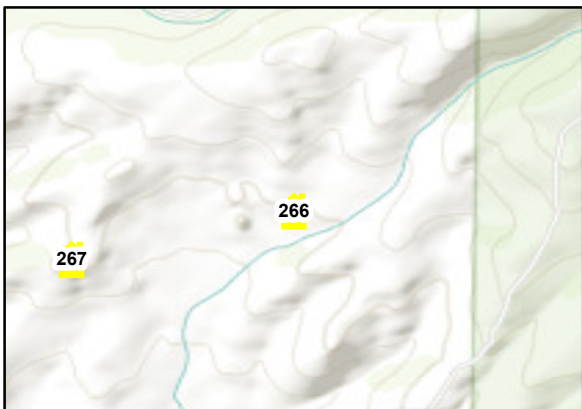
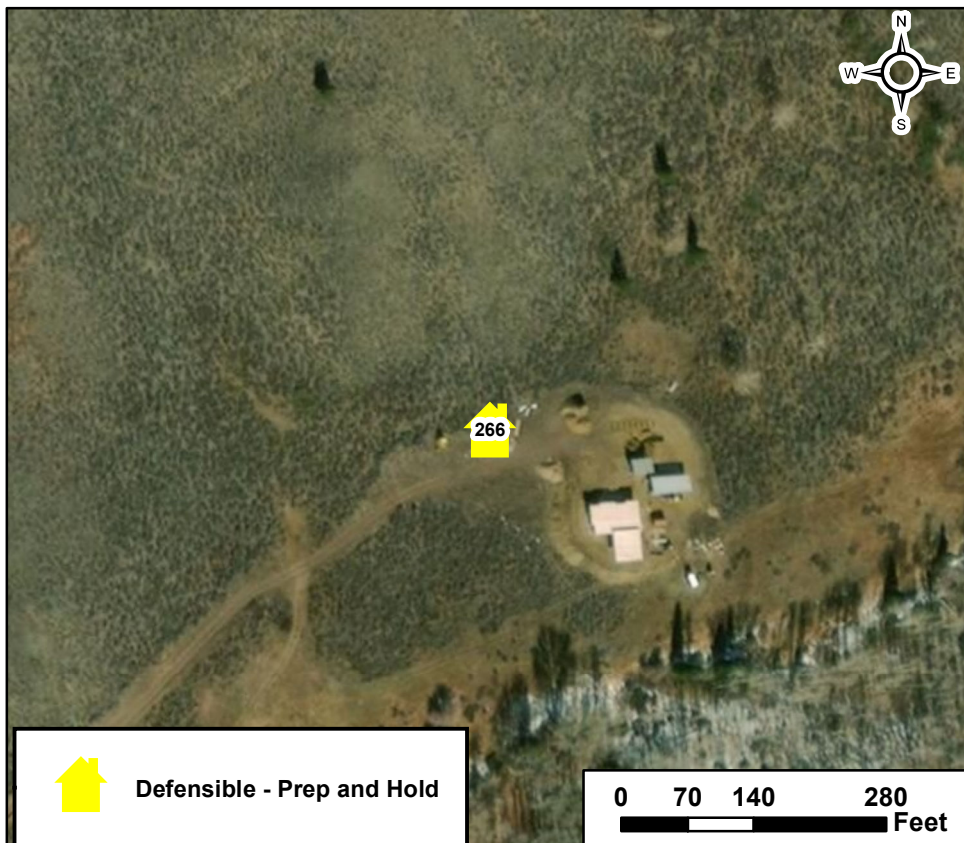
Structure ID: 266

Notes: New construction. One main residence. One secondary residence. One three car garage. One utility building. Two solar power arrays. Two tractors in parking area. Construction debris around structures. Large brush piles from machine work. Large open trench near garage. Good defensible space around entire compound.

1- Type 3/6 engine

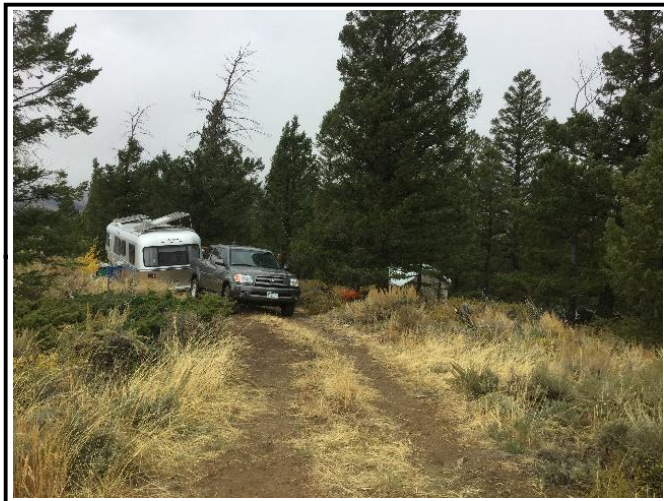
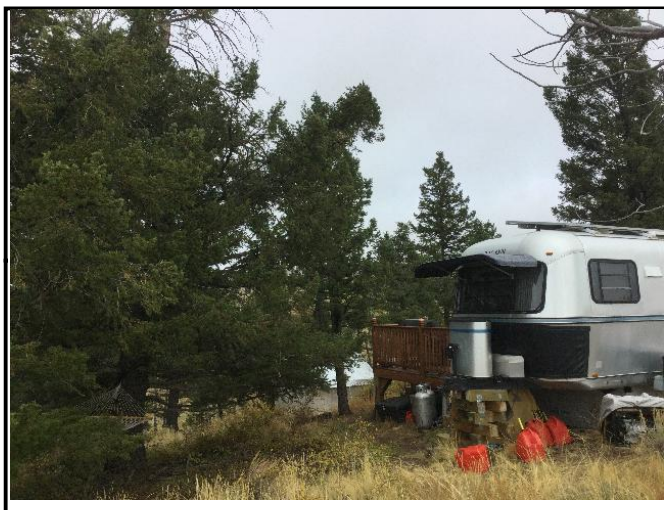
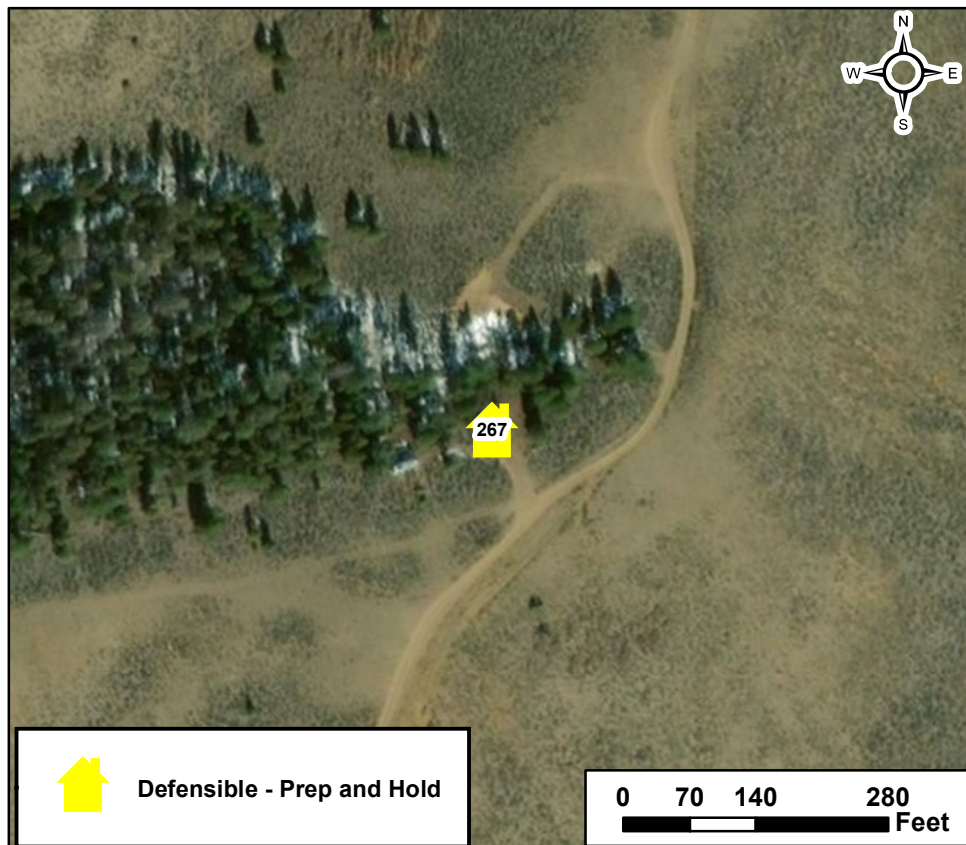
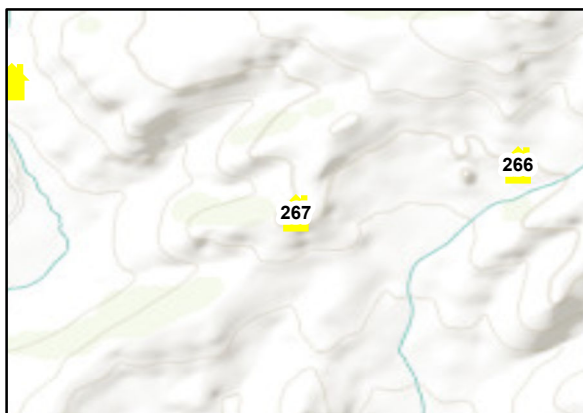
Structure ID: 267

Triage Category: Defensible, Prep and Hold
Type of Structure: Residential
Primary Structures:
Is the building Occupied?: Yes
Outbuildings: 1
Fuel Surrounding Structure: Shrub or timber
Defensible Space: No defensible space
Roof Material: Noncombustible or not applicable
Siding Material: Rock, concrete, metal
Electrical Power: Yes
Gas to Structure: Yes
Hazards: Multiple propane tanks of various sizes. Multiple containers of gasoline. Several wood piles. Barrel with unknown contents.
Access to Site:
Describe Access: Well established dirt road into structure. Driveway easily accessible. Good turn around access. Access for Type 3-6 engines, pick up trucks, and crew carriers.
Comm With ICP: Yes
Water Source: Limited or dependent on electricity
Safety Zone Present: Potential safety zone(s) in area
Mitigation Description: Brush out area. Limb/fall trees near structure. Move wood piles away. Move propane tanks and gasoline away from structure. Remove debris under deck.

Notes: Structure is travel trailer. Trailer is in semi permanent status. Trailer is powered by propane generator. Water well is powered by gasoline generator.

1 Type 3/6 engine. Hose lay around structure.

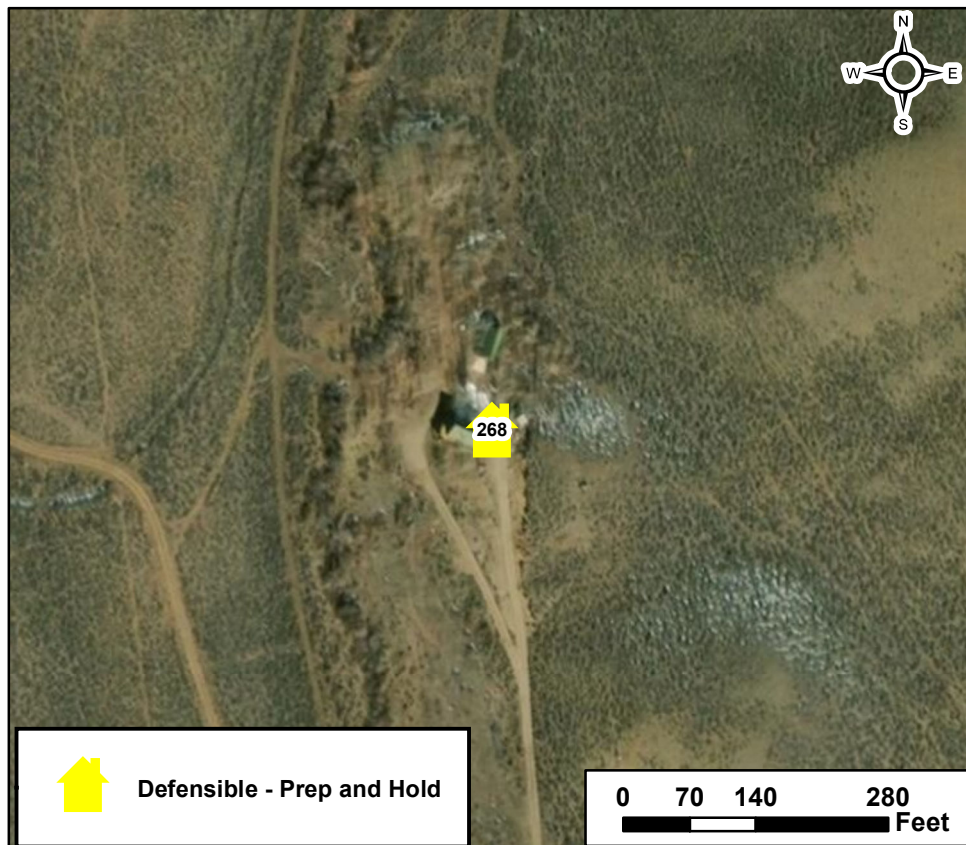
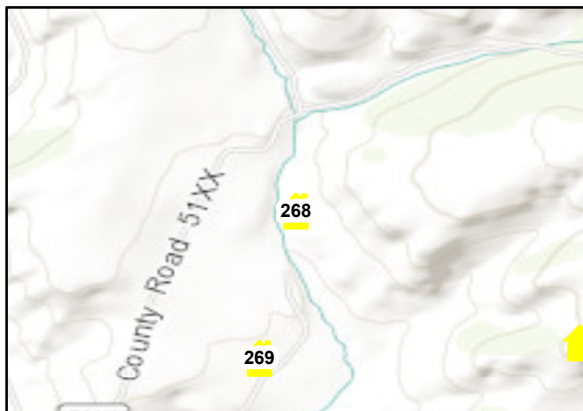
Hazards: Propane tanks. Tractor. Wood piles. Fuel containers.

Small wood sided shed. Multiple vehicles including tractor. Possible water container.

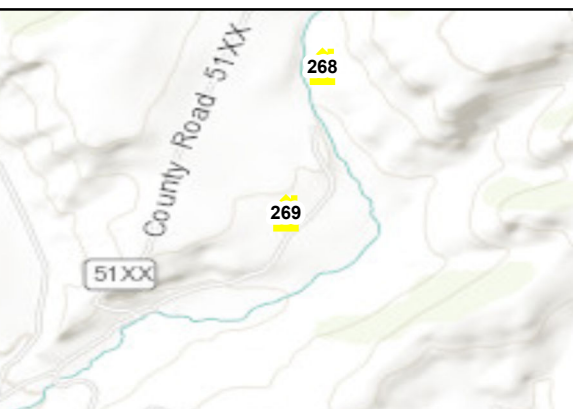
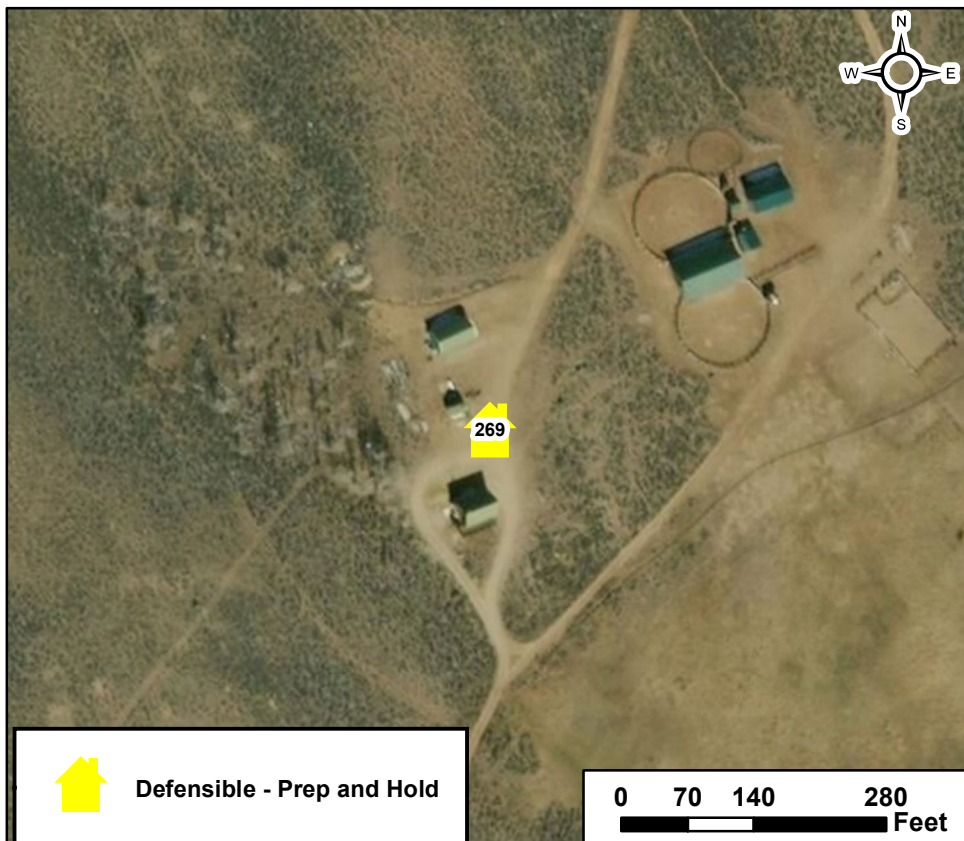
Hazards: Propane tank. Livestock. Fuel inside garage. Wood piles. Drums with unknown content. Open pit of construction debris.

Notes: Log cabin residence. Large steel garage. Multiple livestock shelters. Multiple livestock sheds. Solar and wind power array. Stock tanks with water. Small cabin at beginning of driveway. Steel shipping container at entrance.

1- Type 3/6 engine. Hose lay wrap.

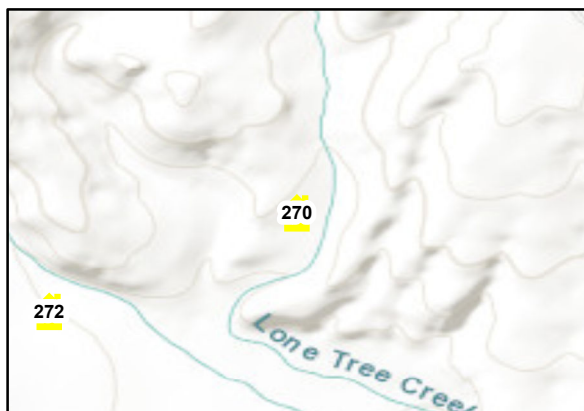
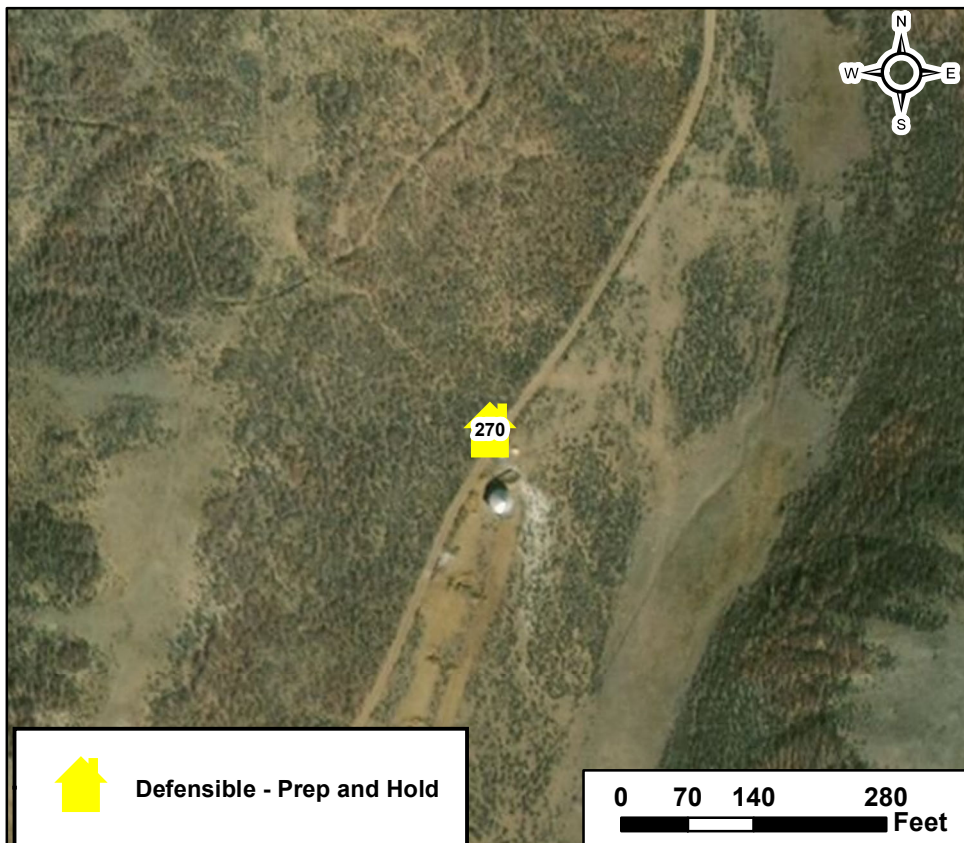
Hazards: Construction debris. Fuel containers.

Notes: 3 yurts. Constructed of plastic Type materials. May burn well. One hurt under construction

1- Type 6. Hose lay wrap.

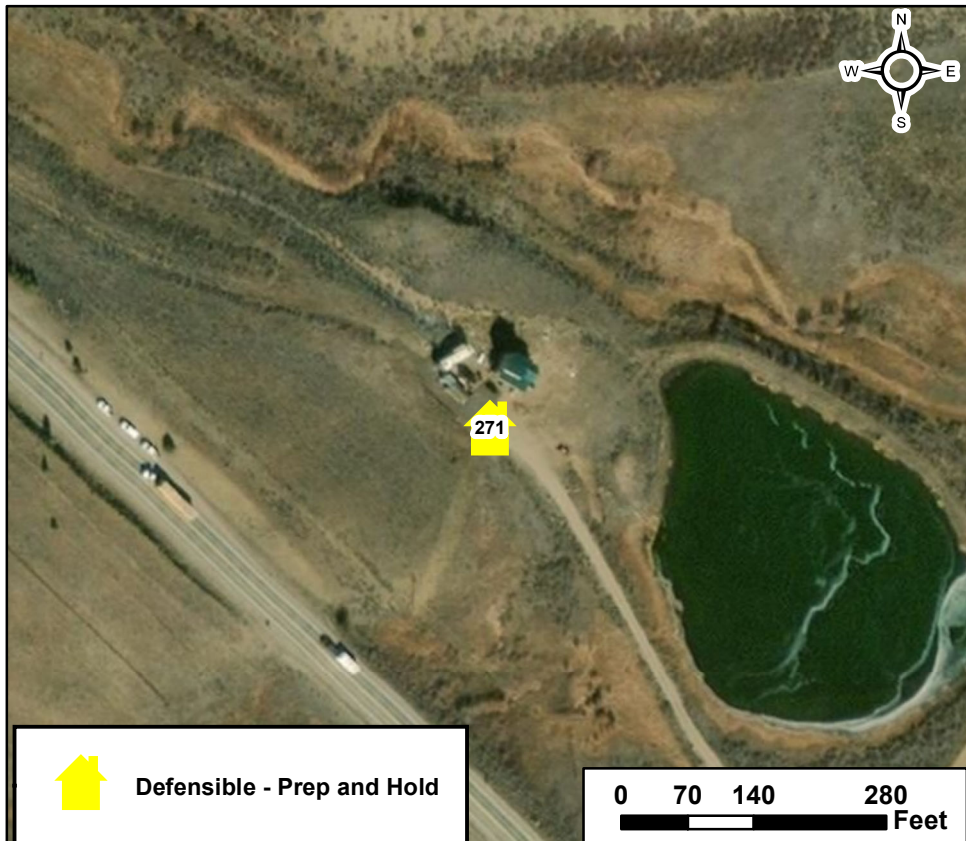
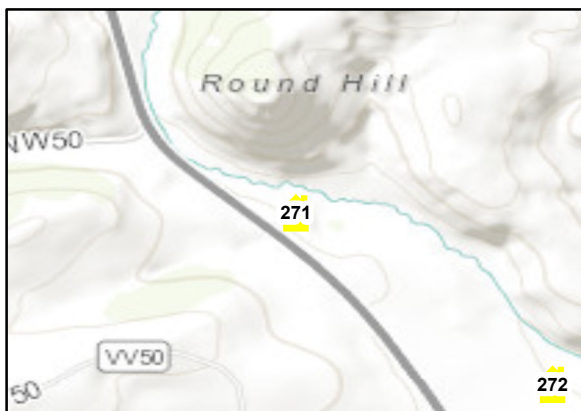
Structure ID: 271

Hazards: Propane tanks. Open trench in back. Wood piles. Powerlines.

Notes: One main residence. Two small sheds. Large travel trailer. Good water source. Large pond next to home.

1- Type 3/6 engine. Hose lay wrap.

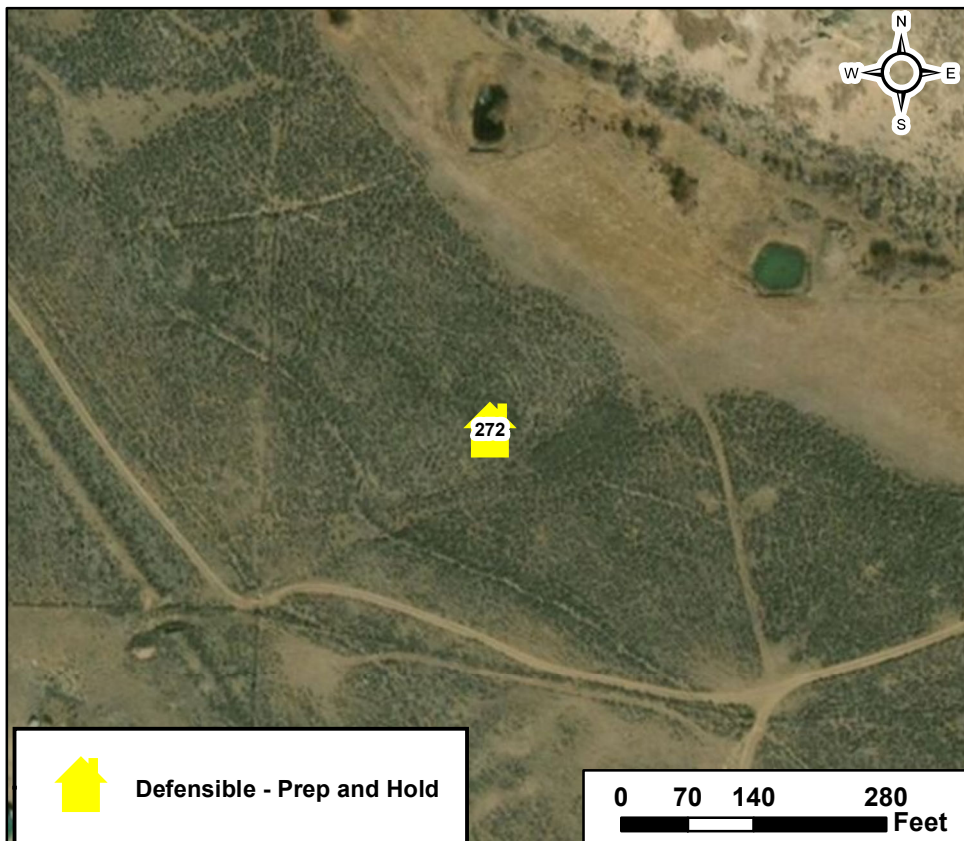
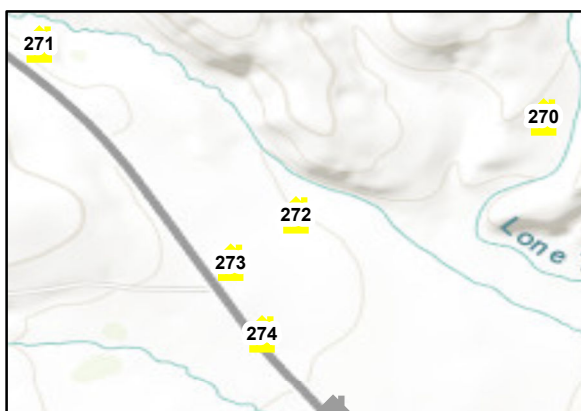
Hazards: Under construction. Construction debris. Open trench.

Notes: New construction. Open trenches. One wood outbuilding.

1- Type 6 engine. Hose lay wrap.

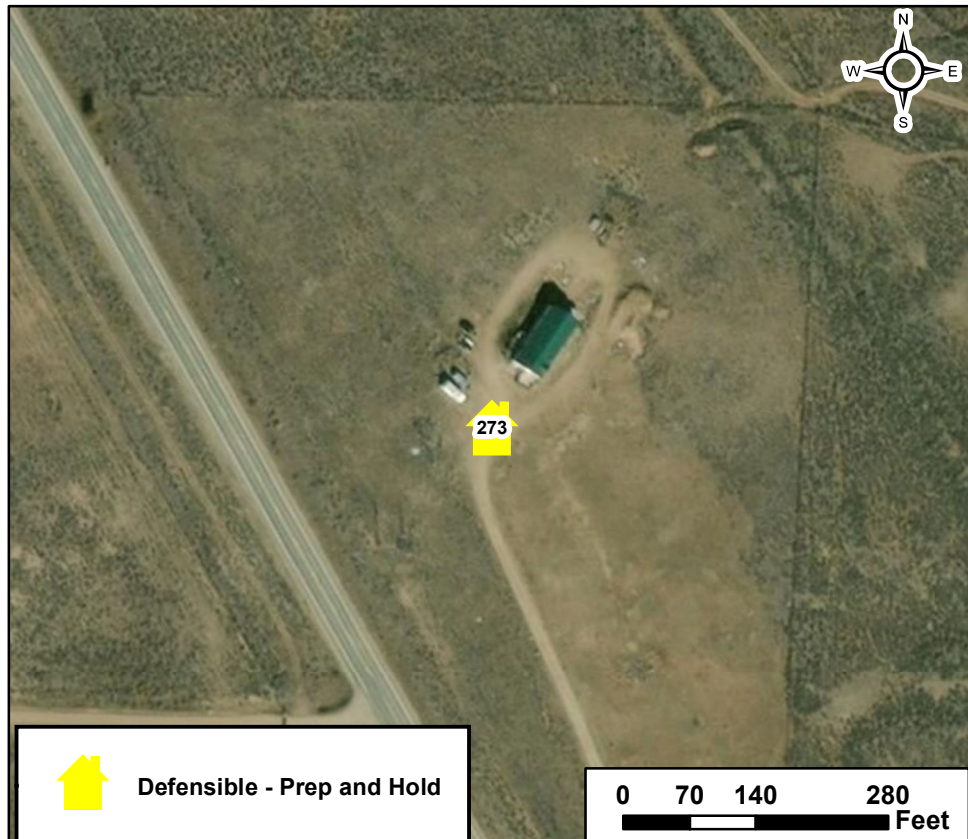
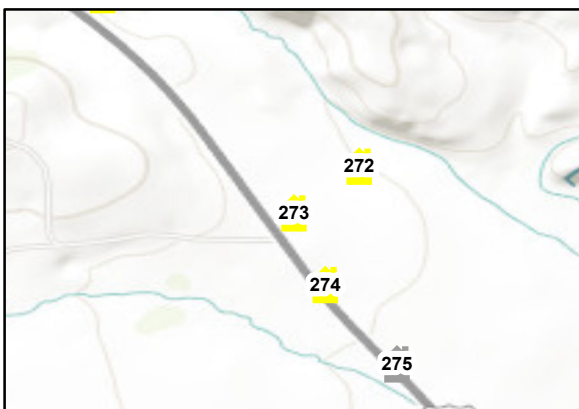
Structure ID: 273

Hazards: Propane tanks. Hazmat in back. Trash piles.

Notes: House is surrounded by driveway. Fuels are grass.

1-Type 3/6 engine. Hose lay wrap.

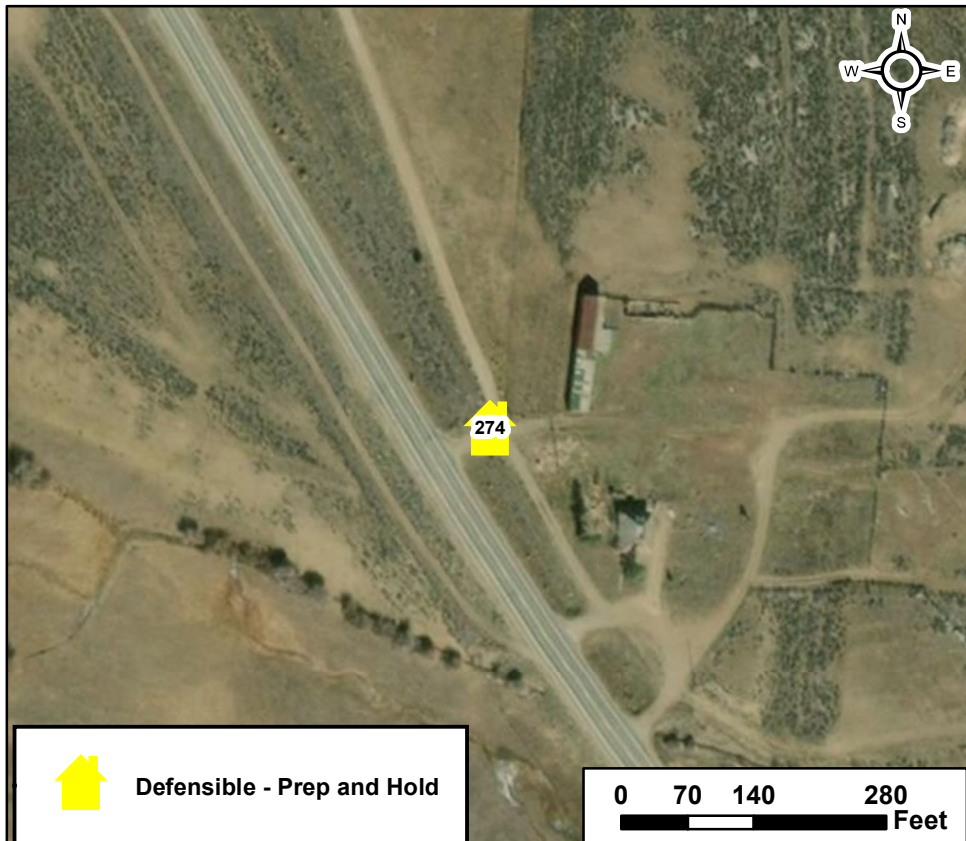
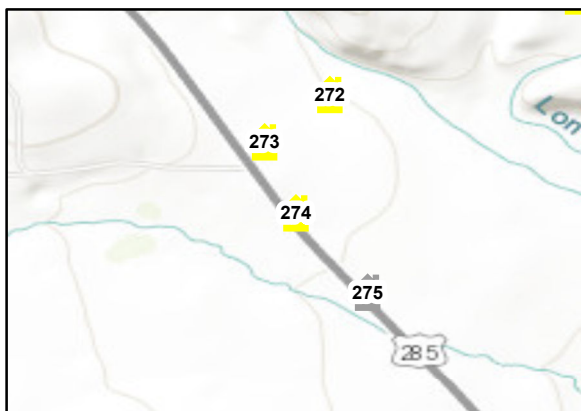
Hazards: Buildings look old and possibly abandon. Power lines. Unknown building contents and use.

Notes: Buildings look abandon or unused.

1- Type 3 engine

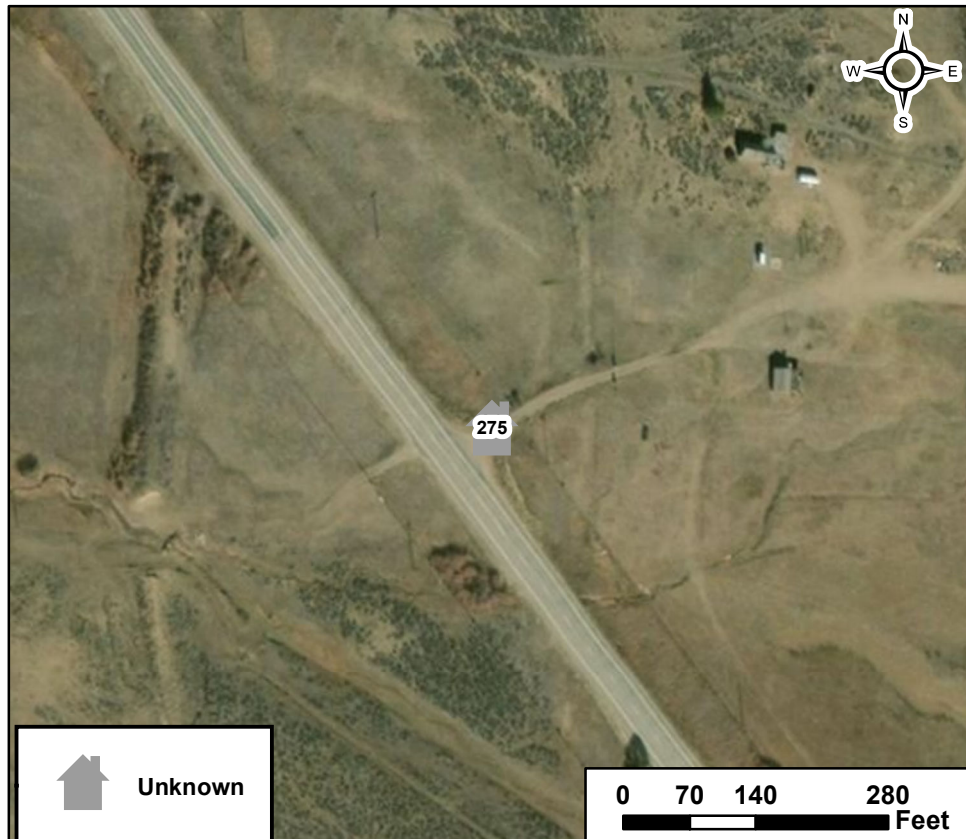
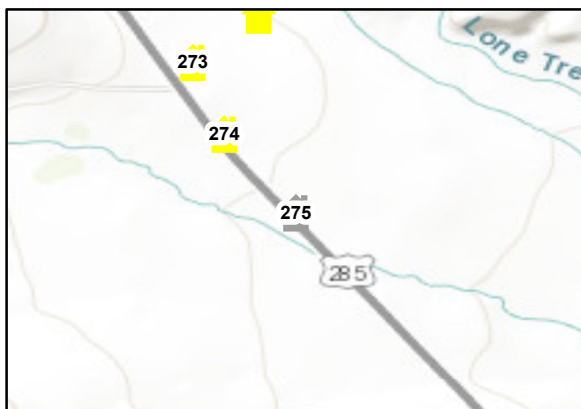
Structure ID: 275

Triage Category: Unknown
Type of Structure: Residential
Primary Structures:
Is the building Occupied?: Unknown
Outbuildings: 12
Fuel Surrounding Structure: Shrub or timber
Defensible Space: Less Than 30 ft treated
Roof Material: Combustible or no roof
Siding Material: Log construction
Electrical Power: Unknown
Gas to Structure: Unknown
Hazards: Unknown
Access to Site:
Describe Access: Direct access off 285. Gate locked. Driveway looks accessible to all types of apparatus.
Comm With ICP: Yes
Water Source: No reliable water source nearby
Safety Zone Present: Potential safety zone(s) in area

Notes: Unknown status. Gate locked. Looks unoccupied. Most buildings look old and unused at this point.
