West Creek Structure Assessment

Structure ID: 401

Location: 9100 highway 50, 401

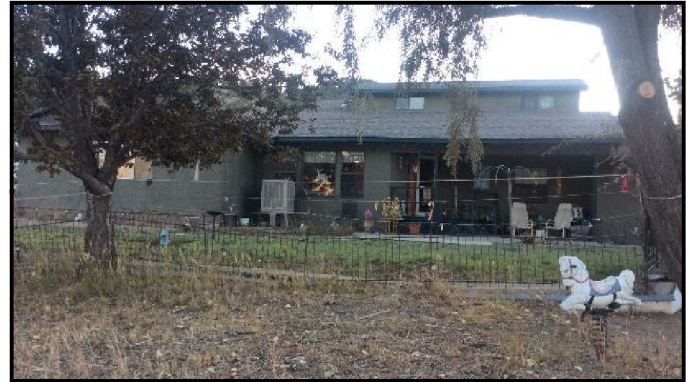
Structure ID: 403

Hazards: Fire wood and attached out buildings

Mitigation Description: Debris removal, some limbing.

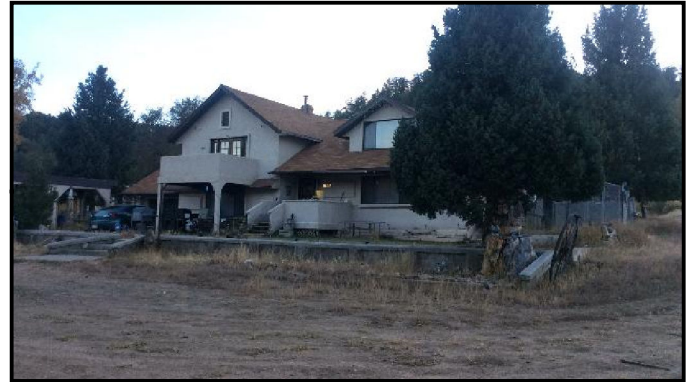
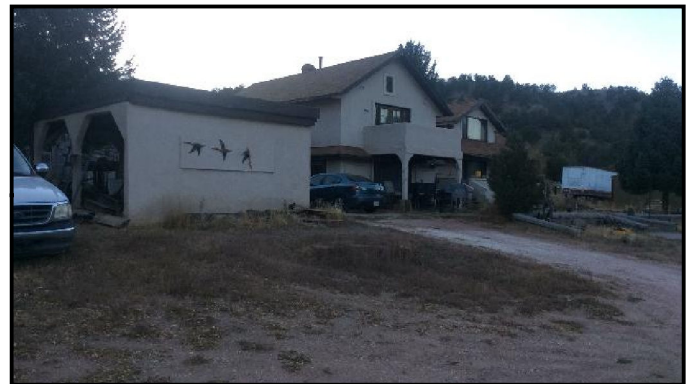
Structure ID: 405

Hazards: Mutable out buildings including a large shop

Mitigation Description: debris removal cleanup

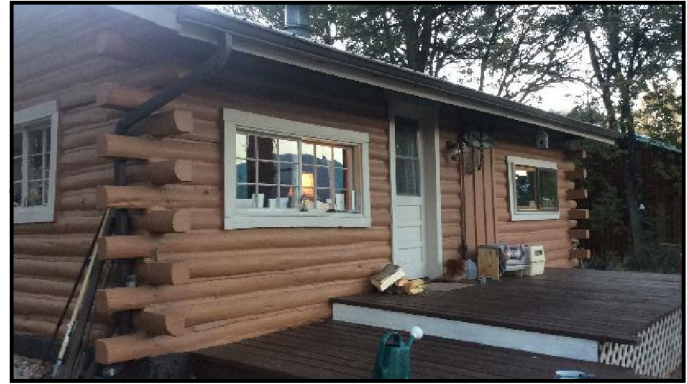
Structure ID: 407

Notes: Well maintained property

Mitigation Description: Debris removal, some limbing, and small tree removal.

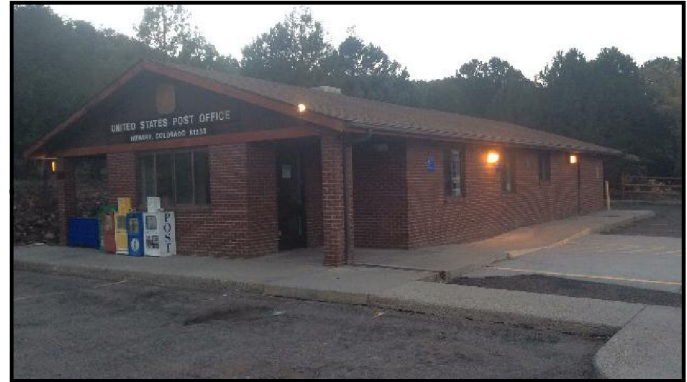
Structure ID: 409

Hazards: Heavy fuel load of timber behind structure

Mitigation Description: Saw work behind building

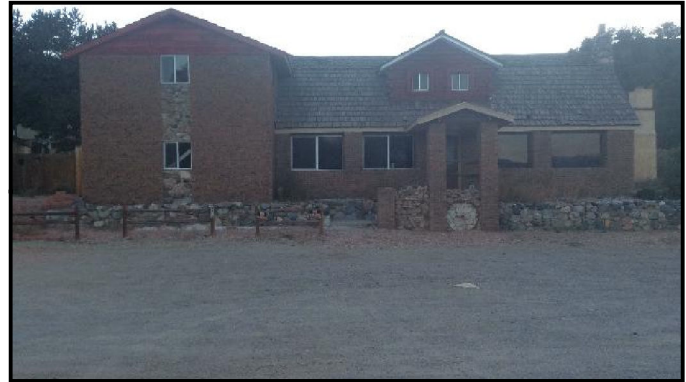
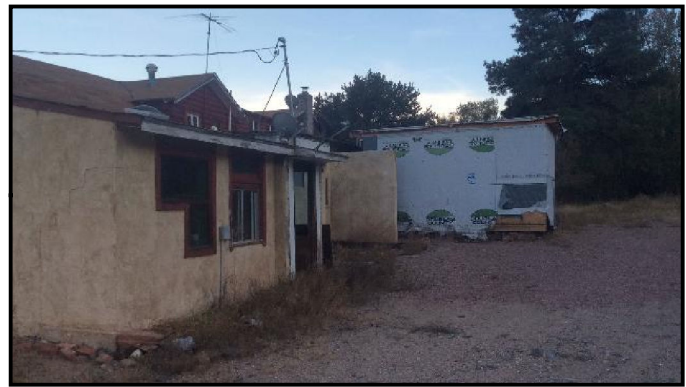
Structure ID: 411

Hazards: Two propane tanks between and behind adjacent building

Mitigation Description: Shrub removal, weed wacking

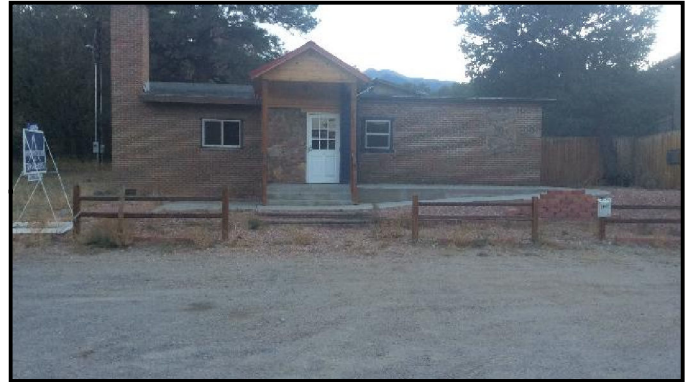
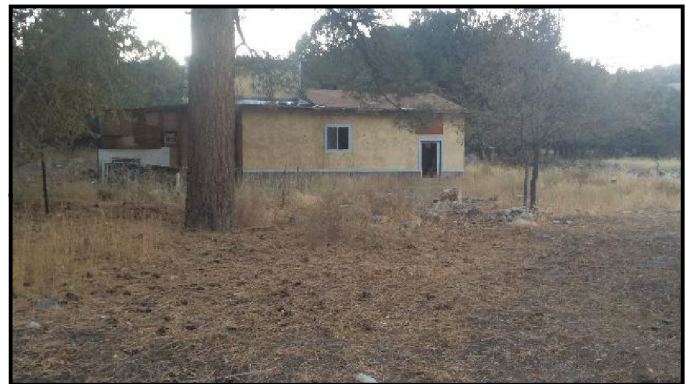
Structure ID: 413

Hazards: Overhead power

Mitigation Description: Weed wacking
removal of brush

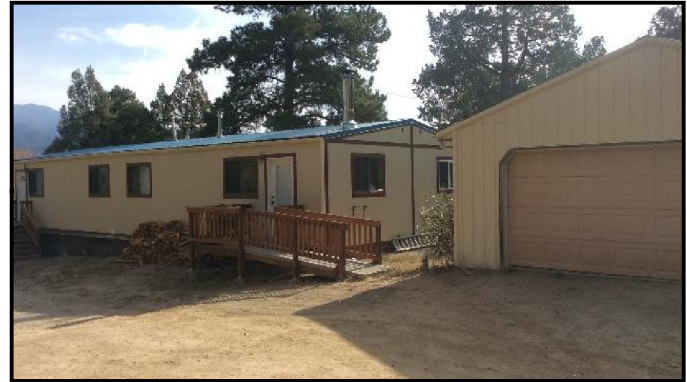
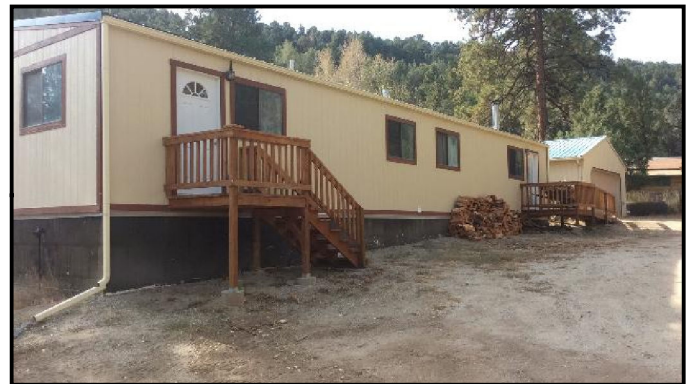
Hazards: Wood pile next to structure , creek in front yard

Mitigation Description: Removal of wood pile, weed wack around property

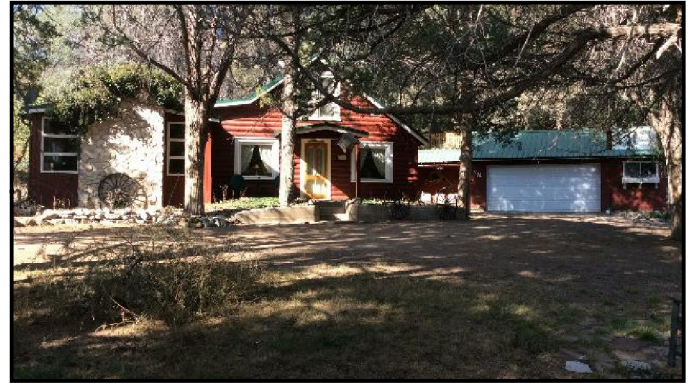
Structure ID: 415

Hazards: Juniper, scrub oak

Mitigation Description: Light work, brushing

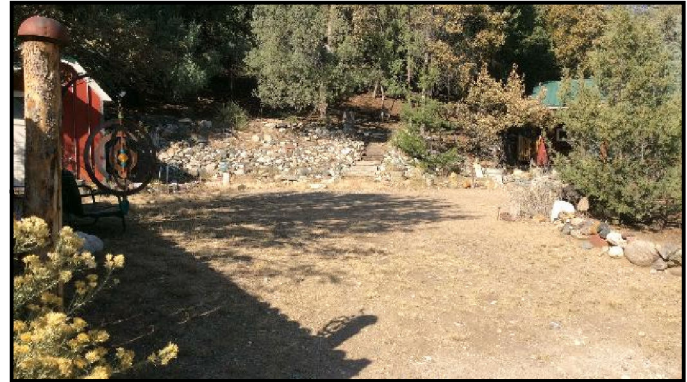
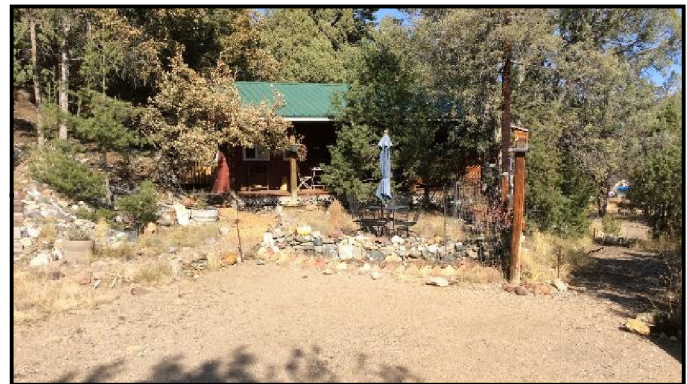
Structure ID: 417

Hazards: Juniper, oak, pine

Notes: Propane behind structure, main structure is a mobile home with roof built over top.

Mitigation Description: Weed wack, light saw work, moving of patio furniture

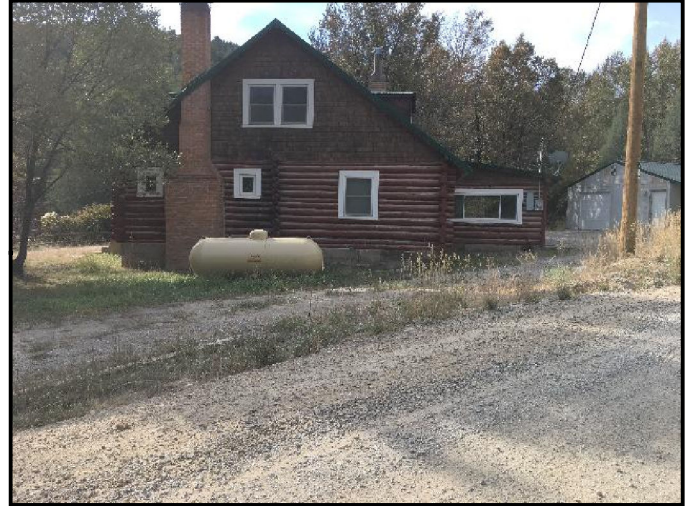
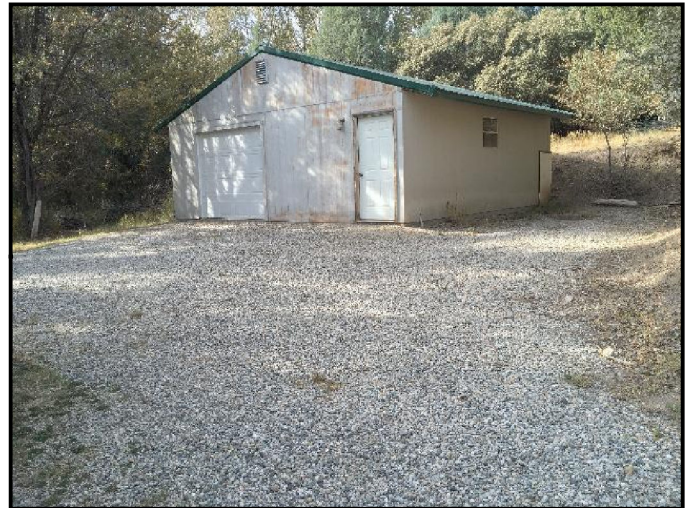
Hazards: None

Notes: Well maintained

Mitigation Description: Weed-eater around house and garage. Pump sprinklers with creek as water source

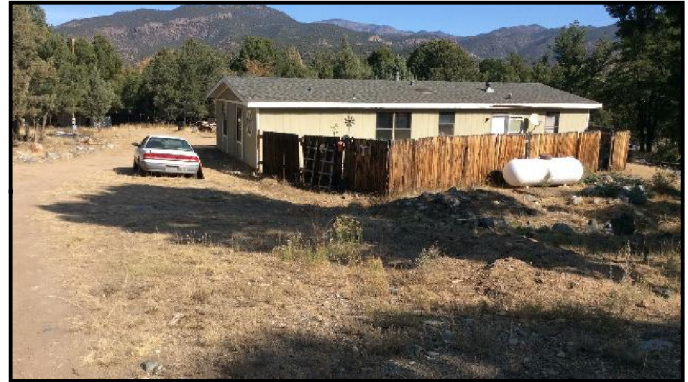
Structure ID: 419

Hazards: Propane tank, wood piles

Notes: Manufactured home, propane close to structure

Mitigation Description: Light saw work, brush removal

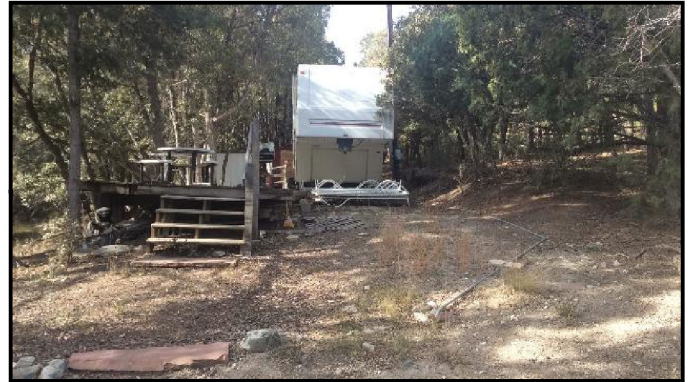
Structure ID: 420

Hazards: Over head powerlines.

Notes: 2 Rv's with attached decks.

Mitigation Description: Limbing, weed wacking, debris removal

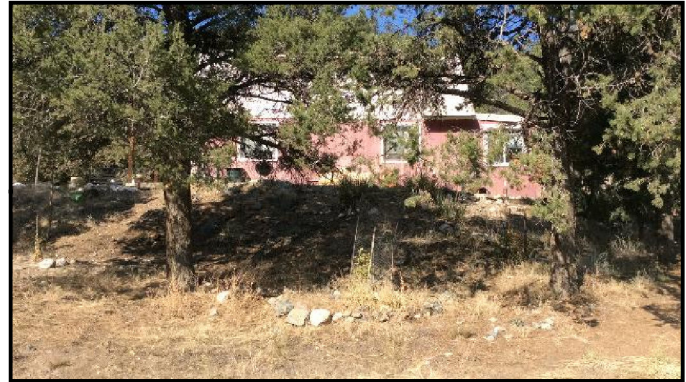
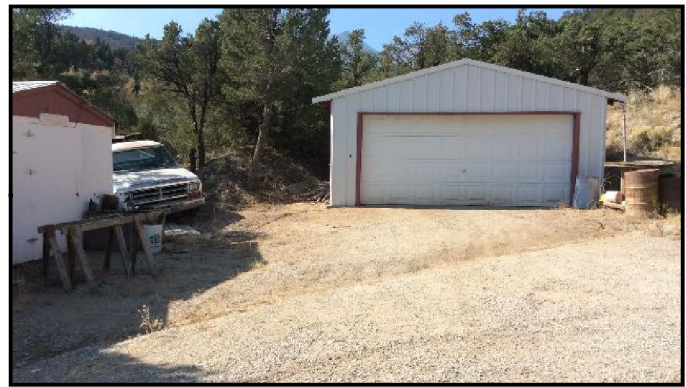
Structure ID: 421

Hazards: Over head power behind main structure, propane right against house on street side.

Notes: Flammable furniture on porch

Mitigation Description: Saw work on hillside behind house, brushing around main structure

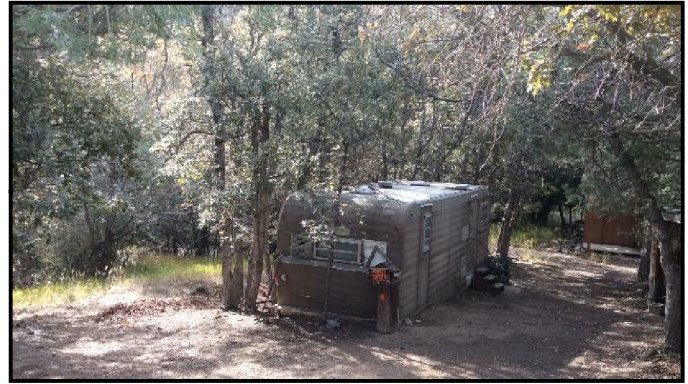
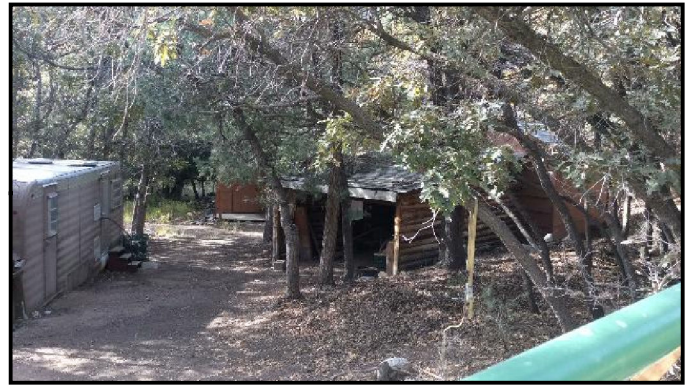
Hazards: Dense oak surrounding primary structure, leaf litter around structure

Notes: Locked gate on entry, main structure is an RV

Mitigation Description: Removal of leaf litter, limbing around structure

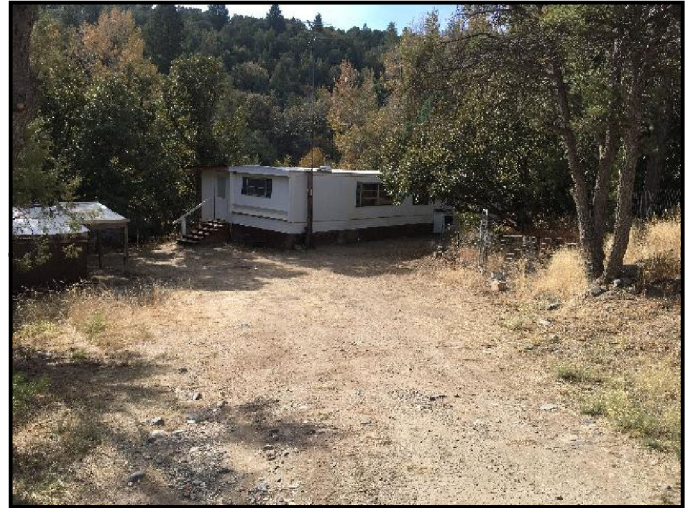
Hazards: None

Notes: Mobile home

Mitigation Description: Weed-eater and limbing. Pump sprinklers with creek as water source

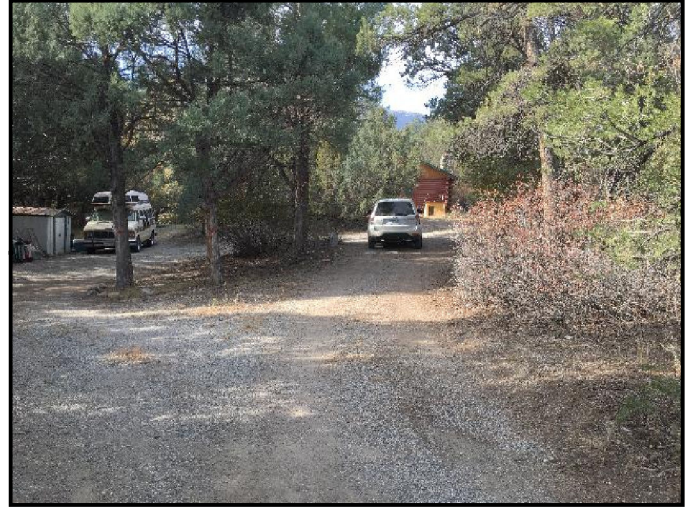
Structure ID: 428

Hazards: None

Notes: Loop driveway for type 6

Mitigation Description: Weed-eater and limbing. Pump sprinklers with creek as water source

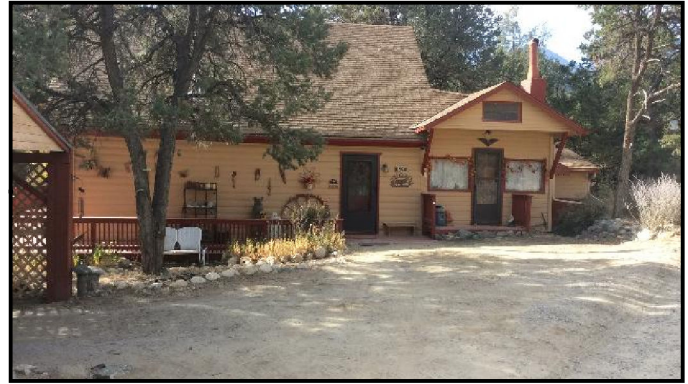
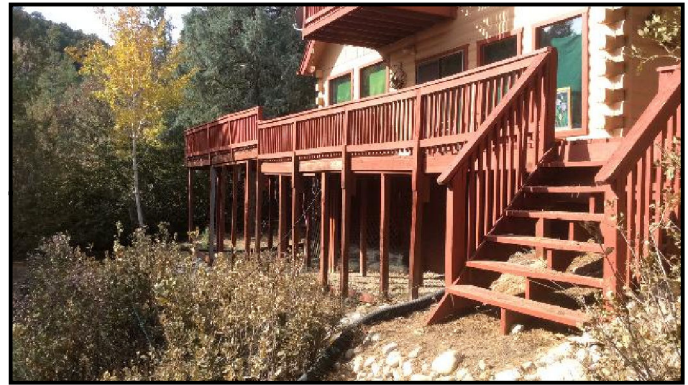
Structure ID: 430

Hazards: Pine duff on roof of out building which is in close proximity of main structure, light fuels next to structure on downhill side

Notes: Light fuels around structure

Mitigation Description: Light fuel removal, limbing and light saw work, weed wacking

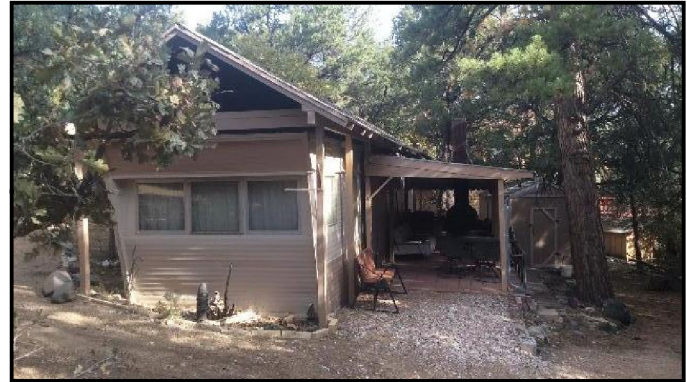
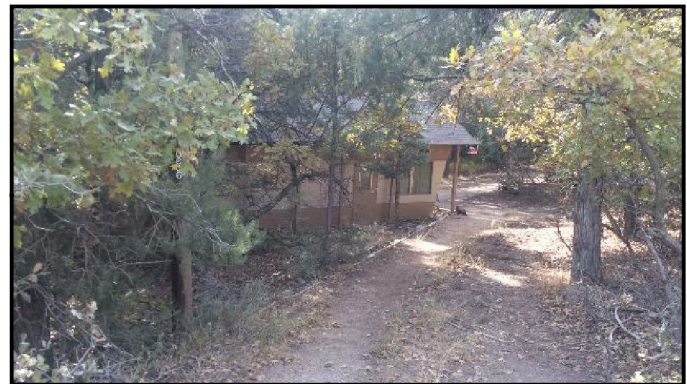
Structure ID: 432

Hazards: Heavy fuels limited access

Notes: Mobile home under permanent canopy.

Mitigation Description: Removal, clearing, limbing of timber, brush, ground litter.

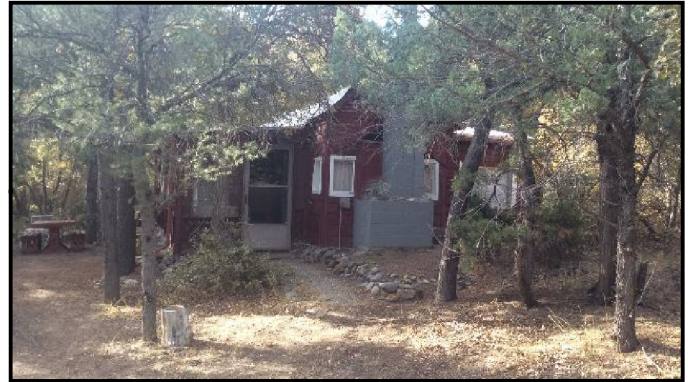
Structure ID: 434

Hazards: Heavy fuels, minimal to no mitigation has been done.

Notes: Older construction, wood siding touching in the ground, light flashes fuel touching on all sides.

Mitigation Description: Cutting, limbing, ground litter removal, sprinkler setup.

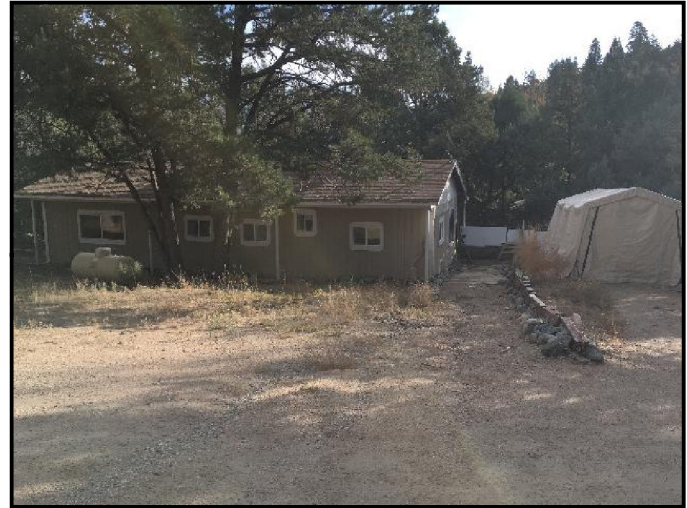
Hazards: None

Mitigation Description: Weed-eater around house, limbing. Pump sprinklers with creek as water source

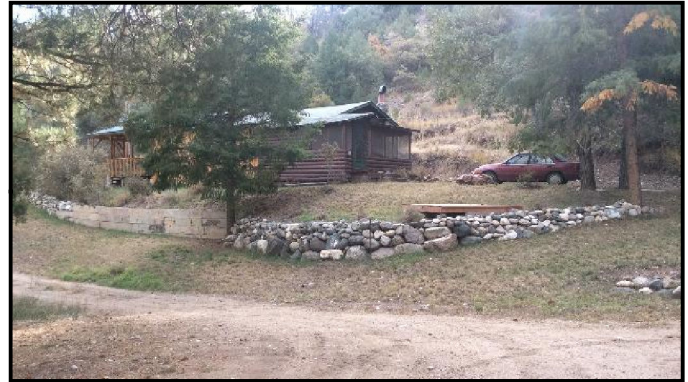
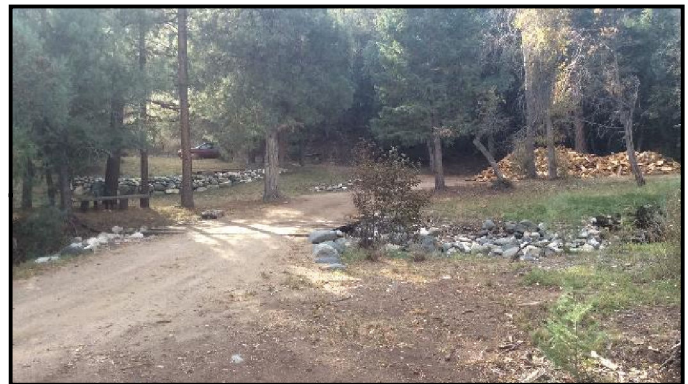
Hazards: Unknown load limits for bridge

Notes: Wood siding touching the ground.

Mitigation Description: Saw work, debris,
ground litter removal

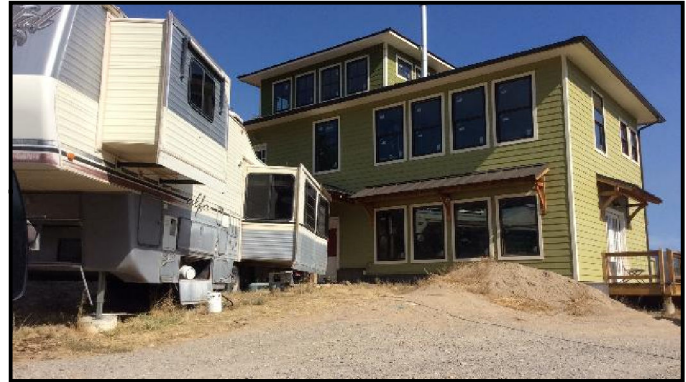
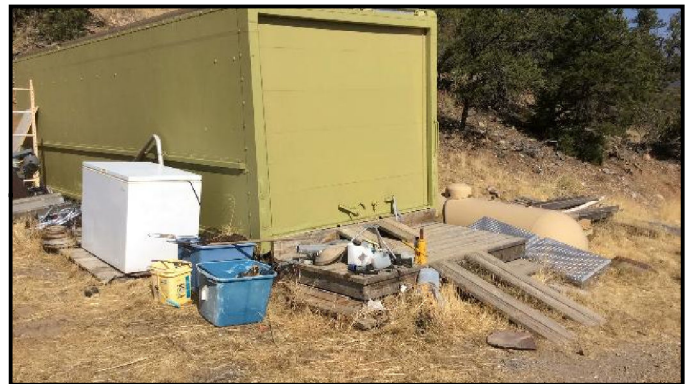
Hazards: House is on steep hillside with pinion. RV next to main structure. Propane tank behind outbuilding. Grass around perimeter of main structure.

Notes: Well mitigated pinion, light weed whacking around structure needed

Mitigation Description: Weed wacking

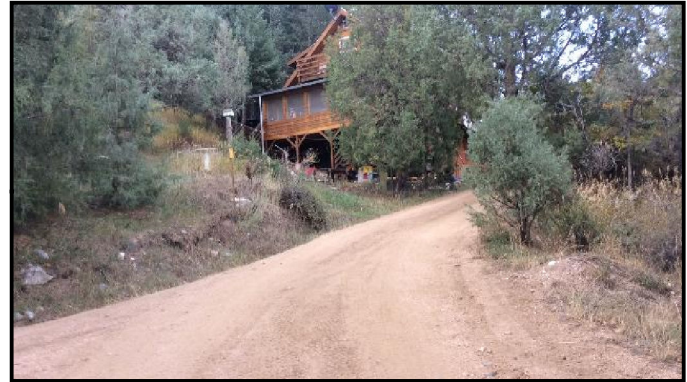
Hazards: Bridge on entry

Mitigation Description: Moderate saw work

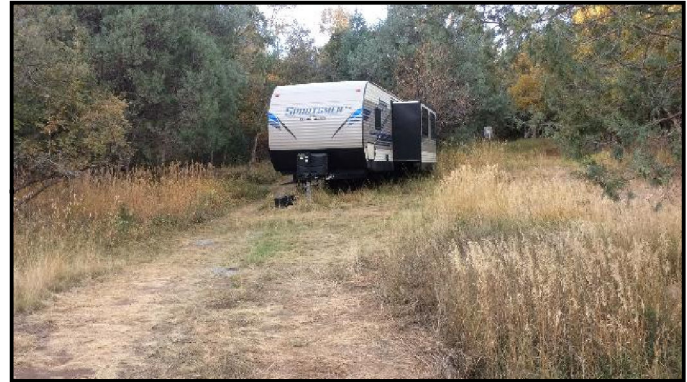
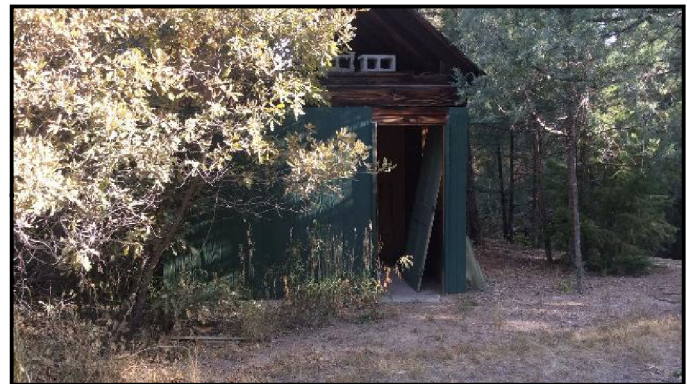
Hazards: Scrub oak/mixed conifer near structure

Notes: Structure is an RV

Mitigation Description: Light saw work/brush removal

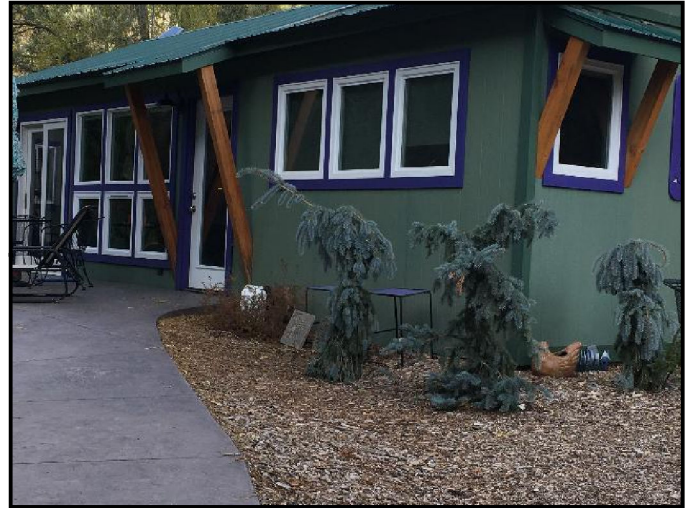
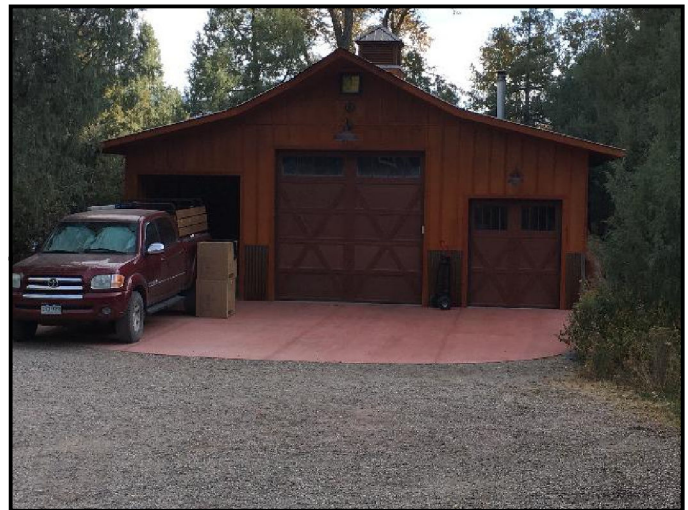
Notes: Well maintained

Mitigation Description: Weed-eater around house and garage. Pump sprinklers with creek as water source

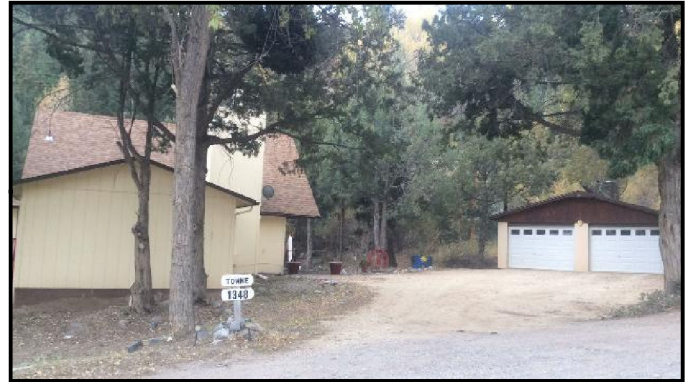
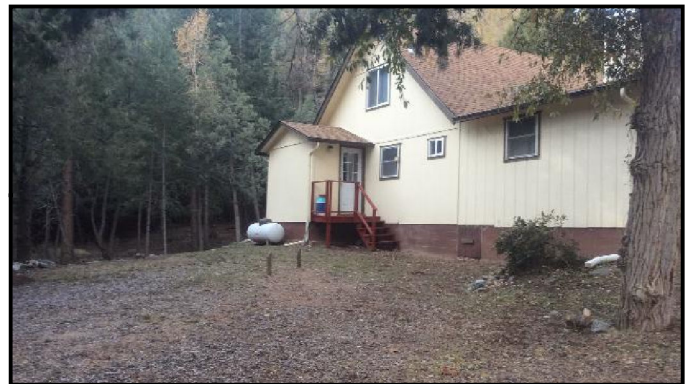
Notes: Good condition well maintained

Mitigation Description: Minimal debris removal, minimal sawwork. Sprinkler set up.

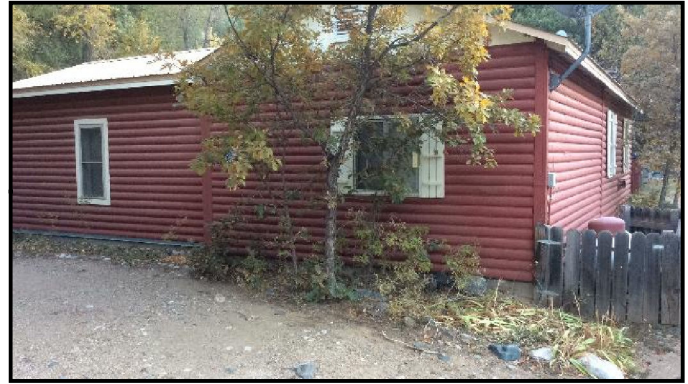
Hazards: Fuel loading close to structure , propane next to structure, wood pile under oak trees, overhead power behind structure.

Notes: Propane next to structure, creek close to structure, scrub oak next to siding

Mitigation Description: Scrub oak next to structure requires light to moderate saw work.

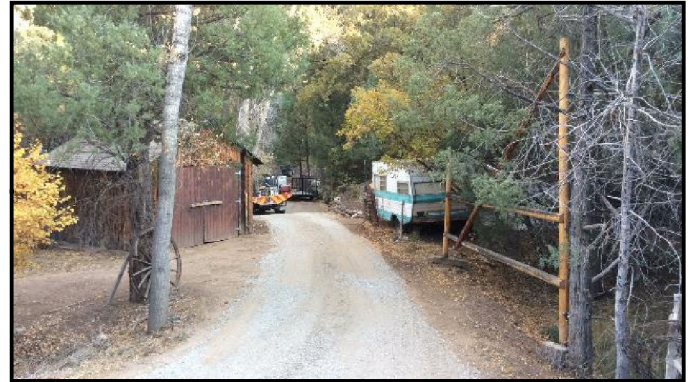
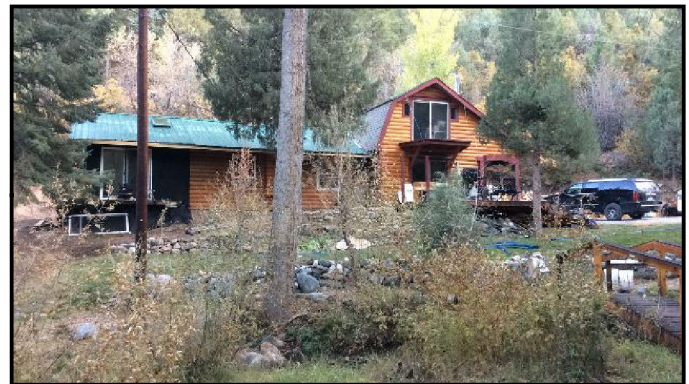
Hazards: Over head power by main structure. Oak/mixed conifer within 30' of house. Large wood pile within 20' of main structure.

Mitigation Description: Moving wood pile near house. Light saw work around structure. Removal of brush around propane tank.

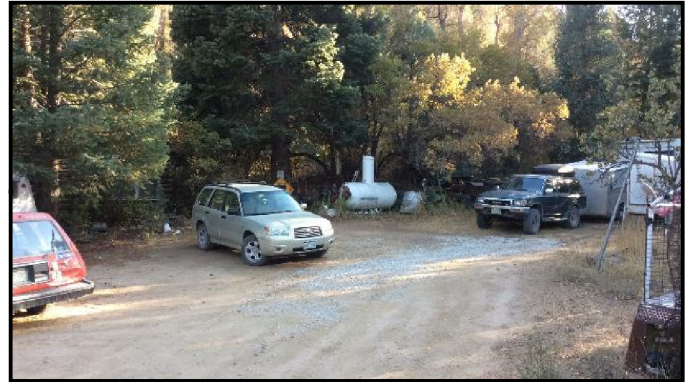
Hazards: Lots of structures around property. Fuel loading of timber close to house.

Mitigation Description: Very dense oak/shrubs/conifer surrounding main structure and out builds. Heavy saw work.

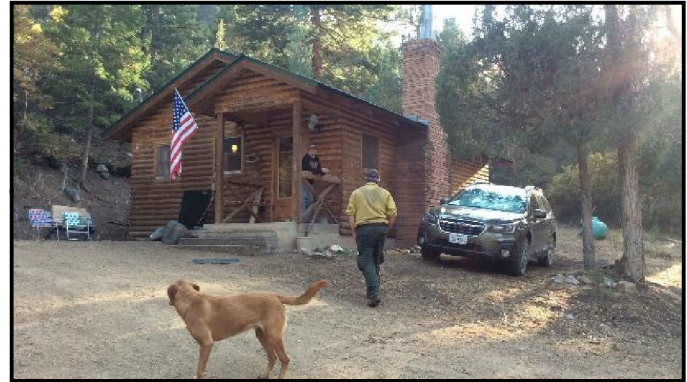
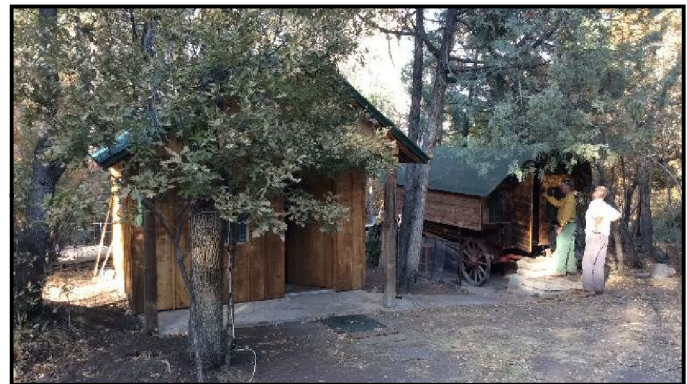
Hazards: Unknown bridge load limit

Notes: Bridge/water crossing to structure

Mitigation Description: Removal of scrub oak/conifer. Light saw work. Weed wacking. Removal of grass from propane tank.

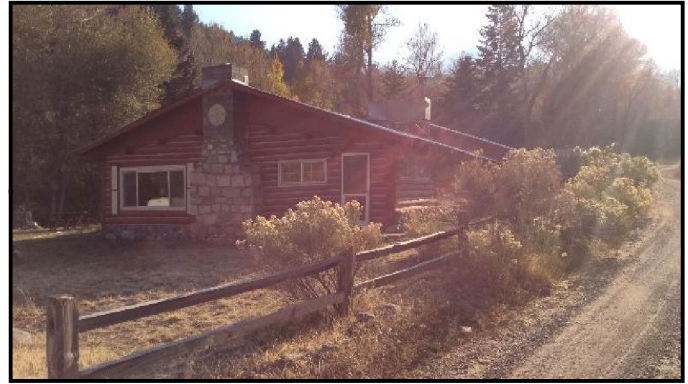
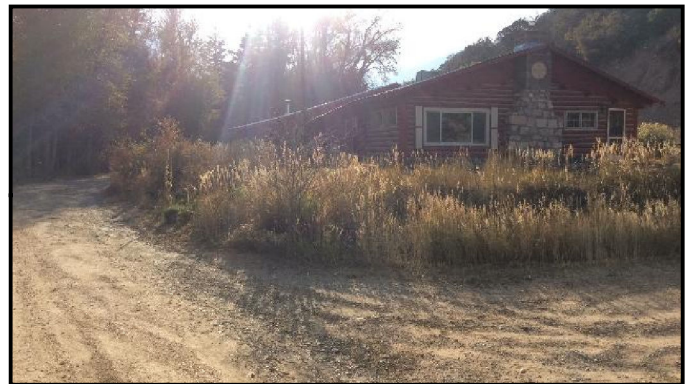
Structure ID: 458

Triage Category: Non-Defensible, Prep and Leave

Hazards: Overhead power, one way in one way out road

Mitigation Description: Weedwacking.

Removal of brush/bushes

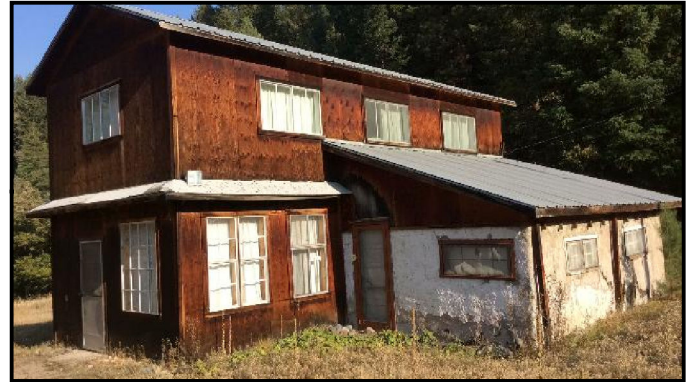
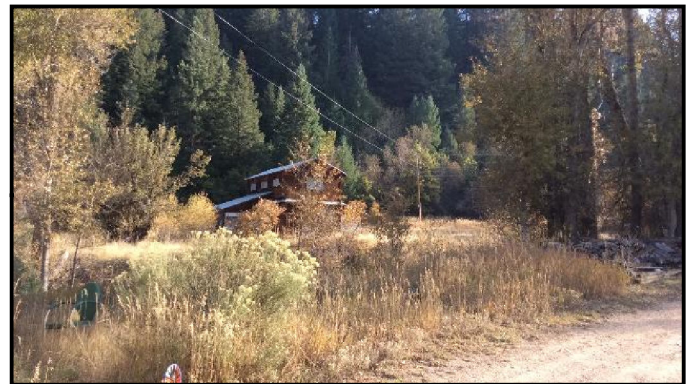
Structure ID: 460

Triage Category: Non-Defensible, Prep and Leave

Hazards: Overhead power. Grass up to structure siding. Heavy fuel load of oak, pinion and juniper on back side of house.

Mitigation Description: Weedwacking, saw work around back of house

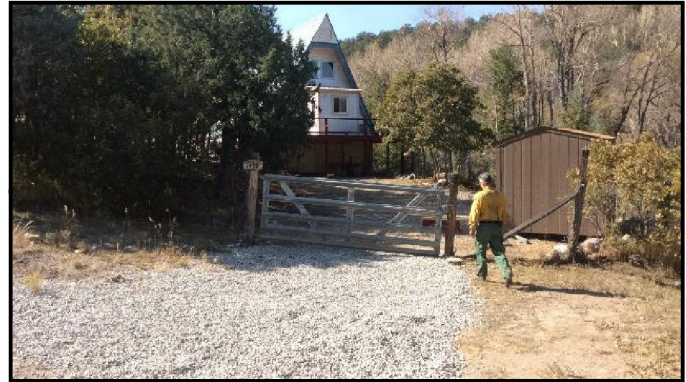
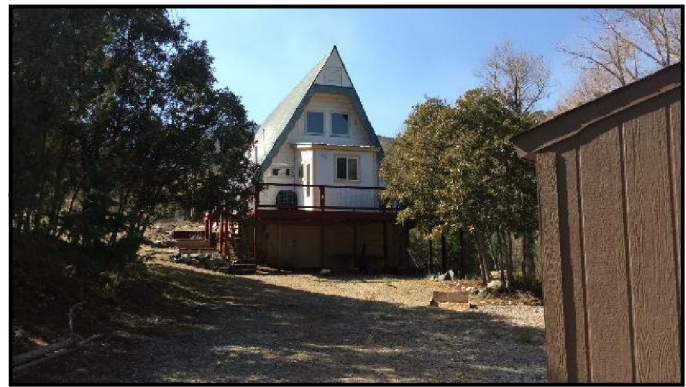
Structure ID: 462

Hazards: Bridge at entry. Overhead power.

Notes: Scrub oak, and juniper within 30'.
Creek 50 feet from structure.

Mitigation Description: Weed wack, moderate saw work

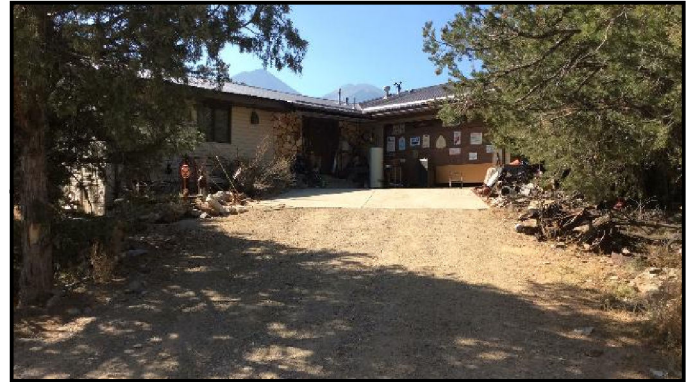
Structure ID: 463

Hazards: Poor accessibility, multiple/many vehicles on site, very tight pinion and juniper up to main structure and throughout property

Notes: Many vehicles on site and fuel cans, poor access. Very tight continuous fuel loading of pinion juniper up to main structure.

Mitigation Description: High amount of saw work, removal of wood pile and combustible materials

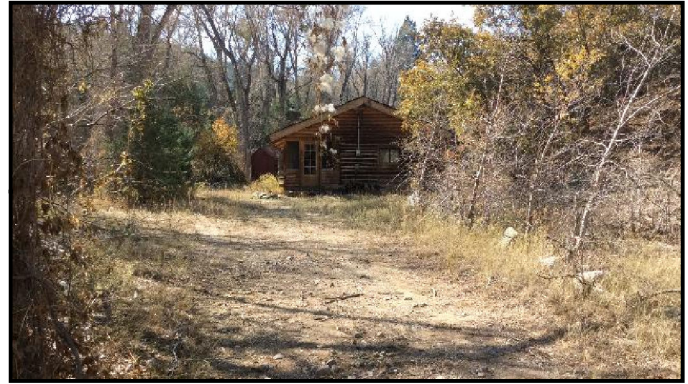
Hazards: Over head power, house built in chimney, scrub oak and juniper not mitigated with in 10 feet of primary structure

Notes: Propane next to structure, stream next to structure.

Mitigation Description: Moderate saw work, weed wack, removal of wood pile by back door

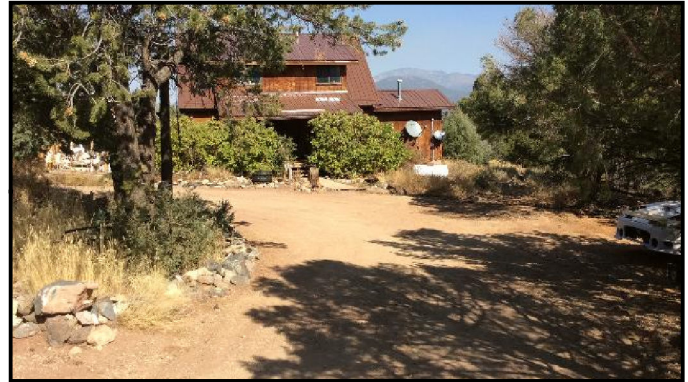
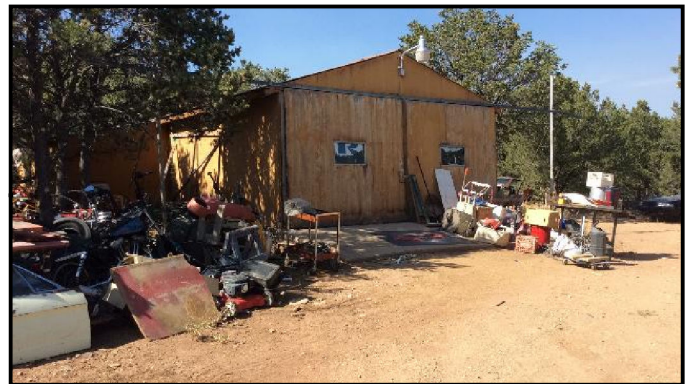
Structure ID: 465

Hazards: Many vehicles, fuel cans

Notes: Tight fuel loading up to main structure

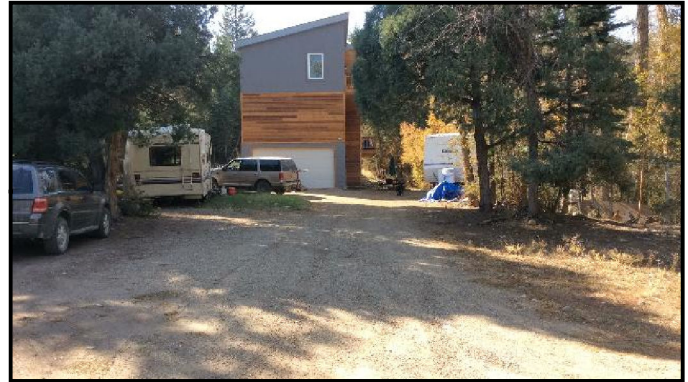
Hazards: Bridge on entrance of drive

Notes: Two RVs on site, dense oak and fir within 40'

Mitigation Description: Moderate saw work, weed wacking

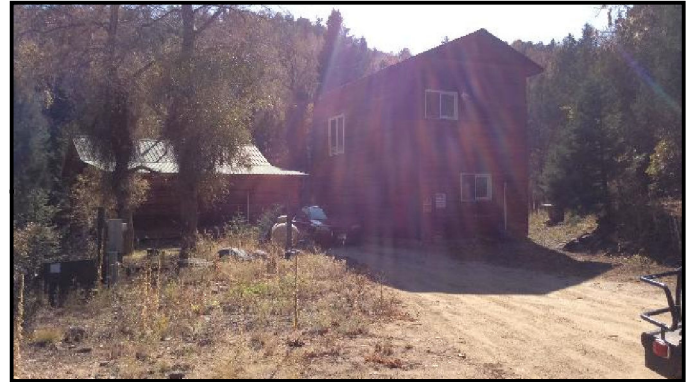
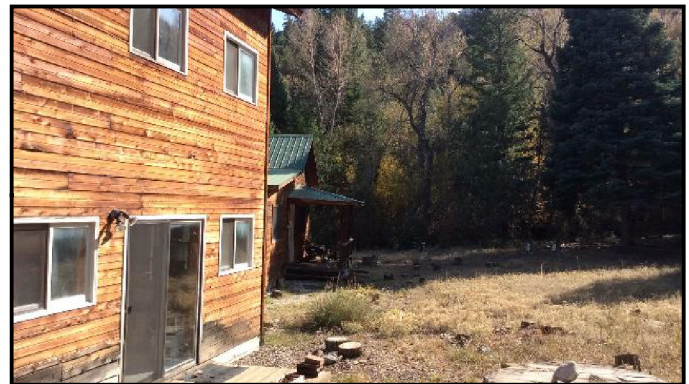
Hazards: Propane close to house. Dense oak, juniper and conifer within 30' of structure. Small (15') defensible space between structure and heavy fuels.

Mitigation Description: Weed wacking around structures. Moderate saw work to create defensible space.

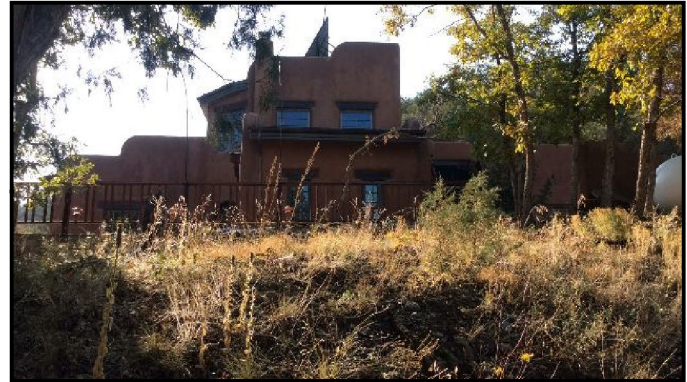
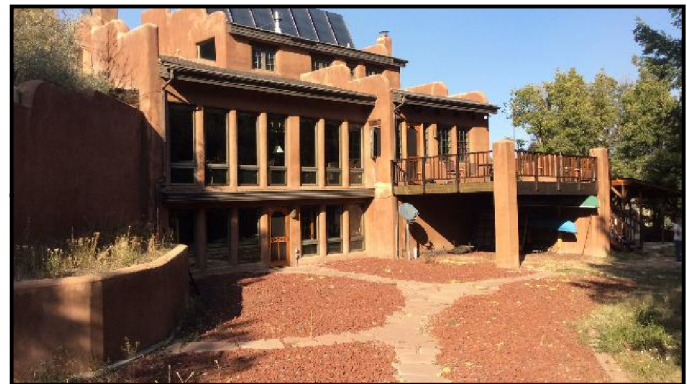
Structure ID: 470

Hazards: Bridge on beginning of driveway. One way in/out. Oak brush/pinion/juniper close to house. Very thick understory close to home and on access to structure.

Notes: Two propane tanks at structure. Thick oak/juniper/pinion backs up to house. Leaf litter needs to be cleared from under propane tanks

Mitigation Description: Saw work behind house and a few trees around propane.
