NPS Wildland Fire Risk Assessment - Community Assessment

Community: Beaver Meadows West Residential Area

Unit - Location: ROMO - Beaver Meadows

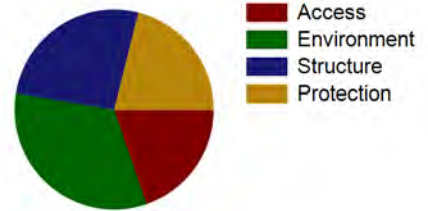
Factors Driving the Ratings

Description of Factors Driving the Ratings: Poor access and no good safety zones

Recommended Treatments: There are few ladder fuels however there are continuous aerial fuels

Recommended Tactics: Evacuate residence

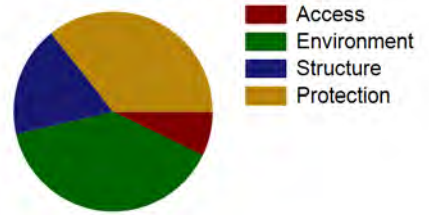
Factors Driving the Ratings

Primary Access: Road
Ingress/Egress: Two or more roads in/out
Access Width: 2 lanes (>24ft)
Access Condition: Surfaced-paved, grade>5%
Bridge Condition: None/nonflammable,load limit will not limit response
Access & Turnarounds: Access is <300 ft from facility w/turnaround
Facility Numbers/Signs: Marked and clearly visible
Defensible Space: 100 ft treated
Fuel Load (w/in 300 ft): Light
Fuel Type (w/in 300ft): Grass,tundra,northern hardwood litter
Topography (w/in 300ft): Slope 5% to 20%
Topographical Features:None
Roof Material: Noncombustible or not applicable
Building Construction: Nonflammable/fire resistant siding,flammable deck
Building Density: Buildings are less than 100 ft apart
Utility Placement: Both underground or none
Water Supply: No reliable water source nearby
Overhead Hazards: No overhead hazards
Safety Zones: Potential safety zone(s) in area
Additional Obstacles: None

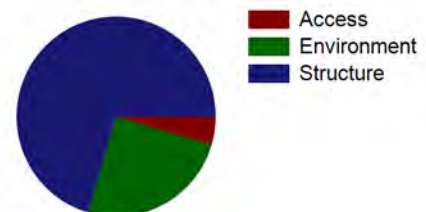
Factors Driving the Ratings

Score: 50
Rating: Moderate

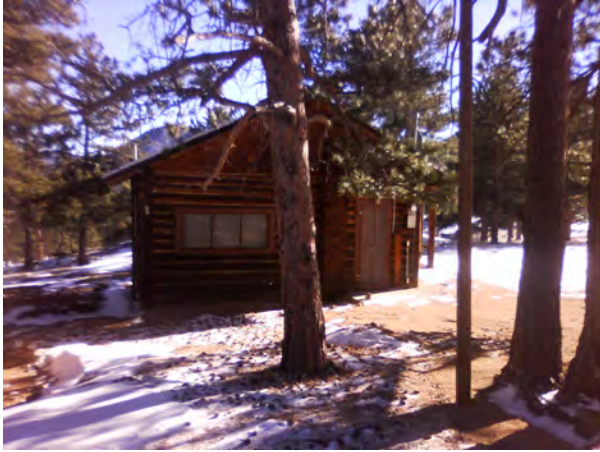
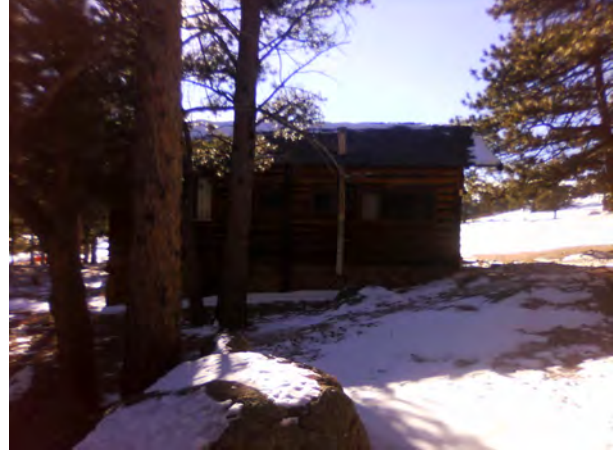
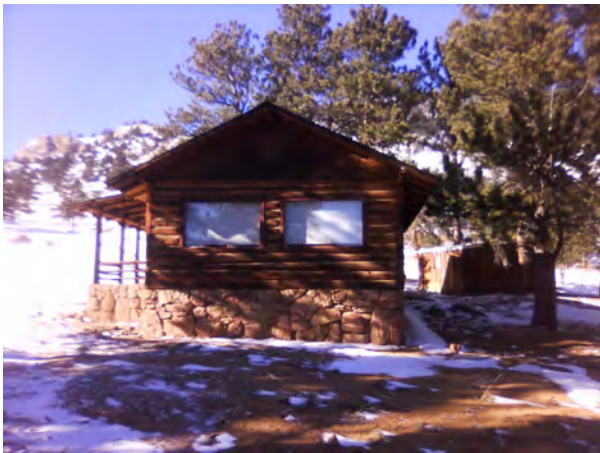
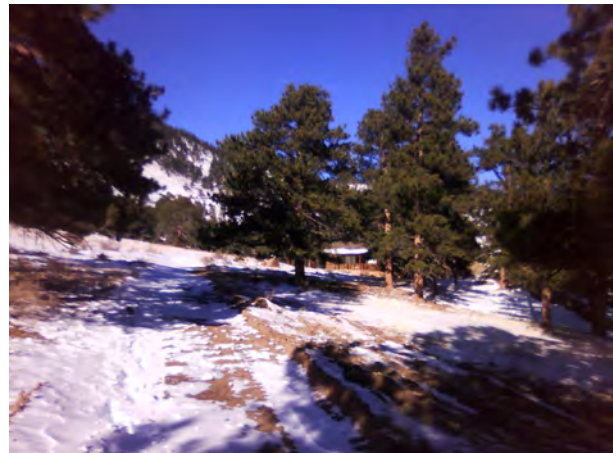
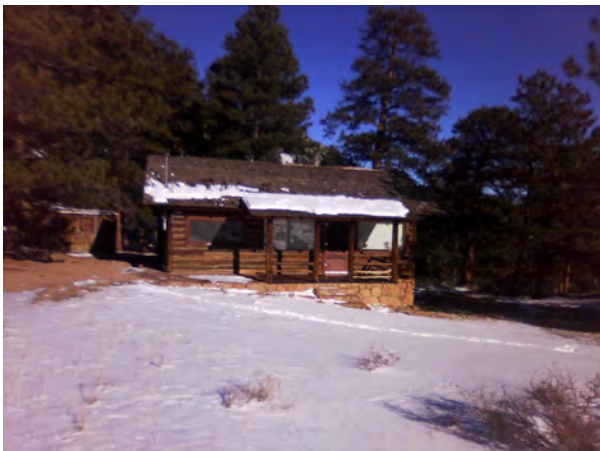
ROMO_30949_Q-0698-H S 1-Bedroom House, Gillen 00000698_D.jpg

Primary Access: Road
Ingress/Egress: Two or more roads in/out
Access Width: 1.5 lanes (>18ft)
Access Condition: Surfaced-paved, grade<5%
Bridge Condition: None/nonflammable,load limit will not limit response
Access & Turnarounds: Access is <300 ft from facility w/turnaround
Facility Number/Sign: Marked and clearly visible
Defensible Space: 30 ft treated
Fuel Load (w/in 300 ft): Light
Fuel Type (w/in 300ft): Grass,shrub,hardwood litter
Topography (w/in 300ft): Slope 5% to 20%
Roof Material: Combustible or no roof
Siding Material: Wood or open sided
Foundation: Closed, < 6in masonry exposed
Fences/Decks: Combustible, adjacent, clear of veg/debris
Firewood: None
Propane Tanks:
Water Supply: Pressurized hydrant(s) or fixed sprinkler system
Overhead Hazards: No overhead hazards
Safety Zones: Potential safety zone(s) in area
Additional Obstacles: Hazmat, UXO,etc. , PLEASE COMMENT
Triage Category:
Hazmat:
Assessment Comments: The building construction is driving the ratings

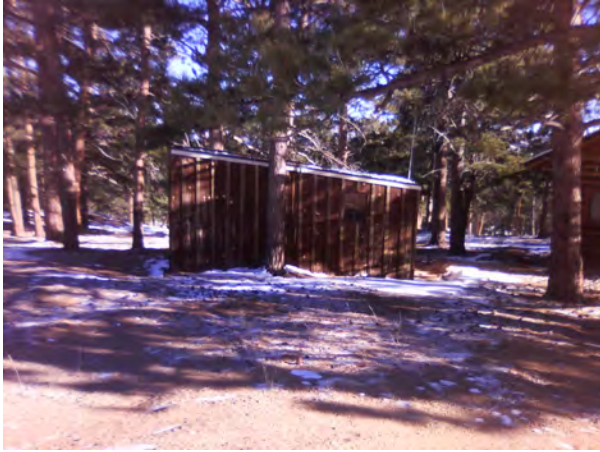
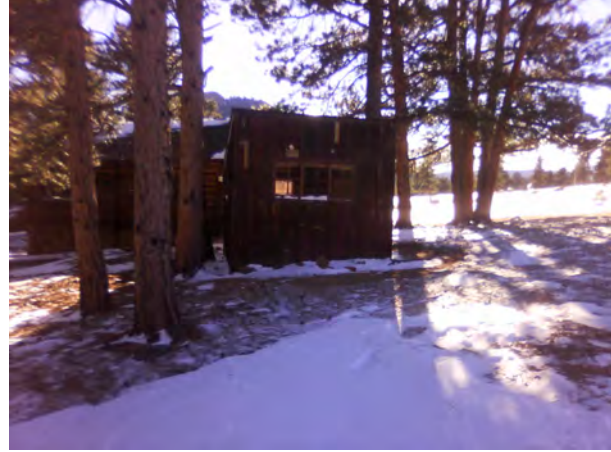
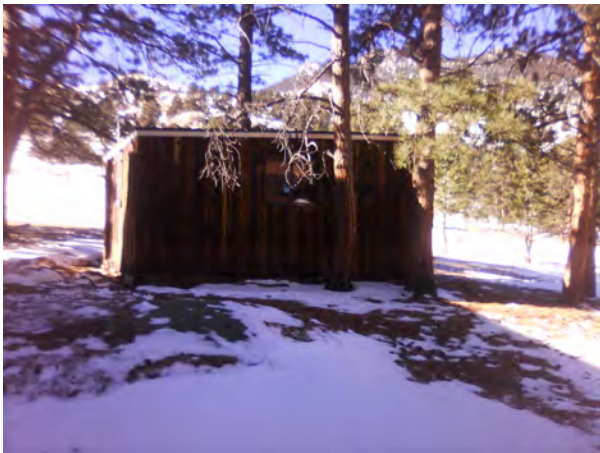
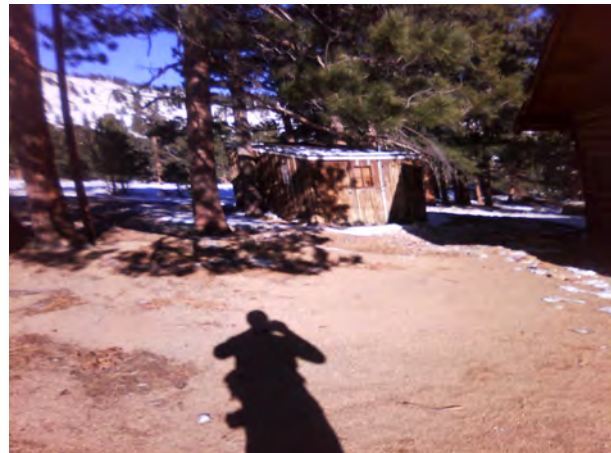
ROMO_30971_B-0812-N Storage, Gillen_D.jpg

Rating: High
Protection Level : Full
Local ID: [Local_ID]
Lat(WGS84): 40° 22.1796' Long(WGS84): -105° 34.3594'

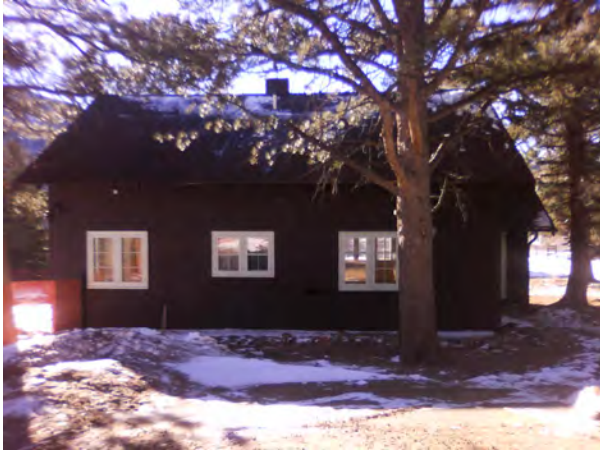
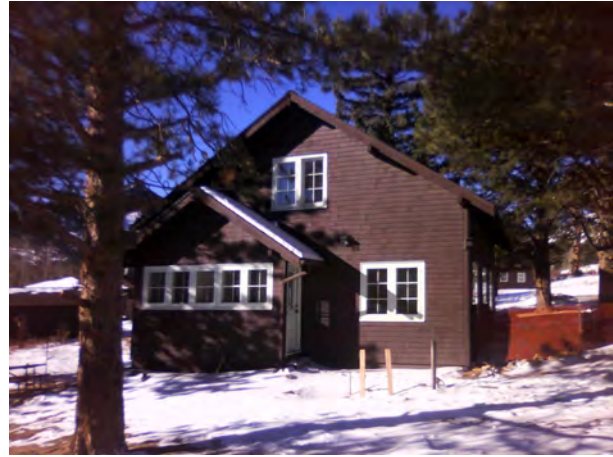
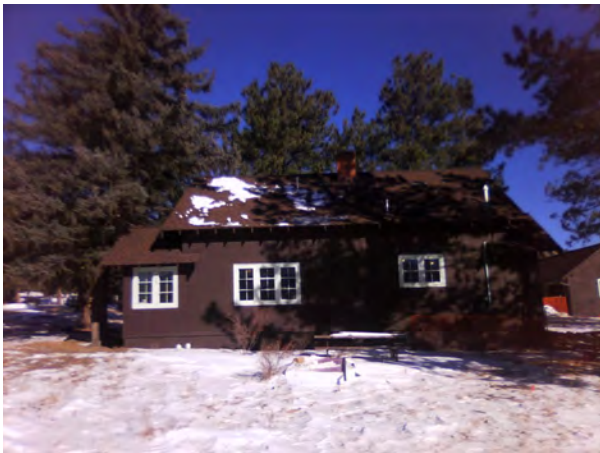
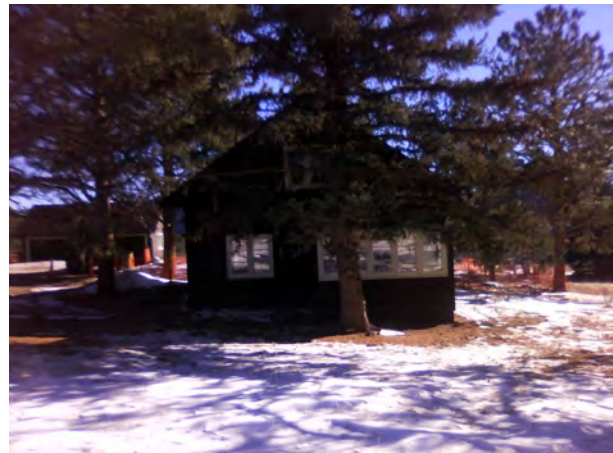
Rating: Low
Protection Level : Full
Local ID: [Local_ID]
Lat(WGS84): 40° 21.8604' Long(WGS84): -105° 33.4334'

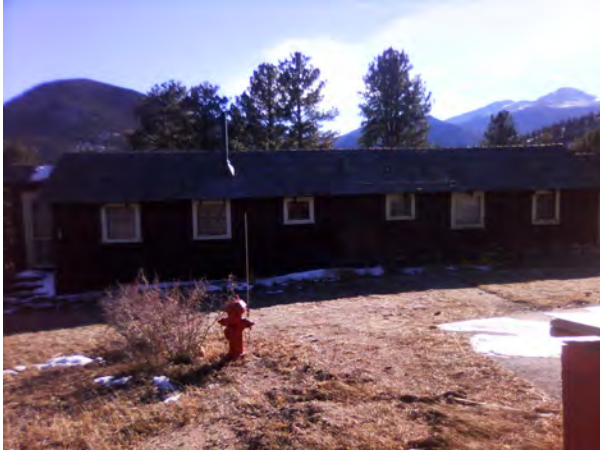
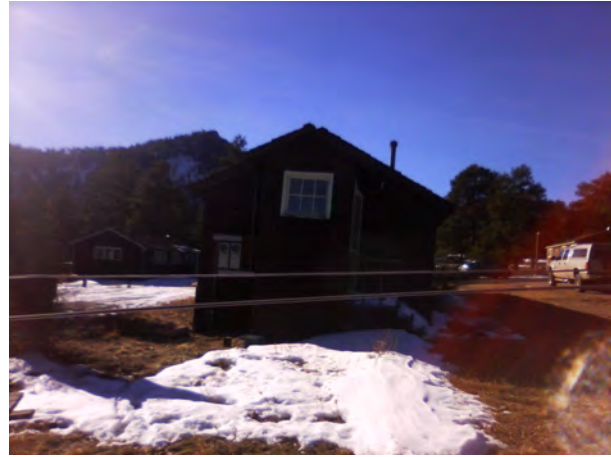
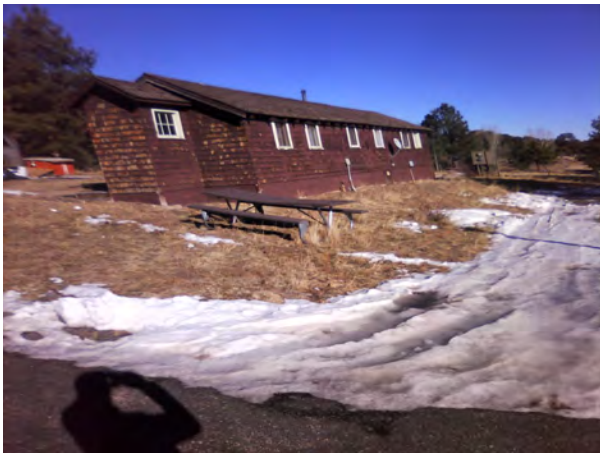
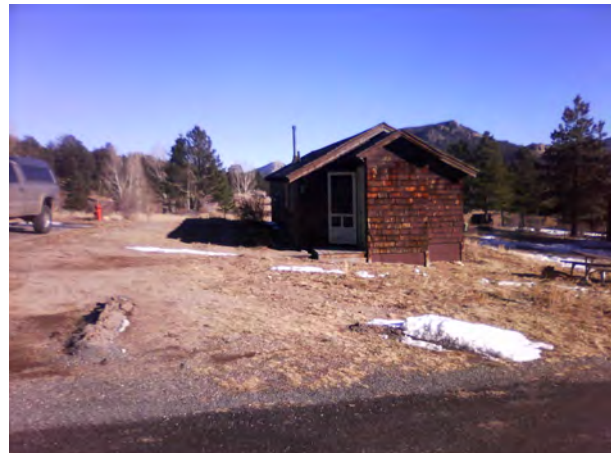
Rating: Moderate
Protection Level : Full
Local ID: [Local_ID]
Lat(WGS84): 40° 21.8848' Long(WGS84): -105° 33.6921'

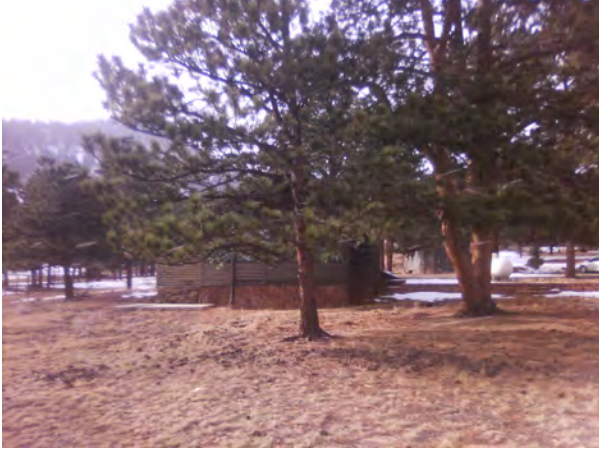
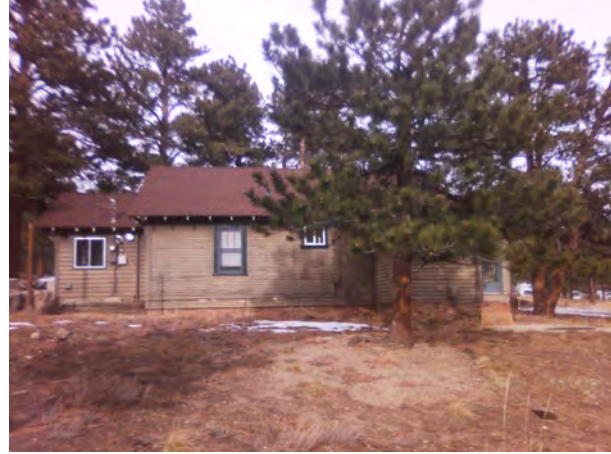
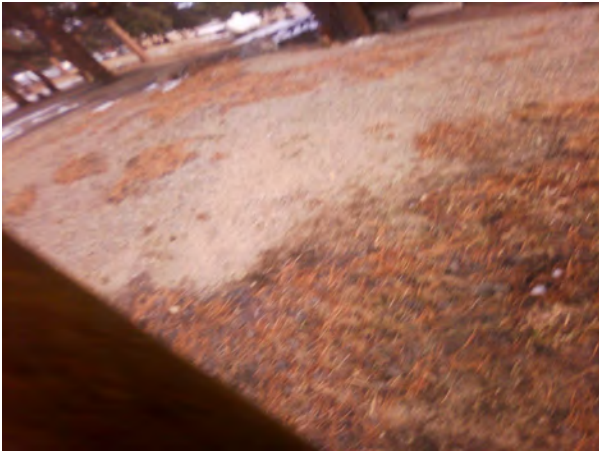
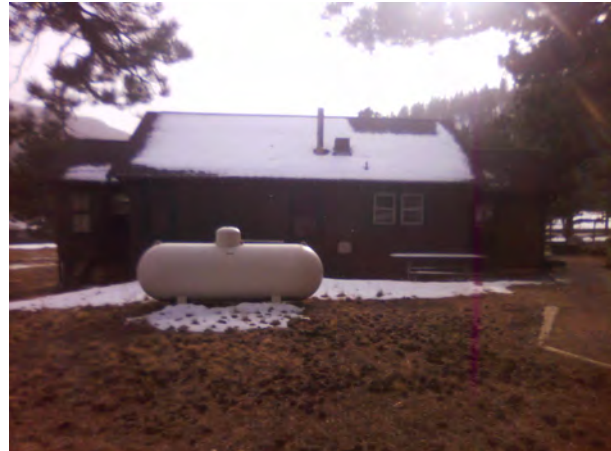
Rating: Low
Protection Level : Full
Local ID: [Local_ID]
Lat(WGS84): 40° 21.6036' Long(WGS84): -105° 33.8336'

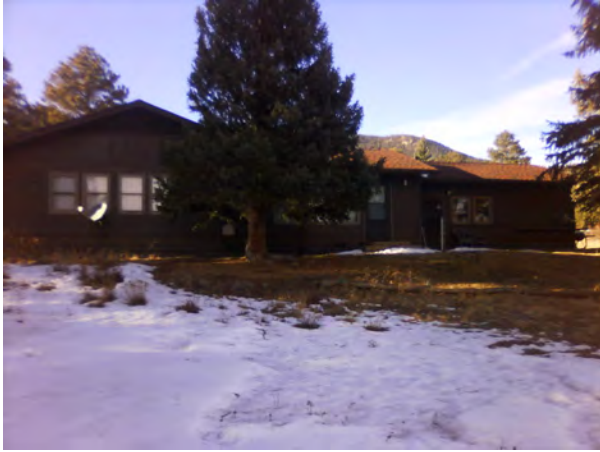
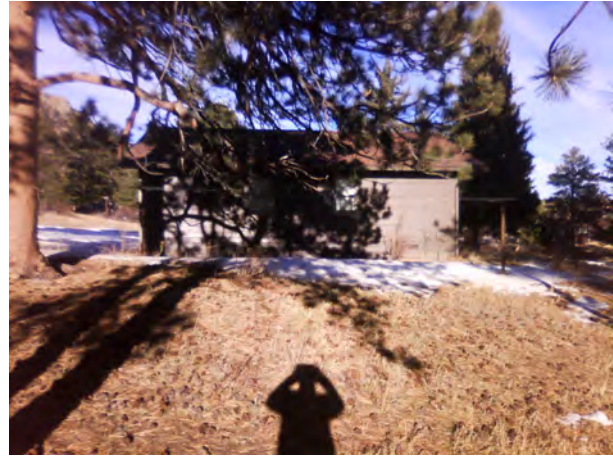
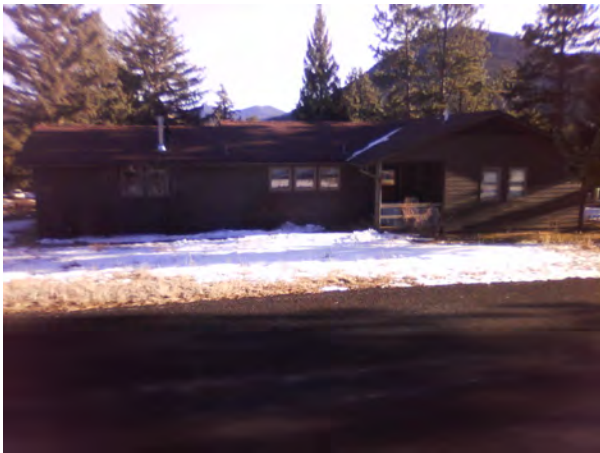
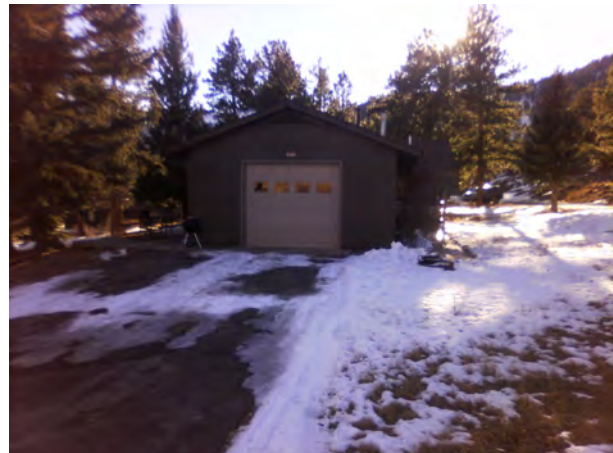
Rating: Moderate
Protection Level : Full
Local ID: [Local_ID]
Lat(WGS84): 40° 21.8586' Long(WGS84): -105° 33.7594'

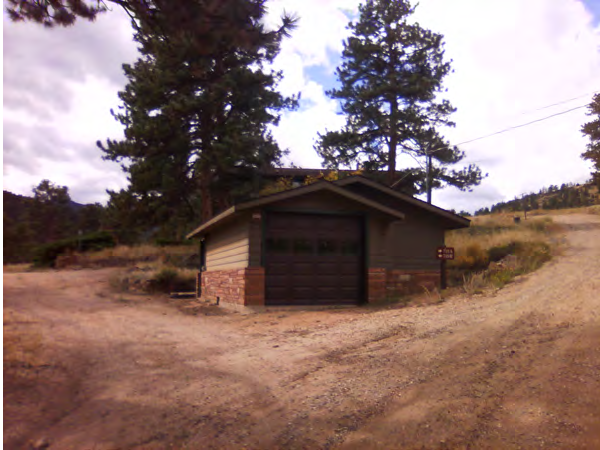
ROMO_30747_B-0850-N Garage by Herman #710, Ypsilon Lane_Front.jpg

Rating: Moderate
Protection Level : Not Designated
Local ID: [Local_ID]
Lat(WGS84): 40° 21.6033' Long(WGS84): -105° 33.4623'

Zone	Treatment Description	Pers Hours	Treatment Cycle	Treatment Priority	Treatment Status	Date Next Treatment Recommended	Equipment Description	Equip Qty
1	Mow dead/dying grass to less than 4 inches -	1	2 Month		Unknown	9/22/2014	-

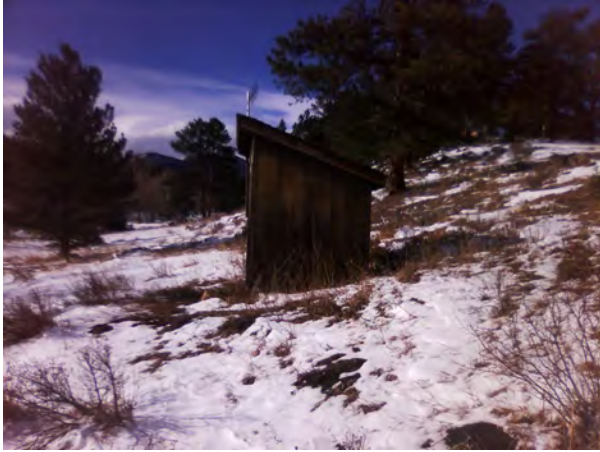
ROMO_98020_B-0603-N Pumphouse, BME_D.jpg

Primary Access: Foot
Ingress/Egress: N/A, access by foot, boat or air only
Access Width: N/A, access by foot, boat or air only
Access Condition: N/A, access by foot, boat or air only
Bridge Condition: None/nonflammable,load limit will not limit response
Access & Turnarounds: N/A,access by foot,boat,or air only
Facility Number/Sign: None or not clearly visible
Defensible Space: <30 ft treated
Fuel Load (w/in 300 ft): Light
Fuel Type (w/in 300ft): Shrub or timber
Topography (w/in 300ft): Slope 5% to 20%
Roof Material: Combustible or no roof
Siding Material: Wood or open sided
Foundation: Closed, < 6in masonry exposed
Fences/Decks: None or noncombustible
Firewood: None
Propane Tanks:
Water Supply: Reliable water source nearby
Overhead Hazards: No overhead hazards
Safety Zones: Potential safety zone(s) in area
Additional Obstacles: None
Triage Category:
Hazmat:
Assessment Comments:

Score: 95
Rating: High

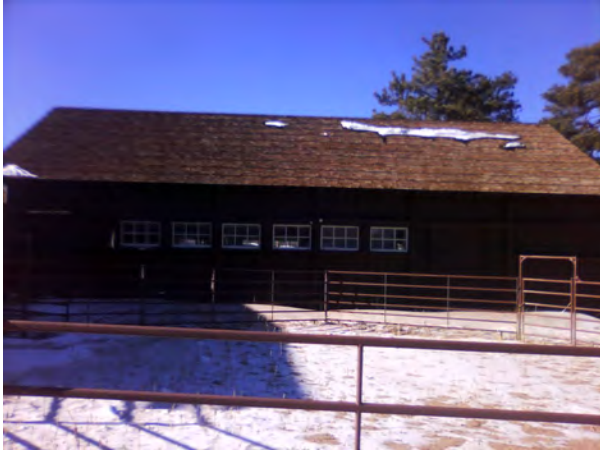
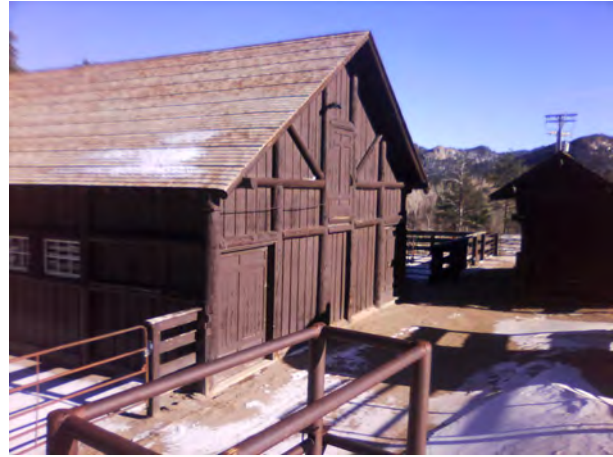
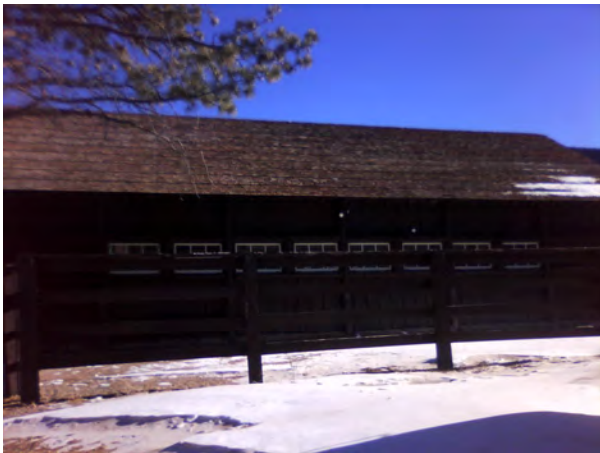
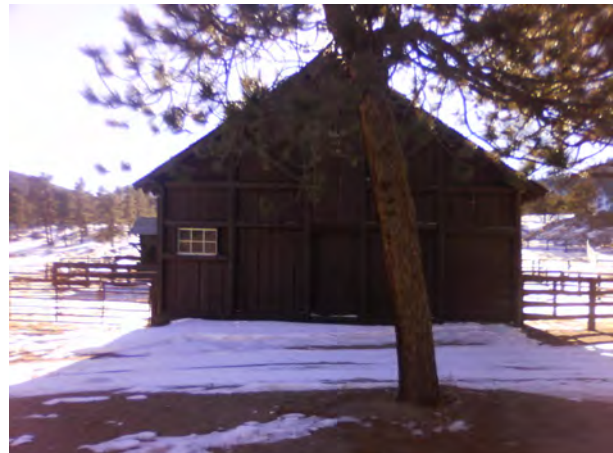
Unit - Location: ROMO - Beaver Meadows
FMSS ID: 27363
Field Crew: Dave Frey
Last Site Visit Date: 12/11/2013

Primary Access: Road
Ingress/Egress: Two or more roads in/out
Access Width: 1.5 lanes (>18ft)
Access Condition: Surfaced-paved, grade<5%
Bridge Condition: None/nonflammable,load limit will not limit response
Access & Turnarounds: Access is <300 ft from facility w/turnaround
Facility Number/Sign: Marked and clearly visible
Defensible Space: >100ft treated
Fuel Load (w/in 300 ft): Moderate
Fuel Type (w/in 300ft): Shrub or timber
Topography (w/in 300ft): Slope 5% to 20%
Roof Material: Noncombustible or not applicable
Siding Material: Rock, concrete, metal
Foundation: Closed, < 6in masonry exposed
Fences/Decks: None or noncombustible
Firewood: 5ft to 30ft from facility
Propane Tanks:
Water Supply: Pressurized hydrant(s) or fixed sprinkler system
Overhead Hazards: No overhead hazards
Safety Zones: Potential safety zone(s) in area
Additional Obstacles: Hazmat, UXO,etc. , PLEASE COMMENT
Triage Category:
Hazmat: This building is located inside the park bone yard with various unknown hazardous materials stored here including flammable material.

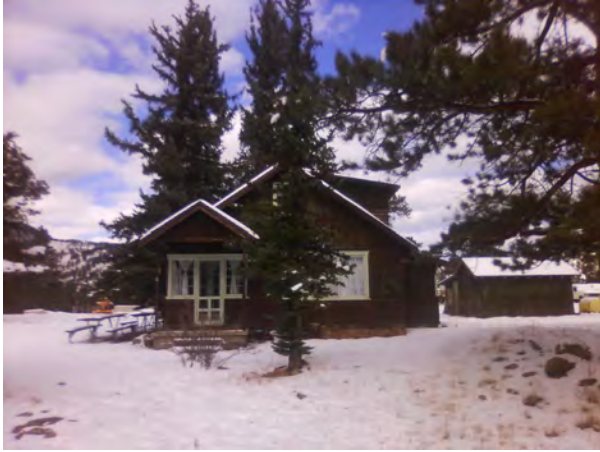
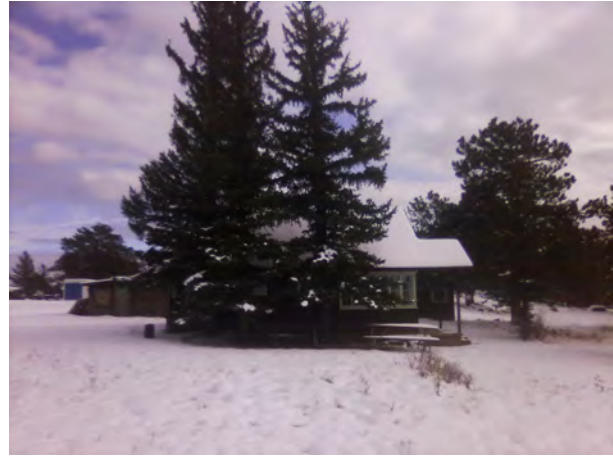
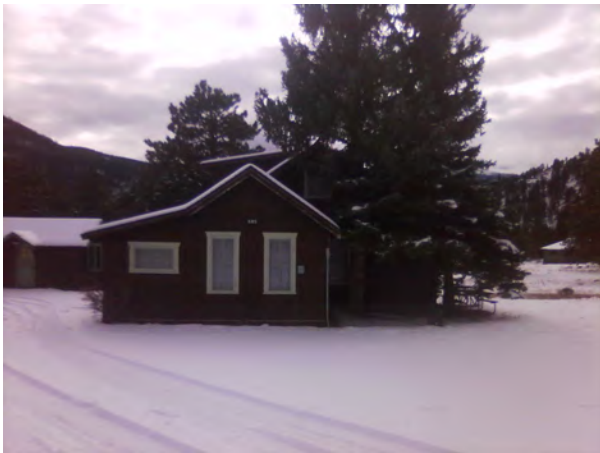
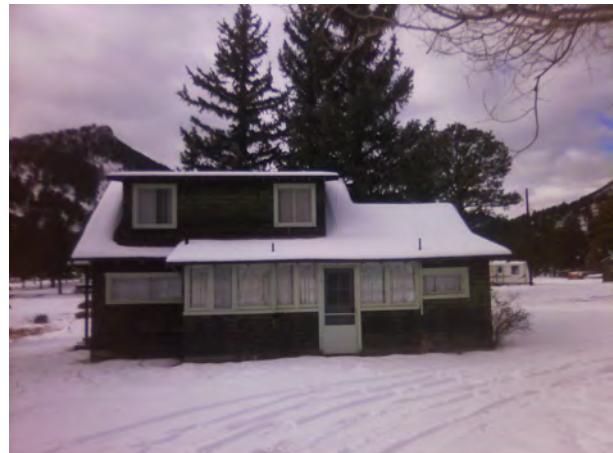
Unit - Location: ROMO - Beaver Meadows
FMSS ID: 30432
Field Crew: Dave Frey
Last Site Visit Date: 12/4/2013

Primary Access: Road
Ingress/Egress: Two or more roads in/out
Access Width: 1.5 lanes (>18ft)
Access Condition: Surfaced-paved, grade<5%
Bridge Condition: None/nonflammable,load limit will not limit response
Access & Turnarounds: Access is <300 ft from facility w/turnaround
Facility Number/Sign: Marked and clearly visible
Defensible Space: >100ft treated
Fuel Load (w/in 300 ft): Moderate
Fuel Type (w/in 300ft): Shrub or timber
Topography (w/in 300ft): Slope <5%
Roof Material: Combustible or no roof
Siding Material: Wood or open sided
Foundation: Closed, < 6in masonry exposed
Fences/Decks: None or noncombustible
Firewood: None
Propane Tanks:
Water Supply: Pressurized hydrant(s) or fixed sprinkler system
Overhead Hazards: No overhead hazards
Safety Zones: Potential safety zone(s) in area
Additional Obstacles: Hazmat, UXO,etc. , PLEASE COMMENT
Triage Category:
Hazmat:
Assessment Comments: Two trees are very close to the building but the surrounding area has good defensible space.

Zone	Treatment Description	Pers Hours	Treatment Cycle	Treatment Priority	Treatment Status	Date Next Treatment Recommended	Equipment Description	Equip Qty
1	Clear adjacent and overhanging fuels to create 10 feet spacing between canopy and structure or chimney openings - Remove two spruce trees adjacent to the structure.	4		Unknown	Planned		-
