NPS Wildland Fire Risk Assessment - Community Assessment

Community: Longs Peak
Unit - Location: ROMO - Longs Peak
Field Crew: Dave Frey
Last Site Visit Date:

NPS Wildand Fire Risk Assessment - **Community Assessment**

NPS Wildand Fire Risk Assessment - Facility Assessment

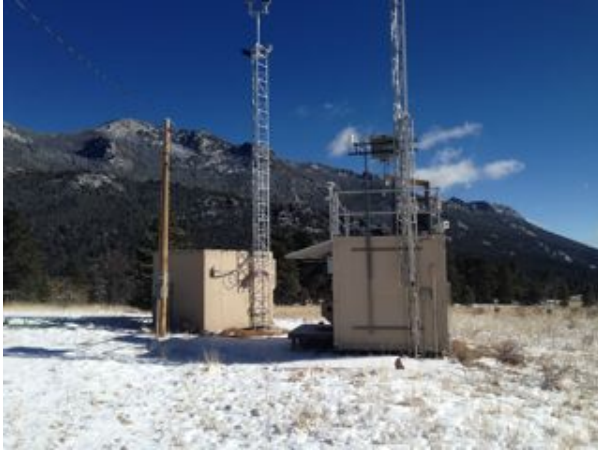
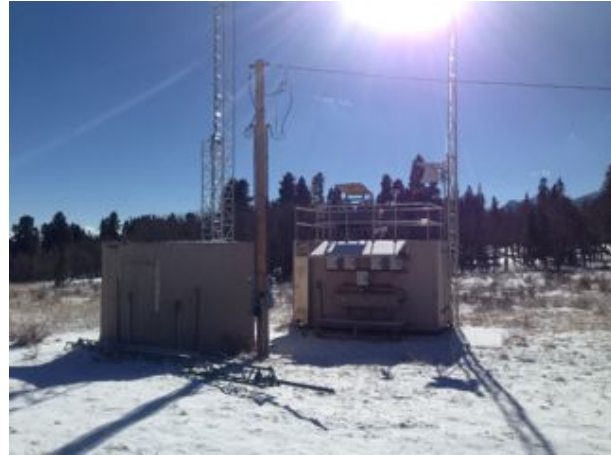
2014_ROMO_23743_B-1040-N Air Monitoring Station - Leiffer Cabin_x.jpg

Rating: Low
Protection Level : Full
Local ID: [Local_ID]
Lat(WGS84): 40° 16.6894' Long(WGS84): -105° 32.7347'

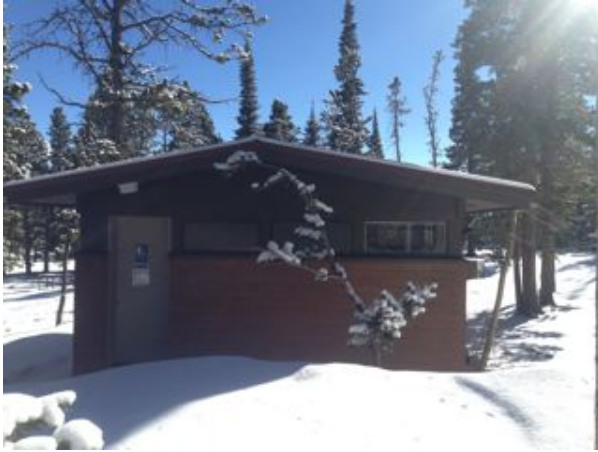
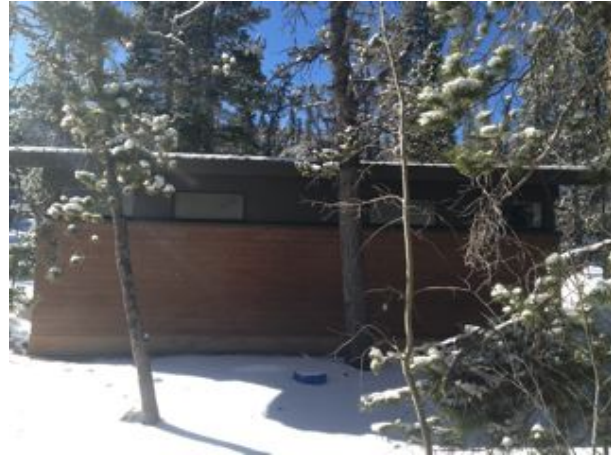
2014_ROMO_23689_B-0343-N Comfort Station - Longs Peak Campgrd_x.jpg

Rating: High
Protection Level : Full
Local ID: [Local_ID]
Lat(WGS84): 40° 16.4988' Long(WGS84): -105° 33.4867'

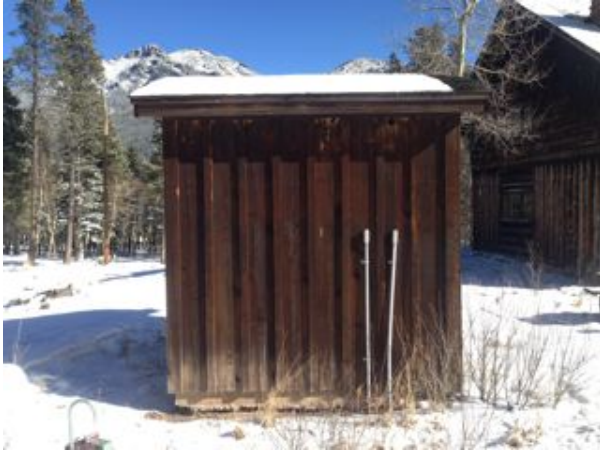
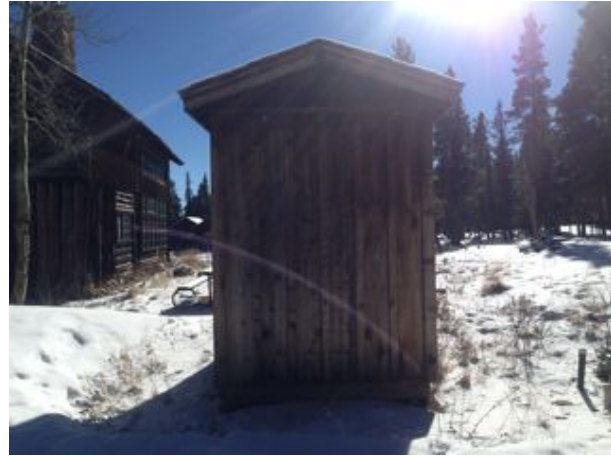
2014_ROMO_98026_B-1025-N Pumphouse, Leiffer_x.jpg

Rating: High
Protection Level : Full
Local ID: [Local_ID]
Lat(WGS84): 40° 16.6167' Long(WGS84): -105° 32.7804'

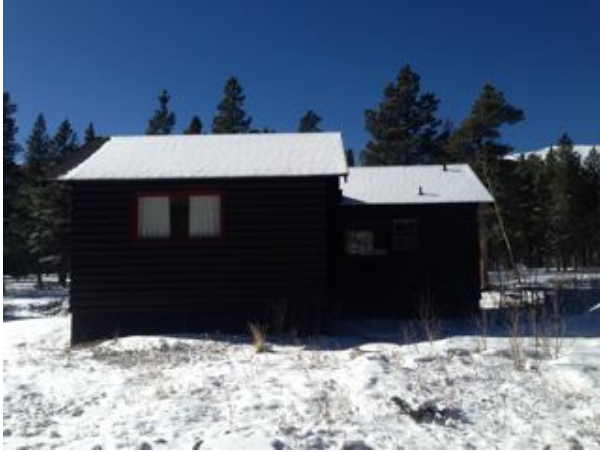
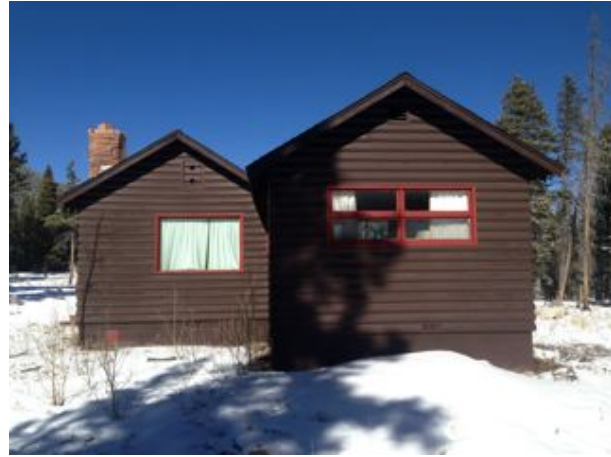
2014_ROMO_23724_B-0837-N Leiffer Cabin, new 00000837_x.jpg

Rating: Moderate
Protection Level : Full
Local ID: [Local_ID]
Lat(WGS84): 40° 16.5901' **Long(WGS84):** -105° 32.7615'
