NPS Wildland Fire Risk Assessment - Community Assessment

Community: Aspenglen Campground
Unit - Location: ROMO - North Entrance
Field Crew: Dave Frey
Last Site Visit Date:

Community Description: Aspenglen campground is located south of the Fall River Entrance station. It is open from late May to late September and has 53 sites in three loops. There are both tent and RV sites in the campground. It is in a ponderosa forest and is a popular tourist destination.

Description of Factors Driving the Ratings: The factors driving the ratings are the access to the community in conjunction with the building materials.

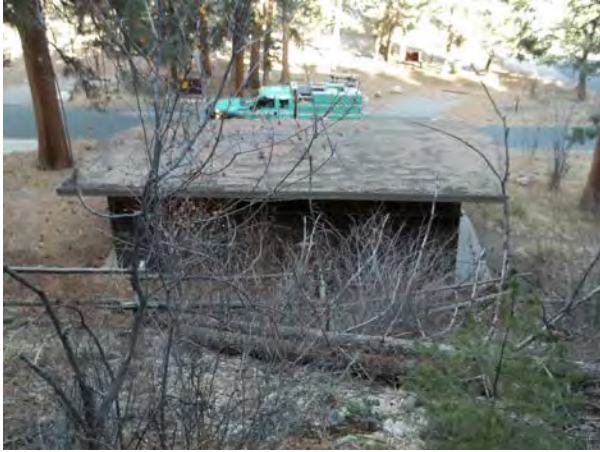
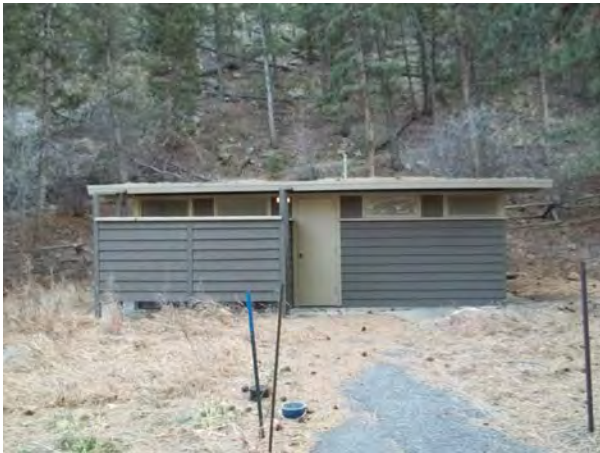
Rating: Moderate
Protection Level : Not Designated
Local ID: [Local_ID]
Lat(WGS84): 40° 23.9416' Long(WGS84): -105° 35.4423'

Zone	Treatment Description	Pers Hours	Treatment Cycle	Treatment Priority	Treatment Status	Date Next Treatment Recommended	Equipment Description	Equip Qty
1	Limb trees 6 to 15 feet above ground -	3		Unknown	Planned		-	
	Roof and gutters should be cleared of vegetative debris -	3		Unknown	Planned		-	
	Flammable ground cover such as leaf litter, woody debris or highly flammable vegetation should be removed -	3		Unknown	Planned		-	
2	Flammable ground cover should be removed or isolated -	3		Unknown	Planned		-

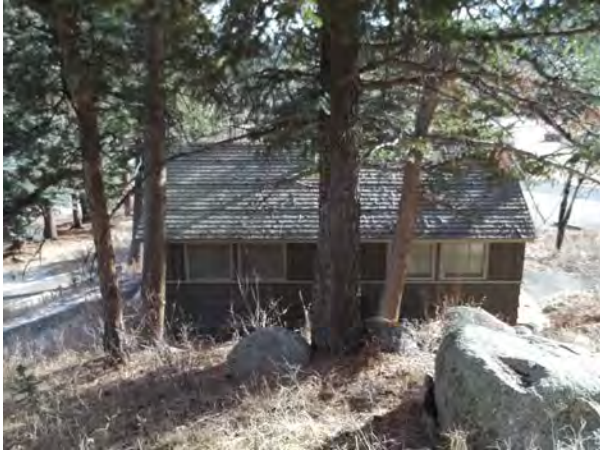
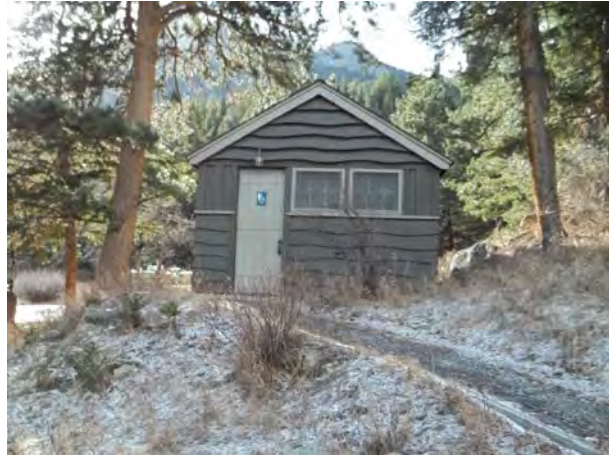
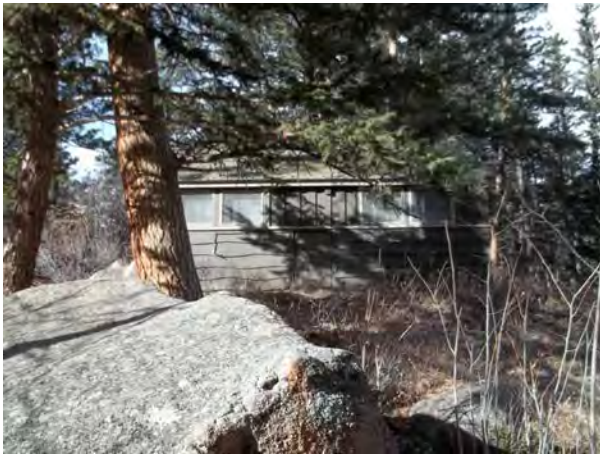
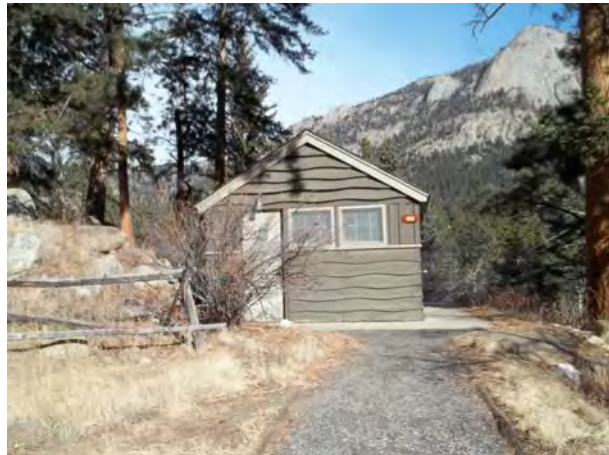
Rating: High
Protection Level : Not Designated
Local ID: [Local_ID]
Lat(WGS84): 40° 23.9774' Long(WGS84): -105° 35.4213'

Zone	Treatment Description	Pers Hours	Treatment Cycle	Treatment Priority	Treatment Status	Date Next Treatment Recommended	Equipment Description	Equip Qty
1	Flammable ground cover such as leaf litter, woody debris or highly flammable vegetation should be removed -	3		Unknown	Planned		-	
	Limb trees 6 to 15 feet above ground -	3		Unknown	Planned		-	
2	Limb trees 6 to 15 feet above ground -	3		Unknown	Planned		-

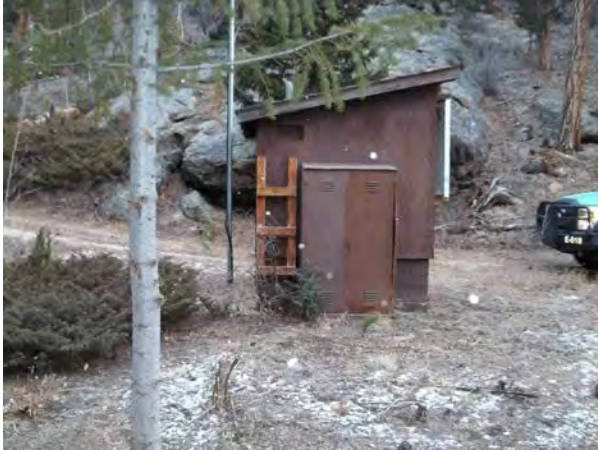
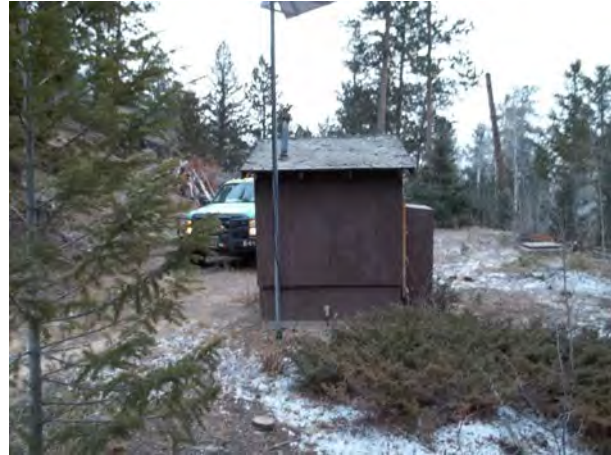
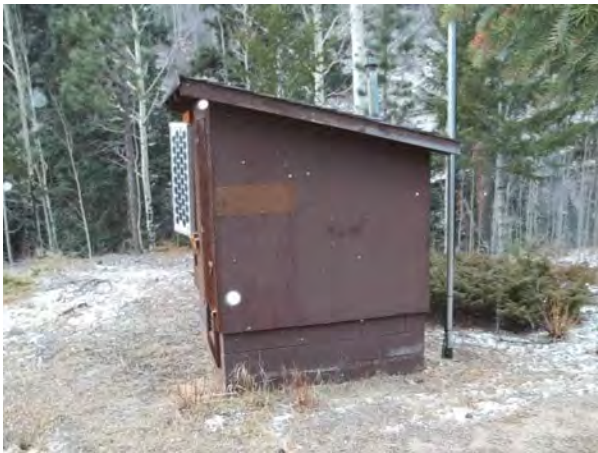
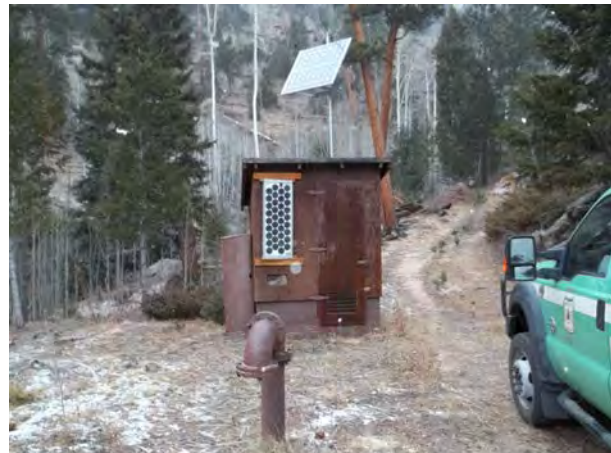
Rating: High
Protection Level : Unknown
Local ID: [Local_ID]
Lat(WGS84): 40° 24.4764' Long(WGS84): -105° 35.5818'

Zone	Treatment Description	Pers Hours	Treatment Cycle	Treatment Priority	Treatment Status	Date Next Treatment Recommended	Equipment Description	Equip Qty
1	Flammable ground cover such as leaf litter, woody debris or highly flammable vegetation should be removed -	3		Unknown	Planned		-	
2	Flammable ground cover should be removed or isolated -	3		Unknown	Planned		-

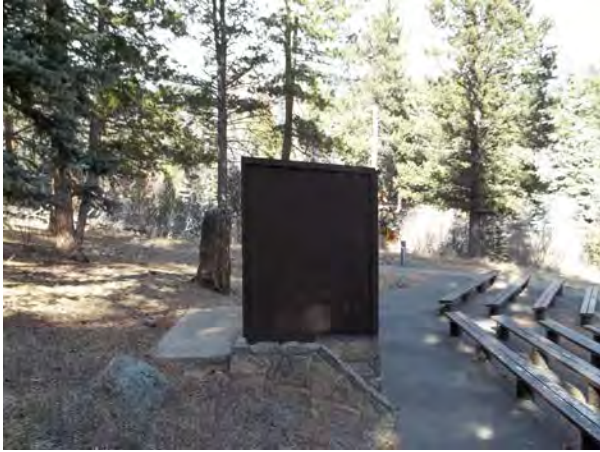
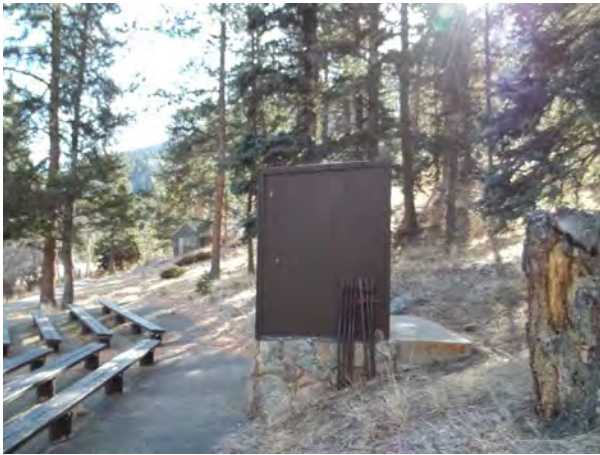
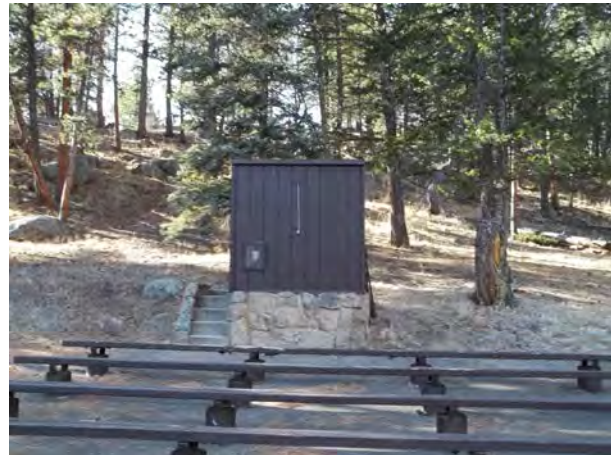
Rating: Low
Protection Level : Unknown
Local ID: [Local_ID]
Lat(WGS84): 40° 24.0204' Long(WGS84): -105° 35.46'

Zone	Treatment Description	Pers Hours	Treatment Cycle	Treatment Priority	Treatment Status	Date Next Treatment Recommended	Equipment Description	Equip Qty
1	Limb trees 6 to 15 feet above ground -	2		Unknown	Planned		-	
	Flammable ground cover such as leaf litter, woody debris or highly flammable vegetation should be removed -	2		Unknown	Planned		-	
2	Flammable ground cover should be removed or isolated -	2		Unknown	Planned		-

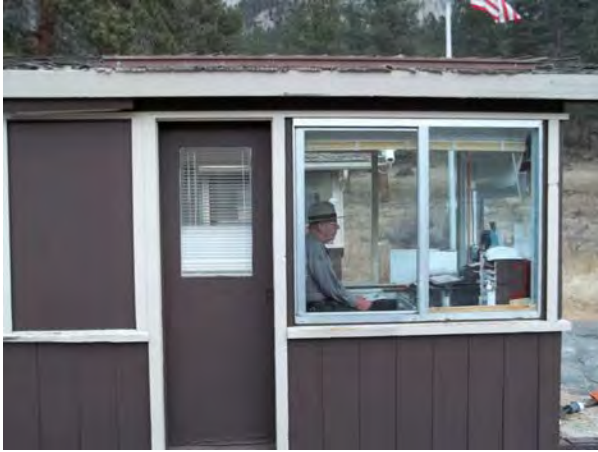
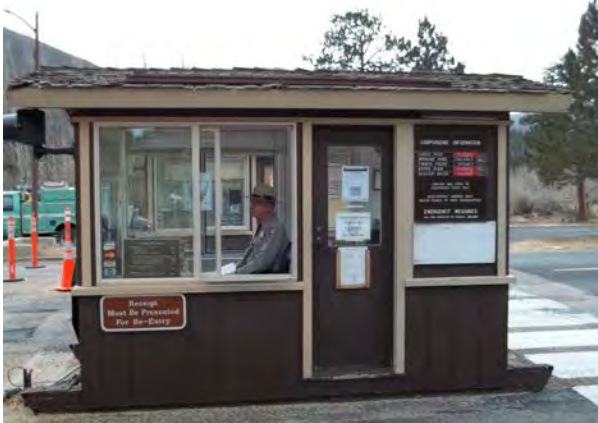
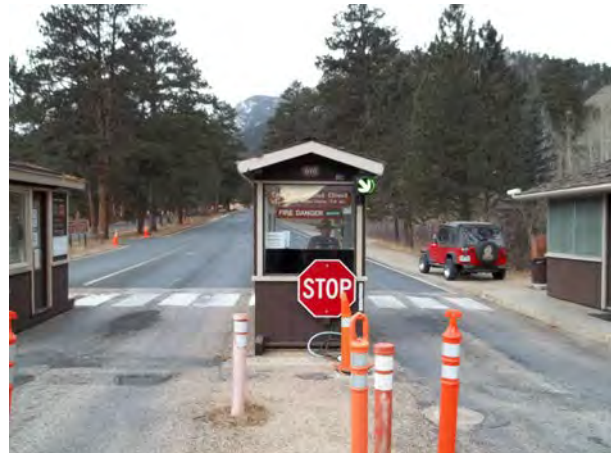
Rating: Low
Protection Level : Not Designated
Local ID: [Local_ID]
Lat(WGS84): 40° 24.2549' Long(WGS84): -105° 35.5162'

Zone	Treatment Description	Pers Hours	Treatment Cycle	Treatment Priority	Treatment Status	Date Next Treatment Recommended	Equipment Description	Equip Qty
2	Mow dead/dying grass to less than 4 inches -	3		Unknown	Planned		-

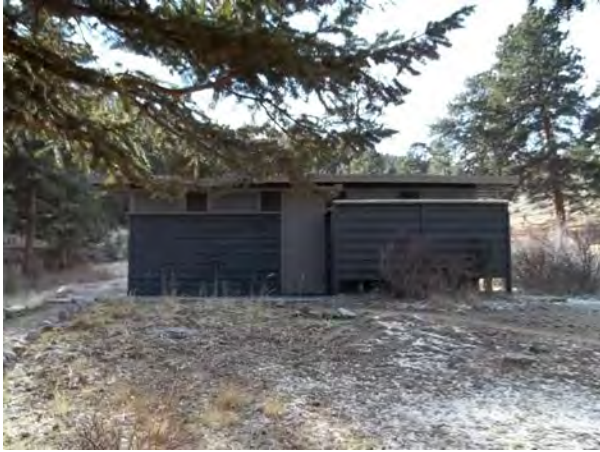
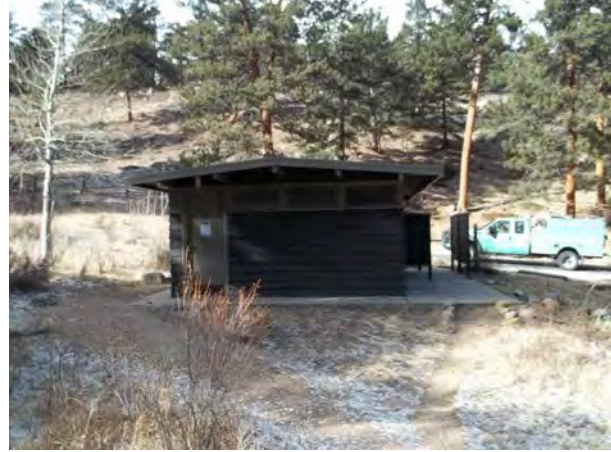
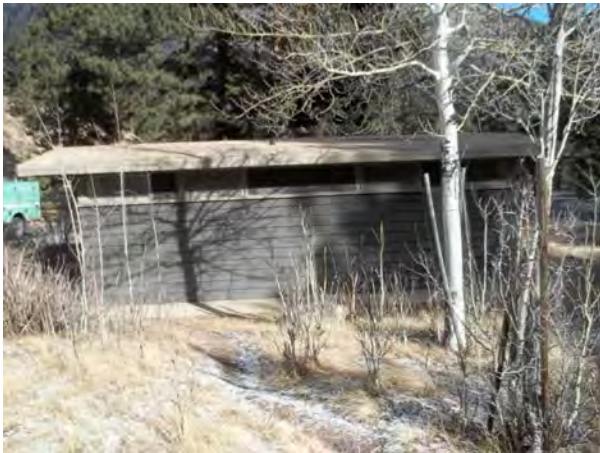
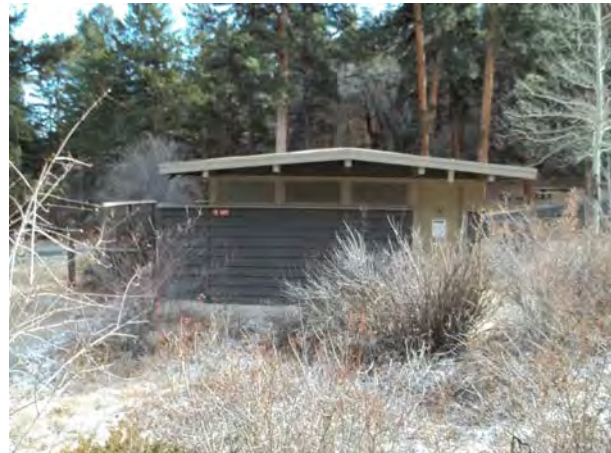
Rating: Moderate
Protection Level : Not Designated
Local ID: [Local_ID]
Lat(WGS84): 40° 23.9327' Long(WGS84): -105° 35.6357'

Zone	Treatment Description	Pers Hours	Treatment Cycle	Treatment Priority	Treatment Status	Date Next Treatment Recommended	Equipment Description	Equip Qty
1	Flammable ground cover such as leaf litter, woody debris or highly flammable vegetation should be removed -	3		Unknown	Planned		-

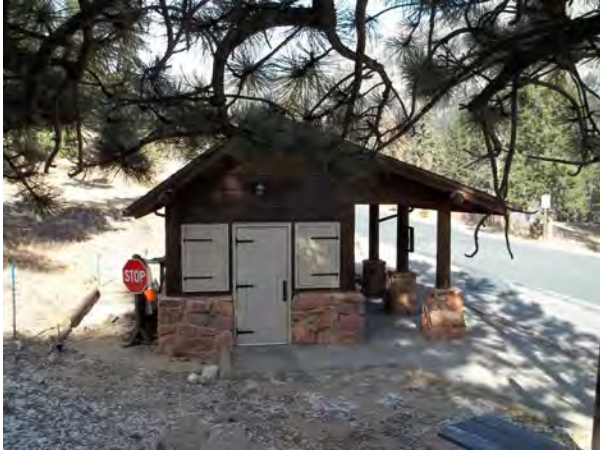
2013_ROMO_25288_B-0992-N Kiosk Aspenglen Campground_D.jpg

Rating: Moderate
Protection Level : Not Designated
Local ID: [Local_ID]
Lat(WGS84): 40° 24.0011' Long(WGS84): -105° 35.5975'

Zone	Treatment Description	Pers Hours	Treatment Cycle	Treatment Priority	Treatment Status	Date Next Treatment Recommended	Equipment Description	Equip Qty
1	Roof and gutters should be cleared of vegetative debris -	3		Unknown	Planned		-	
	Limb trees 6 to 15 feet above ground -	3		Unknown	Planned		-

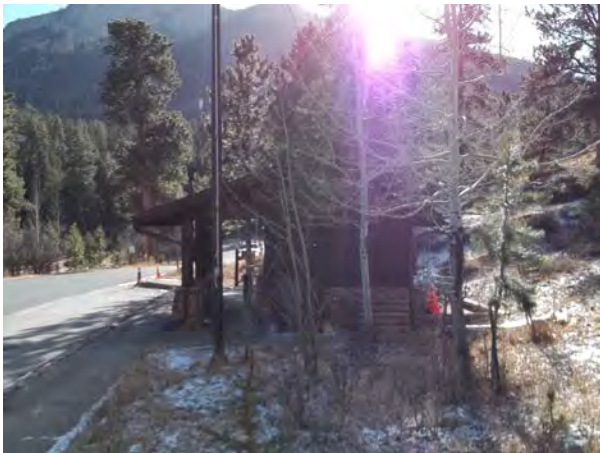
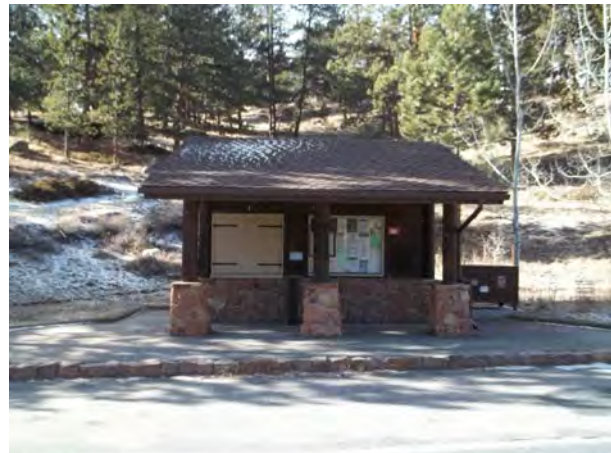
2013_ROMO_25288_B-0992-N Kiosk Aspenglen Campground_C.jpg

Rating: Moderate
Protection Level : Full
Resources of Concern Present? Unknown
Occupied? No
Local ID: [Local_ID]
In a Community? Yes - Fall River Entrance
Lat(WGS84): 40° 24.322' **Long(WGS84):** -105° 35.5304'

Zone	Treatment Description	Pers Hours	Treatment Cycle	Treatment Priority	Treatment Status	Date Next Treatment Recommended	Equipment Description	Equip Qty
1	Roof and gutters should be cleared of vegetative debris -	3		Unknown	Planned		-

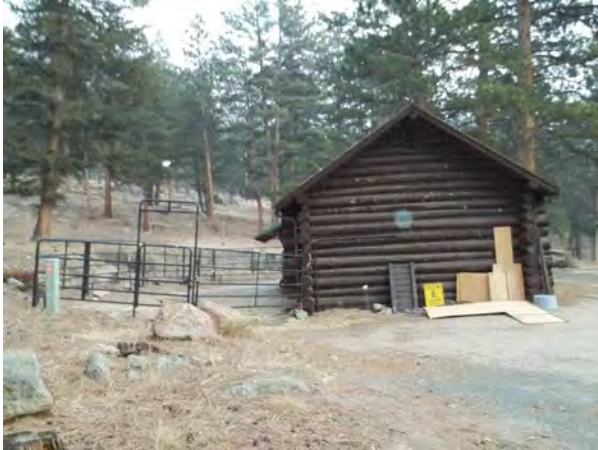
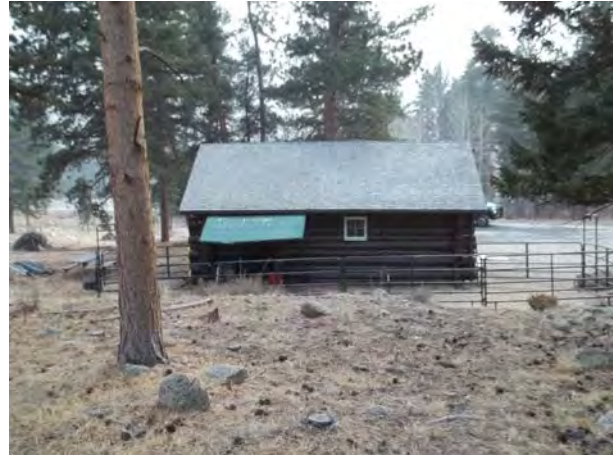
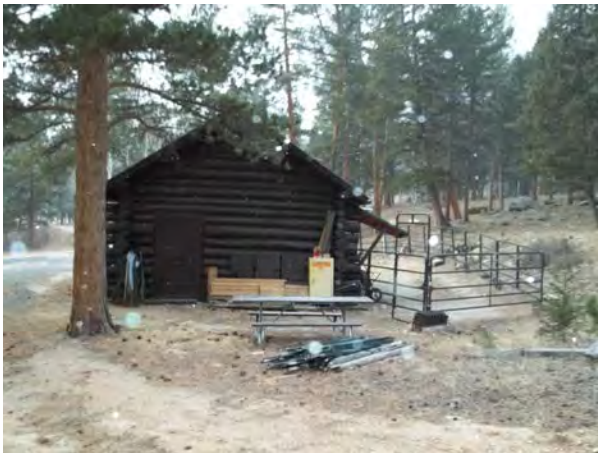
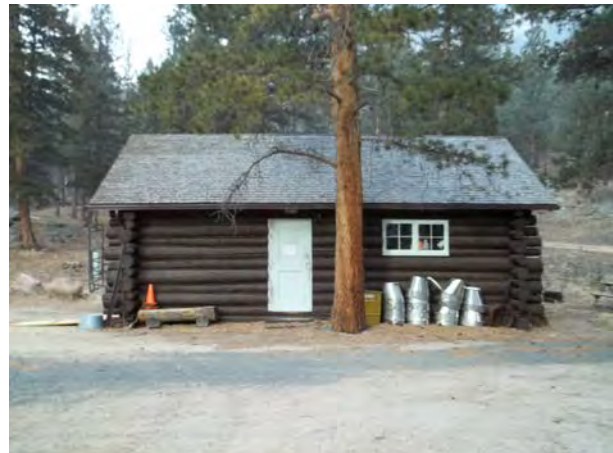
2013_ROMO_24044_B-0168-H Bighorn Storage Shed_D.jpg

Rating: Moderate
Protection Level : Full
Local ID: [Local_ID]
Lat(WGS84): 40° 24.322' Long(WGS84): -105° 35.5304'

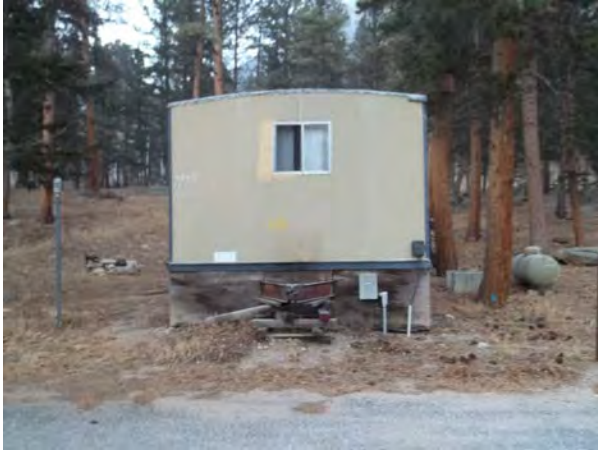
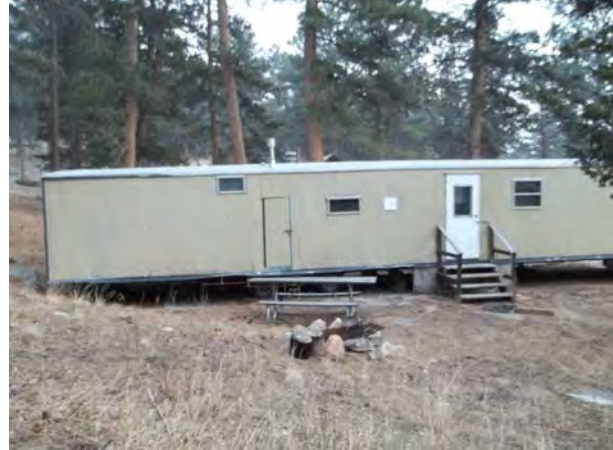
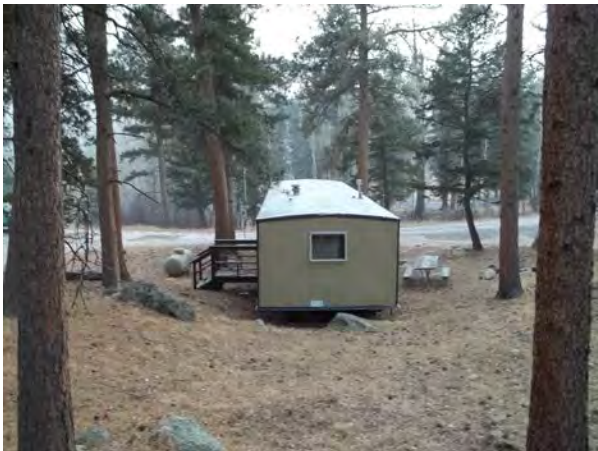
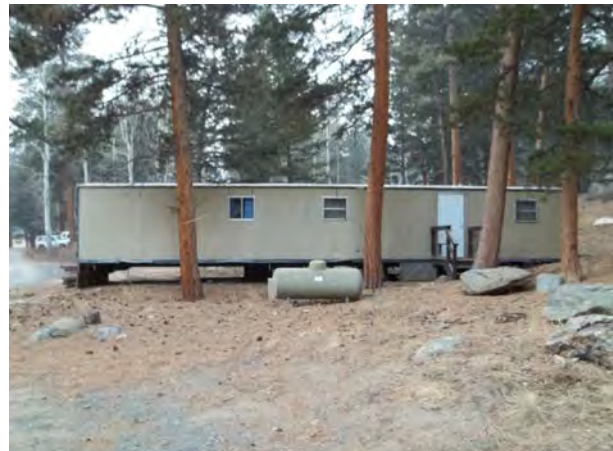
ROMO_73790_S Trailer 00M82250 (A).JPG

Rating: Low
Protection Level : Full
Local ID: [Local_ID]
Lat(WGS84): 40° 24.3264' Long(WGS84): -105° 35.5501'

Zone	Treatment Description	Pers Hours	Treatment Cycle	Treatment Priority	Treatment Status	Date Next Treatment Recommended	Equipment Description	Equip Qty
1	Flammable ground cover such as leaf litter, woody debris or highly flammable vegetation should be removed -	3		Unknown	Planned		-	
2	Flammable ground cover should be removed or isolated -	3		Unknown	Planned		-

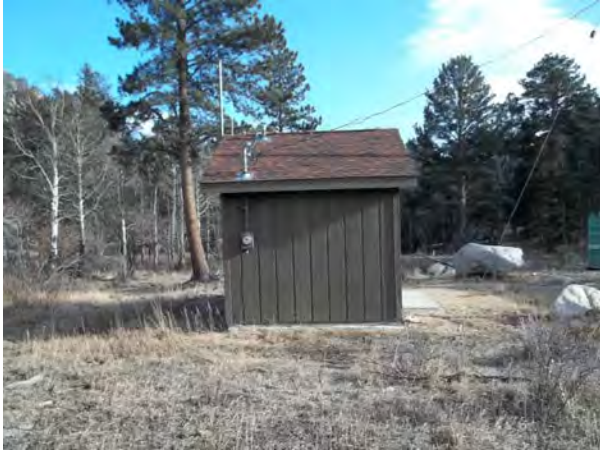
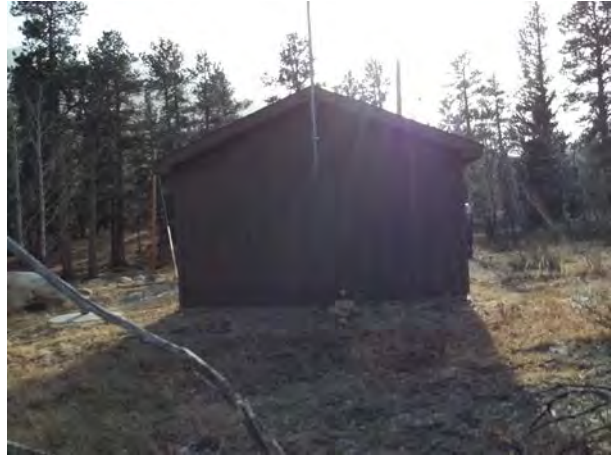
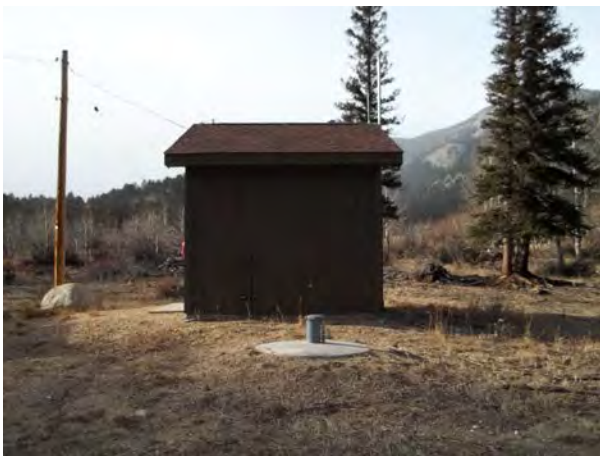
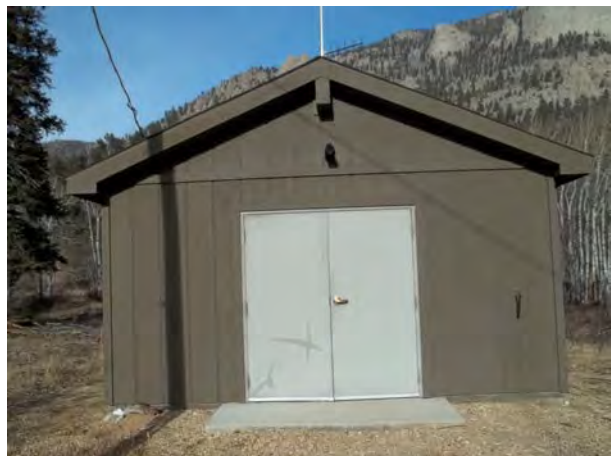
2013_ROMO_98014_B-0688-N Pumphouse, Smith Sisters (Aspenglen)_D.jpg

Rating: Low
Protection Level : Full
Local ID: [Local_ID]
Lat(WGS84): 40° 24.2072' Long(WGS84): -105° 35.5411'

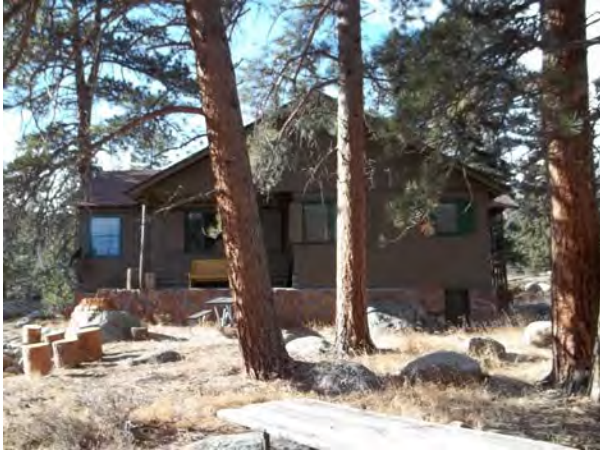
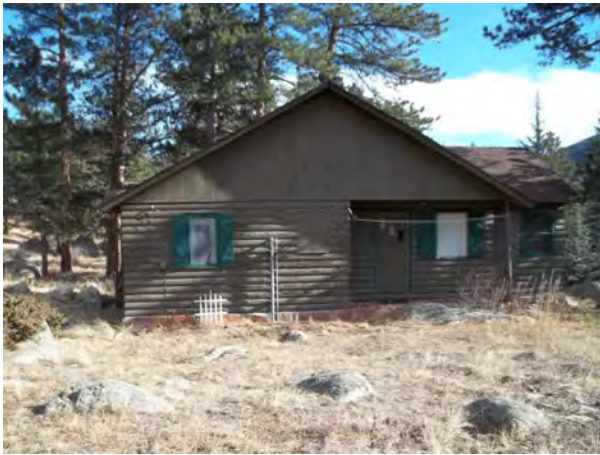
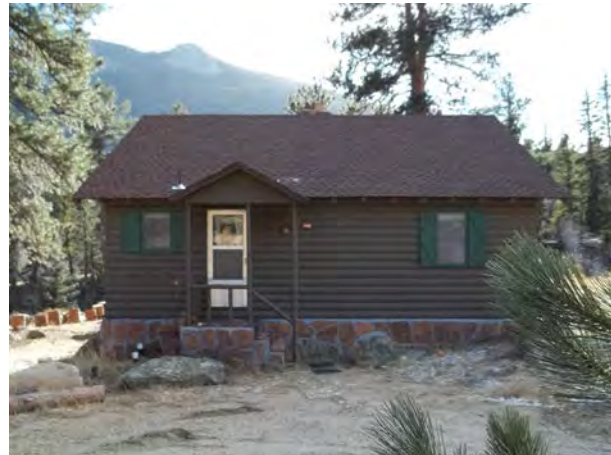
2013_ROMO_24065_Q-0748-N S 1 Bdrm House by AGCG 00000748_D.jpg

Rating: High
Protection Level : Not Designated
Local ID: [Local_ID]
Lat(WGS84): 40° 24.1348' Long(WGS84): -105° 35.5966'

Zone	Treatment Description	Pers Hours	Treatment Cycle	Treatment Priority	Treatment Status	Date Next Treatment Recommended	Equipment Description	Equip Qty
1	Firewood should be moved at least 50 ft from the facility and 15 horizontal feet from tree canopies -	3		Unknown	Planned		-	
	Limb trees 6 to 15 feet above ground -	3		Unknown	Planned		-	
	Flammable ground cover such as leaf litter, woody debris or highly flammable vegetation should be removed -	3		Unknown	Planned		-	
2	Flammable ground cover should be removed or isolated -	3		Unknown	Planned		-

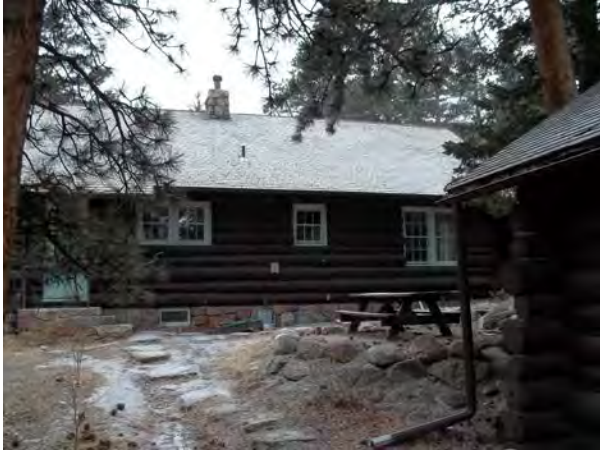
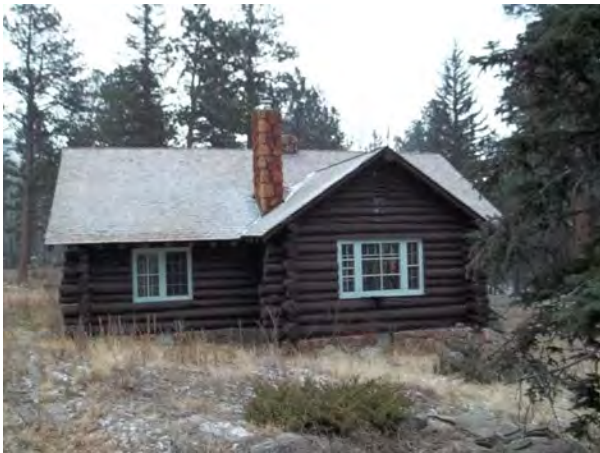
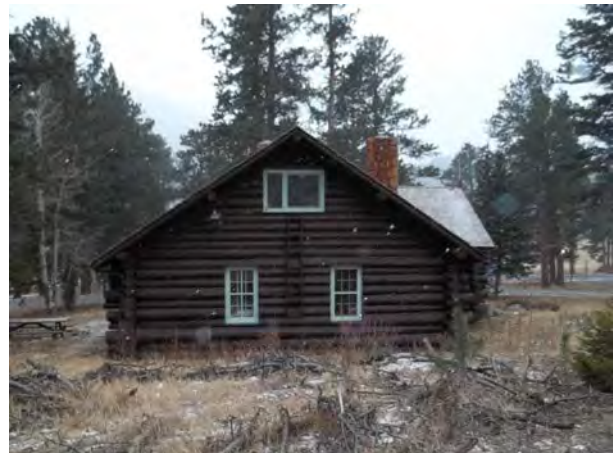
ROMO_24041_Bighorn Ranger Station (B).JPG

Rating: Moderate
Protection Level : Full
Local ID: [Local_ID]
Lat(WGS84): 40° 24.3308' Long(WGS84): -105° 35.6123'

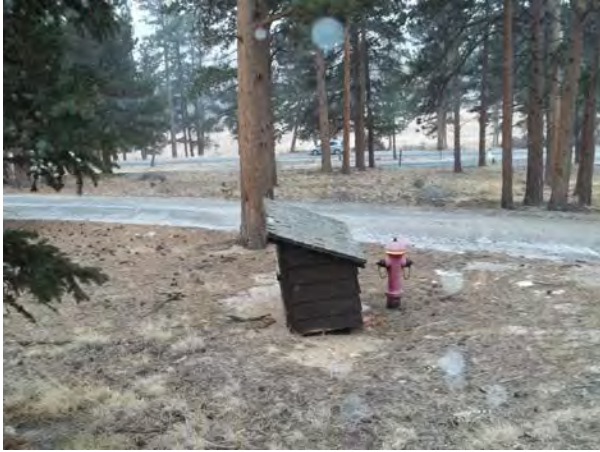
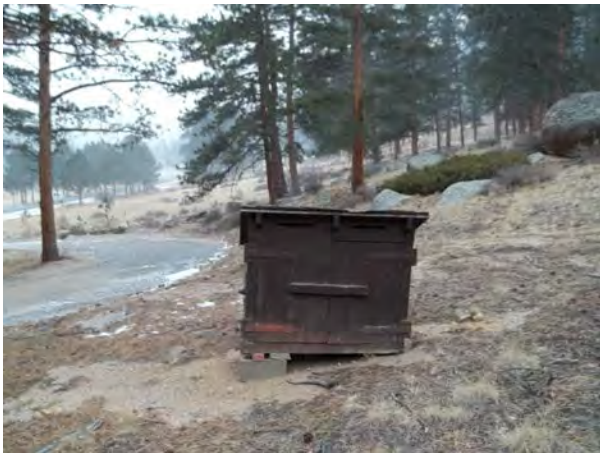
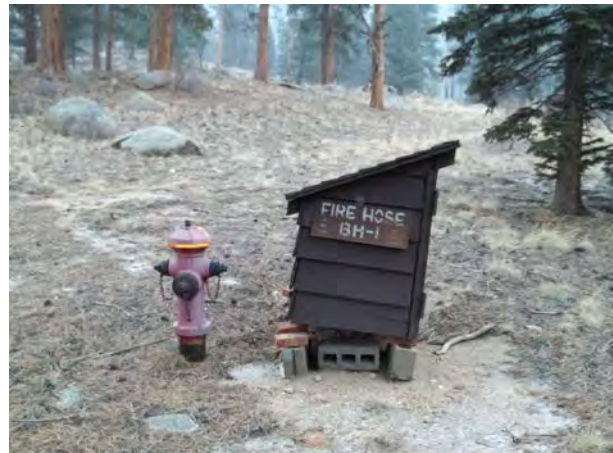
ROMO_24075_Hose House Bighorn (C).JPG

Rating: Moderate
Protection Level : Full
Local ID: [Local_ID]
Lat(WGS84): 40° 24.3233' Long(WGS84): -105° 35.6226'

Zone	Treatment Description	Pers Hours	Treatment Cycle	Treatment Priority	Treatment Status	Date Next Treatment Recommended	Equipment Description	Equip Qty
1	Limb trees 6 to 15 feet above ground -	3		Unknown	Planned		-

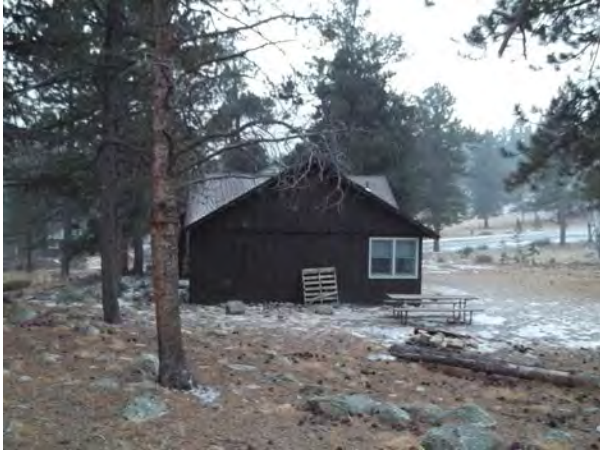
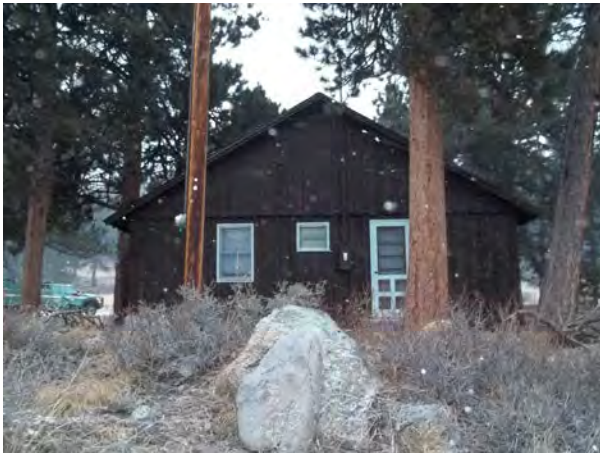
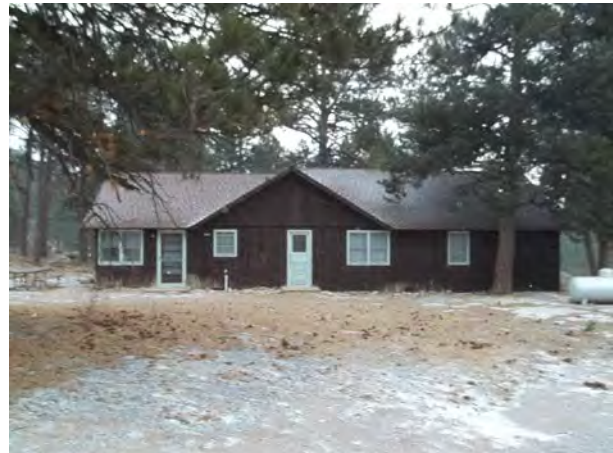
2013_ROMO_24058_Q-0743-H S Seasonal Quarters (Sterling) 00000743_D.jpg

Rating: Low
Protection Level : Full
Local ID: [Local_ID]
Lat(WGS84): 40° 24.1759' Long(WGS84): -105° 36.0451'

Zone	Treatment Description	Pers Hours	Treatment Cycle	Treatment Priority	Treatment Status	Date Next Treatment Recommended	Equipment Description	Equip Qty
1	Clear adjacent and overhanging fuels to create 10 feet spacing between canopy and structure or chimney openings -	3		Unknown	Planned		-

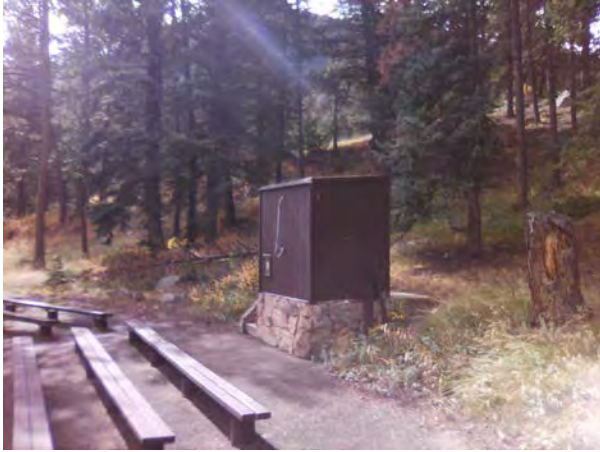
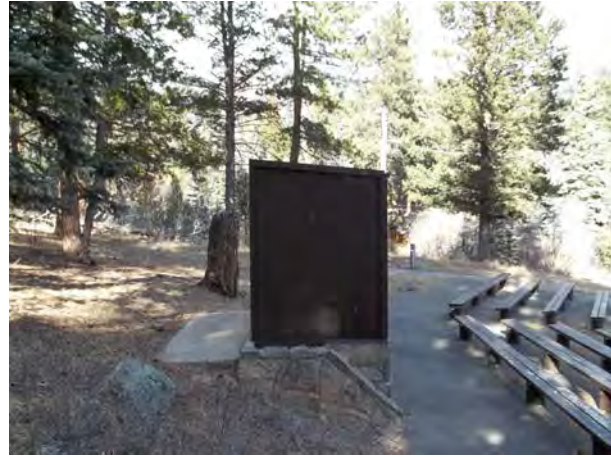
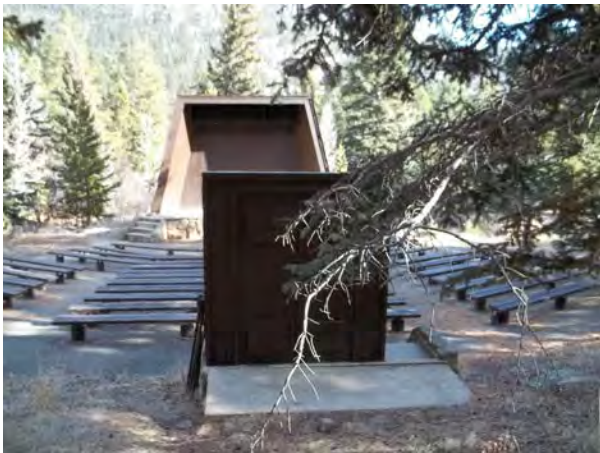
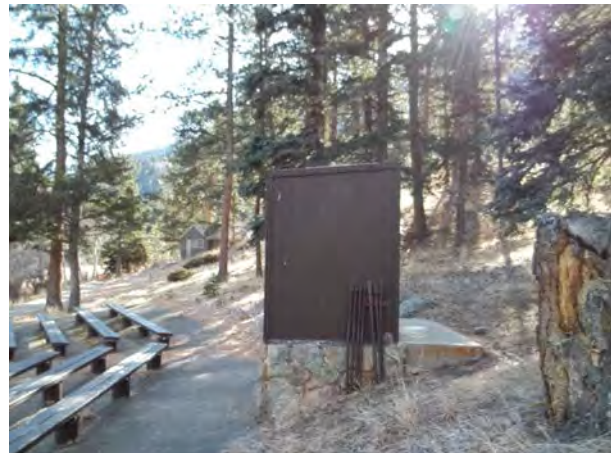
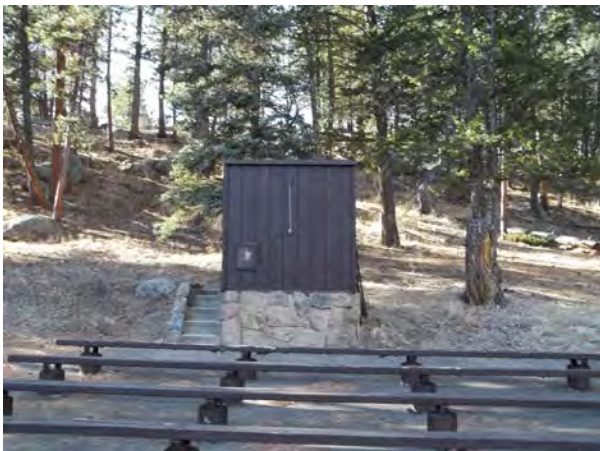
ROMO_Projection Booth AGCG_Projection Booth AGCG_Front.jpg

Rating: Moderate
Protection Level : Not Designated
Local ID: [Local_ID]
Lat(WGS84): 40° 24.0055' Long(WGS84): -105° 35.4347'

Zone	Treatment Description	Pers Hours	Treatment Cycle	Treatment Priority	Treatment Status	Date Next Treatment Recommended	Equipment Description	Equip Qty
1	Limb trees 6 to 15 feet above ground -	3		Unknown	Planned		-

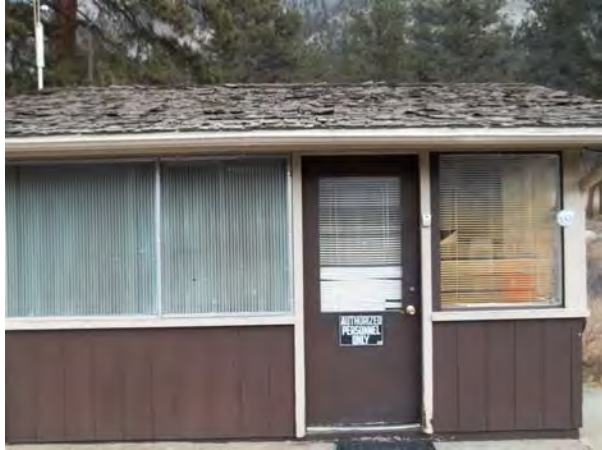
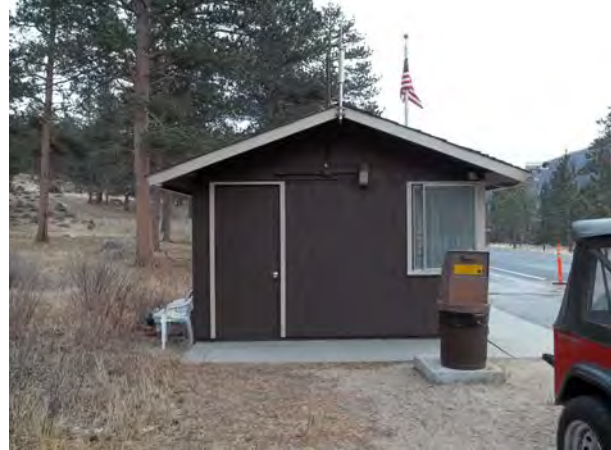
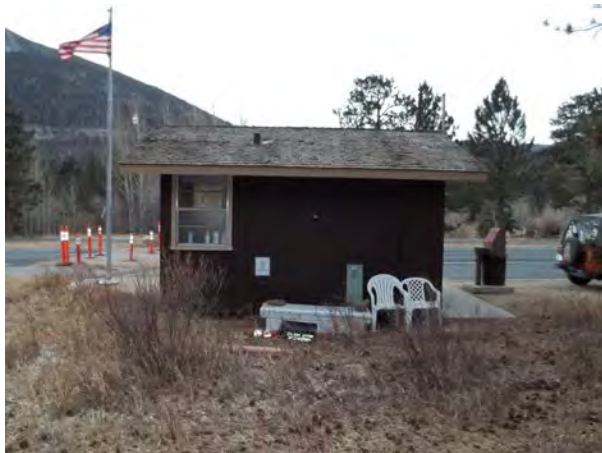
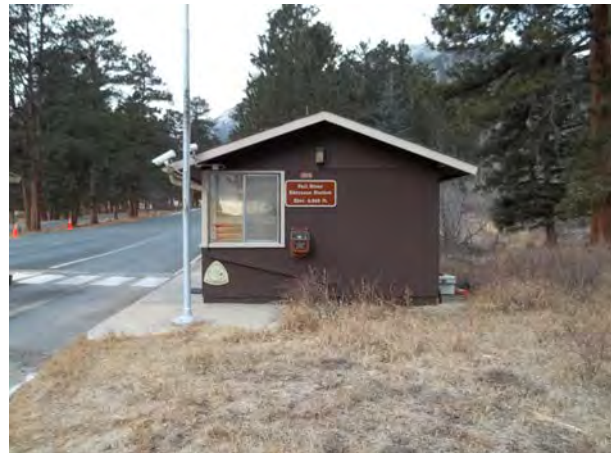
2013_ROMO_24046_B-0353-N Entrance Station Fall River_D.jpg

Score: 65
Rating: Moderate

Rating: Moderate
Protection Level : Not Designated
Local ID: [Local_ID]
Lat(WGS84): 40° 24.2601' Long(WGS84): -105° 35.5135'

Zone	Treatment Description	Pers Hours	Treatment Cycle	Treatment Priority	Treatment Status	Date Next Treatment Recommended	Equipment Description	Equip Qty
1	Flammable ground cover such as leaf litter, woody debris or highly flammable vegetation should be removed -	3		Unknown	Planned		-	
	Clear adjacent and overhanging fuels to create 10 feet spacing between canopy and structure or chimney openings -	3		Unknown	Planned		-	
	Limb trees 6 to 15 feet above ground -	3		Unknown	Planned		-	
2	Mow dead/dying grass to less than 4 inches -	3		Unknown	Planned		-

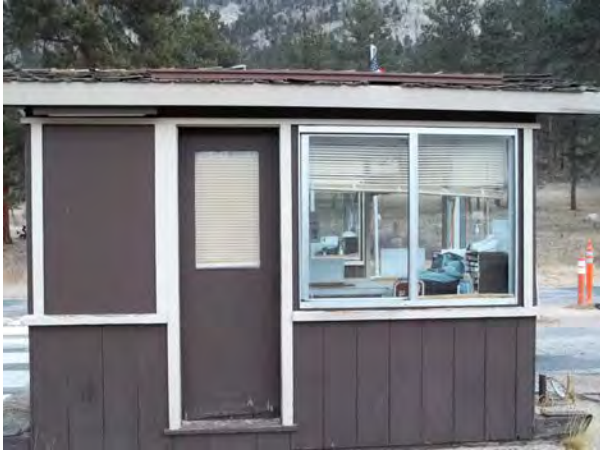
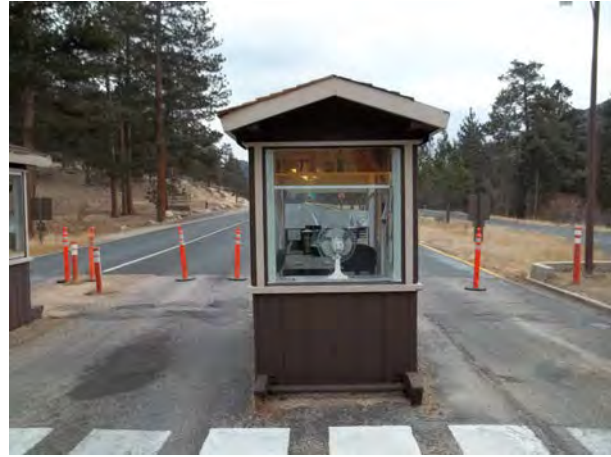
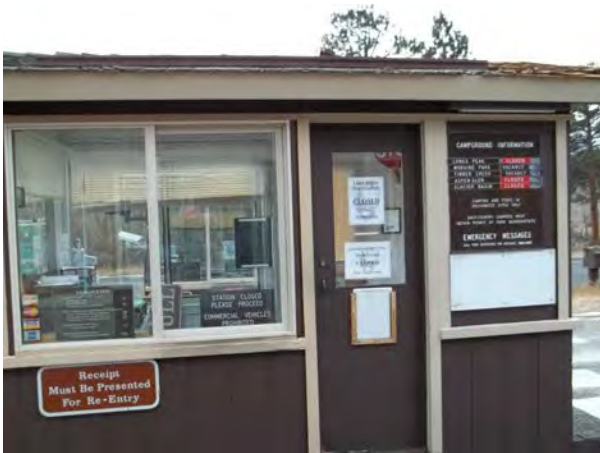
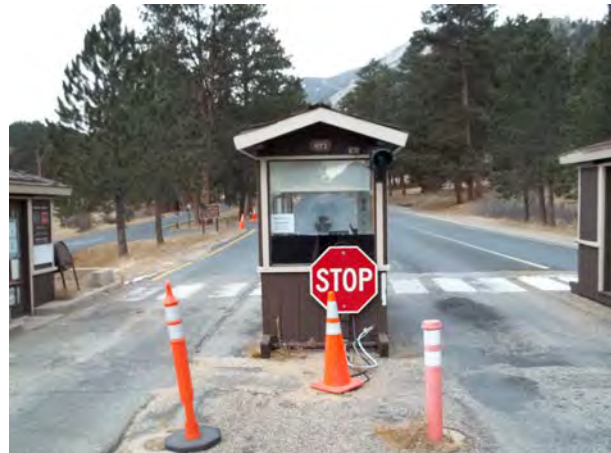
2013_ROMO_24052_B-0671-N Kiosk - Entrance Station Fall River_D.jpg

Score: 55
Rating: Low

Rating: Low
Protection Level : Not Designated
Local ID: [Local_ID]
Lat(WGS84): 40° 24.2576' Long(WGS84): -105° 35.5148'

Zone	Treatment Description	Pers Hours	Treatment Cycle	Treatment Priority	Treatment Status	Date Next Treatment Recommended	Equipment Description	Equip Qty
2	Mow dead/dying grass to less than 4 inches -	3		Unknown	Planned		-

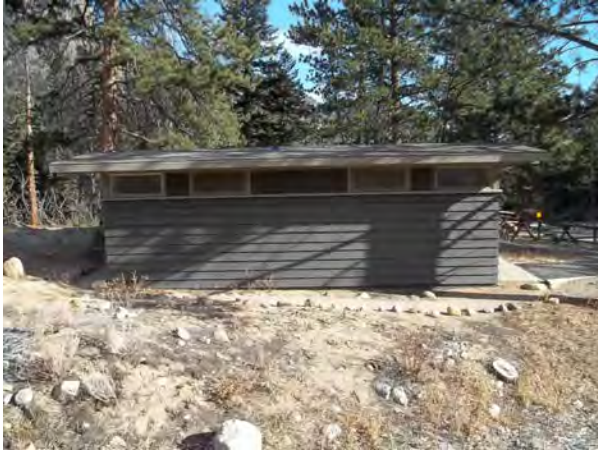
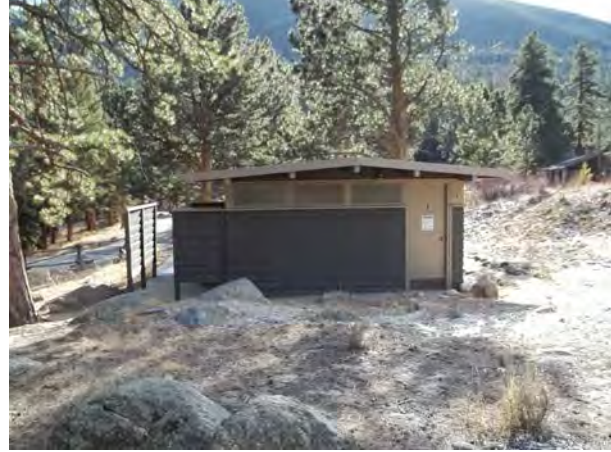
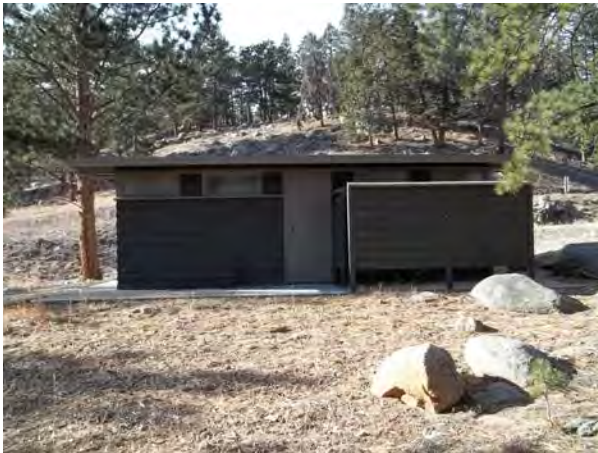
2013_ROMO_25280_B-0366-N Comfort Station Aspenglen Campground_D.jpg

Score: 33
Rating: Low

Rating: Low
Protection Level : Full
Local ID: [Local_ID]
Lat(WGS84): 40° 24.0276' Long(WGS84): -105° 35.5676'

Zone	Treatment Description	Pers Hours	Treatment Cycle	Treatment Priority	Treatment Status	Date Next Treatment Recommended	Equipment Description	Equip Qty
1	Clear adjacent and overhanging fuels to create 10 feet spacing between canopy and structure or chimney openings -	3		Unknown	Planned		-	
2	Flammable ground cover should be removed or isolated -	3		Unknown	Planned		-

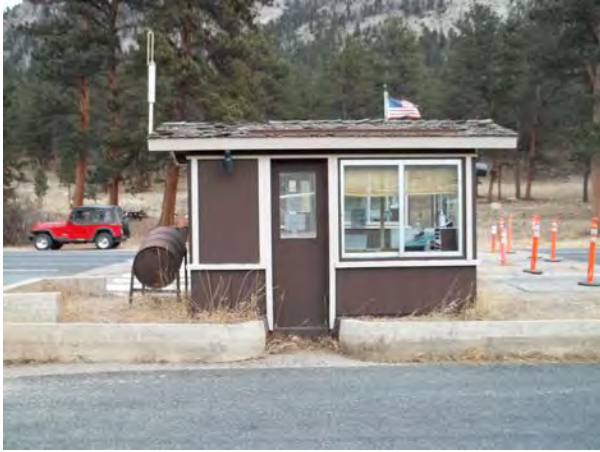
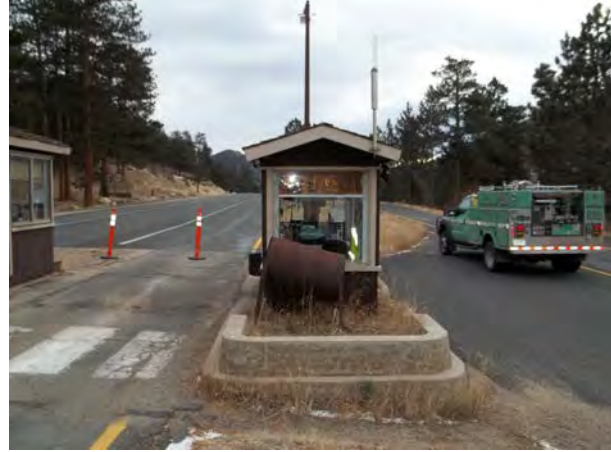
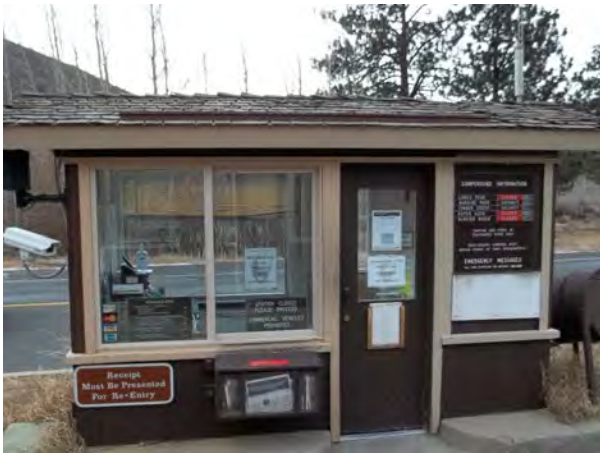
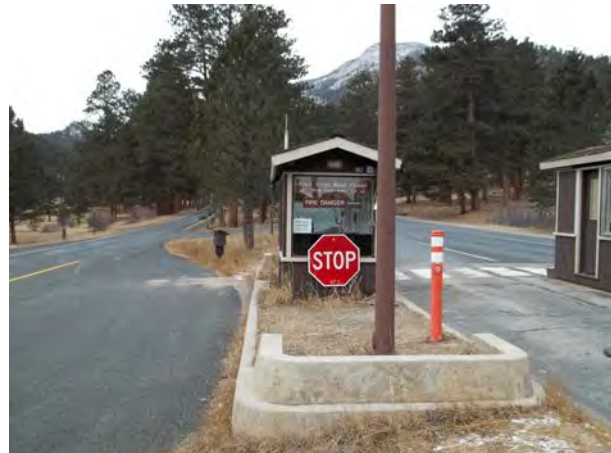
2013_ROMO_24048_B-0669-N Kiosk - Entrance Station Fall River_D.jpg

Score: 55
Rating: Moderate

Rating: Moderate
Protection Level : Unknown
Local ID: [Local_ID]
Lat(WGS84): 40° 24.2522' Long(WGS84): -105° 35.518'

Zone	Treatment Description	Pers Hours	Treatment Cycle	Treatment Priority	Treatment Status	Date Next Treatment Recommended	Equipment Description	Equip Qty
2	Mow dead/dying grass to less than 4 inches -	3		Unknown	Planned		-
