NPS Wildland Fire Risk Assessment - Community Assessment

Community: Wild Basin Entrance Station

Unit - Location: ROMO - Wild Basin

Last Site Visit Date: 9/24/2014

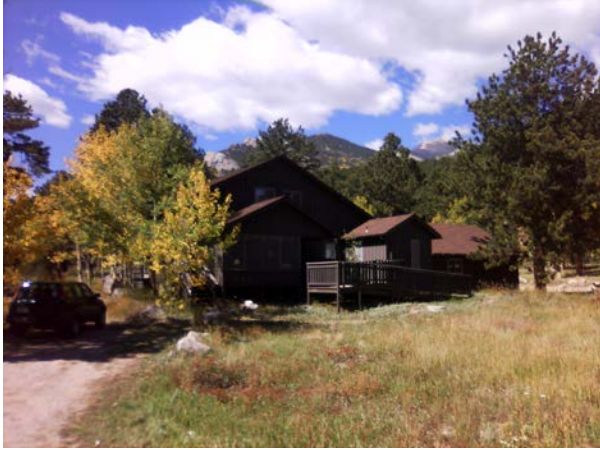
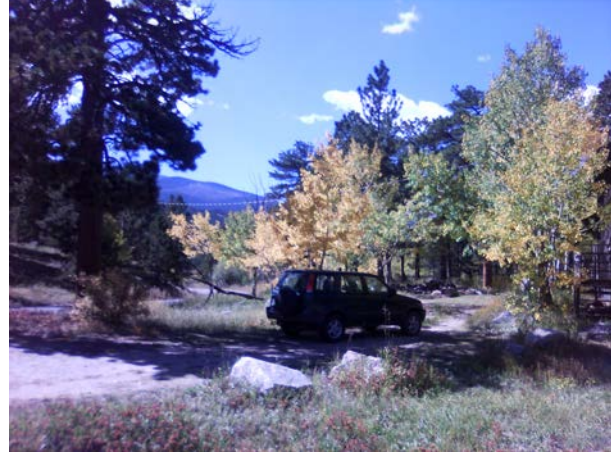
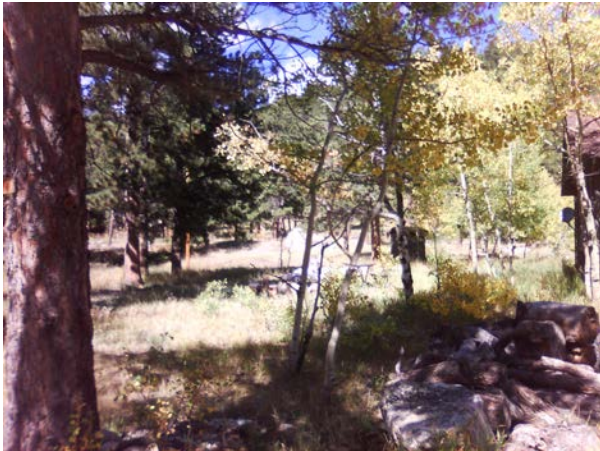
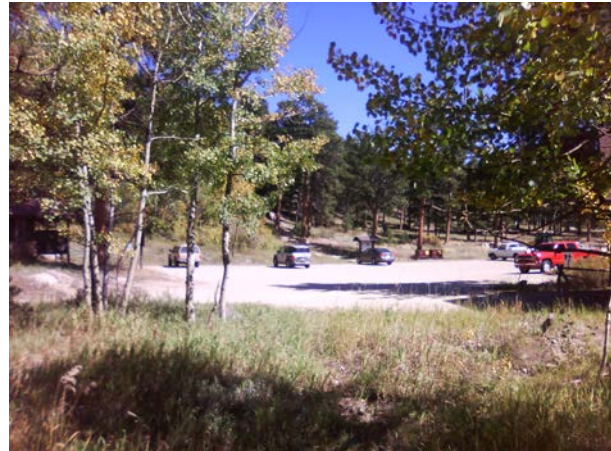
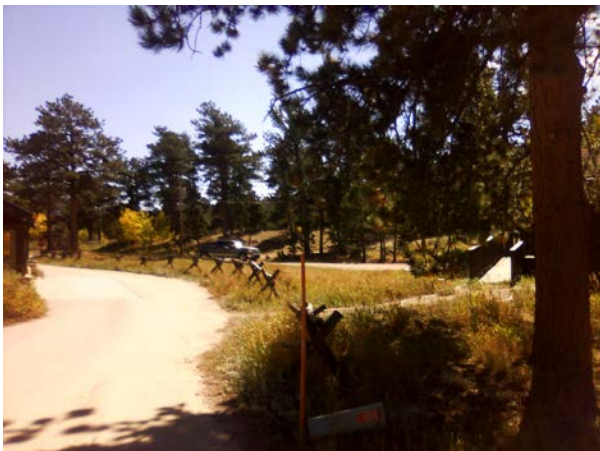
Rating: High
Protection Level : Not Designated
Local ID: [Local_ID]
Lat(WGS84): 40° 13.1673' Long(WGS84): -105° 32.0786'

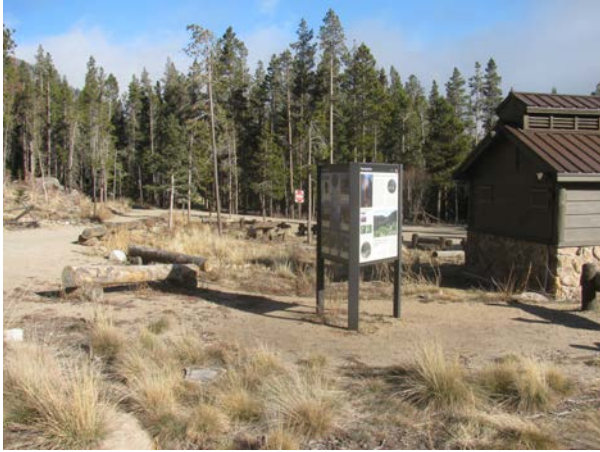
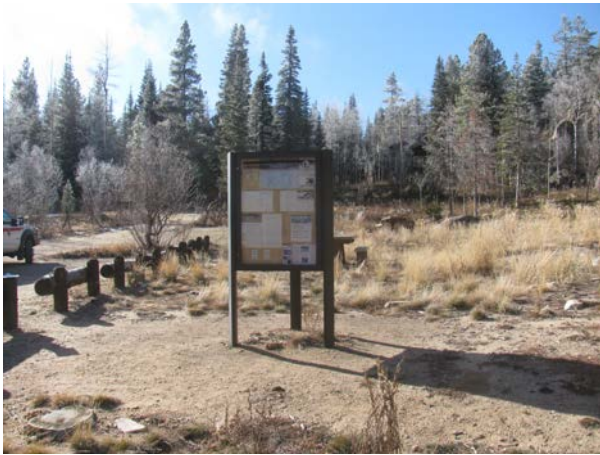
Rating: Moderate
Protection Level : Not Designated
Local ID: [Local_ID]
Lat(WGS84): 40° 12.4924' Long(WGS84): -105° 33.9846'

Zone	Treatment Description	Pers Hours	Treatment Cycle	Treatment Priority	Treatment Status	Date Next Treatment Recommended	Equipment Description	Equip Qty
2	Mow dead/dying grass to less than 4 inches -	5		Unknown	Planned		-

Triage Category	Tactic Description	Pers Hours	Equipment Description	Equip Qty
	Install sprinkler system - May set up sprinklers when panel is de-energized.	5.00	-	
	Other, please describe. - This is a metal kiosk sign surrounded by gravel. no prep work needed	3.00	-	
	Install sprinkler system - Other buildings would have sprinkler system in place, last ditch effort would be burnout. Should be okay after fuels reduction project.	6.00	-	
	Burnout, no line construction necessary - Last minute option.	6.00	-	
	Burnout, no line construction necessary -	3.00	-	
	Fuels reduction -	5.00	-	
	Remove flammable materials -	5.00	-

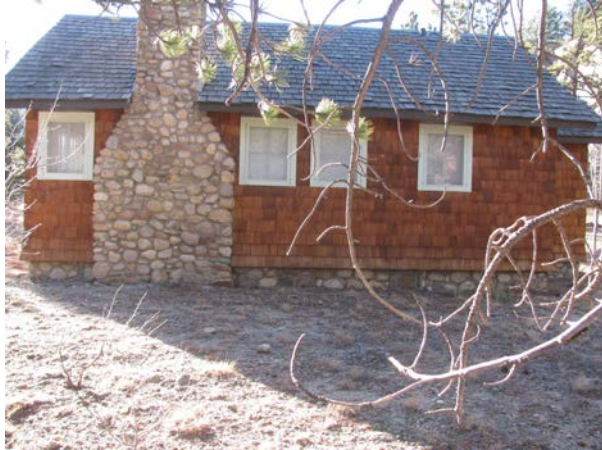
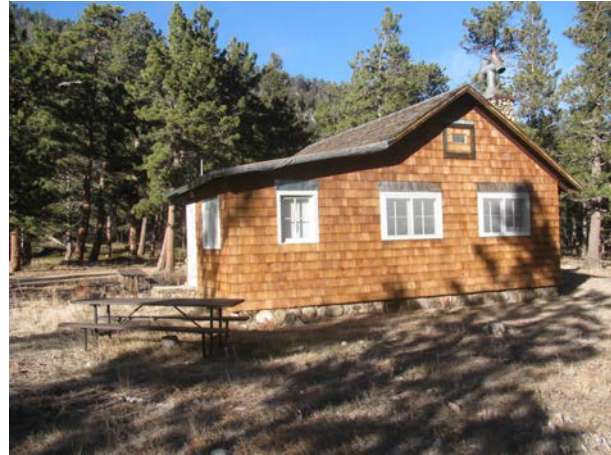
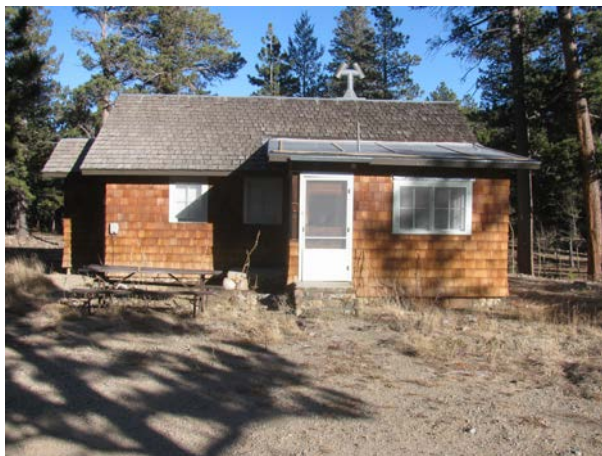
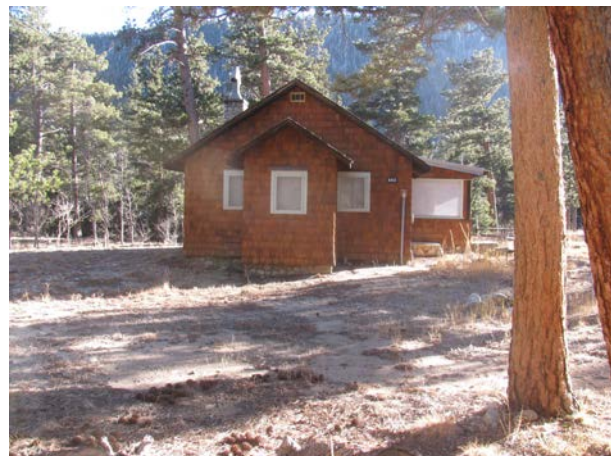
Rating: High
Protection Level : Not Designated
Local ID: [Local_ID]
Lat(WGS84): 40° 12.7096' Long(WGS84): -105° 33.1462'

Zone	Treatment Description	Pers Hours	Treatment Cycle	Treatment Priority	Treatment Status	Date Next Treatment Recommended	Equipment Description	Equip Qty
1	Flammable ground cover such as leaf litter, woody debris or highly flammable vegetation should be removed -	5		Unknown	Planned		-	
2	Mow dead/dying grass to less than 4 inches -	5		Unknown	Planned		-	
	Flammable ground cover should be removed or isolated -	5		Unknown	Planned		-	
3	Remove heavy ground fuels such as logs and stumps - Sign is well defendable with minimal work needed	5		Unknown	Planned		-

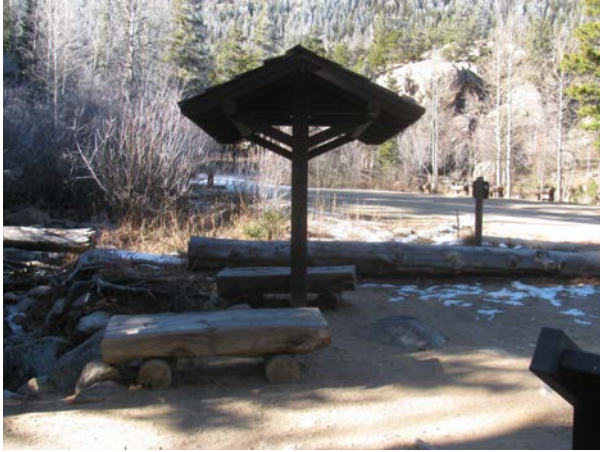
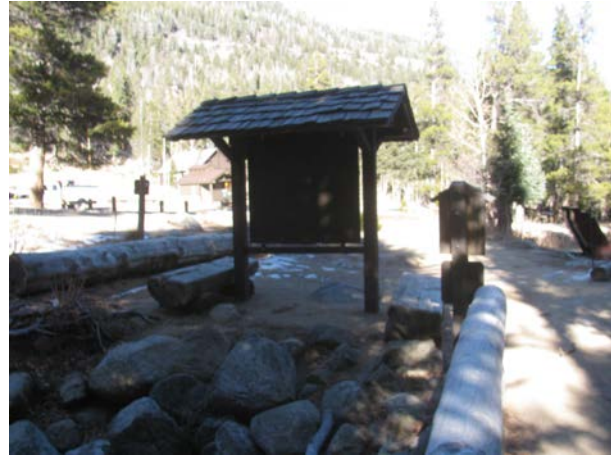
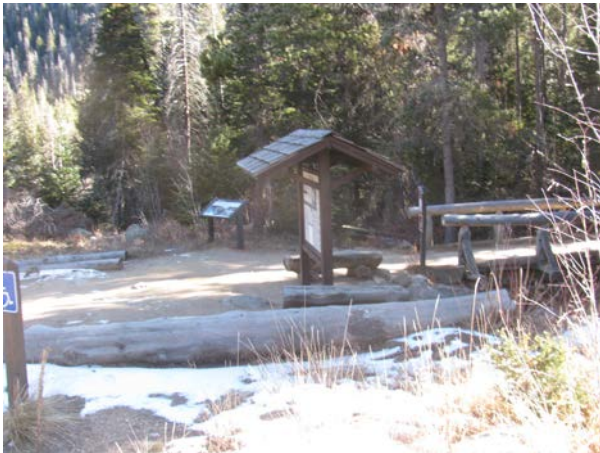
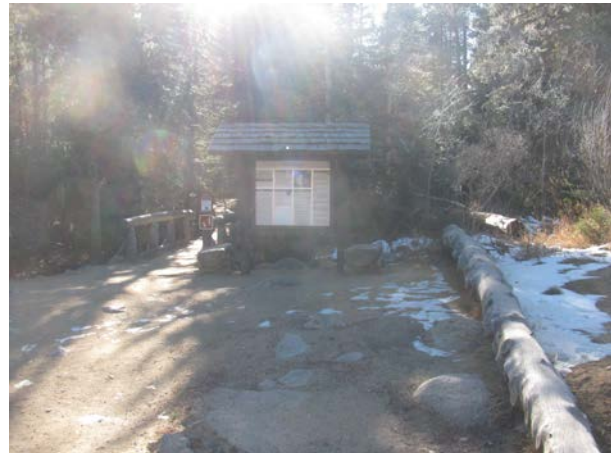
Rating: Moderate
Protection Level : Not Designated
Local ID: [Local_ID]
Lat(WGS84): 40° 12.465' Long(WGS84): -105° 33.9942'

Zone	Treatment Description	Pers Hours	Treatment Cycle	Treatment Priority	Treatment Status	Date Next Treatment Recommended	Equipment Description	Equip Qty
1	Firewood should be moved at least 50 ft from the facility and 15 horizontal feet from tree canopies -	5		Unknown	Planned		-	
	Clear adjacent and overhanging fuels to create 10 feet spacing between canopy and structure or chimney openings -	5		Unknown	Planned		-	
	Roof and gutters should be cleared of vegetative debris -	5		Unknown	Planned		-	
2	Mow dead/dying grass to less than 4 inches -	5		Unknown	Planned		-	
	Flammable ground cover should be removed or isolated -	5		Unknown	Planned		-

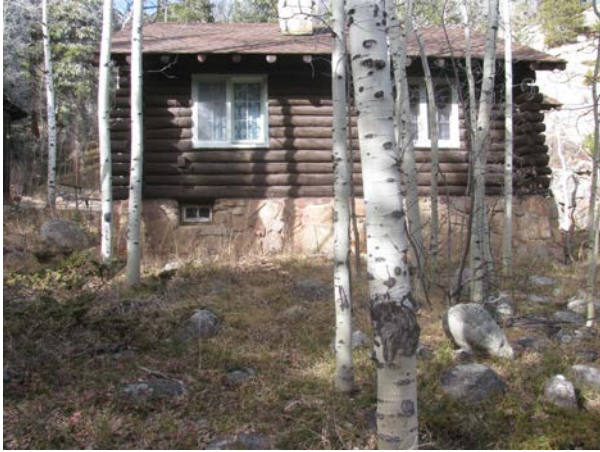
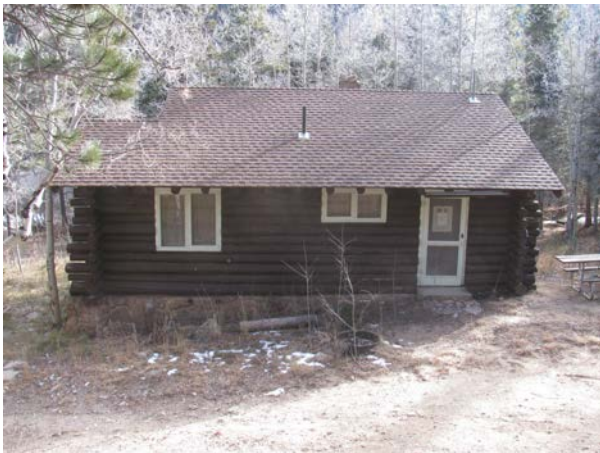
Rating: High
Protection Level : Not Designated
Local ID: [Local_ID]
Lat(WGS84): 40° 12.4902' Long(WGS84): -105° 34.0517'

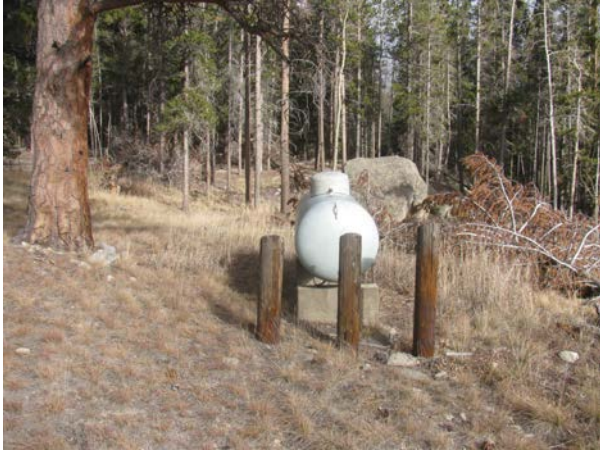
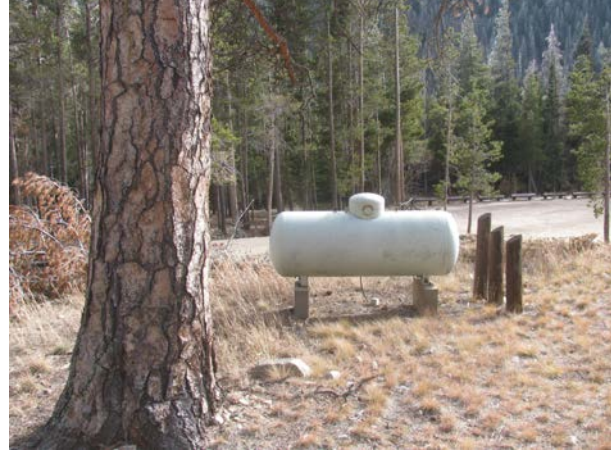
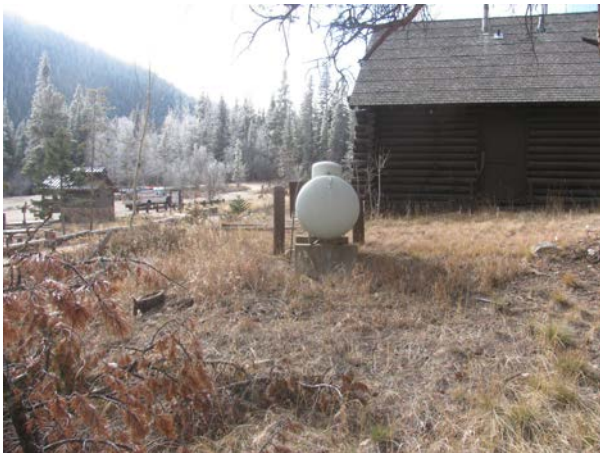
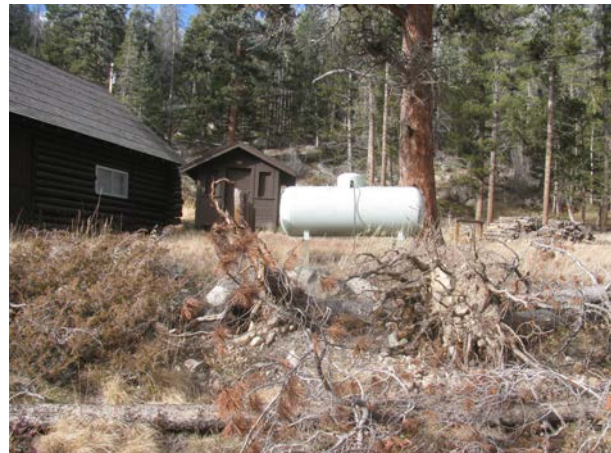
Rating: High
Protection Level : Not Designated
Local ID: [Local_ID]
Lat(WGS84): 40° 12.5132' Long(WGS84): -105° 33.9751'
