Location: 100 Castle Creek Rd, WILDERNESS STREAMS FILING NO. 2

Coordinates (DDM): 38° 46.291' N, 107° 04.891' W

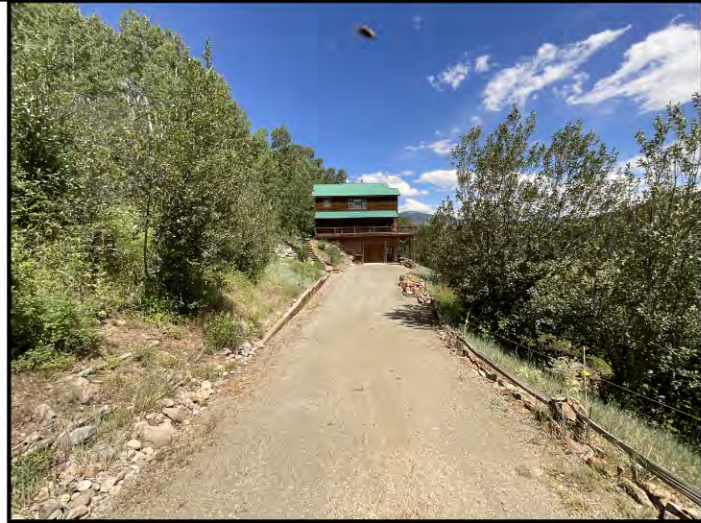
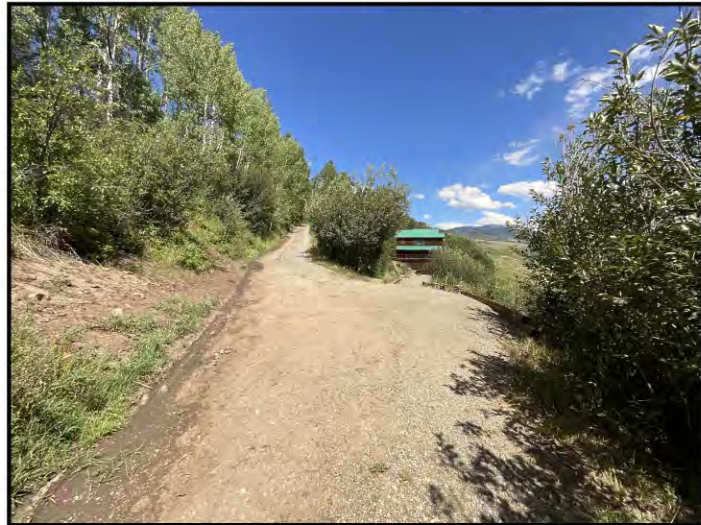
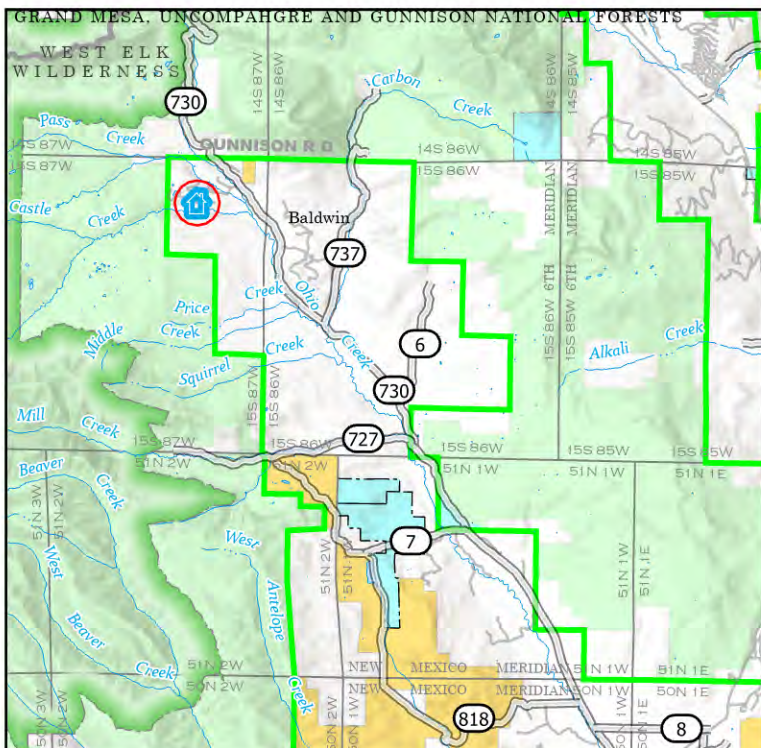
Triage Category: Defensible, Prep and Hold
FIRESCOPE Triage Category: Threatened Defensible
Structure Number: 100 Castle Creek Rd
Collected Date/Time: 8/3/2023 8:23:02 PM
Collected By: Jesse Gallup
Inspector's Position: FFTI
Type of Structure: Residential
Primary Structures: 1
Is the building Occupied?: Yes
Outbuildings: 0
Fuel Surrounding Structure: Shrub or timber
Defensible Space: 30 ft treated
Roof Material: Noncombustible or not applicable
Siding Material: Wood or open sided
Electrical Power: Yes
Gas to Structure: Yes
Hazards: Tight escape route,
Access to Site: T6 Engine
Describe Access: Narrow improved driveway with switchback
Comm With ICP: Yes
Water Source: No reliable water source nearby
Safety Zone Present:
Mitigation Time (in hours): 1
Mitigation Description: Removing combustibles below home
Resources Needed to Protect Structure: 1 engine
FIRESCOPE Tactics: Prep and Defend
Notes: Wood paneling on 2nd and 3rd floor cement garage, old wood porch

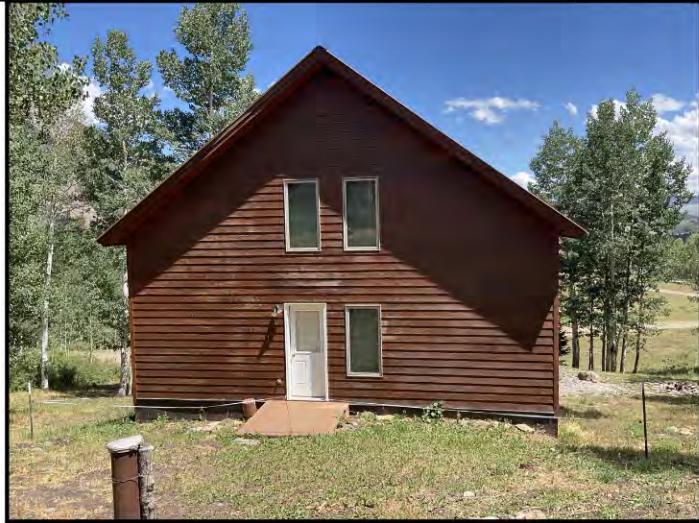
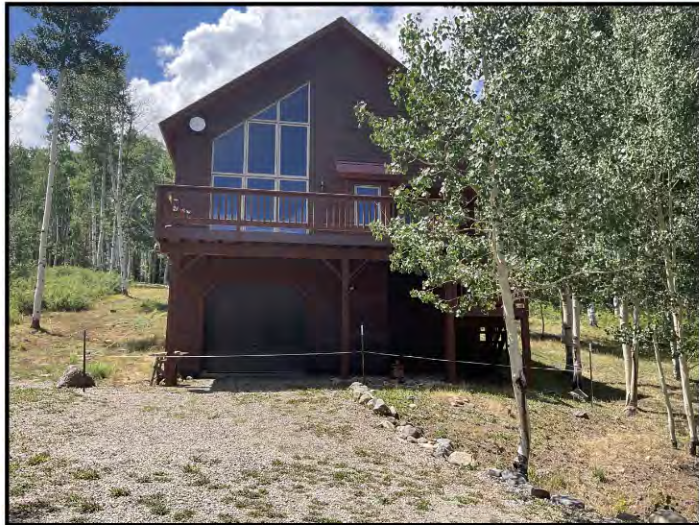
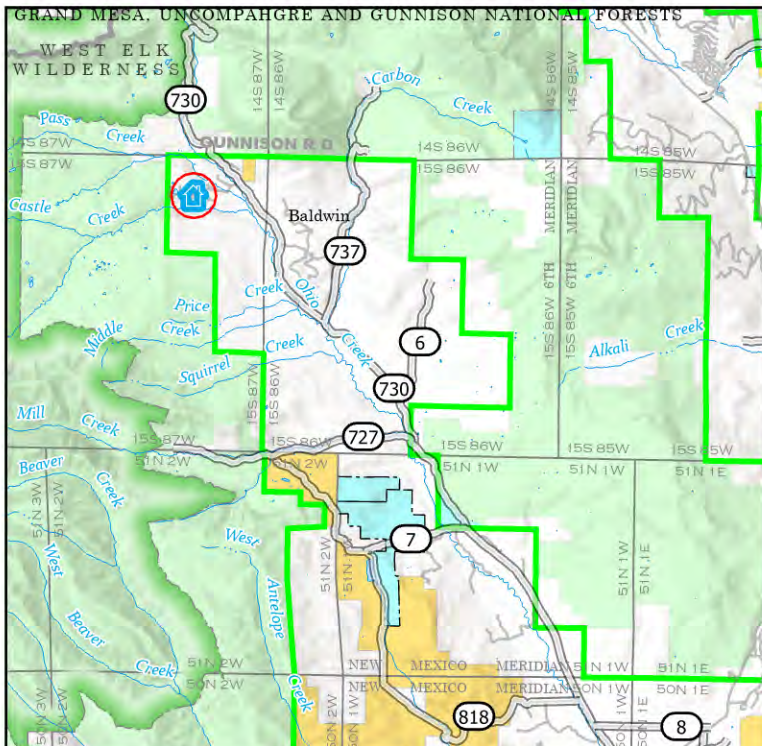
Location: 1022 Sioux Rd, WILDERNESS STREAMS FILING NO. 2

Triage Category: Defensible, Prep and Hold
FIRESCOPE Triage Category: Threatened Defensible
Structure Number: 1022 Sioux Rd
Collected Date/Time: 8/3/2023 8:07:35 PM
Collected By: Cody Peterson
Inspector's Position: ENGB
Type of Structure: Residential
Primary Structures: 1
Is the building Occupied?: No
Outbuildings: 0
Fuel Surrounding Structure: Grass and shrub, hardwood litter
Defensible Space: 100 ft treated
Roof Material: Noncombustible or not applicable
Siding Material: Wood or open sided
Electrical Power: Yes
Gas to Structure: No
Hazards:
Access to Site: T1 Engine
Describe Access: Maintained gravel
Comm With ICP: Yes
Water Source: Reliable water source nearby
Safety Zone Present:
Mitigation Time (in hours): 1
Mitigation Description: Weed eat
Resources Needed to Protect Structure: Engine
FIRESCOPE Tactics: Prep and Defend
Notes:

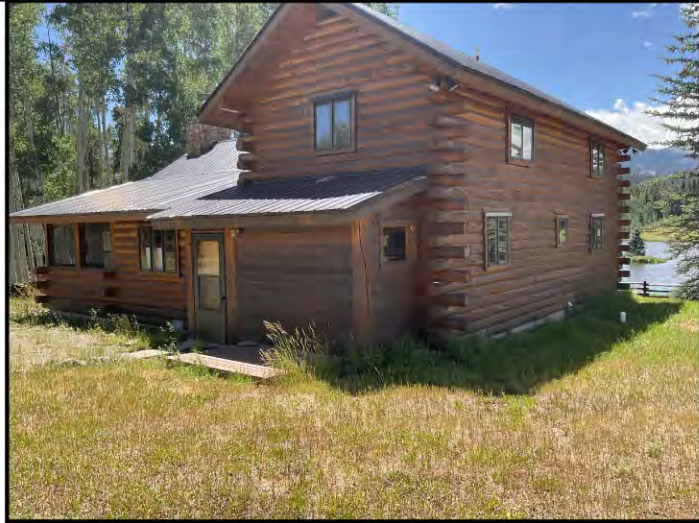
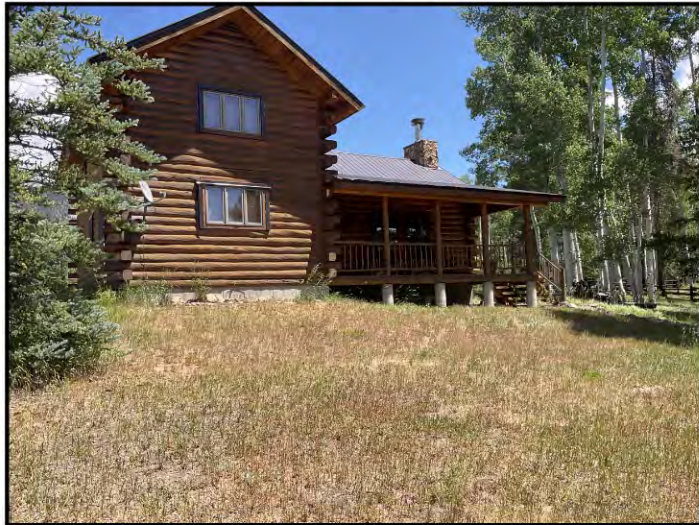
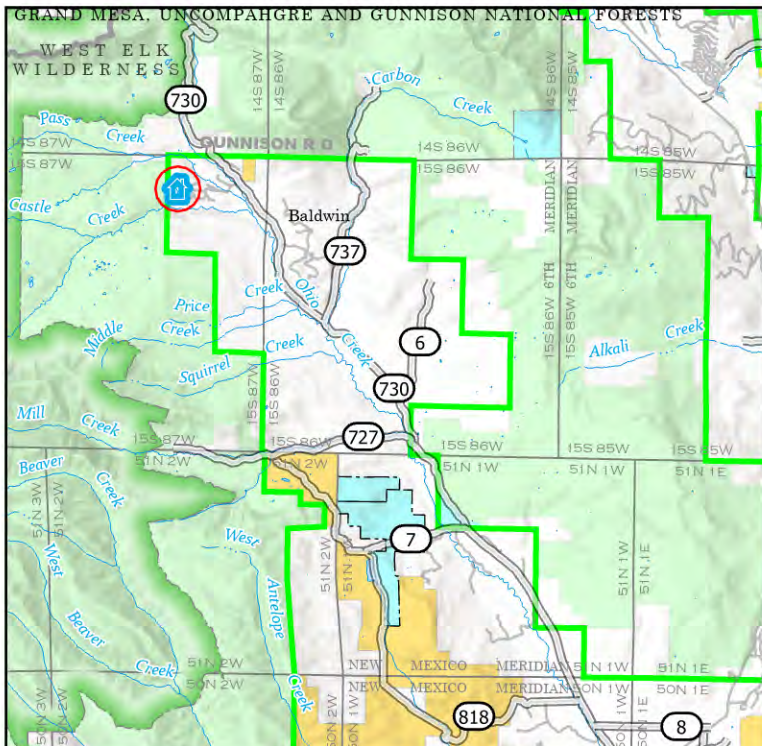
Location: 113 Yuma Trl, WILDERNESS STREAMS FILING NO. 2

Triage Category: Defensible, Prep and Hold
FIRESCOPE Triage Category: Threatened Defensible
Structure Number: 113 Yuma Trl
Collected Date/Time: 8/3/2023 7:09:55 PM
Collected By: Cody Peterson
Inspector's Position: ENGB
Type of Structure: Residential
Primary Structures: 1
Is the building Occupied?: No
Outbuildings: 0
Fuel Surrounding Structure: Grass and shrub, hardwood litter
Defensible Space: 100 ft treated
Roof Material: Noncombustible or not applicable
Siding Material: Log construction
Electrical Power: Yes
Gas to Structure: No
Hazards:
Access to Site: T3/4 Engine
Describe Access: Maintained Gravel
Comm With ICP: Yes
Water Source: Reliable water source nearby
Safety Zone Present:
Mitigation Time (in hours): 1
Mitigation Description: Weed eat
Resources Needed to Protect Structure: Engine
FIRESCOPE Tactics: Prep and Defend
Notes:

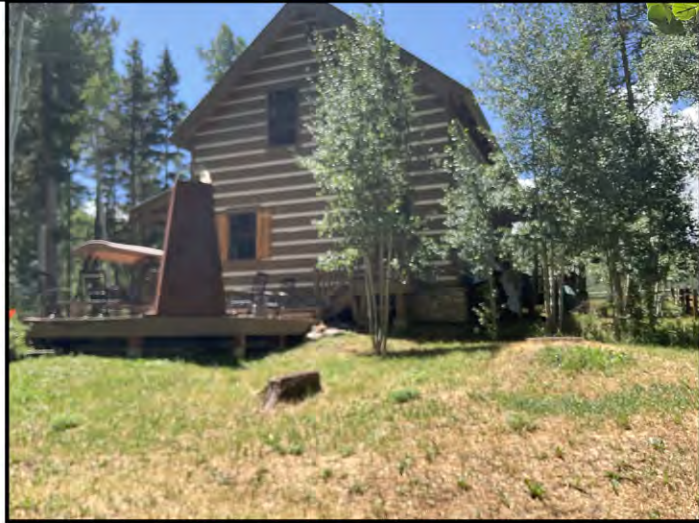
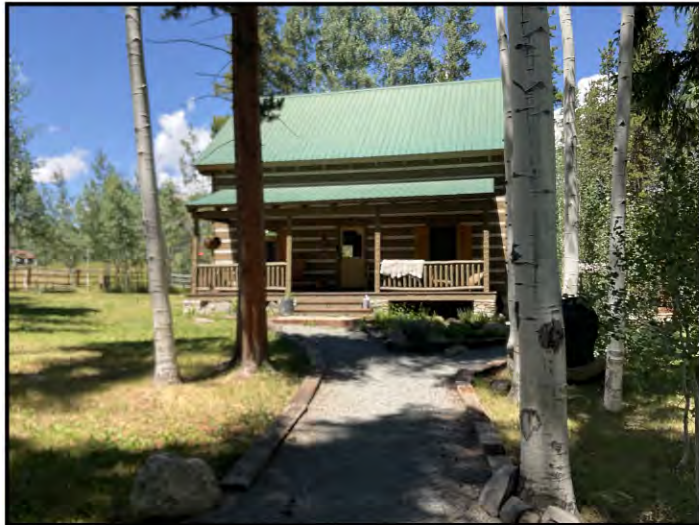
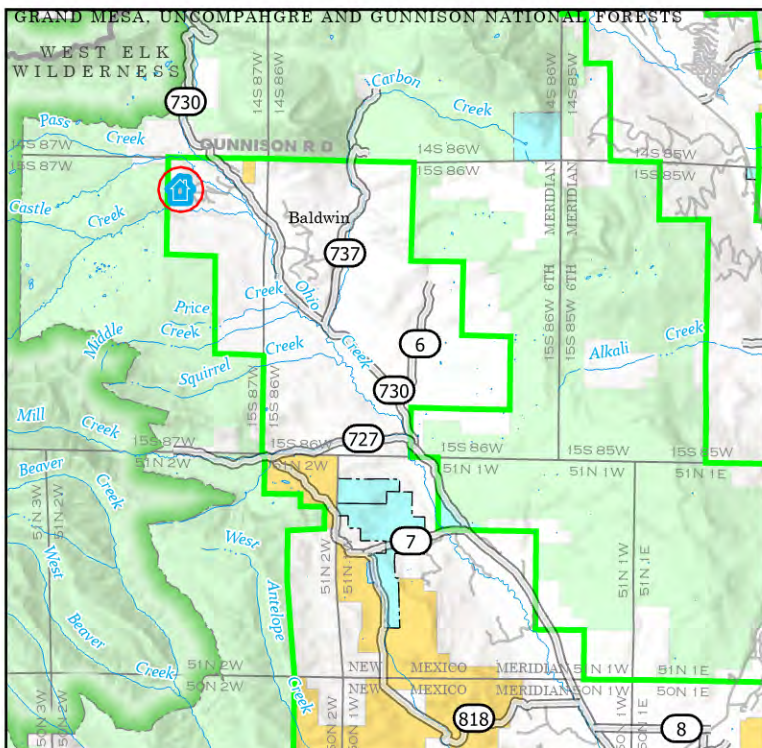
Location: 114 Yuma Trl, WILDERNESS STREAMS FILING NO. 2

Triage Category: Defensible, Prep and Hold
FIRESCOPE Triage Category: Threatened Defensible
Structure Number: 114 Yuma Trl
Collected Date/Time: 8/3/2023 7:17:52 PM
Collected By: Cody Peterson
Inspector's Position: ENGB
Type of Structure: Residential
Primary Structures: 1
Is the building Occupied?: Yes
Outbuildings: 1
Fuel Surrounding Structure: Grass and shrub, hardwood litter
Defensible Space: More than 100ft treated
Roof Material: Noncombustible or not applicable
Siding Material: Wood or open sided
Electrical Power: Yes
Gas to Structure: No
Hazards:
Access to Site: T3/4 Engine
Describe Access: Maintained gravel
Comm With ICP: Yes
Water Source: Reliable water source nearby
Safety Zone Present:
Mitigation Time (in hours): 1
Mitigation Description: Weed eat,
Resources Needed to Protect Structure: Engine
FIRESCOPE Tactics: Prep and Defend
Notes:

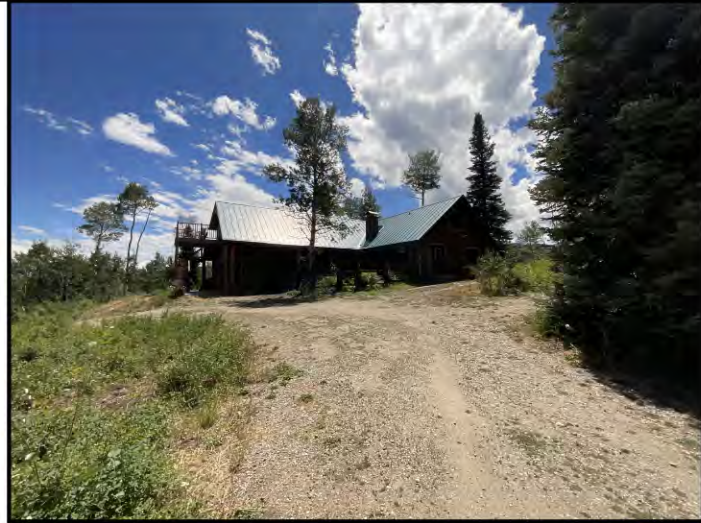
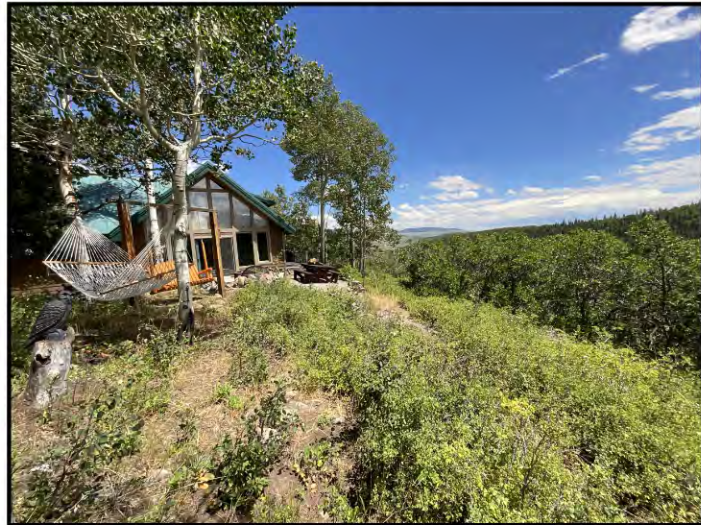
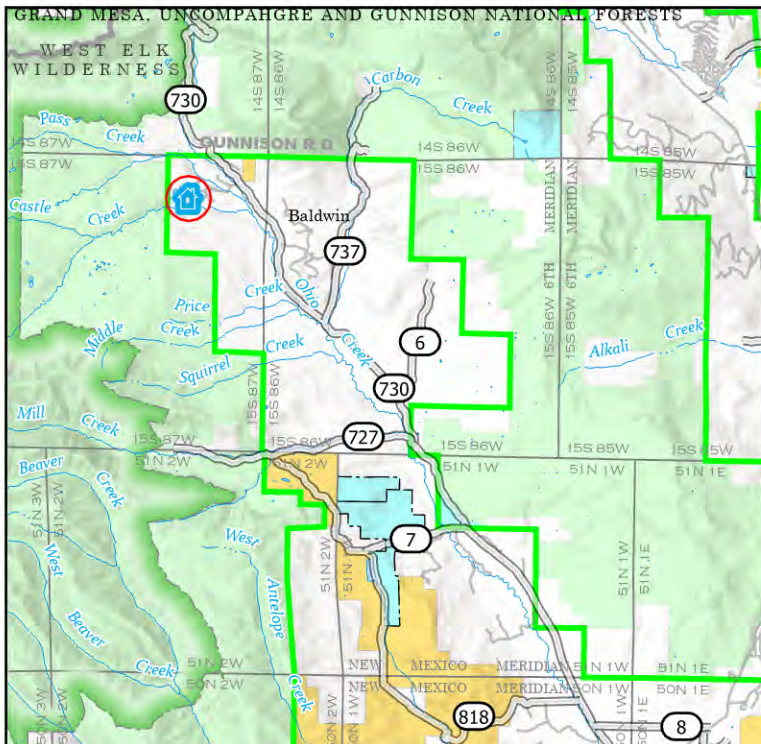
Location: 1142 Sioux Rd, WILDERNESS STREAMS FILING NO. 2

Triage Category: Defensible, Prep and Hold
FIRESCOPE Triage Category: Threatened Defensible
Structure Number: 1142 Sioux Rd
Collected Date/Time: 8/3/2023 8:00:50 PM
Collected By: Bo Knickman
Inspector's Position: Engb
Type of Structure: Residential
Primary Structures: 1
Is the building Occupied?: No
Outbuildings: 1
Fuel Surrounding Structure: Shrub or timber
Defensible Space: Less than 30 ft treated
Roof Material: Noncombustible or not applicable
Siding Material: Wood or open sided
Electrical Power: Yes
Gas to Structure: No
Hazards:
Access to Site: T1 Engine
Describe Access: Short pull through driveway with minimal fuels
Comm With ICP: Yes
Water Source: No reliable water source nearby
Safety Zone Present:
Mitigation Time (in hours): 1
Mitigation Description: Oak brush on south side needs to be cut back, other small grass and shrub around the home, flammable items to be removed against home
Resources Needed to Protect Structure: 1 engine

FIRESCOPE Tactics: Prep and Defend
Notes: 1 shed across the street

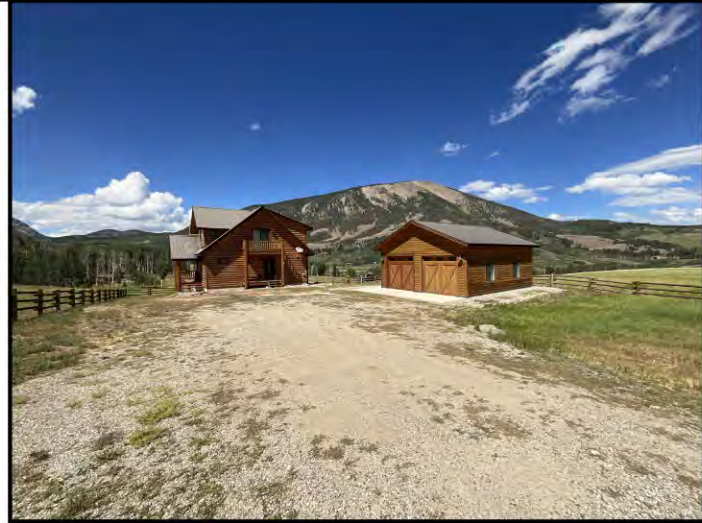
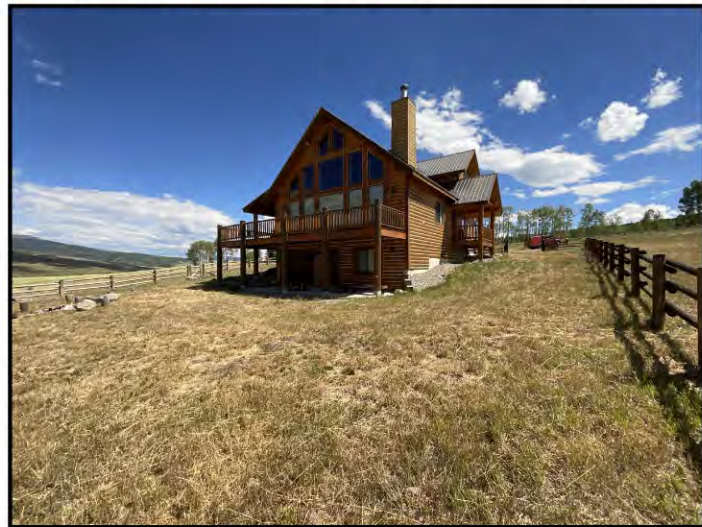
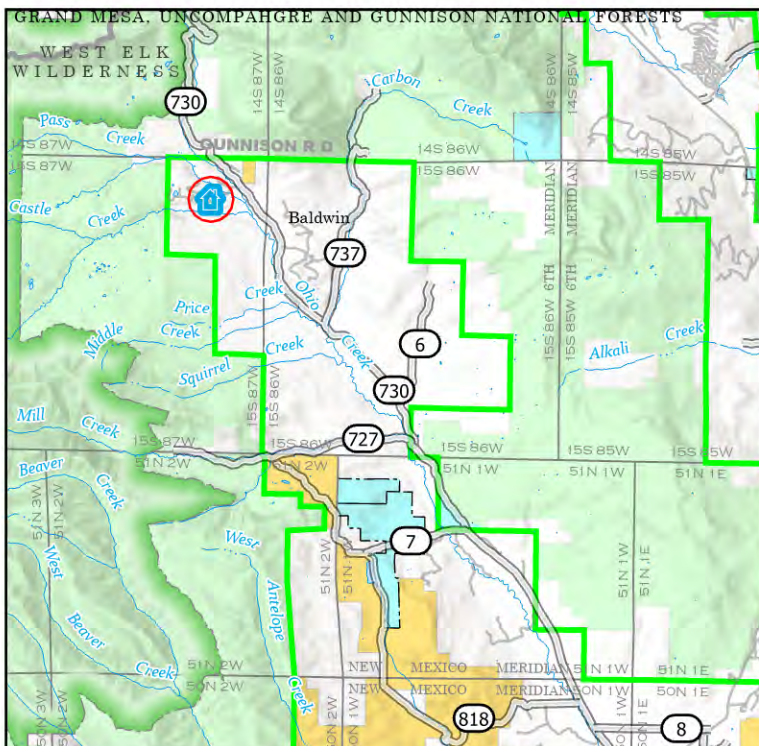
Location: 115 Kiowa Trl, WILDERNESS STREAMS FILING NO. 2

Triage Category: Defensible, Prep and Hold
FIRESCOPE Triage Category: Threatened Defensible
Structure Number: 115 Kiowa Trl
Collected Date/Time: 8/3/2023 9:21:02 PM
Collected By: Bo Knickman
Inspector's Position: Engb
Type of Structure: Residential
Primary Structures: 1
Is the building Occupied?: No
Outbuildings: 1
Fuel Surrounding Structure: Grass and shrub, hardwood litter
Defensible Space: More than 100ft treated
Roof Material: Noncombustible or not applicable
Siding Material: Log construction
Electrical Power: Yes
Gas to Structure: No
Hazards:
Access to Site: T1 Engine
Describe Access: Short wide improved driveway
Comm With ICP: Yes
Water Source: No reliable water source nearby
Safety Zone Present:
Mitigation Time (in hours): 1
Mitigation Description: Removing combustibles from and below deck
Resources Needed to Protect Structure: 1 engine
FIRESCOPE Tactics: Prep and Defend
Notes: 2 car detached garage

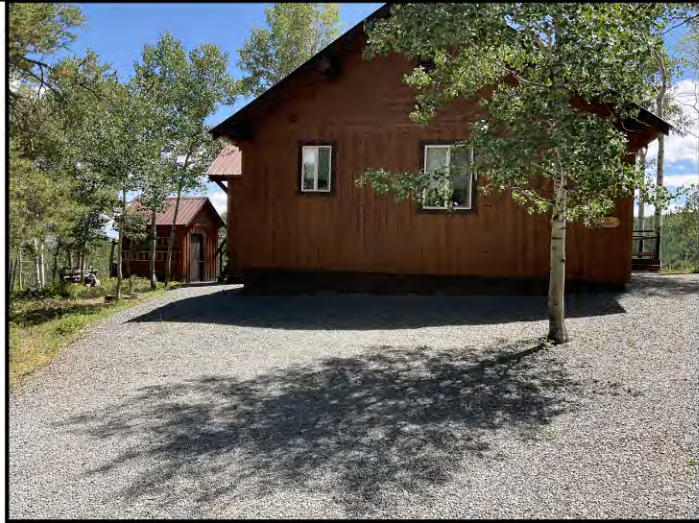
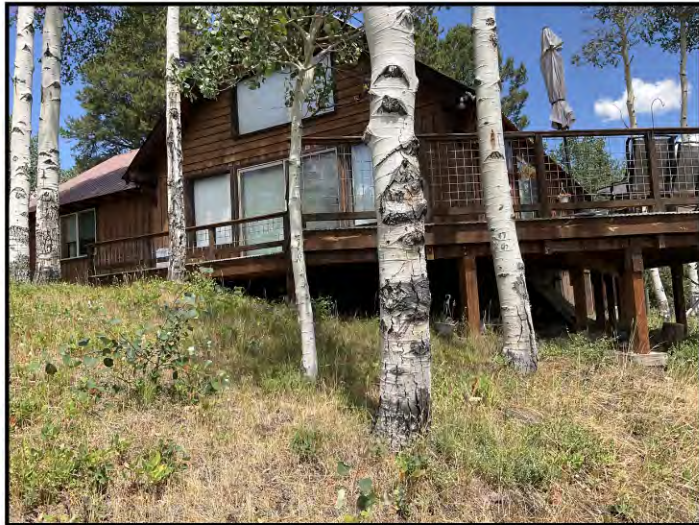
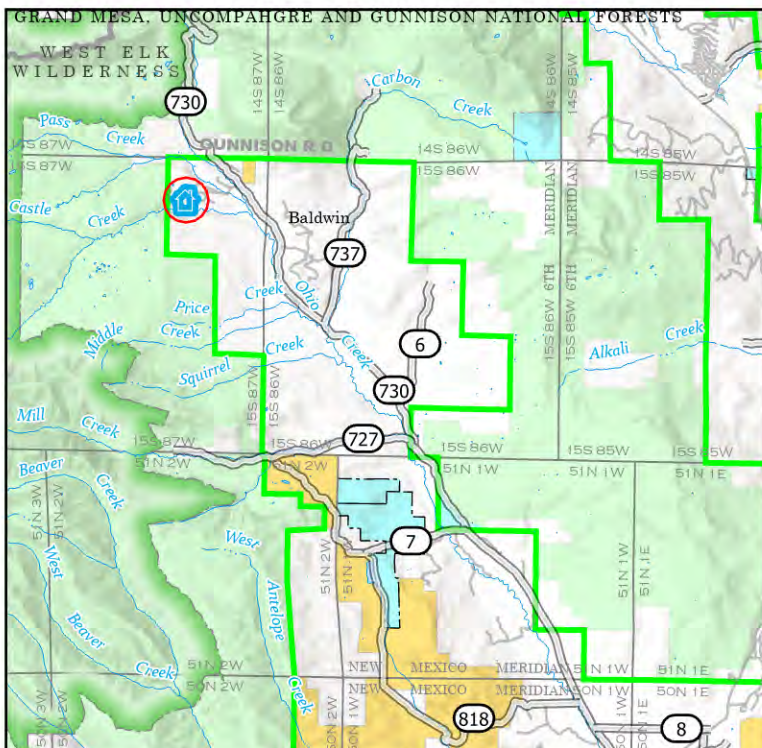
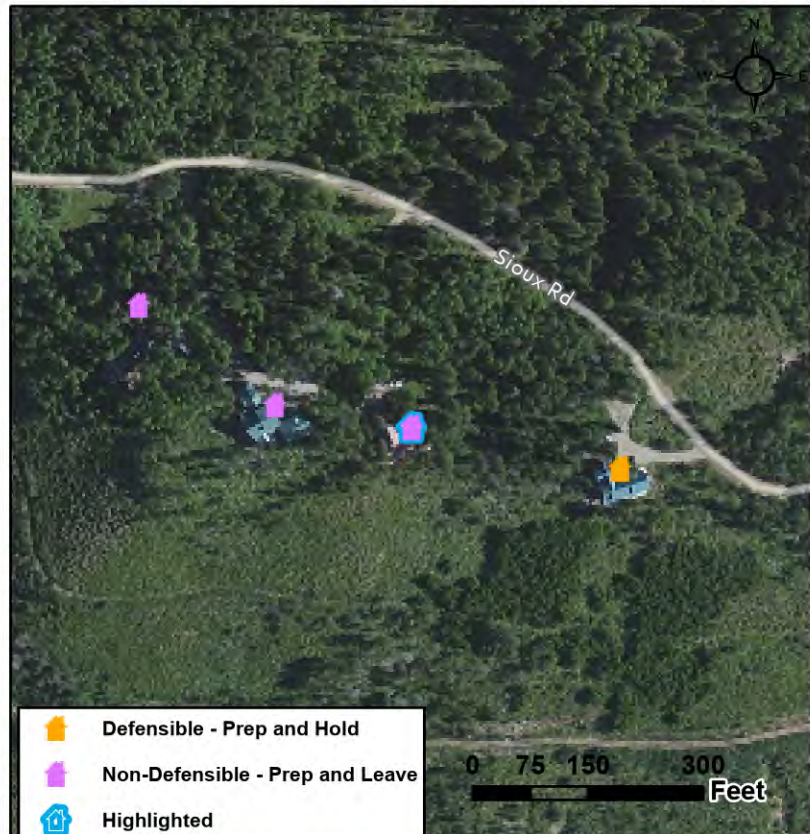
Location: 1210 Sioux Rd, WILDERNESS STREAMS FILING NO. 2

Triage Category: Non-Defensible, Prep and Leave

Notes: Defensible, No safety zone present

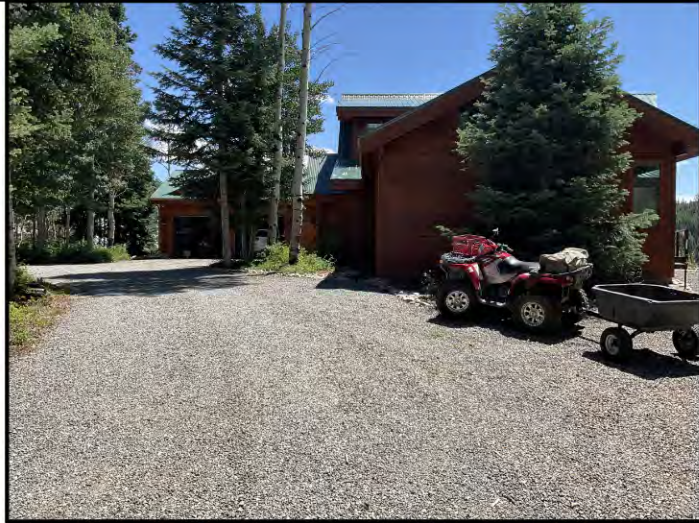
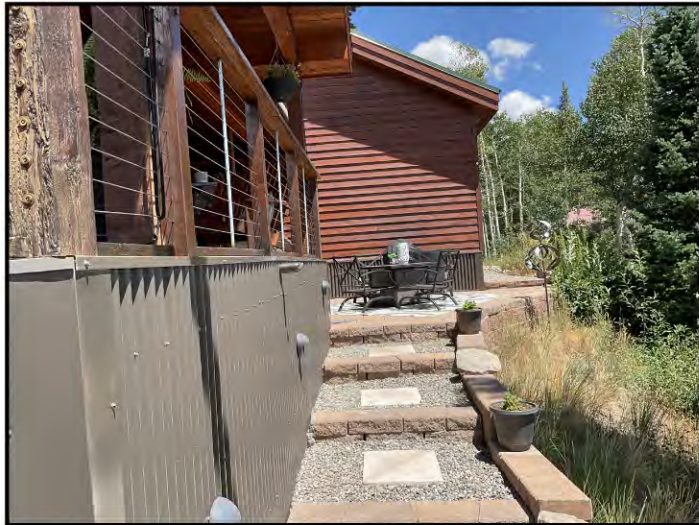
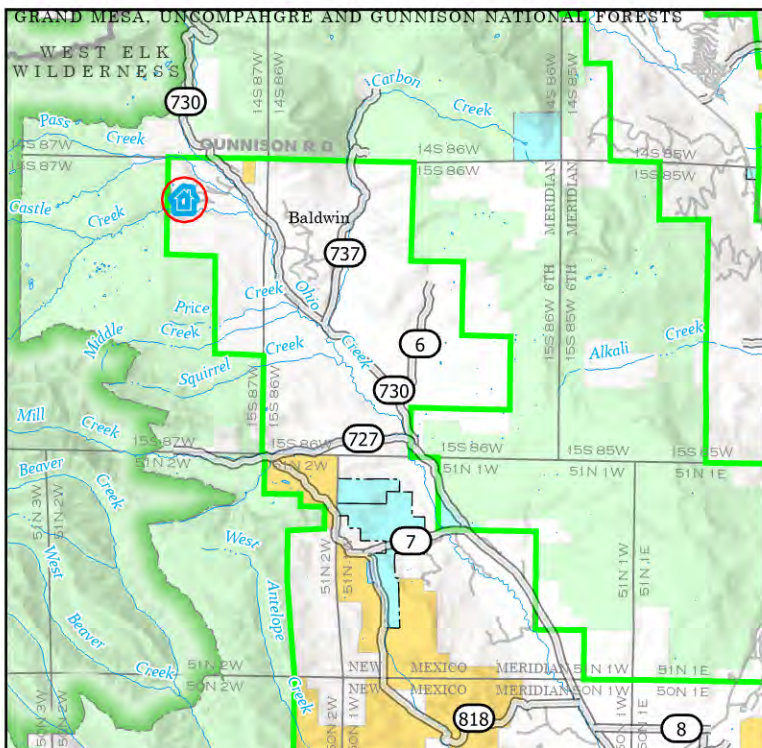
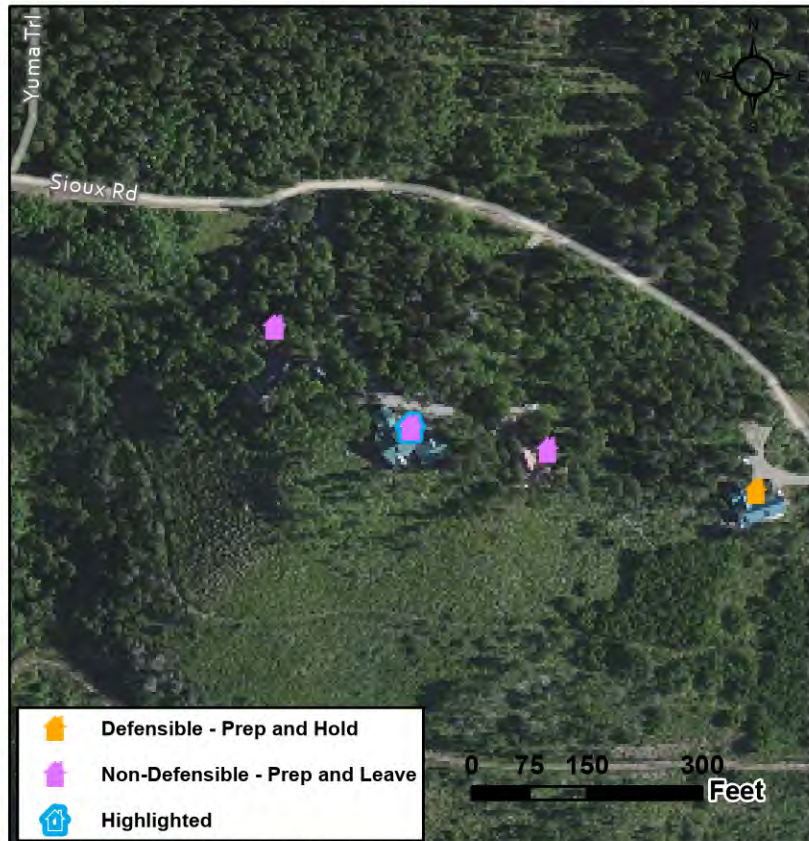
Location: 1262 Sioux Rd, WILDERNESS STREAMS FILING NO. 2

Notes: Defensible, no safety zone present

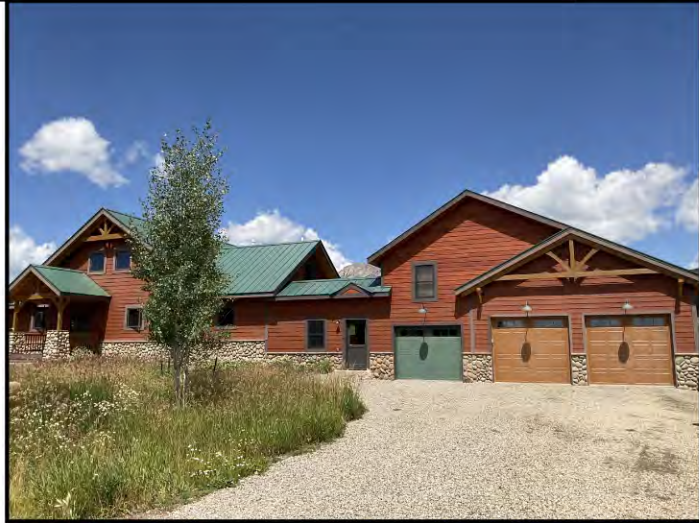
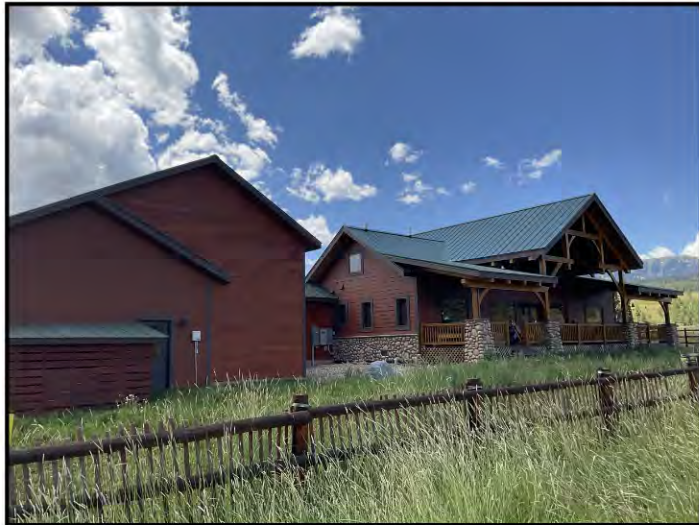
Location: 129 Sioux Rd, WILDERNESS STREAMS FILING NO. 2

Triage Category: Defensible, Prep and Hold
FIRESCOPE Triage Category: Not Threatened
Structure Number: 129 Sioux Rd
Collected Date/Time: 8/3/2023 6:00:32 PM
Collected By: Adam Altergott
Inspector's Position: ENGB
Type of Structure: Residential
Primary Structures: 1
Is the building Occupied?: Yes
Outbuildings: 1
Fuel Surrounding Structure: Grass and shrub, hardwood litter
Defensible Space: Less than 30 ft treated
Roof Material: Noncombustible or not applicable
Siding Material: Rock, concrete, metal
Electrical Power: Yes
Gas to Structure: Yes
Hazards: Propane tank next to garage
Access to Site: T1 Engine
Describe Access: Level gravel access, along rd.
Comm With ICP: Yes
Water Source: Reliable water source nearby
Safety Zone Present:
Mitigation Time (in hours): 1
Mitigation Description: Needs grass cut 30 foot minimum
Resources Needed to Protect Structure: 1 any type Engine
FIRESCOPE Tactics: Prep and Defend
Notes: Newer, hardy construction

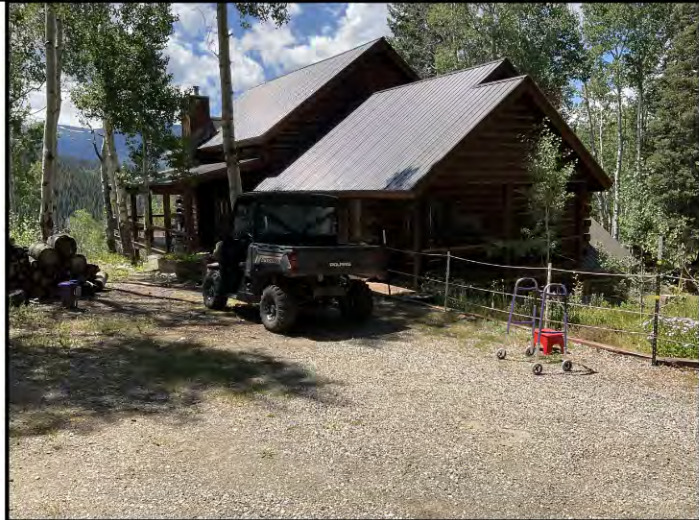
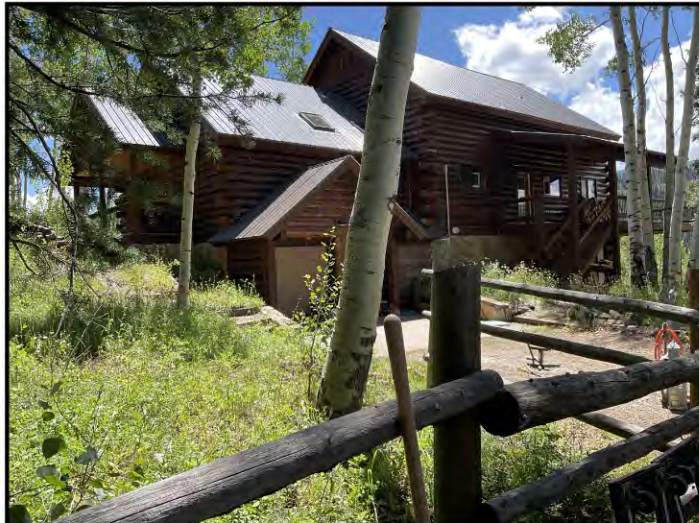
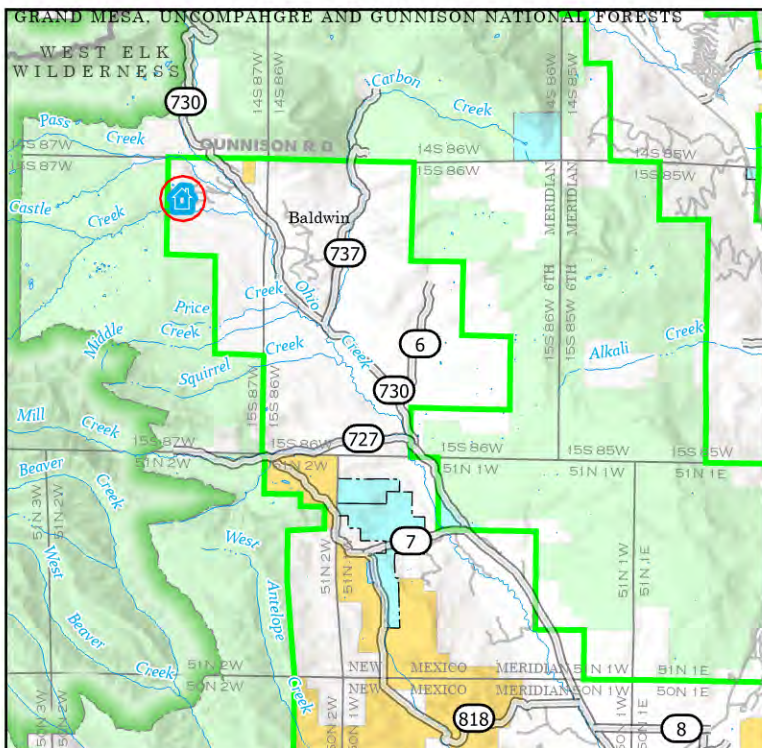
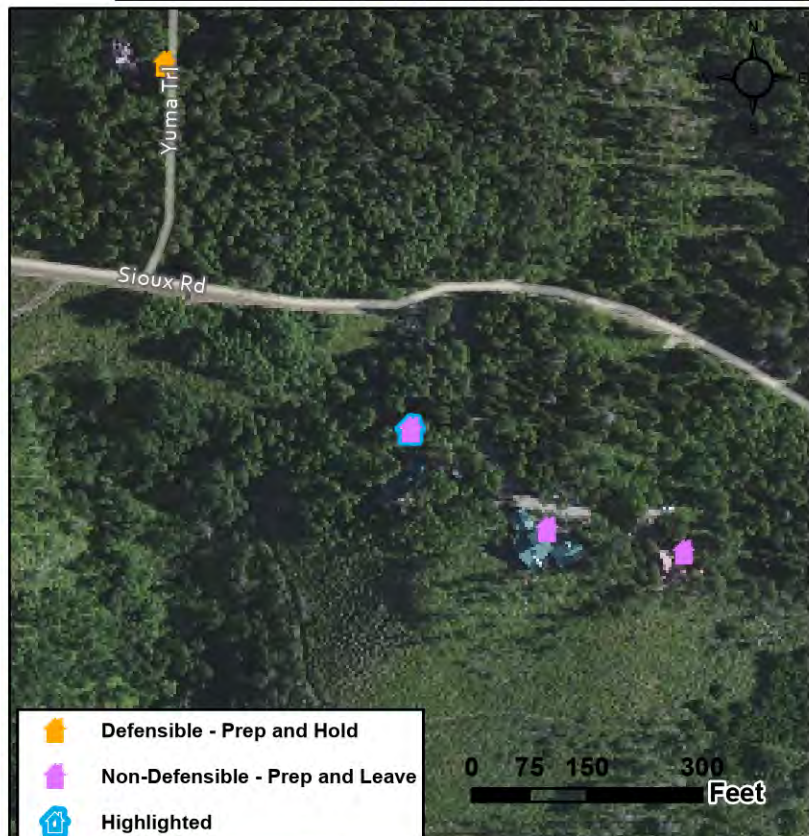
Location: 1310 Sioux Rd, WILDERNESS STREAMS FILING NO. 2

Hazards: Electric fence, mobility limited residence

Notes: Defensible no safety zone present

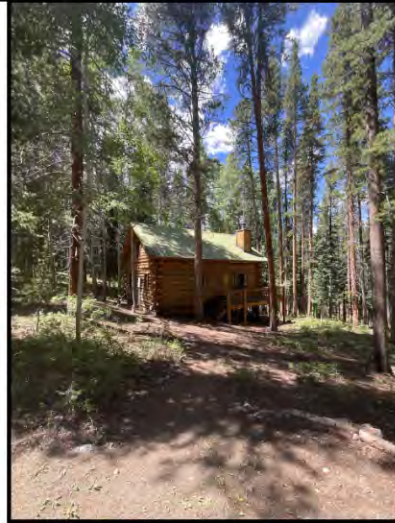
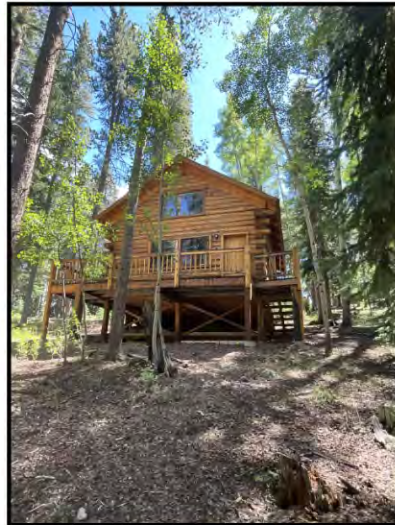
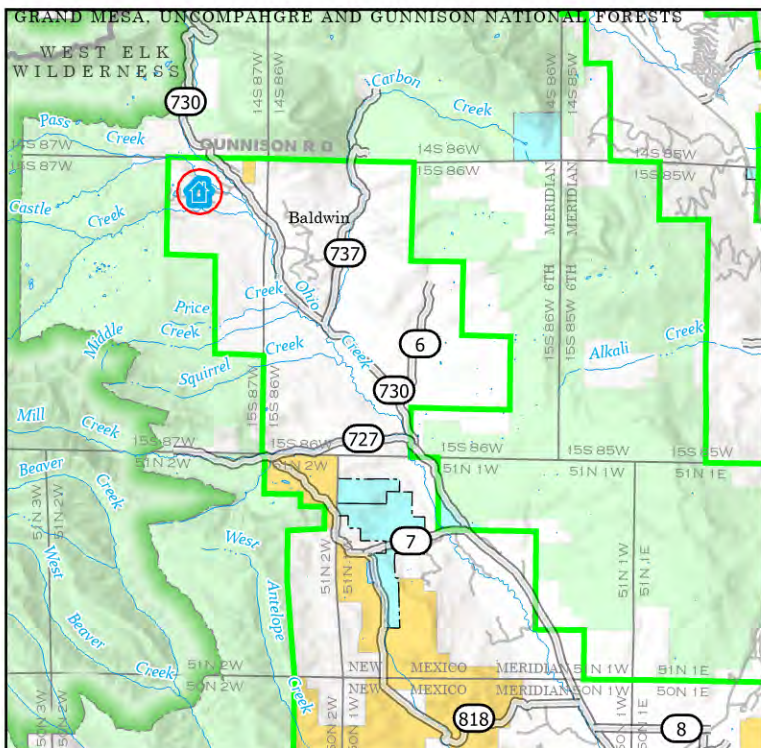
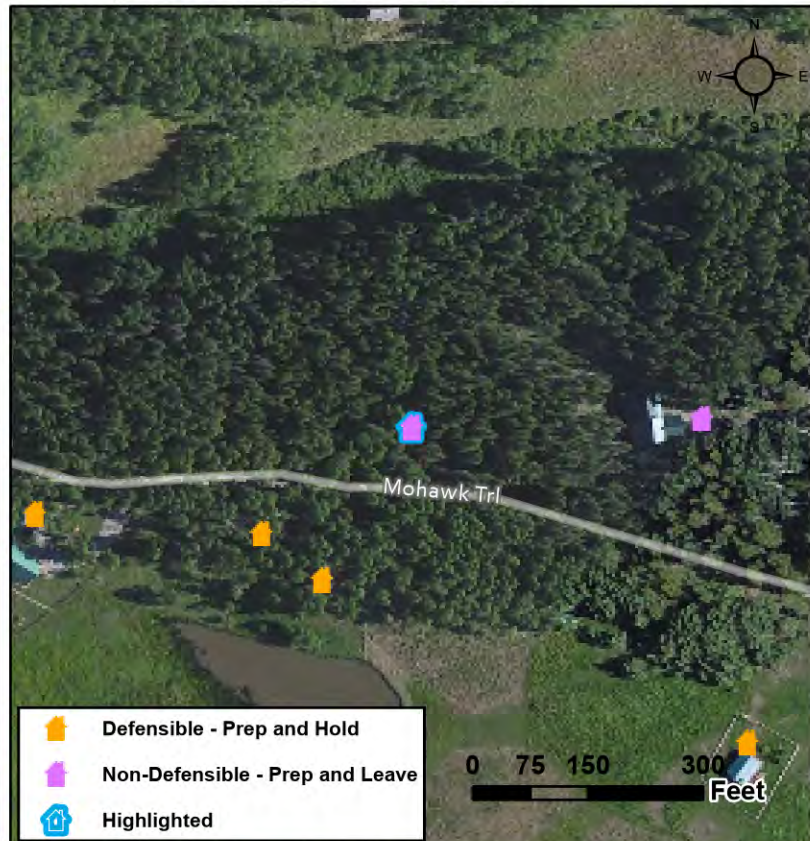
Location: 135 Mohawk Trl, WILDERNESS STREAMS FILING NO. 2

Hazards: Lots of conifer and pines feet from structure

Notes: Log structure metal roof, deck off the north end of structure open ended cabin underneath

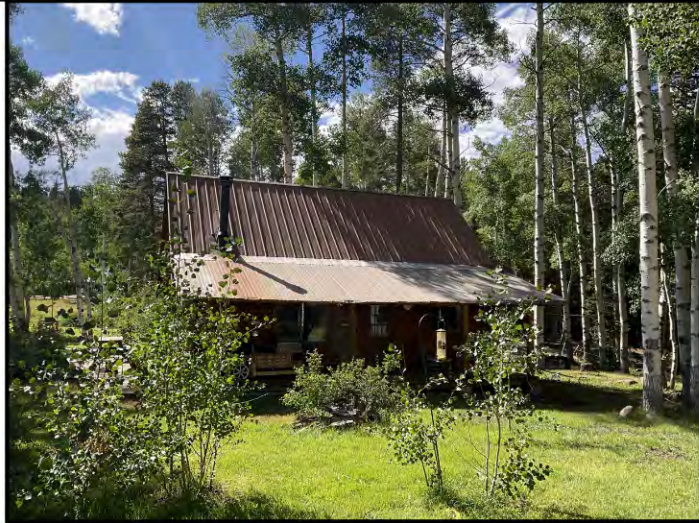
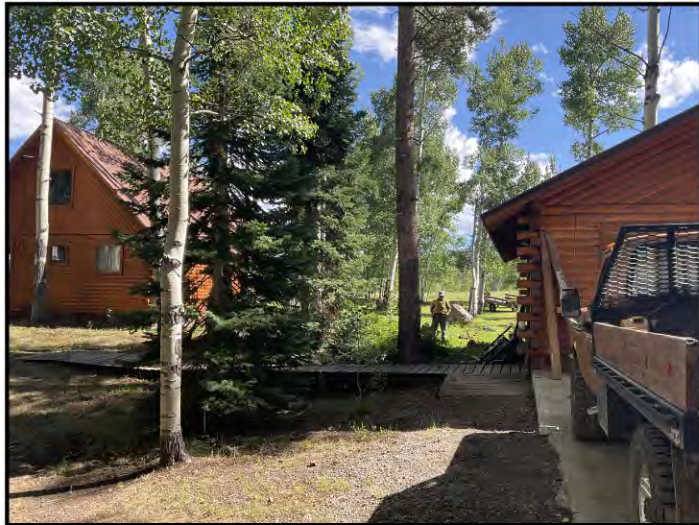
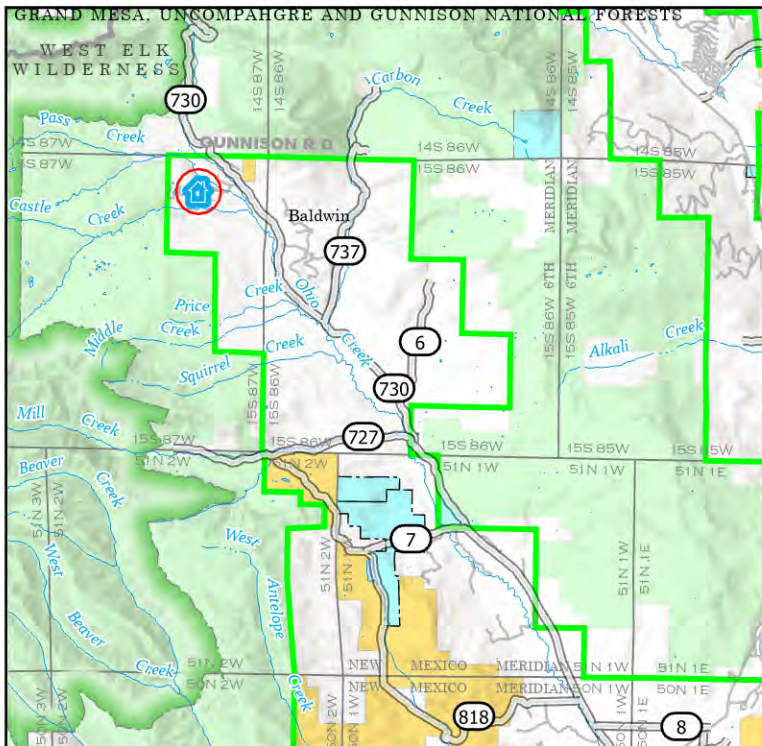
Location: 136 Mohawk Trl, WILDERNESS STREAMS FILING NO. 2

Triage Category: Defensible, Prep and Hold
FIRESCOPE Triage Category: Not Threatened
Structure Number: 136 Mohawk Trl - 1
Collected Date/Time: 8/3/2023 10:05:54 PM
Collected By: Adam Altergott
Inspector's Position: EngB
Type of Structure: Residential
Primary Structures: 1
Is the building Occupied?: No
Outbuildings: 2
Fuel Surrounding Structure: Grass and shrub, hardwood litter
Defensible Space: 100 ft treated
Roof Material: Noncombustible or not applicable
Siding Material: Log construction
Electrical Power: Yes
Gas to Structure: No
Hazards: Live electric fence
Access to Site: T3/4 Engine
Describe Access: Driveway blocked by live electric fence gate
Comm With ICP: Yes
Water Source: Reliable water source nearby
Safety Zone Present:
Mitigation Time (in hours): 2
Mitigation Description: Move firewood away from home and weed wack around woodshed
Resources Needed to Protect Structure: 1 type 3 or 6 engine
FIRESCOPE Tactics: Prep and Defend

Notes: Log home with metal roof, garage with same construction and woodshed

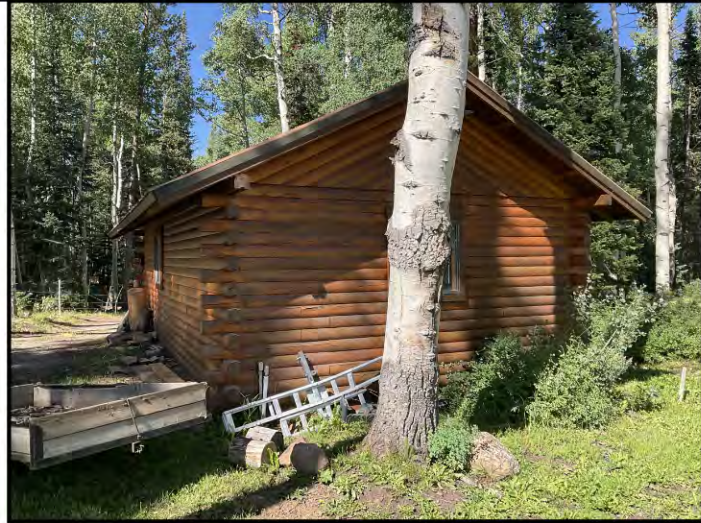
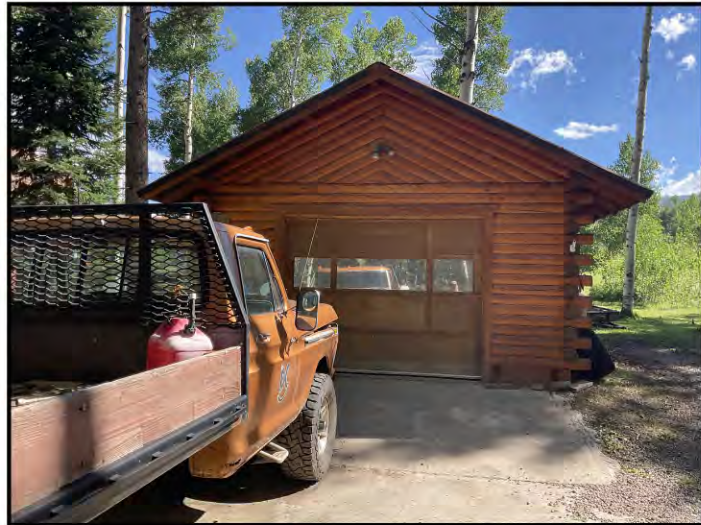
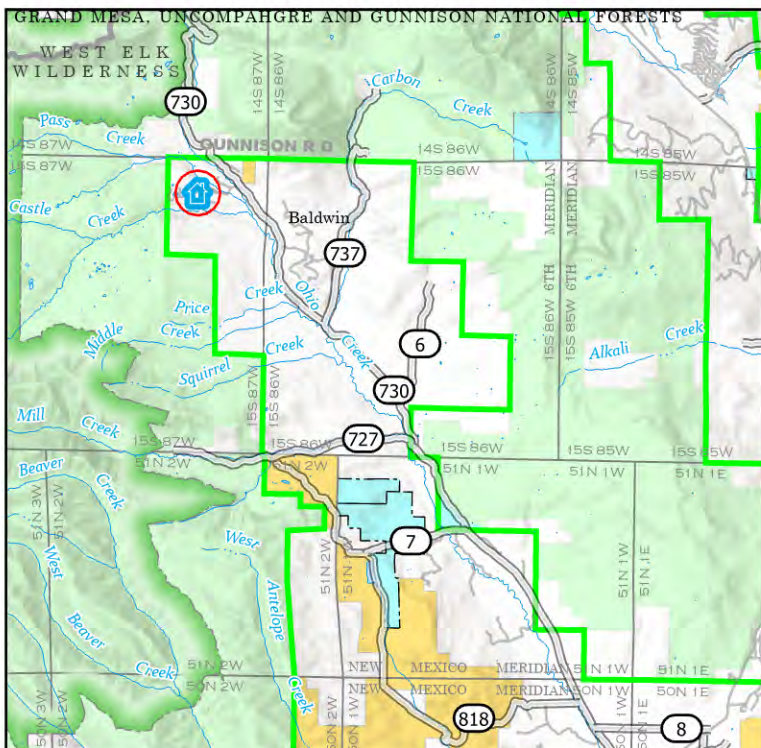
Triage Category: Defensible, Prep and Hold
FIRESCOPE Triage Category: Not Threatened
Structure Number: 136 Mohawk Trl - 2
Collected Date/Time: 8/3/2023 10:05:54 PM
Collected By: Adam Altergott
Inspector's Position: EngB
Type of Structure: Residential
Primary Structures: 1
Is the building Occupied?: No
Outbuildings: 0
Fuel Surrounding Structure: Grass and shrub, hardwood litter
Defensible Space: 100 ft treated
Roof Material: Noncombustible or not applicable
Siding Material: Log construction
Electrical Power: Yes
Gas to Structure: No
Hazards: Live electric fence
Access to Site: T3/4 Engine
Describe Access: Driveway blocked by live electric fence gate
Comm With ICP: Yes
Water Source: Reliable water source nearby
Safety Zone Present:
Mitigation Time (in hours): 1
Mitigation Description: Move wood away from garage
Resources Needed to Protect Structure: 1 type 3 or 6 engine
FIRESCOPE Tactics: Prep and Defend
Notes: Garage with log construction and metal roof

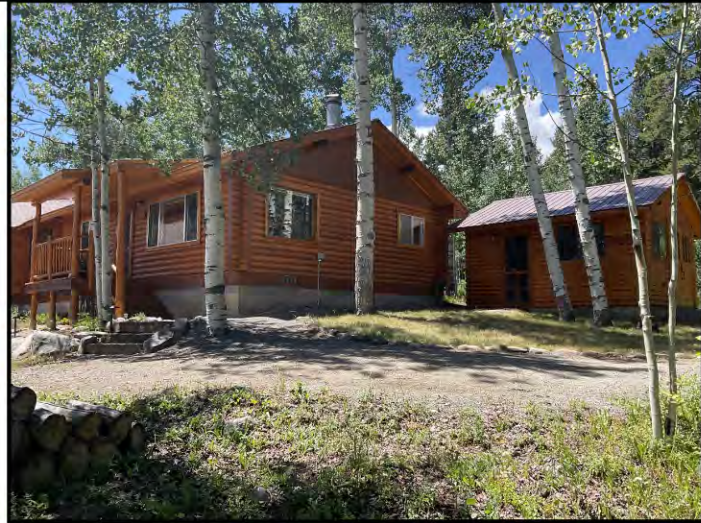
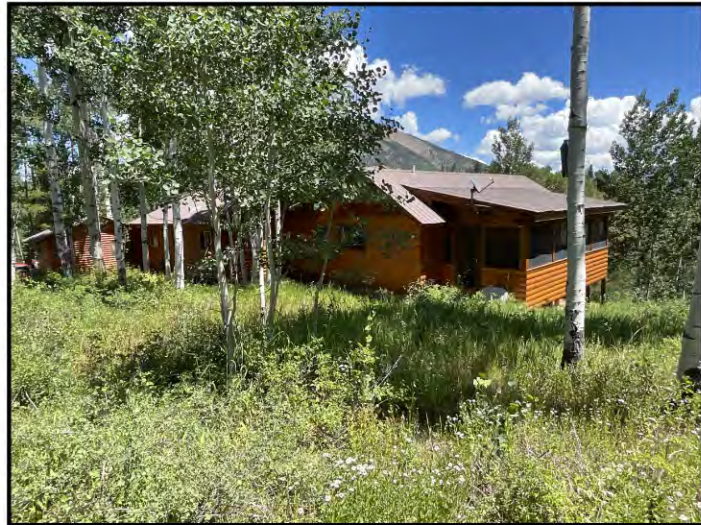
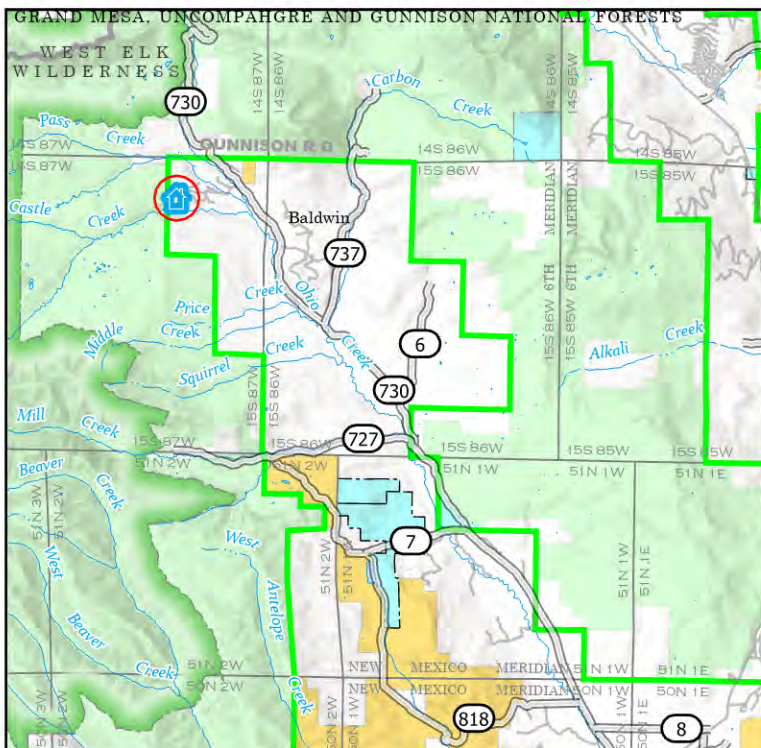
Location: 1400 Sioux Rd, WILDERNESS STREAMS FILING NO. 2

Triage Category: Defensible, Prep and Hold
FIRESCOPE Triage Category: Threatened Defensible
Structure Number: 1400 Sioux Rd
Collected Date/Time: 8/3/2023 6:54:38 PM
Collected By: Cody Peterson
Inspector's Position: ENGB
Type of Structure: Residential
Primary Structures: 1
Is the building Occupied?: Yes
Outbuildings: 2
Fuel Surrounding Structure: Shrub or timber
Defensible Space: 30 ft treated
Roof Material: Noncombustible or not applicable
Siding Material: Log construction
Electrical Power: Yes
Gas to Structure: No
Hazards: No
Access to Site: T3/4 Engine
Describe Access: Maintained gravel
Comm With ICP: Yes
Water Source: Reliable water source nearby
Safety Zone Present:
Mitigation Time (in hours): 1
Mitigation Description: Weed eat
Resources Needed to Protect Structure: Eng,mod
FIRESCOPE Tactics: Prep and Defend
Notes: Tight turn around for larger apparatus
