Location: 100 Castle Creek Rd, WILDERNESS STREAMS FILING NO. 2

Coordinates (DDM): 38° 46.291' N, 107° 04.891' W

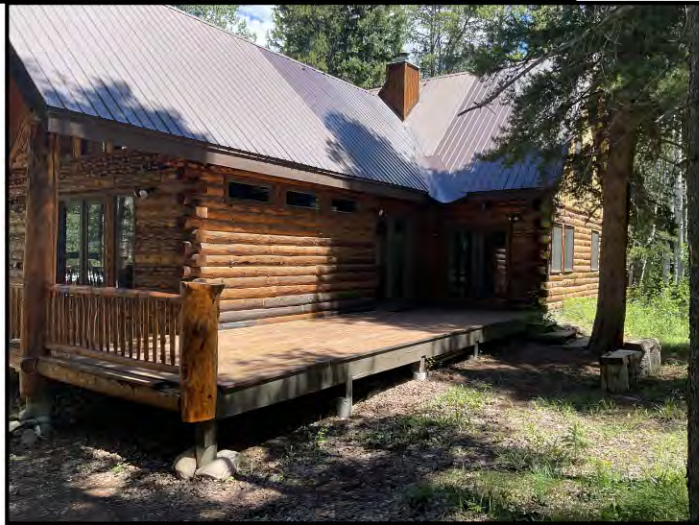
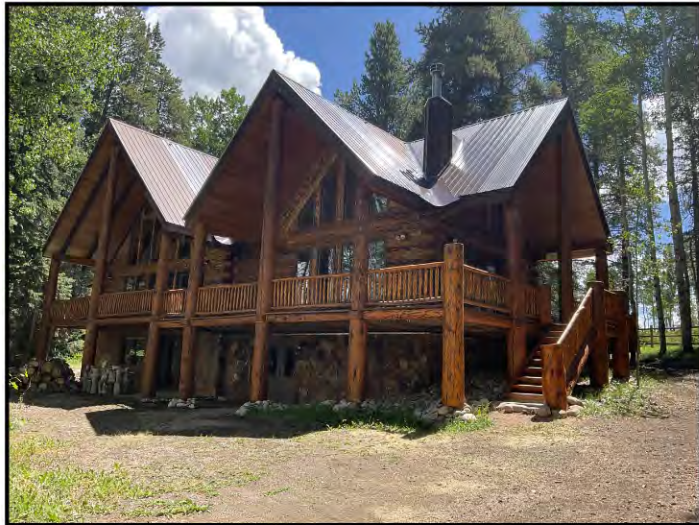
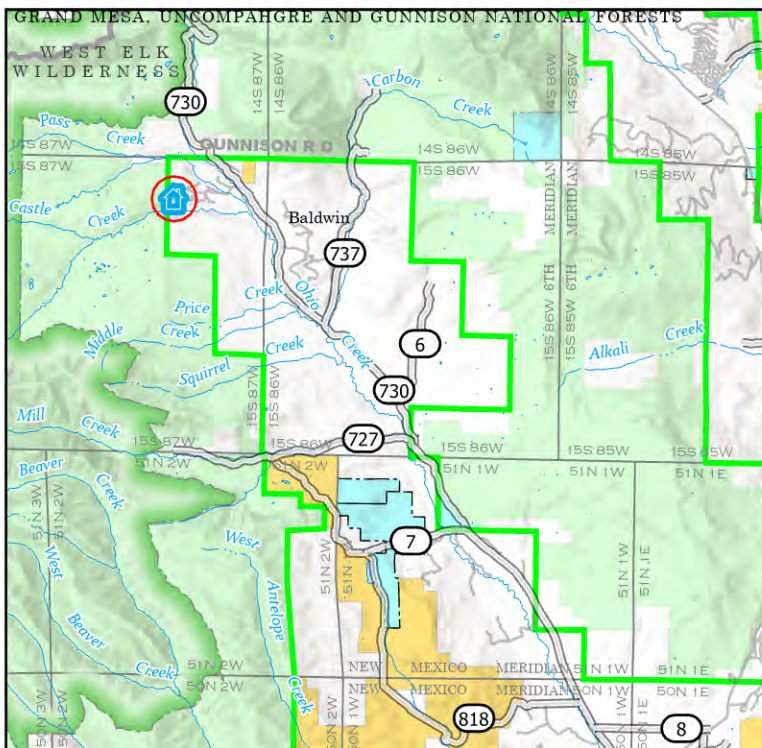
Location: 1466 Sioux Rd, WILDERNESS STREAMS FILING NO. 2

Triage Category: Defensible, Prep and Hold
FIRESCOPE Triage Category: Threatened Defensible
Structure Number: 1466 Sioux Rd
Collected Date/Time: 8/3/2023 6:42:27 PM
Collected By: Cody Peterson
Inspector's Position: ENGB
Type of Structure: Residential
Primary Structures: 1
Is the building Occupied?: No
Outbuildings: 0
Fuel Surrounding Structure: Shrub or timber
Defensible Space: 30 ft treated
Roof Material: Noncombustible or not applicable
Siding Material: Log construction
Electrical Power: Yes
Gas to Structure: No
Hazards:
Access to Site: T3/4 Engine
Describe Access: Maintained gravel
Comm With ICP: Yes
Water Source: Reliable water source nearby
Safety Zone Present:
Mitigation Time (in hours): 2
Mitigation Description: Limb trees, disperse wood pile
Resources Needed to Protect Structure: Engine, Mod
FIRESCOPE Tactics: Prep and Defend
Notes:

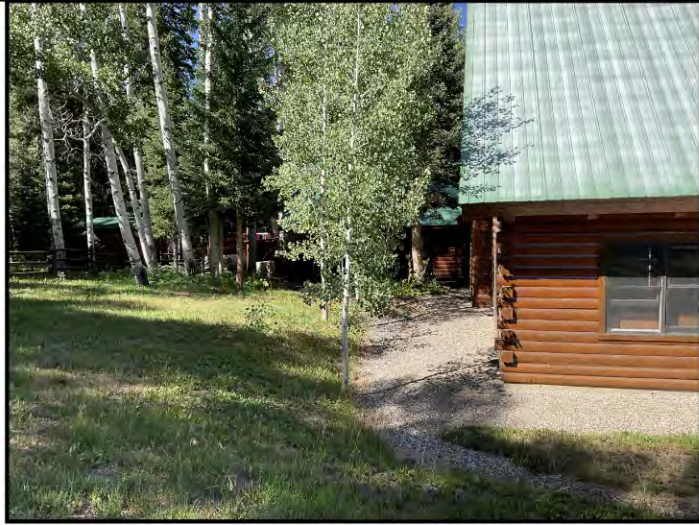
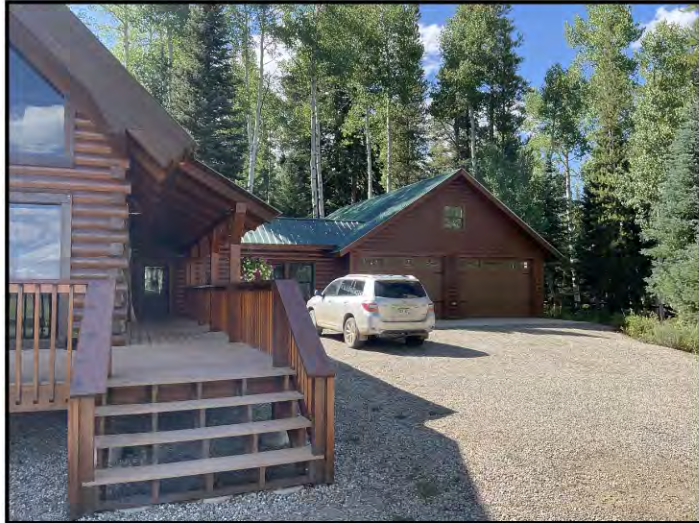
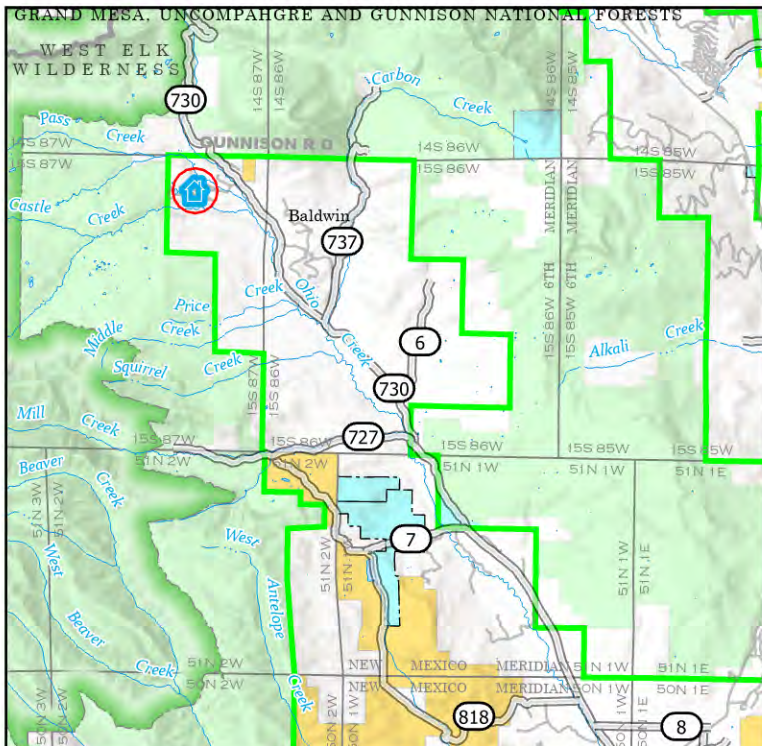
Triage Category: Defensible, Prep and Hold
FIRESCOPE Triage Category: Not Threatened
Structure Number: 148 Mohawk Trl
Collected Date/Time: 8/3/2023 10:07:30 PM
Collected By: Kevin Brueck
Inspector's Position: EngB t
Type of Structure: Residential
Primary Structures: 1
Is the building Occupied?: Yes
Outbuildings: 1
Fuel Surrounding Structure: Grass and shrub, hardwood litter
Defensible Space: 30 ft treated
Roof Material: Noncombustible or not applicable
Siding Material: Wood or open sided
Electrical Power: Yes
Gas to Structure: Yes
Hazards: Above ground ~500 gal propane
Access to Site: T3/4 Engine
Describe Access: Off the main road
Comm With ICP: Yes
Water Source: Reliable water source nearby
Safety Zone Present:
Mitigation Time (in hours): 1
Mitigation Description: Sprinklers
Resources Needed to Protect Structure: Type 6
FIRESCOPE Tactics: Prep and Defend
Notes: Wood porch, pond on adjacent property

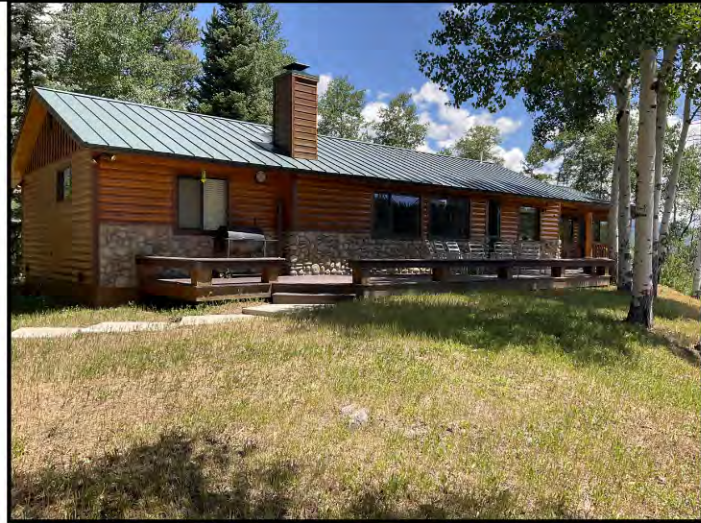
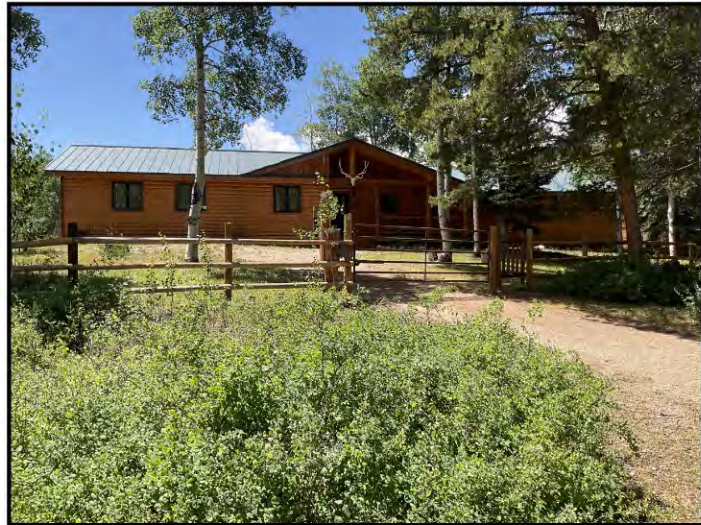
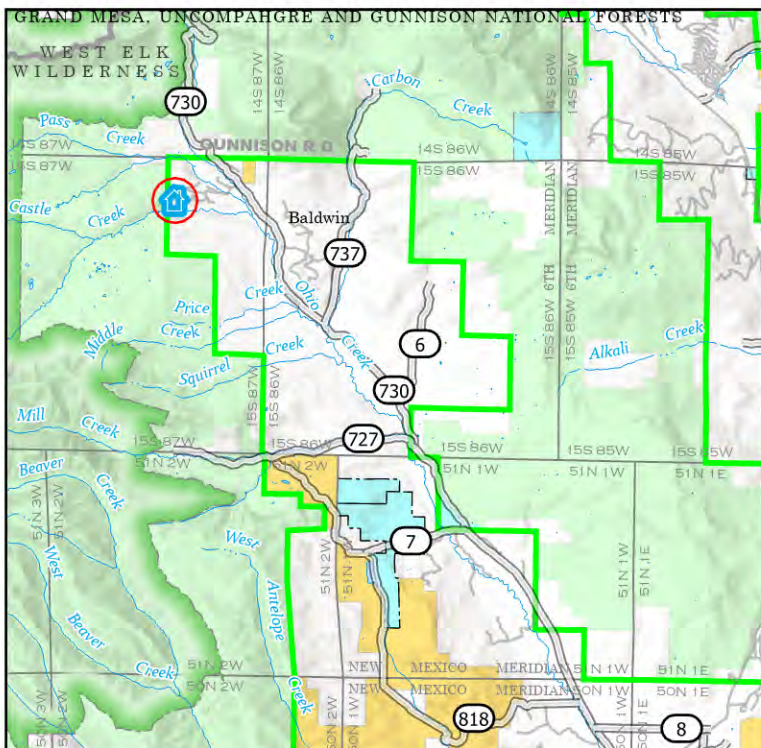
Location: 1532 Sioux Rd, WILDERNESS STREAMS FILING NO. 2

Triage Category: Defensible, Prep and Hold
FIRESCOPE Triage Category: Threatened Defensible
Structure Number: 1532 Sioux Rd
Collected Date/Time: 8/3/2023 6:34:43 PM
Collected By: Cody Peterson
Inspector's Position: ENGB
Type of Structure: Residential
Primary Structures: 1
Is the building Occupied?: Yes
Outbuildings: 1
Fuel Surrounding Structure: Grass and shrub, hardwood litter
Defensible Space: 30 ft treated
Roof Material: Noncombustible or not applicable
Siding Material: Log construction
Electrical Power: Yes
Gas to Structure: No
Hazards: Saddle
Access to Site: T3/4 Engine
Describe Access: Maintained gravel
Comm With ICP: Yes
Water Source: Reliable water source nearby
Safety Zone Present:
Mitigation Time (in hours): 2
Mitigation Description: Limb trees, weed eat,
Resources Needed to Protect Structure: Engine, Mod
FIRESCOPE Tactics: Prep and Defend
Notes: Structure in a saddle

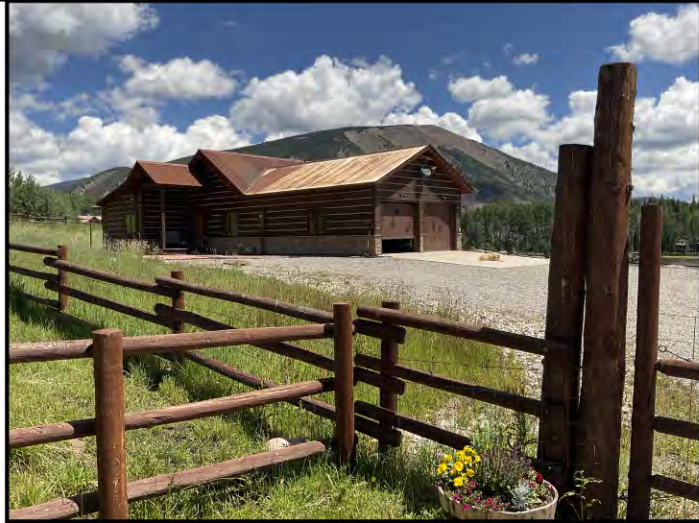
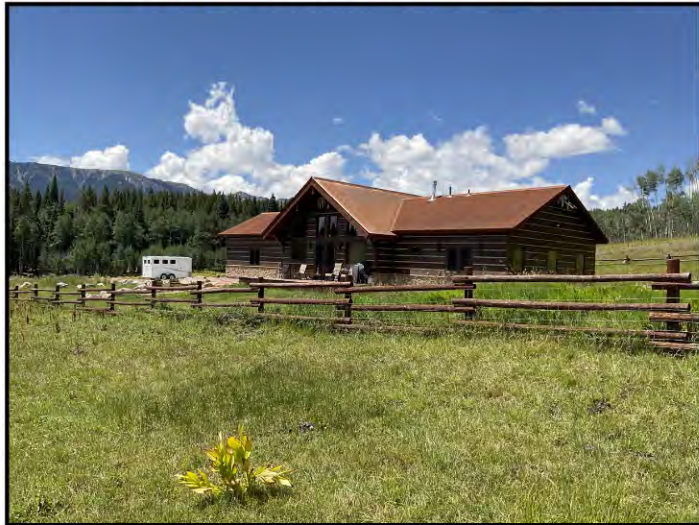
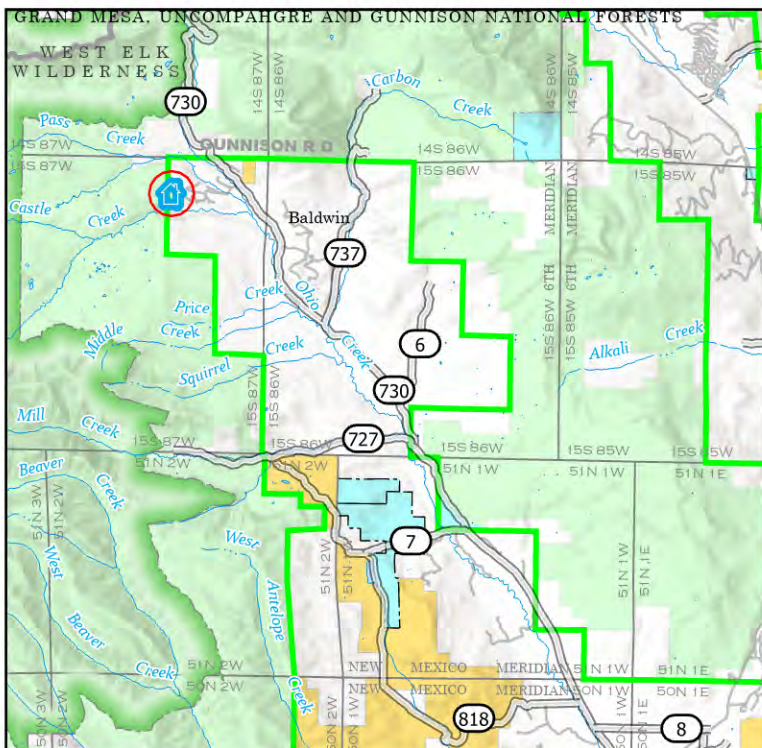
Location: 1555 Sioux Rd, WILDERNESS STREAMS FILING NO. 2

Triage Category: Defensible, Prep and Hold
FIRESCOPE Triage Category: Threatened Defensible
Structure Number: 1555 Sioux Rd
Collected Date/Time: 8/3/2023 6:21:16 PM
Collected By: Cody Peterson
Inspector's Position: ENGB
Type of Structure: Residential
Primary Structures: 1
Is the building Occupied?: Yes
Outbuildings: 1
Fuel Surrounding Structure: Grass and shrub, hardwood litter
Defensible Space: 100 ft treated
Roof Material: Noncombustible or not applicable
Siding Material: Wood or open sided
Electrical Power: Yes
Gas to Structure: Unknown
Hazards:
Access to Site: T3/4 Engine
Describe Access: Maintained gravel
Comm With ICP: Yes
Water Source: Reliable water source nearby
Safety Zone Present:
Mitigation Time (in hours): 1
Mitigation Description: Weed eat
Resources Needed to Protect Structure: Engine
FIRESCOPE Tactics: Prep and Defend
Notes: Fenced

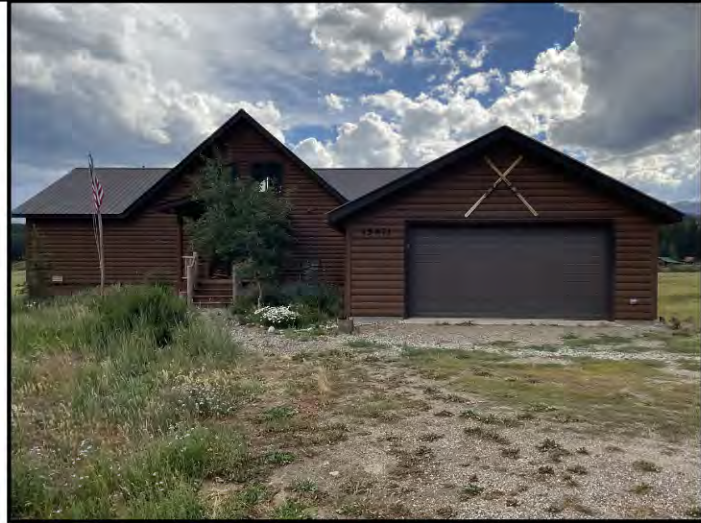
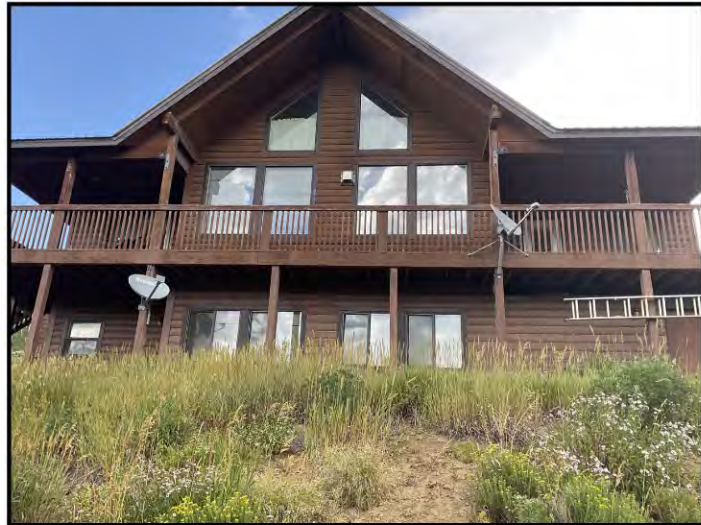
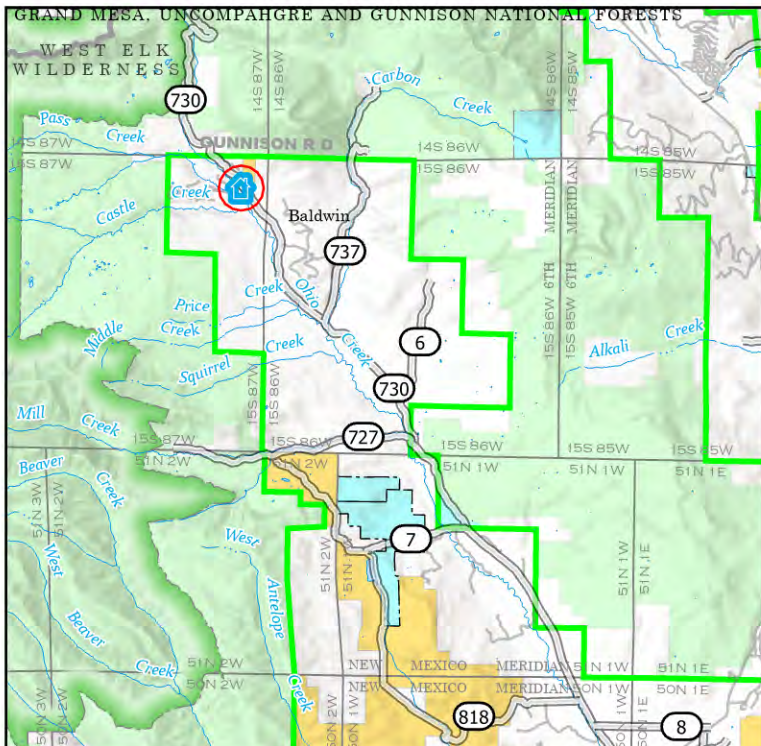
Location: 15671 County Road 730, WILDERNESS STREAMS FILING NO. 2
Coordinates (DDM): 38° 46.535' N, 107° 03.890' W

Triage Category: Defensible, Prep and Hold
FIRESCOPE Triage Category: Threatened Defensible
Structure Number: 15671 County Road 730
Collected Date/Time: 8/2/2023 10:53:18 PM
Collected By: Adam Altergott
Inspector's Position: Engb
Type of Structure: Residential
Primary Structures: 1
Is the building Occupied?: No
Outbuildings: 0
Fuel Surrounding Structure: Grass and shrub, hardwood litter
Defensible Space: Less than 30 ft treated
Roof Material: Noncombustible or not applicable
Siding Material: Log construction
Electrical Power: Yes
Gas to Structure: Unknown
Hazards: None
Access to Site: T1 Engine
Describe Access: Gravel driveway
Comm With ICP: Yes
Water Source: Reliable water source nearby
Safety Zone Present:
Mitigation Time (in hours): 1
Mitigation Description: Weed wack around house
Resources Needed to Protect Structure: 1 Any engine
FIRESCOPE Tactics: Prep and Defend
Notes: Big deck on back, log construction and metal roof

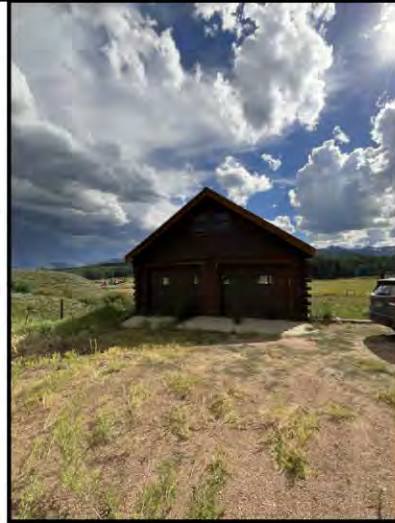
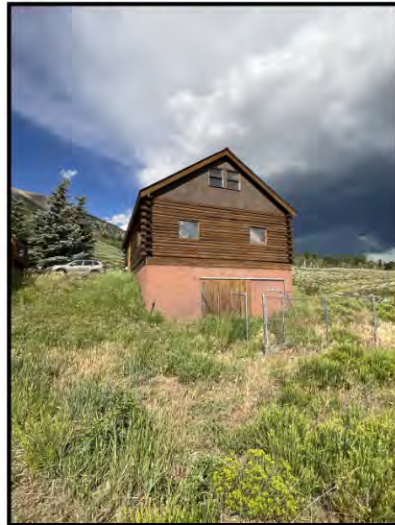
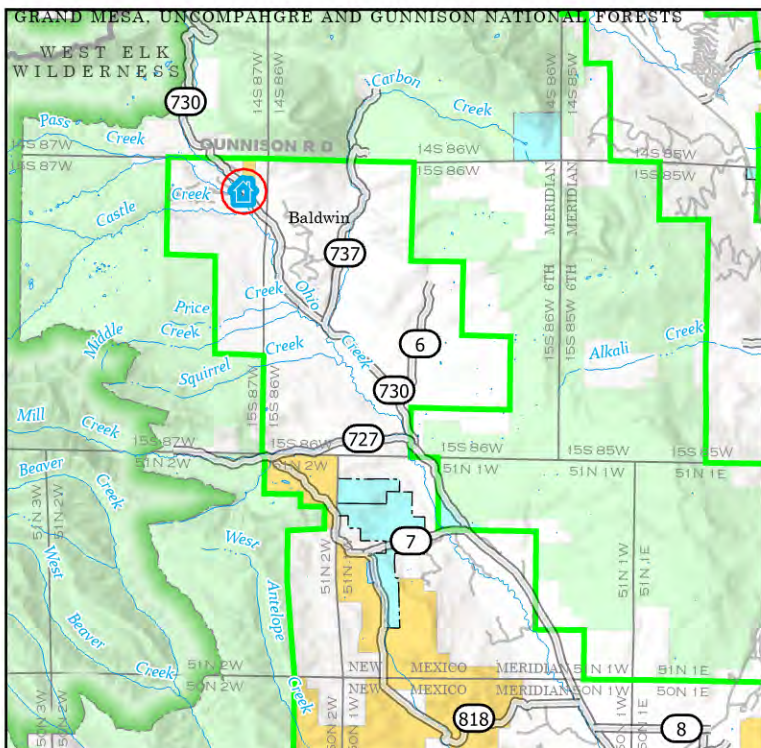
Location: 15789 County Road 730, WILDERNESS STREAMS FILING NO. 2

Triage Category: Defensible, Prep and Hold
FIRESCOPE Triage Category: Threatened Defensible
Structure Number: 15789 County Road 730 - 1
Collected Date/Time: 8/2/2023 10:34:17 PM
Collected By: Adam Altergott
Inspector's Position: EngB
Type of Structure: Outbuilding
Primary Structures: 1
Is the building Occupied?: No
Outbuildings: 1
Fuel Surrounding Structure: Shrub or timber
Defensible Space: 30 ft treated
Roof Material: Noncombustible or not applicable
Siding Material: Log construction
Electrical Power: Yes
Gas to Structure: No
Hazards:
Access to Site: T1 Engine
Describe Access: Driveway
Comm With ICP: Yes
Water Source: Reliable water source nearby
Safety Zone Present:
Mitigation Time (in hours): 1
Mitigation Description: Weed wacking tall grasses and lumber removal
Resources Needed to Protect Structure: Any type engine
FIRESCOPE Tactics: Prep and Defend
Notes: Cinder block foundation log siding

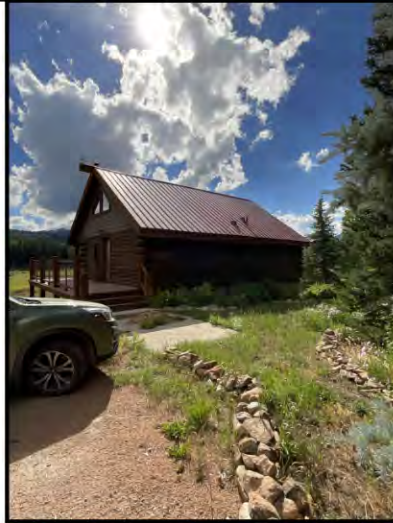
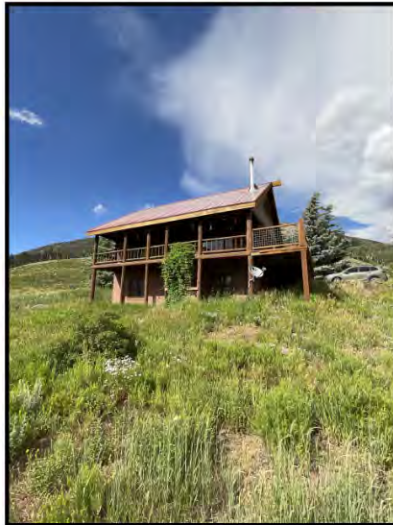
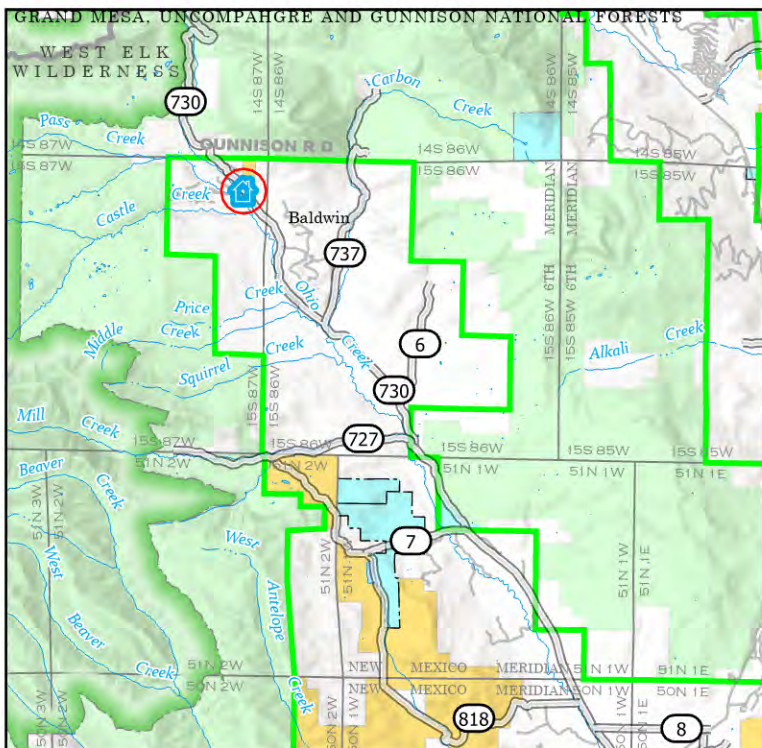
Location: 15789 County Road 730, WILDERNESS STREAMS FILING NO. 2

Triage Category: Defensible, Prep and Hold
FIRESCOPE Triage Category: Threatened Defensible
Structure Number: 15789 County Road 730 - 2
Collected Date/Time: 8/2/2023 10:44:21 PM
Collected By: Adam Altergott
Inspector's Position: EngB
Type of Structure: Residential
Primary Structures: 1
Is the building Occupied?: Yes
Outbuildings: 1
Fuel Surrounding Structure: Shrub or timber
Defensible Space: Less than 30 ft treated
Roof Material: Noncombustible or not applicable
Siding Material: Log construction
Electrical Power: Yes
Gas to Structure: No
Hazards:
Access to Site: T1 Engine
Describe Access: Driveway
Comm With ICP:
Water Source: Reliable water source nearby
Safety Zone Present:
Mitigation Time (in hours): 1
Mitigation Description: Removal of tall grasses
Resources Needed to Protect Structure: Any type engine
FIRESCOPE Tactics: Prep and Defend
Notes:

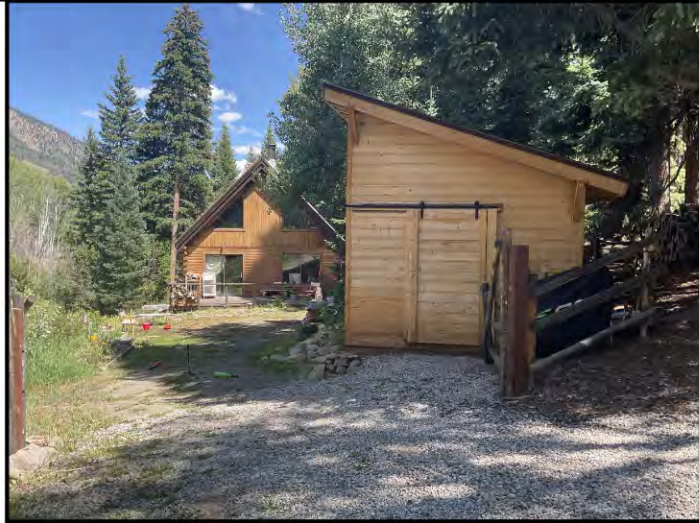
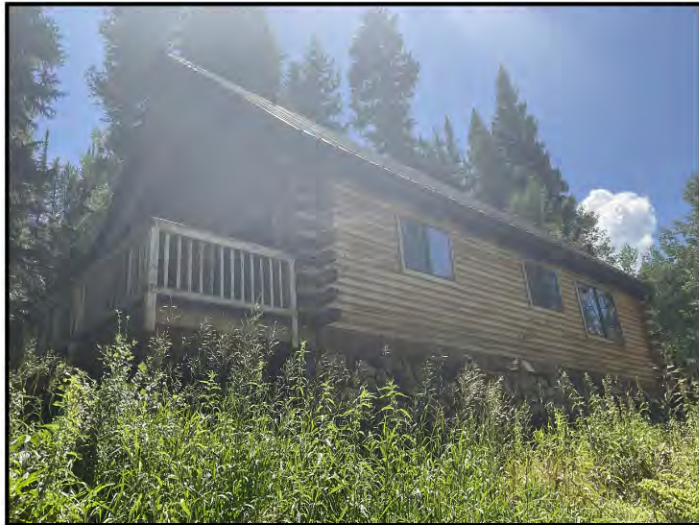
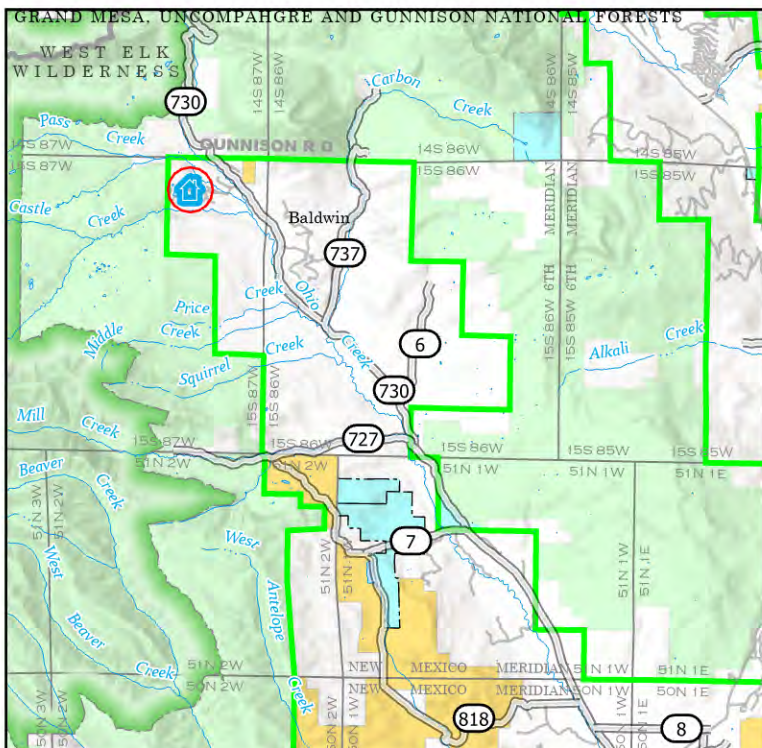
Location: 159 Mohawk Trl, WILDERNESS STREAMS FILING NO. 2

Triage Category: Defensible, Prep and Hold
FIRESCOPE Triage Category: Not Threatened
Structure Number: 159 Mohawk Trl - 1
Collected Date/Time: 8/3/2023 8:12:59 PM
Collected By: Adam Altergott
Inspector's Position: EngB
Type of Structure: Residential
Primary Structures: 1
Is the building Occupied?: Yes
Outbuildings: 1
Fuel Surrounding Structure: Shrub or timber
Defensible Space: Less than 30 ft treated
Roof Material: Noncombustible or not applicable
Siding Material: Log construction
Electrical Power: Yes
Gas to Structure: Unknown
Hazards: Lots of conifer and pines feet from structures
Access to Site: T3/4 Engine
Describe Access: Back into driveway
Comm With ICP: Yes
Water Source: Reliable water source nearby
Safety Zone Present:
Mitigation Time (in hours): 1
Mitigation Description: Rake leaves pine needles. remove wood, firewood, cut shrubs out
Resources Needed to Protect Structure: 1 any 3/4 type engine
FIRESCOPE Tactics: Prep and Defend

Notes: Log structure metal roof, deck off the north end of structure open ended cabin underneath

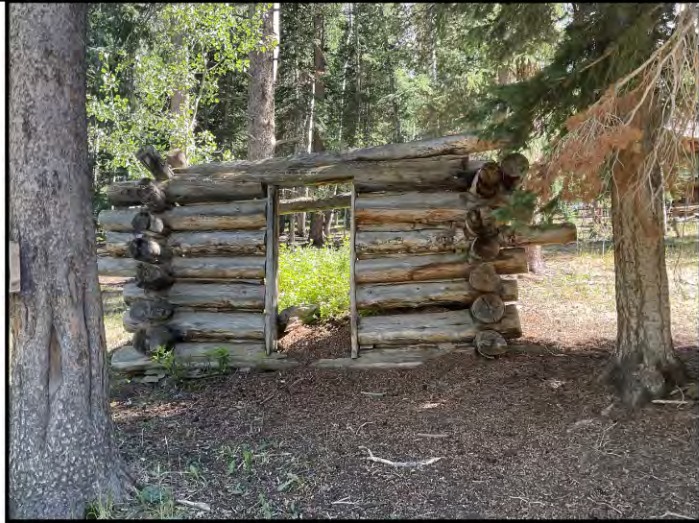
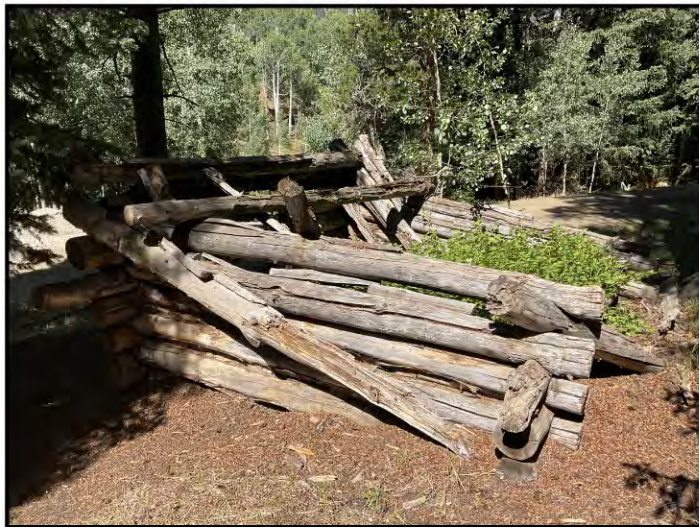
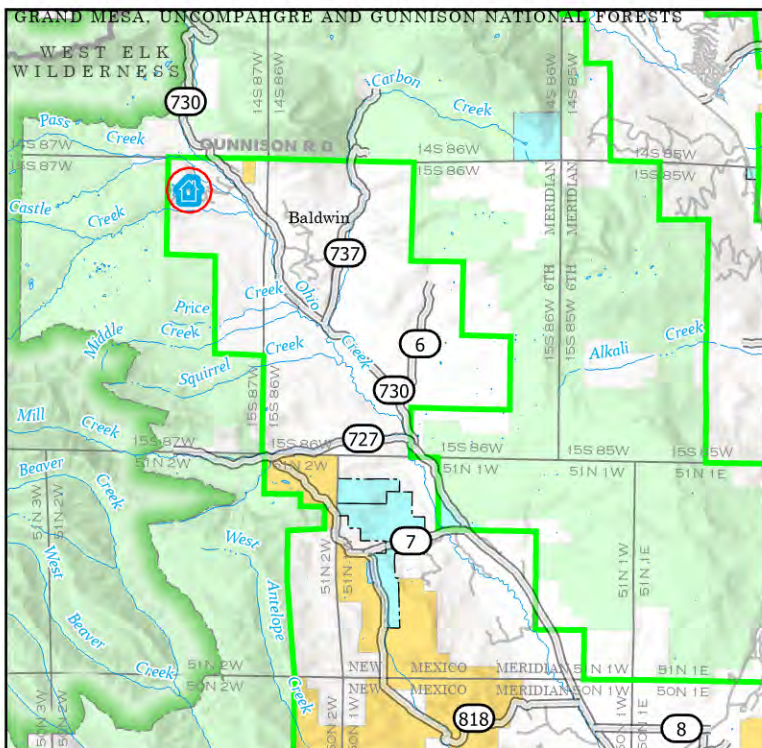
Notes: Old dilapidated cabin

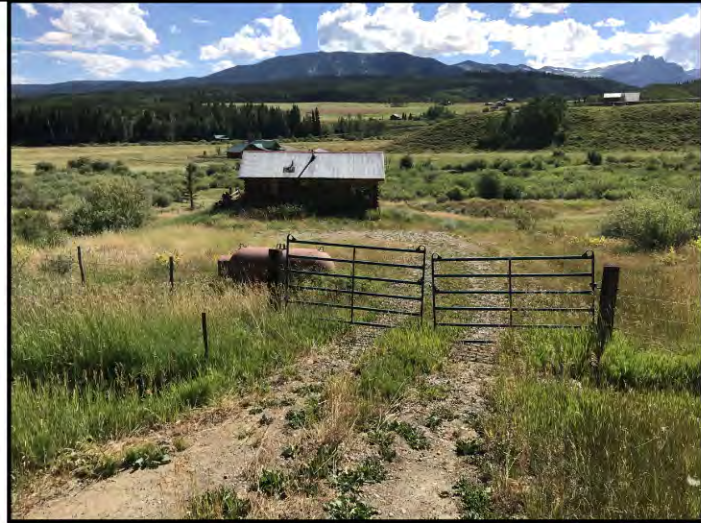
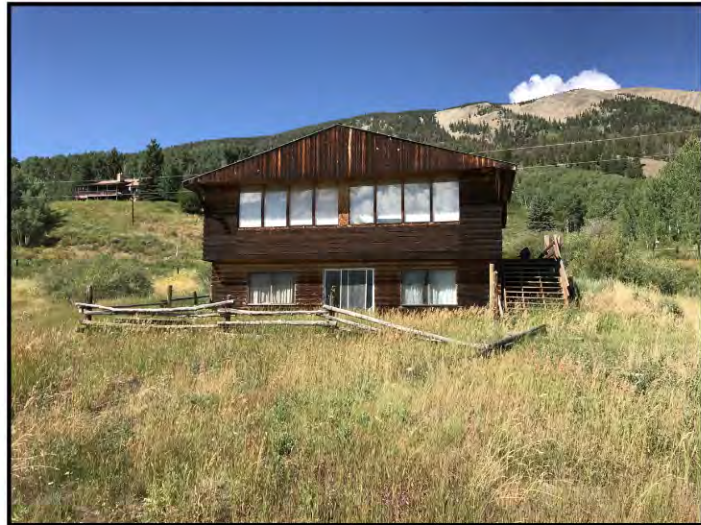
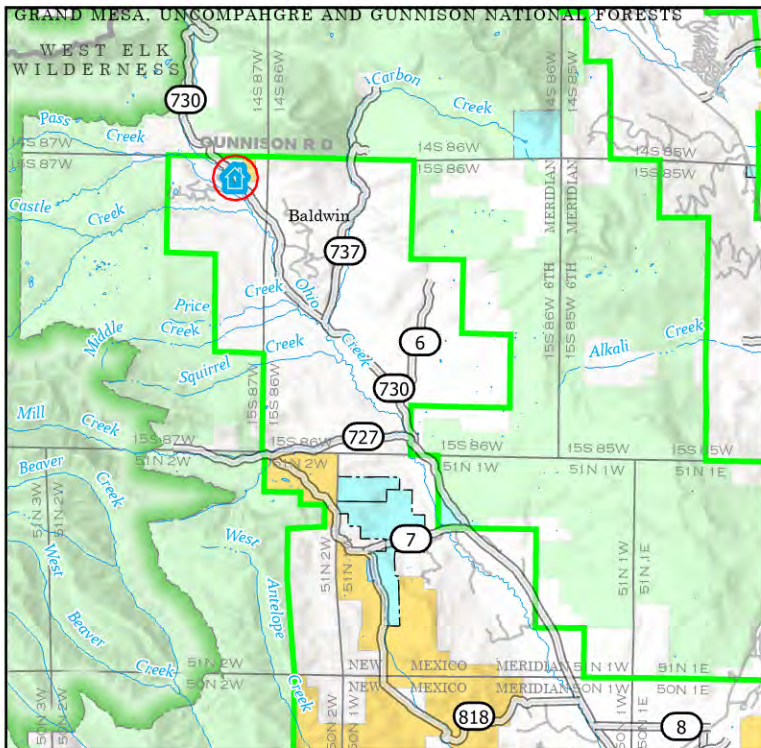
Location: 15953 County Road 730, WILDERNESS STREAMS FILING NO. 2
Coordinates (DDM): 38° 46.716' N, 107° 04.027' W

Triage Category: Defensible, Prep and Hold
FIRESCOPE Triage Category: Threatened Defensible
Structure Number: 15953 County Road 730
Collected Date/Time: 8/3/2023 10:06:00 PM
Collected By: Bela Harrington
Inspector's Position: DIVS t
Type of Structure: Residential
Primary Structures: 1
Is the building Occupied?: No
Outbuildings: 0
Fuel Surrounding Structure: Grass/tundra,northern hardwood litter
Defensible Space: Less than 30 ft treated
Roof Material: Noncombustible or not applicable
Siding Material: Log construction
Electrical Power: Yes
Gas to Structure: Yes
Hazards: Power lines, propane tank
Access to Site: T3/4 Engine
Describe Access: Narrow gravel driveway off of CR730
Comm With ICP: Yes
Water Source: Reliable water source nearby
Safety Zone Present:
Mitigation Time (in hours): 2
Mitigation Description: Mowing and brushing
Resources Needed to Protect Structure: 1 engine any type
FIRESCOPE Tactics: Prep and Defend

Notes: Good access all around, deck on south side.
 Looks like vacation home.

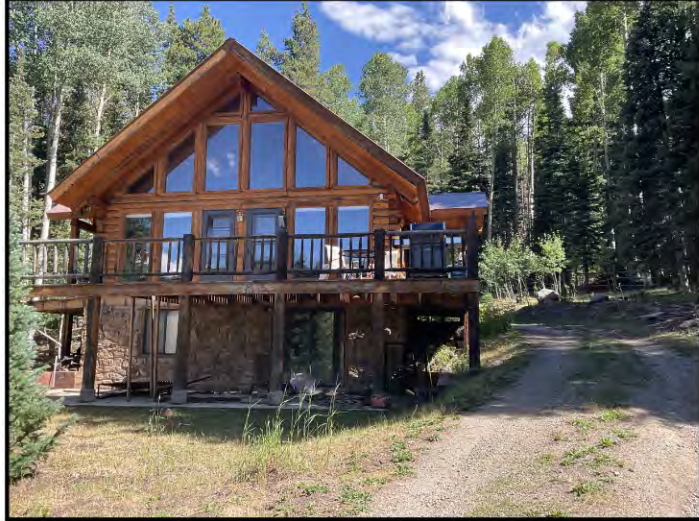
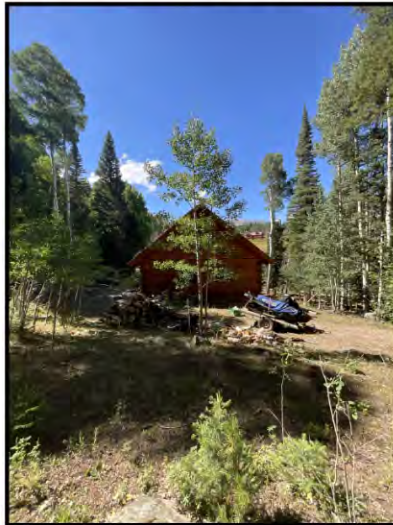
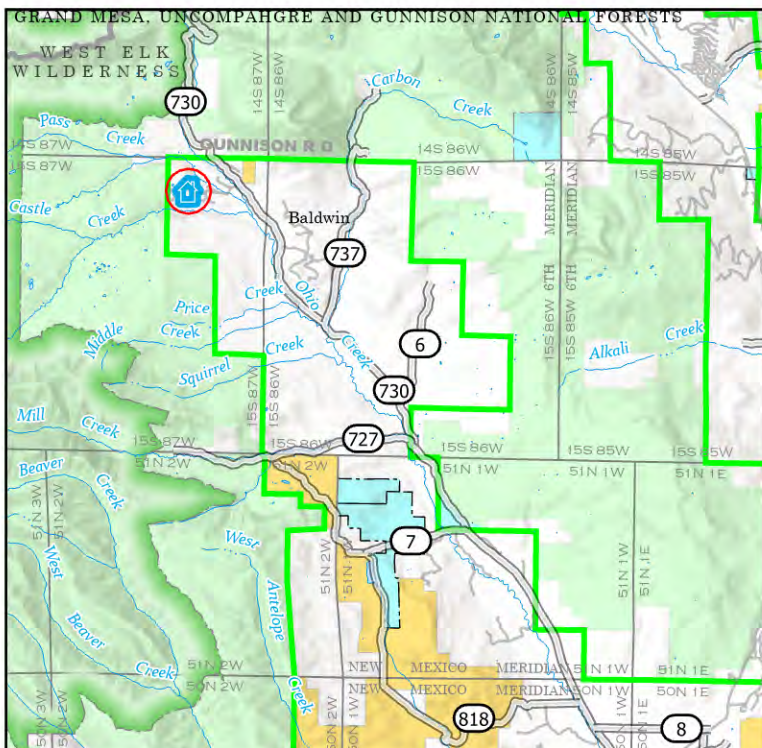
Location: 160 Mohawk Trl, WILDERNESS STREAMS FILING NO. 2

Triage Category: Non-Defensible, Prep and Leave
FIRESCOPE Triage Category: Not Threatened
Structure Number: 160 Mohawk Trl
Collected Date/Time: 8/3/2023 9:42:00 PM
Collected By: Adam Altergott
Inspector's Position: ENGB
Type of Structure: Residential
Primary Structures: 1
Is the building Occupied?: Yes
Outbuildings: 1
Fuel Surrounding Structure: Shrub or timber
Defensible Space: Less than 30 ft treated
Roof Material: Noncombustible or not applicable
Siding Material: Log construction
Electrical Power: Yes
Gas to Structure: No
Hazards: Unstable deck surrounding building lots of gas cans
Access to Site: T3/4 Engine
Describe Access: Turn around access
Comm With ICP: Yes
Water Source: Reliable water source nearby
Safety Zone Present:
Mitigation Time (in hours): 3
Mitigation Description: Removal of firewood gas cans lumber and dead trees surrounding house
Resources Needed to Protect Structure: 1 type 3 or 4 engine
FIRESCOPE Tactics: Prep and Go

Notes: Unstable deck

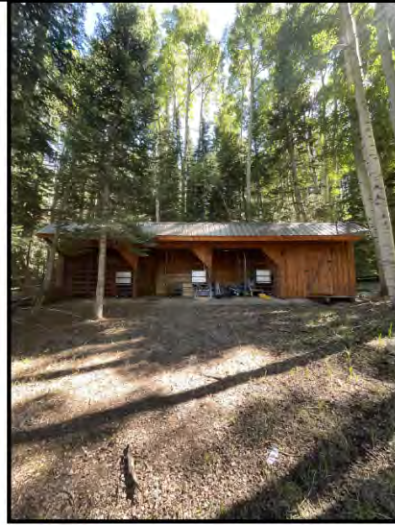
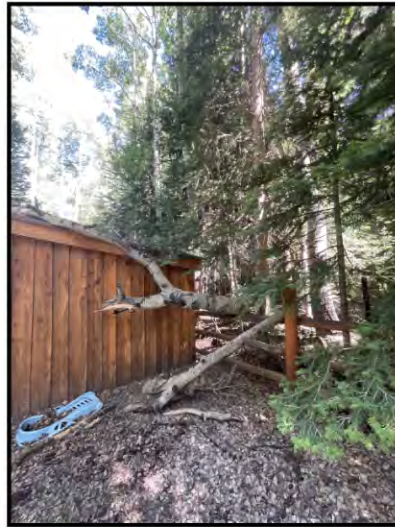
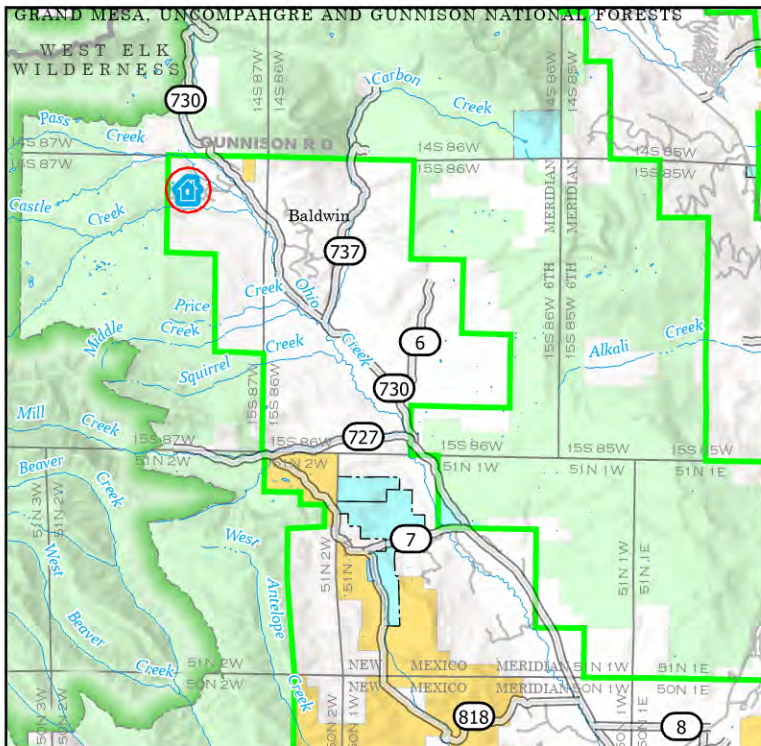
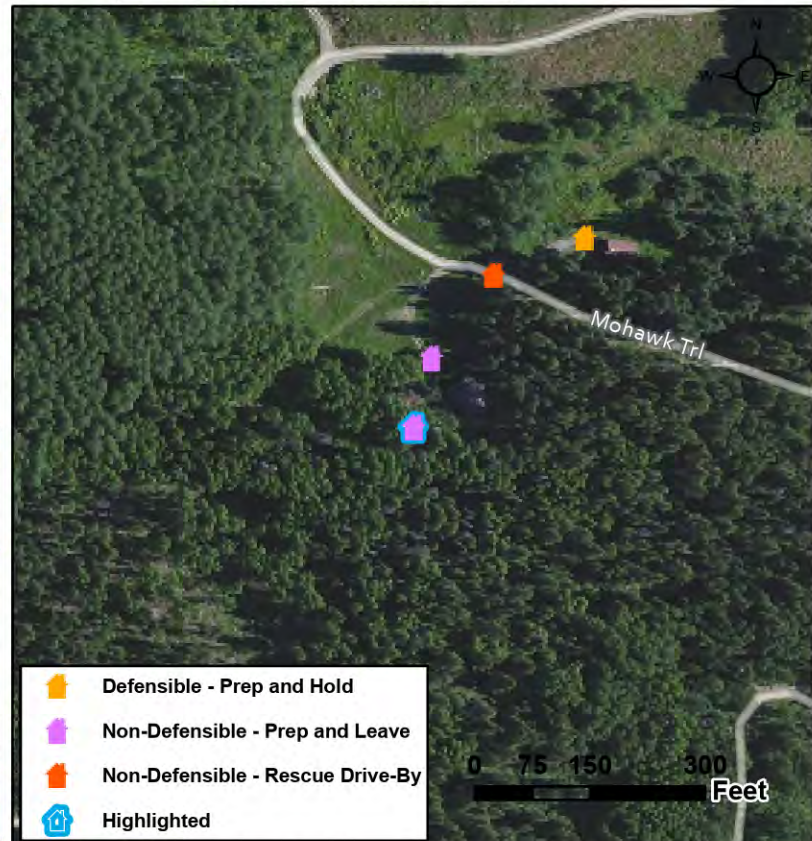
Hazards: Dead trees surrounding structure and thick forest behind

Notes: Lots of dead tree and lumber surrounding and inside old horse stalls

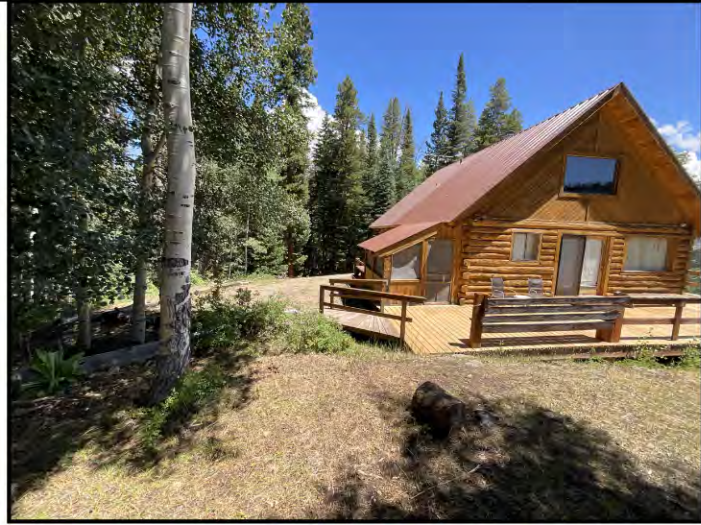
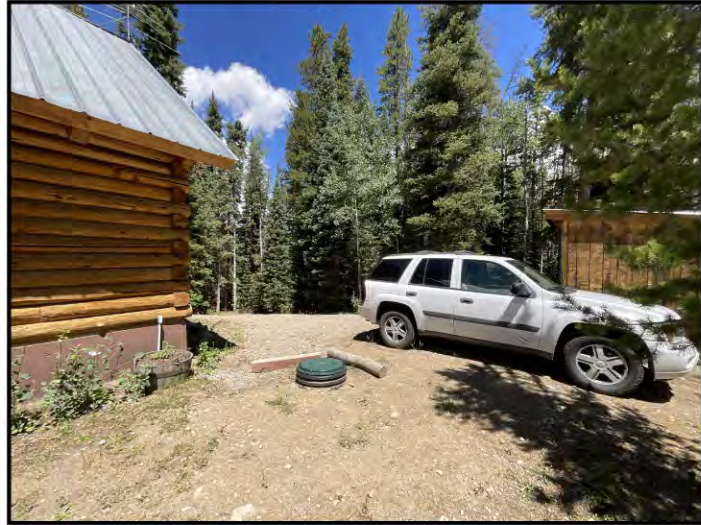
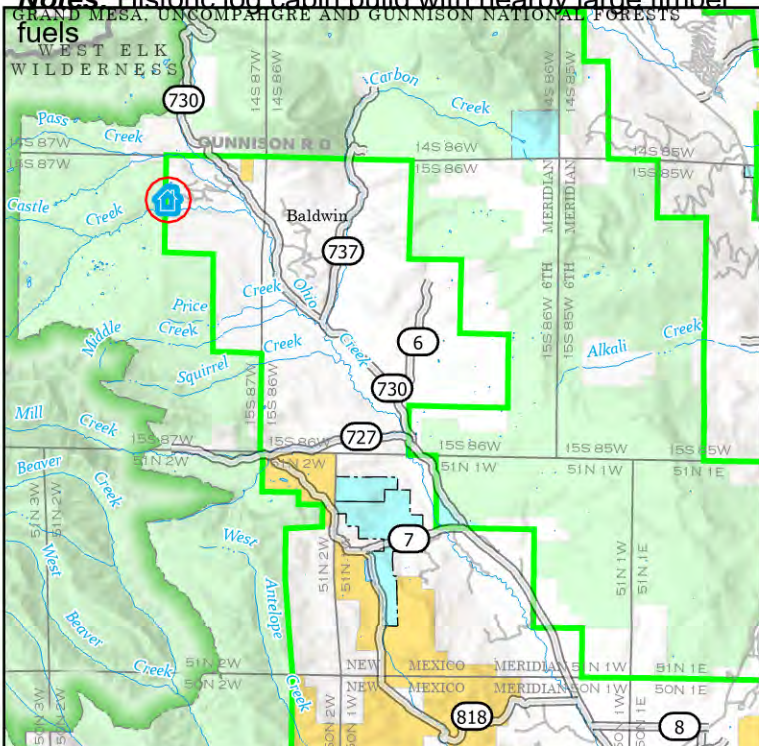
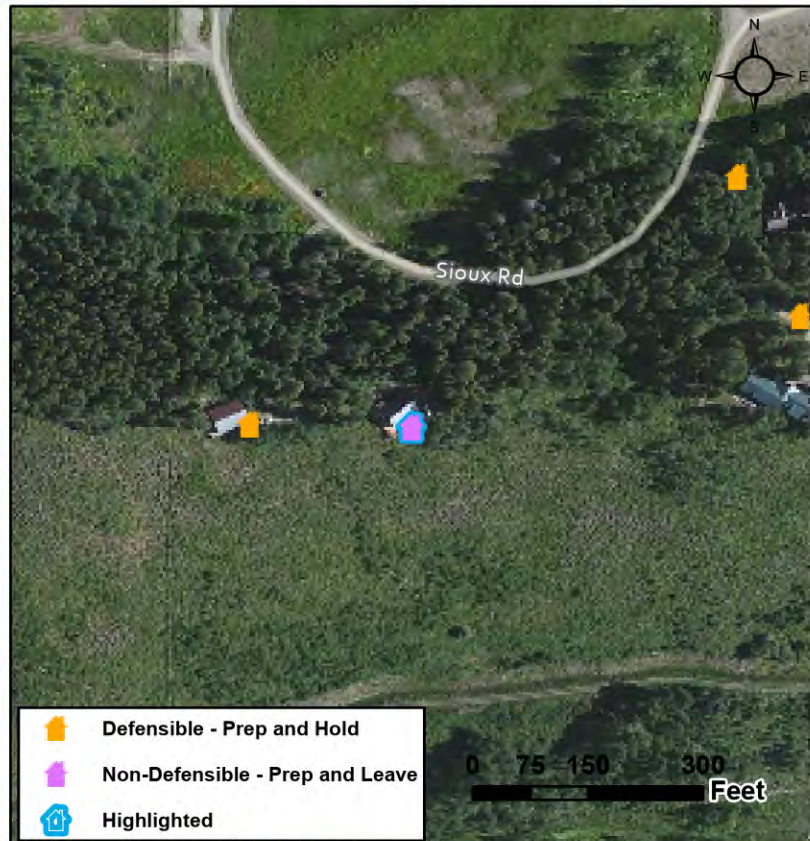
Hazards: Large timber around 50% of home with lots of dead and down, steep hill on back side of structure

Notes: Historic log cabin build with nearby large timber fuels

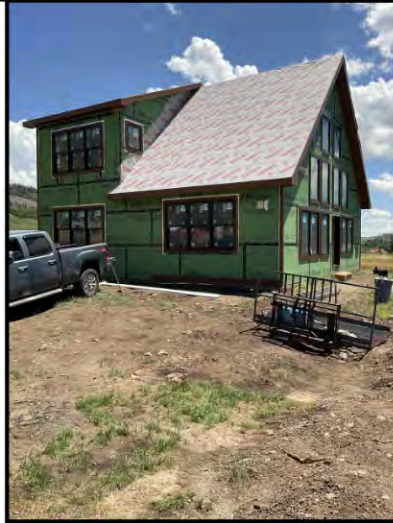
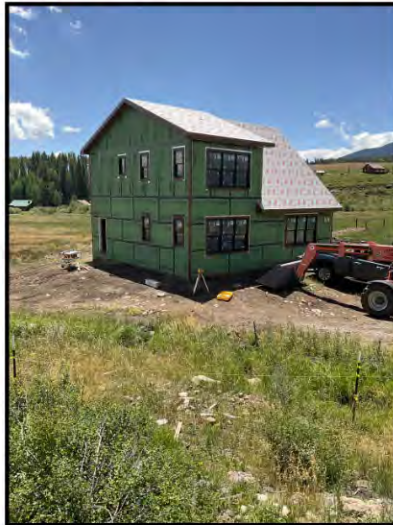
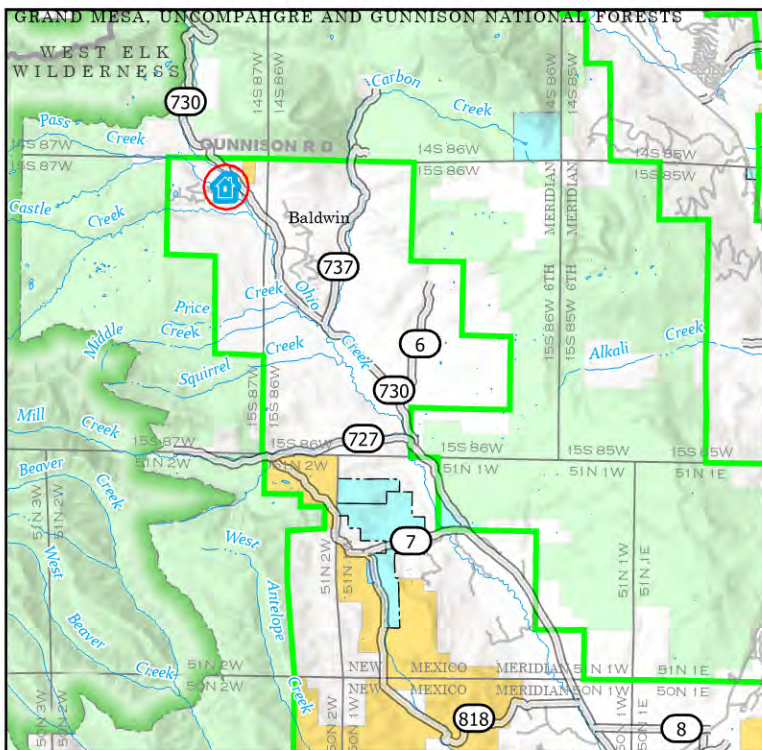
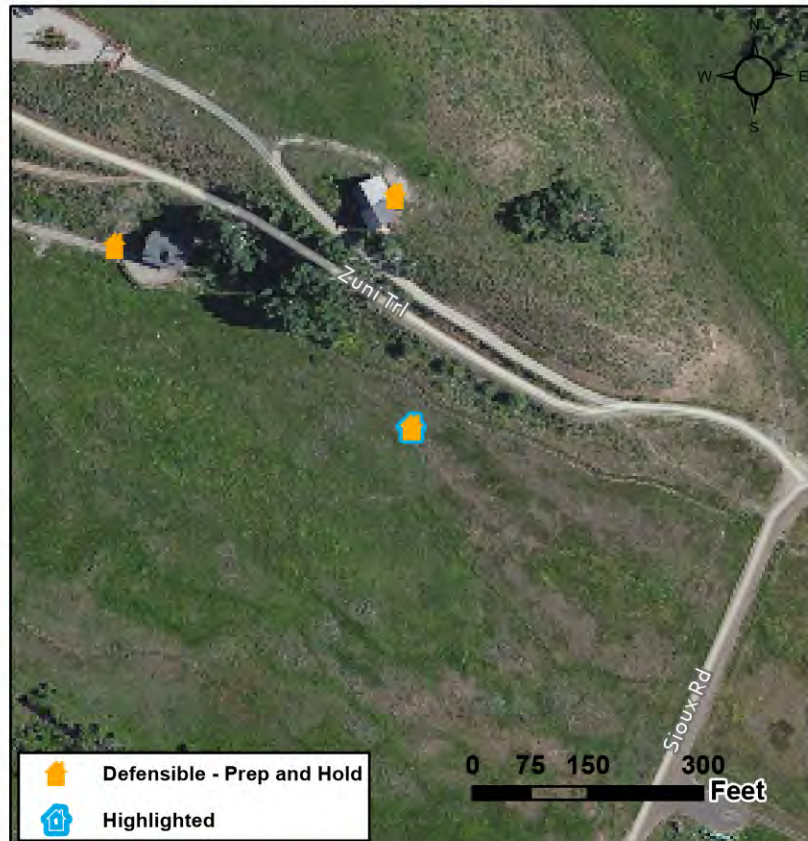
Location: 168 Zuni Trl, WILDERNESS STREAMS FILING NO. 2

Triage Category: Defensible, Prep and Hold
FIRESCOPE Triage Category: Not Threatened
Structure Number: 168 Zuni Trl
Collected Date/Time: 8/3/2023 6:54:56 PM
Collected By: Kevin Bruek
Inspector's Position: EngB t
Type of Structure: Residential
Primary Structures: 1
Is the building Occupied?: No
Outbuildings: 0
Fuel Surrounding Structure: Grass and shrub, hardwood litter
Defensible Space: Less than 30 ft treated
Roof Material: Noncombustible or not applicable
Siding Material: Wood or open sided
Electrical Power: Yes
Gas to Structure: Unknown
Hazards: Construction Site
Access to Site: T3/4 Engine
Describe Access: Narrow gravel slope
Comm With ICP: Yes
Water Source: No reliable water source nearby
Safety Zone Present:
Mitigation Time (in hours): 2
Mitigation Description: Clearing combustibles and tall grass away from the structure
Resources Needed to Protect Structure: Type 6
FIRESCOPE Tactics: Prep and Defend
Notes: Under construction
