Location: 100 Castle Creek Rd, WILDERNESS STREAMS FILING NO. 2

Coordinates (DDM): 38° 46.291' N, 107° 04.891' W

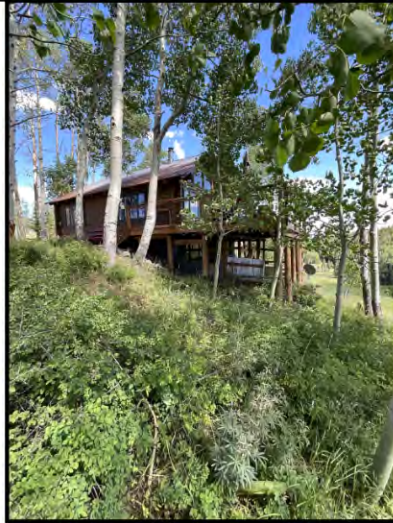
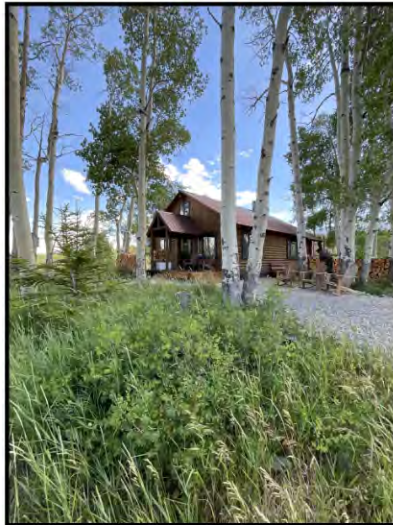
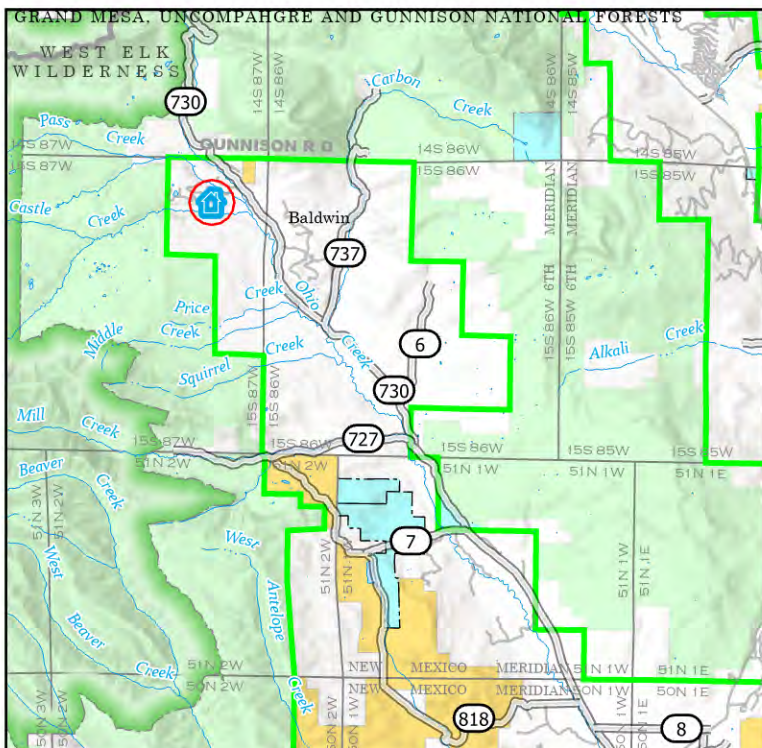
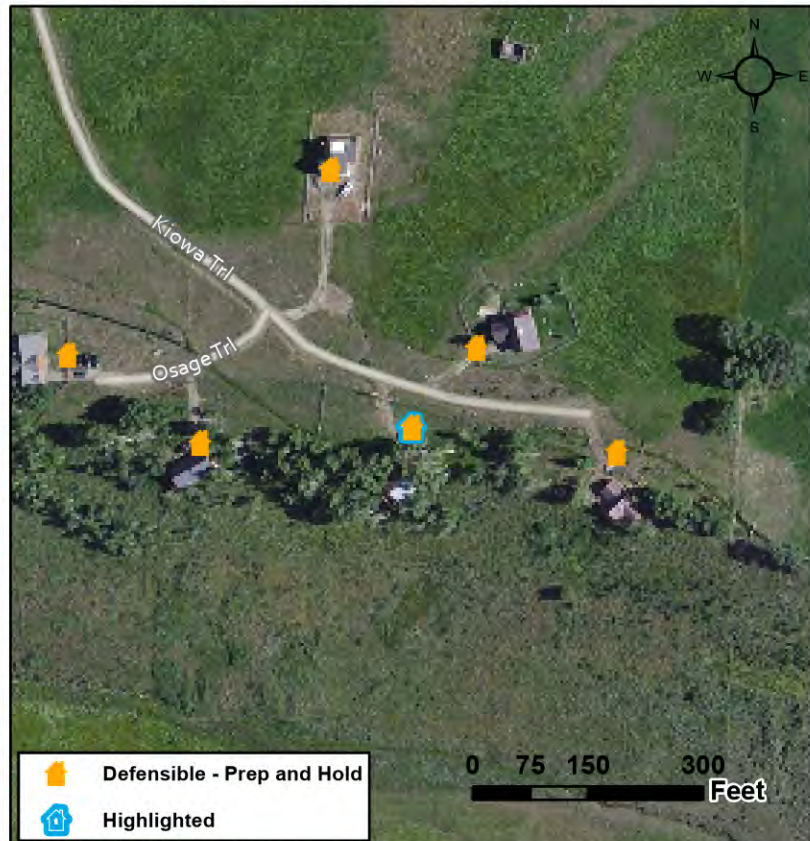
Location: 172 Kiowa Tr, WILDERNESS STREAMS FILING NO. 2

Triage Category: Defensible, Prep and Hold
FIRESCOPE Triage Category: Threatened Defensible
Structure Number: 172 Kiowa Trl
Collected Date/Time: 8/3/2023 9:15:41 PM
Collected By: Cody Peterson
Inspector's Position: ENGB
Type of Structure: Residential
Primary Structures: 1
Is the building Occupied?: Yes
Outbuildings: 1
Fuel Surrounding Structure: Grass and shrub, hardwood litter
Defensible Space: 30 ft treated
Roof Material: Noncombustible or not applicable
Siding Material: Log construction
Electrical Power: Yes
Gas to Structure: No
Hazards: Tagged hazard trees- standing dead aspen
Access to Site: T1 Engine
Describe Access: Maintained gravel
Comm With ICP: Yes
Water Source: Reliable water source nearby
Safety Zone Present:
Mitigation Time (in hours): 1
Mitigation Description: Weed eat, disburse wood from front and side
Resources Needed to Protect Structure: Engine
FIRESCOPE Tactics: Prep and Defend
Notes: Top ridge

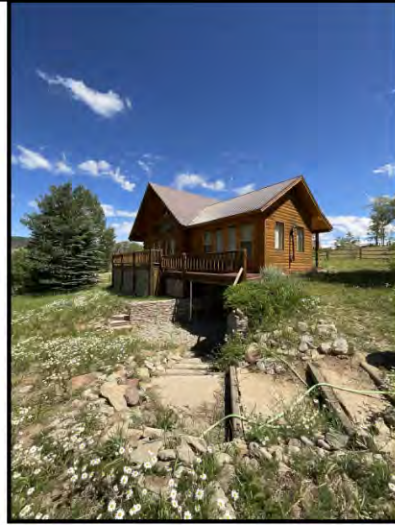
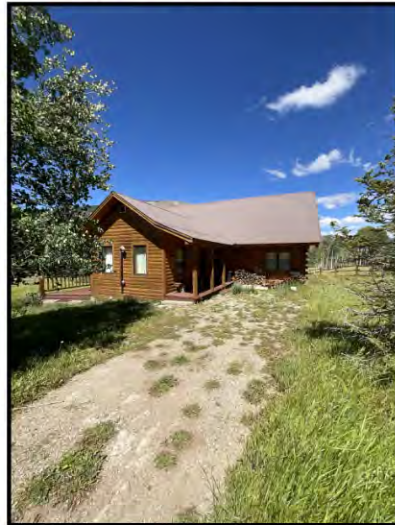
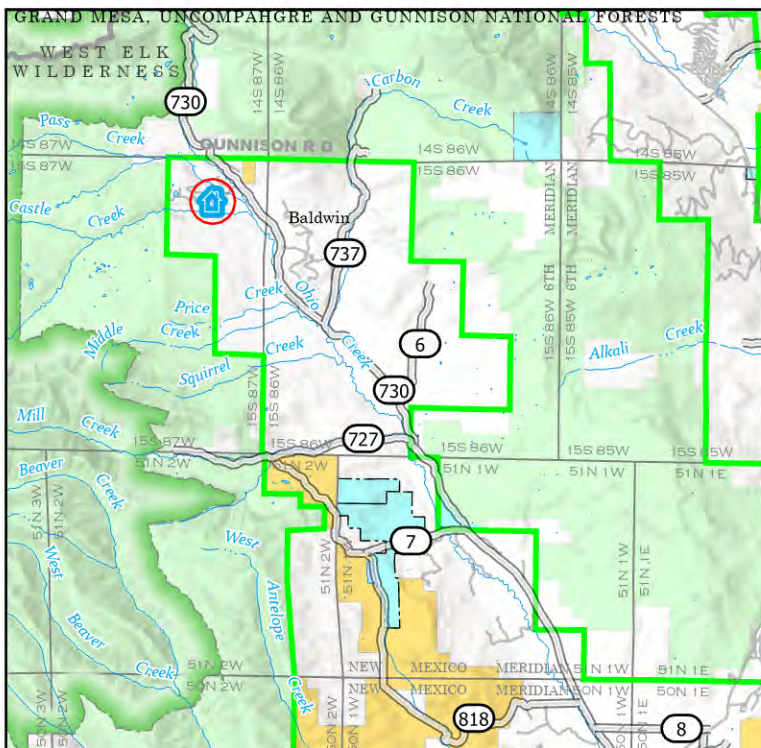
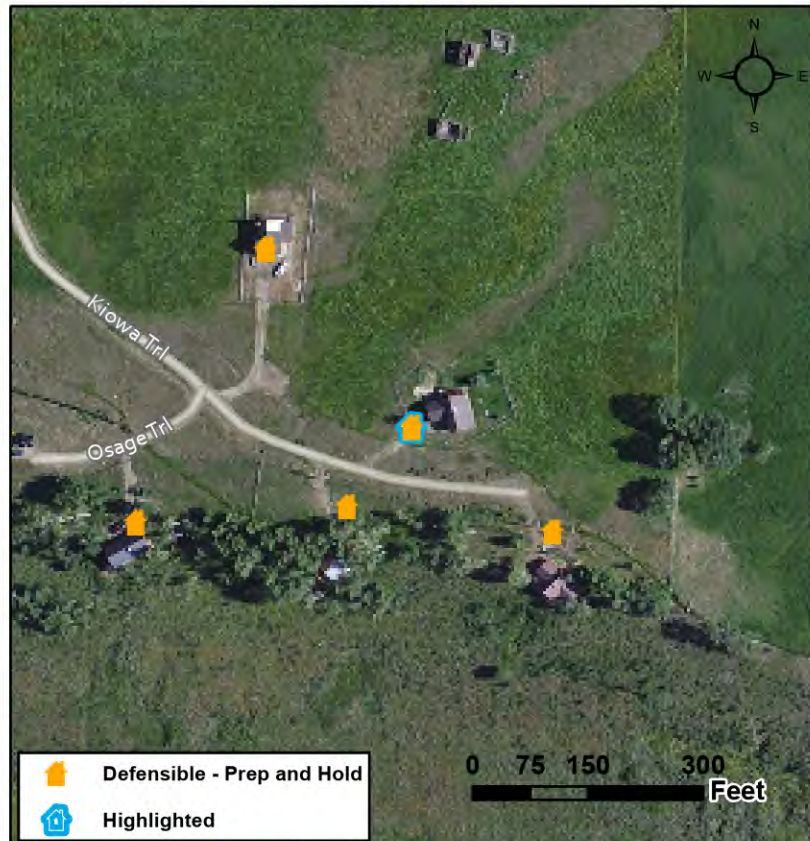
Location: 173 Kiowa Trl, WILDERNESS STREAMS FILING NO. 2

Triage Category: Defensible, Prep and Hold
FIRESCOPE Triage Category: Threatened Defensible
Structure Number: 173 Kiowa Trl
Collected Date/Time: 8/3/2023 9:09:52 PM
Collected By: Cody Peterson
Inspector's Position: ENGB
Type of Structure: Residential
Primary Structures: 1
Is the building Occupied?: No
Outbuildings: 6
Fuel Surrounding Structure: Grass and shrub, hardwood litter
Defensible Space: 30 ft treated
Roof Material: Noncombustible or not applicable
Siding Material: Log construction
Electrical Power: Yes
Gas to Structure: No
Hazards:
Access to Site: T1 Engine
Describe Access: Maintained gravel
Comm With ICP: Yes
Water Source: Reliable water source nearby
Safety Zone Present:
Mitigation Time (in hours): 1
Mitigation Description: Weed eat, limb trees
Resources Needed to Protect Structure: Engine
FIRESCOPE Tactics: Prep and Defend
Notes: 6 historical structures to the north of primary structure

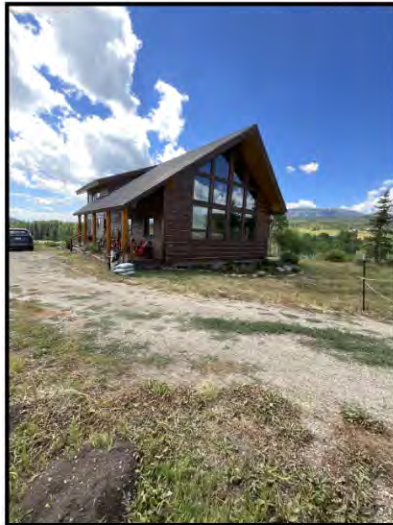
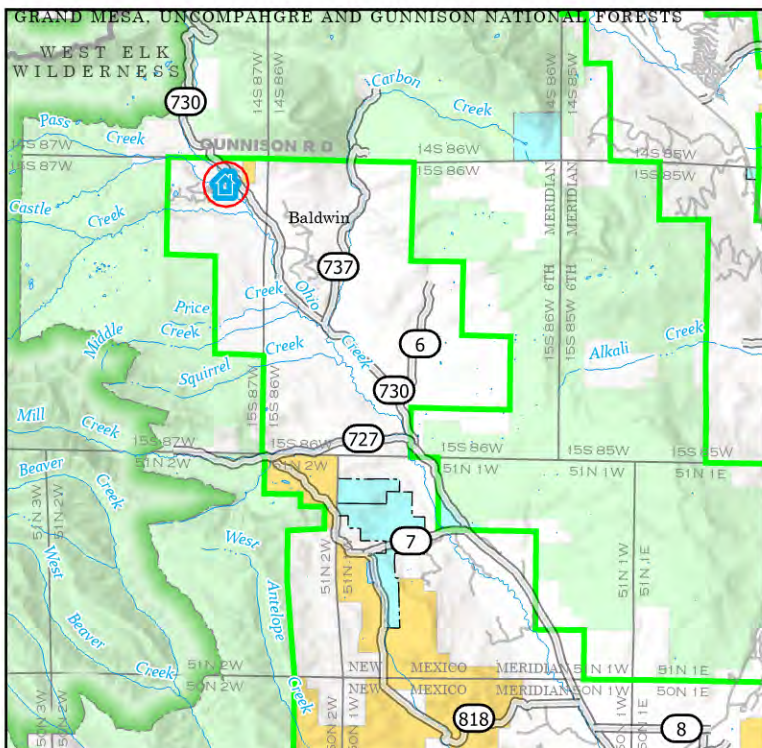
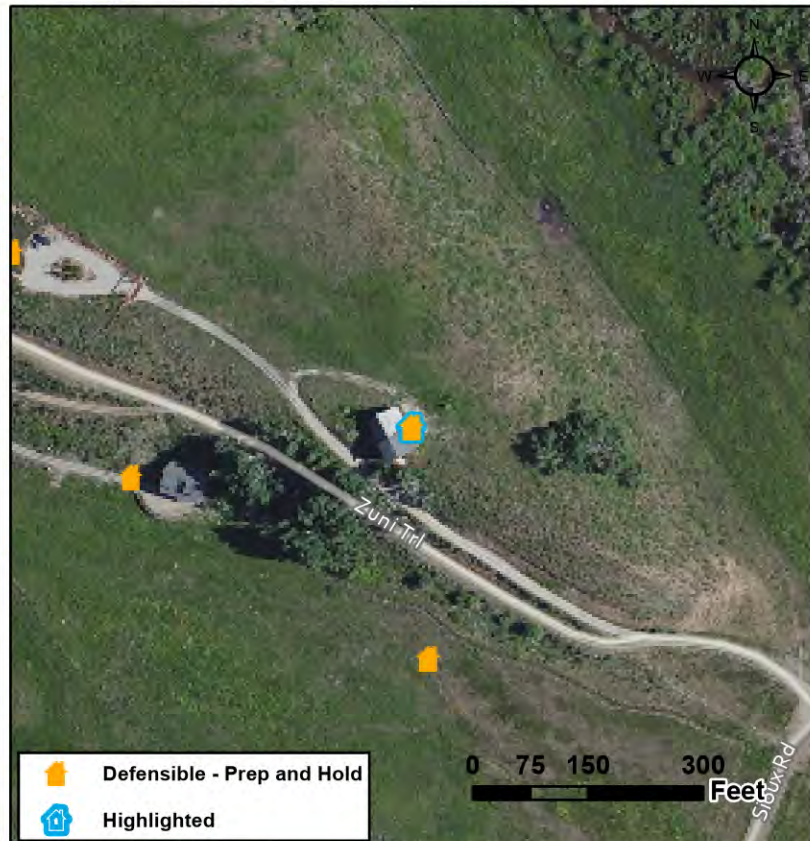
Location: 173 Zuni Trl, WILDERNESS STREAMS FILING NO. 2

Triage Category: Defensible, Prep and Hold
FIRESCOPE Triage Category: Not Threatened
Structure Number: 173 Zuni Trl
Collected Date/Time:
Collected By: Kevin Brueck
Inspector's Position: Eng b t
Type of Structure: Residential
Primary Structures: 1
Is the building Occupied?: Yes
Outbuildings:
Fuel Surrounding Structure: Shrub or timber
Defensible Space: Less than 30 ft treated
Roof Material: Noncombustible or not applicable
Siding Material: Wood or open sided
Electrical Power: Yes
Gas to Structure: Yes
Hazards: Slope preheating fuels
Access to Site: T1 Engine
Describe Access: Maintained gravel drive-moderate slope
Comm With ICP: Yes
Water Source: No reliable water source nearby
Safety Zone Present:
Mitigation Time (in hours): 2
Mitigation Description: Clear trees, shrubs, tall grass
Resources Needed to Protect Structure: T6
FIRESCOPE Tactics: Prep and Defend
Notes: Wood front and rear porch

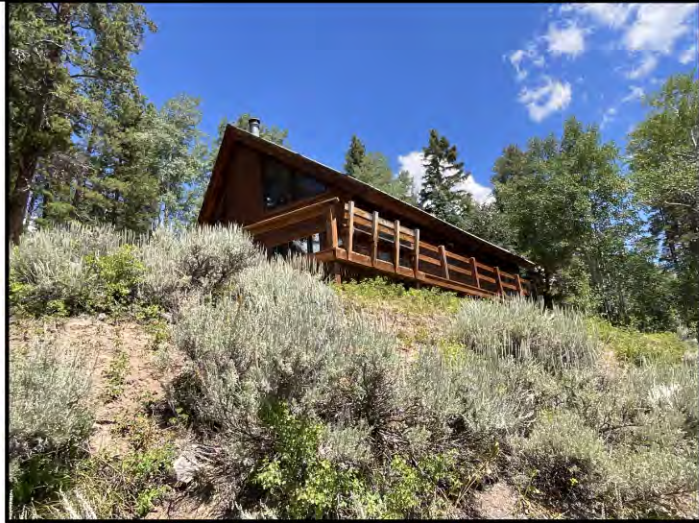
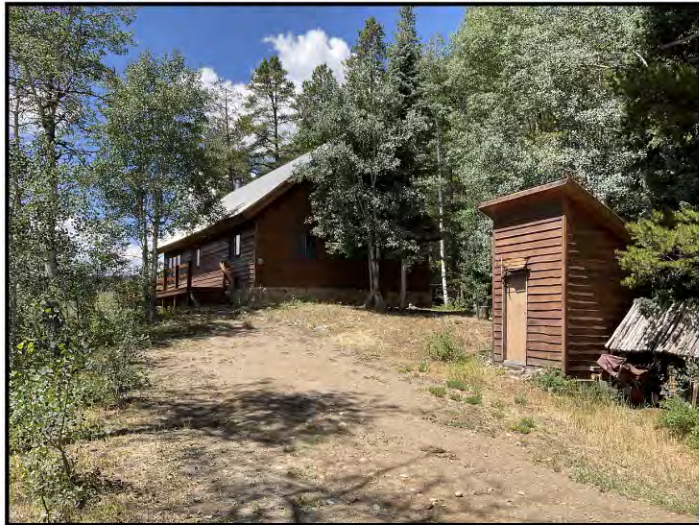
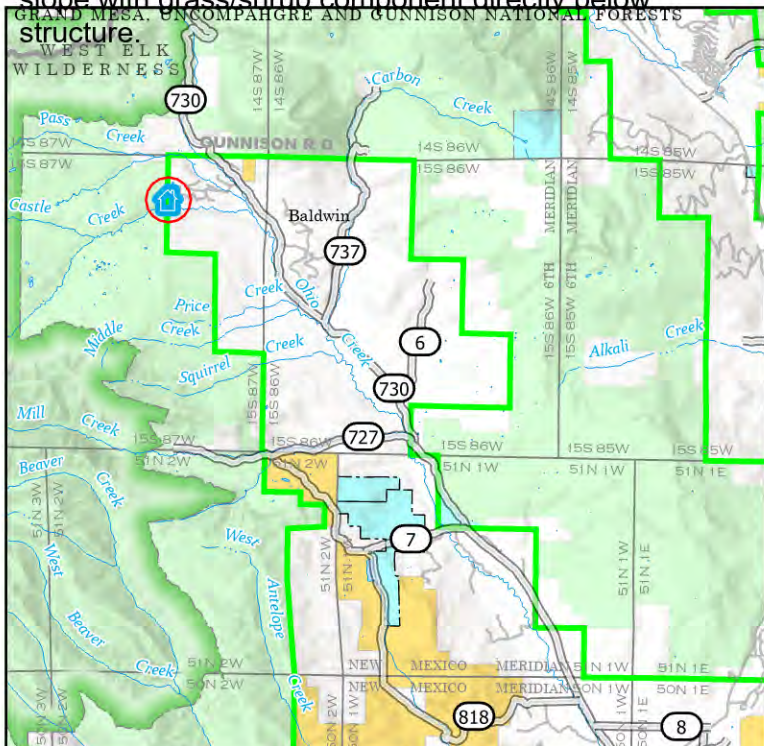
Location: 1730 Sioux Rd, WILDERNESS STREAMS FILING NO. 2

Triage Category: Defensible, Prep and Hold
FIRESCOPE Triage Category: Threatened Defensible
Structure Number: 1730 Sioux Rd
Collected Date/Time: 8/3/2023 6:30:43 PM
Collected By: Bo Knickman
Inspector's Position: Engb
Type of Structure: Residential
Primary Structures: 1
Is the building Occupied?: Yes
Outbuildings: 1
Fuel Surrounding Structure: Shrub or timber
Defensible Space: Less than 30 ft treated
Roof Material: Noncombustible or not applicable
Siding Material: Wood or open sided
Electrical Power: Yes
Gas to Structure: No
Hazards: No safety zone at home, safety zone at base of driveway, tactical maneuver to the bottom of driveway will be highly likely.
Access to Site: T3/4 Engine
Describe Access: 300 foot steep driveway, small turn around at top, driveway is in timber and is not tenable in fire conditions
Comm With ICP: Yes
Water Source: No reliable water source nearby
Safety Zone Present:
Mitigation Time (in hours): 1

Mitigation Description: Removing fuels adjacent to home, especially down slope on south side. Sprinkler kit recommended.
Resources Needed to Protect Structure: 1 engine
FIRESCOPE Tactics: Bump and Run
Notes: Timber bumping the home to the north, steep slope with grass/shrub component directly below structure

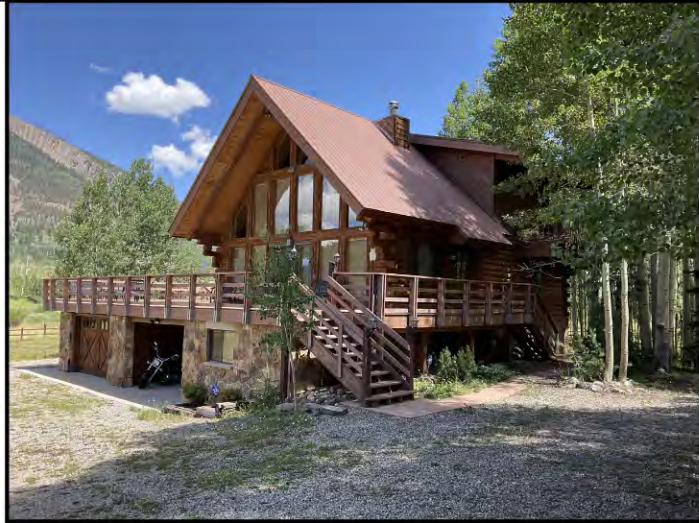
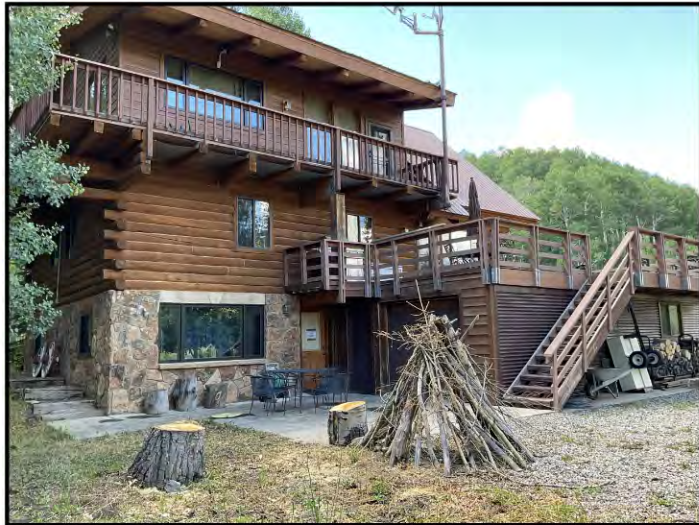
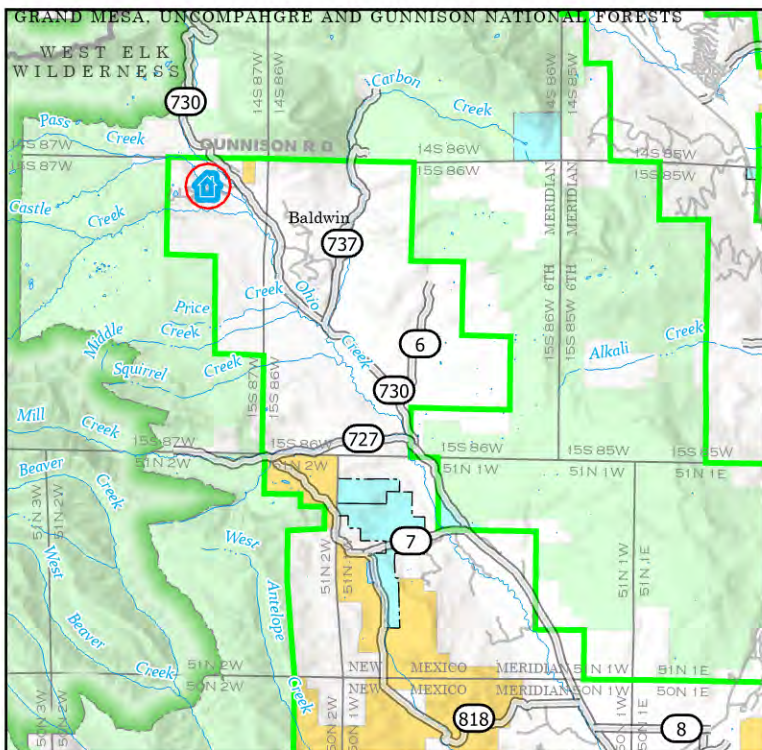
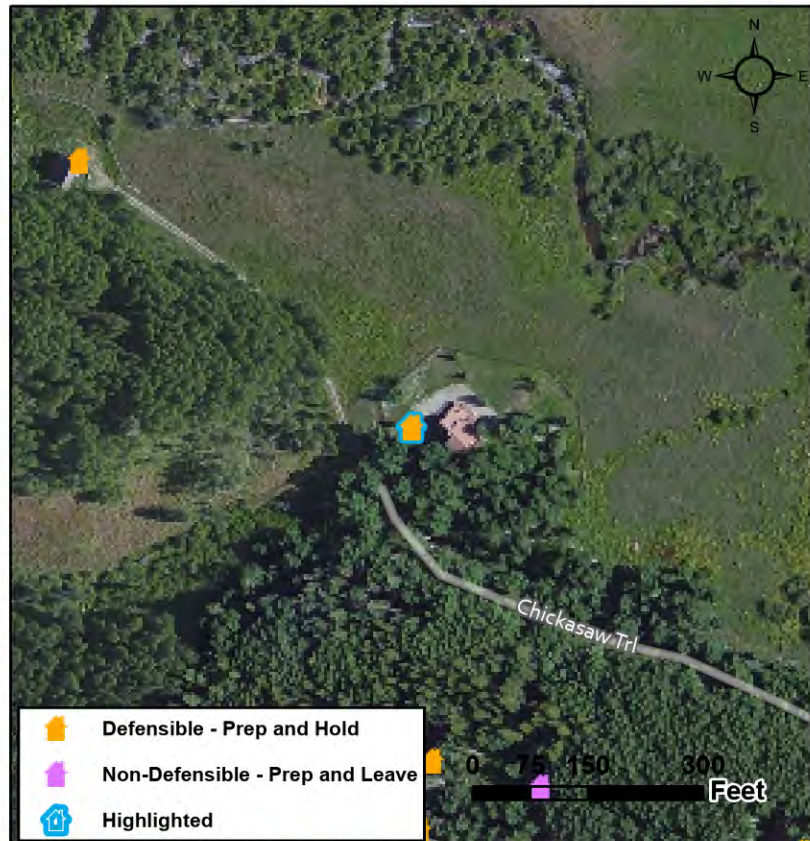
Location: 175 Chickasaw Trl, WILDERNESS STREAMS FILING NO. 2

Triage Category: Defensible, Prep and Hold
FIRESCOPE Triage Category: Not Threatened
Structure Number: 175 Chickasaw Trl
Collected Date/Time: 8/3/2023 7:44:21 PM
Collected By: Adam Altergott
Inspector's Position: Engb
Type of Structure: Residential
Primary Structures: 1
Is the building Occupied?: No
Outbuildings: 0
Fuel Surrounding Structure: Shrub or timber
Defensible Space: 30 ft treated
Roof Material: Noncombustible or not applicable
Siding Material: Log construction
Electrical Power: Yes
Gas to Structure: Unknown
Hazards: None
Access to Site: T3/4 Engine
Describe Access: Narrow gravel road
Comm With ICP: Yes
Water Source: Reliable water source nearby
Safety Zone Present:
Mitigation Time (in hours): 1
Mitigation Description: Move firewood away from house
Resources Needed to Protect Structure: 1 type 3-4
FIRESCOPE Tactics: Prep and Defend
Notes: Log construction with metal roof

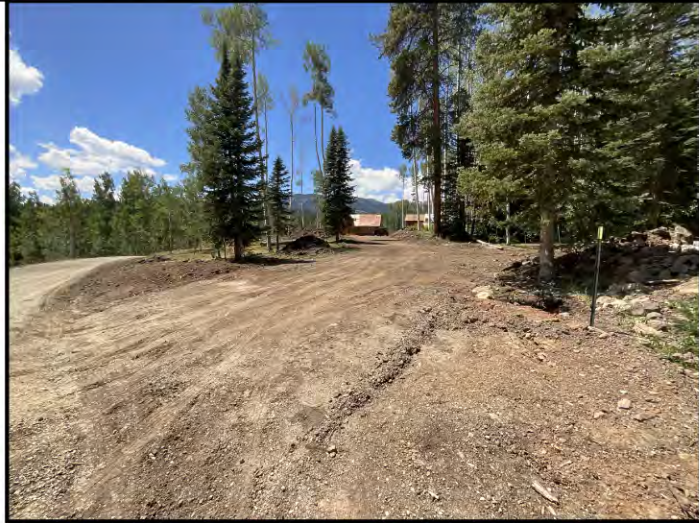
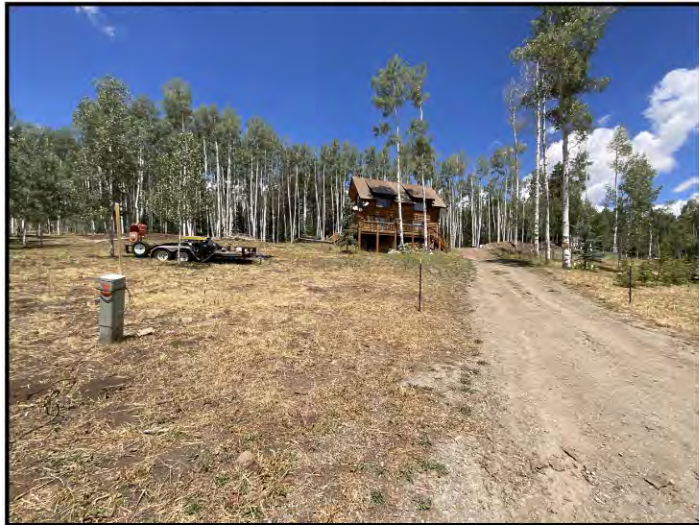
Location: 1796 Sioux Rd, WILDERNESS STREAMS FILING NO. 2

Triage Category: Defensible, Prep and Hold
FIRESCOPE Triage Category: Threatened Defensible
Structure Number: 1796 Sioux Rd - 1
Collected Date/Time: 8/3/2023 5:53:39 PM
Collected By: Jesse Gallup
Inspector's Position: FFTI
Type of Structure: Residential
Primary Structures: 1
Is the building Occupied?: Yes
Outbuildings: 1
Fuel Surrounding Structure: Grass and shrub, hardwood litter
Defensible Space: More than 100ft treated
Roof Material: Noncombustible or not applicable
Siding Material: Log construction
Electrical Power: Yes
Gas to Structure: No
Hazards: Active logging area, heavy equipment
Access to Site: T3/4 Engine
Describe Access: Unimproved dirt driveway
Comm With ICP: Yes
Water Source: Limited or dependent on electricity
Safety Zone Present:
Mitigation Time (in hours): 1
Mitigation Description: Remove combustible material from under porch
Resources Needed to Protect Structure: 1 engine
FIRESCOPE Tactics: Prep and Defend

Notes: Log cabin like structure with defensible area. Logging operation behind main structure.

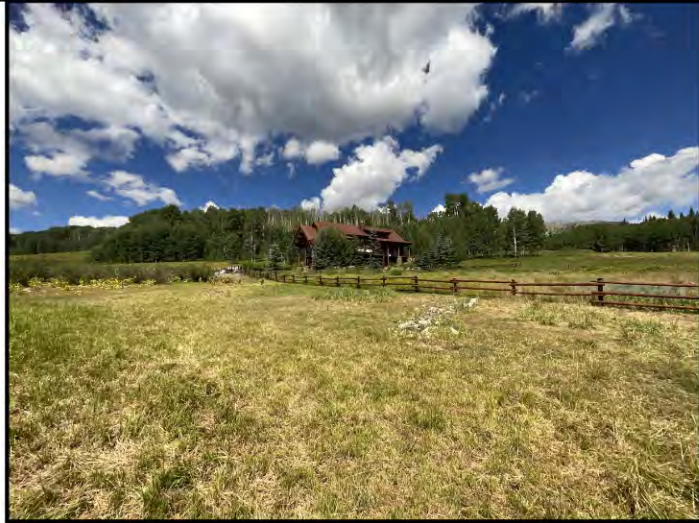
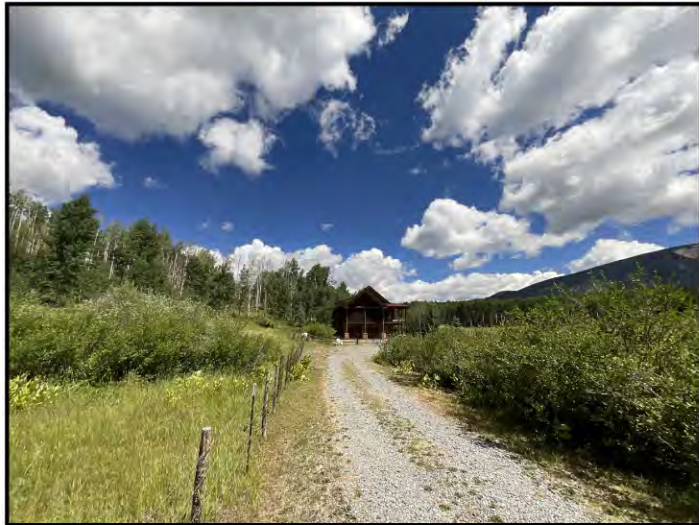
Triage Category: Defensible, Prep and Hold
FIRESCOPE Triage Category: Threatened Defensible
Structure Number: 1800 Sioux Rd
Collected Date/Time: 8/3/2023 5:40:59 PM
Collected By: Zak Slutzky
Inspector's Position: EngB(t)
Type of Structure: Residential
Primary Structures: 1
Is the building Occupied?: No
Outbuildings: 0
Fuel Surrounding Structure: Shrub or timber
Defensible Space: 30 ft treated
Roof Material: Noncombustible or not applicable
Siding Material: Wood or open sided
Electrical Power: Yes
Gas to Structure: Yes
Hazards: Adjacent above ground propane tank, Electric fence, livestock
Access to Site: T3/4 Engine
Describe Access: Semi improved long driveway, with turnarounds - not tenable egress under fire conditions
Comm With ICP: Yes
Water Source: No reliable water source nearby
Safety Zone Present:
Mitigation Time (in hours): 1
Mitigation Description: Brushing, grass mowing
Resources Needed to Protect Structure: 1 engine

FIRESCOPE Tactics: Prep and Defend
Notes: 3 story residential type 4 construction

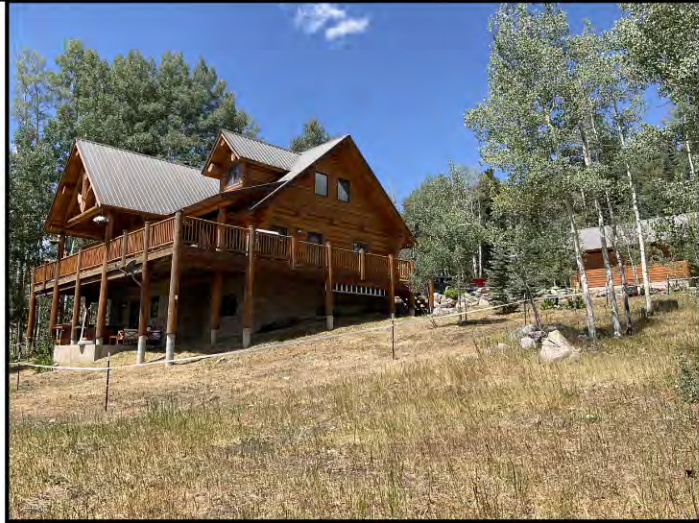
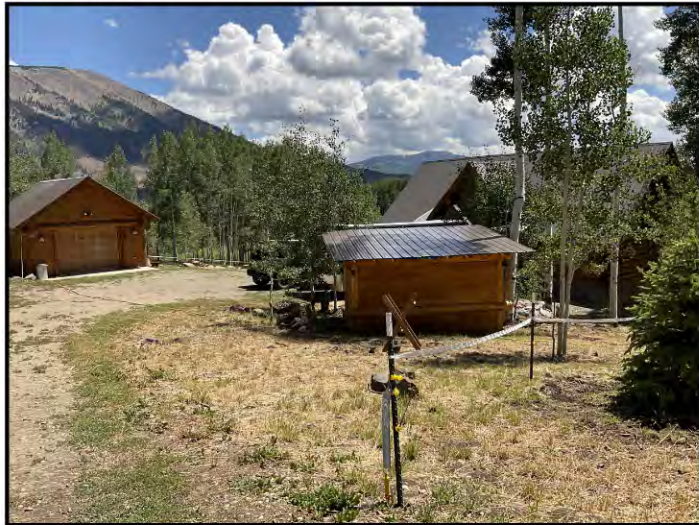
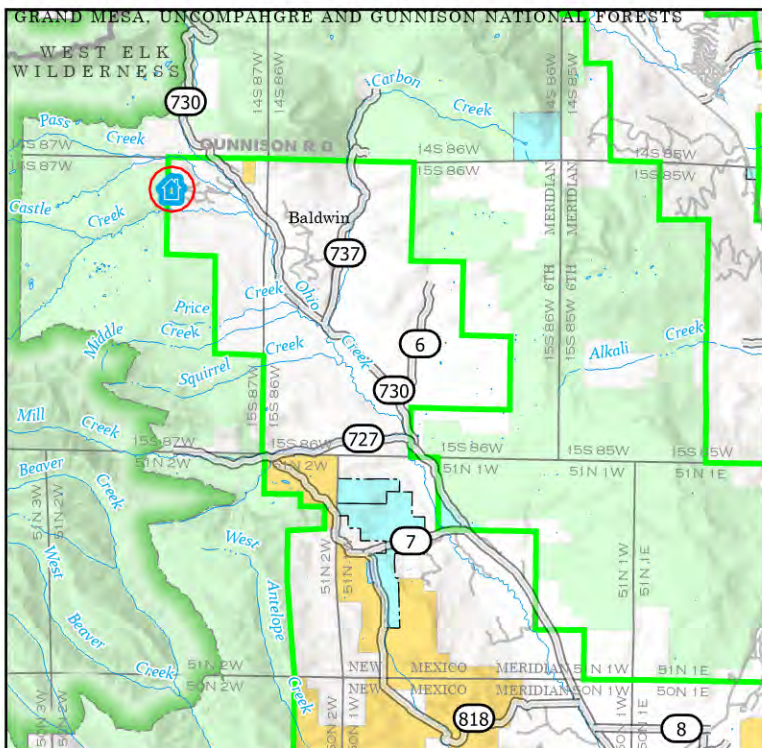
Location: 1815 Sioux Rd, WILDERNESS STREAMS FILING NO. 2

Triage Category: Defensible, Prep and Hold
FIRESCOPE Triage Category: Threatened Defensible
Structure Number: 1815 Sioux Rd
Collected Date/Time: 8/3/2023 6:06:36 PM
Collected By: Fritz Rogowski
Inspector's Position: Engb
Type of Structure: Residential
Primary Structures: 1
Is the building Occupied?: Yes
Outbuildings: 2
Fuel Surrounding Structure: Grass and shrub, hardwood litter
Defensible Space: 100 ft treated
Roof Material: Noncombustible or not applicable
Siding Material: Log construction
Electrical Power: Yes
Gas to Structure: Yes
Hazards: Underground propane tank
Access to Site: T3/4 Engine
Describe Access: Improved drieway
Comm With ICP: Yes
Water Source: Limited or dependent on electricity
Safety Zone Present:
Mitigation Time (in hours): 1
Mitigation Description: Remove minor fuels, handline, sprinkler kit
Resources Needed to Protect Structure: 1 engine crew
FIRESCOPE Tactics: Prep and Defend
Notes: Heavy timber construction with fuel mitigation in place

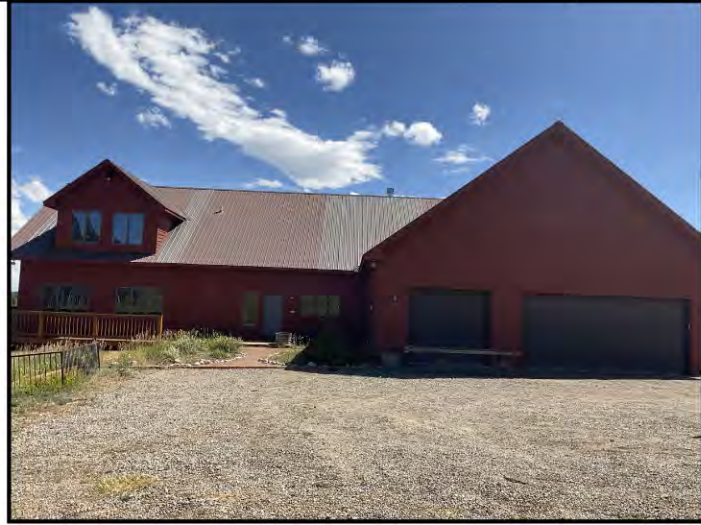
Triage Category: Defensible, Prep and Hold
FIRESCOPE Triage Category: Not Threatened
Structure Number: 184 Mohawk Trl
Collected Date/Time: 8/3/2023 9:23:22 PM
Collected By: Adam Altergott
Inspector's Position: EngB
Type of Structure: Residential
Primary Structures: 1
Is the building Occupied?: No
Outbuildings: 0
Fuel Surrounding Structure: Grass and shrub, hardwood litter
Defensible Space: Less than 30 ft treated
Roof Material: Noncombustible or not applicable
Siding Material: Wood or open sided
Electrical Power: Yes
Gas to Structure: No
Hazards: None
Access to Site: T3/4 Engine
Describe Access: Narrow gravel road with tight turnaround
Comm With ICP: Yes
Water Source: No reliable water source nearby
Safety Zone Present:
Mitigation Time (in hours): 1
Mitigation Description: Weedwack weeds and grass and move material from under deck.
Resources Needed to Protect Structure: 1 type 3 or 6 engine
FIRESCOPE Tactics: Prep and Defend

Notes: Metal roof with wood siding and large deck

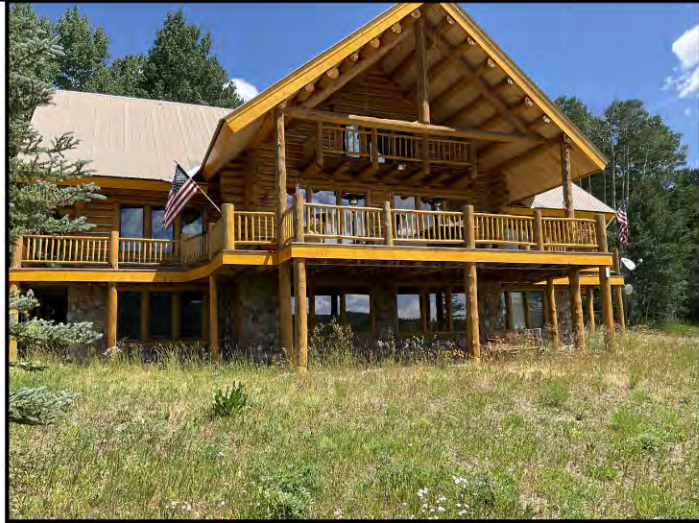
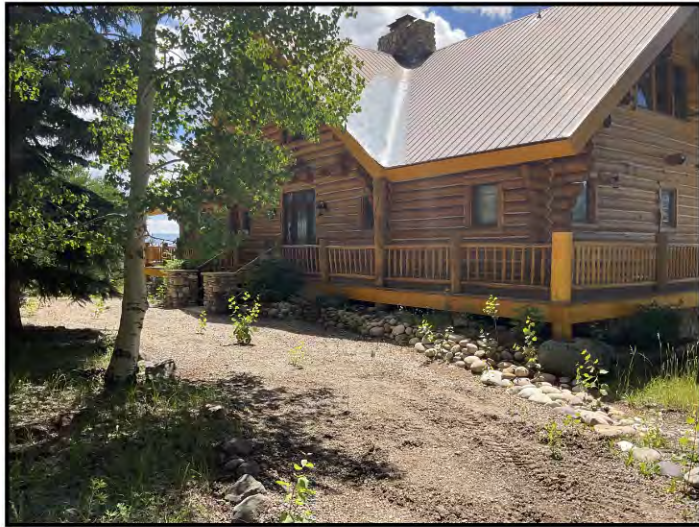
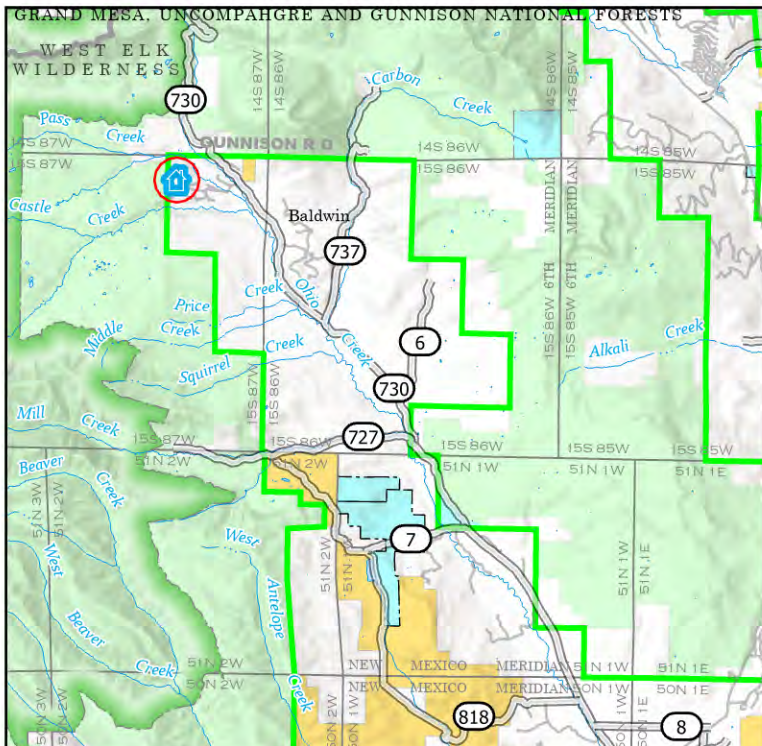
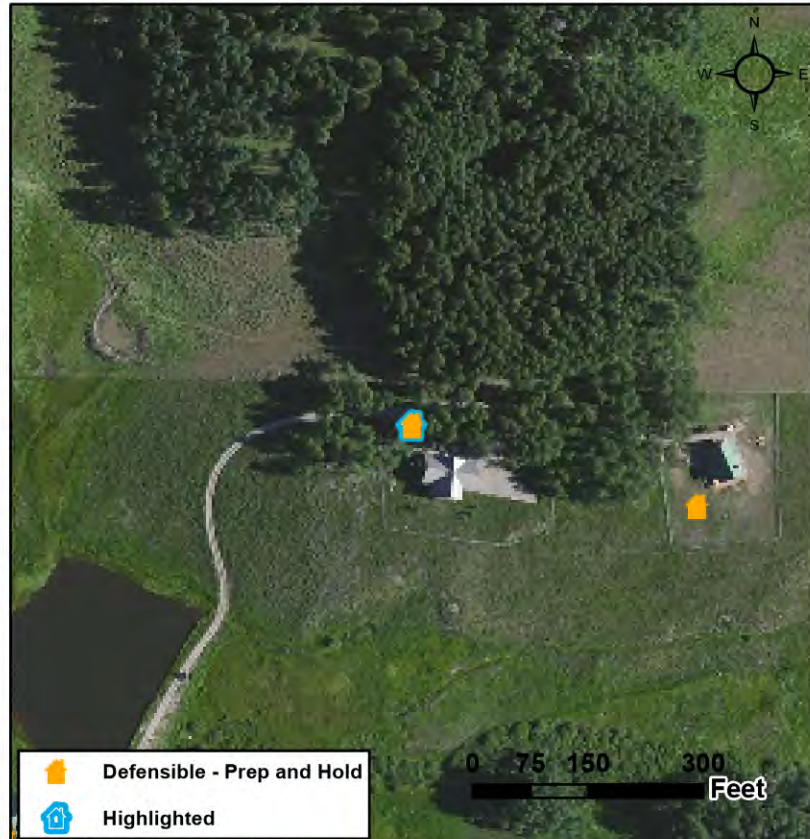
Location: 1851 Sioux Rd, WILDERNESS STREAMS FILING NO. 2

Triage Category: Defensible, Prep and Hold
FIRESCOPE Triage Category: Threatened Defensible
Structure Number: 1851 Sioux Rd
Collected Date/Time: 8/3/2023 5:57:47 PM
Collected By: Cody Peterson
Inspector's Position: ENGB
Type of Structure: Residential
Primary Structures: 1
Is the building Occupied?: Yes
Outbuildings: 0
Fuel Surrounding Structure: Shrub or timber
Defensible Space: 30 ft treated
Roof Material: Noncombustible or not applicable
Siding Material: Log construction
Electrical Power: Yes
Gas to Structure: Yes
Hazards:
Access to Site: T3/4 Engine
Describe Access: Maintained Gravel
Comm With ICP: Yes
Water Source: Reliable water source nearby
Safety Zone Present:
Mitigation Time (in hours): 1
Mitigation Description: Limb trees
Resources Needed to Protect Structure: Engine
FIRESCOPE Tactics: Prep and Defend
Notes:

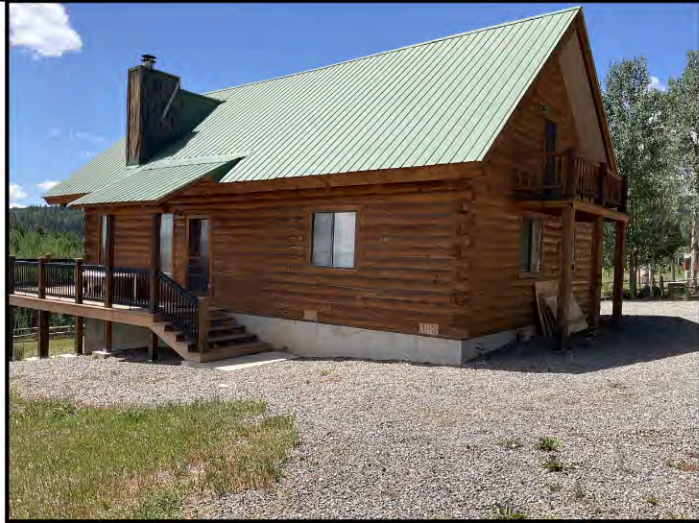
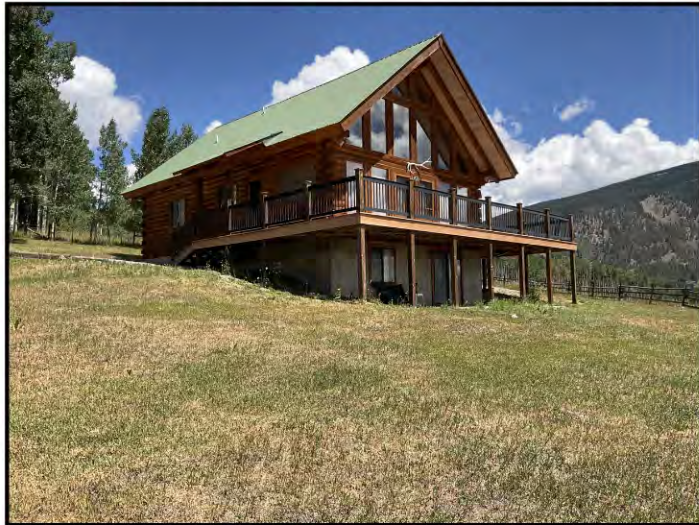
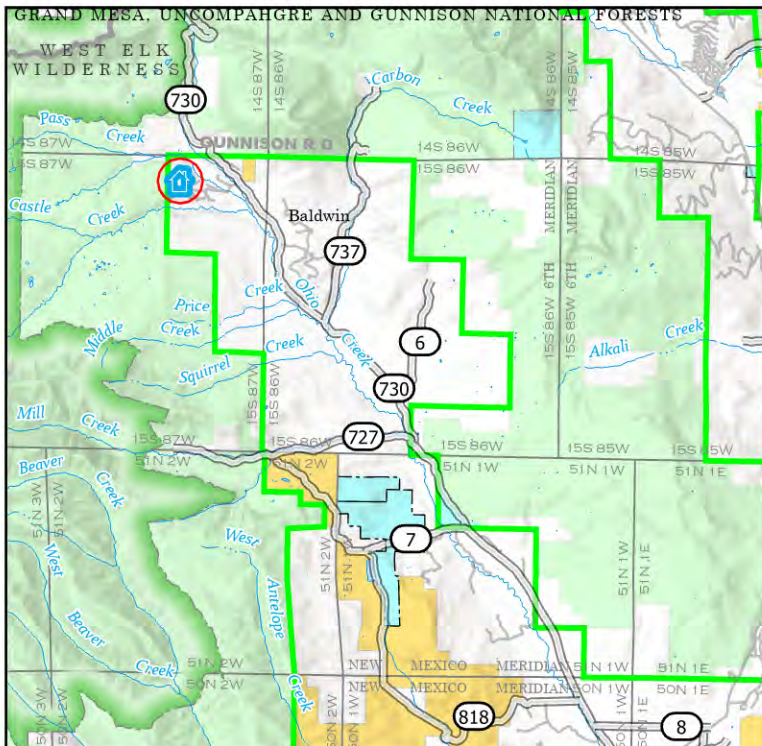
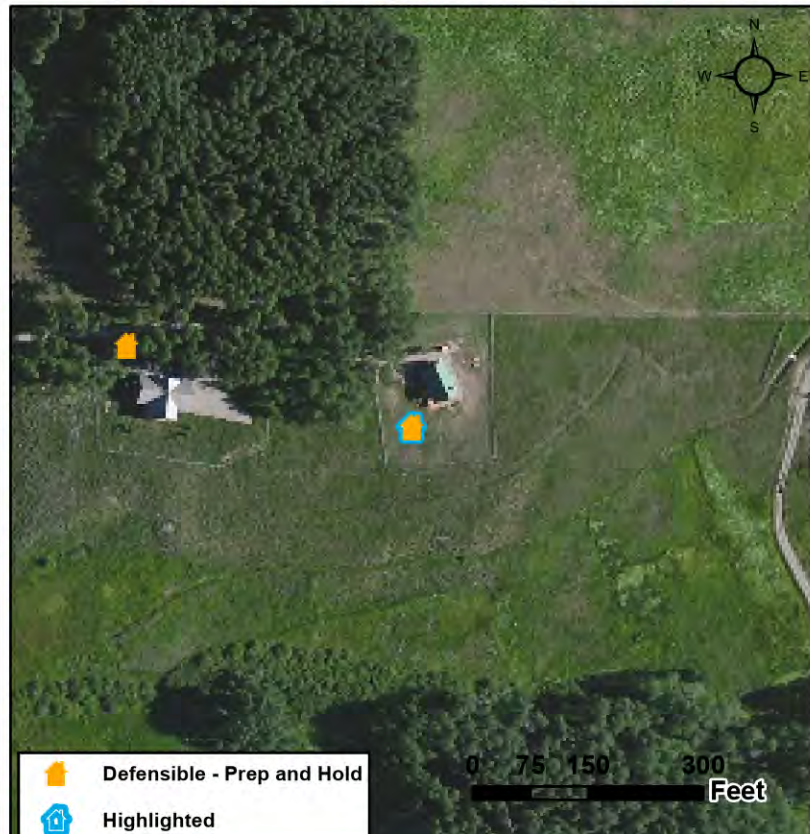
Triage Category: Defensible, Prep and Hold
FIRESCOPE Triage Category: Threatened Defensible
Structure Number: 1853 Sioux Rd
Collected Date/Time: 8/3/2023 6:08:07 PM
Collected By: Cody Peterson
Inspector's Position: ENGB
Type of Structure: Residential
Primary Structures: 1
Is the building Occupied?: Unknown
Outbuildings: 0
Fuel Surrounding Structure:
Defensible Space: 100 ft treated
Roof Material: Noncombustible or not applicable
Siding Material: Log construction
Electrical Power: Yes
Gas to Structure: No
Hazards:
Access to Site: T3/4 Engine
Describe Access: Maintained gravel
Comm With ICP: Yes
Water Source: Reliable water source nearby
Safety Zone Present:
Mitigation Time (in hours): 1
Mitigation Description: Deck items
Resources Needed to Protect Structure: Engine
FIRESCOPE Tactics: Prep and Defend
Notes:

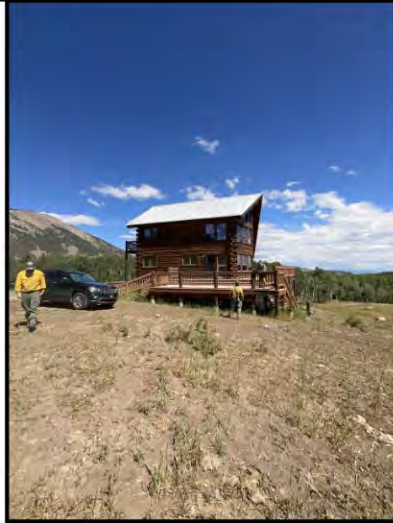
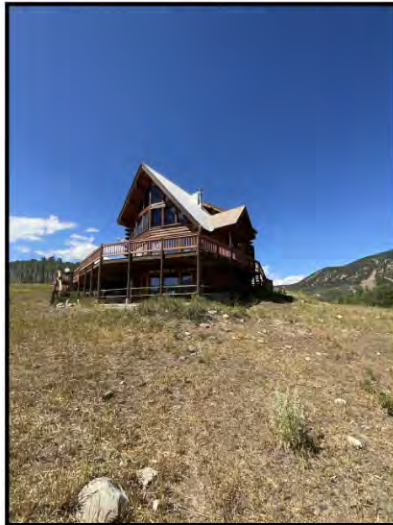
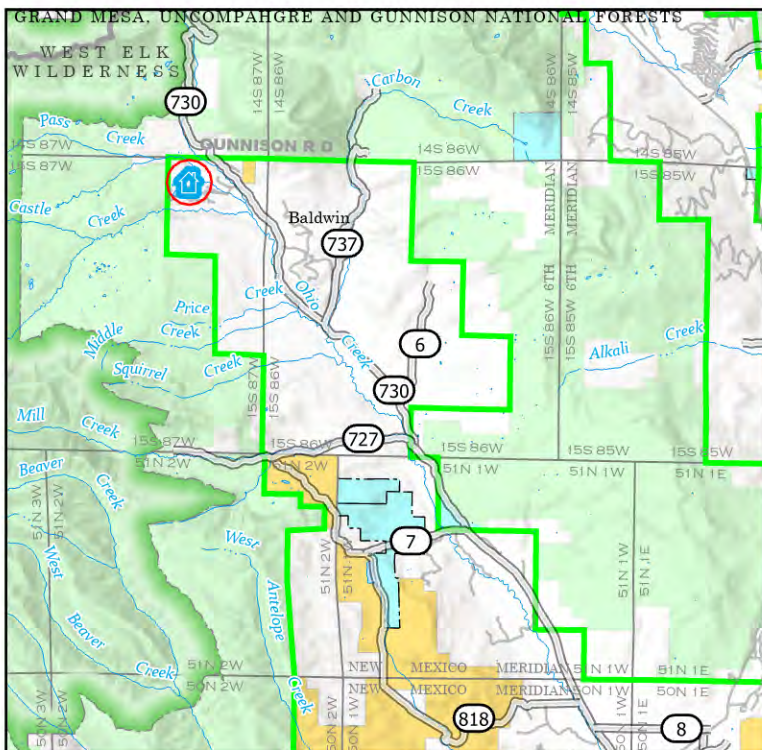
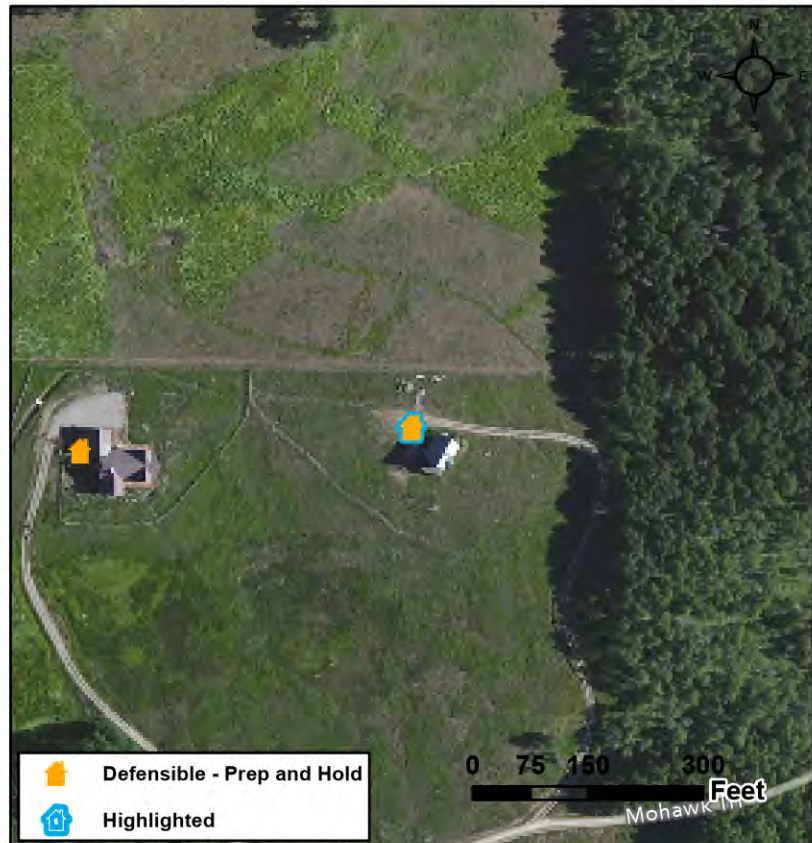
Location: 196 Mohawk Trl, WILDERNESS STREAMS FILING NO. 2

Triage Category: Defensible, Prep and Hold
FIRESCOPE Triage Category: Not Threatened
Structure Number: 196 Mohawk Trl
Collected Date/Time: 8/3/2023 9:06:12 PM
Collected By: Adam Altergott
Inspector's Position: EngB
Type of Structure: Residential
Primary Structures: 1
Is the building Occupied?: Yes
Outbuildings: 0
Fuel Surrounding Structure: Grass and shrub, hardwood litter
Defensible Space: 30 ft treated
Roof Material: Noncombustible or not applicable
Siding Material: Log construction
Electrical Power: Yes
Gas to Structure: No
Hazards:
Access to Site: T3/4 Engine
Describe Access: Gravel narrow slightly steep
Comm With ICP: Yes
Water Source: No reliable water source nearby
Safety Zone Present:
Mitigation Time (in hours): 1
Mitigation Description: Weed wacking around structure removal of decking under deck
Resources Needed to Protect Structure: 1 any type 3 or 4 engine
FIRESCOPE Tactics: Prep and Defend
Notes: Large south facing deck

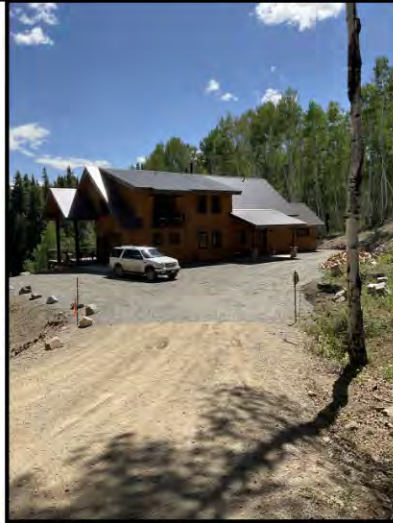
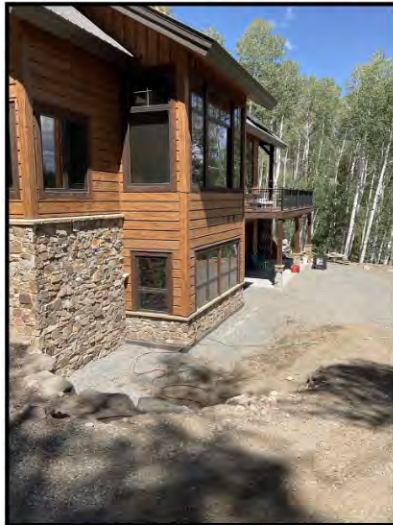
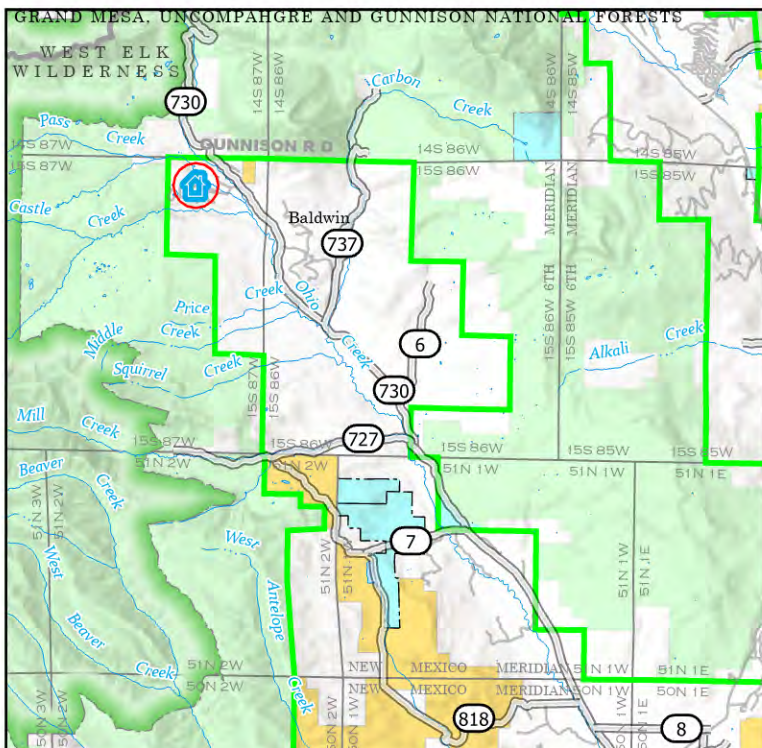
Location: 201 Mohawk Trl, WILDERNESS STREAMS FILING NO. 2

Triage Category: Non-Defensible, Prep and Leave
FIRESCOPE Triage Category: Not Threatened
Structure Number: 201 Mohawk Trl
Collected Date/Time: 8/3/2023 8:51:54 PM
Collected By: Kevin Brueck
Inspector's Position: EngB t
Type of Structure: Residential
Primary Structures: 1
Is the building Occupied?: Yes
Outbuildings: 0
Fuel Surrounding Structure: Shrub or timber
Defensible Space: 30 ft treated
Roof Material: Noncombustible or not applicable
Siding Material: Rock, concrete, metal
Electrical Power: Yes
Gas to Structure: Unknown
Hazards: Solar panels
Access to Site: T3/4 Engine
Describe Access: Narrow dirt road
Comm With ICP: Yes
Water Source: No reliable water source nearby
Safety Zone Present:
Mitigation Time (in hours): 1
Mitigation Description: Remove combustibles that are close to the house
Resources Needed to Protect Structure: Type 6
FIRESCOPE Tactics: Prep and Go
Notes: Walk out basement and porch on Charlie side

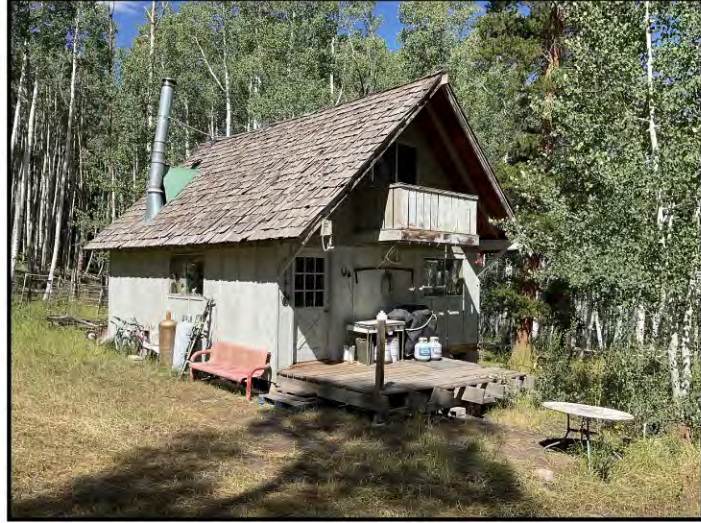
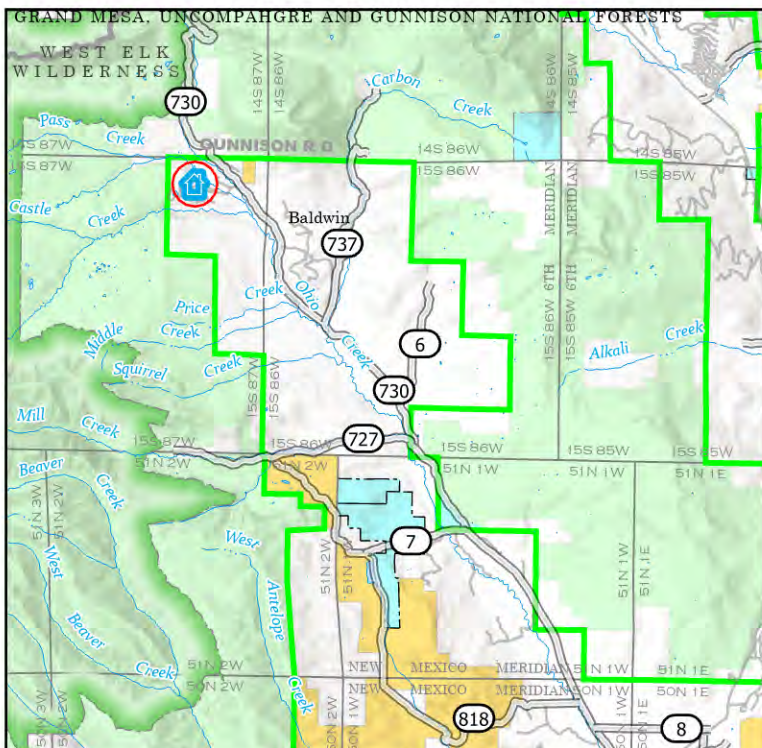
Triage Category: Non-Defensible, Prep and Leave
FIRESCOPE Triage Category: Not Threatened
Structure Number: 204 Mohawk Trl
Collected Date/Time: 8/3/2023 9:46:47 PM
Collected By: Kevin Brueck
Inspector's Position: EngB t
Type of Structure: Residential
Primary Structures: 1
Is the building Occupied?: No
Outbuildings: 1
Fuel Surrounding Structure: Shrub or timber
Defensible Space: Less than 30 ft treated
Roof Material: Combustible or no roof
Siding Material: Wood or open sided
Electrical Power: Unknown
Gas to Structure: Unknown
Hazards: Pile of propane cans on the porch
Access to Site: T6 Engine
Describe Access: Narrow, two track, entrance is easy to miss
Comm With ICP: Yes
Water Source: No reliable water source nearby
Safety Zone Present:
Mitigation Time (in hours): 5
Mitigation Description: Limping trees, clearing scrap and other combustibles materials away from structure, sprinklers
Resources Needed to Protect Structure: Type 6

FIRESCOPE Tactics: Prep and Go
Notes: Hunting cabin
