Location: 100 Castle Creek Rd, WILDERNESS STREAMS FILING NO. 2

Coordinates (DDM): 38° 46.291' N, 107° 04.891' W

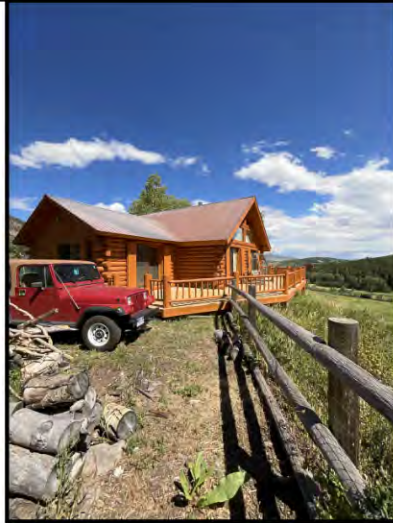
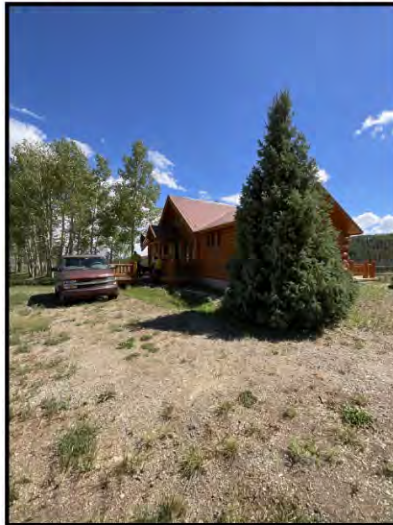
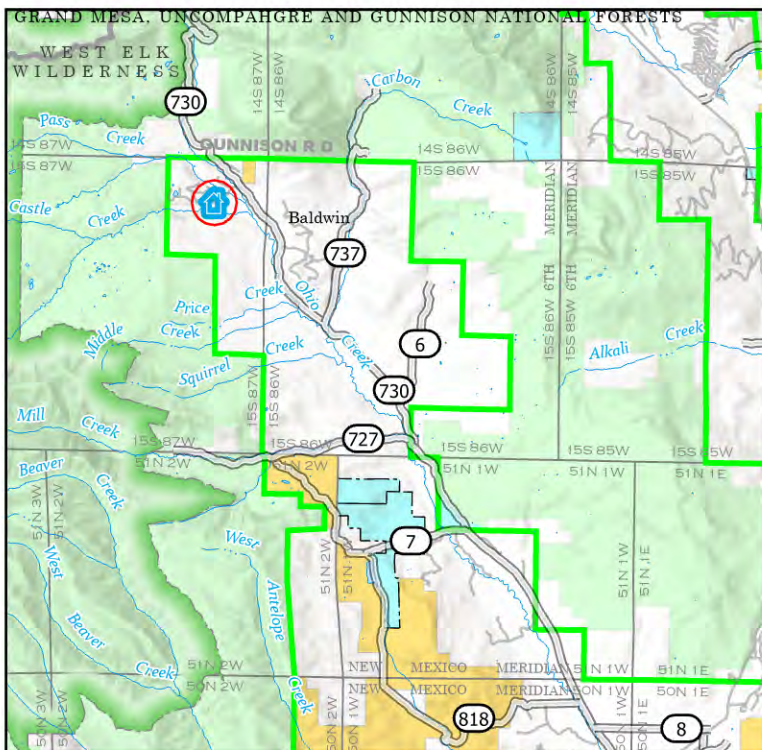
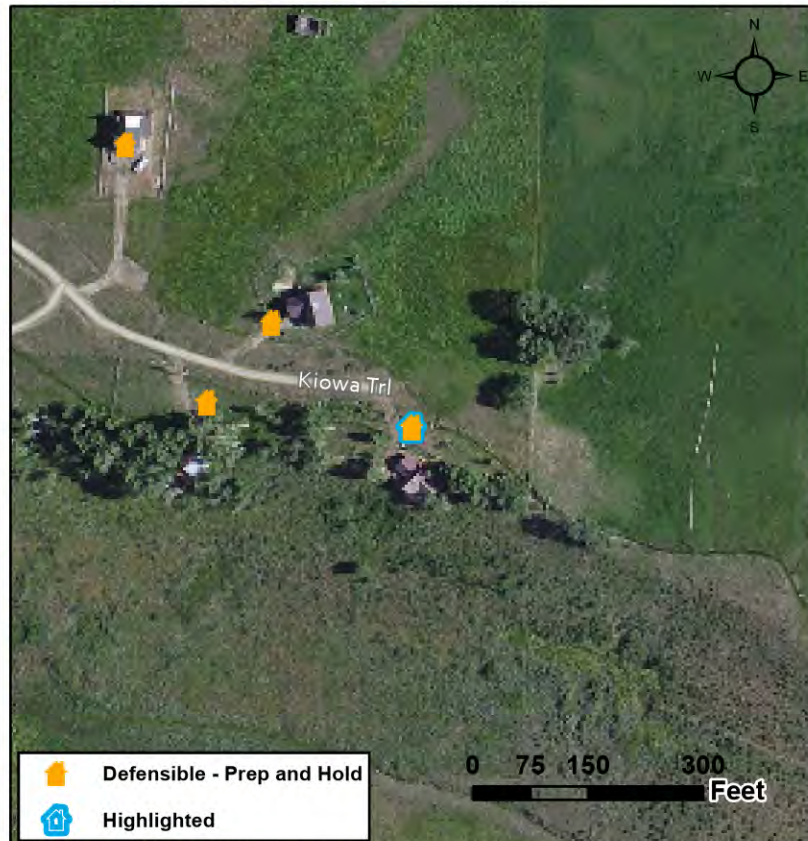
Triage Category: Defensible, Prep and Hold
FIRESCOPE Triage Category: Threatened Defensible
Structure Number: 205 Kiowa Trl
Collected Date/Time: 8/3/2023 9:03:22 PM
Collected By: Cody Peterson
Inspector's Position: ENGB
Type of Structure: Residential
Primary Structures: 1
Is the building Occupied?: Yes
Outbuildings: 1
Fuel Surrounding Structure: Grass and shrub, hardwood litter
Defensible Space: 100 ft treated
Roof Material: Noncombustible or not applicable
Siding Material: Log construction
Electrical Power: Yes
Gas to Structure: No
Hazards: Top ridge
Access to Site: T1 Engine
Describe Access: Maintained gravel
Comm With ICP: Yes
Water Source: Reliable water source nearby
Safety Zone Present:
Mitigation Time (in hours): 1
Mitigation Description: Weed eat, disburse wood pile, limb spruce tree
Resources Needed to Protect Structure: Engine
FIRESCOPE Tactics: Prep and Defend
Notes: Top ridge

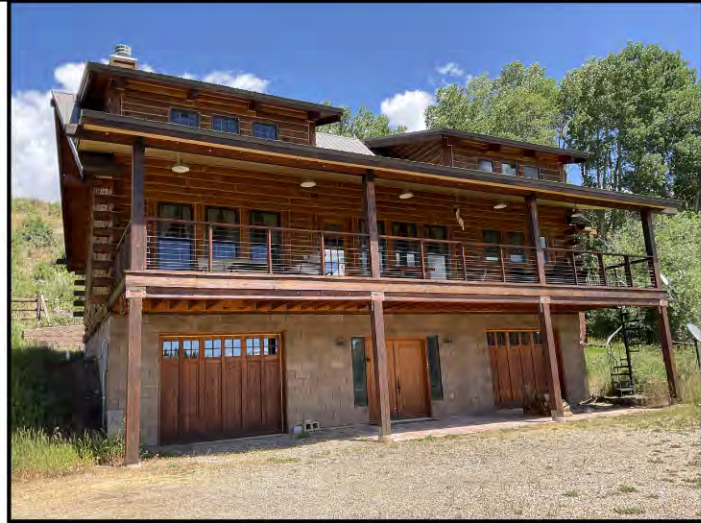
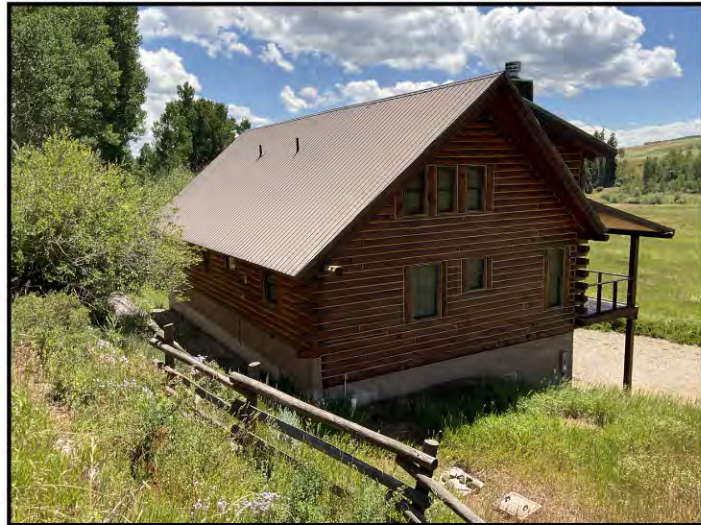
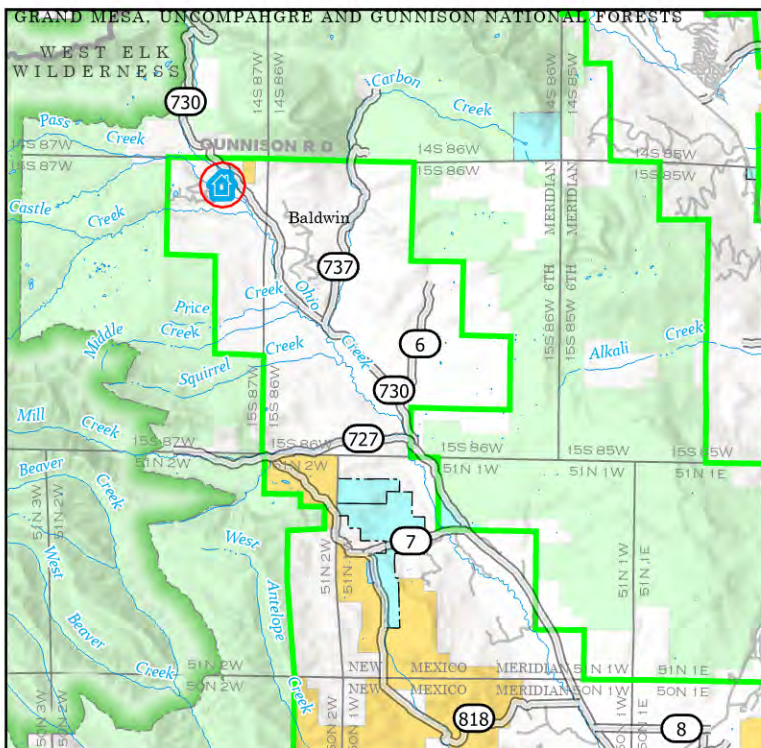
Triage Category: Defensible, Prep and Hold
FIRESCOPE Triage Category: Not Threatened
Structure Number: 214 Zuni Trl
Collected Date/Time: 8/3/2023 6:39:23 PM
Collected By: Adam Altergott
Inspector's Position: EngB
Type of Structure: Residential
Primary Structures: 1
Is the building Occupied?: No
Outbuildings: 0
Fuel Surrounding Structure: Grass and shrub, hardwood litter
Defensible Space: Less than 30 ft treated
Roof Material: Noncombustible or not applicable
Siding Material: Log construction
Electrical Power: Yes
Gas to Structure: Yes
Hazards:
Access to Site: T3/4 Engine
Describe Access: Tight gravel road no turn around in driveway, back down driveway
Comm With ICP: Yes
Water Source: Reliable water source nearby
Safety Zone Present:
Mitigation Time (in hours): 2
Mitigation Description: Weed whacking around home move the firewood and lumber away and cut the snag behind home
Resources Needed to Protect Structure: 1 Type 3 or 6

FIRESCOPE Tactics: Prep and Defend
Notes: Propane tank with enclosed fence

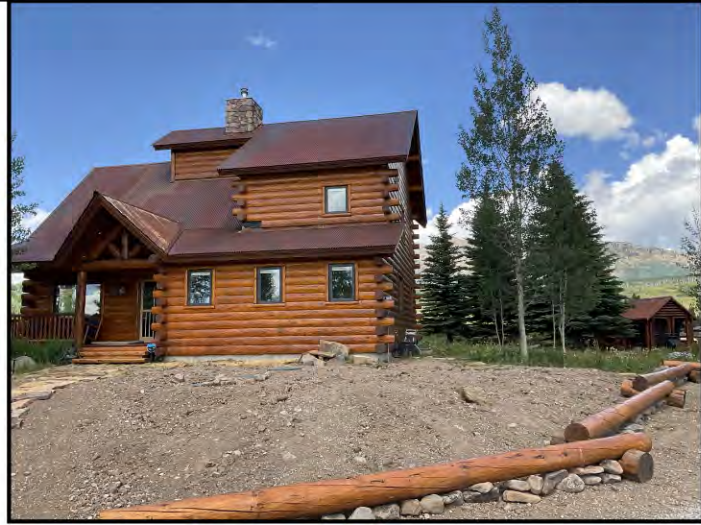
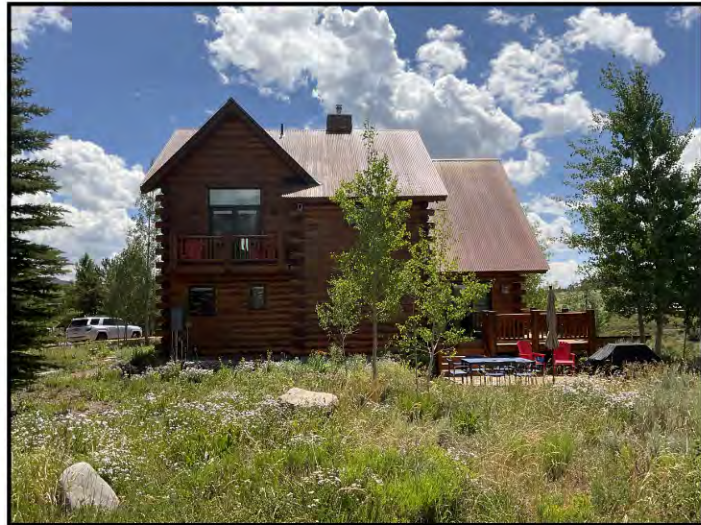
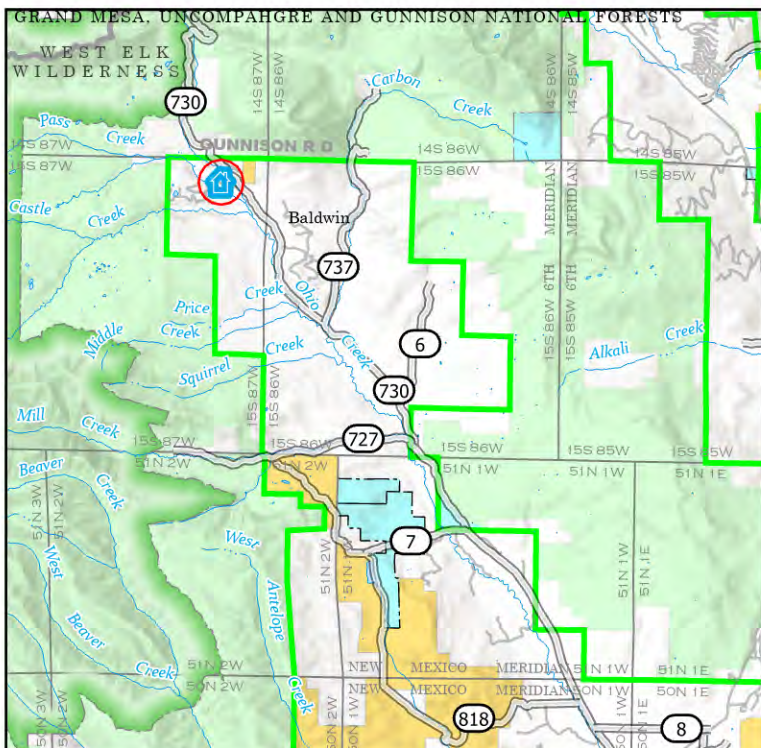
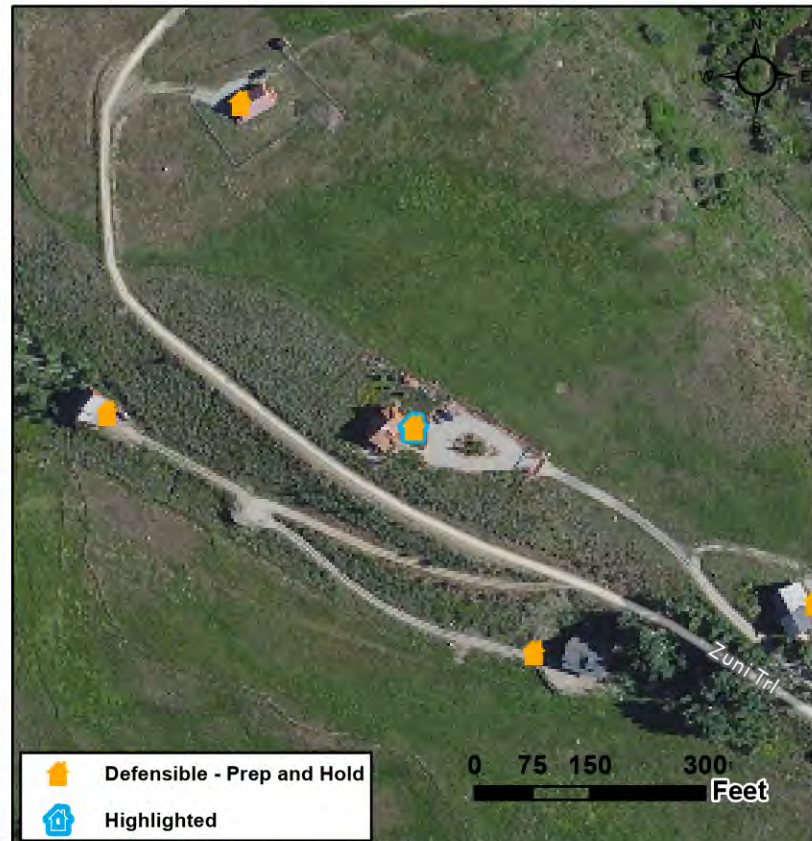
Triage Category: Defensible, Prep and Hold
FIRESCOPE Triage Category: Not Threatened
Structure Number: 215 Zuni Trl
Collected Date/Time: 8/3/2023 6:14:26 PM
Collected By: Adam Altergott
Inspector's Position: Engb
Type of Structure: Residential
Primary Structures: 1
Is the building Occupied?: Yes
Outbuildings: 1
Fuel Surrounding Structure: Shrub or timber
Defensible Space: Less than 30 ft treated
Roof Material: Noncombustible or not applicable
Siding Material: Log construction
Electrical Power: Yes
Gas to Structure: Yes
Hazards: None
Access to Site: T1 Engine
Describe Access: Gravel driveway with turnaround
Comm With ICP: Yes
Water Source: Reliable water source nearby
Safety Zone Present:
Mitigation Time (in hours): 2
Mitigation Description: Weedwack brush
Resources Needed to Protect Structure: Any engine
FIRESCOPE Tactics: Prep and Defend
Notes: Log construction with metal roof and storage building.

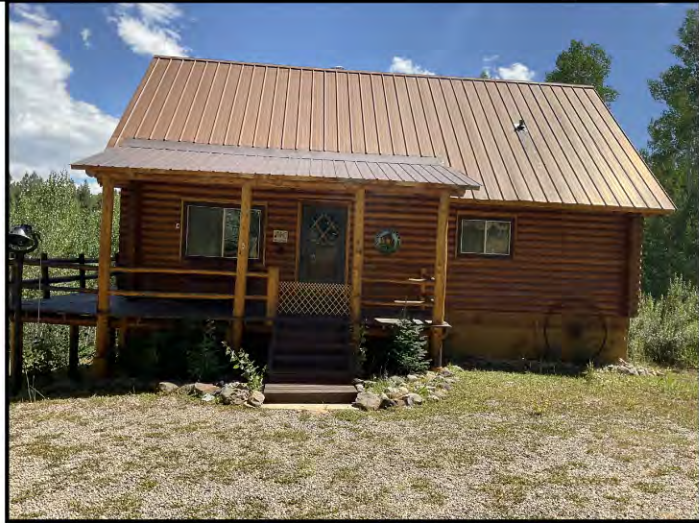
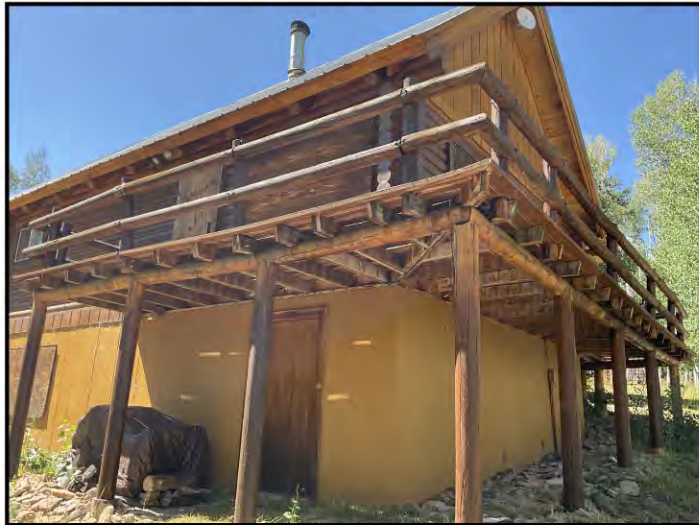
Triage Category: Non-Defensible, Prep and Leave
FIRESCOPE Triage Category: Not Threatened
Structure Number: 227 Mohawk Trl
Collected Date/Time: 8/3/2023 9:04:20 PM
Collected By: Kevin Brueck
Inspector's Position: EngB t
Type of Structure: Residential
Primary Structures: 1
Is the building Occupied?: Unknown
Outbuildings: 0
Fuel Surrounding Structure: Shrub or timber
Defensible Space: Less than 30 ft treated
Roof Material: Noncombustible or not applicable
Siding Material: Log construction
Electrical Power: Yes
Gas to Structure: Unknown
Hazards: Electric fence
Access to Site: T6 Engine
Describe Access: Narrow road, tough to get out
Comm With ICP: Yes
Water Source: No reliable water source nearby
Safety Zone Present:
Mitigation Time (in hours): 1
Mitigation Description: Clear slash and firewood near property, limb up some trees
Resources Needed to Protect Structure: Type 6
FIRESCOPE Tactics: Prep and Go
Notes:

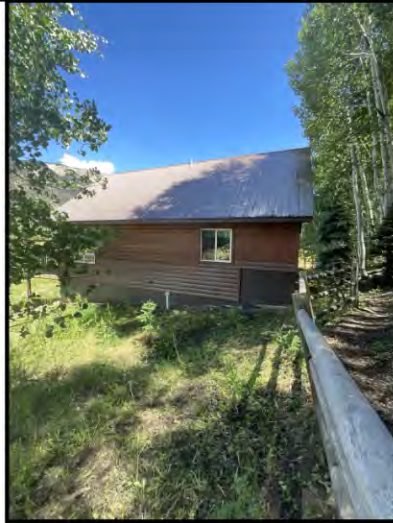
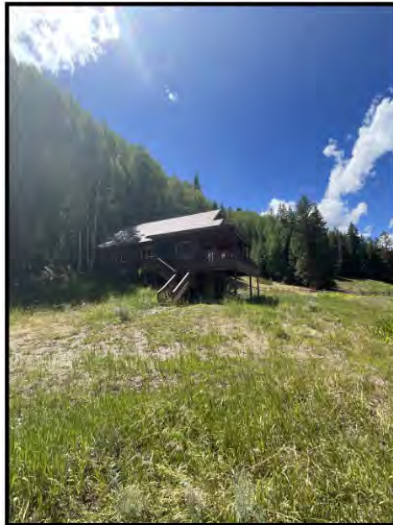
Triage Category: Defensible, Prep and Hold
FIRESCOPE Triage Category: Not Threatened
Structure Number: 237 Chickasaw Trl
Collected Date/Time: 8/3/2023 7:56:26 PM
Collected By: Adam Altergott
Inspector's Position: EngB
Type of Structure: Residential
Primary Structures: 1
Is the building Occupied?: No
Outbuildings: 0
Fuel Surrounding Structure: Shrub or timber
Defensible Space: Less than 30 ft treated
Roof Material: Noncombustible or not applicable
Siding Material: Log construction
Electrical Power: Yes
Gas to Structure: Yes
Hazards: Propane tank north end of house
Access to Site: T3/4 Engine
Describe Access: Gravel road one way in one way out
Comm With ICP: Yes
Water Source: Reliable water source nearby
Safety Zone Present:
Mitigation Time (in hours): 2
Mitigation Description: Weed wacking and some small tree removal behind house
Resources Needed to Protect Structure: 1 type 3 or 4 engine
FIRESCOPE Tactics: Prep and Defend

Notes: Log panel siding

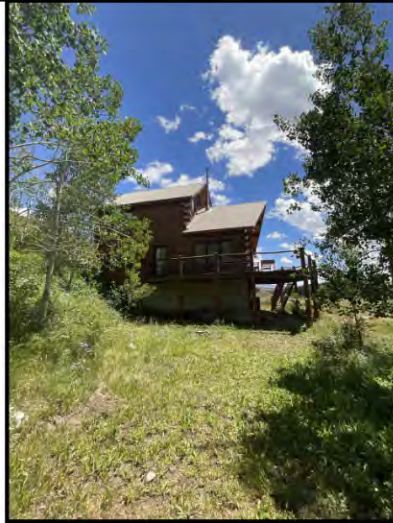
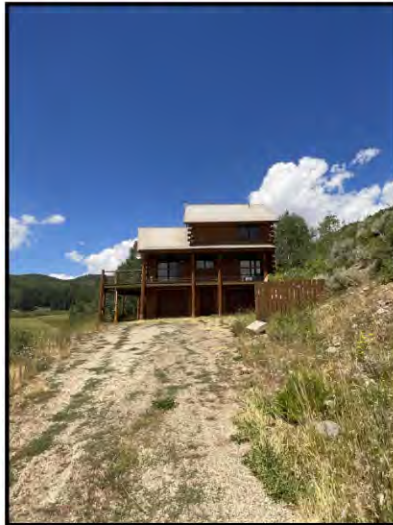
Location: 256 Zuni Trl, WILDERNESS STREAMS FILING NO. 2

Triage Category: Defensible, Prep and Hold
FIRESCOPE Triage Category: Not Threatened
Structure Number: 256 Zuni Trl
Collected Date/Time: 8/3/2023 6:39:23 PM
Collected By: Adam Altergott
Inspector's Position: EngB
Type of Structure: Residential
Primary Structures: 1
Is the building Occupied?: No
Outbuildings: 0
Fuel Surrounding Structure: Grass and shrub, hardwood litter
Defensible Space: Less than 30 ft treated
Roof Material: Noncombustible or not applicable
Siding Material: Log construction
Electrical Power: Yes
Gas to Structure: No
Hazards: Snag tree on north end of home
Access to Site: T3/4 Engine
Describe Access: Tight gravel road no turn around in driveway
Comm With ICP: Yes
Water Source: Reliable water source nearby
Safety Zone Present:
Mitigation Time (in hours): 2
Mitigation Description: Weed whacking around home move the firewood and lumber away and cut the snag behind home
Resources Needed to Protect Structure: Type 3 or 6

FIRESCOPE Tactics: Prep and Defend
Notes: Large deck around 3/4 of home built into hillside

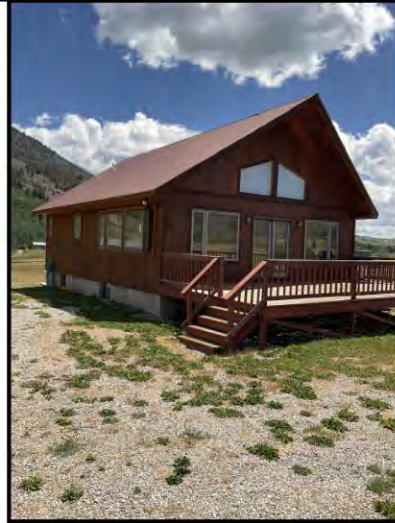
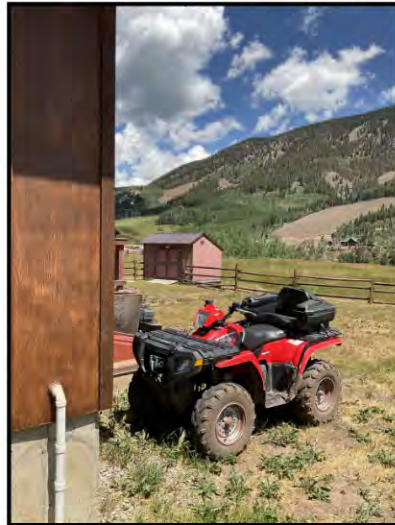
Location: 299 Zuni Trl, WILDERNESS STREAMS FILING NO. 2

Triage Category: Defensible, Prep and Hold
FIRESCOPE Triage Category: Not Threatened
Structure Number: 299 Zuni Trl
Collected Date/Time:
Collected By: Kevin Brueck
Inspector's Position: EngB t
Type of Structure: Residential
Primary Structures: 1
Is the building Occupied?: Yes
Outbuildings: 1
Fuel Surrounding Structure: Grass and shrub, hardwood litter
Defensible Space: 30 ft treated
Roof Material: Noncombustible or not applicable
Siding Material: Wood or open sided
Electrical Power: Yes
Gas to Structure: No
Hazards:
Access to Site: T1 Engine
Describe Access: Gravel road
Comm With ICP: Yes
Water Source: No reliable water source nearby
Safety Zone Present:
Mitigation Time (in hours): 1
Mitigation Description: Remove clear items from porch and around house
Resources Needed to Protect Structure: T6
FIRESCOPE Tactics: Prep and Defend
Notes: Wood porch

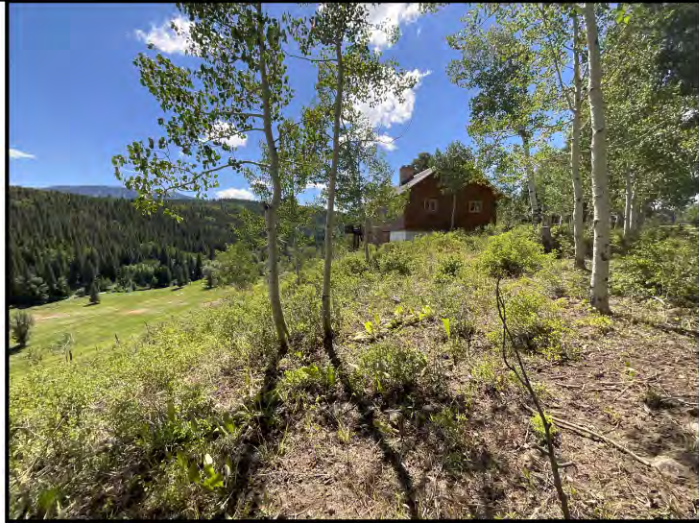
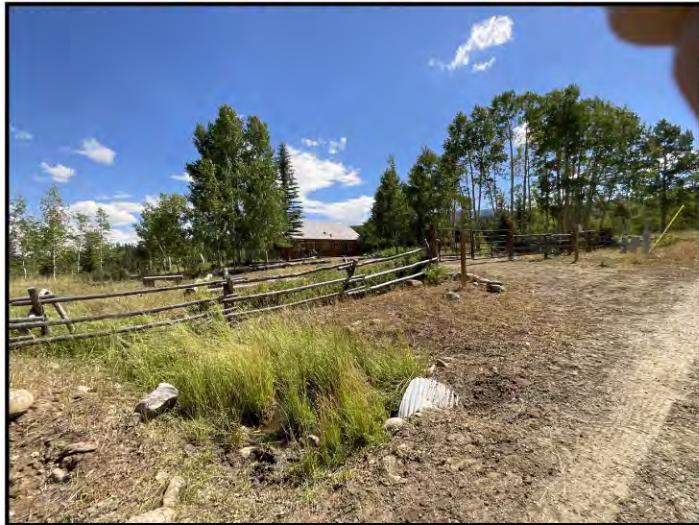
Location: 30 Osage Tr, WILDERNESS STREAMS FILING NO. 2

Triage Category: Defensible, Prep and Hold
FIRESCOPE Triage Category: Threatened Defensible
Structure Number: 30 Osage Trl
Collected Date/Time: 8/3/2023 9:11:02 PM
Collected By: Zak Slutzky
Inspector's Position: EngB (t)
Type of Structure: Residential
Primary Structures: 1
Is the building Occupied?: Unknown
Outbuildings: 0
Fuel Surrounding Structure: Grass and shrub, hardwood litter
Defensible Space: 30 ft treated
Roof Material: Noncombustible or not applicable
Siding Material: Wood or open sided
Electrical Power: Yes
Gas to Structure: Unknown
Hazards: Livestock, slope and wind alignment potential - light fuels downslope
Access to Site: T1 Engine
Describe Access: Unimproved 75' driveway no turnaround
Comm With ICP: Yes
Water Source: Limited or dependent on electricity
Safety Zone Present:
Mitigation Time (in hours): 1
Mitigation Description: Grass mowing, brushing
Resources Needed to Protect Structure: 1 engine
FIRESCOPE Tactics: Prep and Defend

Notes: Small 2 story residential

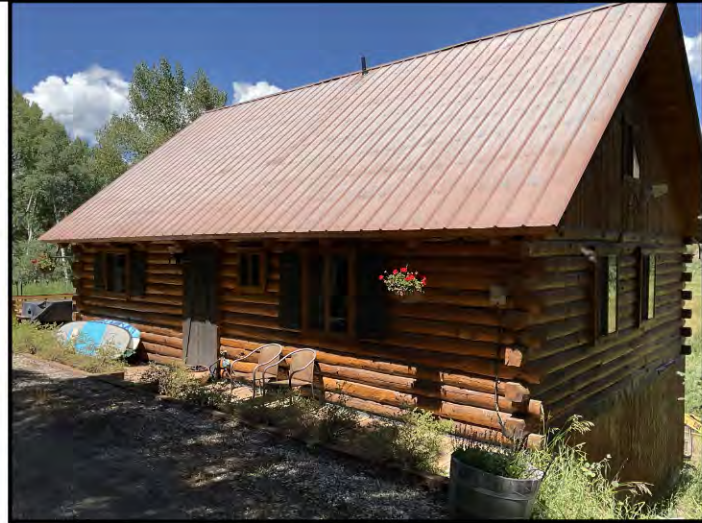
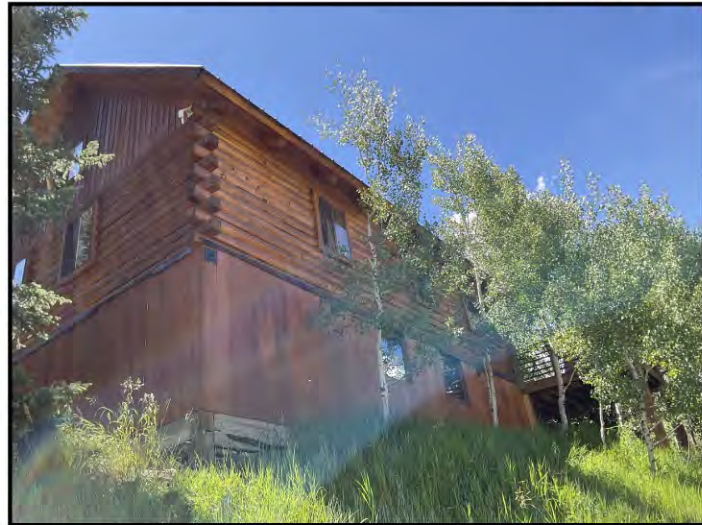
Location: 319 Sioux Rd, WILDERNESS STREAMS FILING NO. 2

Triage Category: Defensible, Prep and Hold
FIRESCOPE Triage Category: Not Threatened
Structure Number: 319 Sioux Rd
Collected Date/Time: 8/3/2023 7:29:05 PM
Collected By: Adam Altergott
Inspector's Position: ENGB
Type of Structure: Residential
Primary Structures: 1
Is the building Occupied?: Yes
Outbuildings: 0
Fuel Surrounding Structure: Grass and shrub, hardwood litter
Defensible Space: Less than 30 ft treated
Roof Material: Noncombustible or not applicable
Siding Material: Log construction
Electrical Power: Yes
Gas to Structure: No
Hazards: No gas
Access to Site: T1 Engine
Describe Access: Through gate or stage along road
Comm With ICP: Yes
Water Source: Reliable water source nearby
Safety Zone Present:
Mitigation Time (in hours): 2
Mitigation Description: Limping up spruce trees along home, weed and grass cutting
Resources Needed to Protect Structure: 1 any type engine
FIRESCOPE Tactics: Prep and Defend
Notes: Deck over east side

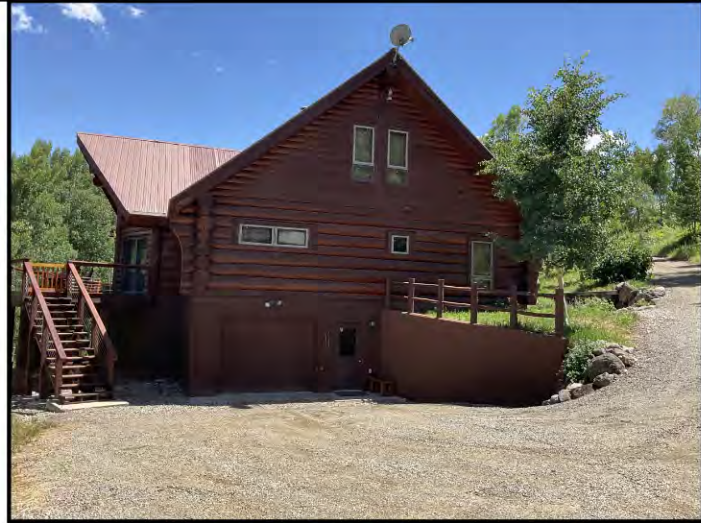
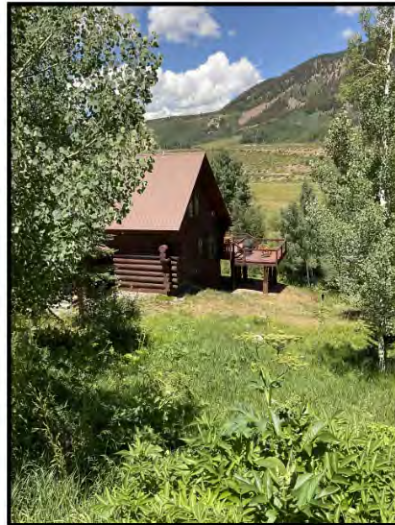
Location: 373 Sioux Rd, WILDERNESS STREAMS FILING NO. 2
Coordinates (DDM): 38° 46.510' N, 107° 04.432' W

Triage Category: Defensible, Prep and Hold
FIRESCOPE Triage Category: Not Threatened
Structure Number: 373 Sioux Rd
Collected Date/Time: 8/3/2023 7:30:15 PM
Collected By: Kevin Bruek
Inspector's Position: EngB t
Type of Structure: Residential
Primary Structures: 1
Is the building Occupied?: Yes
Outbuildings: 0
Fuel Surrounding Structure: Shrub or timber
Defensible Space: Less than 30 ft treated
Roof Material: Noncombustible or not applicable
Siding Material: Wood or open sided
Electrical Power: Yes
Gas to Structure: Yes
Hazards:
Access to Site: T3/4 Engine
Describe Access: Gated, steep Drive way
Comm With ICP: Yes
Water Source: Reliable water source nearby
Safety Zone Present:
Mitigation Time (in hours): 2
Mitigation Description: Clear tall grass, limb trees
Resources Needed to Protect Structure: Type 6
FIRESCOPE Tactics: Prep and Defend
Notes:

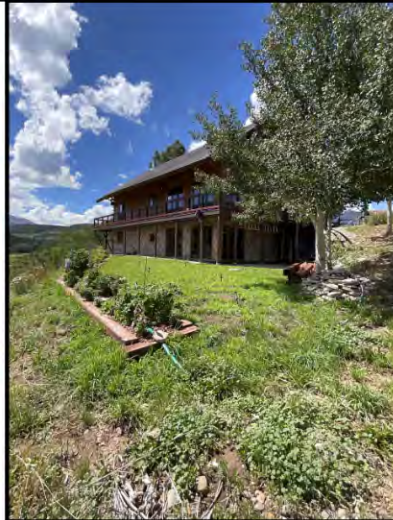
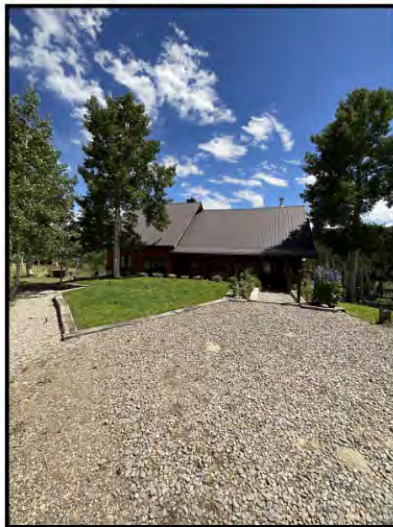
Triage Category: Defensible, Prep and Hold
FIRESCOPE Triage Category: Threatened Defensible
Structure Number: 38 Inca Trl
Collected Date/Time: 8/3/2023 8:29:46 PM
Collected By: Cody Peterson
Inspector's Position: ENGB
Type of Structure: Residential
Primary Structures: 1
Is the building Occupied?: Yes
Outbuildings: 0
Fuel Surrounding Structure: Grass and shrub, hardwood litter
Defensible Space: 100 ft treated
Roof Material: Noncombustible or not applicable
Siding Material: Log construction
Electrical Power: Yes
Gas to Structure: No
Hazards: Mid-slope
Access to Site: T1 Engine
Describe Access: Maintained gravel
Comm With ICP: Yes
Water Source: Reliable water source nearby
Safety Zone Present:
Mitigation Time (in hours): 1
Mitigation Description: Weed eat
Resources Needed to Protect Structure:
FIRESCOPE Tactics: Prep and Defend
Notes: Mid-slope

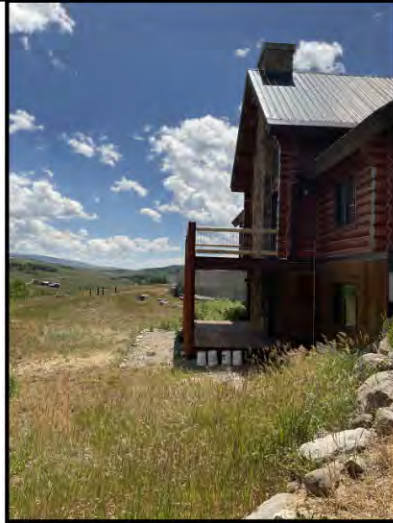
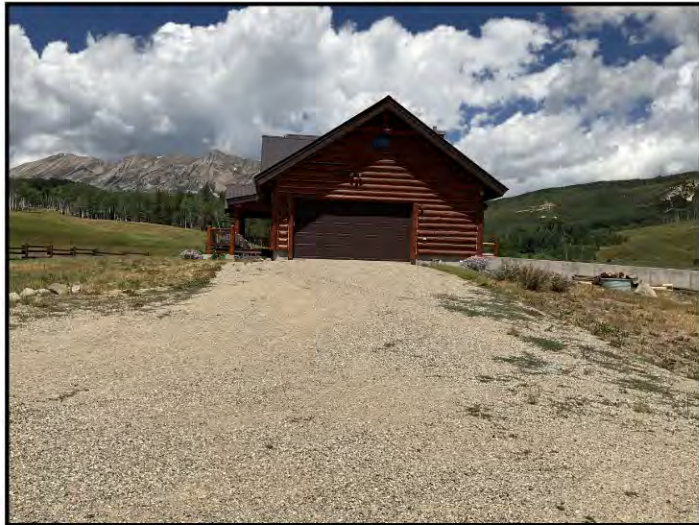
Location: 385 Zuni Trl, WILDERNESS STREAMS FILING NO. 2

Triage Category: Defensible, Prep and Hold
FIRESCOPE Triage Category: Not Threatened
Structure Number: 385 Zuni Trl
Collected Date/Time: 8/3/2023 6:29:43 PM
Collected By: Kevin Brueck
Inspector's Position: EngB t
Type of Structure: Residential
Primary Structures: 1
Is the building Occupied?: No
Outbuildings: 0
Fuel Surrounding Structure: Grass and shrub, hardwood litter
Defensible Space: 30 ft treated
Roof Material: Noncombustible or not applicable
Siding Material: Log construction
Electrical Power: Yes
Gas to Structure: No
Hazards: Transformer by gate
Access to Site: T3/4 Engine
Describe Access: Gravel road, Gated
Comm With ICP: Yes
Water Source: No reliable water source nearby
Safety Zone Present:
Mitigation Time (in hours): 1
Mitigation Description: Trim shrub/ Bush
Resources Needed to Protect Structure: Type 6
FIRESCOPE Tactics: Prep and Defend
Notes: Front and back porch, walk out basement

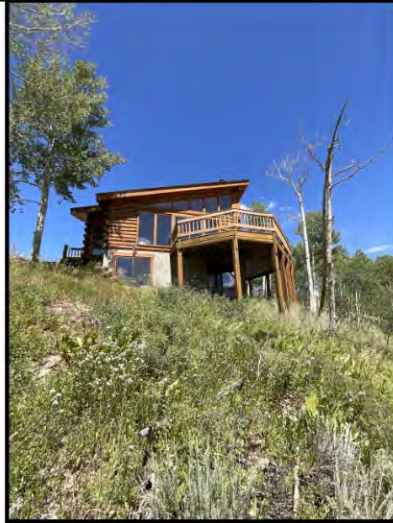
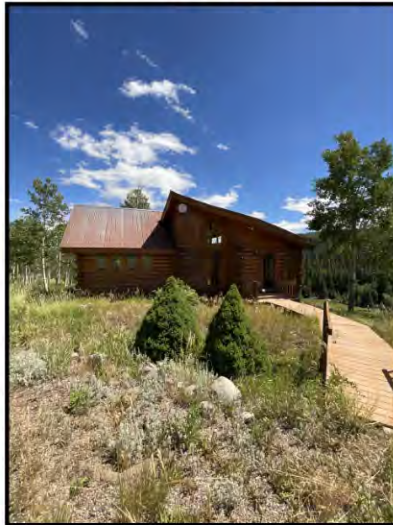
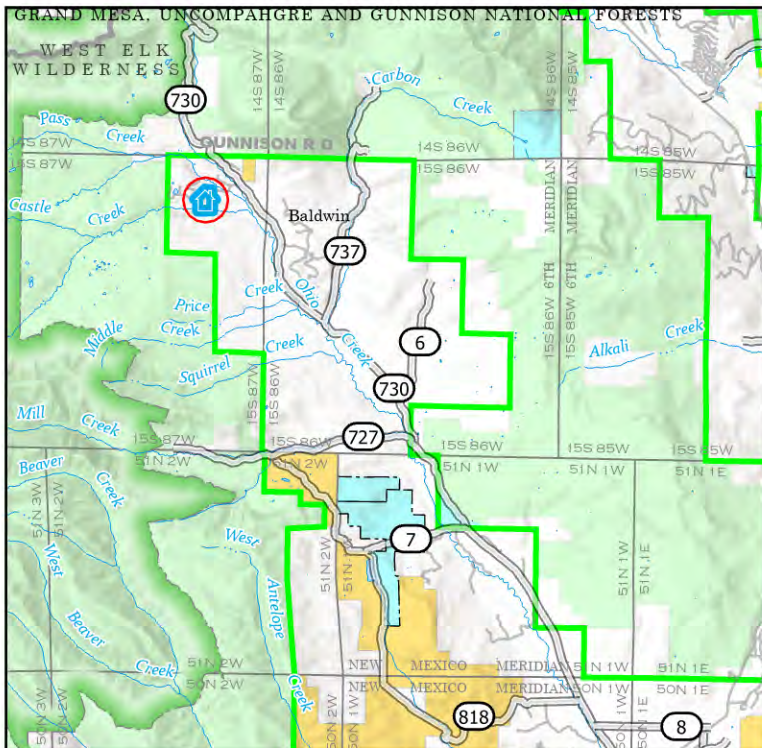
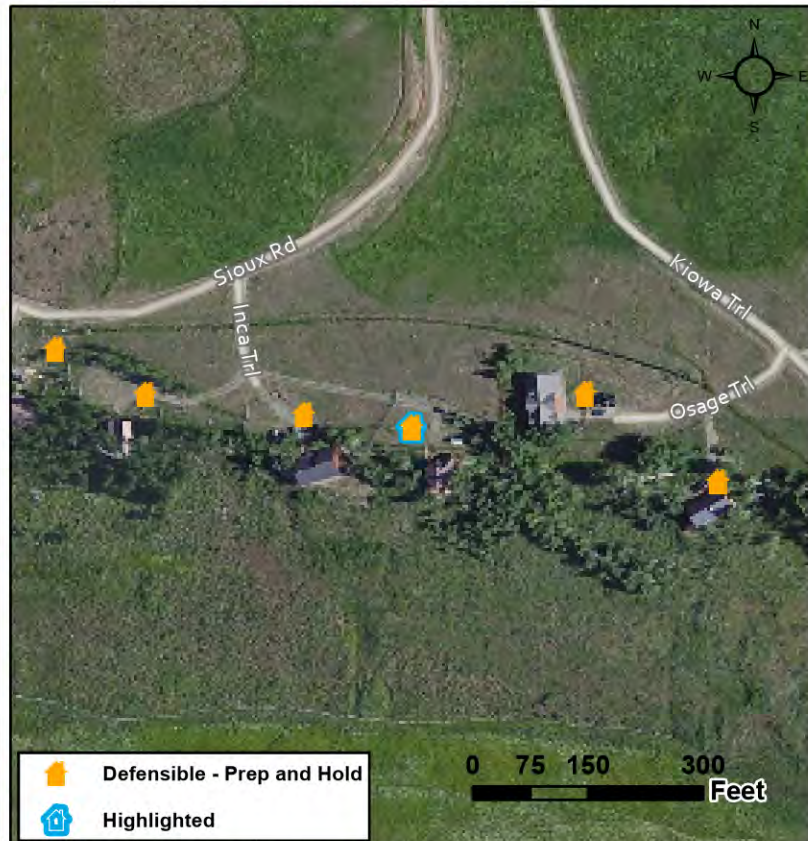
Triage Category: Defensible, Prep and Hold
FIRESCOPE Triage Category: Threatened Defensible
Structure Number: 45 Inca Trl
Collected Date/Time: 8/3/2023 8:36:12 PM
Collected By: Cody Peterson
Inspector's Position: ENGB
Type of Structure: Residential
Primary Structures: 1
Is the building Occupied?: No
Outbuildings: 0
Fuel Surrounding Structure: Grass and shrub, hardwood litter
Defensible Space: 100 ft treated
Roof Material: Noncombustible or not applicable
Siding Material: Log construction
Electrical Power: Yes
Gas to Structure: No
Hazards: Top ridge, aspen snag
Access to Site: T1 Engine
Describe Access: Maintained gravel
Comm With ICP: Yes
Water Source: Reliable water source nearby
Safety Zone Present:
Mitigation Time (in hours): 1
Mitigation Description: Weed eat, disburse wood pile under deck and patio furniture
Resources Needed to Protect Structure: Engine
FIRESCOPE Tactics: Prep and Defend
Notes: Top ridge

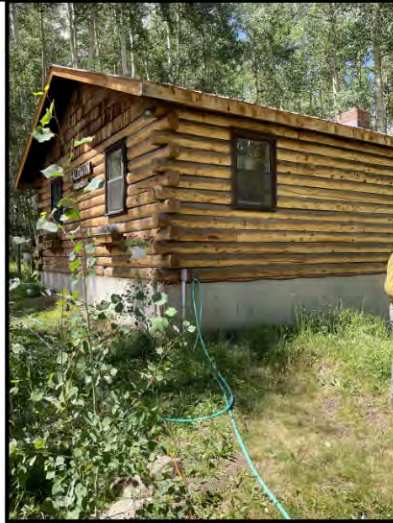
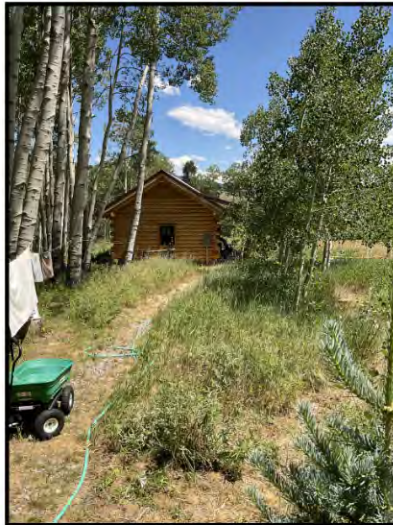
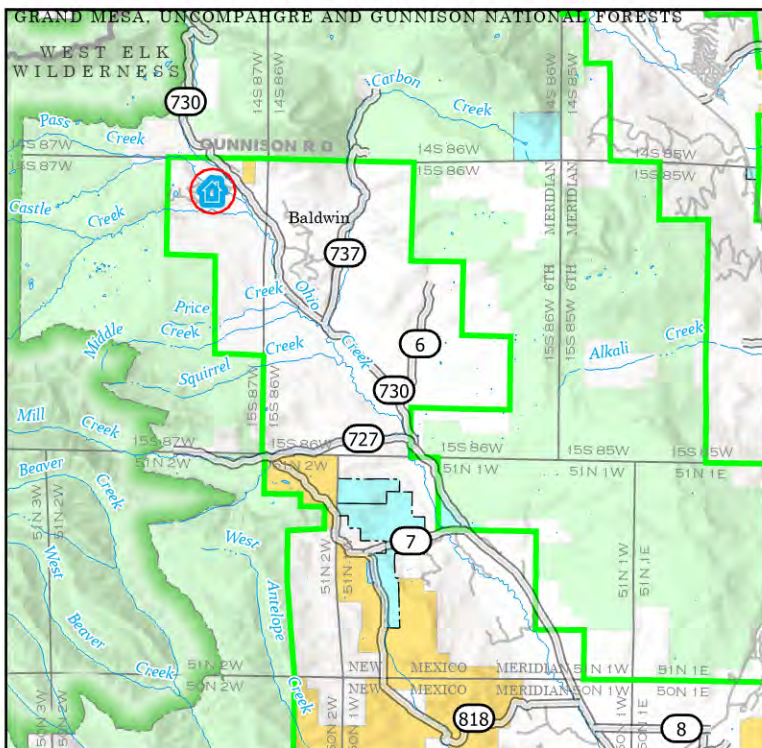
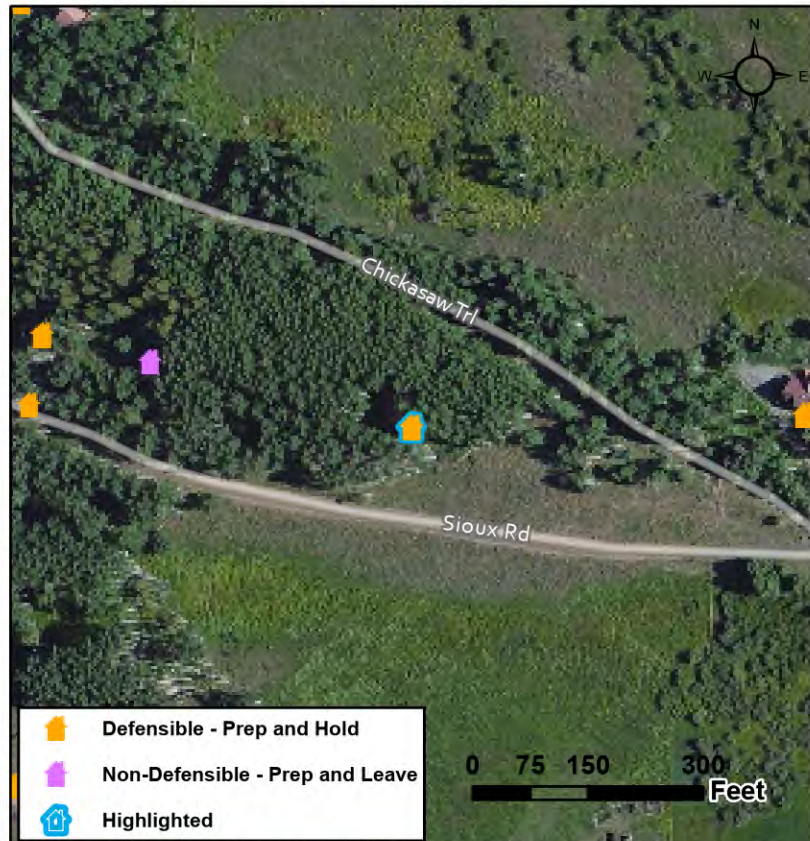
Location: 453 Sioux Rd, WILDERNESS STREAMS FILING NO. 2

Triage Category: Defensible, Prep and Hold
FIRESCOPE Triage Category: Not Threatened
Structure Number: 453 Sioux Rd
Collected Date/Time: 8/3/2023 7:53:05 PM
Collected By: Kevin Brueck
Inspector's Position: EngB t
Type of Structure: Residential
Primary Structures: 1
Is the building Occupied?: Yes
Outbuildings:
Fuel Surrounding Structure: Shrub or timber
Defensible Space: Less than 30 ft treated
Roof Material: Noncombustible or not applicable
Siding Material: Log construction
Electrical Power: Yes
Gas to Structure: Unknown
Hazards: On an aggressive slope
Access to Site: T3/4 Engine
Describe Access: Main Road
Comm With ICP: Yes
Water Source: No reliable water source nearby
Safety Zone Present:
Mitigation Time (in hours): 5
Mitigation Description: Clear trees, remove leaf litter, limb, tall grasses
Resources Needed to Protect Structure: Type 3
FIRESCOPE Tactics: Prep and Defend
Notes: Bunk house as the other structure

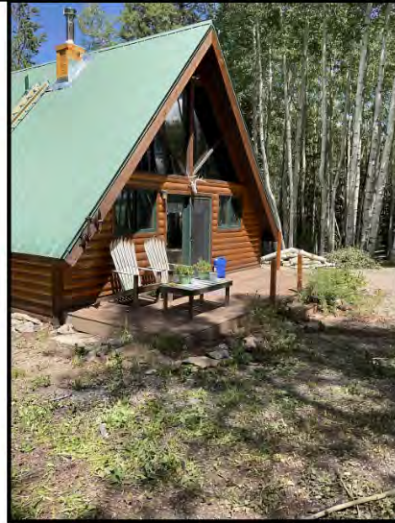
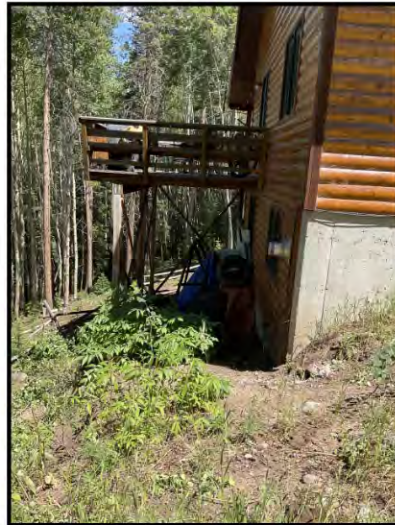
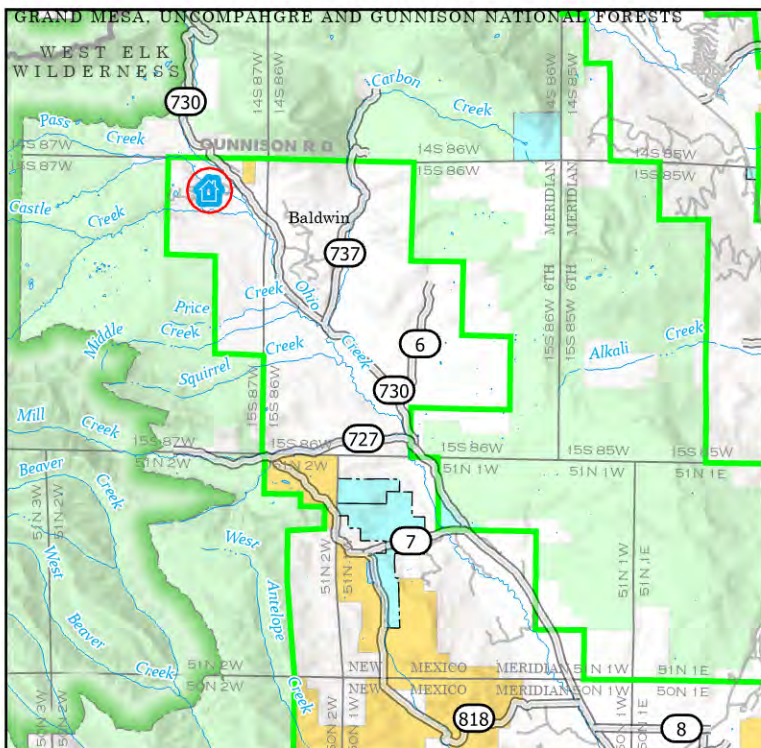
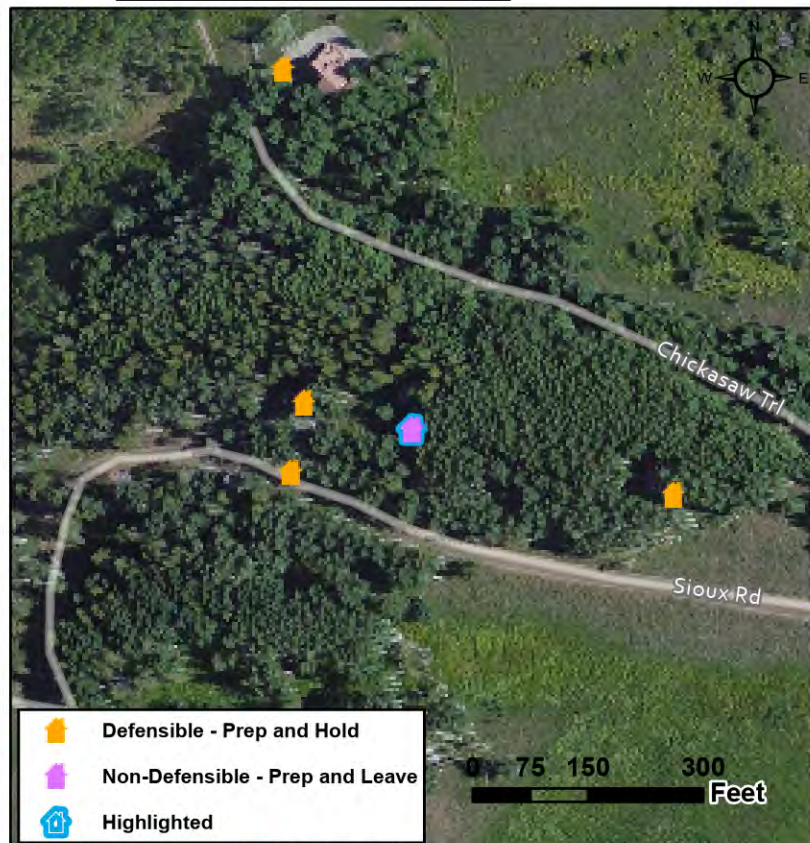
FIRESCOPE Tactics: Prep and Go

Notes: Porch and balcony in the back

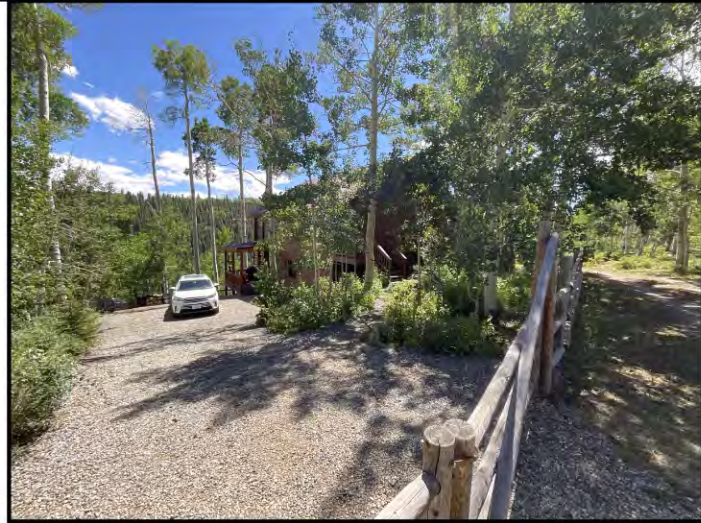
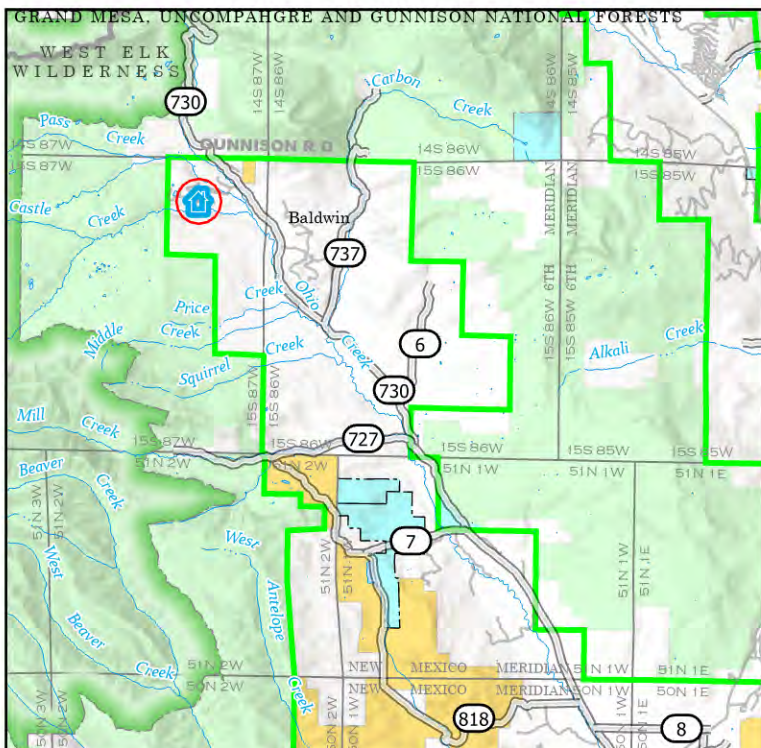
Location: 52 Castle Creek Rd, WILDERNESS STREAMS FILING NO. 2

Triage Category: Defensible, Prep and Hold
FIRESCOPE Triage Category: Threatened Defensible
Structure Number: 52 Castle Creek Rd
Collected Date/Time: 8/3/2023 8:32:43 PM
Collected By: Jesse Gallup
Inspector's Position: FFTI
Type of Structure: Residential
Primary Structures: 1
Is the building Occupied?: Yes
Outbuildings: 0
Fuel Surrounding Structure: Grass and shrub, hardwood litter
Defensible Space: Less than 30 ft treated
Roof Material: Noncombustible or not applicable
Siding Material: Log construction
Electrical Power: Yes
Gas to Structure: Unknown
Hazards: Brush around home , steep hill behind structure
Access to Site: T3/4 Engine
Describe Access: Gravel 2 track with easy access
Comm With ICP: Yes
Water Source: Limited or dependent on electricity
Safety Zone Present:
Mitigation Time (in hours): 1
Mitigation Description: Removal of combustibles around structure, sprinklers around home
Resources Needed to Protect Structure: 1 engine

FIRESCOPE Tactics: Prep and Defend
Notes: New build log construction with lots of small fuels around structure

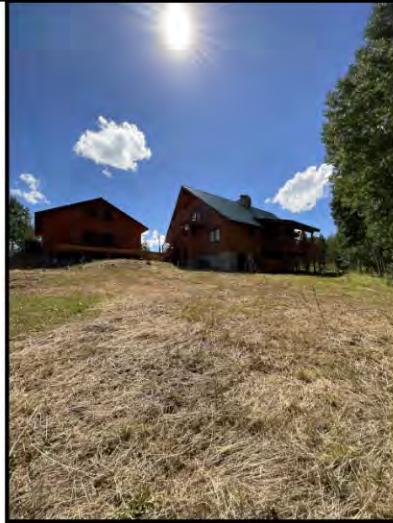
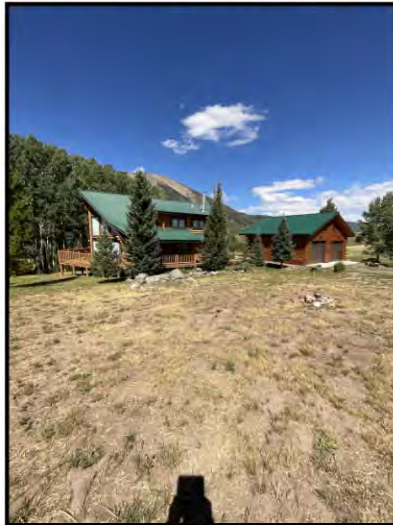
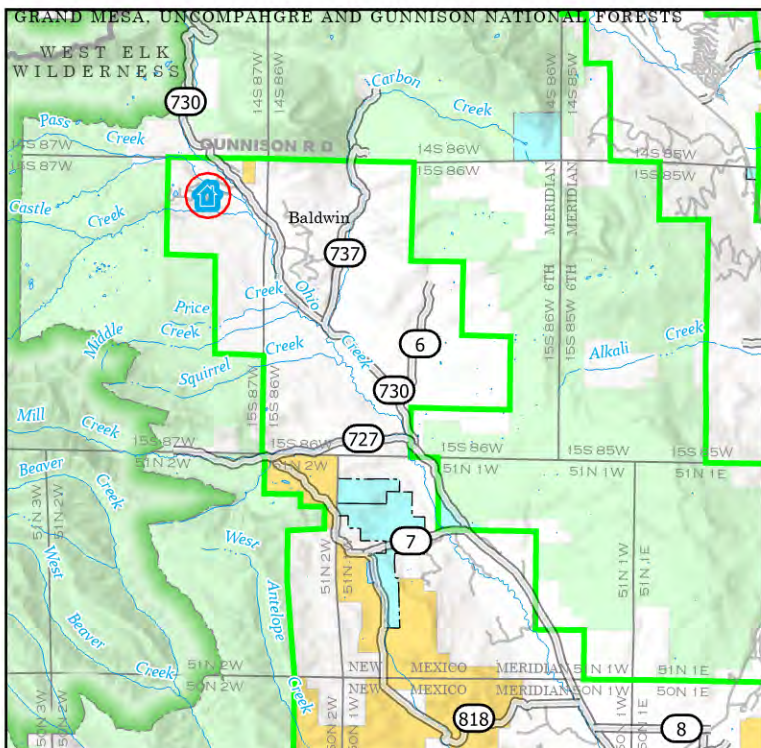
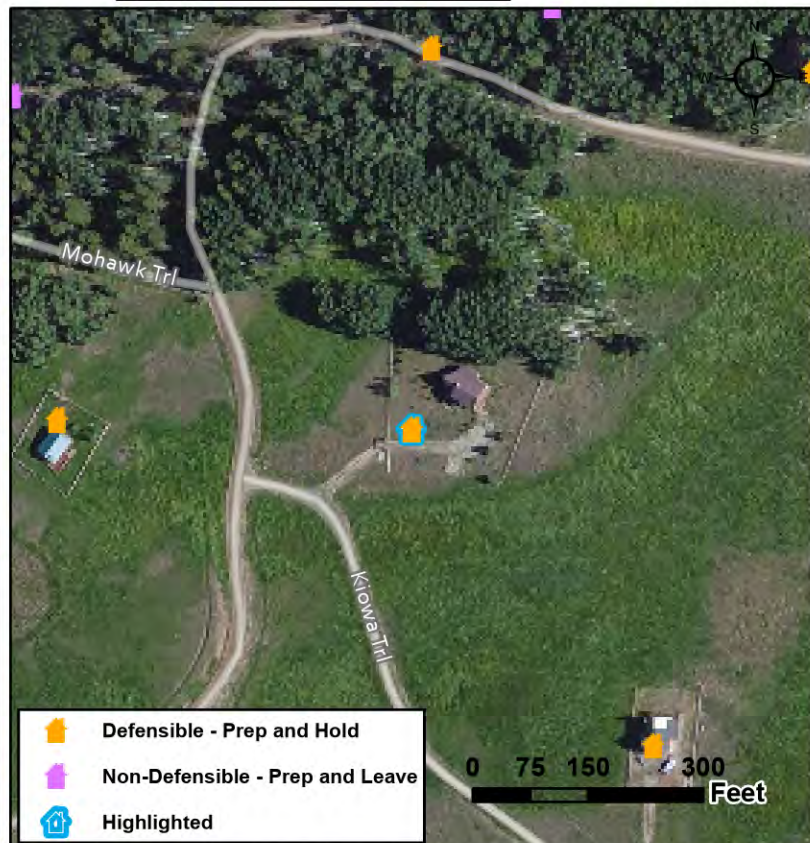
Location: 57 Kiowa Trl, WILDERNESS STREAMS FILING NO. 2

Triage Category: Defensible, Prep and Hold
FIRESCOPE Triage Category: Threatened Defensible
Structure Number: 57 Kiowa Trl
Collected Date/Time: 8/3/2023 9:26:07 PM
Collected By: Cody Peterson
Inspector's Position: ENGB
Type of Structure: Residential
Primary Structures: 1
Is the building Occupied?: No
Outbuildings: 1
Fuel Surrounding Structure: Grass and shrub, hardwood litter
Defensible Space: 100 ft treated
Roof Material: Noncombustible or not applicable
Siding Material: Log construction
Electrical Power: Yes
Gas to Structure: Yes
Hazards: Open unfinished porch, NG fed generator
Access to Site: T1 Engine
Describe Access: Maintained gravel
Comm With ICP: Yes
Water Source: Reliable water source nearby
Safety Zone Present:
Mitigation Time (in hours): 1
Mitigation Description: Weed eat
Resources Needed to Protect Structure:
FIRESCOPE Tactics: Prep and Defend
Notes:
