Location: 100 Castle Creek Rd, WILDERNESS STREAMS FILING NO. 2

Coordinates (DDM): 38° 46.291' N, 107° 04.891' W

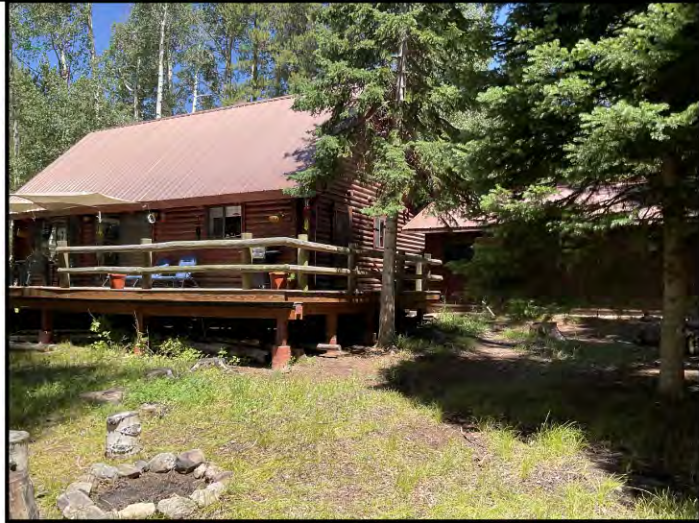
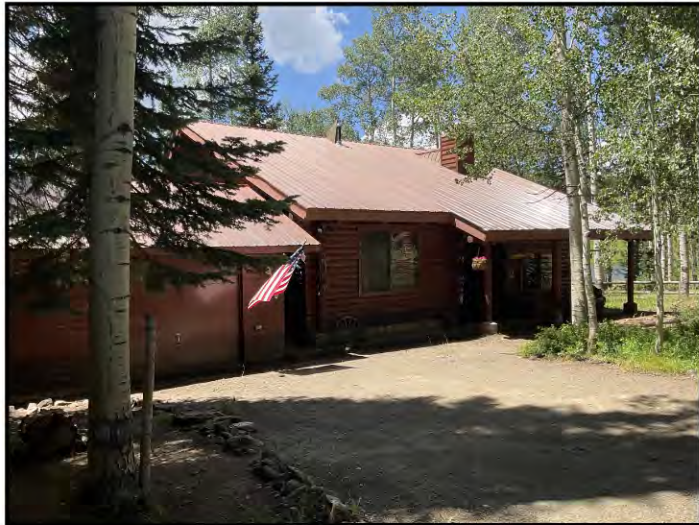
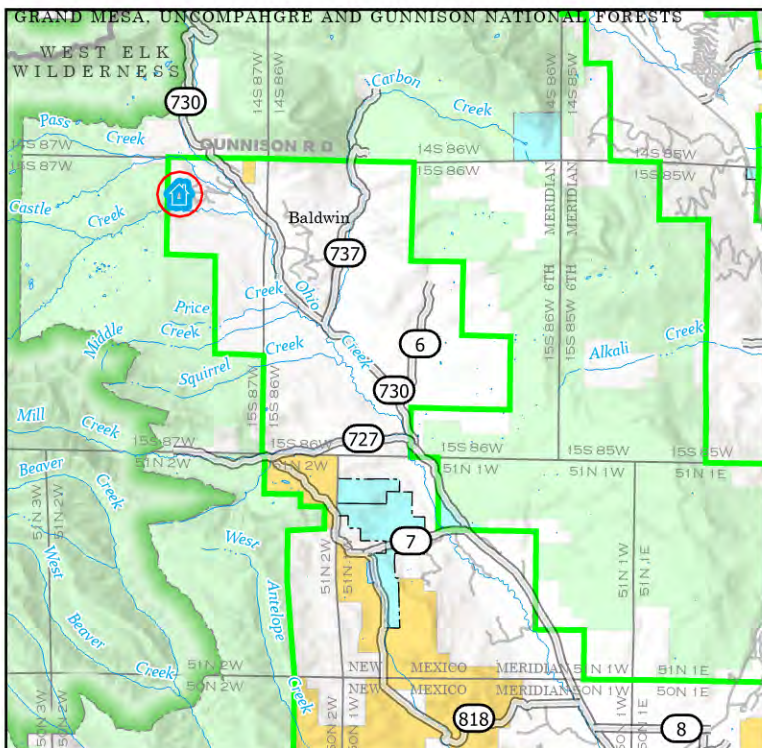
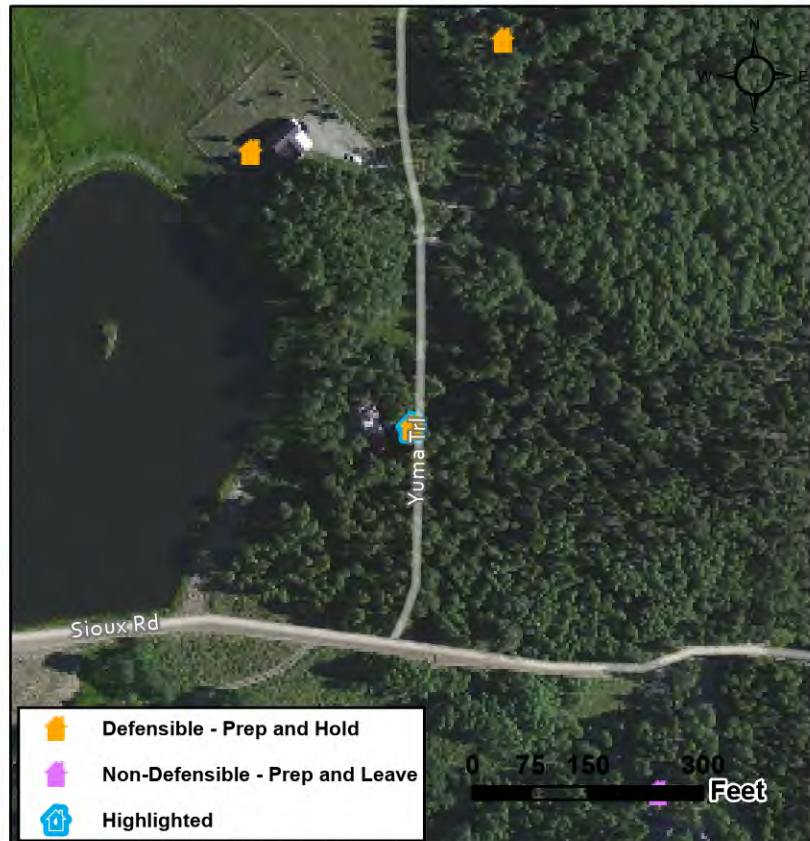
Location: 57 Yuma Tr, WILDERNESS STREAMS FILING NO. 2

Triage Category: Defensible, Prep and Hold
FIRESCOPE Triage Category: Threatened Defensible
Structure Number: 57 Yuma Tr
Collected Date/Time: 8/3/2023 7:32:26 PM
Collected By: Cody Peterson
Inspector's Position: ENGB
Type of Structure: Residential
Primary Structures: 1
Is the building Occupied?: No
Outbuildings: 1
Fuel Surrounding Structure: Shrub or timber
Defensible Space: 30 ft treated
Roof Material: Noncombustible or not applicable
Siding Material: Log construction
Electrical Power: Yes
Gas to Structure: No
Hazards:
Access to Site: T1 Engine
Describe Access: Maintained gravel
Comm With ICP: Yes
Water Source: Reliable water source nearby
Safety Zone Present:
Mitigation Time (in hours): 1
Mitigation Description: Weed eat, limb trees, disburse wood pile, deck contents
Resources Needed to Protect Structure: Engine
FIRESCOPE Tactics: Prep and Defend
Notes:

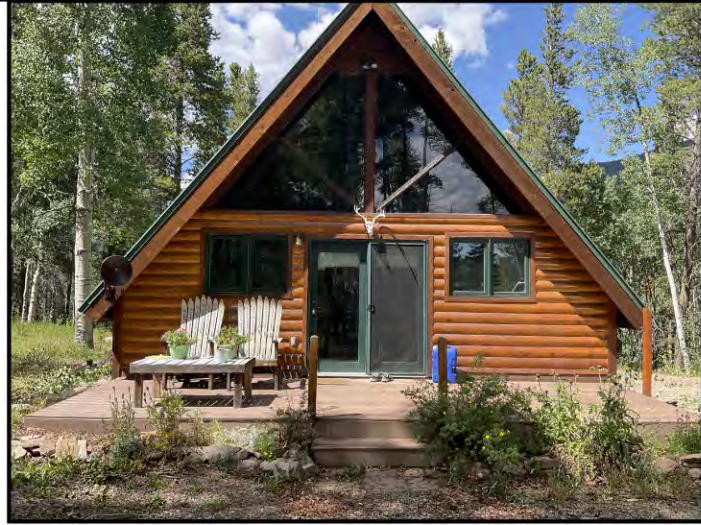
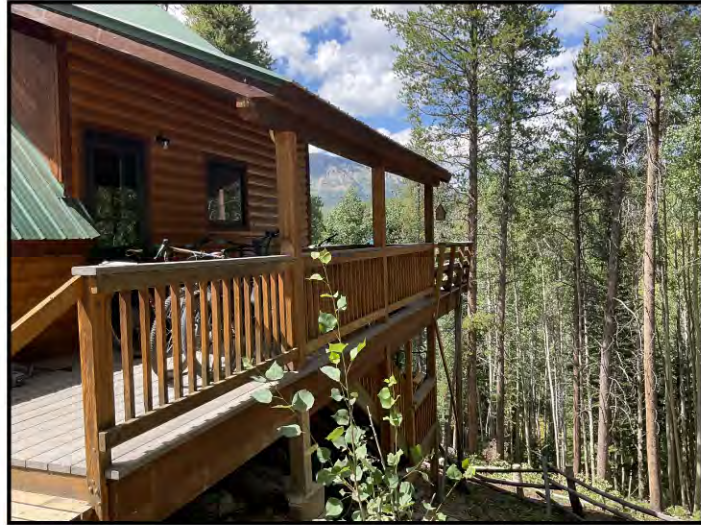
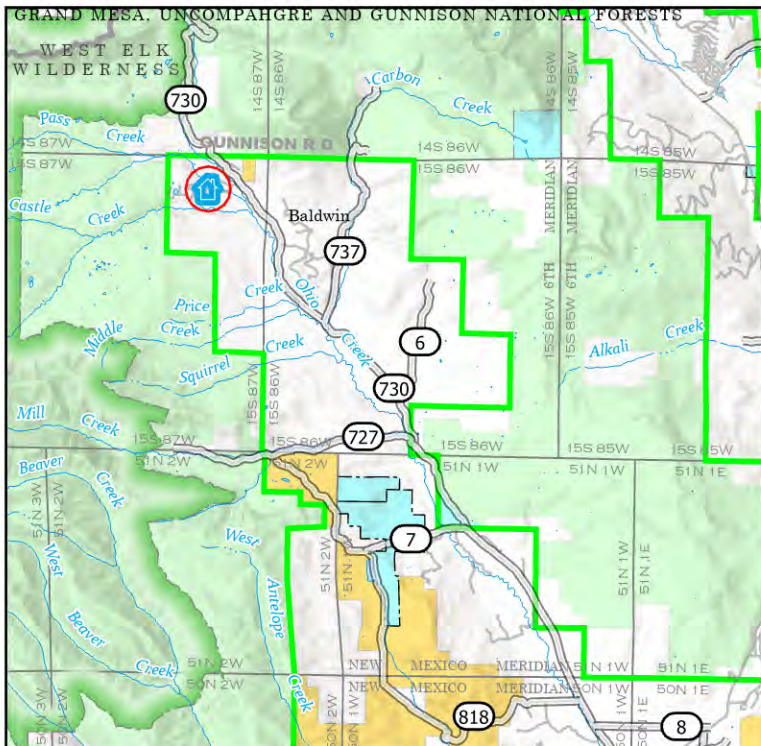
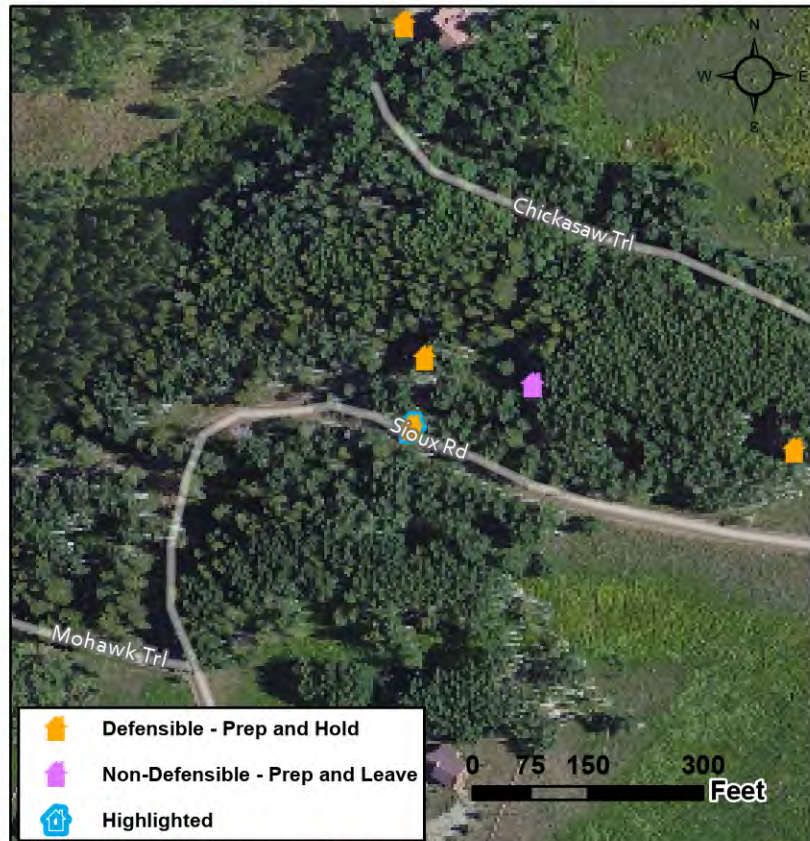
Location: 591 Sioux Rd, WILDERNESS STREAMS FILING NO. 2

Triage Category: Defensible, Prep and Hold
FIRESCOPE Triage Category: Threatened Defensible
Structure Number: 591 Sioux Rd - 1
Collected Date/Time: 8/2/2023 9:07:32 PM
Collected By: Tim Daly
Inspector's Position: OPBD
Type of Structure: Residential
Primary Structures: 1
Is the building Occupied?: Yes
Outbuildings: 0
Fuel Surrounding Structure: Shrub or timber
Defensible Space: Less than 30 ft treated
Roof Material: Noncombustible or not applicable
Siding Material: Log construction
Electrical Power: Yes
Gas to Structure: Yes
Hazards:
Access to Site: T3/4 Engine
Describe Access: CR 730 to Sioux Road
Comm With ICP: Yes
Water Source: No reliable water source nearby
Safety Zone Present:
Mitigation Time (in hours): 2
Mitigation Description: Fuel mitigation, handling, sprinkler setup with pumpkin
Resources Needed to Protect Structure: 1 type 3 engine
FIRESCOPE Tactics: Prep and Defend
Notes: Underground electric and gas

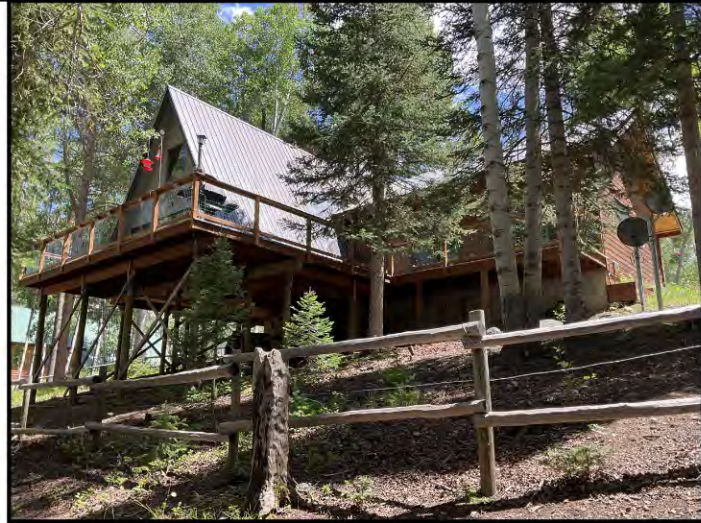
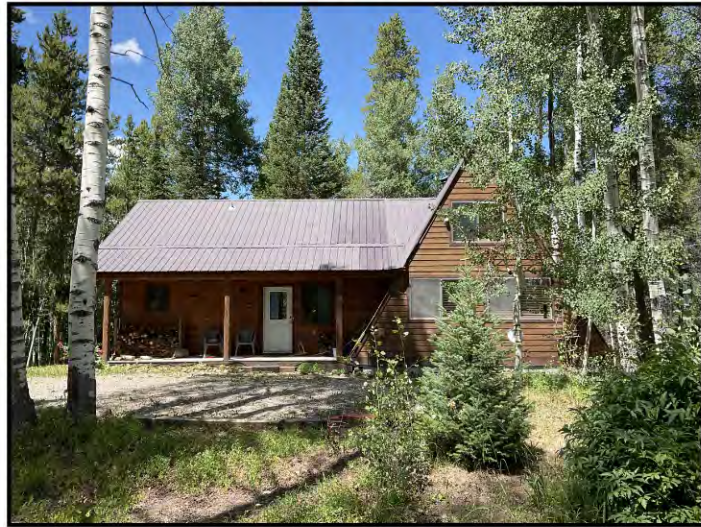
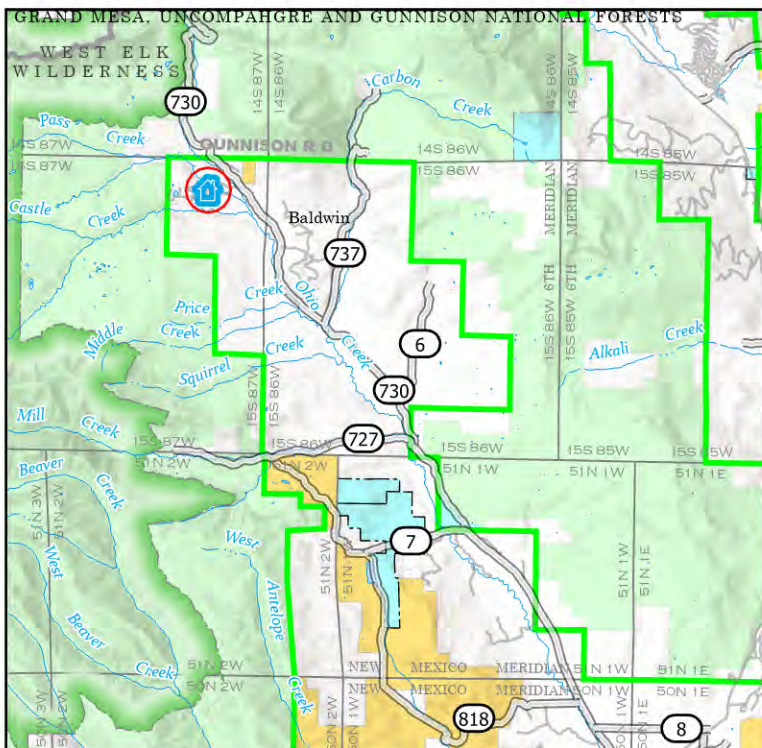
Location: 591 Sioux rd, WILDERNESS STREAMS FILING NO. 2

Triage Category: Defensible, Prep and Hold
FIRESCOPE Triage Category: Not Threatened
Structure Number: 591 Sioux Rd - 2
Collected Date/Time: 8/3/2023 8:12:59 PM
Collected By: Adam Altergott
Inspector's Position: EngB
Type of Structure: Residential
Primary Structures: 1
Is the building Occupied?: No
Outbuildings: 0
Fuel Surrounding Structure: Shrub or timber
Defensible Space: 30 ft treated
Roof Material: Noncombustible or not applicable
Siding Material: Wood or open sided
Electrical Power: Yes
Gas to Structure: Unknown
Hazards: Nearby dead standing aspen snags
Access to Site: T1 Engine
Describe Access: Back into driveway, 9 foot gate entrance
Comm With ICP: Yes
Water Source: Reliable water source nearby
Safety Zone Present:
Mitigation Time (in hours): 2
Mitigation Description: Rake leaves, remove wood, firewood, cut grass
Resources Needed to Protect Structure: 1 any type engine
FIRESCOPE Tactics: Prep and Defend
Notes: A frame build Suspended floor plan, large heat, fire access to underneath structure

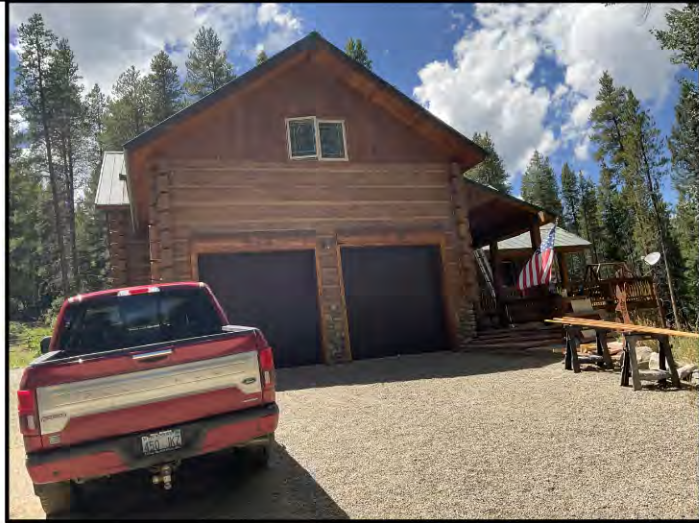
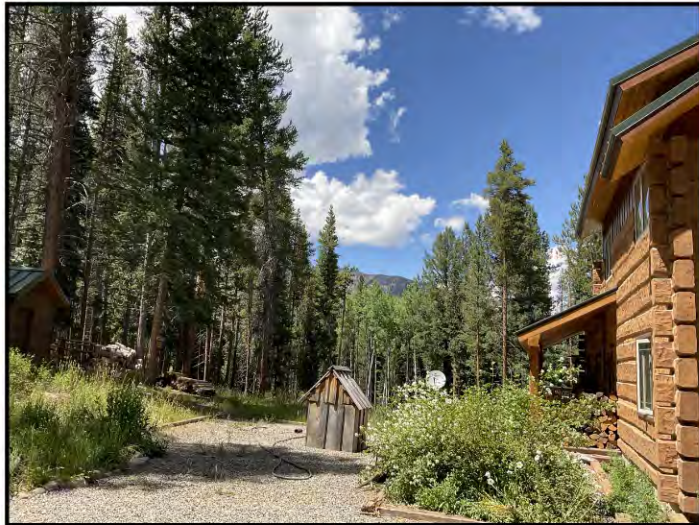
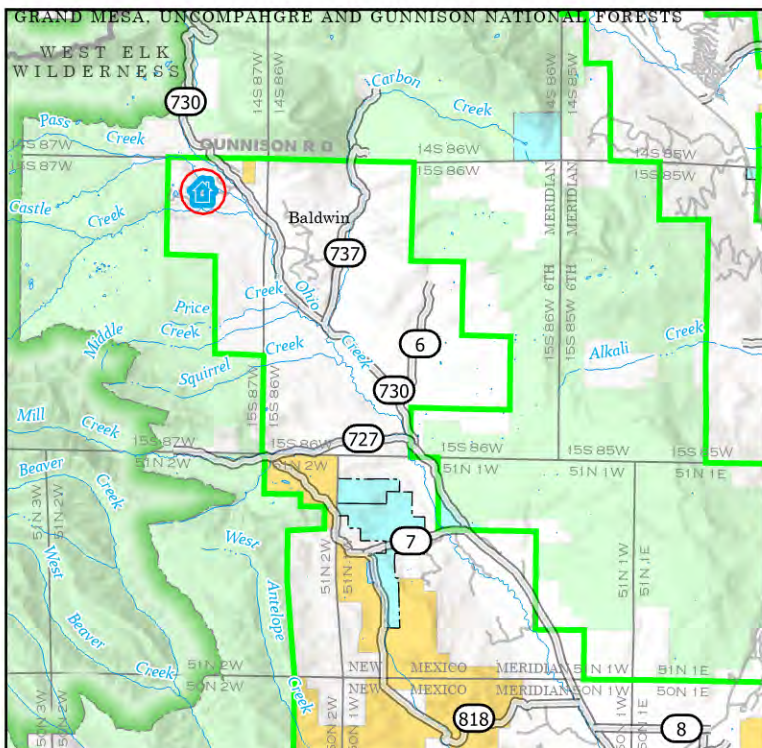
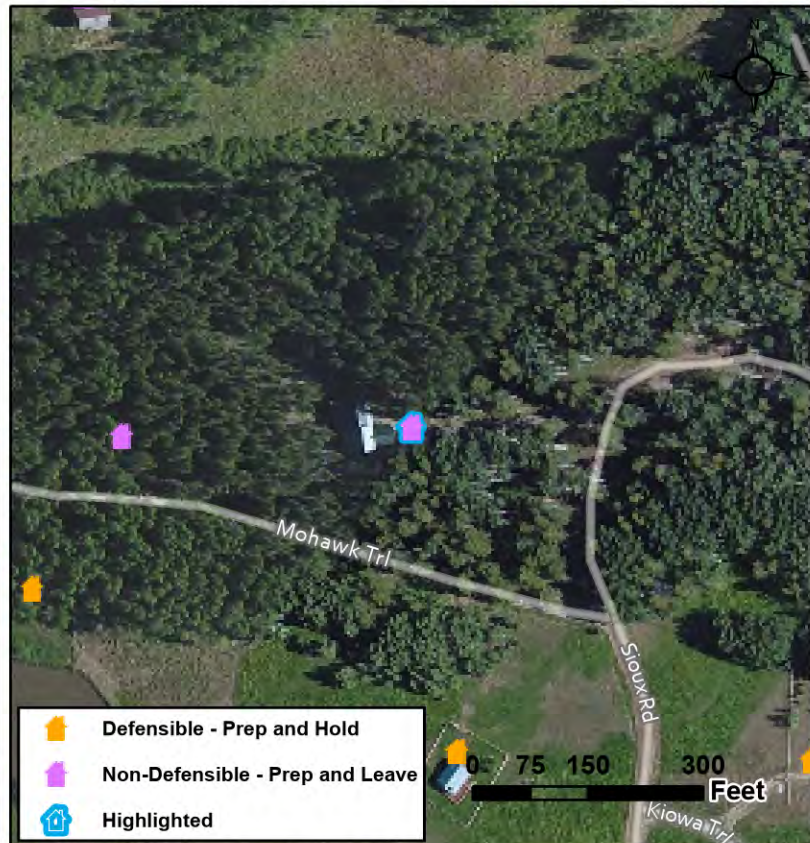
Location: 643 Sioux Rd, WILDERNESS STREAMS FILING NO. 2

Triage Category: Non-Defensible, Prep and Leave
FIRESCOPE Triage Category: Not Threatened
Structure Number: 643 Sioux Rd
Collected Date/Time: 8/3/2023 8:23:07 PM
Collected By: Kevin Brueck
Inspector's Position: EngB t
Type of Structure: Residential
Primary Structures: 1
Is the building Occupied?: Yes
Outbuildings: 1
Fuel Surrounding Structure: Shrub or timber
Defensible Space: Less than 30 ft treated
Roof Material: Noncombustible or not applicable
Siding Material: Rock, concrete, metal
Electrical Power: Yes
Gas to Structure: Yes
Hazards: Right up against slope
Access to Site: T3/4 Engine
Describe Access: Gravel driveway off the main road
Comm With ICP: Yes
Water Source: No reliable water source nearby
Safety Zone Present:
Mitigation Time (in hours): 2
Mitigation Description: Sprinklers,remove combustibles, clearing out under the porch
Resources Needed to Protect Structure: Type 3
FIRESCOPE Tactics: Prep and Go
Notes: 2

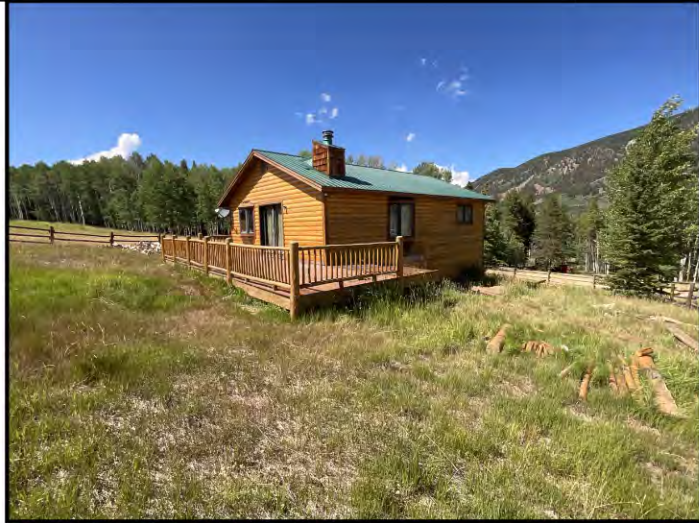
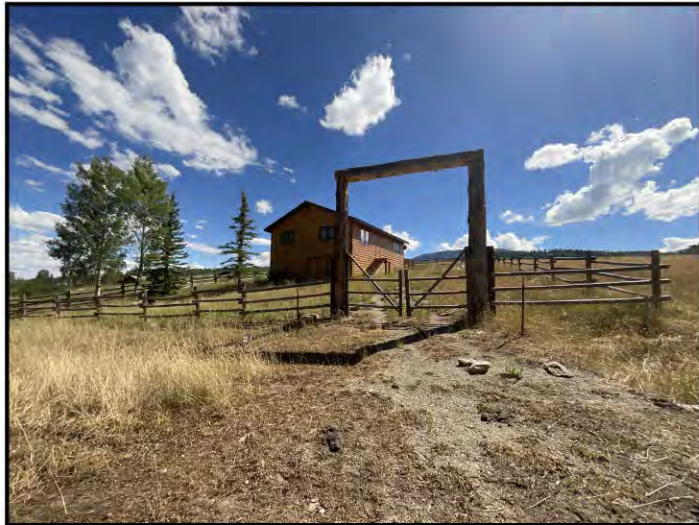
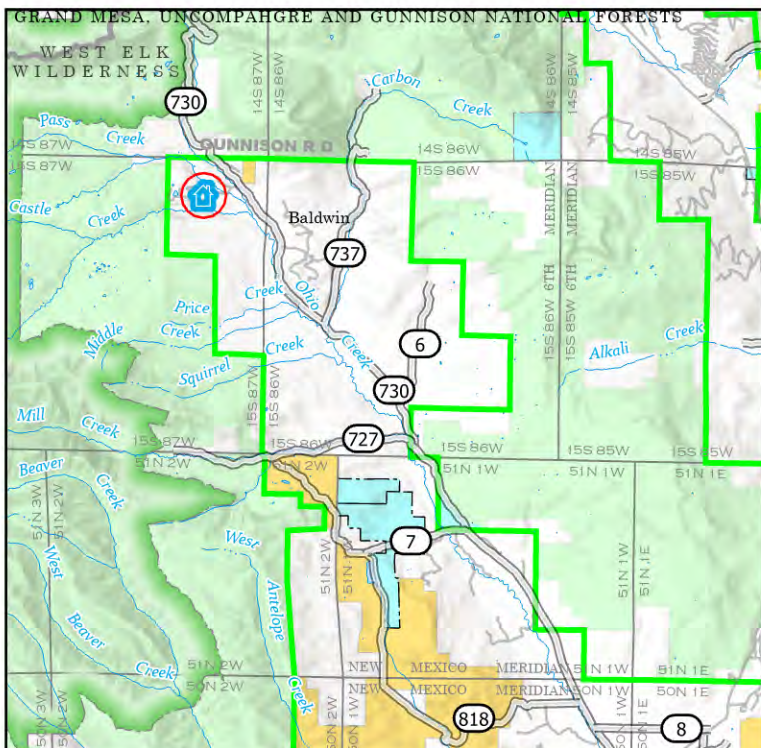
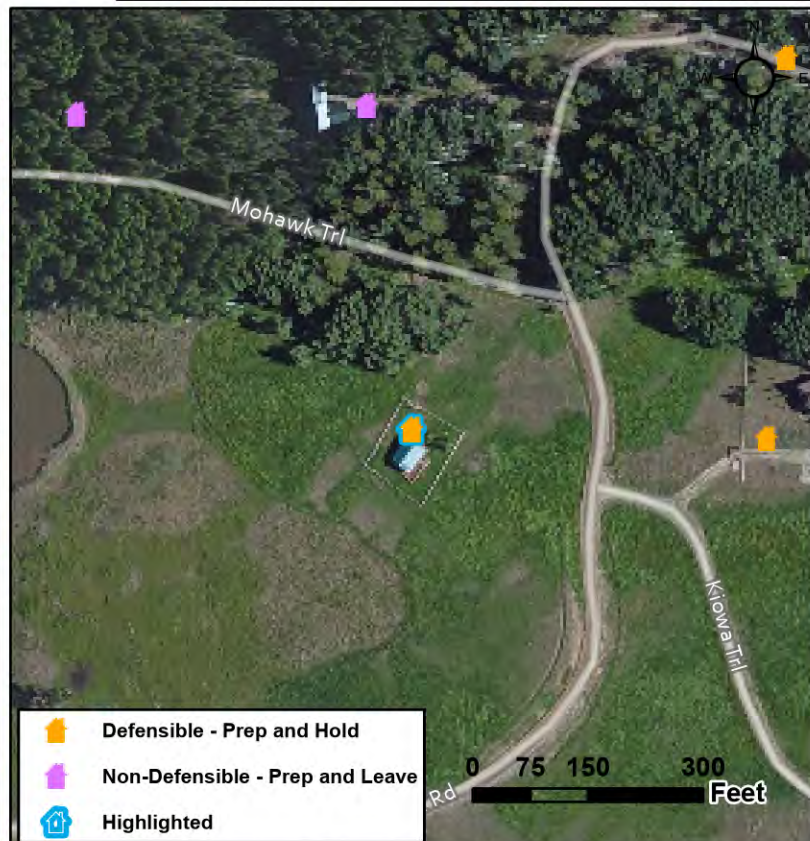
Location: 66 Mohawk Trl, WILDERNESS STREAMS FILING NO. 2

Triage Category: Defensible, Prep and Hold
FIRESCOPE Triage Category: Threatened Defensible
Structure Number: 66 Mohawk Trl
Collected Date/Time: 8/3/2023 9:38:58 PM
Collected By: Bo Knickman
Inspector's Position: Engb
Type of Structure: Residential
Primary Structures: 1
Is the building Occupied?: No
Outbuildings:
Fuel Surrounding Structure:
Defensible Space: 30 ft treated
Roof Material: Noncombustible or not applicable
Siding Material: Wood or open sided
Electrical Power: Yes
Gas to Structure: No
Hazards:
Access to Site: T3/4 Engine
Describe Access: Tight 100 foot driveway
Comm With ICP: Yes
Water Source: No reliable water source nearby
Safety Zone Present:
Mitigation Time (in hours): 1
Mitigation Description: Remove grass directly adjacent to structure
Resources Needed to Protect Structure: 1 engine
FIRESCOPE Tactics: Prep and Defend
Notes:

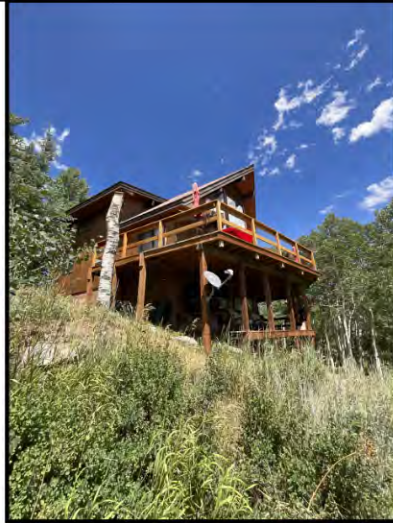
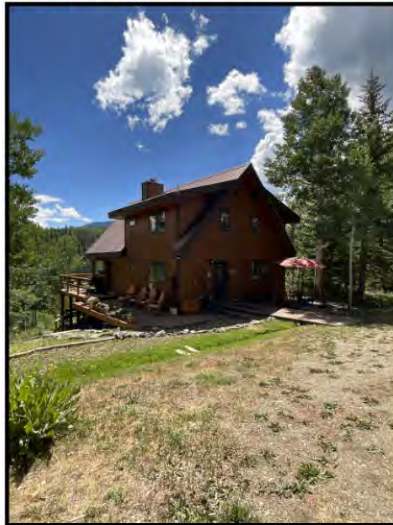
Triage Category: Defensible, Prep and Hold
FIRESCOPE Triage Category: Threatened Defensible
Structure Number: 794 Sioux Rd
Collected Date/Time: 8/3/2023 8:21:06 PM
Collected By: Cody Peterson
Inspector's Position: ENGB
Type of Structure: Residential
Primary Structures: 1
Is the building Occupied?: Yes
Outbuildings: 1
Fuel Surrounding Structure: Grass and shrub, hardwood litter
Defensible Space: 30 ft treated
Roof Material: Noncombustible or not applicable
Siding Material: Wood or open sided
Electrical Power: Yes
Gas to Structure: No
Hazards: Mid-slope
Access to Site: T1 Engine
Describe Access: Maintained gravel
Comm With ICP: Yes
Water Source: Reliable water source nearby
Safety Zone Present:
Mitigation Time (in hours): 1
Mitigation Description: Limb trees, weed eat, disburse wood pile under deck
Resources Needed to Protect Structure: Engine
FIRESCOPE Tactics: Prep and Defend
Notes: Mid-slope

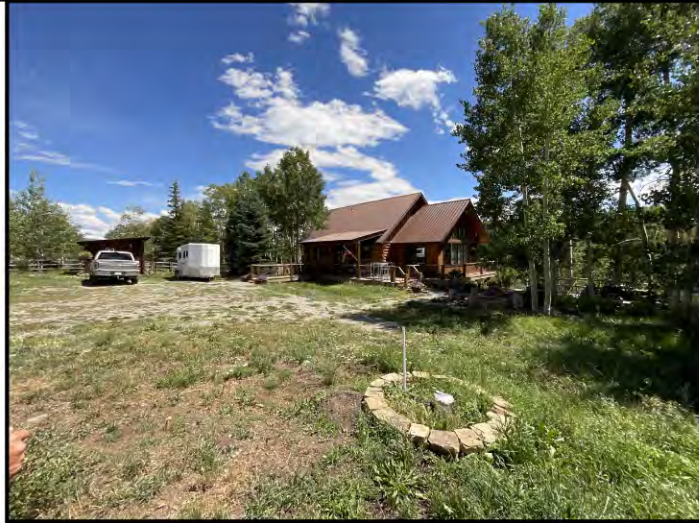
Location: 846 Sioux Rd, WILDERNESS STREAMS FILING NO. 2

Triage Category: Defensible, Prep and Hold
FIRESCOPE Triage Category: Threatened Defensible
Structure Number: 846 Sioux Rd
Collected Date/Time: 8/3/2023 8:39:56 PM
Collected By: Jesse Gallup
Inspector's Position: FFTI
Type of Structure: Residential
Primary Structures: 1
Is the building Occupied?: Yes
Outbuildings: 1
Fuel Surrounding Structure: Grass and shrub, hardwood litter
Defensible Space: 30 ft treated
Roof Material: Noncombustible or not applicable
Siding Material: Log construction
Electrical Power: Yes
Gas to Structure: Yes
Hazards: Steep hill on back side of structure
Access to Site: T3/4 Engine
Describe Access: Dirt driveway with easy access
Comm With ICP: Yes
Water Source: Limited or dependent on electricity
Safety Zone Present:
Mitigation Time (in hours): 1
Mitigation Description: Removal of combustibles from structure , sprinkler set up
Resources Needed to Protect Structure: 1 engine
FIRESCOPE Tactics: Prep and Defend

Notes: Modern log construction with fire wood on porch. Small combustible material around home

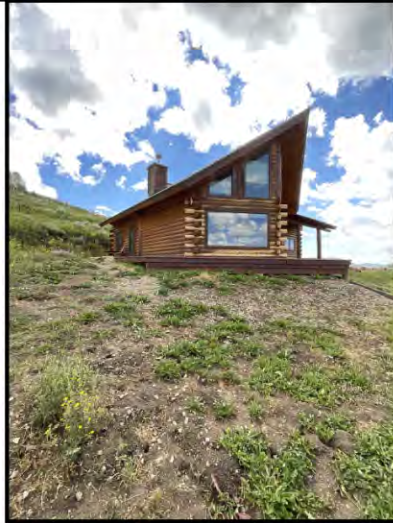
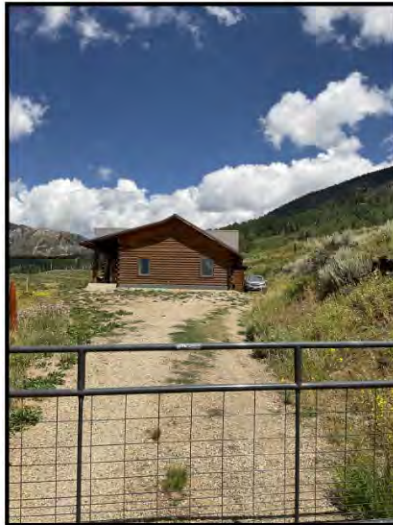
Location: 87 Sioux Rd, WILDERNESS STREAMS FILING NO. 2

Triage Category: Defensible, Prep and Hold
FIRESCOPE Triage Category: Not Threatened
Structure Number: 87 Sioux Rd
Collected Date/Time:
Collected By: Kevin Brueck
Inspector's Position: EngB T
Type of Structure: Residential
Primary Structures: 1
Is the building Occupied?: Yes
Outbuildings: 0
Fuel Surrounding Structure: Grass and shrub, hardwood litter
Defensible Space: Less than 30 ft treated
Roof Material: Noncombustible or not applicable
Siding Material: Log construction
Electrical Power: Yes
Gas to Structure: Yes
Hazards: Overhead power line
Access to Site: T3/4 Engine
Describe Access: Gravel drive, unlocked gate
Comm With ICP: Yes
Water Source: No reliable water source nearby
Safety Zone Present:
Mitigation Time (in hours): 1
Mitigation Description: Remove tall grass/shrubs
Resources Needed to Protect Structure: T6
FIRESCOPE Tactics: Prep and Defend
Notes: Wood deck NW corner, log home metal roof

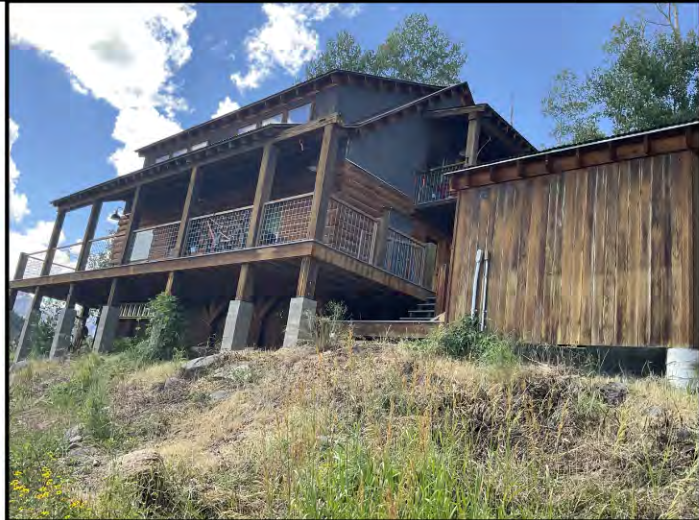
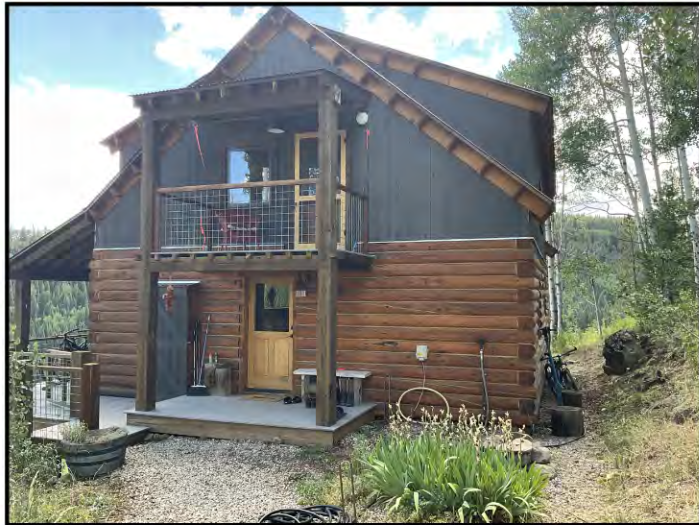
Location: 964 Sioux Rd, WILDERNESS STREAMS FILING NO. 2

Triage Category: Defensible, Prep and Hold
FIRESCOPE Triage Category: Threatened Defensible
Structure Number: 964 Sioux Rd
Collected Date/Time: 8/3/2023 7:46:49 PM
Collected By: Cody Peterson
Inspector's Position: ENGB
Type of Structure: Residential
Primary Structures: 1
Is the building Occupied?: Yes
Outbuildings: 2
Fuel Surrounding Structure: Grass and shrub, hardwood litter
Defensible Space: 30 ft treated
Roof Material: Noncombustible or not applicable
Siding Material: Log construction
Electrical Power: Yes
Gas to Structure: Yes
Hazards:
Access to Site: T3/4 Engine
Describe Access: Maintained gravel
Comm With ICP: Yes
Water Source: Reliable water source nearby
Safety Zone Present:
Mitigation Time (in hours): 1
Mitigation Description: Weed eat
Resources Needed to Protect Structure:
FIRESCOPE Tactics: Prep and Defend
Notes: Mid-slope; wood frame and log combo
