Spring Creek

CO-GFX-230097

Structure Triage Assessment
3 July 2023

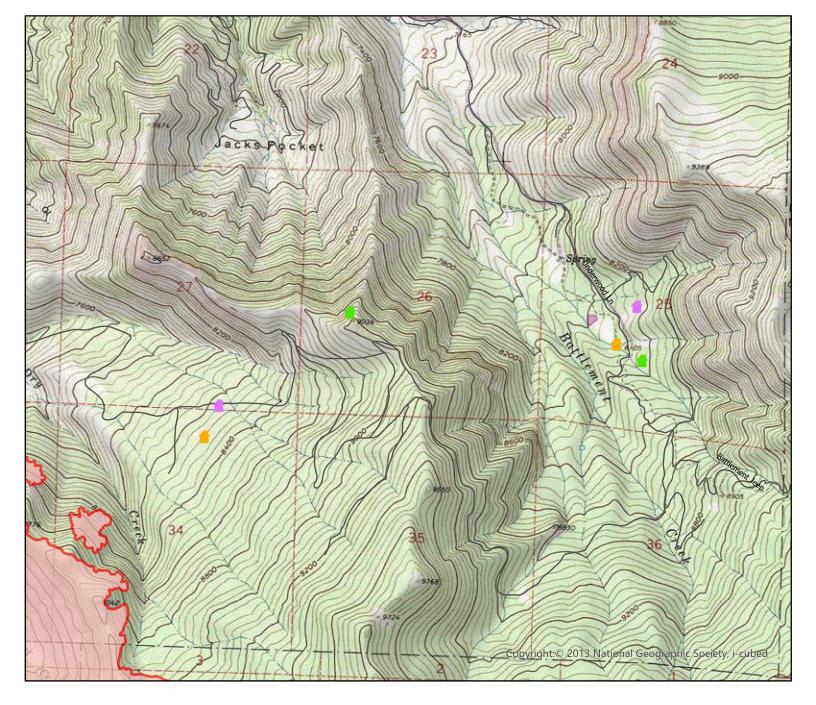
Structure Number: 1

Triage Category: Defensible, Prep and Hold

Fuel Surrounding Structure: Shrub or timber

Defensible Space: 30 ft treated

Roof Material: Noncombustible or not applicable

Siding Material: Wood or open sided

Hazards: Propane tank with plastic cord to house

Mitigation Description: Thin and brush shrubs, set up sprinkler system, turn on pump, move propane tanks etc

from garage
