STRUCTURE
PROTECTION PLAN
FOR MILL CREEK
BLOCK

Structure Protection Plan

Mill Creek Rd.

Location: Hwy 12 and the subdivisions off of Mill Creek Rd.

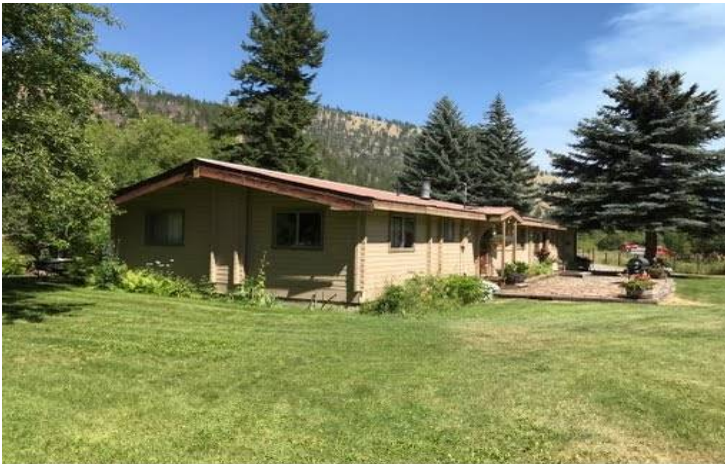
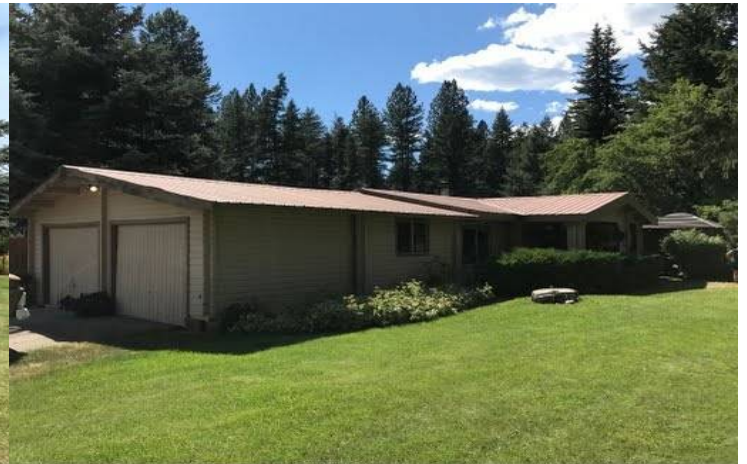
Structure Number: 3791
Structure Name: 12285 Mill Creek
SubDivision: Mill Creek
GPS Location, Lat. 46 45.18258
GPS Location, Long. 114 12.5064
Safety Zone Present: No **Where is Safety Zone:** No good safety zone.
Type of Structure: Residential **Primary Structures:** 1 **Outbuildings:** 5
Surrounding Fuels: Grass,Shrub,Timber **Defensible Space:** 30-50 Feet
Structure Triage Category: Defensible, Stand Alone
Roof Material: Metal **Siding Material:** Wood
Heat Traps: Wood Deck
Electrical Power: Overhead **Gas to Structure:** None
Hazards: Fuels,No Turn Around
Lots of shrubs and small trees near home on north side. No turn around for larger engines. Could back a T 3/4 engine into driveway.
Hazard Notes:
Access to Site: T6 Engine **Best Access From:** HWY 12 and Mill Creek Road.
Comm with ICP: Radio
Water Source: Creek
Mitigation Time: None Needed
Notes: Electric pump located on north west side of structure, on Mill Creek.

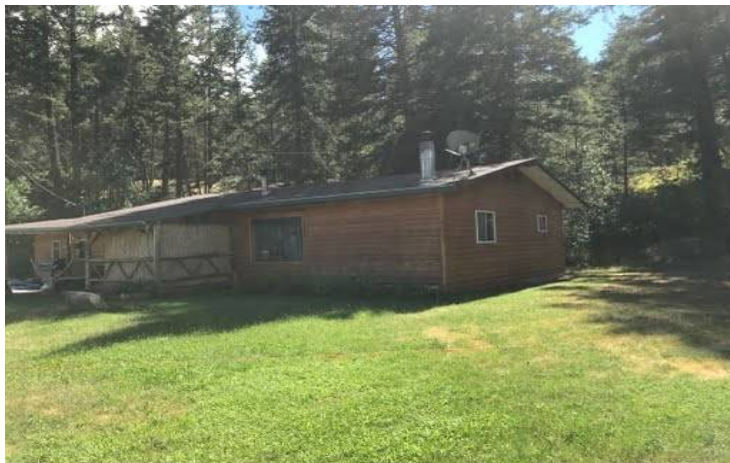
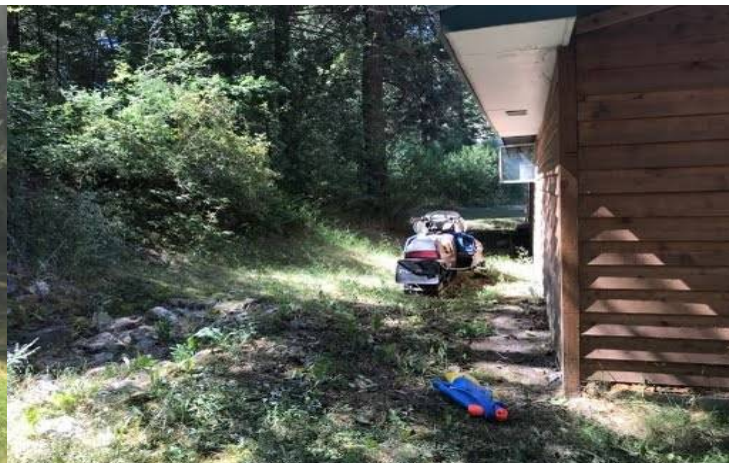
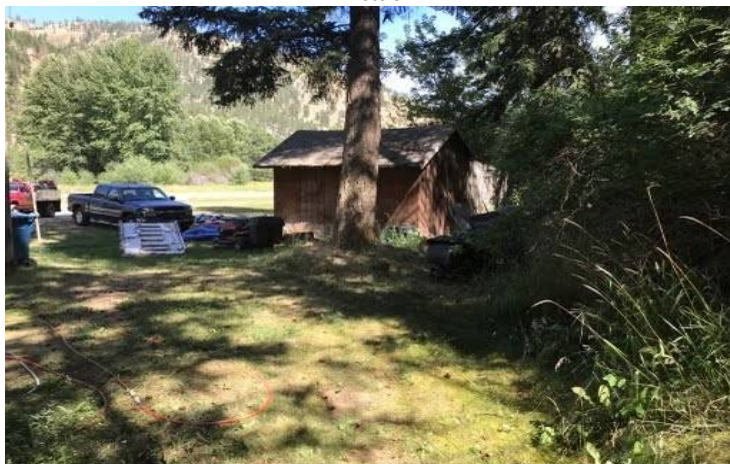
Structure Number: 3800
Structure Name: 12595 Mill Creek Rd
SubDivision: Mill Creek
GPS Location, Lat: 46 45.06006
GPS Location, Long: 114 12.47268
Safety Zone Present: No **Where is Safety Zone:** Out to Hwy 12
Type of Structure: Residential **Primary Structures:** 1 **Outbuildings:** 3
Surrounding Fuels: Timber **Defensible Space:** None
Structure Triage Category: Non-Defensible, Prep and Leave
Roof Material: Metal **Siding Material:** Wood
Heat Traps: Wood Deck
Electrical Power: Overhead **Gas to Structure:** None
Hazards: Fuels
Hazard Notes: Heavy timber right up to house, top of a short slope
Access to Site: T3/4 Engine **Best Access From:** Mill Creek RD.
Comm with ICP: Radio, Cell Service
Water Source: None
Mitigation Time: More Than 5 Hours
Other Resources Needed to Protect: Falling team, handcrew, sprinkler system
Notes: Heavy timber up to house. House is at top of slope. Lot of debris around structures. Will need lots of work, pumpkin and sprinklers.

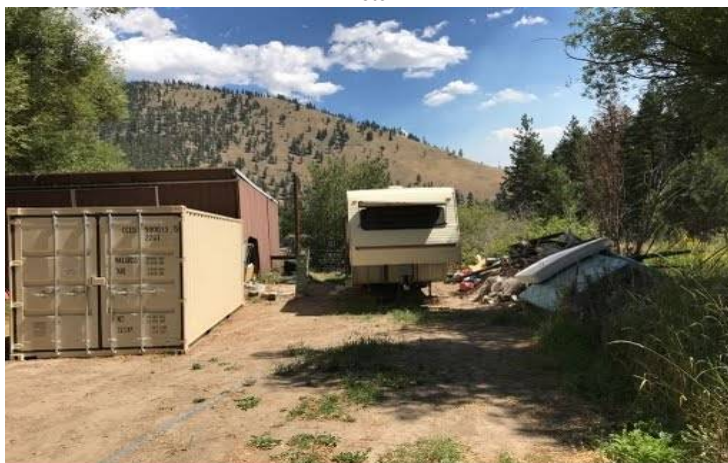
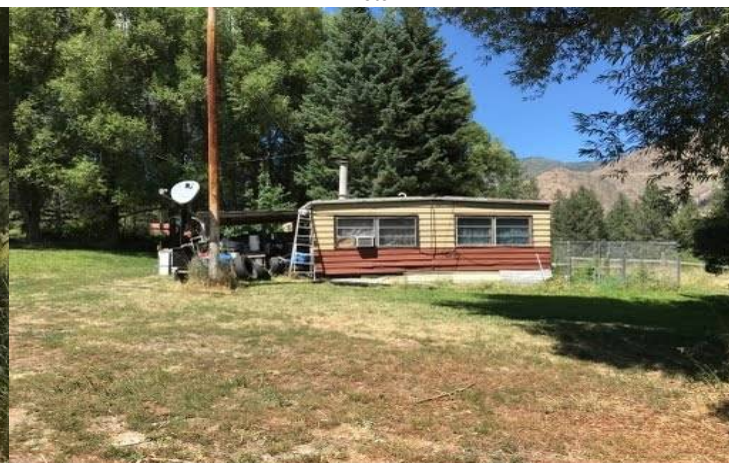
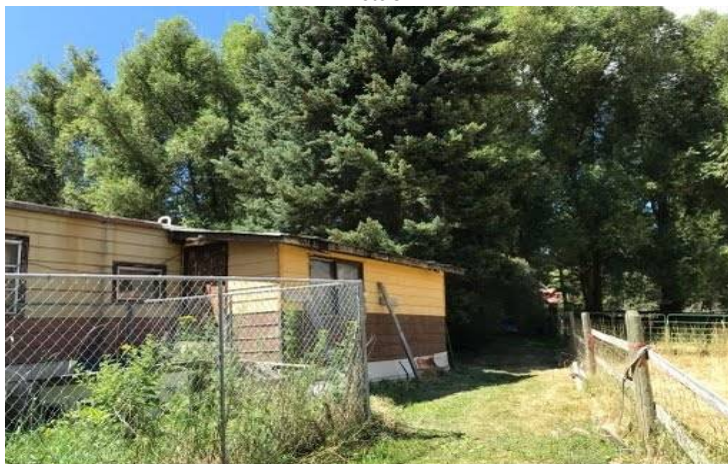
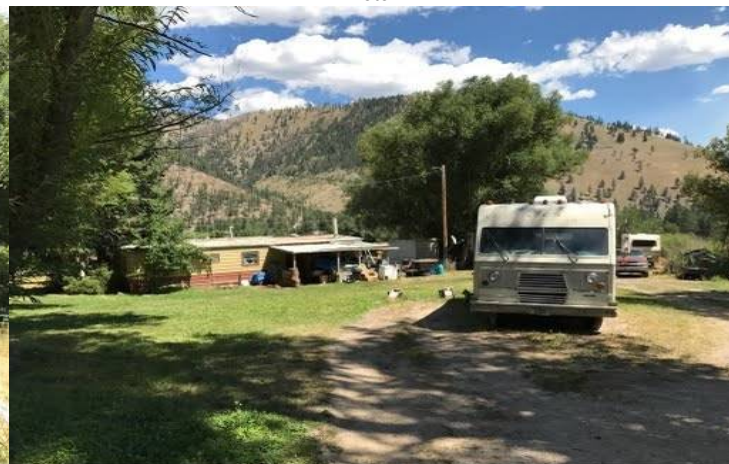
Structure Number: 3896
Structure Name: 12820 Mill Creek Rd
SubDivision: Mill Creek
GPS Location, Lat. 46 44.8989
GPS Location, Long. 114 12.4557
Safety Zone Present: No
Type of Structure: Residential
Surrounding Fuels: Grass, Timber
Structure Triage Category: Defensible, Prep and Hold
Roof Material: Metal
Heat Traps: Other Receptor
Electrical Power: Overhead
Hazards: HazMat
Hazard Notes: Fuel tank next to shed
Access to Site: T1 Engine
Comm with ICP: Radio
Water Source: Faucet / Hose, Creek
Mitigation Time: 1-2 Hours
Collected By: LoLo 632

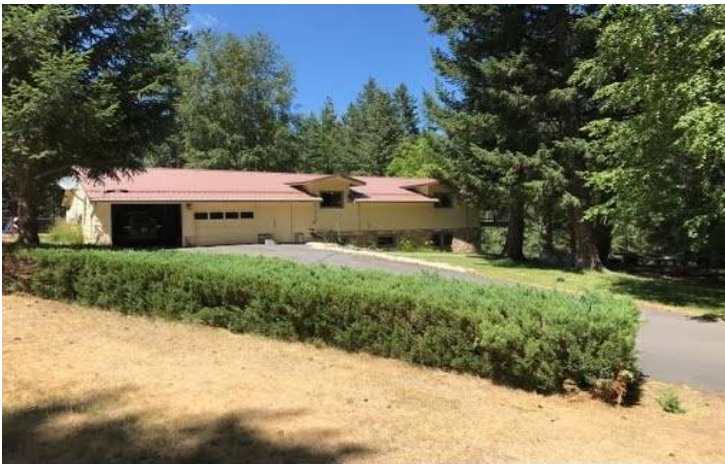
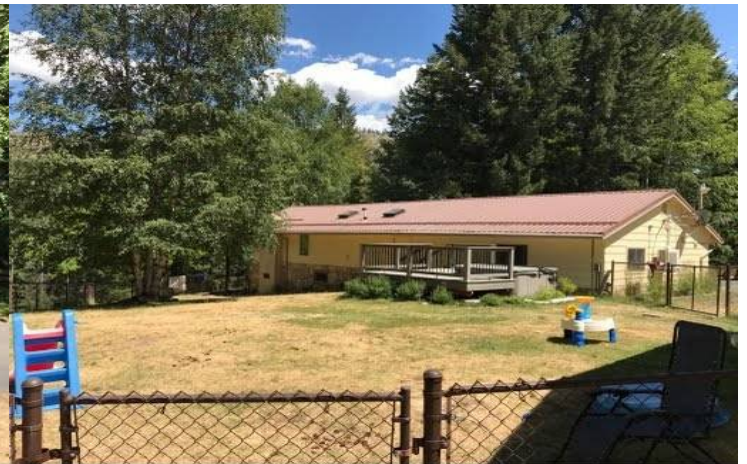
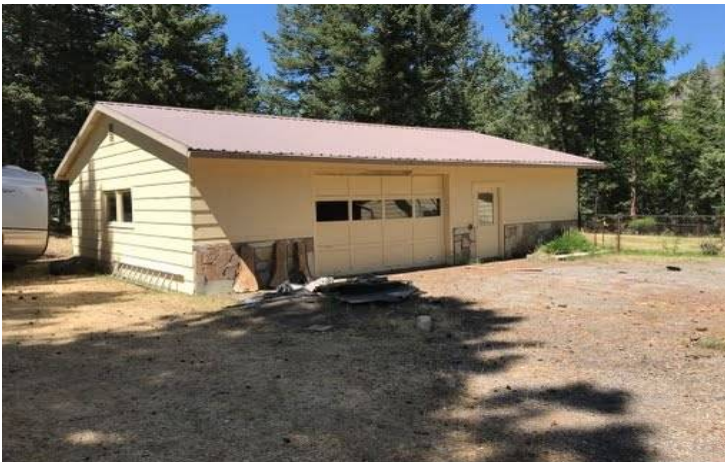
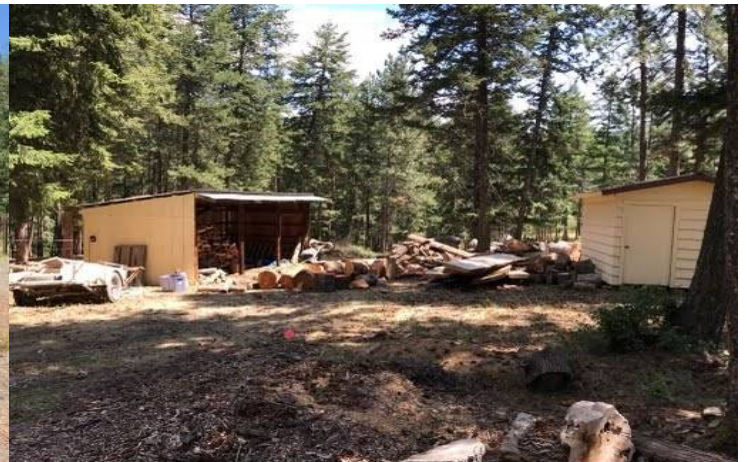
Structure Number: 3824
Structure Name: 12820 Mill Creek Road
SubDivision: Mill Creek
GPS Location, Lat. 46 44.83392
GPS Location, Long. 114 12.43944
Safety Zone Present: Yes
Type of Structure: Residential
Surrounding Fuels: Grass, Timber
Structure Triage Category: Defensible, Stand Alone
Roof Material: Metal
Heat Traps:
Electrical Power: Overhead
Hazards: Terrain, Fuels, HazMat

Hazard Notes: Slope leading up to home, mature trees next to home, large amount of firewood stored in outbuilding
Access to Site: T1 Engine
Comm with ICP: Radio
Water Source: Faucet / Hose, Large Pond
Mitigation Time: Less Than An Hour
Other Resources Needed to Protect: None
Notes: Home at the end of long narrow driveway, firewood shed 75 yards away from home, pond at bottom of driveway, good defensible space

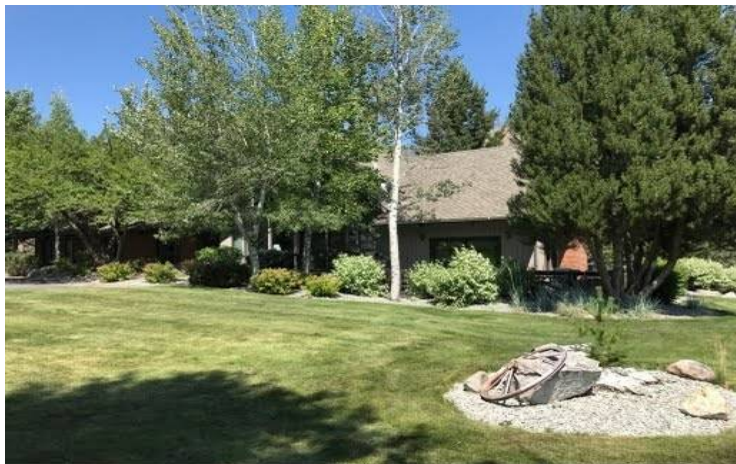
Photo 1

Structure Number: 3780
Structure Name: 12349 Arena Road
SubDivision: Arena Drive
GPS Location, Lat. 46 45.1911
GPS Location, Long. 114 13.32006
Safety Zone Present: Yes
Type of Structure: Residential
Surrounding Fuels: Grass, Timber
Structure Triage Category: Defensible, Stand Alone
Roof Material: Composite
Heat Traps: Wood Deck, Rain Gutters
Electrical Power: Underground
Hazards: Animals
Hazard Notes: Horses, cattle
Access to Site: T3/4 Engine
Comm with ICP: Radio
Water Source: Creek
Mitigation Time: None Needed
Notes: Propane tank located west of residence, 10-15 feet.

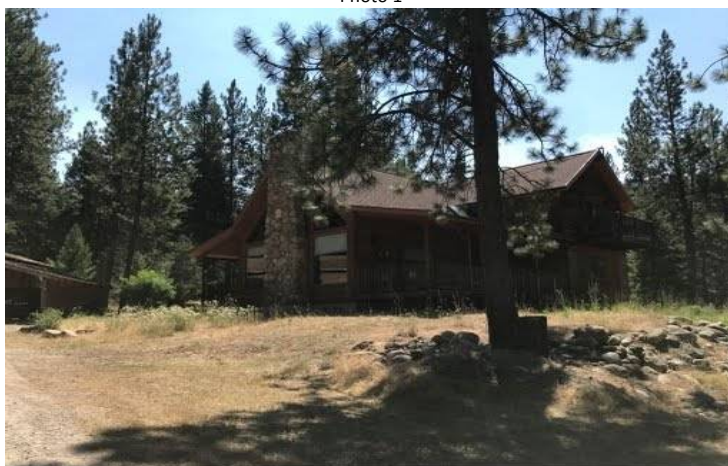
Photo 3

Structure Number: 3782
Structure Name: 12494 Arena Rd
SubDivision: Arena Drive
GPS Location, Lat. 46 45.02016
GPS Location, Long. 114 13.38996
Safety Zone Present: Yes
Type of Structure: Residential
Surrounding Fuels: Grass, Timber
Structure Triage Category: Defensible, Stand Alone
Roof Material: Composite
Heat Traps: Wood Deck, Rain Gutters
Electrical Power: Underground
Hazards: Fuels
Access to Site: T3/4 Engine
Comm with ICP: Radio
Water Source: Creek
Mitigation Time: None Needed
Notes: Gas pump located in Mill Creek South of residence down trail, 750 ft.

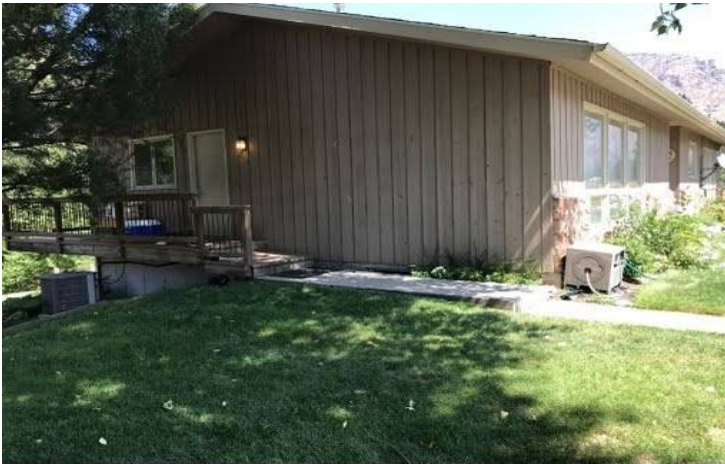
Photo 3

Structure Number: 3781
Structure Name: 12521 Arena Rd
SubDivision: Arena Drive
GPS Location, Lat. 46 45.1566
GPS Location, Long. 114 13.5291
Safety Zone Present: Yes
Type of Structure: Residential
Surrounding Fuels: Grass
Structure Triage Category: Defensible, Stand Alone
Roof Material: Composite
Heat Traps: Rain Gutters
Electrical Power: Underground
Hazards: Animals
Hazard Notes: Horses
Access to Site: T1 Engine
Comm with ICP: Radio
Water Source:
Mitigation Time: None Needed
Notes: Access to Lolo Creek on North side of house, 150-200 ft from residence.

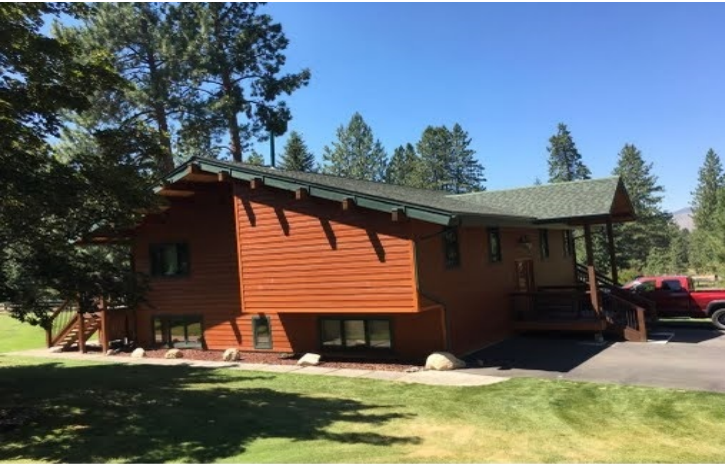
Photo 3

Structure Number: 3785
Structure Name: 12568 Arena Drive
SubDivision: Arena Drive
GPS Location, Lat. 46 45.03606
GPS Location, Long. 114 13.44036
Safety Zone Present: Yes
Type of Structure: Residential
Surrounding Fuels: Grass, Timber
Structure Triage Category: Defensible, Prep and Hold
Roof Material: Composite
Heat Traps:
Electrical Power: Underground
Hazards:
Access to Site: T1 Engine
Comm with ICP: Radio
Water Source: Faucet / Hose
Mitigation Time: 1-2 Hours
Notes: Home is no factor 200 ft irrigated grass. Shop at the back of the property backs up to the timber and will take hours to clear behind.

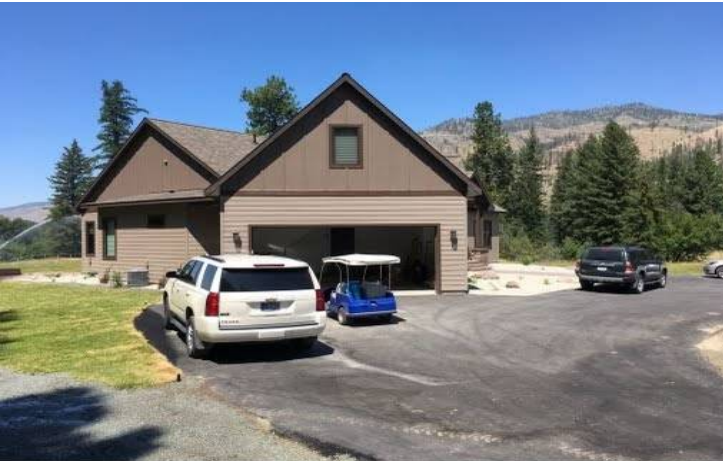
Photo 3

Structure Number: 3777
Structure Name: 12690 Arena Dr
SubDivision: Arena Drive
GPS Location, Lat. 46 44.99808
GPS Location, Long. 114 13.665
Safety Zone Present: Yes
Type of Structure: Residential
Surrounding Fuels: Grass, Timber
Structure Triage Category: Defensible, Prep and Hold
Roof Material: Composite
Heat Traps:
Electrical Power: Underground
Hazards:
Access to Site: T1 Engine
Comm with ICP: Radio
Water Source: Faucet / Hose
Mitigation Time: 1-2 Hours
Other Resources Needed to Protect: Engine crew to clean up area
Notes: New house and garage. Fairly good clearance from trees, owner has limbed up trees in the area.

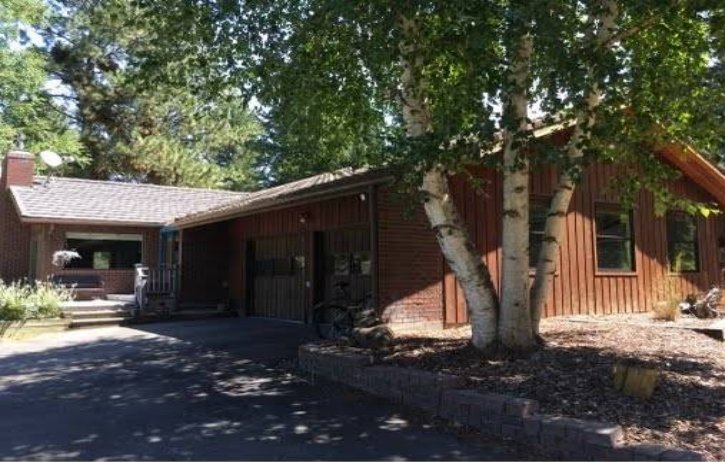
Photo 3

Structure Number: 3778
Structure Name: 12740 Arena Drive
SubDivision: Arena Drive
GPS Location, Lat. 46 44.95416
GPS Location, Long. 114 13.53366
Safety Zone Present: Yes
Type of Structure: Residential
Surrounding Fuels: Grass, Timber
Structure Triage Category: Defensible, Prep and Hold
Roof Material: Composite
Heat Traps: Wood Deck
Electrical Power: Overhead
Hazards:
Access to Site: T1 Engine
Comm with ICP: Radio
Water Source: Faucet / Hose
Mitigation Time: 2-3 Hours
Other Resources: 1 engine crew with saws. 50 ft behind house is base of slope, heavy timber and understory
Needed to Protect: Will take multiple sprinklers behind house
Notes: Irrigated lawn, back of house is 30 ft from base of slope with heavy timber and understory.
