Suppression Repair

Beachie Creek
ORWIF-200299
Riverside
ORMHF-000859
10/06/20
Page: 5

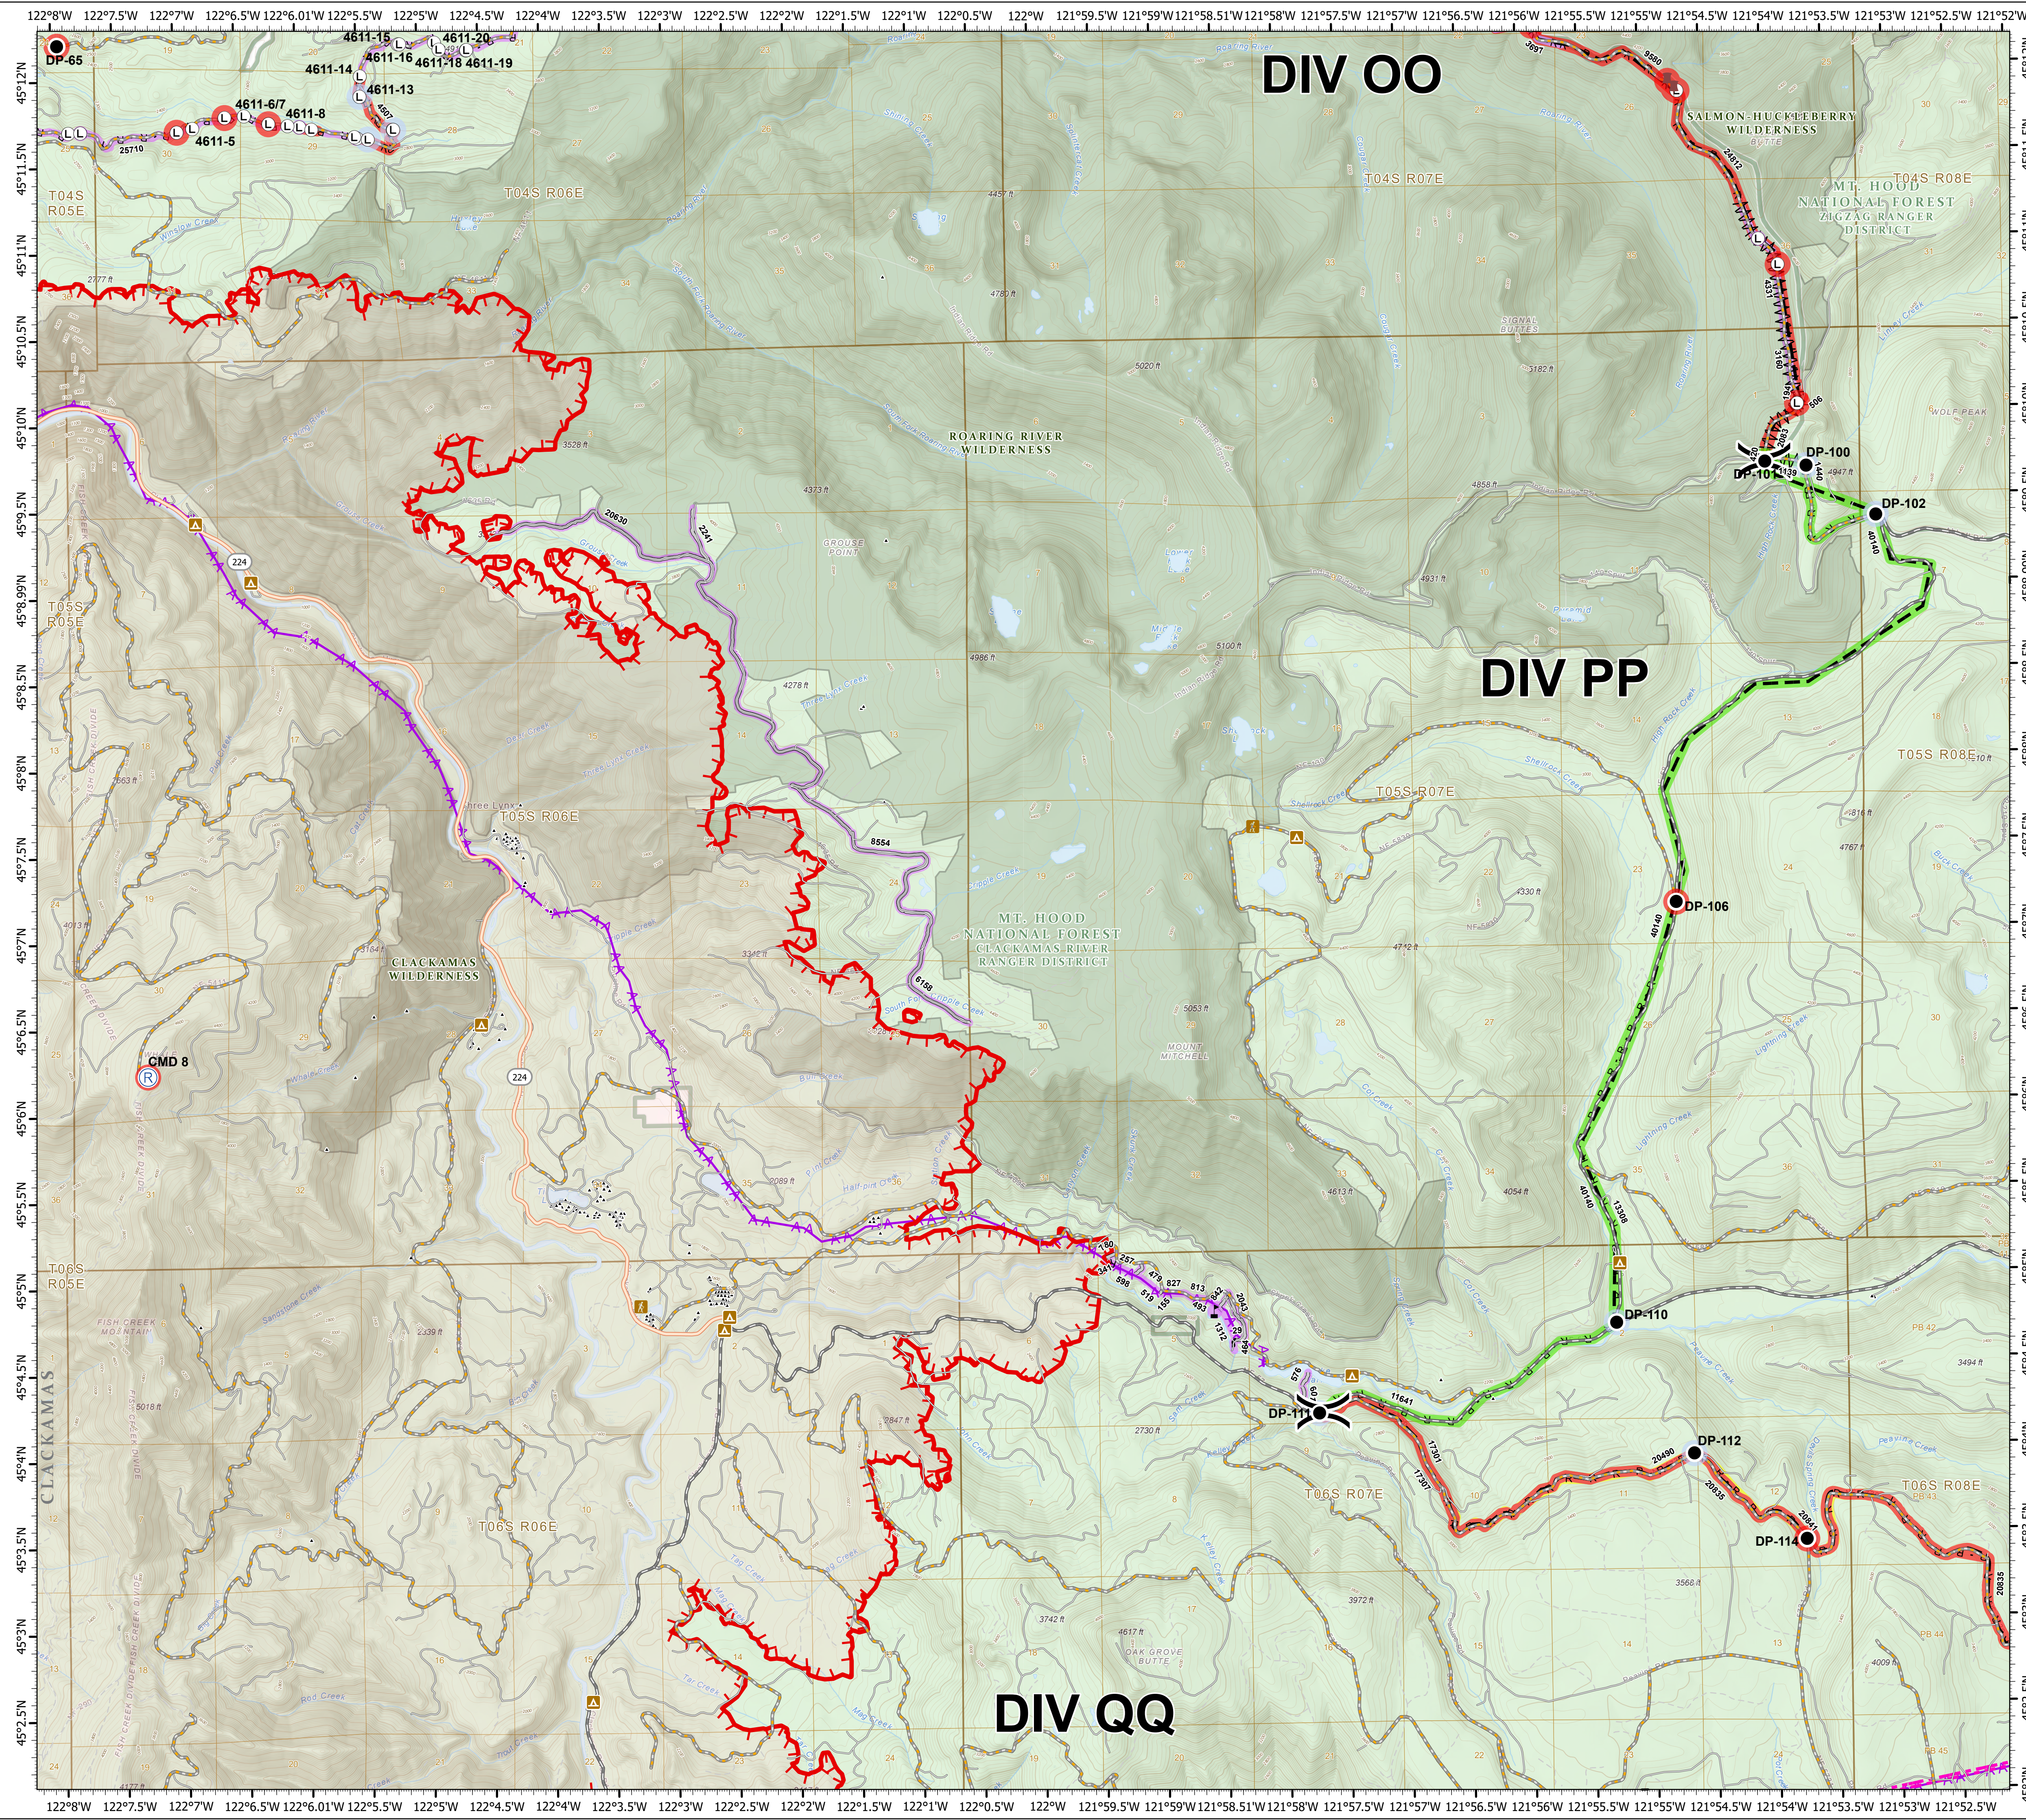
FC Point Type	Repair Status	Repair Comments	Label
Dozer Push	Repair Needed	18 inch thick slash highly scattered here where soil is exposed. -Lin kyan	4611-67
Dozer Push	Repair Needed	18 inch thick slash highly scattered slash on top of exposed soil. In kyan 10-3-20	4611-8
Drop Point	Completed - Inspected		DP-101
Drop Point	No Repair Needed		DP-100
Drop Point	No Repair Needed		DP-102
Drop Point	No Repair Needed		DP-110
Drop Point	No Repair Needed		DP-111
Drop Point	No Repair Needed		DP-112
Drop Point	Repair Needed		DP-106
Drop Point	Repair Needed		DP-114
Drop Point	Repair Needed		DP-65
Landing or Log Deck	Repair Needed		4611-10
Landing or Log Deck	Repair Needed		4611-14
Landing or Log Deck	Repair Needed		4611-15
Landing or Log Deck	Repair Needed		4611-16
Landing or Log Deck	Repair Needed		4611-17
Landing or Log Deck	Repair Needed		4611-18
Landing or Log Deck	Repair Needed		4611-19
Landing or Log Deck	Repair Needed		4611-20

FC Point Type	Repair Status	Repair Comments	Label
Landing or Log Deck	Repair Needed	18 inch thick slash lightly scattered on the exposed soil at turn around across (south) from log deck. -Lin kyan 10-3-20	4611-13
Landing or Log Deck	No Repair Needed		4611-12
Landing or Log Deck	No Repair Needed		4611-11
Landing or Log Deck	Repair Needed		4611-9
Landing or Log Deck	Repair Needed		4611-5
Landing or Log Deck	Repair Needed		4611-6
Landing or Log Deck	Repair Needed		4611-7
Landing or Log Deck	Repair Needed		4611-13
Landing or Log Deck	Repair Needed		4611-14
Landing or Log Deck	Repair Needed		4611-15
Landing or Log Deck	Repair Needed		4611-16
Landing or Log Deck	Repair Needed		4611-17
Landing or Log Deck	Repair Needed		4611-18
Landing or Log Deck	Repair Needed		4611-19
Landing or Log Deck	Repair Needed		4611-20
Landing or Log Deck	Repair Needed		4611-4
Landing or Log Deck	Repair Needed		4611-13
Landing or Log Deck	Repair Needed		4611-14

FC Line Type	Repair Status	Repair Comments	Length Feet
Road as Completed Line	Unknown		780
Road as Completed Line	Repair Needed	Significant mch. Slash piles will need to be disposed of. Flush cut purges and stumps where needed. Chipping needed.	
Road as Completed Line	Repair Needed	Chipper needed after fire-M. DeAngelo Sep 15, 2020. Equipment currently masticating (9/28). Crews may be needed to break up and spread highly concentrated material in the ditch	
Road as Completed Line	Repair Needed	Light chipping needed	420
Road as Completed Line	In Progress	Chipping needed	20496
Road as Completed Line	Completed - Inspected	Sweeping of debris and light chipping need at intersection of DP 102	
Road as Completed Line	Completed - Inspected	Sweeping of debris	1440
Road as Completed Line	Completed - Inspected	Chipping needed to clear ditches	11641
Road as Completed Line	Completed - Inspected	Chipping needed north of Shellock Campground	13308

Planned Fire Line	Unknown		464
Planned Fire Line	Repair Needed	Equipment currently masticating (9/28). Crews may be needed to break up and spread highly concentrated material in the ditch	17307
Planned Fire Line	Repair Needed	Chipping needed	20841
Planned Fire Line	Repair Needed	Road grading, remove berms, repair cut and fill slopes (marked separately), and chipping - Sung	24812
Planned Fire Line	In Progress	Chipping needed	20835
Planned Fire Line	Completed - Inspected	Equipment currently masticating (9/28). Crews may be needed to break up and spread highly concentrated material in the ditch	17301
Planned Fire Line	Completed - Inspected	Chipping needed throughout NF 58 and entry to NF 5830 and NF 150. Crews needed to sweep debris.	40140
Other	Unknown		257
Other	Unknown		479
Other	Unknown		493
Other	Unknown		519
Other	Unknown		598

FC Line Type	Repair Status	Repair Comments	Length Feet
Other	Unknown		813
Other	Unknown		827
Other	Unknown		1312
Line Break Completed	Unknown		3160
Line Break Completed	Unknown		4331
Line Break Completed	Repair Needed	Logs in ditch need to be removed. Chip smaller material. Berms need to be knocked down. Rocky debris behind shoulder needs additional repair	2083
Line Break Completed	Completed - Inspected	Light chipping and sweeping needed	1139
Completed Dozer Line	Repair Needed	Pull in berms, may not be needed until log deck is removed	194
Completed Dozer Line	Repair Needed		506
Access or Improved Road	Unknown		29
Access or Improved Road	Unknown		155
Access or Improved Road	Unknown		341
Access or Improved Road	Unknown		576
Access or Improved Road	Unknown		601
Access or Improved Road	Unknown		842
Access or Improved Road	Unknown		2043
Access or Improved Road	Unknown		2241
Access or Improved Road	Unknown		6158
