# Suppression Repair

Beachie Creek  
ORWIF-200299  
Riverside 2  
10/13/20  
Page: 2

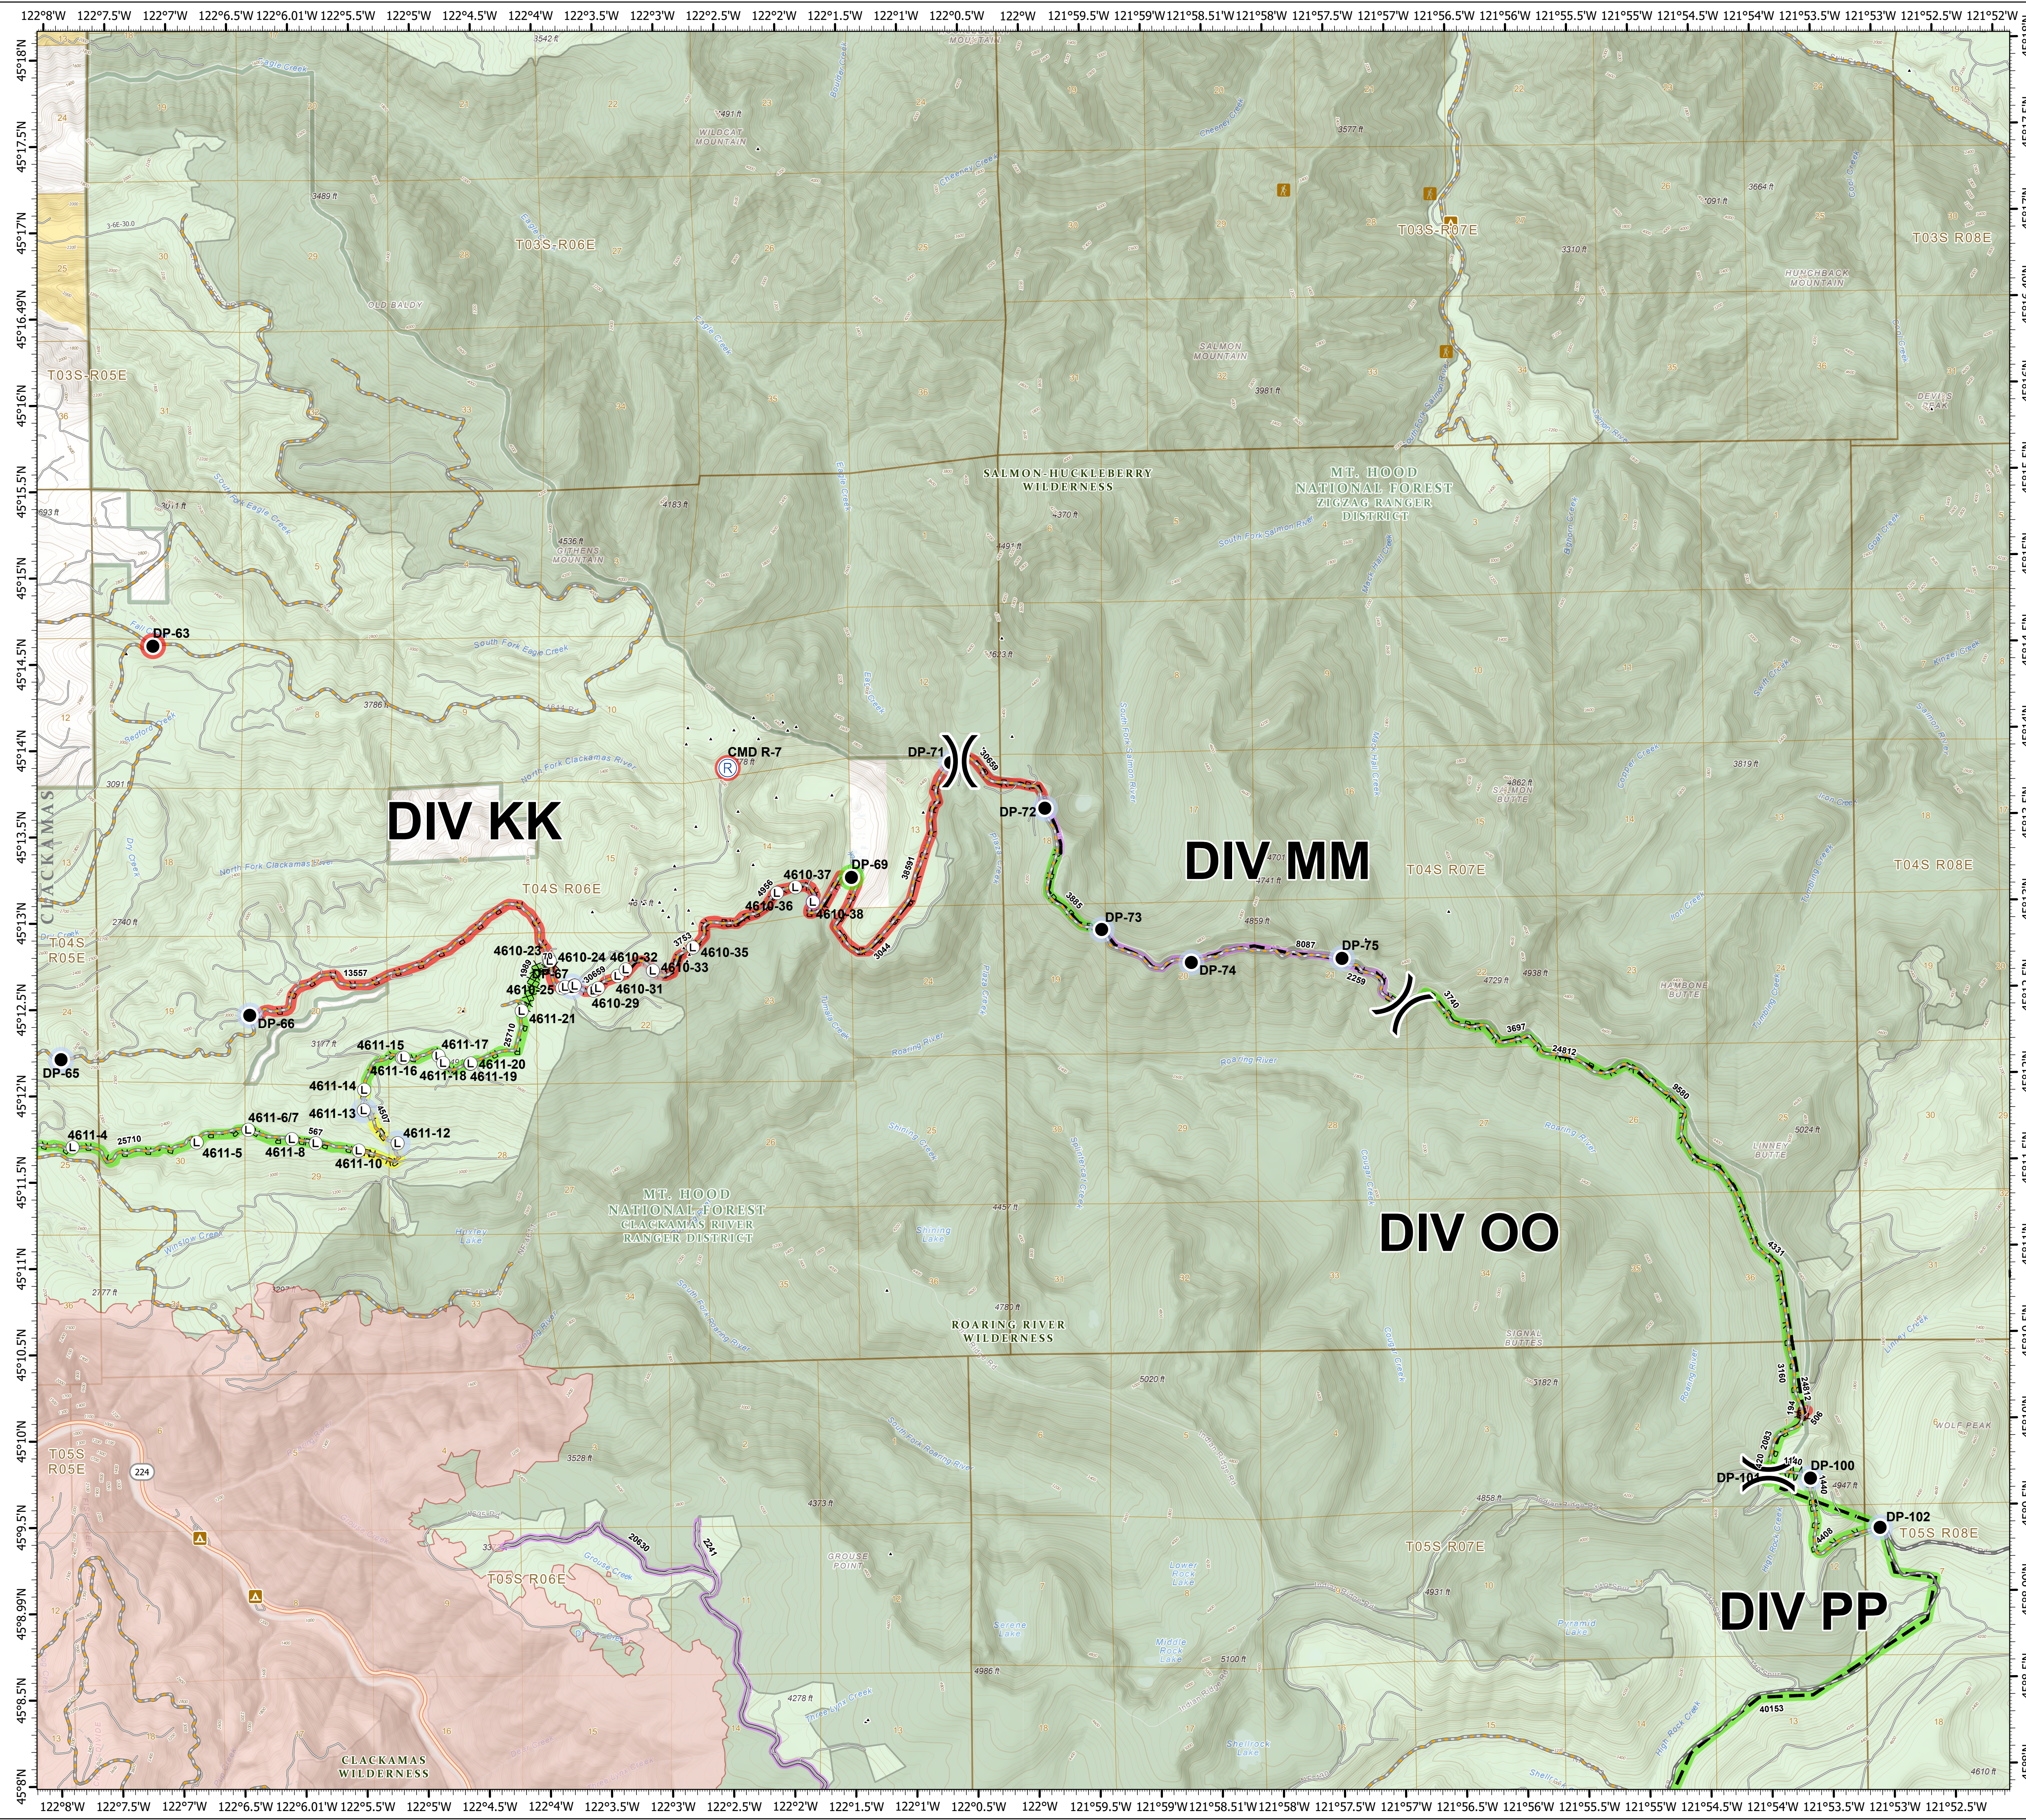
FC Point Type	Repair Status	Repair Comments	Label
Drop Point	Completed - Inspected		DP-101
Drop Point	Completed - Inspected	Pulled back slash piled by culvert and scattered seed native seed if needed. 4/Jan 10-9-20	DP-64
Drop Point	Completed - Inspected	Unit will return to monitor beaver dam and seed if needed. 4/Jan 10-9-20	DP-69
Drop Point	No Repair Needed		DP-100
Drop Point	No Repair Needed		DP-102
Drop Point	No Repair Needed		DP-65
Drop Point	No Repair Needed		DP-66
Drop Point	No Repair Needed		DP-67
Drop Point	No Repair Needed		DP-71
Drop Point	No Repair Needed		DP-72
Drop Point	No Repair Needed		DP-73
Drop Point	No Repair Needed		DP-74
Drop Point	No Repair Needed		DP-75
Drop Point	Repair Needed	Cover exposed soil with either slash or native seed 4/Jan 10-8-20	DP-63
Landing or Log Deck			4610-26
Landing or Log Deck			4610-23
Landing or Log Deck			4610-24
Landing or Log Deck			4610-25
Landing or Log Deck			4610-27

FC Line Type	Repair Status	Repair Comments	Length Feet
Road as Completed Line	Unknown		2259
Road as Completed Line	Unknown		3044
Road as Completed Line	Repair Needed		3753
Road as Completed Line	Repair Needed	Needs grading of berm caused by dozer. Masticated edge needs follow up hand cutting (stems were cut too long).	4956
Road as Completed Line	Repair Needed	4610 segment 2 - Begin grading to remove berm on roadside from tracked equipment and waterbar. begin slash removal from drainage features. barricade? light grading. 4610 brushing and mts - road prism needs brushed, ditches pulled and graded to remove mts and have proper drainage. Will require spot rock. starts at 150 spur, this segment has work rutting	13557
Road as Completed Line	Repair Needed	remove masticator debris from ditches and culvert. grade road for drainage and waterbar. remove berm on shoulder scatter large slash accumulation	30659

Road as Completed Line	In Progress	excavator cleaning ditch. READ Kidwell 10-6	4507
Road as Completed Line	Completed - Inspected	10/10/2020mkell_nfc-Per robertsanders_nfc-Inspected 10/09/2020 Completed. unknown dates/illavou-Completed fuel break. Unknown date unknown collector/light chipping needed	420
Road as Completed Line	Completed - Inspected	10/07/2020mkell_nfc-Inspected. 10/06/2020kidwell-Remove slash in ditch roadside	567
Road as Completed Line	Completed - Inspected	Sweeping of debris	1440
Road as Completed Line	Completed - Inspected	Logs in ditch need to be removed. Chip smaller material. Berms need to be knocked down. Rocky debris behind shoulder needs additional repair	2083
Road as Completed Line	Completed - Inspected	10/10/2020mkell_nfc-Per robertsanders_nfc-Inspected 10/09/2020 Completed. unknown dates/illavou-Completed fuel break	3160
Road as Completed Line	Completed - Inspected	10/10/2020mkell_nfc-Per robertsanders_nfc-Inspected 10/09/2020 Completed. unknown dates/illavou-Completed fuel break	3697
