# Suppression Repair

Beachie Creek  
ORWIF-200299  
Riverside  
ORMHF-000859  
10/10/20  
Page: 2

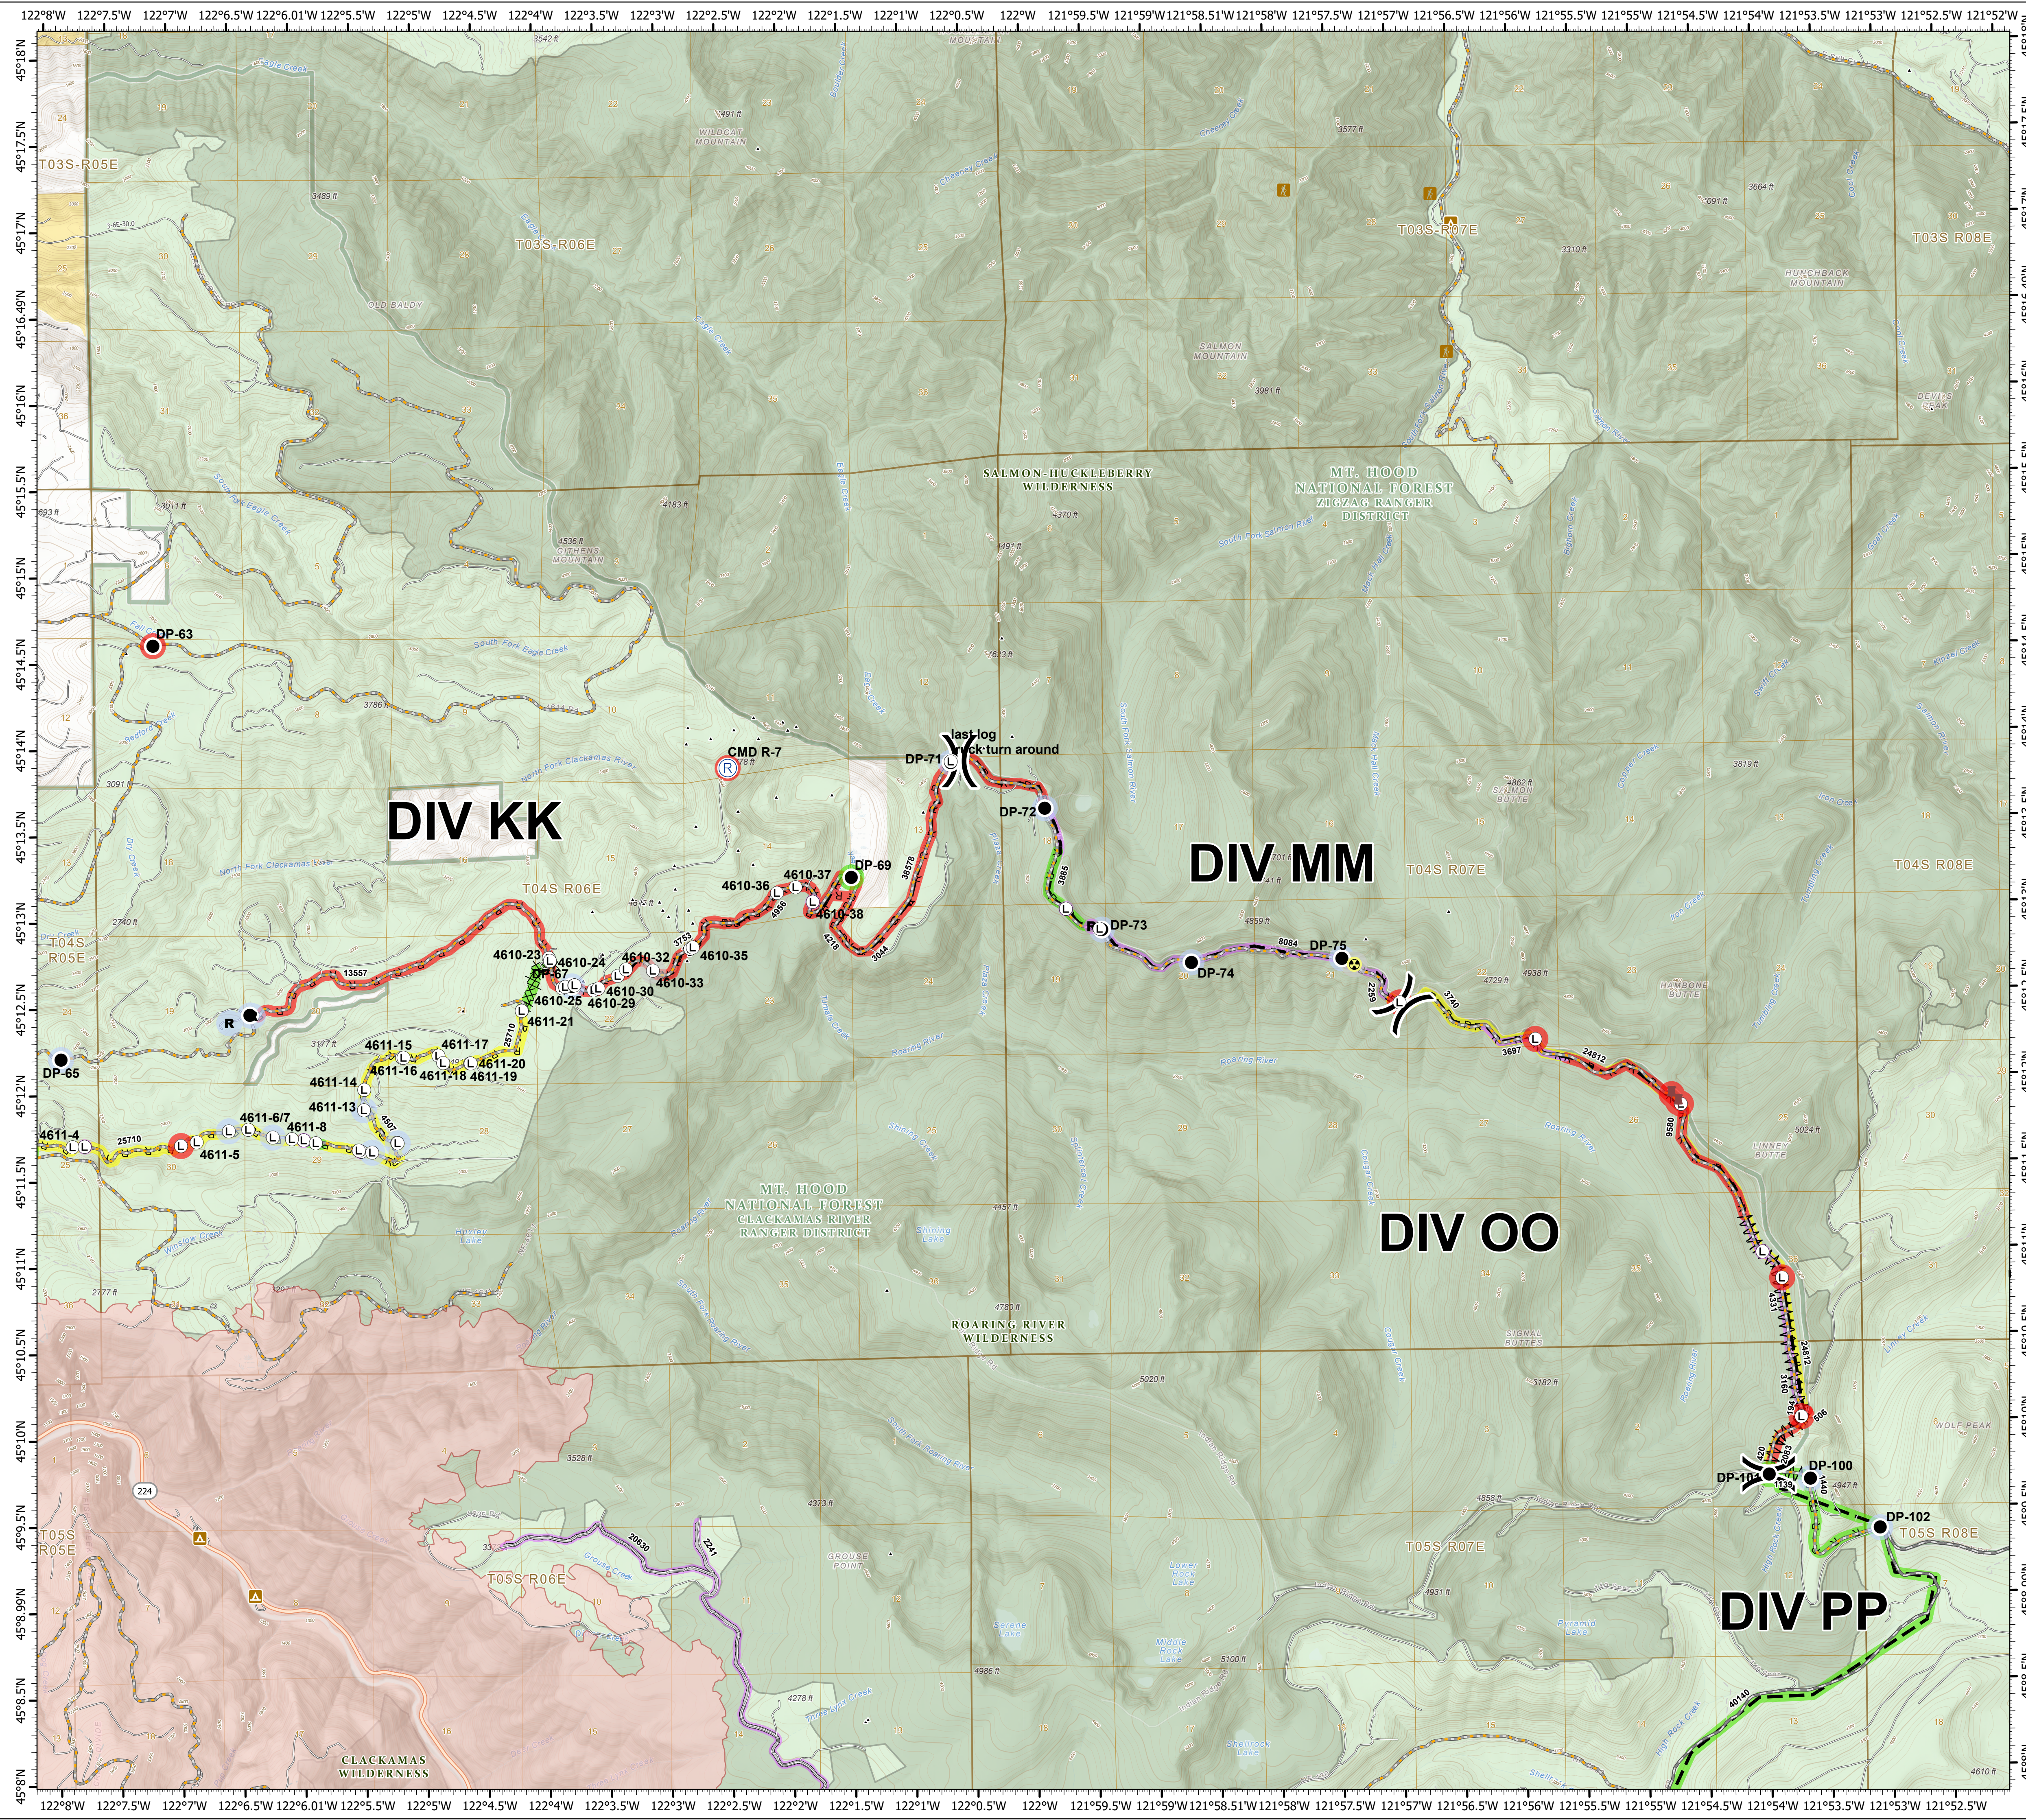
1:33,000 - 10/9/2020 2220  
Acres from GIS  
North American 1983 Datum, Lat/Long Grid
