Lick Creek Fire (OR-UMF-658)

Green Ridge Fire (OR-UMF-659)

Combined Suppression Repair Plan

Pomeroy Ranger District Umatilla National Forest

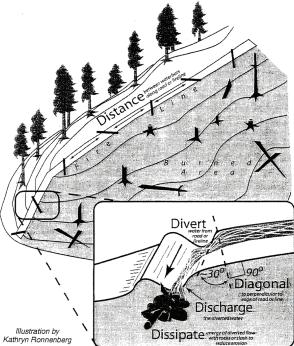
- **Diagonal**: A diagonal waterbar has a gentle slope along its base that leads the water off. Build them at 15-30 degrees from horizontal and drained away from the fire burned area if possible

- **Divert:** A good waterbar will divert the water off the fireline. To do this the waterbar must be sufficiently deep to handle all the flow for as long as it is needed. Excavation is much more effective than fill in making a durable and effective waterbar (a ditch or a dip beats a dike)

- **Discharge:** A good waterbar is not a dam it must have an open outlet.
- **Dissipate:** A good waterbar should dissipate the flow just below the outlet to exhaust its eroding power and cause it to filter into the soil. This may require placing slash, rock, or debris below the outlet, or fudging a bit on distance to take advantage of natural features that will dissipate the water's erosive energy.

Figure 1: Example of properly constructed waterbar on fire line.

Dozer Line	Handline
• <20% grade – 100 foot spacing	• <20% – 100 foot spacing
• >20%-40% grade – 50 foot spacing	• 20%-40% – 50 foot spacing
• >40% grade – 25 foot spacing	• $>40\% - 25$ foot spacing
• Cut water bars at least one foot deep	• Cut water bars at least 6 inches deep
<ul> <li>Cut water bars towards green on exterior dozer line</li> </ul>	<ul> <li>Cut water bars toward green on exterior handline</li> </ul>
