NPS Wildland Fire Risk Assessment - Community Assessment

Community: Bear Lake
Unit - Location: ROMO - Bear Lake Road
Field Crew: Dave Frey
Last Site Visit Date:

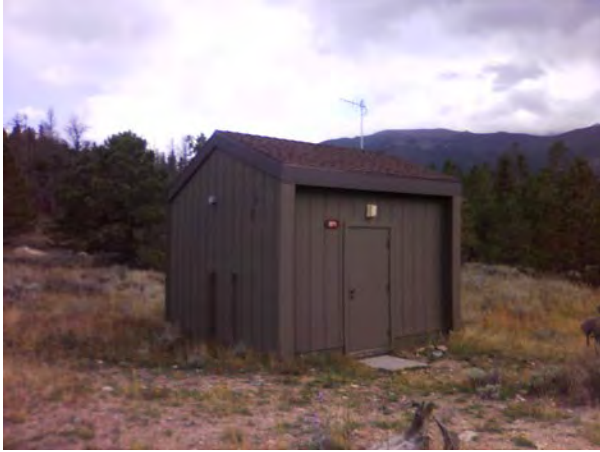
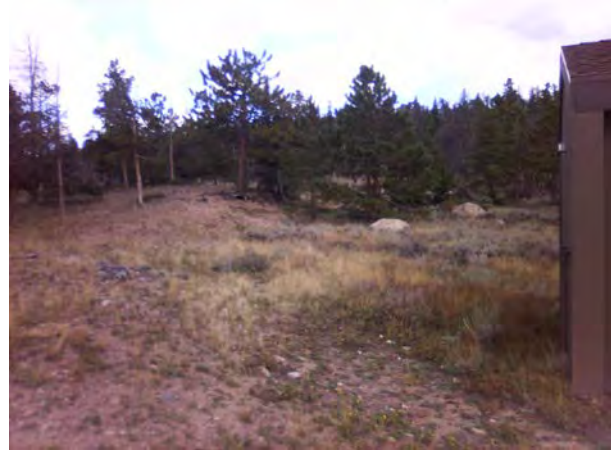
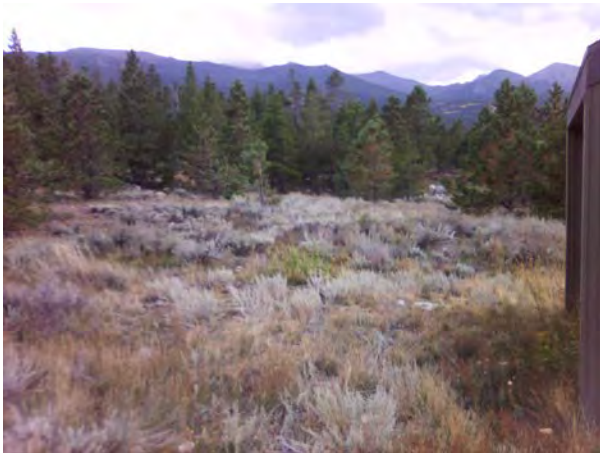
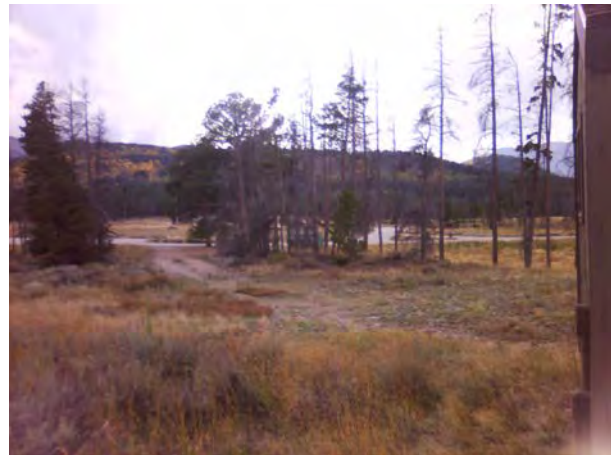
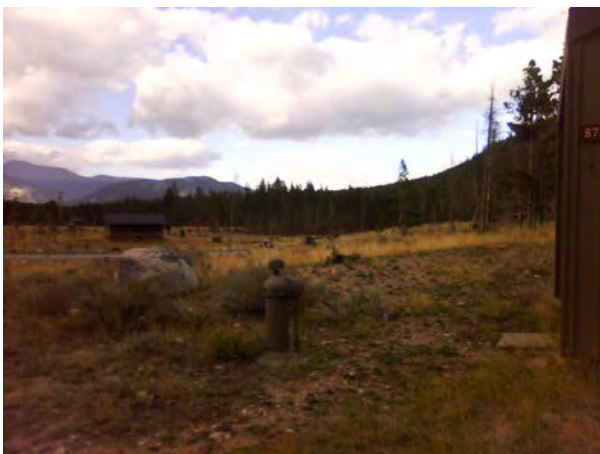
ROMO_98019_B-0871-N Pumphouse, Glacier Basin Campground_Front.jpg

ROMO_98019_B-0871-N Pumphouse, Glacier Basin Campground_D.jpg

ROMO_98019_B-0871-N Pumphouse, Glacier Basin Campground_C.jpg

ROMO_98019_B-0871-N Pumphouse, Glacier Basin Campground_B.jpg

ROMO_98019_B-0871-N Pumphouse, Glacier Basin Campground_A.jpg

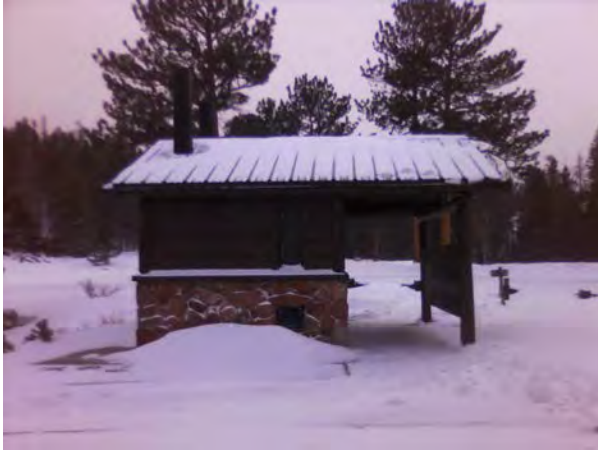
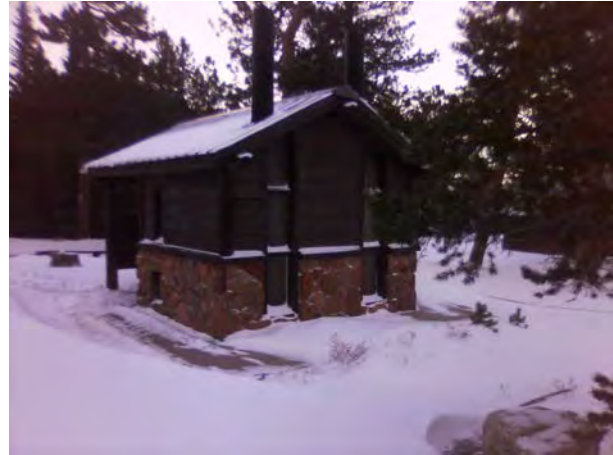
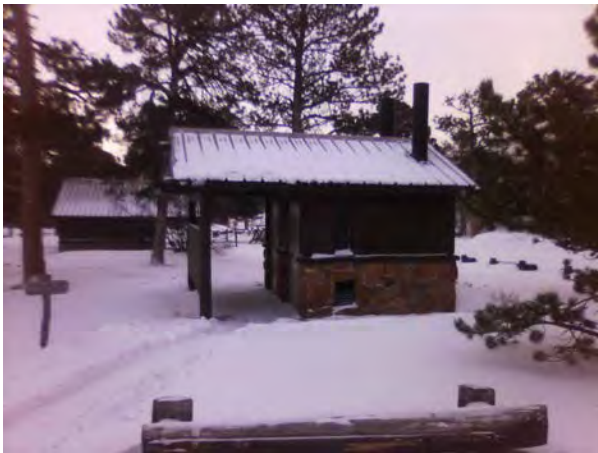
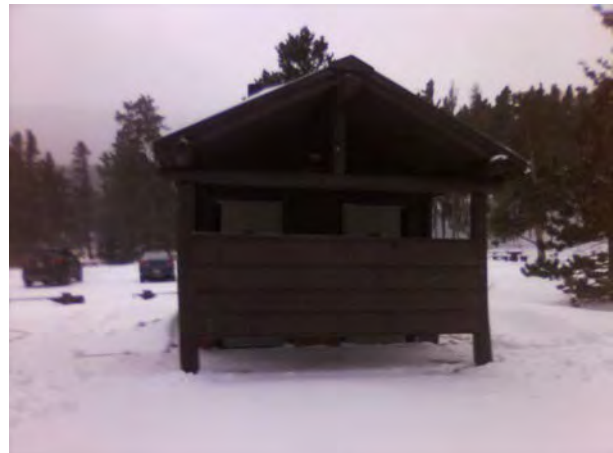
ROMO_31816_B-1059-N Vault Toilet, Sprague Lake_D.jpg

ROMO_31816_B-1059-N Vault Toilet, Sprague Lake_C.jpg

ROMO_31816_B-1059-N Vault Toilet, Sprague Lake_B.jpg

ROMO_31816_B-1059-N Vault Toilet, Sprague Lake_A.jpg

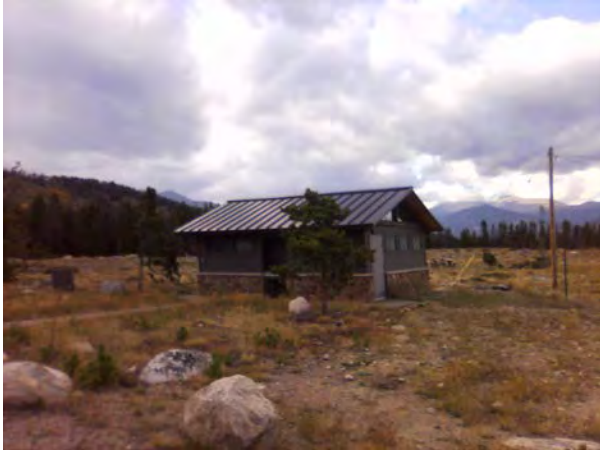
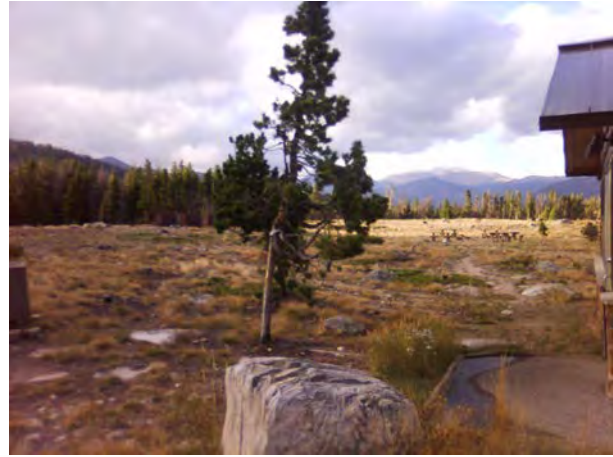
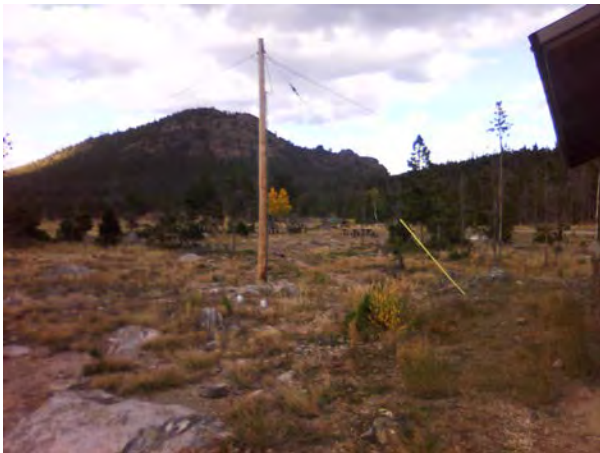
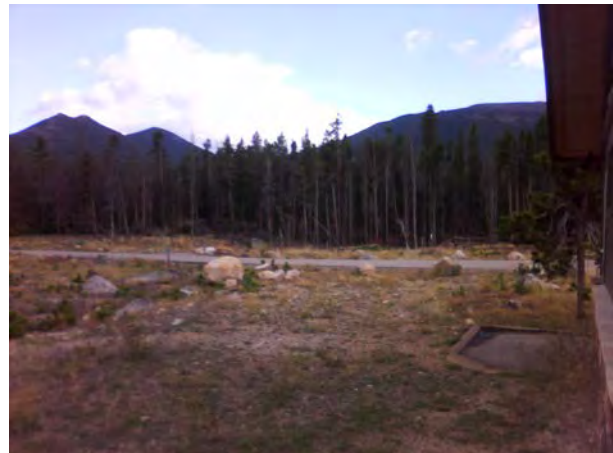
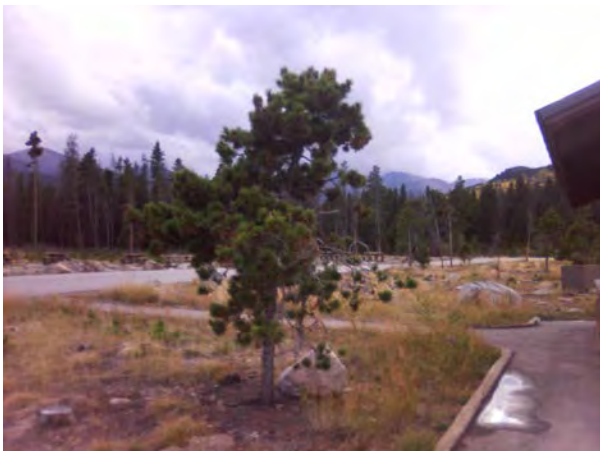
ROMO_31759_B-0502-N Comfort Station, GBCG Group Site_Front.jpg

ROMO_31759_B-0502-N Comfort Station, GBCG Group Site_D.jpg

ROMO_31759_B-0502-N Comfort Station, GBCG Group Site_C.jpg

ROMO_31759_B-0502-N Comfort Station, GBCG Group Site_B.jpg

ROMO_31759_B-0502-N Comfort Station, GBCG Group Site_A.jpg

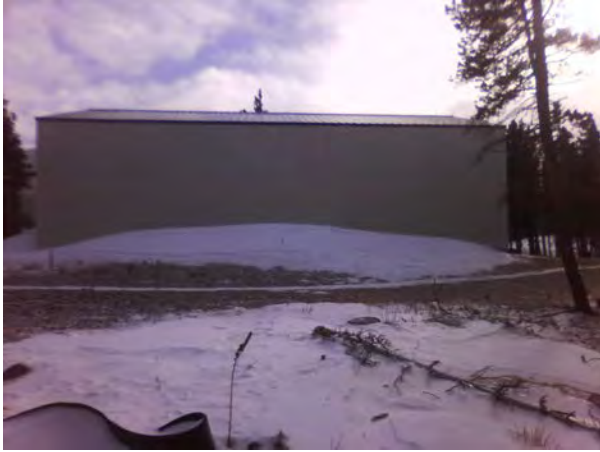
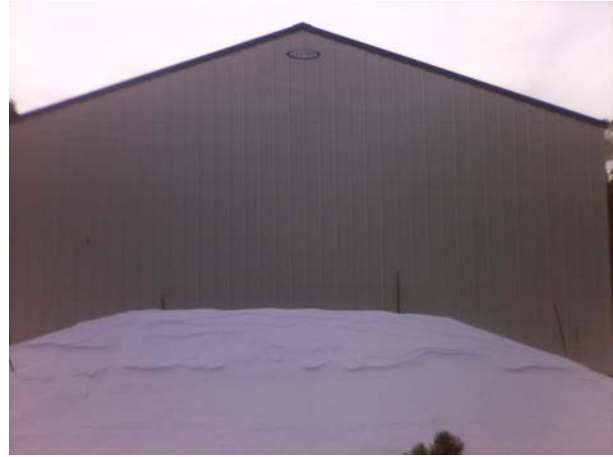
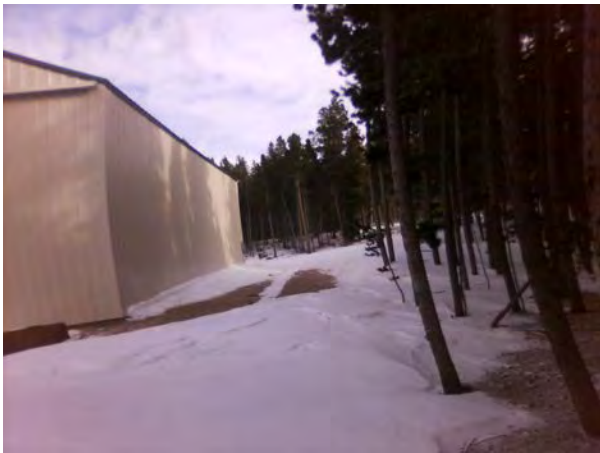
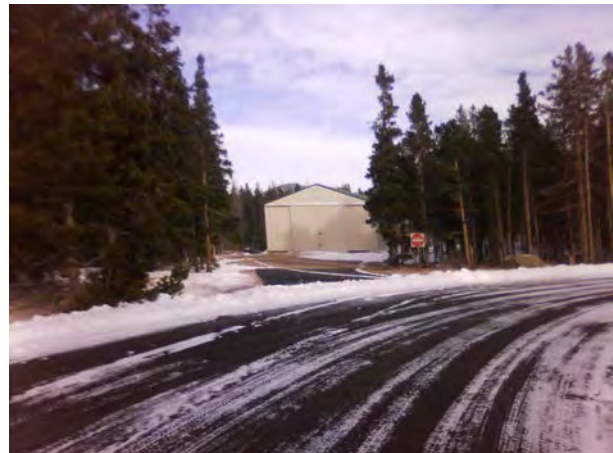
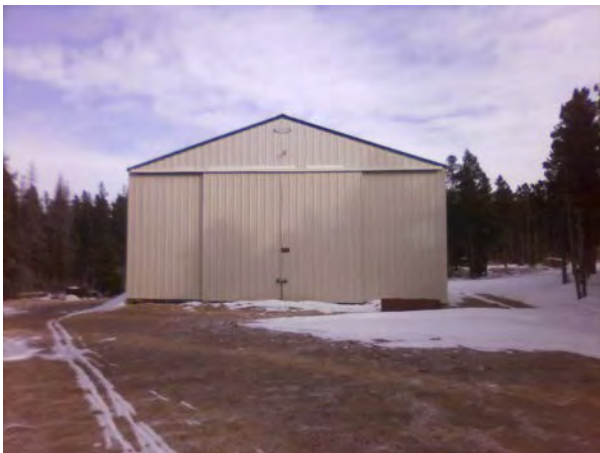
ROMO_86481_B-1084-N Hay Barn Glacier Creek Livery_D.jpg

ROMO_86481_B-1084-N Hay Barn Glacier Creek Livery_C.jpg

ROMO_86481_B-1084-N Hay Barn Glacier Creek Livery_B.jpg

ROMO_86481_B-1084-N Hay Barn Glacier Creek Livery_A-1.jpg

ROMO_86481_B-1084-N Hay Barn Glacier Creek Livery_A.jpg

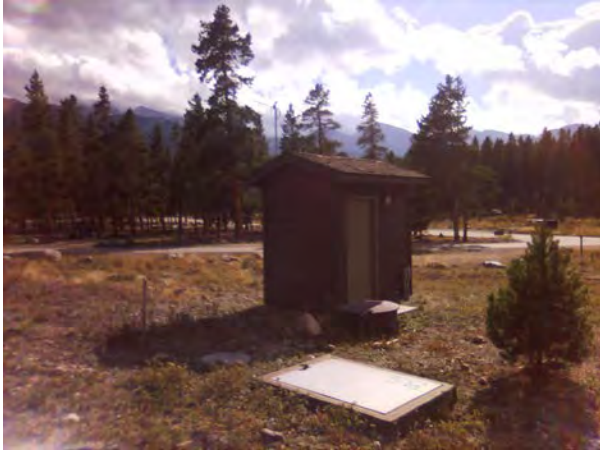
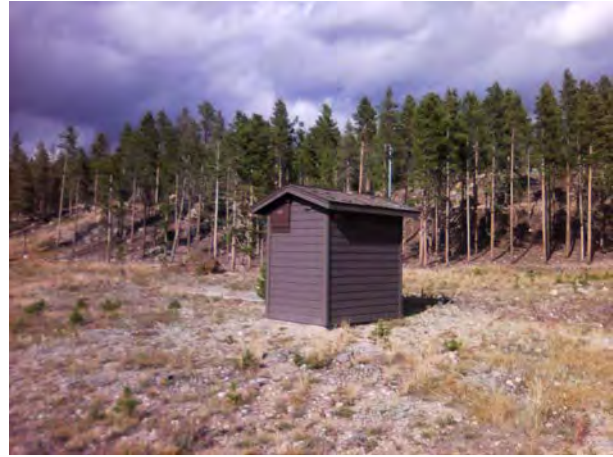
ROMO_31768_B-0994-N Lift Station Control Building_Front2.jpg

ROMO_31768_B-0994-N Lift Station Control Building_Front.jpg
