NPS Wildland Fire Risk Assessment - Community Assessment

Community: Green Mountain
Unit - Location: ROMO - Kawuneeche Valley
Field Crew: Vaughn
Last Site Visit Date: 10/1/2014

Community Description: Includes the Green Mountain community consisting of cabins and outbuildings that may be used by park staff during the Summer.

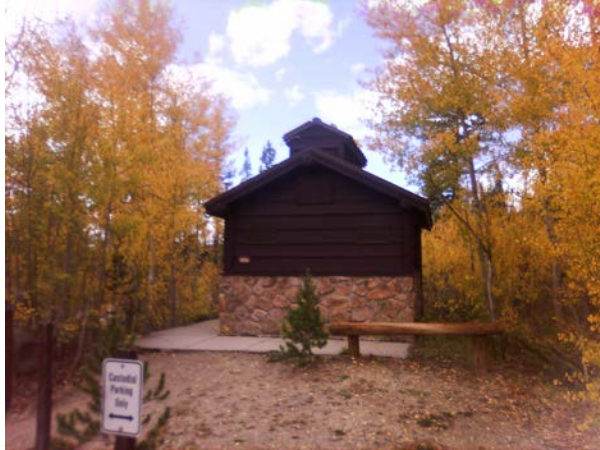
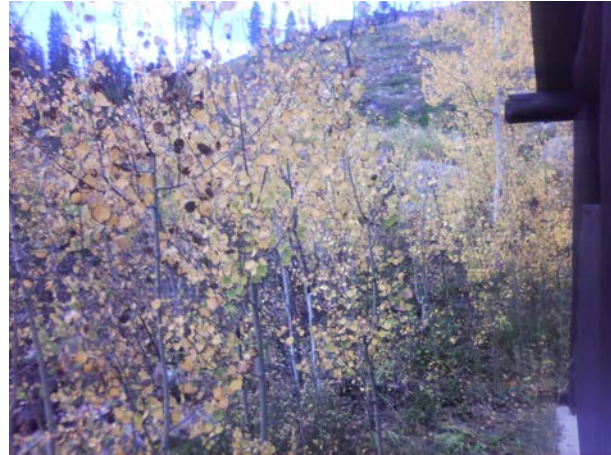
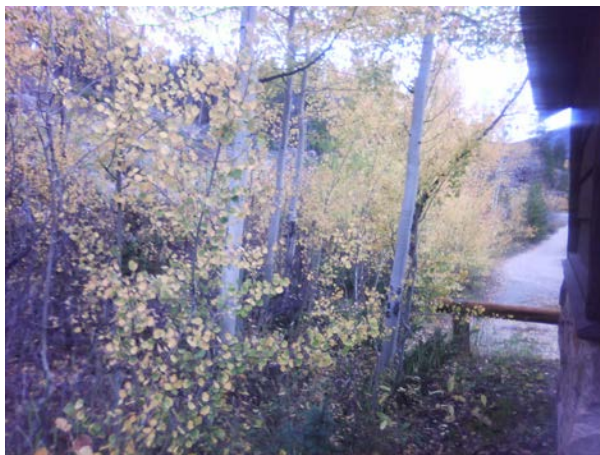
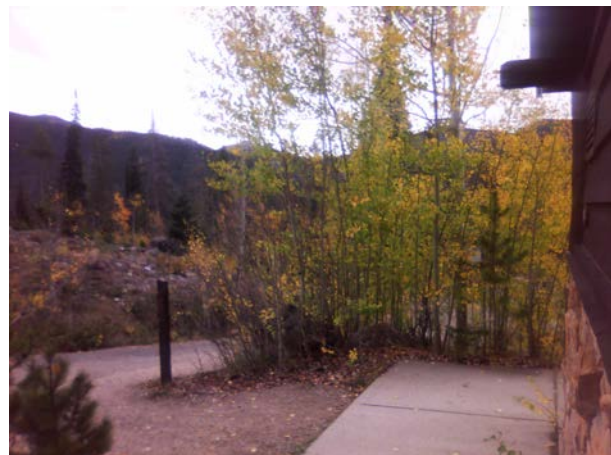
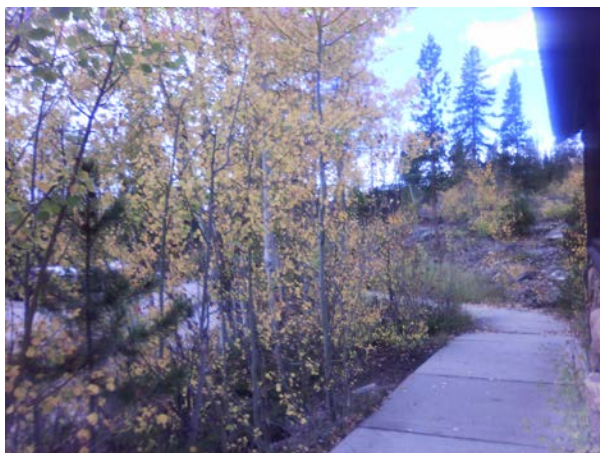
ROMO_14697_B-1034-N Vault Toilet - North Inlet_Front.jpg

Unit - Location: ROMO - Kawuneeche Valley
FMSS ID: 14697
Field Crew: Vaughn
Last Site Visit Date: 9/29/2014

Rating: High
Protection Level : Not Designated
Local ID: [Local_ID]
Lat(WGS84): 40° 15.4018' Long(WGS84): -105° 48.8839'

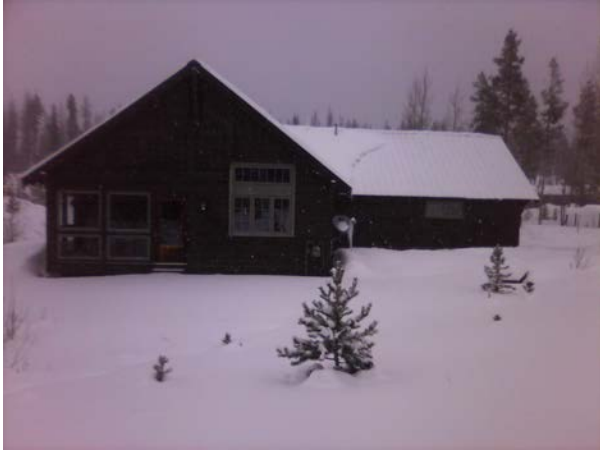
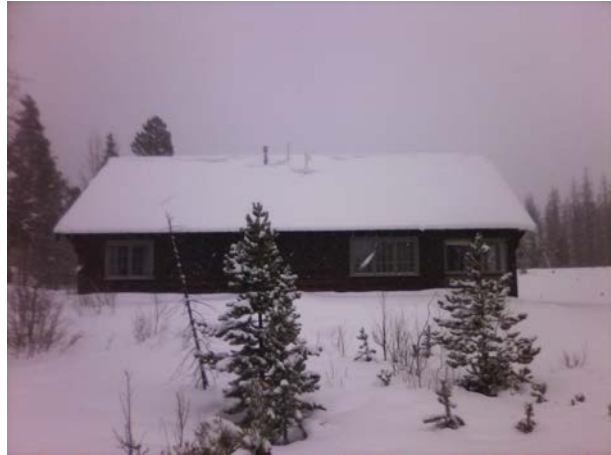
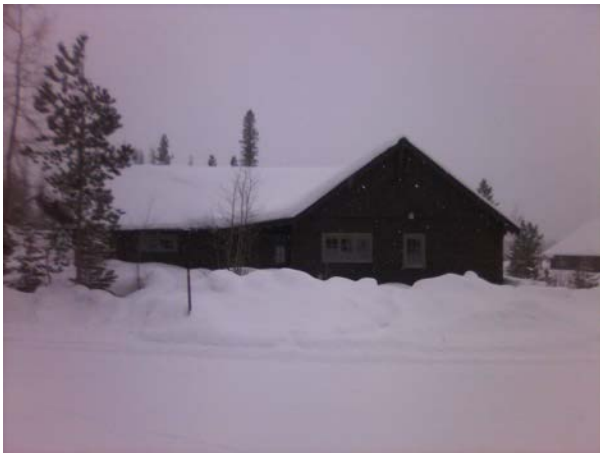
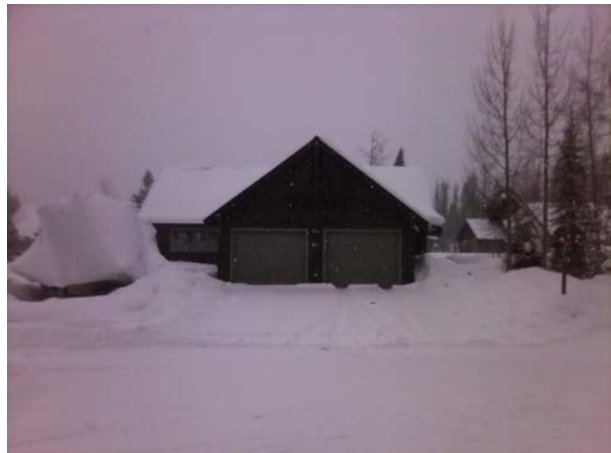
ROMO_14707_Q-0463-N P 2-bdrm house 00000463 CRD_D.jpg

Unit - Location: ROMO - Kawuneeche Valley
FMSS ID: 14707
Field Crew: Dave Frey
Last Site Visit Date: 2/6/2014

Rating: Low
Protection Level : Full
Local ID: [Local_ID]
Lat(WGS84): 40° 16.0279' Long(WGS84): -105° 50.1448'

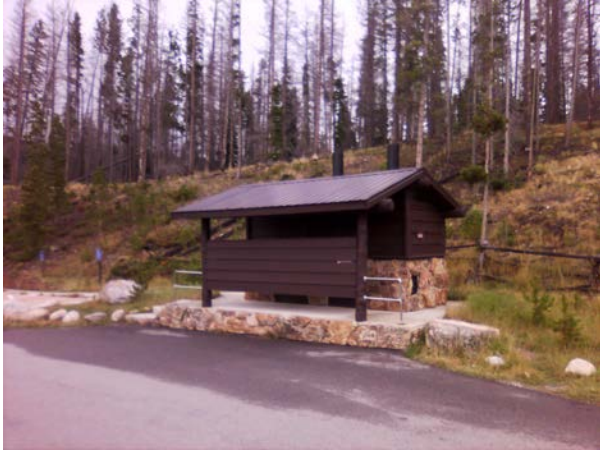
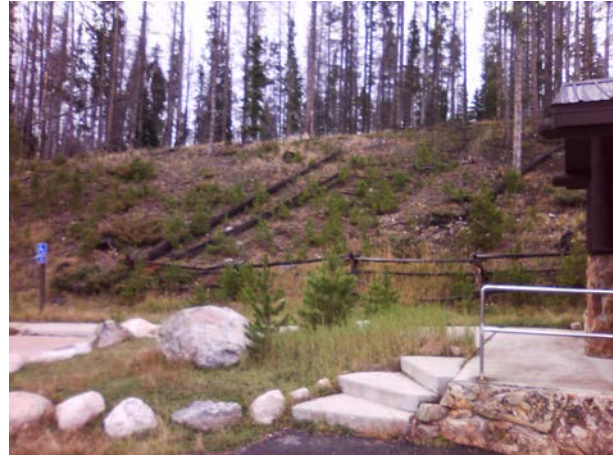
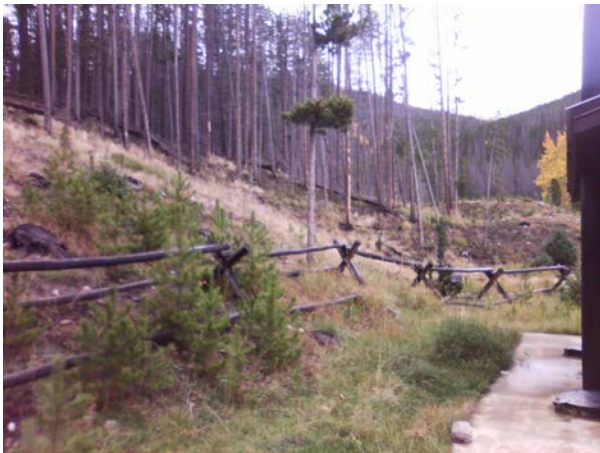
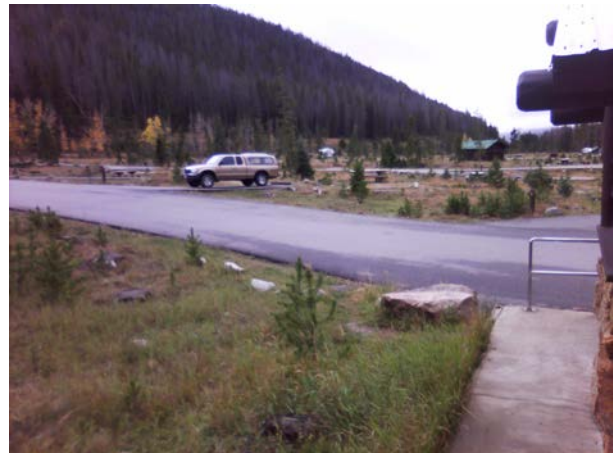
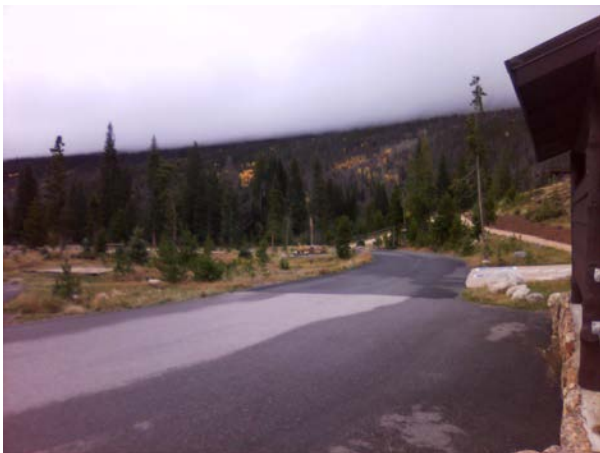
ROMO__B-1093-N Vault Toilet SST TCCG_Front.jpg

Unit - Location: ROMO - Kawuneeche Valley
FMSS ID:
Field Crew: Vaughn
Last Site Visit Date: 10/1/2014

Rating: Moderate
Protection Level : Not Designated
Local ID: [Local_ID]
Lat(WGS84): 40° 22.791' Long(WGS84): -105° 51.1027'

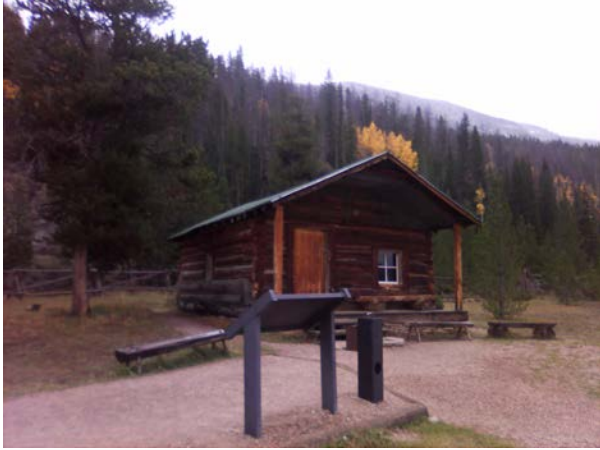
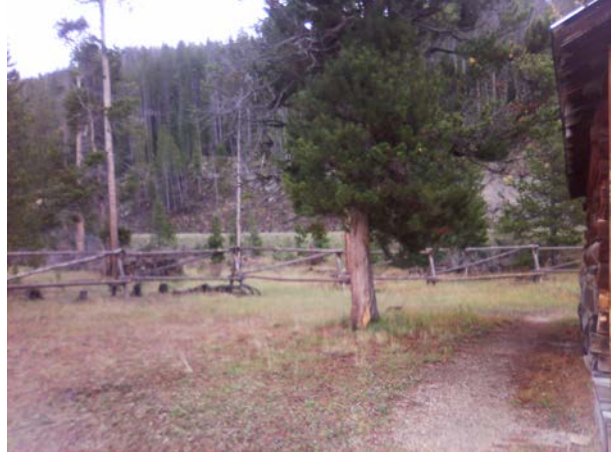
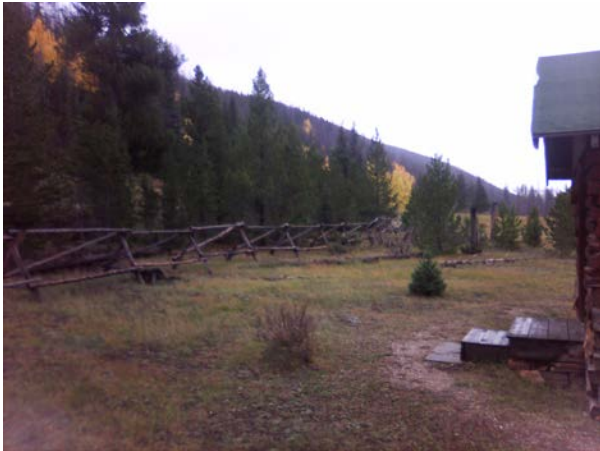
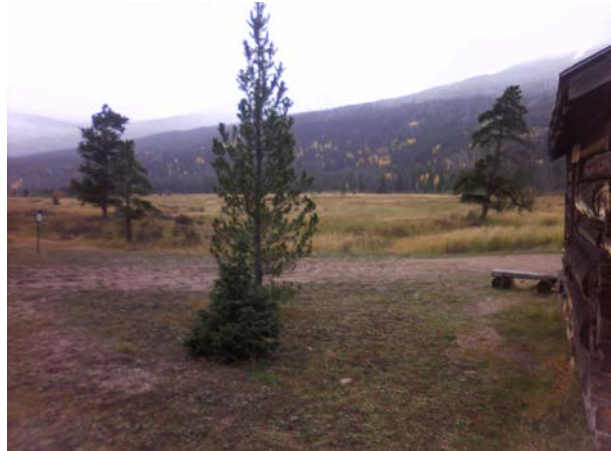
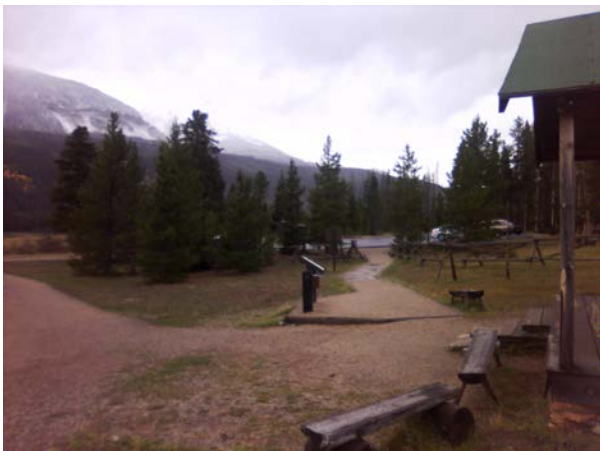
ROMO_14786_B-0783-H Fleshut Cabin_Front.jpg

Unit - Location: ROMO - Kawuneeche Valley
FMSS ID: 14786
Field Crew: Vaughn
Last Site Visit Date: 9/30/2014

Rating: Moderate
Protection Level : Not Designated
Local ID: [Local_ID]
Lat(WGS84): 40° 22.3359' Long(WGS84): -105° 51.2618'
