Pilatus Business Aircraft Ltd.
Broomfield, Colorado

SERVICE BULLETIN

PC-12/47E

Report Title: SERVICE BULLETIN - ECONNECT GUI SW 3.0 UPGRADE

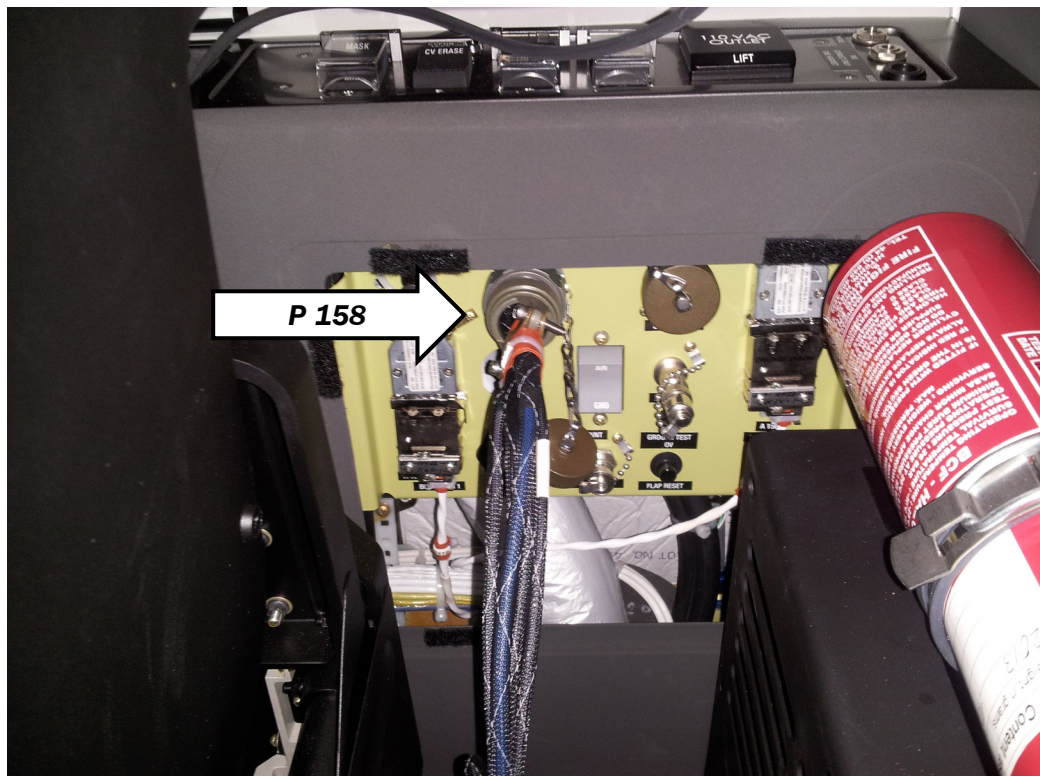
Figure 3-2 eConnect Maintenance Harness Connected

- (3) IF Figure 3-1 (or similar) does NOT appear, continue below, otherwise this SB is completed and continue to section 3.H.
- (4) POWER DOWN the eConnect system and CABIN BUS
- (5) OBEY the safety precautions for Electrical Power Maintenance Practices given in AMM 12-B-24-00-00-00A-901A-A.
- (6) OBEY safety precautions for Electronic Discharge (ESD) protection i.a.w. AMM DMC-12-B-20-00-00-00A-901A-A.
- (7) DE-ENERGIZE the aircraft electrical system, Reference AMM 12-B-24-00-00-00A-901A-A.
- (8) LOCATE and REMOVE panel 21QZ (Maintenance Interface, RH Rear Lower Cockpit Sidewall) given in AMM 12-B-06-20-00-00A-040B-A
- (9) CONNECT the eConnect Maintenance Harness (Item 1 in Table 2-2) to the AVIONICS connector (P 158). See Figure 3-2.

- (6) OPEN your web browser and CONNECT to <http://10.0.9.1>
- (7) The eConnect graphical user interface should appear and select the MAINTENANCE page
- (8) VERIFY the “UPDATE SOFTWARE” pull-down menu does no longer list any updates
- (9) Disconnect from the eConnect aircraft SSID
- (10) DE-ENERGIZE the aircraft electrical system, Reference AMM 12-B-24-00-00-00A-901A-A.
- (11) REMOVE the eConnect Maintenance Harness (Item 1 in Table 2-2) from the AVIONICS connector (P 158). See Figure 3-2.
- (12) CLOSE panel 21QZ (Maintenance Interface) given in AMM 12-B-06-20-00-00A-040B-A

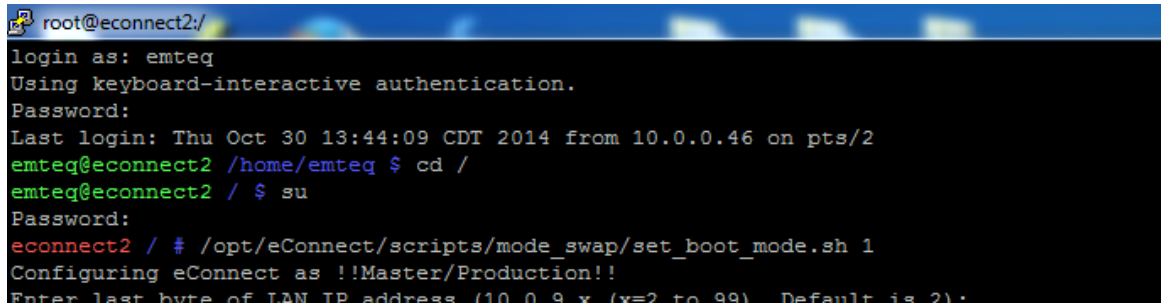
Figure 3-4 PuTTY SSH Command Prompt

```
root@econnect2:/  
login as: emteq  
Using keyboard-interactive authentication.  
Password:  
Last login: Thu Oct 30 13:44:09 CDT 2014 from 10.0.0.46 on pts/2  
emteq@econnect2 /home/emteq $ cd /  
emteq@econnect2 / $ su  
Password:  
econnect2 / # /opt/eConnect/scripts/mode_swap/set_boot_mode.sh 1  
Configuring eConnect as !!Master/Production!!  
Enter last byte of LAN IP address (10.0.9.x (x=2 to 99). Default is 2):
```

- (11) At the command prompt (Figure 3-4) ENTER the following login credentials (all entries are case sensitive):
 - (a) Login as: **emteq** [ENTER]
 - (b) Password: **Q3tm36170** (password will not display/press [ENTER] after entry)
- (12) At the command prompt (Figure 3-5) EXECUTE the following commands:
 - (a) **cd /** [ENTER]
 - (b) **su** [ENTER]
 - (c) (Password:) **root** [ENTER]
 - (d) **cd /opt/scenes** [ENTER]
 - (e) **ls** [ENTER]
- (13) The “ls” (LIST) command prompt lists the content of the previously selected (“CD, CHANGE DIRECTORY”) “scenes” directory; VERIFY if a file “autoupdate.sh” (shown in yellow box) is LISTED in this directory as shown in Figure 3-5 below

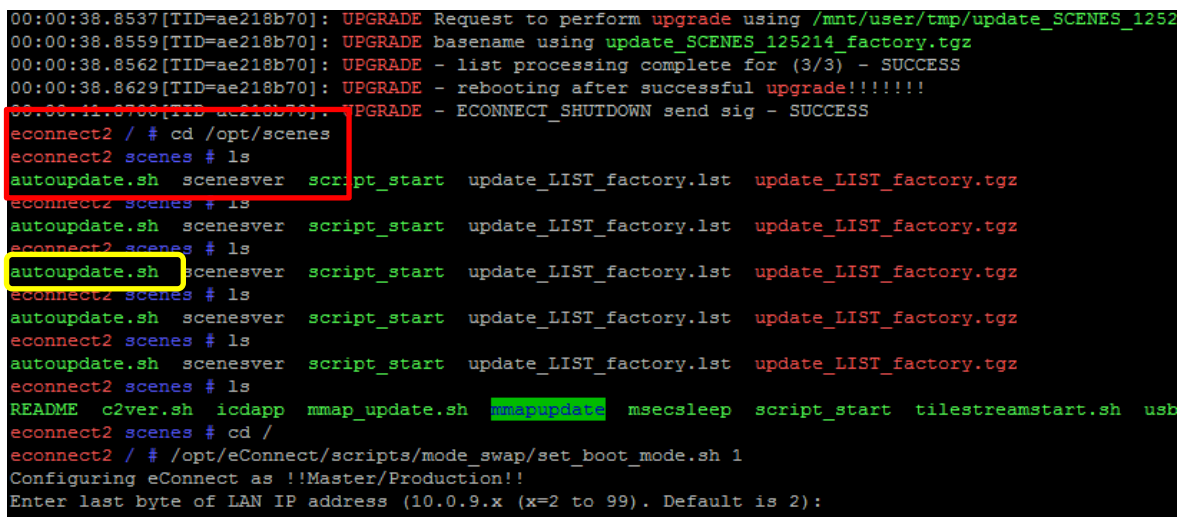
Figure 3-5 PuTTY SSH Command Prompt List Command

00:00:41.8700[TID=ae218b70]: UPGRADE - ECONNECT_SHUTDOWN send sig - SUCCESS  
econnect2 / # cd /opt/scenes  
econnect2 scenes # ls  
autoupdate.sh  scenesver  script_start  update_LIST_factory.lst  update_LIST_factory.tgz  
econnect2 scenes # ls  
autoupdate.sh  scenesver  script_start  update_LIST_factory.lst  update_LIST_factory.tgz  
econnect2 scenes # ls  
autoupdate.sh  scenesver  script_start  update_LIST_factory.lst  update_LIST_factory.tgz  
econnect2 scenes # ls  
autoupdate.sh  scenesver  script_start  update_LIST_factory.lst  update_LIST_factory.tgz  
econnect2 scenes # ls  
autoupdate.sh  scenesver  script_start  update_LIST_factory.lst  update_LIST_factory.tgz  
econnect2 scenes # ls  
README  c2ver.sh  icdapp  mmap_update.sh  mmapupdate  msecsleep  script_start  tilestreamstart.sh  usb  
econnect2 scenes # cd /  
econnect2 / # /opt/eConnect/scripts/mode_swap/set_boot_mode.sh 1  
Configuring eConnect as !!Master/Production!!

- (14) REPEAT previous step (3.C.(12)(e)) execute the “ls” → [ENTER] (LIST) command prompt to REFRESH listing UNTIL “autoupdate.sh” is NO LONGER LISTED in the directory

- (15) Once verified that the “autoupdate.sh” file (Step (14)/Figure 3-5) has CLEARED, continue to next sections depending on system configuration

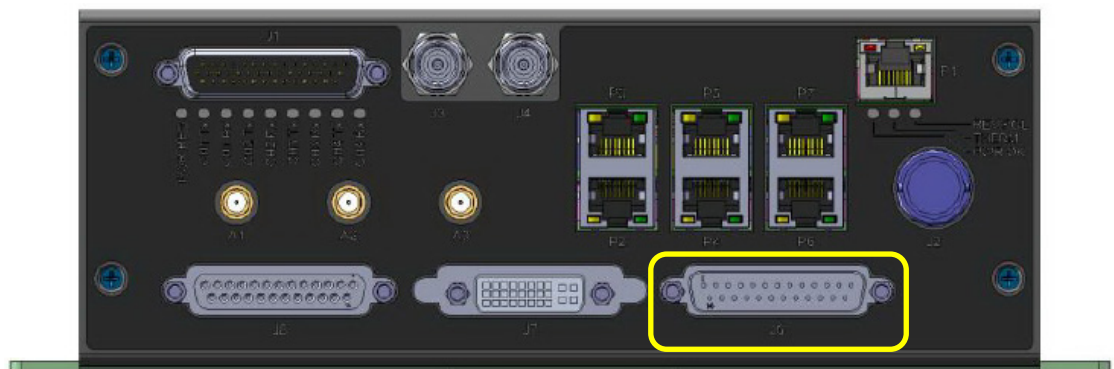
Figure 3-15 - CWR450-5000-0X eConnect (XM Version) Front Panel Layout

- (1) DE-ENERGIZE the aircraft electrical system, Reference AMM 12-B-24-00-00-00A-901A-A.
- (2) OPEN circuit breaker CB_RW3 (CABIN IFE) and (IF INSTALLED) CB_RX3 (XM AUDIO) on the RH AFT CB PNL.
- (3) REMOVE the RH STORAGE CABINET i.a.w. AMM 12-B-25-21-06-00A-920A-A
- (4) DO NOT DISCONNECT eConnect Harnesses as the system is required to POWER UP
- (5) REMOVE connector A 196P6 (see Figure 3-15 (P6 shown in yellow box) (Short Ethernet Patch Cable on eConnect)

- (15) RECONNECT connector A 196P6 (see Figure 3-15 (P6 shown in yellow box) (Short Ethernet Patch Cable on eConnect)
- (16) VERIFY all connections to the eConnect are made correctly and connectors are fully secured and stowed in place

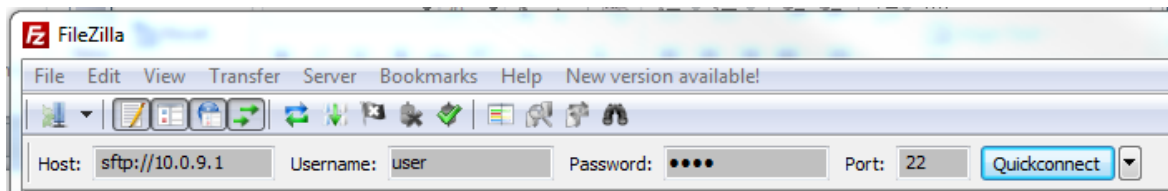
Figure 3-17 FTP Client Log-In

- (1) CONNECT to the eConnect SSID with your device
- (2) Using an FTP Client tool connect to the eConnect FTP server using the following credentials:
 - a. Host: sftp://10.0.9.1
 - b. Username: user
 - c. Password: user
 - d. Port: 22

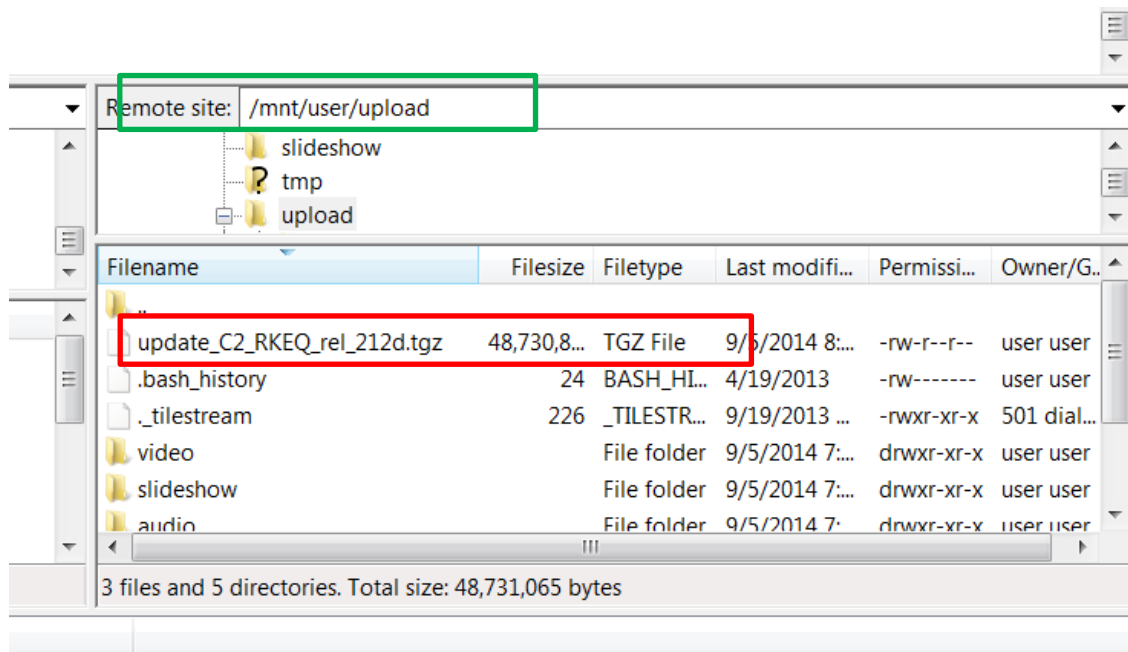
Figure 3-18 FTP Client Tool

- (3) Locate the media file directory called “/mnt/user/upload” on the FTP server
- (4) Locate any files with the “*.tgz” and “*.lst” file extensions
- (5) DELETE all located files
