INFRARED INTERPRETER'S DAILY LOG

Incident Name:	IR Interpreter(s):	Local Dispatch Phone:	Interpreted Size:
Hayes Two WA-OLP-000153	Maximillian Wahlberg	PSICC (425-783-6150)	Cox Valley: 137 acres
Cox Valley	mwahlberg@fs.fed.us		Godkin: 54 acres
Godkin			Growth last period:
			Unknown (first flight since
			8/1)
Flight Time:	Interpreter(s) location:	GACC IR Liaison:	National Coordinator:
0238 PDT	Portland, OR	Jim Grace	Melinda McGann
Flight Date:	Interpreter(s) Phone:	GACC IR Liaison Phone:	National Coord. Phone:
8/20/2016	928-273-0779	541-771-4521	208-387-5900
Ordered By:	A Number:	Aircraft/Scanner System:	Pilots/Techs:
WAOLP (510-409-5532)	A-4	N144z / Phoenix	N144Z Flight Crew left: Don Boyce right: Kris Nelson tech: Rob Navarro
IRIN Comments on imagery:		Weather at time of flight:	Flight Objective:
Imagery was misaligned with one of the three scan boxes (the		Clear	Map heat perimeter, intense
central box, representing the Hayes Two fire).			heat, scattered heat, and

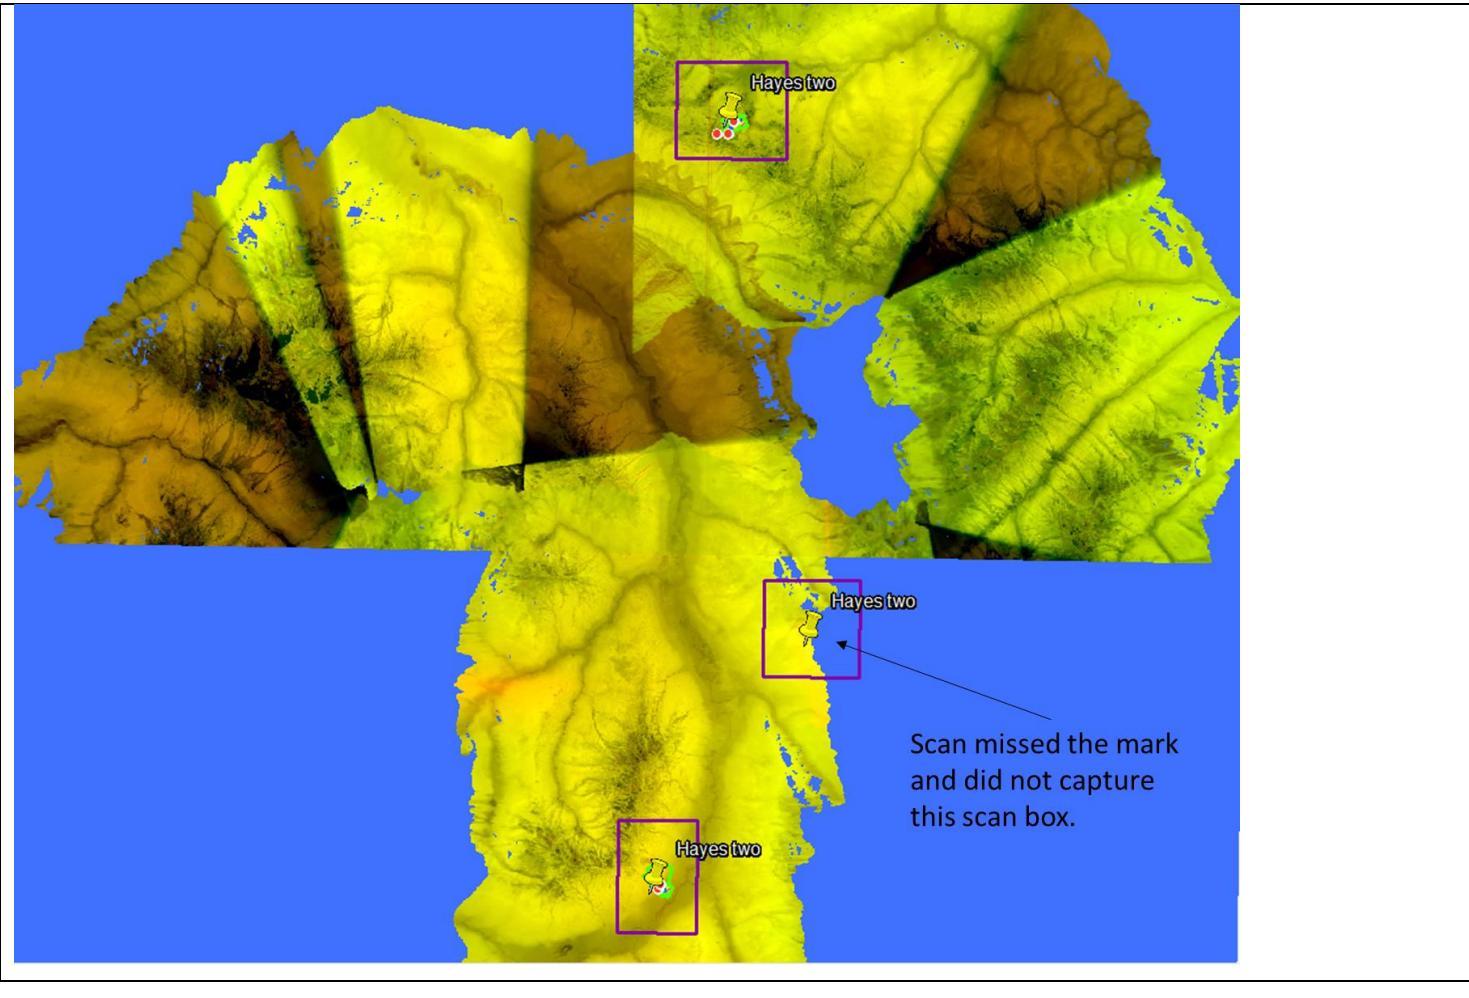
Tonight's scan was misaligned with the requested scan box for Hayes Two. As a result, it was not possible to map the Hayes Two fire (see graphic on next page). The other two fires (Godkin and Cox Valley) were adequately scanned and interpreted. Mapping began with previous IR flight perimeter from 8/1.
