SPRING SUPPRESSION REPAIR

Smith River Complex - Coon Repair Area

94,639 acres as of 11/13/2023
Map Date 05/17/2024

Smith River Complex
CA-SRF-000968

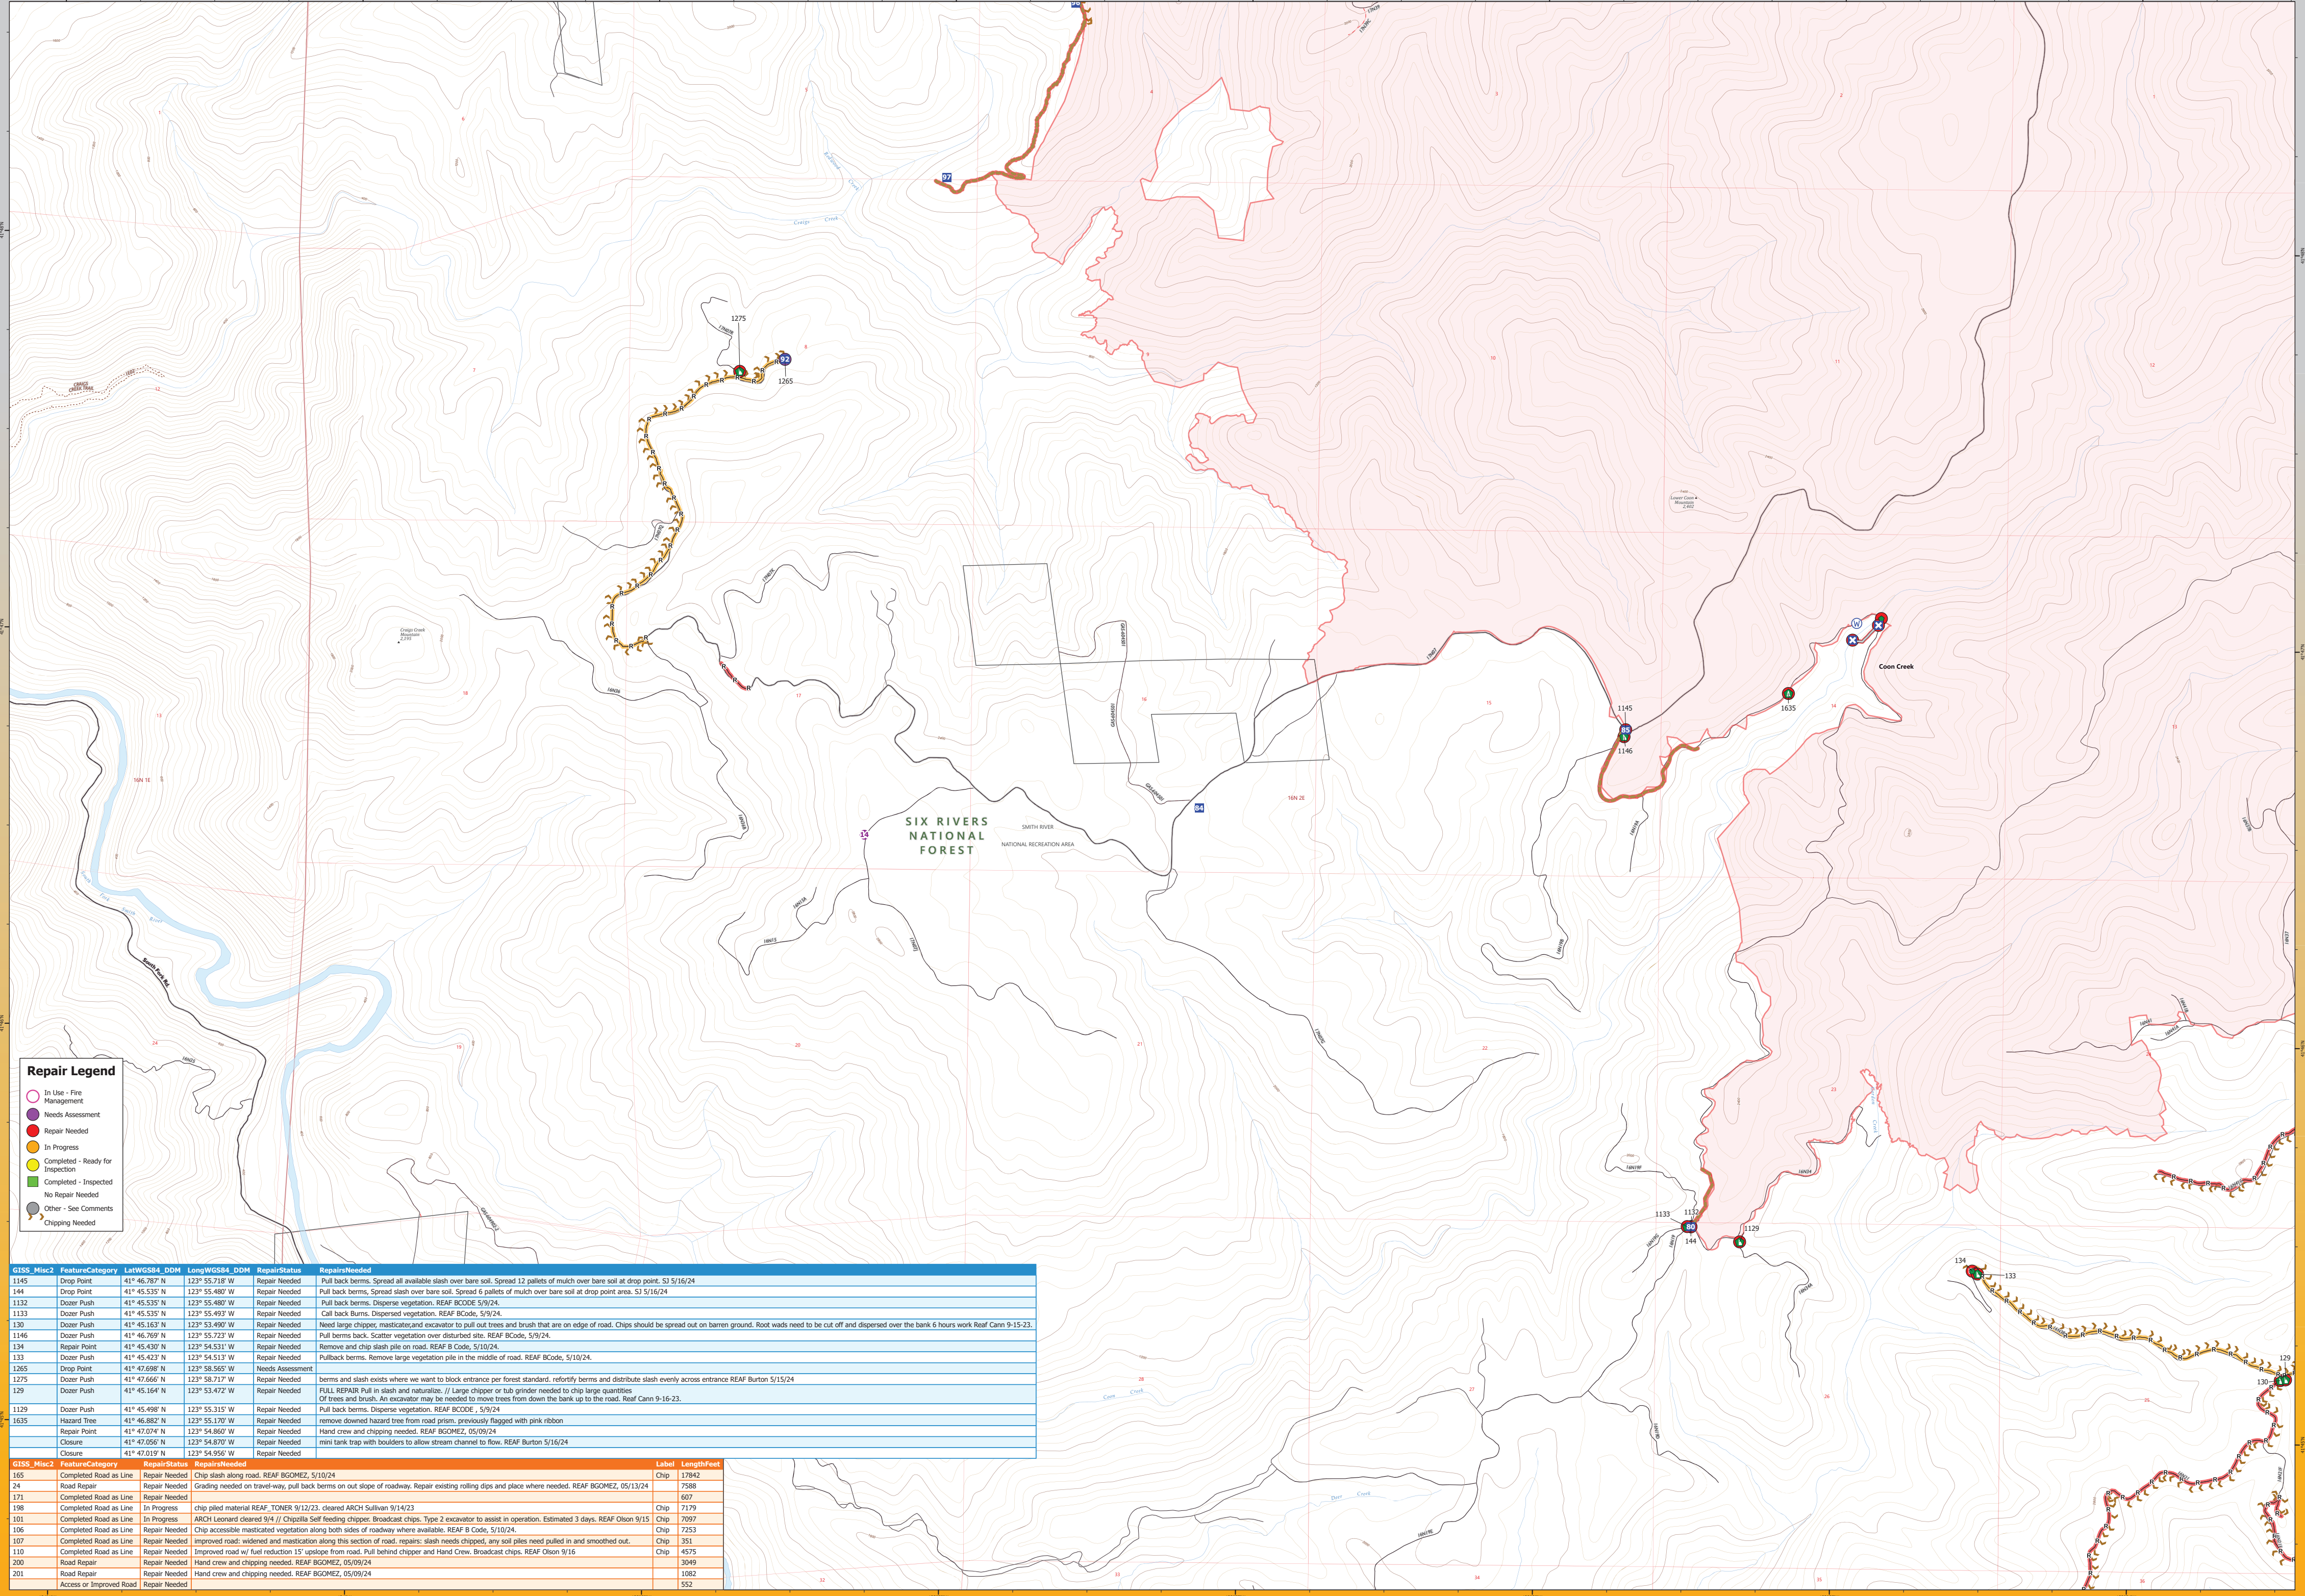
GISS_Misc2	FeatureCategory	LatWGS84_DDM	LongWGS84_DDM	RepairStatus	RepairsNeeded
1145	Drop Point	41° 46.787' N	123° 55.718' W	Repair Needed	Pull back berms. Spread all available slash over bare soil. Spread 12 pallets of mulch over bare soil at drop point. S3 5/16/24
144	Drop Point	41° 45.535' N	123° 55.480' W	Repair Needed	Pull back berms. Spread slash over bare soil. Spread 6 pallets of mulch over bare soil at drop point area. S3 5/16/24
1132	Dozer Push	41° 45.535' N	123° 55.480' W	Repair Needed	Pull back berms. Disperse vegetation. REAF BCODE, 5/9/24
1133	Dozer Push	41° 45.535' N	123° 55.493' W	Repair Needed	Call back Burns. Dispersed vegetation. REAF BCODE, 5/9/24
1130	Dozer Push	41° 45.152' N	123° 53.490' W	Repair Needed	Need large chipper, masticator and excavator to pull out trees and brush that are on edge of road. Chips should be spread out on barren ground. Root wads need to be cut off and dispersed over the bank 6 hours work Reaf Cann 9-15-23.

1146	Dozer Push	41° 46.769' N	123° 55.723' W	Repair Needed	Pull berms back. Scatter vegetation over disturbed site. REAF BCODE, 5/9/24.
134	Repair Point	41° 45.430' N	123° 54.531' W	Repair Needed	Remove and chip slash pile on road. REAF B Code, 5/10/24.
133	Dozer Push	41° 45.423' N	123° 54.513' W	Repair Needed	Pullback berms. Remove large vegetation pile in the middle of road. REAF BCODE, 5/10/24.
1265	Drop Point	41° 47.698' N	123° 58.565' W	Needs Assessment	FULL REPAIR Pull in slash and naturalize. // Large chipper or tub grinder needed to chip large quantities of trees and brush. An excavator may be needed to move trees from down the bank up to the road. Reaf Cann 9-16-23.
1275	Dozer Push	41° 47.666' N	123° 58.717' W	Repair Needed	berms and slash exists where we want to block entrance per forest standard. reformat berms and distribute slash evenly across entrance REAF Burton 5/15/24
129	Dozer Push	41° 45.164' N	123° 53.472' W	Repair Needed	FULL REPAIR Pull in slash and naturalize. // Large chipper or tub grinder needed to chip large quantities of trees and brush. An excavator may be needed to move trees from down the bank up to the road. Reaf Cann 9-16-23.

1129	Dozer Push	41° 45.498' N	123° 55.315' W	Repair Needed	Pull back berms. Disperse vegetation. REAF BCODE , 5/9/24
1635	Hazard Tree	41° 46.882' N	123° 55.170' W	Repair Needed	remove downed hazard tree from road prism. previously flagged with pink ribbon
	Repair Point	41° 47.074' N	123° 54.860' W	Repair Needed	Hand crew and chipping needed. REAF BCODE, 05/09/24
	Closure	41° 47.056' N	123° 54.870' W	Repair Needed	mint tank trap with boulders to allow stream channel to flow. REAF Burton 5/16/24
	Closure	41° 47.019' N	123° 54.956' W	Repair Needed

GISS_Misc2	FeatureCategory	RepairStatus	RepairsNeeded	Label	LengthFeet
165	Completed Road as Line	Repair Needed	Chip slash along road. REAF BCODE, 5/10/24	Chip	17842
24	Road Repair	Repair Needed	Grading needed on travel-way, pull back berms on out slope of roadway. Repair existing rolling dips and place where needed. REAF BCODE, 05/13/24		7588
171	Completed Road as Line	Repair Needed			607
198	Completed Road as Line	In Progress	chip piled material REAF_TONER 9/12/23, cleared ARCH Sullivan 9/14/23	Chip	7179
101	Completed Road as Line	In Progress	ARCH Leonard cleared 9/4 // Chizolla Self feeding chipper. Broadcast chips. Type 2 excavator to assist in operation. Estimated 3 days. REAF Olson 9/15	Chip	2097
106	Completed Road as Line	Repair Needed	Chip accessible masticated vegetation along both sides of roadway where available. REAF B Code, 5/10/24.	Chip	7253
107	Completed Road as Line	Repair Needed	improved road: widened and mastication along this section of road. repairs: slash needs chipped, any soil piles need pulled in and smoothed out.	Chip	351

110	Completed Road as Line	Repair Needed	Improved road w/ fuel reduction 15' upstoge from road. Pull behind chipper and Hand Crew. Broadcast chips. REAF Olson 9/16	Chip	4575
200	Road Repair	Repair Needed	Hand crew and chipping needed. REAF BCODE, 05/09/24	Chip	3049
201	Road Repair	Repair Needed	Hand crew and chipping needed. REAF BCODE, 05/09/24		1082
	Access or Improved Road	Repair Needed			552
