Subject: Wash Fire BAER Approval

BURNED-AREA REPORT
(Reference FSH 2509.13)

A. Fire Name: Wash Fire

F. Forest: Nez Perce-Clearwater

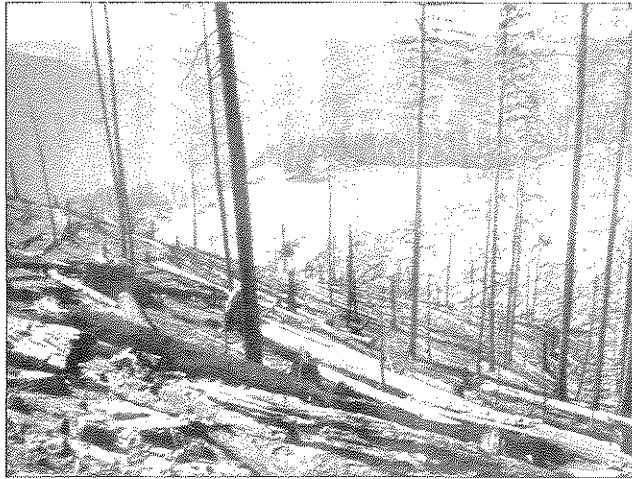
Overlooking a tributary to Little Creek, a drainage within the Lower Meadow Creek subwatershed in the Selway River basin
