**STRUCTURE
PROTECTION PLAN
FOR MACINTOSH
MANOR 07/29/2017**

Structure Protection Plan

Macintosh Manor

Location: On Hwy 12 South of Lolo to the Old Hwy 93 turnoff area

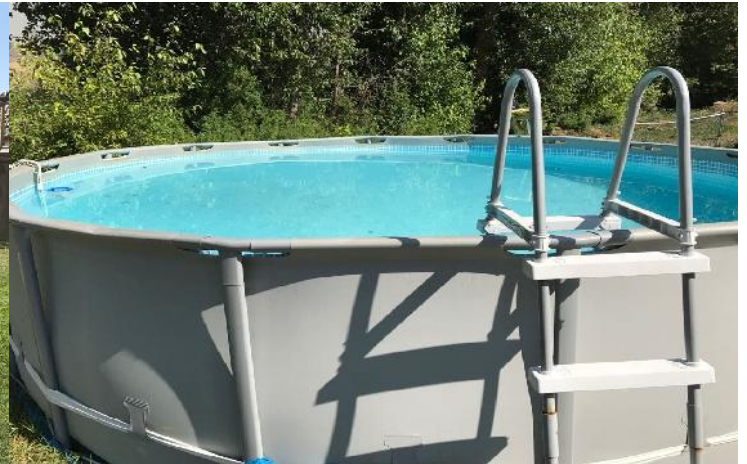
Photo 3

Structure Number:
Structure Name: 13460 Sapphire Dr
SubDivision: Macintosh Manor
GPS Location, Lat. 46 42.95736
GPS Location, Long. 114 4.65474
Safety Zone Present: No
Type of Structure: Residential
Surrounding Fuels: Grass, Timber
Structure Triage Category: Non-Defensible, Prep and Leave
Roof Material: Composite
Heat Traps: Wood Deck, Rain Gutters
Electrical Power: Overhead
Hazards:
Access to Site: T1 Engine
Comm with ICP: Radio, Cell Service
Water Source: Faucet / Hose
Mitigation Time: None Needed
Notes: Approximately 500 gallon pool in back yard. GPS location is incorrect

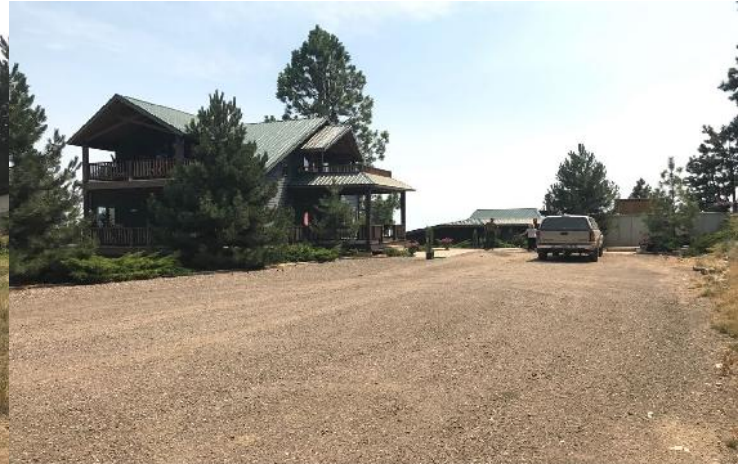
Photo 2

Structure Number:
Structure Name: 15118 Rock Ridge Rd
SubDivision: Macintosh Manor
GPS Location, Lat. 46 43.47192
GPS Location, Long. 114 6.22134
Safety Zone Present: No
Type of Structure: Residential
Surrounding Fuels: Grass, Timber
Structure Triage Category: Defensible, Stand Alone
Roof Material: Metal
Heat Traps: Wood Deck, Rain Gutters
Electrical Power: Underground
Hazards: Terrain, No Turn Around, Animals, HazMat

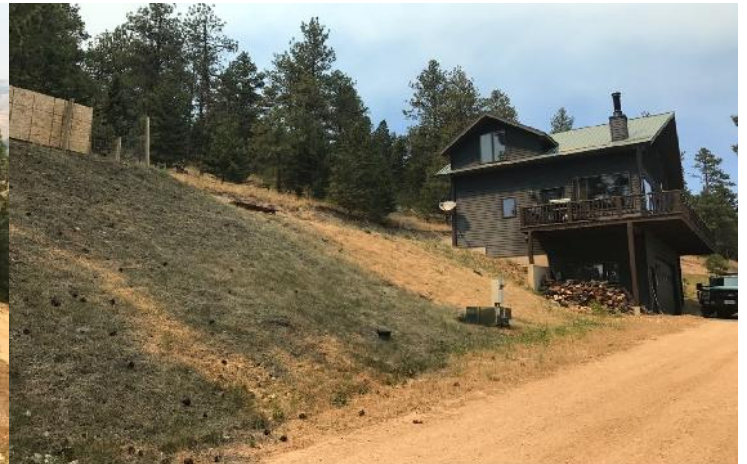
Photo 2

Structure Number:
Structure Name: 15222 Rock Ridge Rd
SubDivision: Macintosh Manor
GPS Location, Lat. 46 43.49058
GPS Location, Long. 114 6.11574
Safety Zone Present: No
Type of Structure: Residential
Surrounding Fuels: Grass, Timber
Structure Triage Category: Defensible, Stand Alone
Roof Material: Metal
Heat Traps: Wood Deck
Electrical Power: Underground
Hazards: Terrain, HazMat

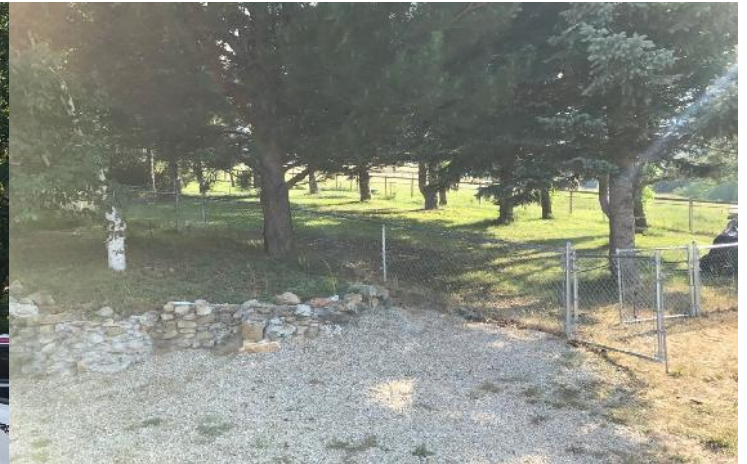
Photo 3

Structure Number:
Structure Name: 15675 Queen Anne's Ln
SubDivision: Macintosh Manor
GPS Location, Lat. 46 43.2918
GPS Location, Long. 114 5.30148
Safety Zone Present: Yes **Where is Safety Zone:** Open fields surrounding the house.o
Type of Structure: Residential **Primary Structures:** **Outbuildings:**
Surrounding Fuels: Grass **Defensible Space:** >100 Feet
Structure Triage Category: Defensible, Stand Alone
Roof Material: Metal **Siding Material:** Wood
Heat Traps: Open Eaves, Wood Deck, Rain Gutters
Electrical Power: Underground **Gas to Structure:** Aboveground
Hazards: Animals
Access to Site: T3/4 Engine **Best Access From:** Queen Anne's Ln
Comm with ICP: Radio, Cell Service
Water Source: Faucet / Hose
Mitigation Time: None Needed
Other Resources Needed to Protect: None
Notes: Travel trailer and tractor equipment outside home.

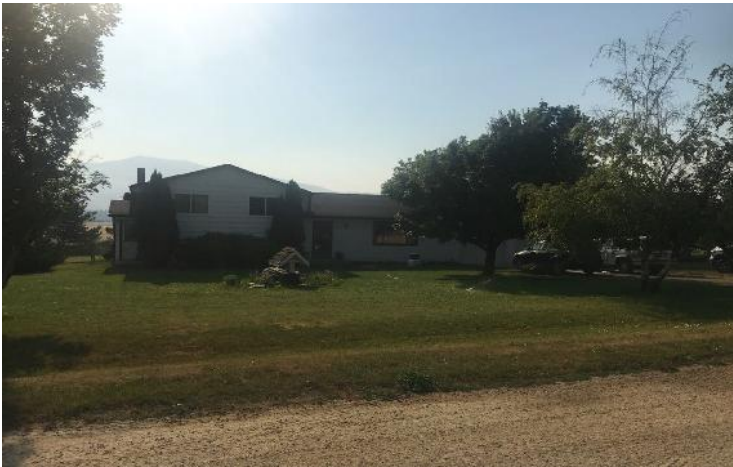
Collected Date/Time: 07/29/2017 16:25:23
Photo 2

Structure Number:
Structure Name: 16120 Falcon Ln
SubDivision: Macintosh Manor
GPS Location, Lat. 46 42.98496
GPS Location, Long. 114 5.1723
Safety Zone Present: Yes
Type of Structure: Residential
Surrounding Fuels: Grass
Structure Triage Category: Defensible, Stand Alone
Roof Material: Composite
Heat Traps: Wood Deck,Rain Gutters
Electrical Power: Underground
Hazards:
Access to Site: T1 Engine
Comm with ICP: Radio,Cell Service
Water Source: Faucet / Hose
Mitigation Time: None Needed
Other Resources Needed to Protect: T6 patrol
Collected By: COCO 482
Photo 1

Where is Safety Zone: Manicured lawn all around house
Primary Structures:
Defensible Space: >100 Feet
Outbuildings:
Siding Material: Wood
Gas to Structure: None
Best Access From: HWY 93 to Rowan Rd. to Falcon Lane

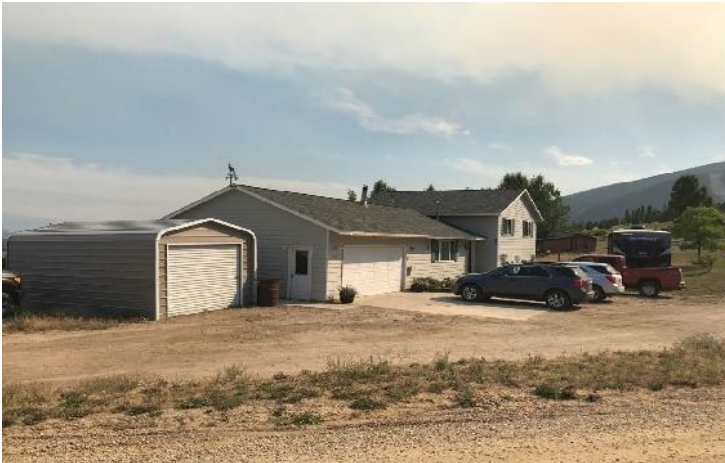
Photo 1

Structure Number:
Structure Name: 16121 Folsom Rd
SubDivision: Macintosh Manor
GPS Location, Lat. 46 43.02306
GPS Location, Long. 114 5.96862
Safety Zone Present: Yes
Type of Structure: Residential
Surrounding Fuels: Grass
Structure Triage Category: Defensible, Stand Alone
Roof Material: Composite
Heat Traps: Wood Deck,Rain Gutters
Electrical Power: Underground
Hazards: HazMat

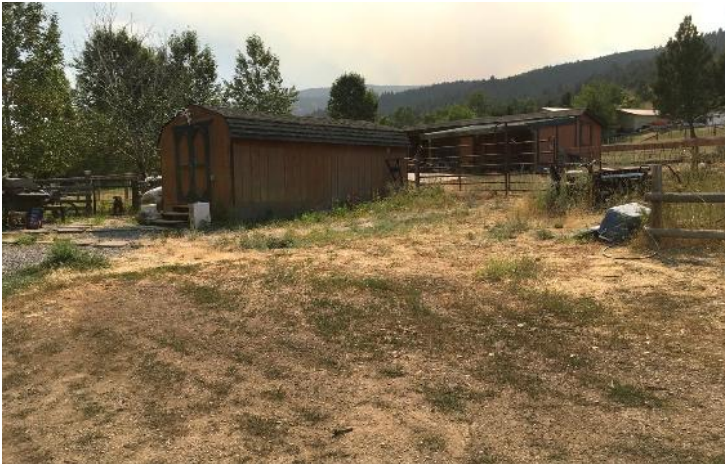
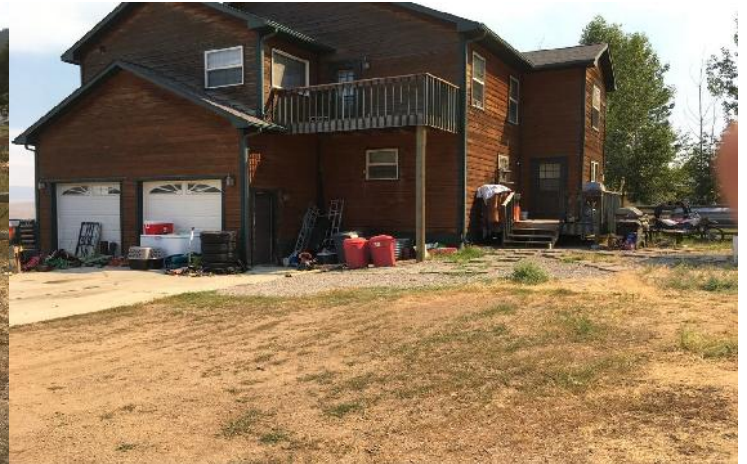
Collected By: E-27 Florence
Photo 1

Structure Number:
Structure Name: 16123 Highland Dr.
SubDivision: Macintosh Manor
GPS Location, Lat. 46 42.99108
GPS Location, Long. 114 5.97468
Safety Zone Present: No **Where is Safety Zone:** South of structure at neighbors
Type of Structure: Residential **Primary Structures:** **Outbuildings:**
Surrounding Fuels: Grass **Defensible Space:** 30-50 Feet
Structure Triage Category: Non-Defensible, Prep and Leave
Roof Material: Composite **Siding Material:** Wood
Heat Traps: Open Eaves, Wood Deck, Rain Gutters
Electrical Power: Underground **Gas to Structure:** Aboveground
Hazards: Fuels, No Turn Around, Septic Tank
Access to Site: T6 Engine **Best Access From:** Highland dr
Comm with ICP: Radio, Cell Service
Water Source: Faucet / Hose
Mitigation Time: More Than 5 Hours
Notes: Unkempt with small equipment, tires etc.

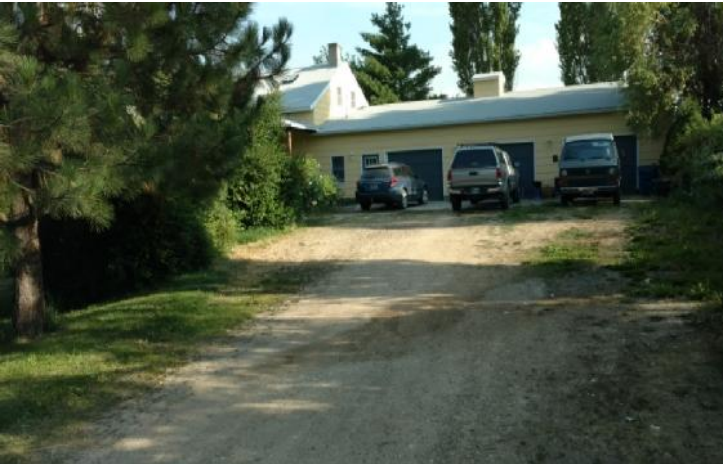
Photo 2

Structure Number:
Structure Name: 16125 Queen Anns lane
SubDivision: Macintosh Manor
GPS Location, Lat. 46 42.97848
GPS Location, Long. 114 5.30394
Safety Zone Present: No
Type of Structure: Residential
Surrounding Fuels: Grass,Shrub,Timber
Structure Triage Category: Defensible, Stand Alone
Roof Material: Composite
Heat Traps: Wood Deck
Electrical Power: Underground
Hazards:
Access to Site: T1 Engine
Comm with ICP: Radio,Cell Service
Water Source: Faucet / Hose,Creek
Mitigation Time: Less Than An Hour
Other Resources Needed to Protect: Type 6 to patrol

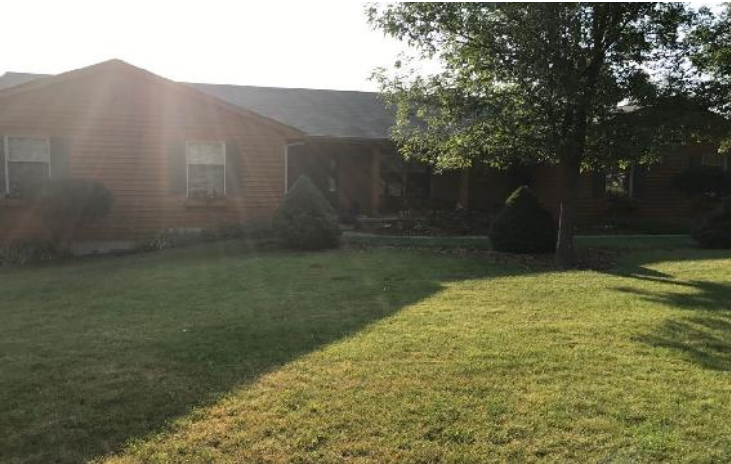
Photo 2

Structure Number:
Structure Name: 16130 Queen Anne's In
SubDivision: Macintosh Manor
GPS Location, Lat. 46 43.01136
GPS Location, Long. 114 5.25846
Safety Zone Present: No
Type of Structure: Residential
Surrounding Fuels: Grass
Structure Triage Category: Defensible, Stand Alone
Roof Material: Composite
Heat Traps: Wood Deck,Rain Gutters
Electrical Power: Underground
Hazards:
Access to Site: T1 Engine
Comm with ICP: Radio,Cell Service
Water Source: Faucet / Hose
Mitigation Time: None Needed
Other Resources Needed to Protect: One engine to patrol
Notes: No prep needed

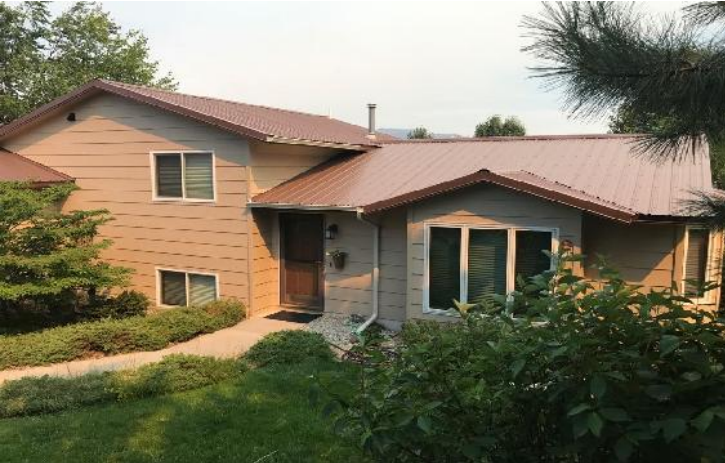
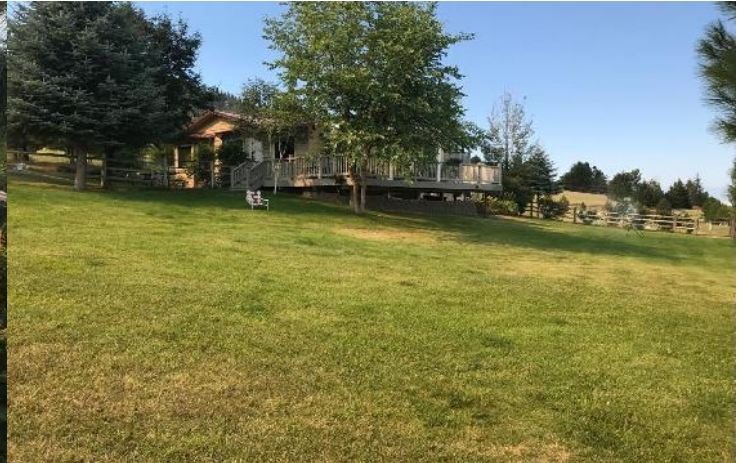
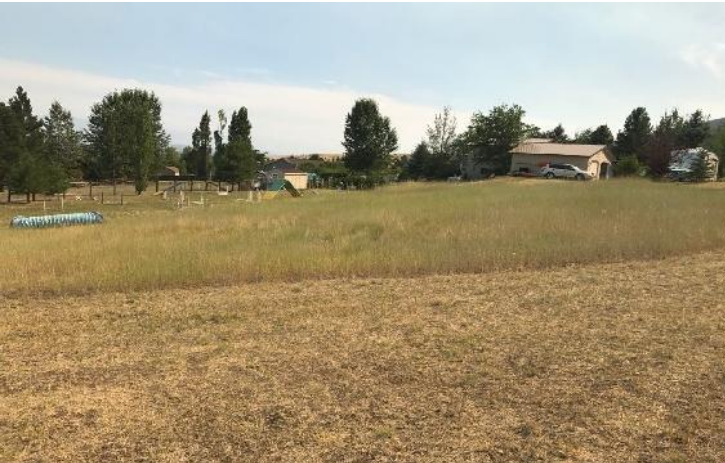
Structure Number:
Structure Name: 16155 Folsom Rd
SubDivision: Macintosh Manor
GPS Location, Lat. 46 42.97686
GPS Location, Long. 114 6.06366
Safety Zone Present: Yes
Type of Structure: Residential
Surrounding Fuels: Grass, Shrub
Structure Triage Category: Defensible, Stand Alone
Roof Material: Metal
Heat Traps: Wood Deck, Rain Gutters
Electrical Power: Underground
Hazards: HazMat
Access to Site: T1 Engine
Comm with ICP: Radio, Cell Service
Water Source: Faucet / Hose
Mitigation Time: None Needed
Other Resources Needed to Protect: None.
Collected By: E 632

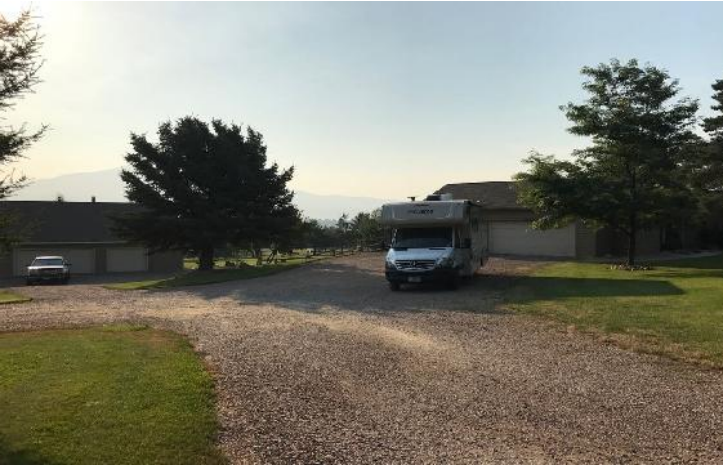
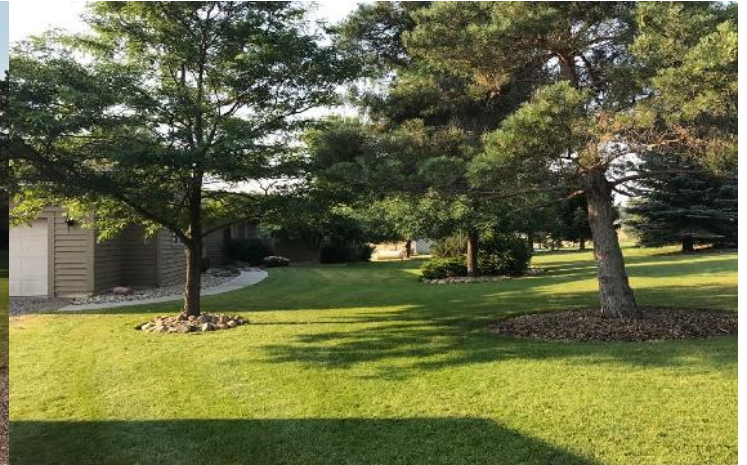
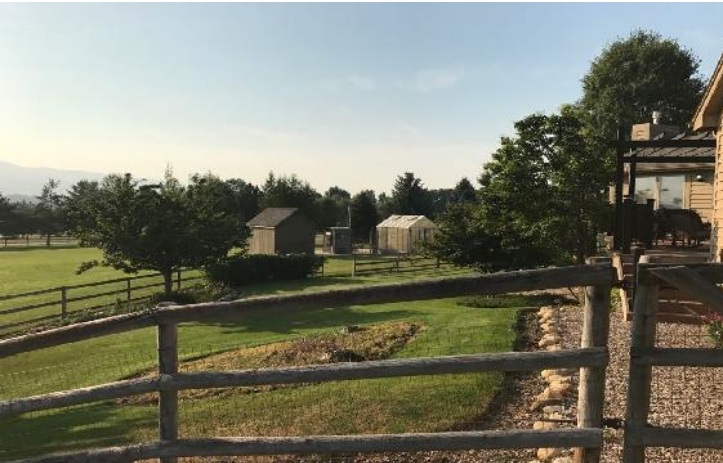
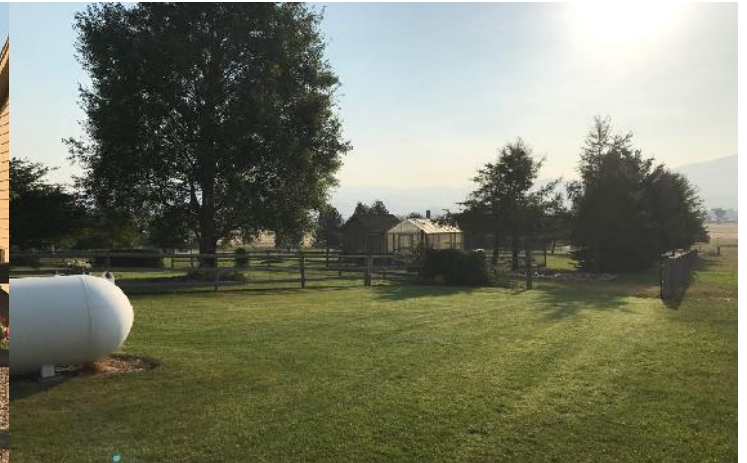
Structure Number:
Structure Name: 16170 Queen Ann's Ln
SubDivision: Macintosh Manor
GPS Location, Lat. 46 42.9681
GPS Location, Long. 114 5.25558
Safety Zone Present: No
Type of Structure: Residential
Surrounding Fuels: Grass, Timber
Structure Triage Category: Defensible, Prep and Hold
Roof Material: Composite
Heat Traps: Open Eaves, Wood Deck, Rain Gutters
Electrical Power: Underground
Hazards:
Access to Site: T1 Engine
Comm with ICP: Radio, Cell Service
Water Source: Faucet / Hose
Mitigation Time: Less Than An Hour
Other Resources Needed to Protect: Engine crew.
Collected By: COCO 482

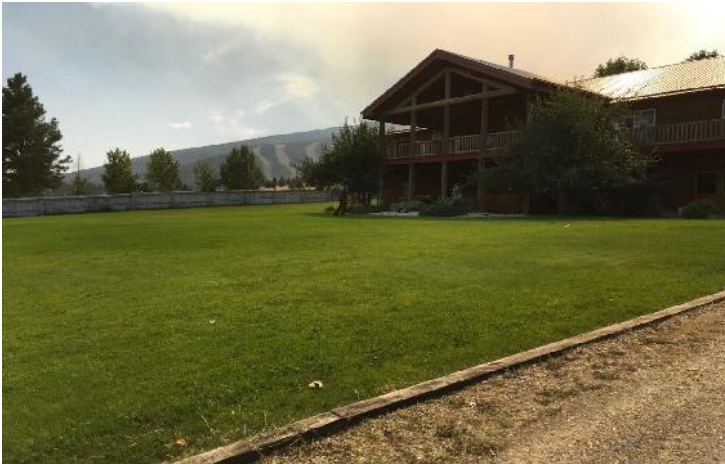
Collected Date/Time: 07/29/2017 16:25:11
Photo 2

Structure Number:
Structure Name: 16191 Highland Dr.
SubDivision: Macintosh Manor
GPS Location, Lat. 46 42.9663
GPS Location, Long. 114 5.99232
Safety Zone Present: Yes
Type of Structure: Residential
Surrounding Fuels: Grass
Structure Triage Category: Defensible, Prep and Hold
Roof Material: Metal
Heat Traps: Wood Deck, Rain Gutters
Electrical Power: Underground
Hazards: Septic Tank
Access to Site: T3/4 Engine
Comm with ICP: Radio, Cell Service
Water Source: Faucet / Hose
Mitigation Time: Less Than An Hour
Notes: Row of cottonwoods west of house, 50 feet away. One of the few structures with a large patch of green grass. Acceptable safety zone for an engine company. Attached garage.

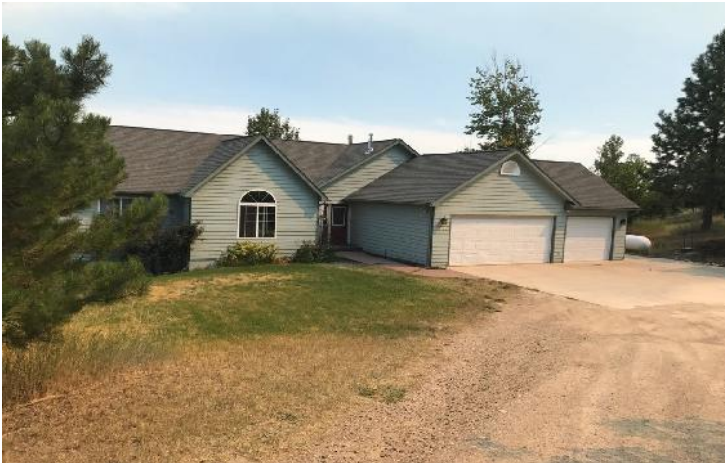
Photo 1

Structure Number:
Structure Name: 16197 Folsom Rd
SubDivision: Macintosh Manor
GPS Location, Lat. 46 42.9549
GPS Location, Long. 114 6.1134
Safety Zone Present: Yes
Type of Structure: Residential
Surrounding Fuels: Grass
Structure Triage Category: Defensible, Stand Alone
Roof Material: Composite
Heat Traps: Wood Deck,Rain Gutters
Electrical Power: Underground
Hazards: HazMat

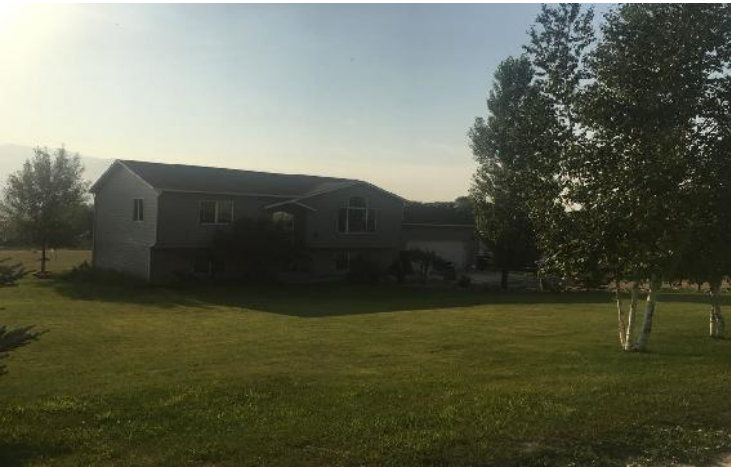
Photo 2

Structure Number:
Structure Name: 16210 Queen Anne's Lane
SubDivision: Macintosh Manor
GPS Location, Lat. 46 42.93828
GPS Location, Long. 114 5.26152
Safety Zone Present: Yes
Type of Structure: Residential
Surrounding Fuels: Grass
Structure Triage Category: Defensible, Stand Alone
Roof Material: Composite
Heat Traps: Wood Deck,Rain Gutters
Electrical Power: Underground
Hazards:
Access to Site: T1 Engine
Comm with ICP: Radio,Cell Service
Water Source: Faucet / Hose
Mitigation Time: None Needed
Other Resources Needed to Protect: Type 6 engine to patrol
Collected By: COCO 482
Photo 1

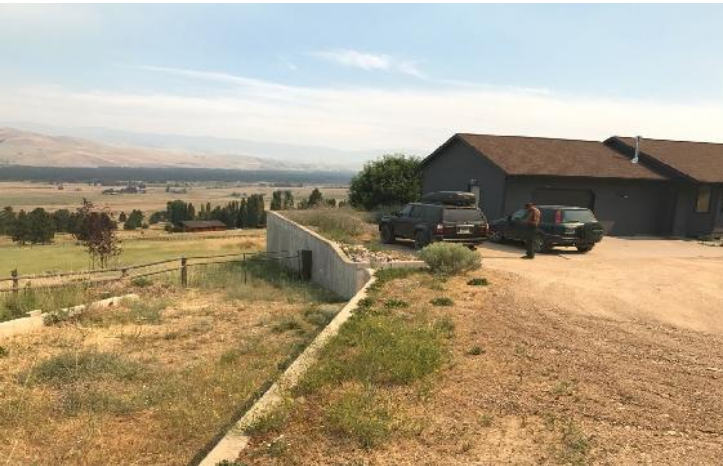
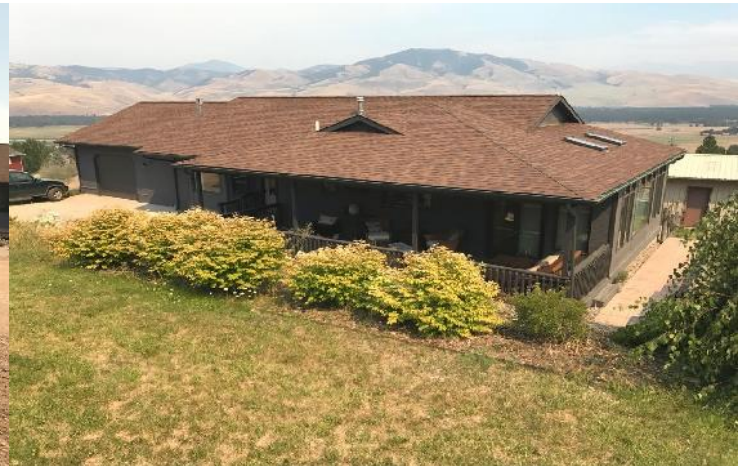
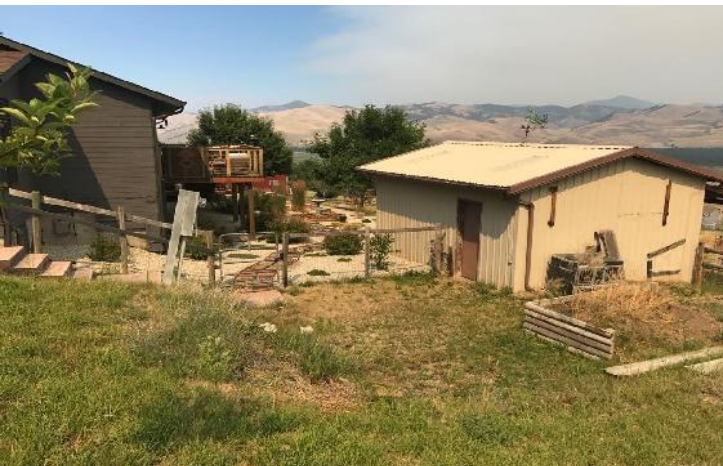
Structure Number:
Structure Name: 16325 Folsom Rd
SubDivision: Macintosh Manor
GPS Location, Lat. 46 42.88566
GPS Location, Long. 114 6.17112
Safety Zone Present: No
Type of Structure: Residential
Surrounding Fuels: Grass
Structure Triage Category: Defensible, Stand Alone
Roof Material: Composite
Heat Traps: Wood Deck, Rain Gutters
Electrical Power: Underground
Hazards: HazMat

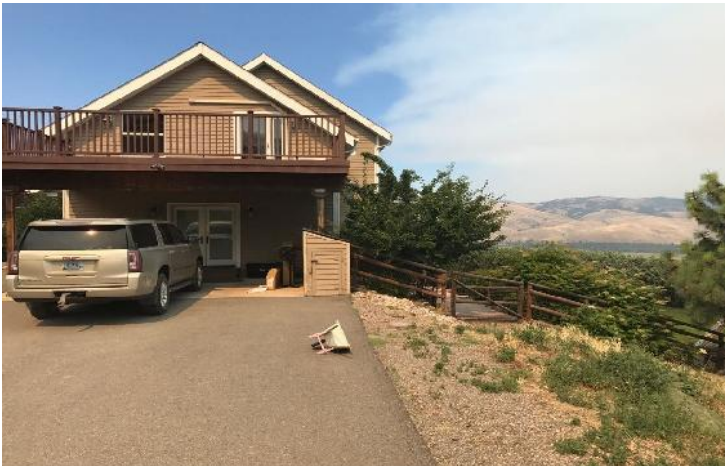
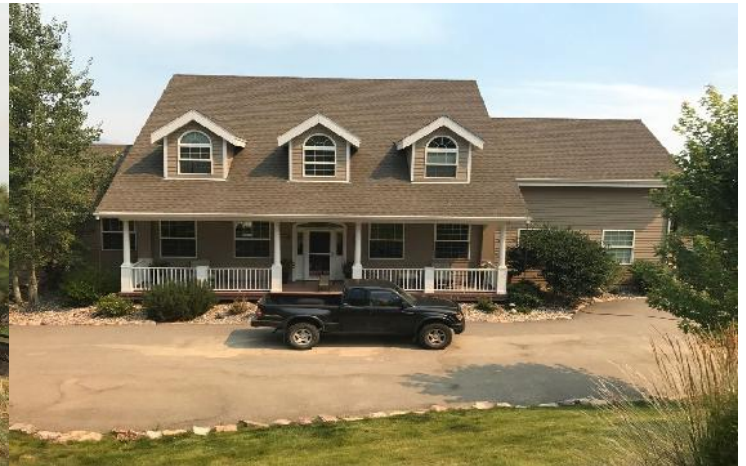
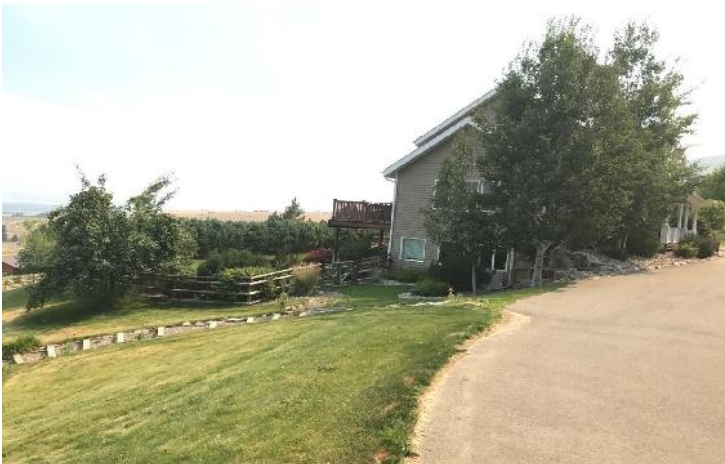
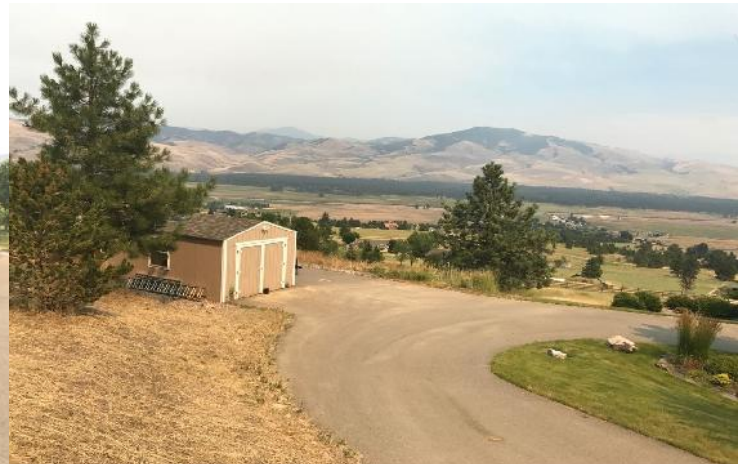
Structure Number:
Structure Name: 16374 Folsom Rd
SubDivision: Macintosh Manor
GPS Location, Lat. 46 42.88782
GPS Location, Long. 114 6.24996
Safety Zone Present: No
Type of Structure: Residential
Surrounding Fuels: Grass,Shrub,Timber
Structure Triage Category: Defensible, Stand Alone
Roof Material: Composite
Heat Traps: Wood Deck
Electrical Power: Underground
Hazards: Animals,HazMat

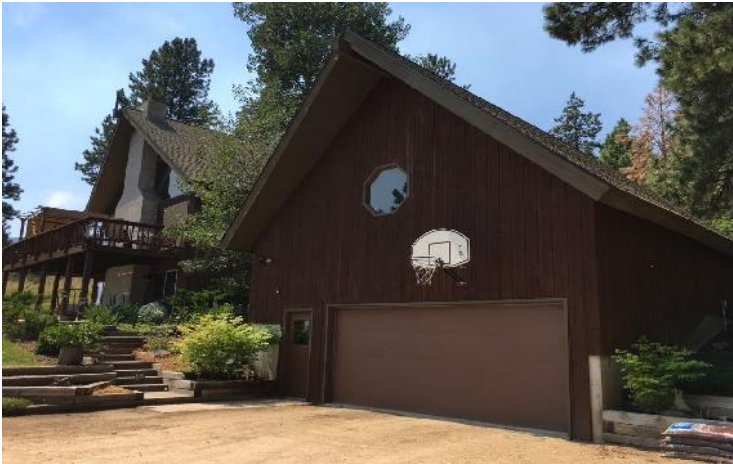
Structure Number:
Structure Name: 16375 Folsom Rd
SubDivision: Macintosh Manor
GPS Location, Lat. 46 42.71082
GPS Location, Long. 114 6.4941
Safety Zone Present: No **Where is Safety Zone:** Ten minutes down winding road to Hwy 93
Type of Structure: Residential **Primary Structures:** **Outbuildings:**
Surrounding Fuels: Grass, Timber **Defensible Space:** 30-50 Feet
Structure Triage Category: Non-Defensible, Prep and Leave
Roof Material: Composite **Siding Material:** Wood
Heat Traps: Open Eaves, Wood Deck
Electrical Power: Underground **Gas to Structure:**
Hazards: Terrain, Fuels, No Turn Around, Septic Tank
Access to Site: T6 Engine **Best Access From:** Hwy 93 to Rowan...Dundee...sandy...highland...Folsom...
Comm with ICP: Radio, Cell Service
Water Source: Faucet / Hose
Mitigation Time: 1-2 Hours
Other Resources Needed to Protect: Sawyers to cut small dead standing ponderosa upslope.
Notes: Loop driveway. Less tactically challenging on southern fork of loop. Best ingress is south fork of driveway. Homeowner intends on setting sprinklers on the roof. A type 3 or 4 could access the structure from the south fork of the driveway. The homeowner

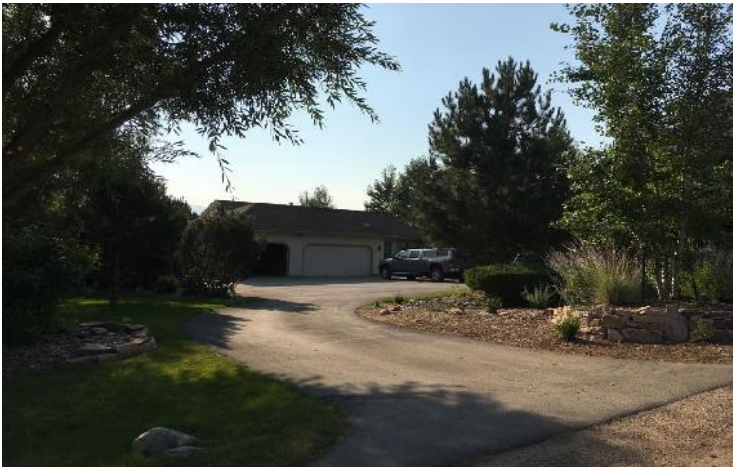
Structure Number:
Structure Name: 16380 Queen Anne's Lane
SubDivision: Macintosh Manor
GPS Location, Lat. 46 42.86592
GPS Location, Long. 114 5.28228
Safety Zone Present: Yes
Type of Structure: Residential
Surrounding Fuels: Grass,Shrub,Timber
Structure Triage Category: Defensible, Prep and Hold
Roof Material: Composite
Heat Traps: Wood Deck,Rain Gutters
Electrical Power: Underground
Hazards: Septic Tank
Access to Site: T3/4 Engine
Comm with ICP: Radio,Cell Service
Water Source: Faucet / Hose,Creek
Mitigation Time: 1-2 Hours
Other Resources Needed to Protect: Sawyers to cut ornamental shrubs away from structure...
Collected By: E-27 Florence

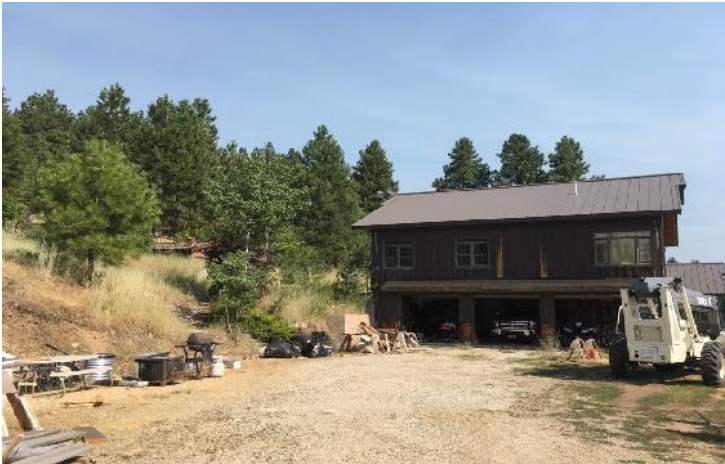
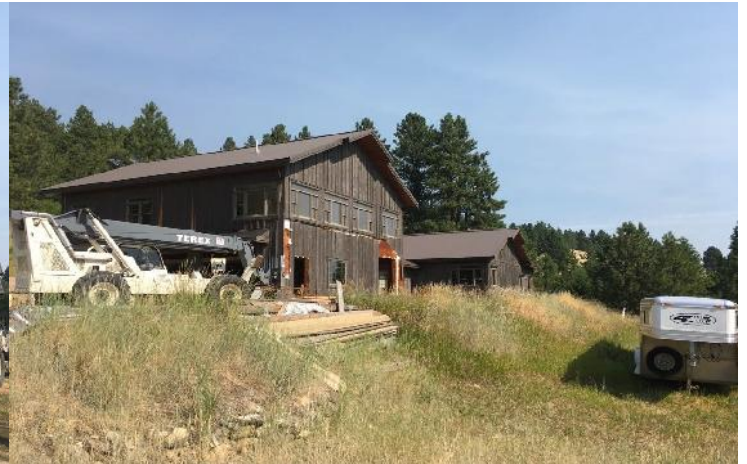
Structure Number:
Structure Name: 16405 Folsom Rd
SubDivision: Macintosh Manor
GPS Location, Lat. 46 42.81096
GPS Location, Long. 114 6.44058
Safety Zone Present: No **Where is Safety Zone:** Safety zone is about a ten minute drive back to Hwy 93
Type of Structure: Residential **Primary Structures:** **Outbuildings:**
Surrounding Fuels: Grass, Timber **Defensible Space:** 30-50 Feet
Structure Triage Category: Non-Defensible, Prep and Leave
Roof Material: Metal **Siding Material:** Wood
Heat Traps: Open Eaves
Electrical Power: Underground **Gas to Structure:** None
Hazards: Terrain, Fuels, No Turn Around, Animals, Septic Tank
Access to Site: T6 Engine **Best Access From:** Rowan Rd to Dundee Dr to Sandy Ln to Highland Dr to Folsom.
Comm with ICP: Radio, Cell Service
Water Source: Faucet / Hose, Porta-Tank/Pumpkin
Mitigation Time: 3-4 Hours
Notes: Owner has a 450 gallon poly tank that he will have filled with an external pump available for our use. Owner is a general contractor, and therefore stores leftover supplies from jobs at his residence. Florence engine E-27 has homeowner's contact informat

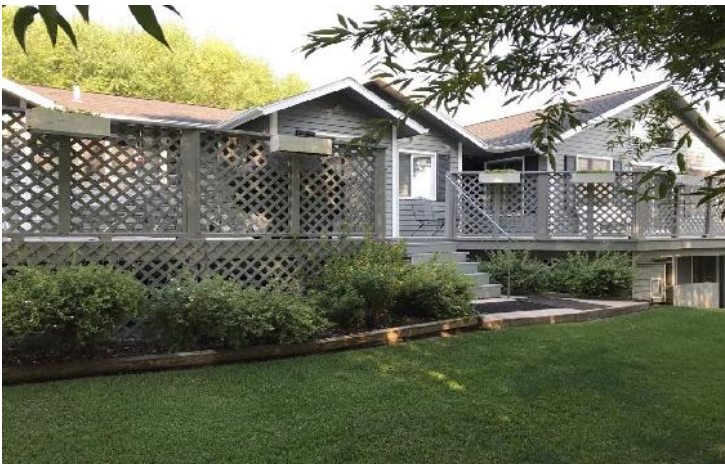
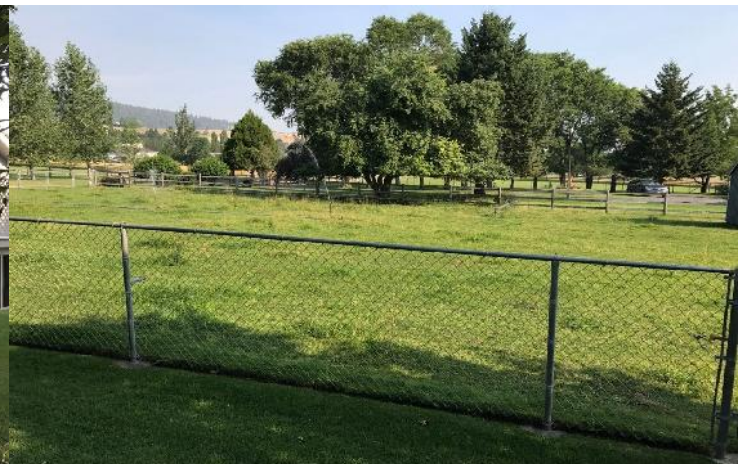
Structure Number:
Structure Name: 16435 Falcon Rd
SubDivision: Macintosh Manor
GPS Location, Lat. 46 42.81432
GPS Location, Long. 114 5.1987
Safety Zone Present: Yes
Type of Structure: Residential
Surrounding Fuels: Grass
Structure Triage Category: Defensible, Stand Alone
Roof Material: Composite
Heat Traps: Wood Deck, Rain Gutters
Electrical Power: Underground
Hazards: HazMat
Access to Site: T1 Engine
Comm with ICP: Radio, Cell Service
Water Source: Faucet / Hose
Mitigation Time: None Needed
Other Resources Needed to Protect: None
Notes: Owner has sprinkler system in yard.

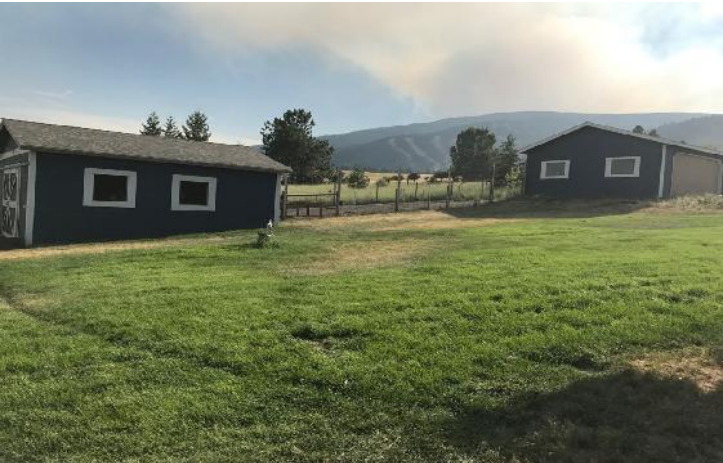
Structure Number:
Structure Name: 16490 Folsom RD
SubDivision: Macintosh Manor
GPS Location, Lat. 46 43.1643
GPS Location, Long. 114 6.22824
Safety Zone Present: No
Type of Structure: Residential
Surrounding Fuels: Grass, Timber
Structure Triage Category: Defensible, Stand Alone
Roof Material: Composite
Heat Traps: Wood Deck, Rain Gutters
Electrical Power: Underground
Hazards: HazMat

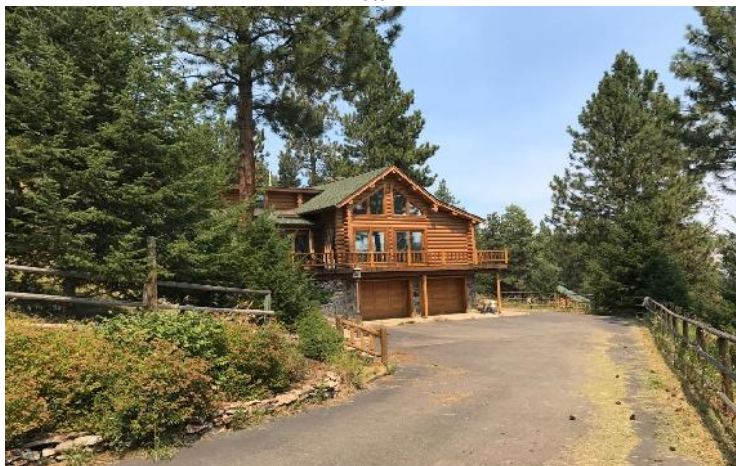
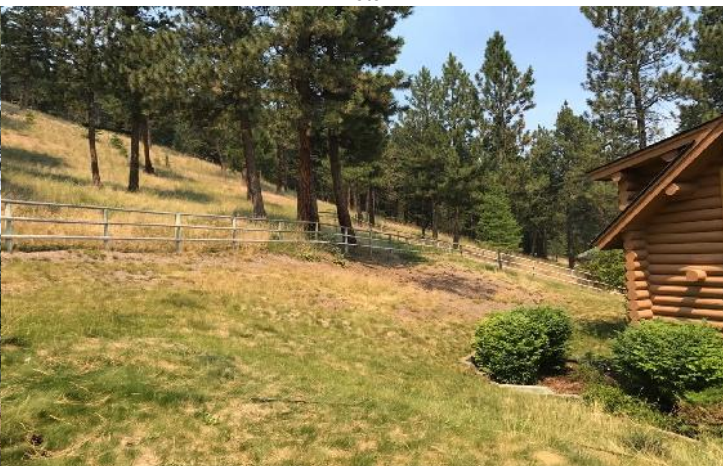
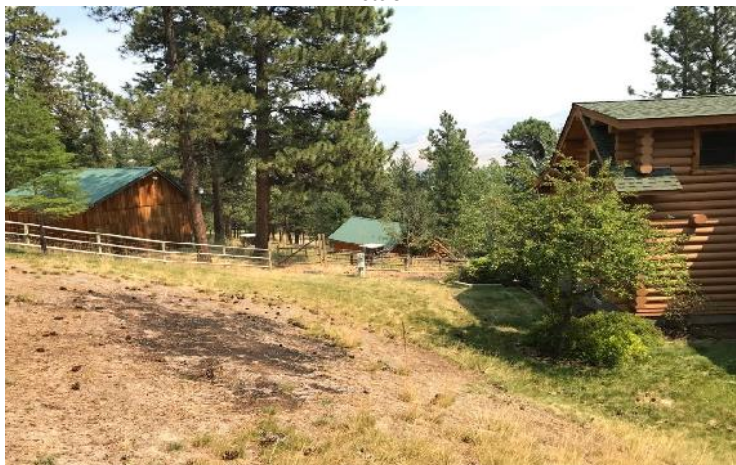
Safety Zone Present: No
Type of Structure: Residential
Surrounding Fuels: Grass, Shrub, Timber
Structure Triage Category: Non-Defensible, Prep and Leave
Roof Material: Composite
Heat Traps: Wood Deck, Other Receptor
Electrical Power:
Hazards: Terrain, Fuels, Septic Tank

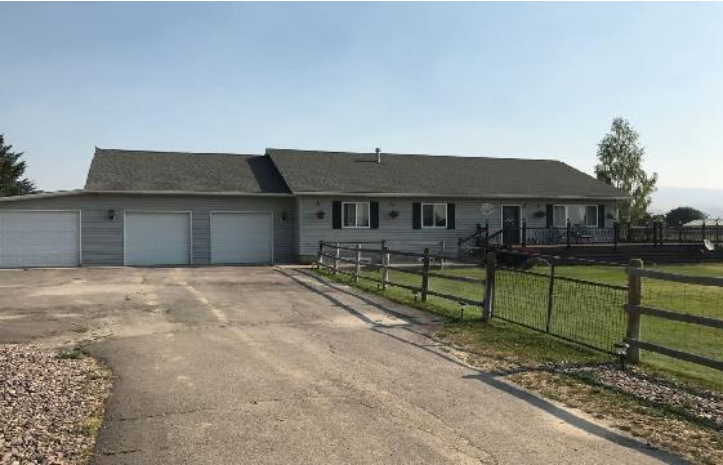
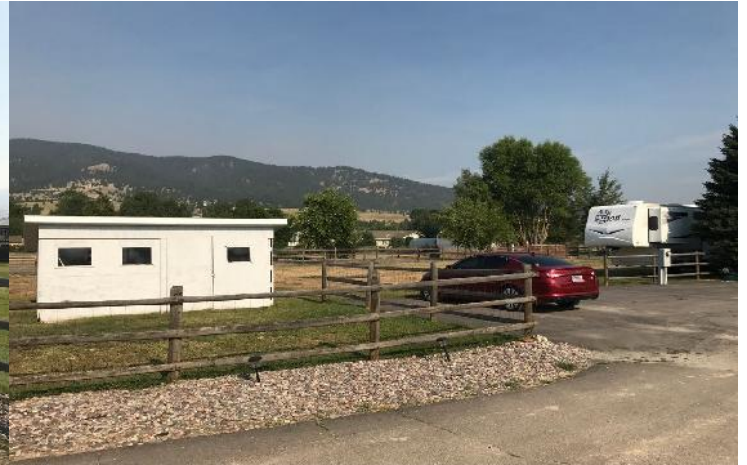
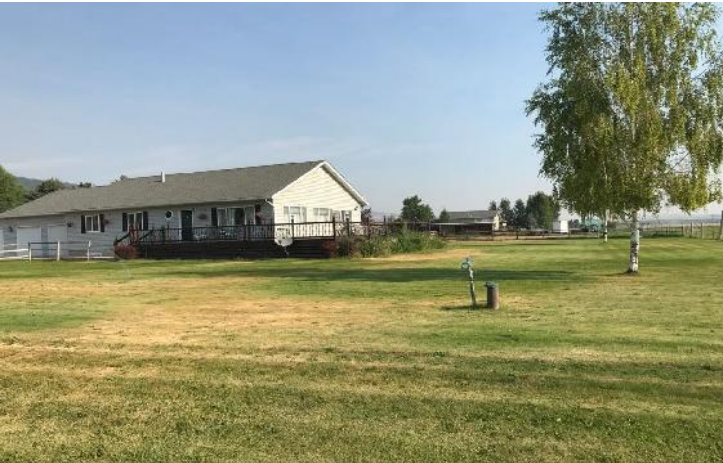
Structure Number:
Structure Name: 6020 Crist Ln
SubDivision: Macintosh Manor
GPS Location, Lat. 46 42.81432
GPS Location, Long. 114 4.91046
Safety Zone Present: No
Type of Structure: Residential
Surrounding Fuels: Grass, Timber
Structure Triage Category: Defensible, Prep and Hold
Roof Material: Metal
Heat Traps: Wood Deck
Electrical Power: Underground
Hazards: Septic Tank
Access to Site: T1 Engine
Comm with ICP: Radio, Cell Service
Water Source: Faucet / Hose
Mitigation Time: Less Than An Hour
Other Resources Needed to Protect: Engine crew.
Collected By: COCO 482

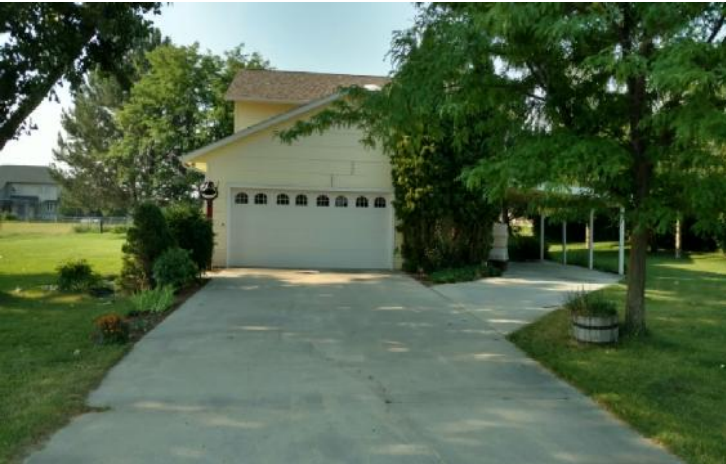
Hazards:
Access to Site: T1 Engine
Comm with ICP: Radio, Cell Service
Water Source: Faucet / Hose
Mitigation Time: None Needed
Other Resources Needed to Protect: 1 engine to Patrol

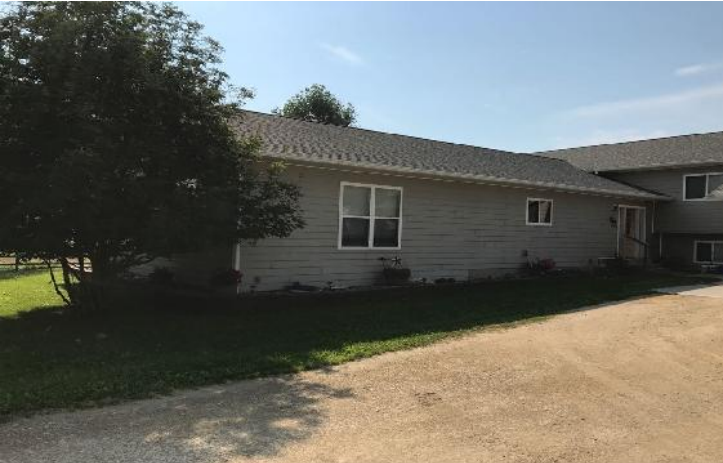
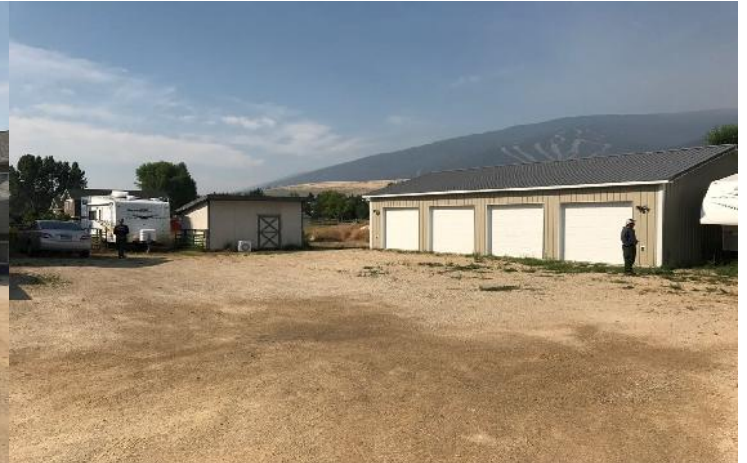
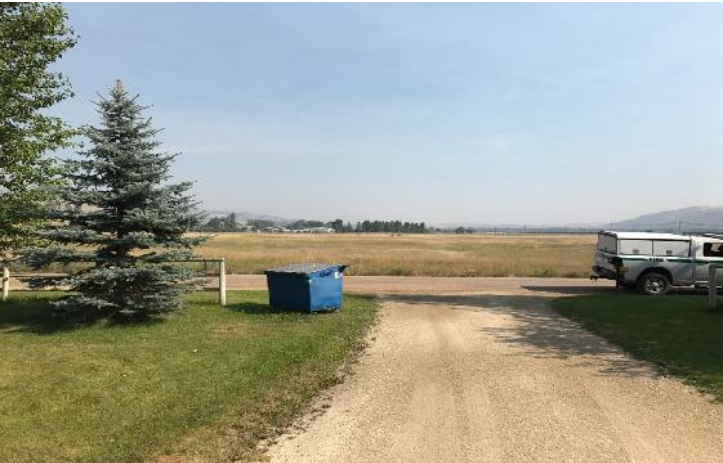
Structure Number:
Structure Name: 6025 Rowan Rd
SubDivision: Macintosh Manor
GPS Location, Lat. 46 42.90582
GPS Location, Long. 114 4.9146
Safety Zone Present: Yes
Type of Structure: Residential
Surrounding Fuels: Grass
Structure Triage Category: Defensible, Stand Alone
Roof Material: Composite
Heat Traps: Wood Deck, Rain Gutters
Electrical Power: Underground
Hazards: Septic Tank
Access to Site: T1 Engine
Comm with ICP: Radio, Cell Service
Water Source: Faucet / Hose
Mitigation Time: None Needed
Other Resources Needed to Protect: Possible sprinkler system.
Collected By: TNF-65

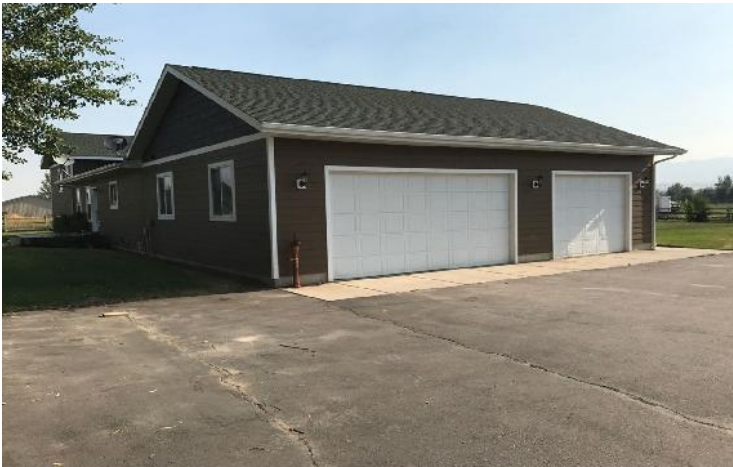
Structure Number:
Structure Name: 6044 Crist Ln
SubDivision: Macintosh Manor
GPS Location, Lat. 46 42.83976
GPS Location, Long. 114 4.93128
Safety Zone Present: Yes
Type of Structure: Residential
Surrounding Fuels: Grass
Structure Triage Category: Defensible, Stand Alone
Roof Material: Composite
Heat Traps: Wood Deck,Rain Gutters
Electrical Power: Underground
Hazards:
Access to Site: T1 Engine
Comm with ICP: Radio,Cell Service
Water Source: Faucet / Hose
Mitigation Time: None Needed
Other Resources Needed to Protect: One engine to patrol
Collected By: COCO 482
Photo 1

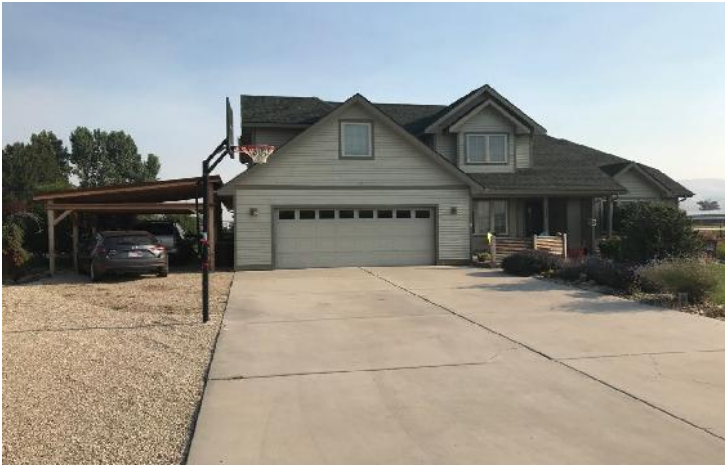
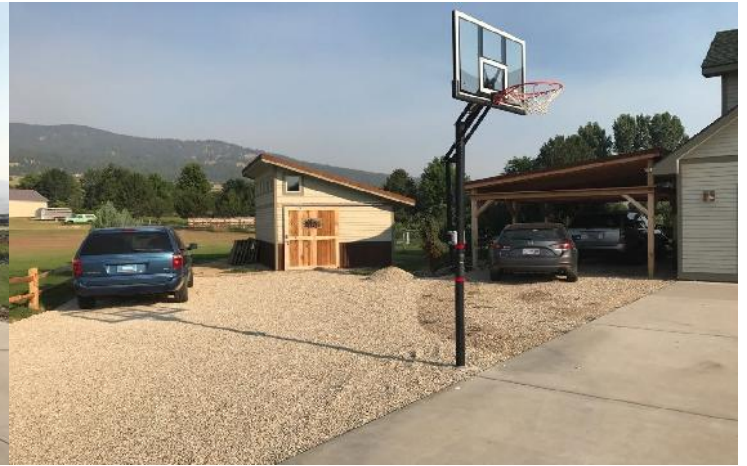
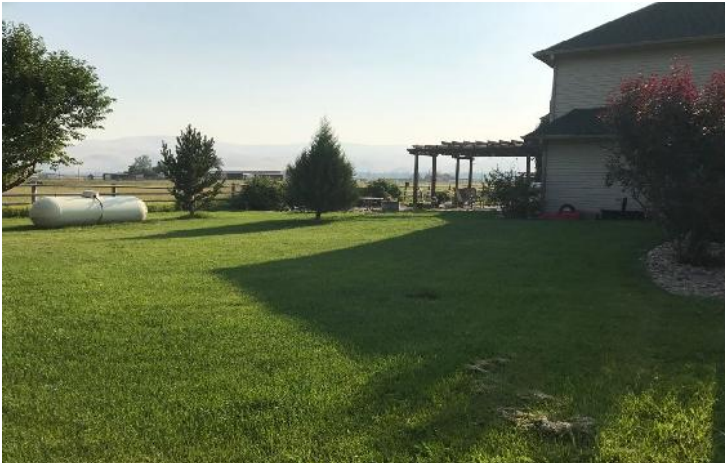
Safety Zone Present: Yes
Type of Structure: Residential
Surrounding Fuels: Grass
Structure Triage Category: Defensible, Stand Alone
Roof Material: Composite
Heat Traps:
Electrical Power: Underground
Hazards: HazMat
Access to Site: T1 Engine
Comm with ICP: Radio, Cell Service
Water Source: Faucet / Hose
Mitigation Time: None Needed
Other Resources Needed to Protect: None
Collected By: Lolo 632

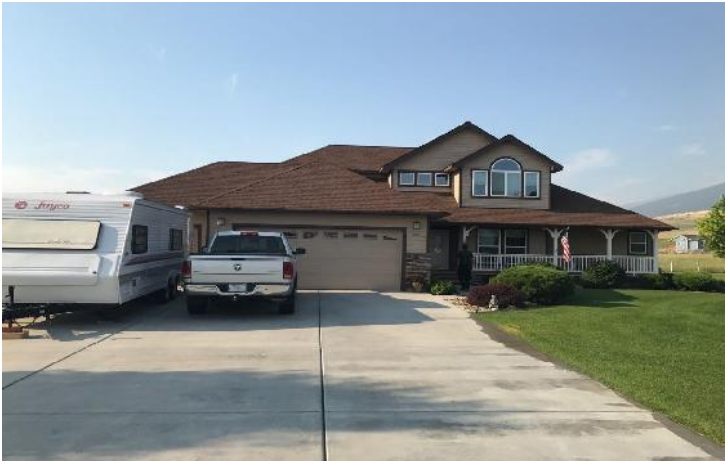
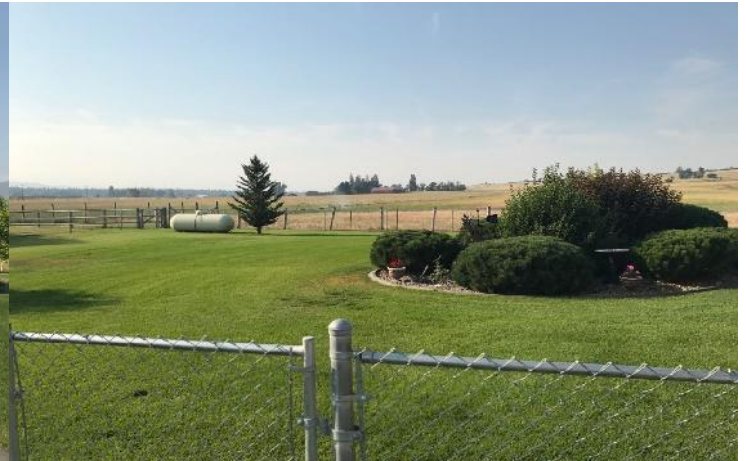
Structure Number:
Structure Name: 6049 Ray Lane
SubDivision: Macintosh Manor
GPS Location, Lat. 46 42.72522
GPS Location, Long. 114 4.89474
Safety Zone Present: Yes
Type of Structure: Residential
Surrounding Fuels: Grass
Structure Triage Category: Defensible, Stand Alone
Roof Material: Composite
Heat Traps:
Electrical Power: Underground
Hazards: HazMat
Access to Site: T1 Engine
Comm with ICP: Radio, Cell Service
Water Source: Faucet / Hose
Mitigation Time: None Needed
Collected By: Lolo 632

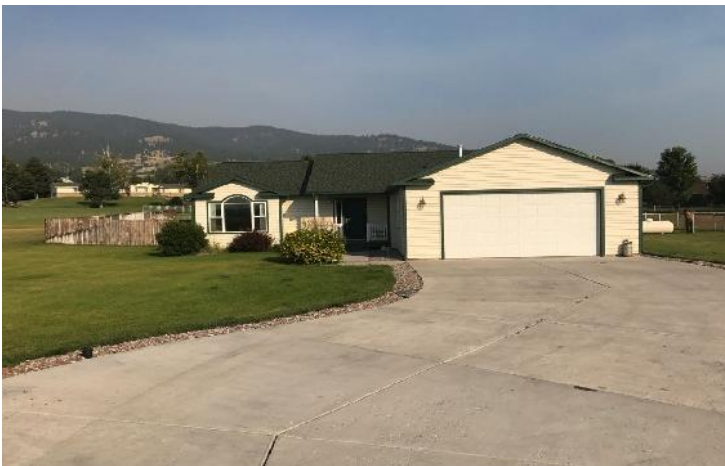
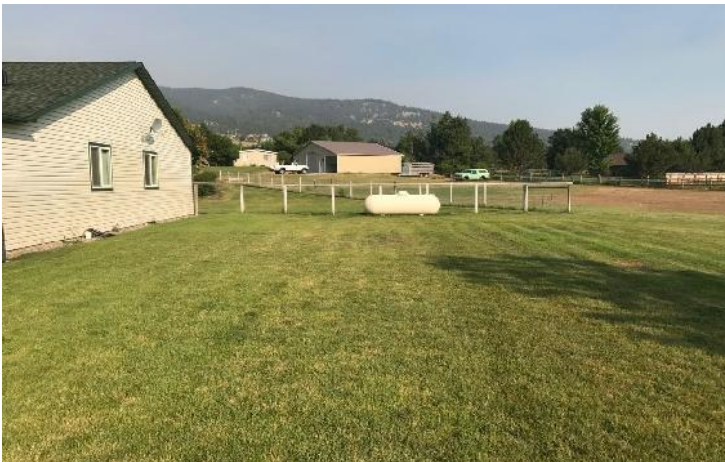
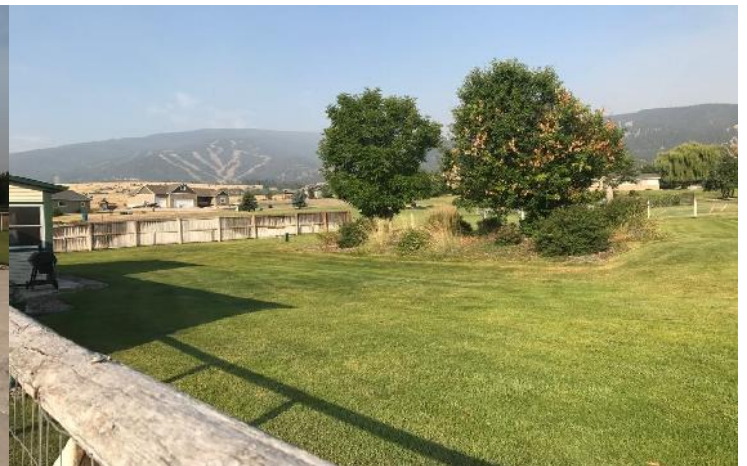
Safety Zone Present: Yes
Type of Structure: Residential
Surrounding Fuels: Grass
Structure Triage Category: Defensible, Stand Alone
Roof Material: Composite
Heat Traps:
Electrical Power: Underground
Hazards: HazMat
Access to Site: T1 Engine
Comm with ICP: Radio, Cell Service
Water Source: Faucet / Hose
Mitigation Time: None Needed
Other Resources Needed to Protect: None
Collected By: Lolo 632
