**STRUCTURE
PROTECTION PLAN
FOR MACINTOSH
MANOR 07/29/2017**

Structure Protection Plan

Macintosh Manor

Location: On Hwy 12 South of Lolo to the Old Hwy 93 turnoff area

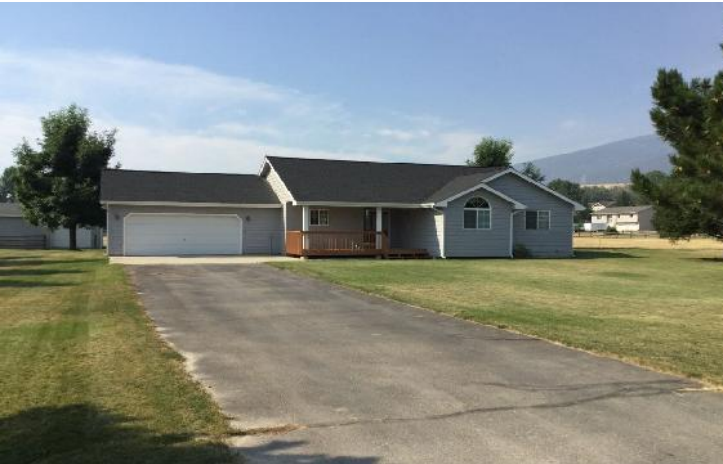
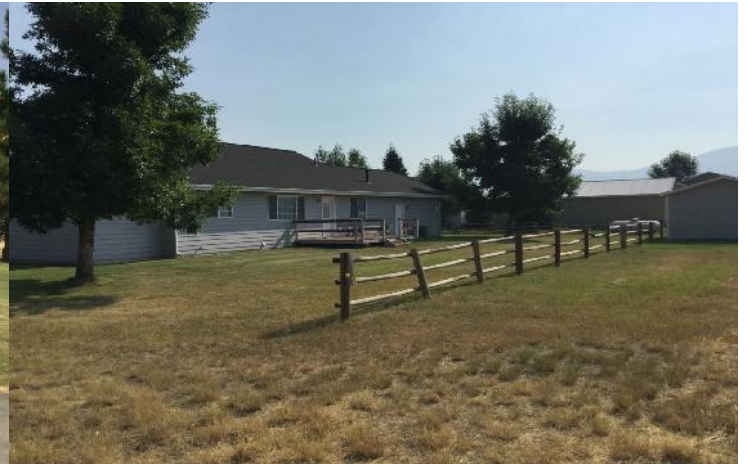
Structure Number:
Structure Name: 6105 Rowan Rd
SubDivision: Macintosh Manor
GPS Location, Lat. 46 42.89652
GPS Location, Long. 114 4.9662
Safety Zone Present: Yes
Type of Structure: Residential
Surrounding Fuels: Grass
Structure Triage Category: Defensible, Stand Alone
Roof Material: Composite
Heat Traps: Wood Deck, Rain Gutters
Electrical Power: Underground
Hazards: Septic Tank, HazMat
Access to Site: T1 Engine
Comm with ICP: Radio, Cell Service
Water Source: Faucet / Hose
Mitigation Time: None Needed
Other Resources Needed to Protect: None
Notes: None

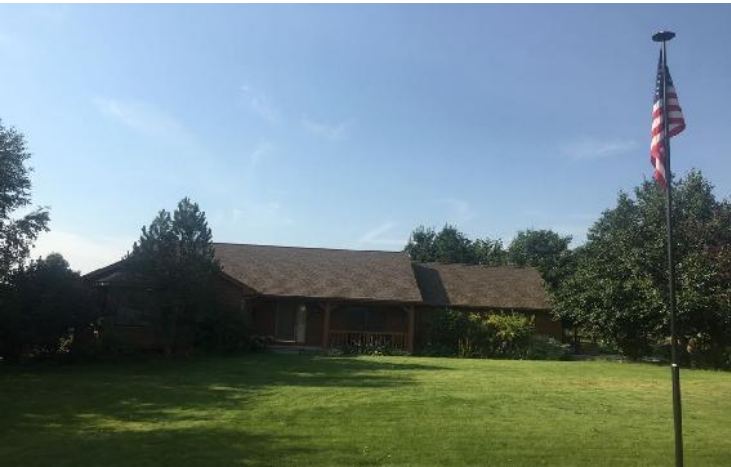
Structure Number:
Structure Name: 6125 Crist Lane
SubDivision: Macintosh Manor
GPS Location, Lat. 46 42.7872
GPS Location, Long. 114 4.98852
Safety Zone Present: No
Type of Structure: Residential
Surrounding Fuels: Grass, Shrub
Structure Triage Category: Defensible, Stand Alone
Roof Material: Composite
Heat Traps: Wood Deck, Rain Gutters
Electrical Power: Underground
Hazards: Fuels
Access to Site: T1 Engine
Comm with ICP: Radio, Cell Service
Water Source: Faucet / Hose
Mitigation Time: Less Than An Hour
Other Resources Needed to Protect: T6 patrol
Collected By: COCO 482
Photo 1

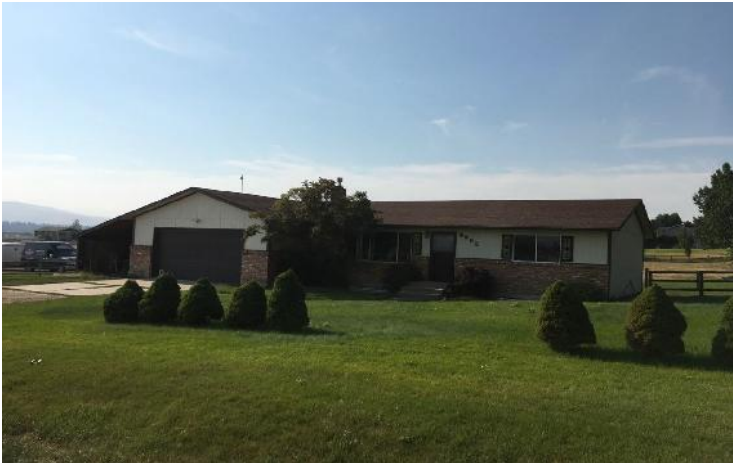
Structure Number:
Structure Name: 6205 Rowan Dr
SubDivision: Macintosh Manor
GPS Location, Lat. 46 42.90726
GPS Location, Long. 114 5.06322
Safety Zone Present: Yes
Type of Structure: Residential
Surrounding Fuels: Grass
Structure Triage Category: Defensible, Stand Alone
Roof Material: Composite
Heat Traps: Open Eaves, Wood Deck, Rain Gutters
Electrical Power: Underground
Hazards: Septic Tank
Access to Site: T1 Engine
Comm with ICP: Radio, Cell Service
Water Source: Faucet / Hose
Mitigation Time: Less Than An Hour
Collected By: E-27 Florence

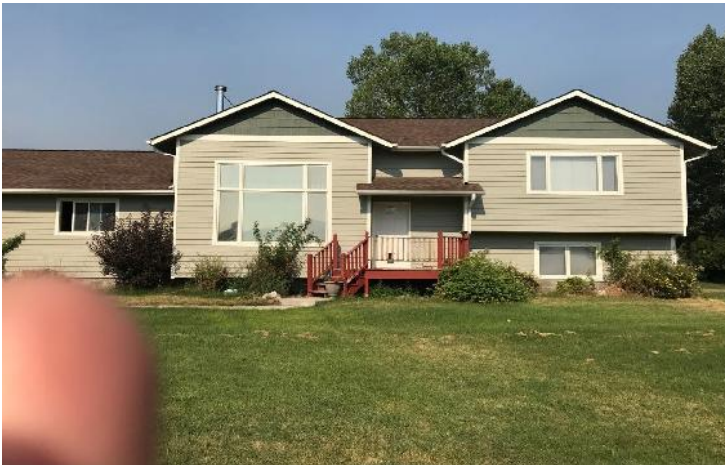
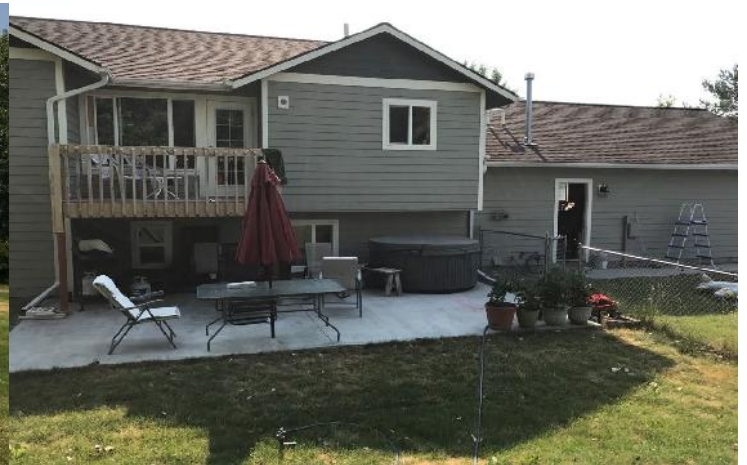
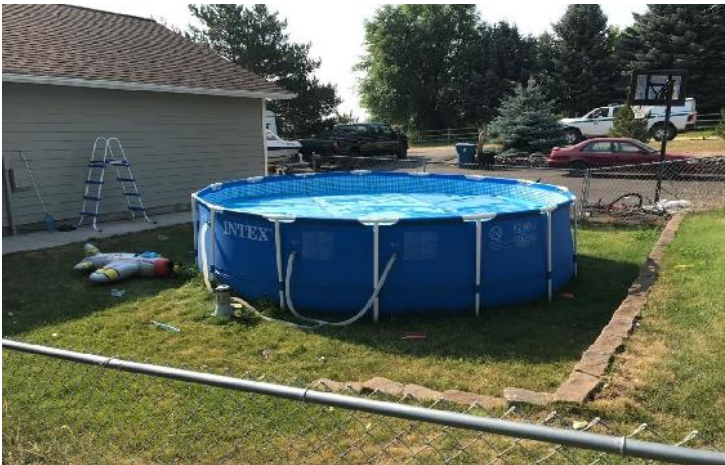
Structure Number:
Structure Name: 6220 Crist Ln
SubDivision: Macintosh Manor
GPS Location, Lat. 46 42.79806
GPS Location, Long. 114 5.07714
Safety Zone Present: Yes
Type of Structure: Residential
Surrounding Fuels: Grass
Structure Triage Category: Defensible, Stand Alone
Roof Material: Composite
Heat Traps: Open Eaves, Wood Deck, Rain Gutters
Electrical Power: Underground
Hazards: Fuels
Access to Site: T1 Engine
Comm with ICP: Radio, Cell Service
Water Source: Faucet / Hose, Porta-Tank/Pumpkin
Mitigation Time: Less Than An Hour
Other Resources Needed to Protect: Pool in backyard could be used as a pumpkin
Collected By: TNF-65

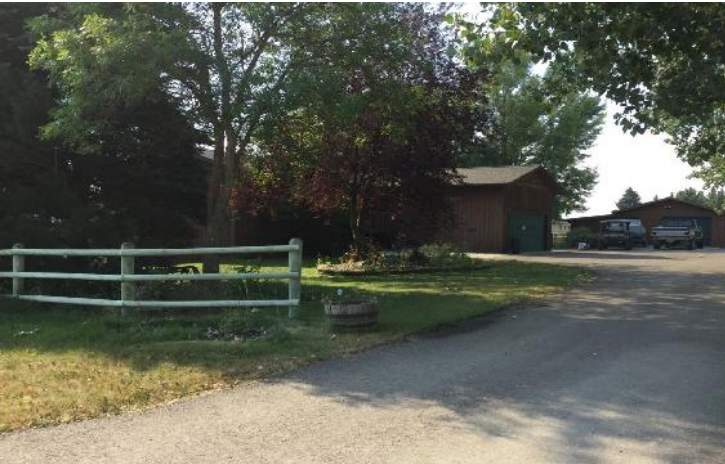
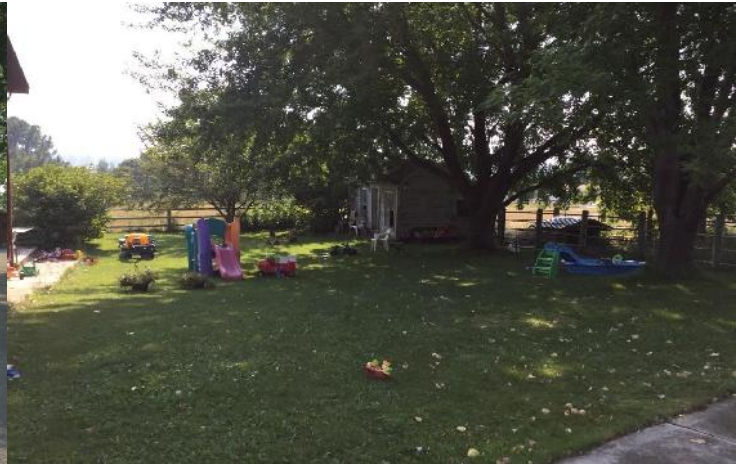
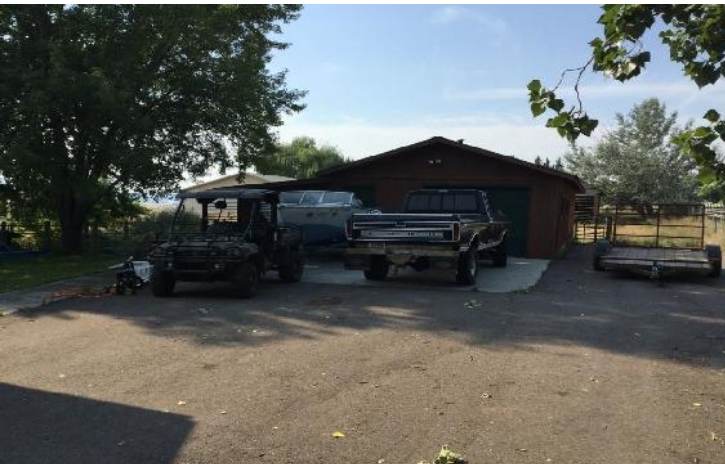
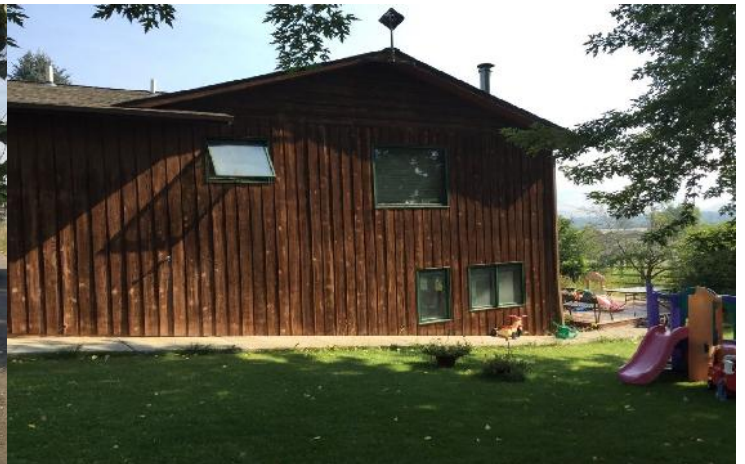
Structure Number:
Structure Name: 6225 Christ Lane
SubDivision: Macintosh Manor
GPS Location, Lat. 46 42.78186
GPS Location, Long. 114 5.08512
Safety Zone Present: Yes
Type of Structure: Residential
Surrounding Fuels: Grass, Timber
Structure Triage Category: Defensible, Stand Alone
Roof Material: Composite
Heat Traps: Wood Deck, Rain Gutters
Electrical Power: Underground
Hazards:
Access to Site: T1 Engine
Comm with ICP: Radio, Cell Service
Water Source: Faucet / Hose
Mitigation Time: Less Than An Hour
Other Resources: None
Needed to Protect:
Notes: None
