**HENDRIX
OR-RSF-278
Structures Assessed**

Datum: North American 1983
07/25/2018
 Day Shift
 Perimeter as of: 07/25/18 @ 0152

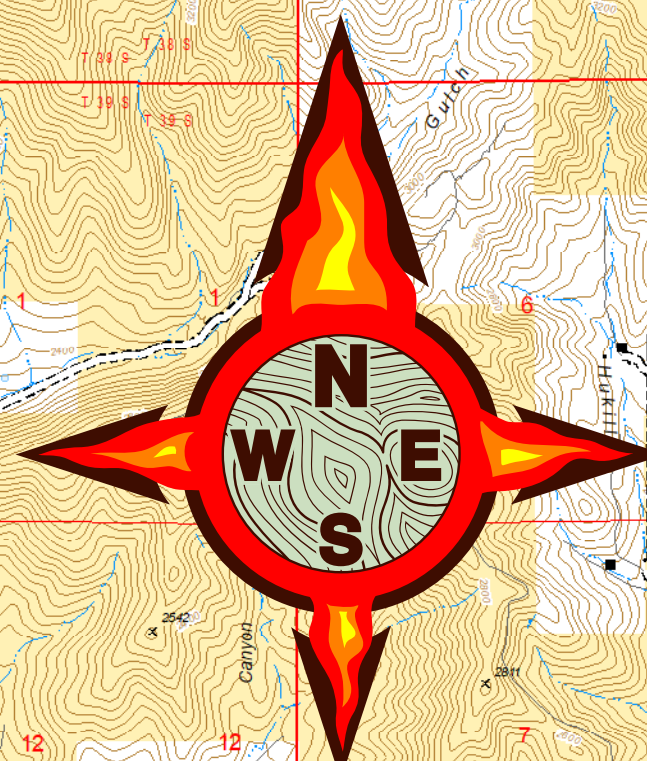
Dog Creek Community
 Locked gate, combo
 Single lane road, no good turnaround at gate
 Creek/potential water source

Dog Prairie 5150, 5160
 Two addresses, minimum two residences/structures (visual)
 Decent clearance around one structure except for tall grass.
 Second structure has a few trees close.
 Did not get closer than gate.
 Had not picked up level two Evac notice from gate.
 Gate locked.

Grapsy Gulch 6330, 6360
 Multiple no trespassing signs.
 One lane access rd through
 timber, overgrown understory.
 Gated, dummy locked.
 Did not go to structures.
 Two addresses, minimum two
 structures expected (map).
 Unknown defensibility at this time.

Dog Prairie 5170
 Very steep drive, minimal pullouts.
 Chain across, combo lock.
 Assuming one residence (minimum one structure).
 Did not continue last chain/no trespass signs

Grapsy Gulch 6300
 Gated, locked, multiple no trespassing signs.
 Single lane drive through timber with some
 recent work done to drive.
 Creek parallels drive 50-100 off.
 Level two Evac notice still in gate.
 Minimum one structure.

Wrangle Camp
 Two historic Structures
 Newer FS outhouse

16001 Wagner Creek - Fence Residence
 -Homeowner priority 1: main house
 -90 Acres total landowner property
 -landowner will set up Rainbird to be turned on if they leave
 -Water tanks combined hold 4400 gal combined
 -small pond next to woodshed 600 gal.
 -LPG Tanks within 100' below House
 -Dilapidated log outbuilding to N is NOT important
 to landowner - do not defend
 -Multiple skid roads contour below the house. Relatively clean.
 -Could be used in fire op.
 -Smaller cabin - 10 mi below house
 -Dozer line below lower cabin
 -Log decks 100-200 yds below lower cabin

16099 Wagner Cr Rd Schumaker Residence
 -30 acres timber and chaparral
 -2 story main house metal roof, cement fiberboard siding,
 stucco foundation
 -50 ft clearance
 -wood shop with open foundation underneath
 -LPG tank 100' away
 -Narrow loop driveway, 1/2 mile, limited pullouts,
 good turnarounds
 -Water tanks combine for approx 10,000 gallons
 -Ice cream
 -Lower small structure has concrete walls with cedar
 cladding, metal roof, timber within 5 feet.
 -Improvements are OK. Cut trees and brush.
 -Recommend fuel reduction on island and below main
 house and around lower house.
 -Trigger point, fire crossing alternate (PACE)
 -Recommend staging of sprinklers, pumps, foldatank
 equipment for both structures

McDonald Creek Rd Cabin
 -built in a small stand of trees in a large meadow
 with subalpine ground cover, light fuels
 -rustic cabin
 -road access for 16 engines
 -locked cable gate 1/4 mile down road
 -plenty of clearance beside timber stand.
 -Could be lit around and protected with single engine

Fill Site In Creek
 Needs:
 Mark 3 w Kit
 200 feet 1.5 hose
 Gated wye
 P cord
 2000 gal foldatank
