# HENDRIX OR-RSF-278 Structures Assessed

Datum: North American 1983  
**07/26/2018**  
 Day Shift  
 Perimeter as of: 07/25/18 @ 2206

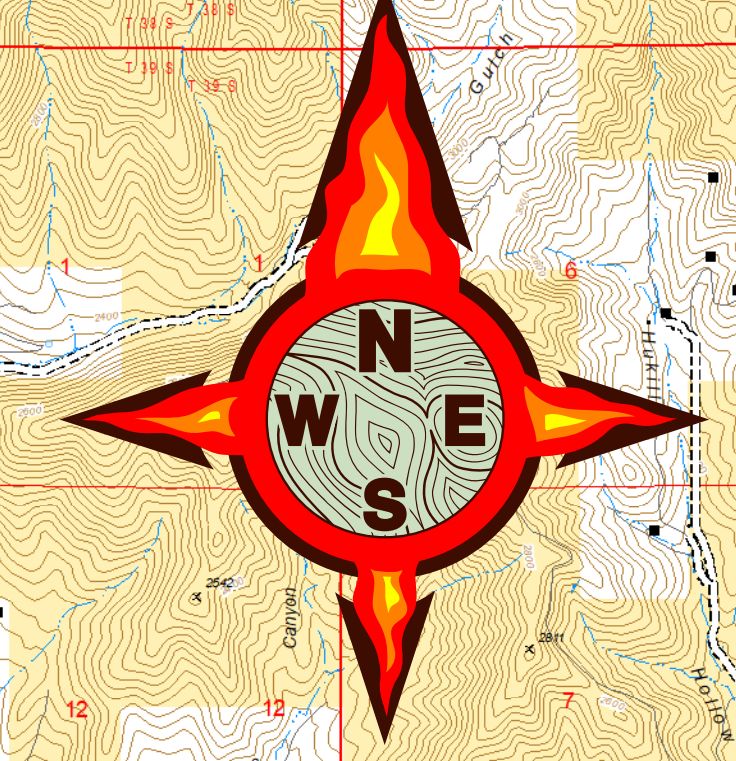
**Dog Creek Community**  
 Locked gate, combo  
 Single lane road, no good turnaround at gate  
 Creek/potential water source

**Dog Prairie 5150, 5160**  
 Two addresses, minimum two residences/structures (visual)  
 Decent clearance around one structure except for tall grass.  
 Second structure has a few trees close.  
 Did not get closer than gate.  
 Had not picked up level two Evac notice from gate.  
 Gate locked.

**Dog Prairie 5170**  
 Very steep drive, minimal pullouts.  
 Chain across, combo lock.  
 Assuming one residence (minimum one structure).  
 Did not continue last chain/no trespass signs

**Crapsey Gulch 6330, 6360**  
 Multiple no trespassing signs.  
 One lane access rd through  
 timber, overgrown understory.  
 Gated, dummy locked.  
 Did not go to structures.  
 Two addresses, minimum two  
 structures expected (map).  
 Unknown defensibility at this time.

**Crapsey Gulch 6300**  
 Gated, locked, multiple no trespassing signs.  
 Single lane drive through timber with some  
 recent work done to drive.  
 Creek parallels drive 50-100 off.  
 Level two Evac notice still in gate.  
 Minimum one structure.

No through access from 1099-755  
 through to Dog Creek Area

**16001 Wagner Creek - Fence Residence**  
 -Homeowner priority 2: blue shipping container has tools/shop  
 -90 Acres total landowner property  
 -landowner will set up Rainbird to be turned on if they leave  
 -Water tanks combined hold 4400 gal combined  
 -small pond next to woodshed 600 gal.  
 -LPG Tanks within 100' below House  
 -Dilapidated log outbuilding to N is NOT important  
 to landowner - do not defend  
 -Multiple skid roads contour below the house. Relatively clean.  
 -Could be used in fire op.  
 -Smaller cabin 10 mi below house  
 -Dozer line below lower cabin  
 -Log decks 100-200 yds below lower cabin

**16099 Wagner Cr Rd Schumaker Residence**  
 -30 acres timber and chaparral  
 -2 story main house metal roof, cement fiberboard siding,  
 stucco foundation  
 -50 ft clearance  
 -wood shop with open foundation underneath  
 -LPG tank 100' away  
 -Narrow loop driveway, 1/2 mile, limited pullouts,  
 good turnarounds  
 -Water tanks combine for approx 10,000 gallons  
 -Ice cream  
 -Lower small structure has concrete walls with cedar  
 cladding, metal roof, timber within 5 feet  
 -Improvements are OK. Cut trees and brush.  
 -Recommend fuel reduction on island and below main  
 house and around lower house.  
 -Trigger point, fire crossing alternate (PACE)  
 -Recommend staging of sprinklers, pumps, foldatank  
 equipment for both structures

**McDonald Creek Rd Cabin**  
 -built in a small stand of trees in a large meadow  
 with subalpine ground cover, light fuels  
 -rustic cabin  
 -road access for 16 engines  
 -locked cable gate 1/4 mile down road  
 -plenty of clearance beside timber stand.  
 -Could be lit around and protected with single engine

**Fill Site In Creek**  
 Needs:  
 Mark 3 w Kit  
 200 feet 1.5 hose  
 Gated wye  
 P cord  
 2000 gal foldatank

**Wrangle Camp**  
 Two historic Structures  
 Newer FS outhouse
