Suppression Repair

Beachie Creek
ORWIF-200299
Riverside 5
10/03/20
Page: 5

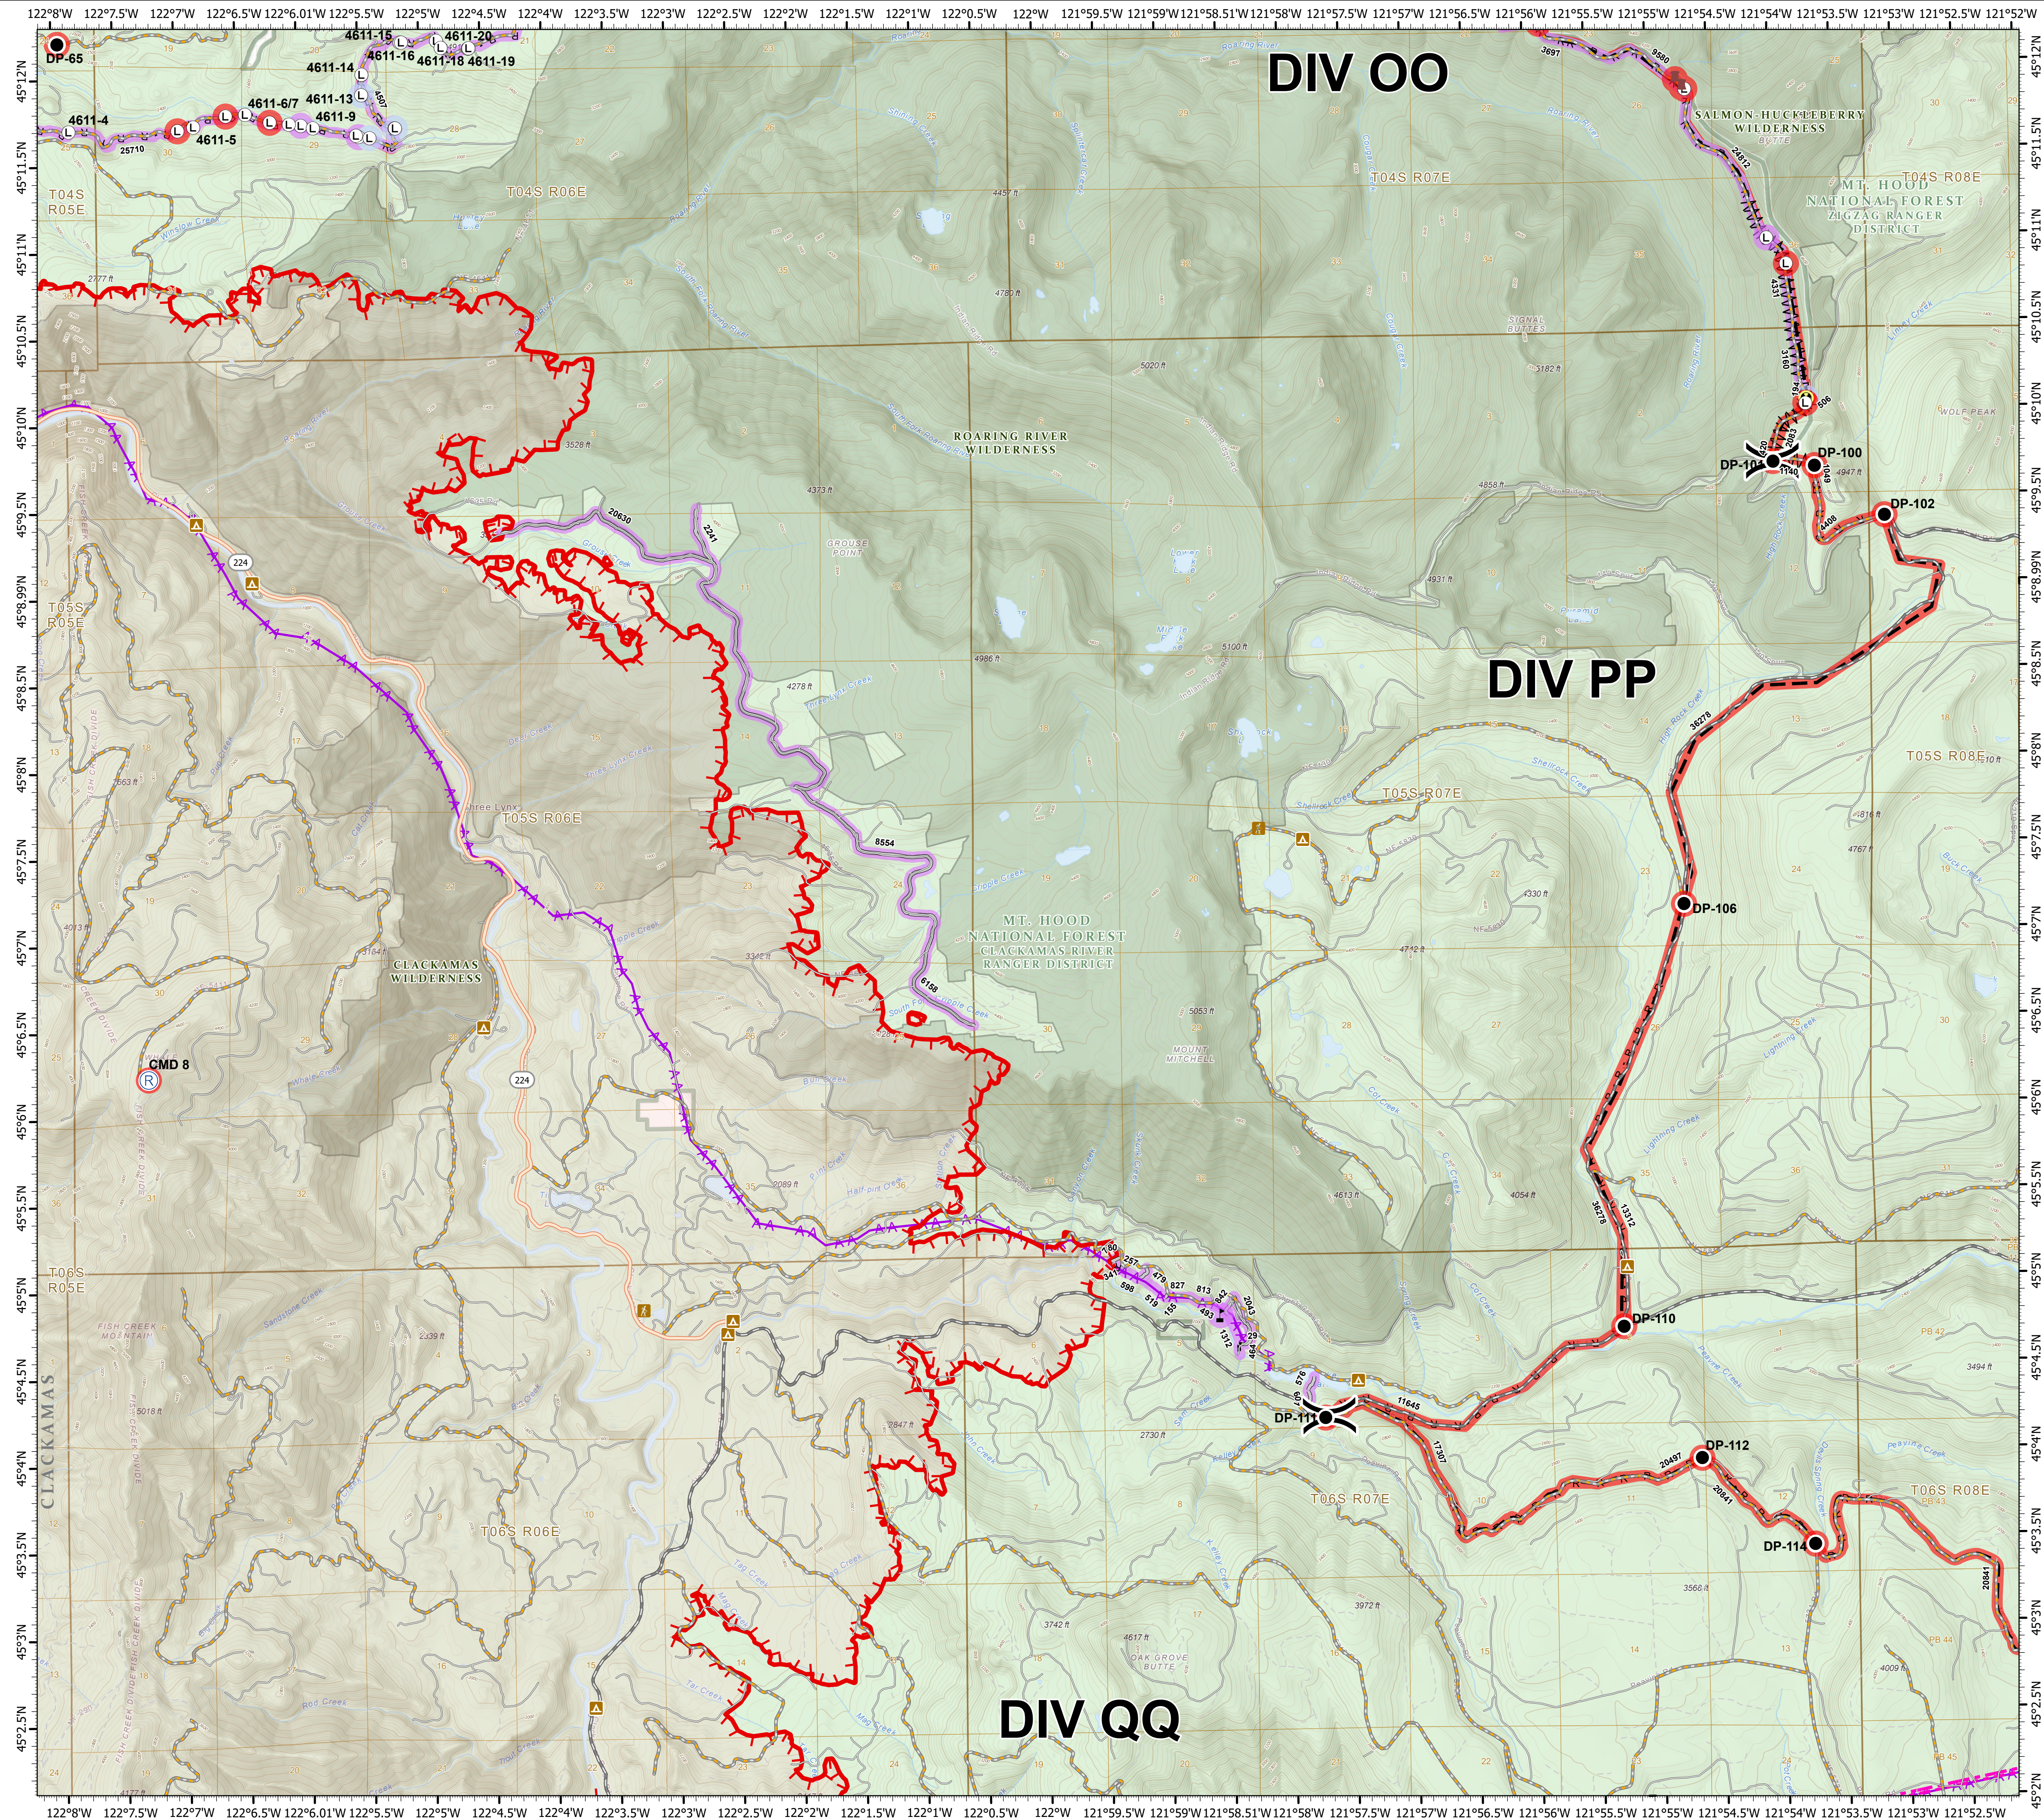
FC Line Type	Repair Status	Repair Comments	Length Feet
Road as Completed Line	Unknown		780
Road as Completed Line	Repair Needed	Light chipping needed	420
Road as Completed Line	Repair Needed	Sweeping of debris	1049
Road as Completed Line	Repair Needed	Sweeping of debris and light chipping need at intersection of DP-102	4408
Road as Completed Line	Repair Needed	Chipping needed to clear ditches	11645
Road as Completed Line	Repair Needed	Chipping needed north of Shelrock Campground	13312
Road as Completed Line	Repair Needed	Chipping needed	20497
Planned Fire Line	Unknown		464
Planned Fire Line	Repair Needed	Equipment currently masticating (9/28). Crews may be needed to break up and spread highly concentrated material in the ditch	17307
Planned Fire Line	Repair Needed	Equipment currently masticating (9/28). Crews may be needed to break up and spread highly concentrated material in the ditch	17307
Planned Fire Line	Repair Needed	Chipping needed	20841

Planned Fire Line	Repair Needed	Chipping needed	20841
Planned Fire Line	Repair Needed	Road grading, remove berms, repair cut and fill slopes (marked separately), and chipping. See map.	24812
Planned Fire Line	Repair Needed	Chipping needed throughout NF 58 and entry to NF 5830 and NF 150. Crews needed to sweep debris.	36278
Other	Unknown		257
Other	Unknown		479
Other	Unknown		493
Other	Unknown		519
Other	Unknown		598
Other	Unknown		813
Other	Unknown		827
Other	Unknown		1312
Line Break Completed	Unknown		3160
Line Break Completed	Unknown		4331
Line Break Completed	Repair Needed	Light chipping and sweeping needed	1140
Line Break Completed	Repair Needed	Logs in ditch need to be removed. Chip smaller material. Berms need to be knocked down. Rocky debris behind shoulder needs additional repair	2083
Completed Dozer Line	Repair Needed	Pull in berms, may not be needed until log deck is removed	194
Completed Dozer Line	Repair Needed		506
