Suppression Repair

Beachie Creek
ORWIF-200299
Riverside 5
10/04/20
Page: 5

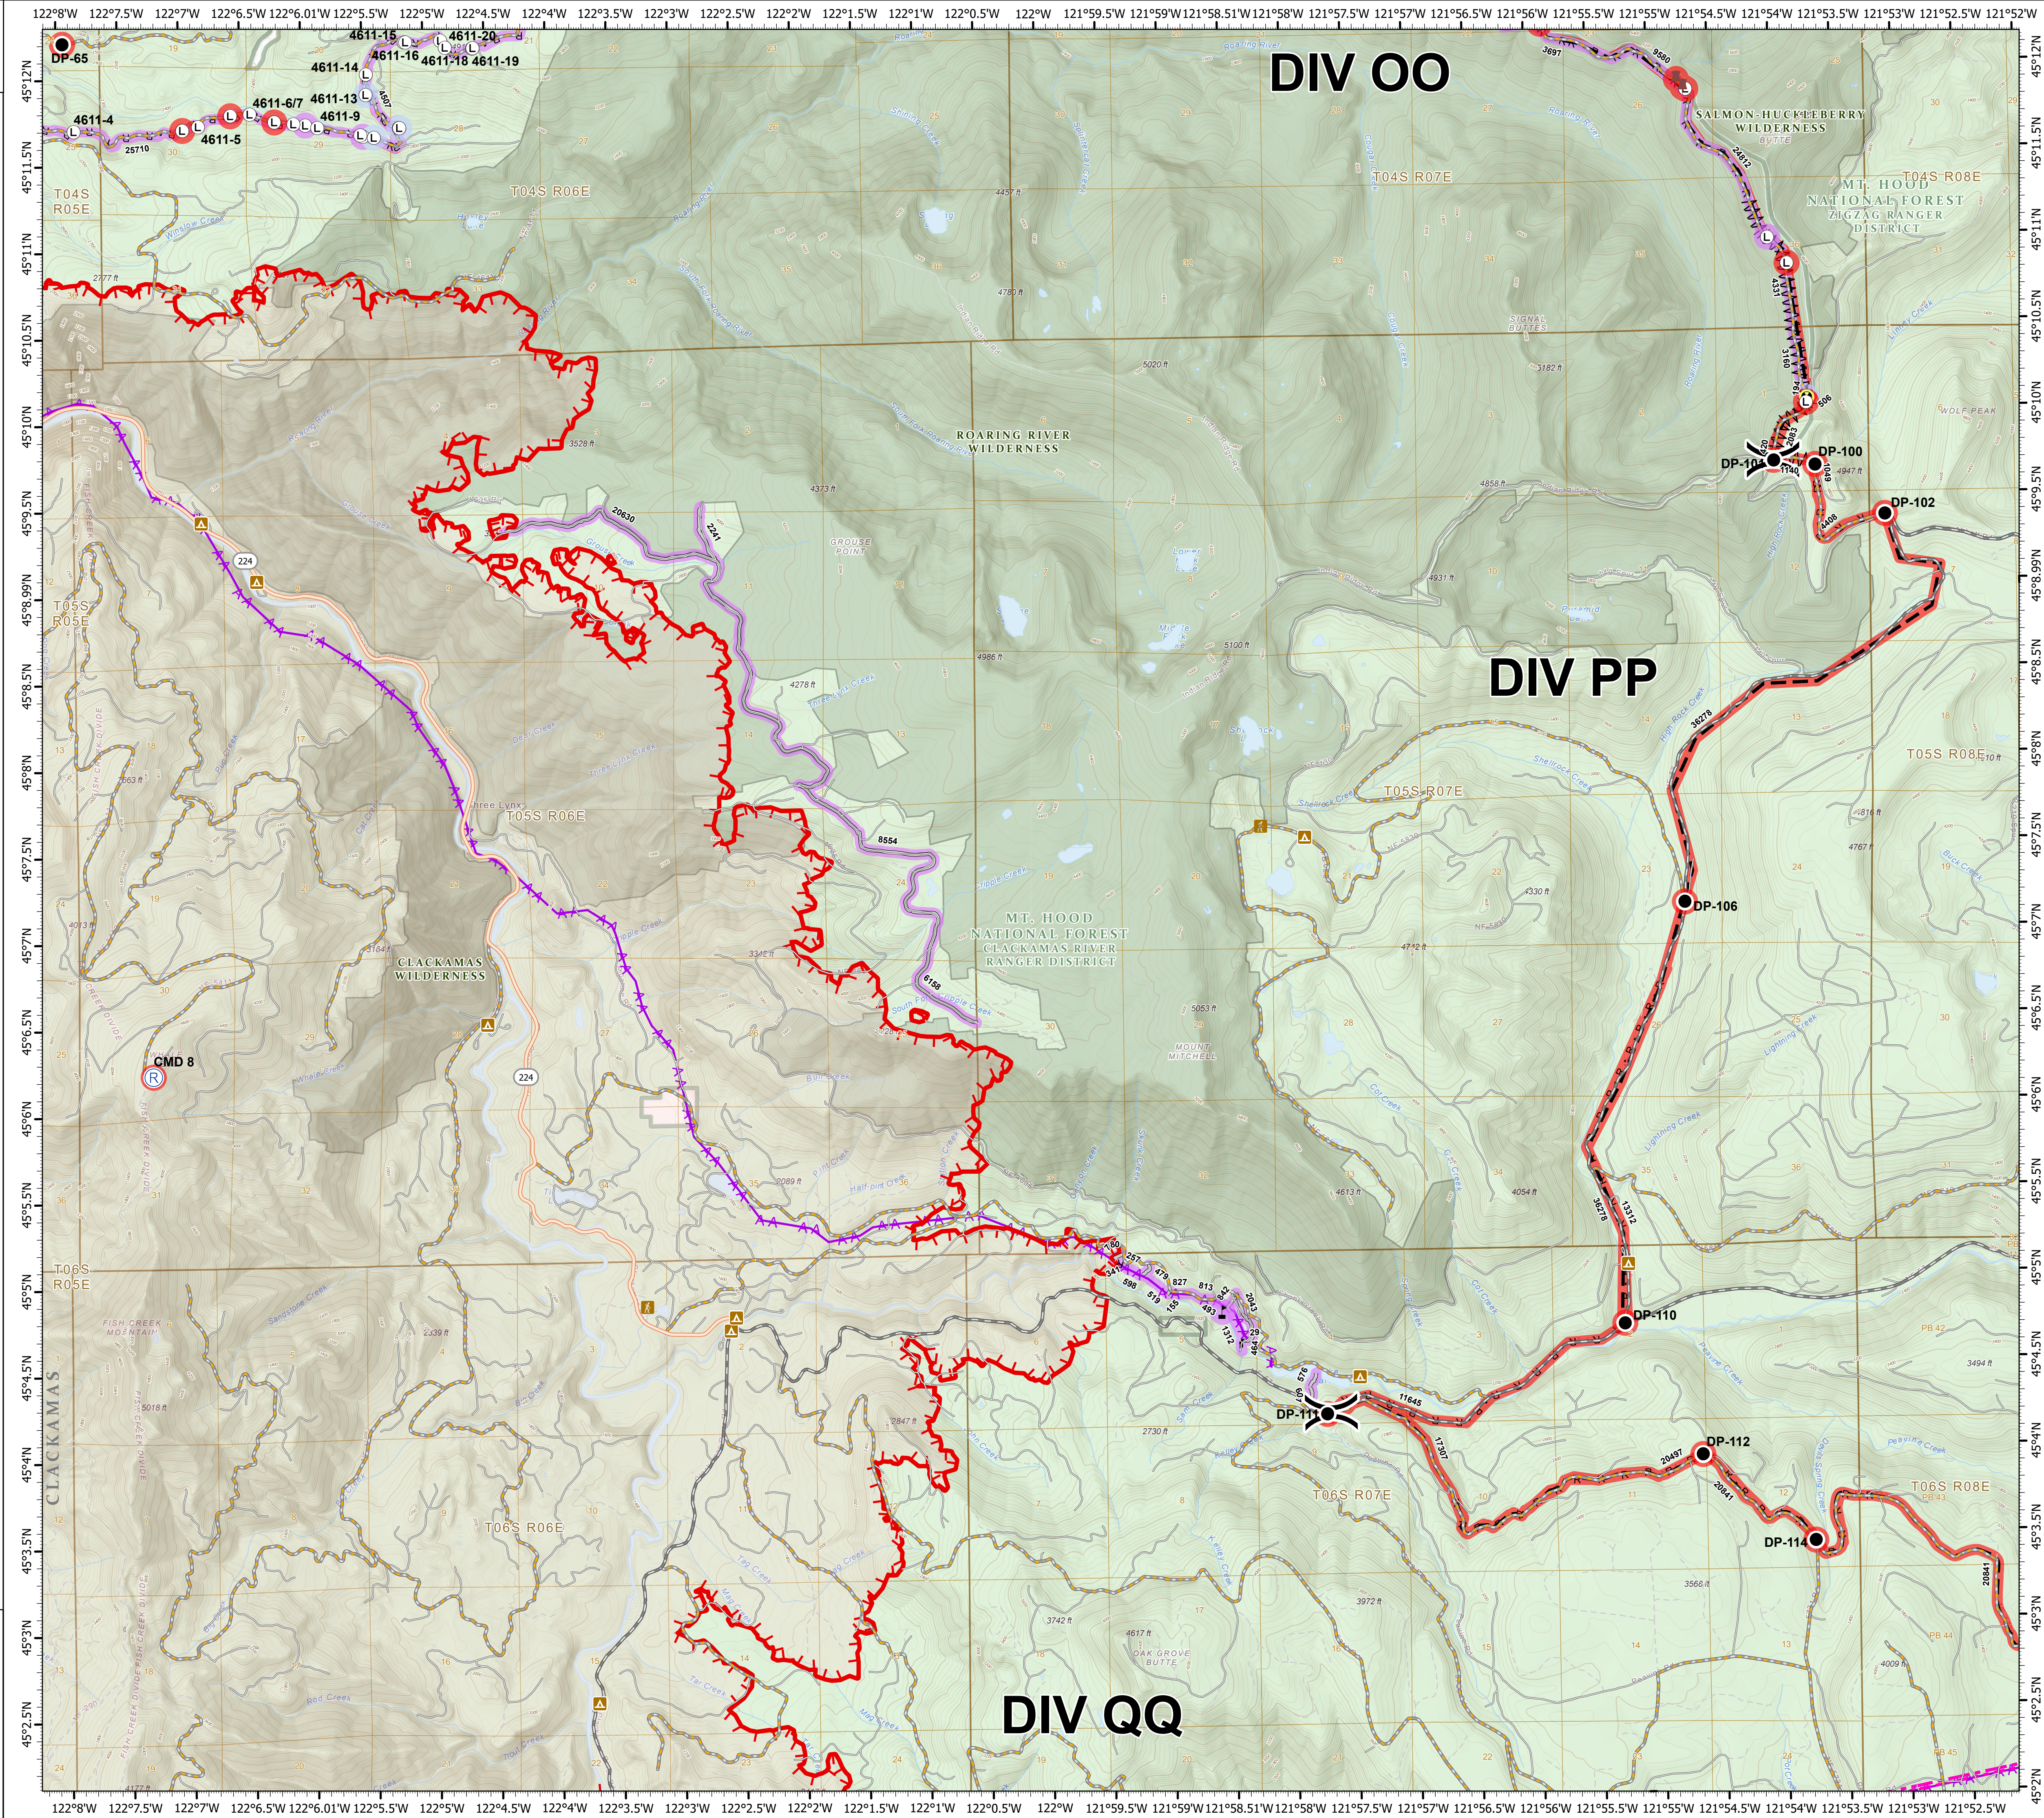
FC Line Type	Repair Status	Repair Comments	Length Feet
Road as Completed Line	Unknown		780
Road as Completed Line	Repair Needed	Light chipping needed	420
Road as Completed Line	Repair Needed	Sweeping of debris	1049
Road as Completed Line	Repair Needed	Sweeping of debris and light chipping need at intersection of DP-102	4408
Road as Completed Line	Repair Needed	Chipping needed to clear ditches	11645
Road as Completed Line	Repair Needed	Chipping needed north of Shelrock Campground	13312
Road as Completed Line	Repair Needed	Chipping needed	20497
Planned Fire Line	Unknown		464
Planned Fire Line	Repair Needed	Equipment currently masticating (9/28). Crews may be needed to break up and spread highly concentrated material in the ditch	17307
Planned Fire Line	Repair Needed	Equipment currently masticating (9/28). Crews may be needed to break up and spread highly concentrated material in the ditch	17307
Planned Fire Line	Repair Needed	Chipping needed	20841

Planned Fire Line	Repair Needed	Chipping needed	20841
Planned Fire Line	Repair Needed	Road grading, remove berms, repair cut and fill slopes (marked separately), and chipping. See map.	24812
Planned Fire Line	Repair Needed	Chipping needed throughout NF 58 and entry to NF 5830 and NF 150. Crews needed to sweep debris.	36278
Other	Unknown		257
Other	Unknown		479
Other	Unknown		493
Other	Unknown		519
Other	Unknown		598
Other	Unknown		813
Other	Unknown		827
Other	Unknown		1312
Line Break Completed	Unknown		3160
Line Break Completed	Unknown		4331
Line Break Completed	Repair Needed	Light chipping and sweeping needed	1140
Line Break Completed	Repair Needed	Logs in ditch need to be removed. Chip smaller material. Berms need to be knocked down. Rocky debris behind shoulder needs additional repair	2083
Completed Dozer Line	Repair Needed	Pull in berms, may not be needed until log deck is removed	194
Completed Dozer Line	Repair Needed		506
