# Suppression Repair

Beachie Creek  
ORWIF-200299  
Riverside  
ORMHF-000859  
**Beachie 7**

10/09/20  
Page: 14

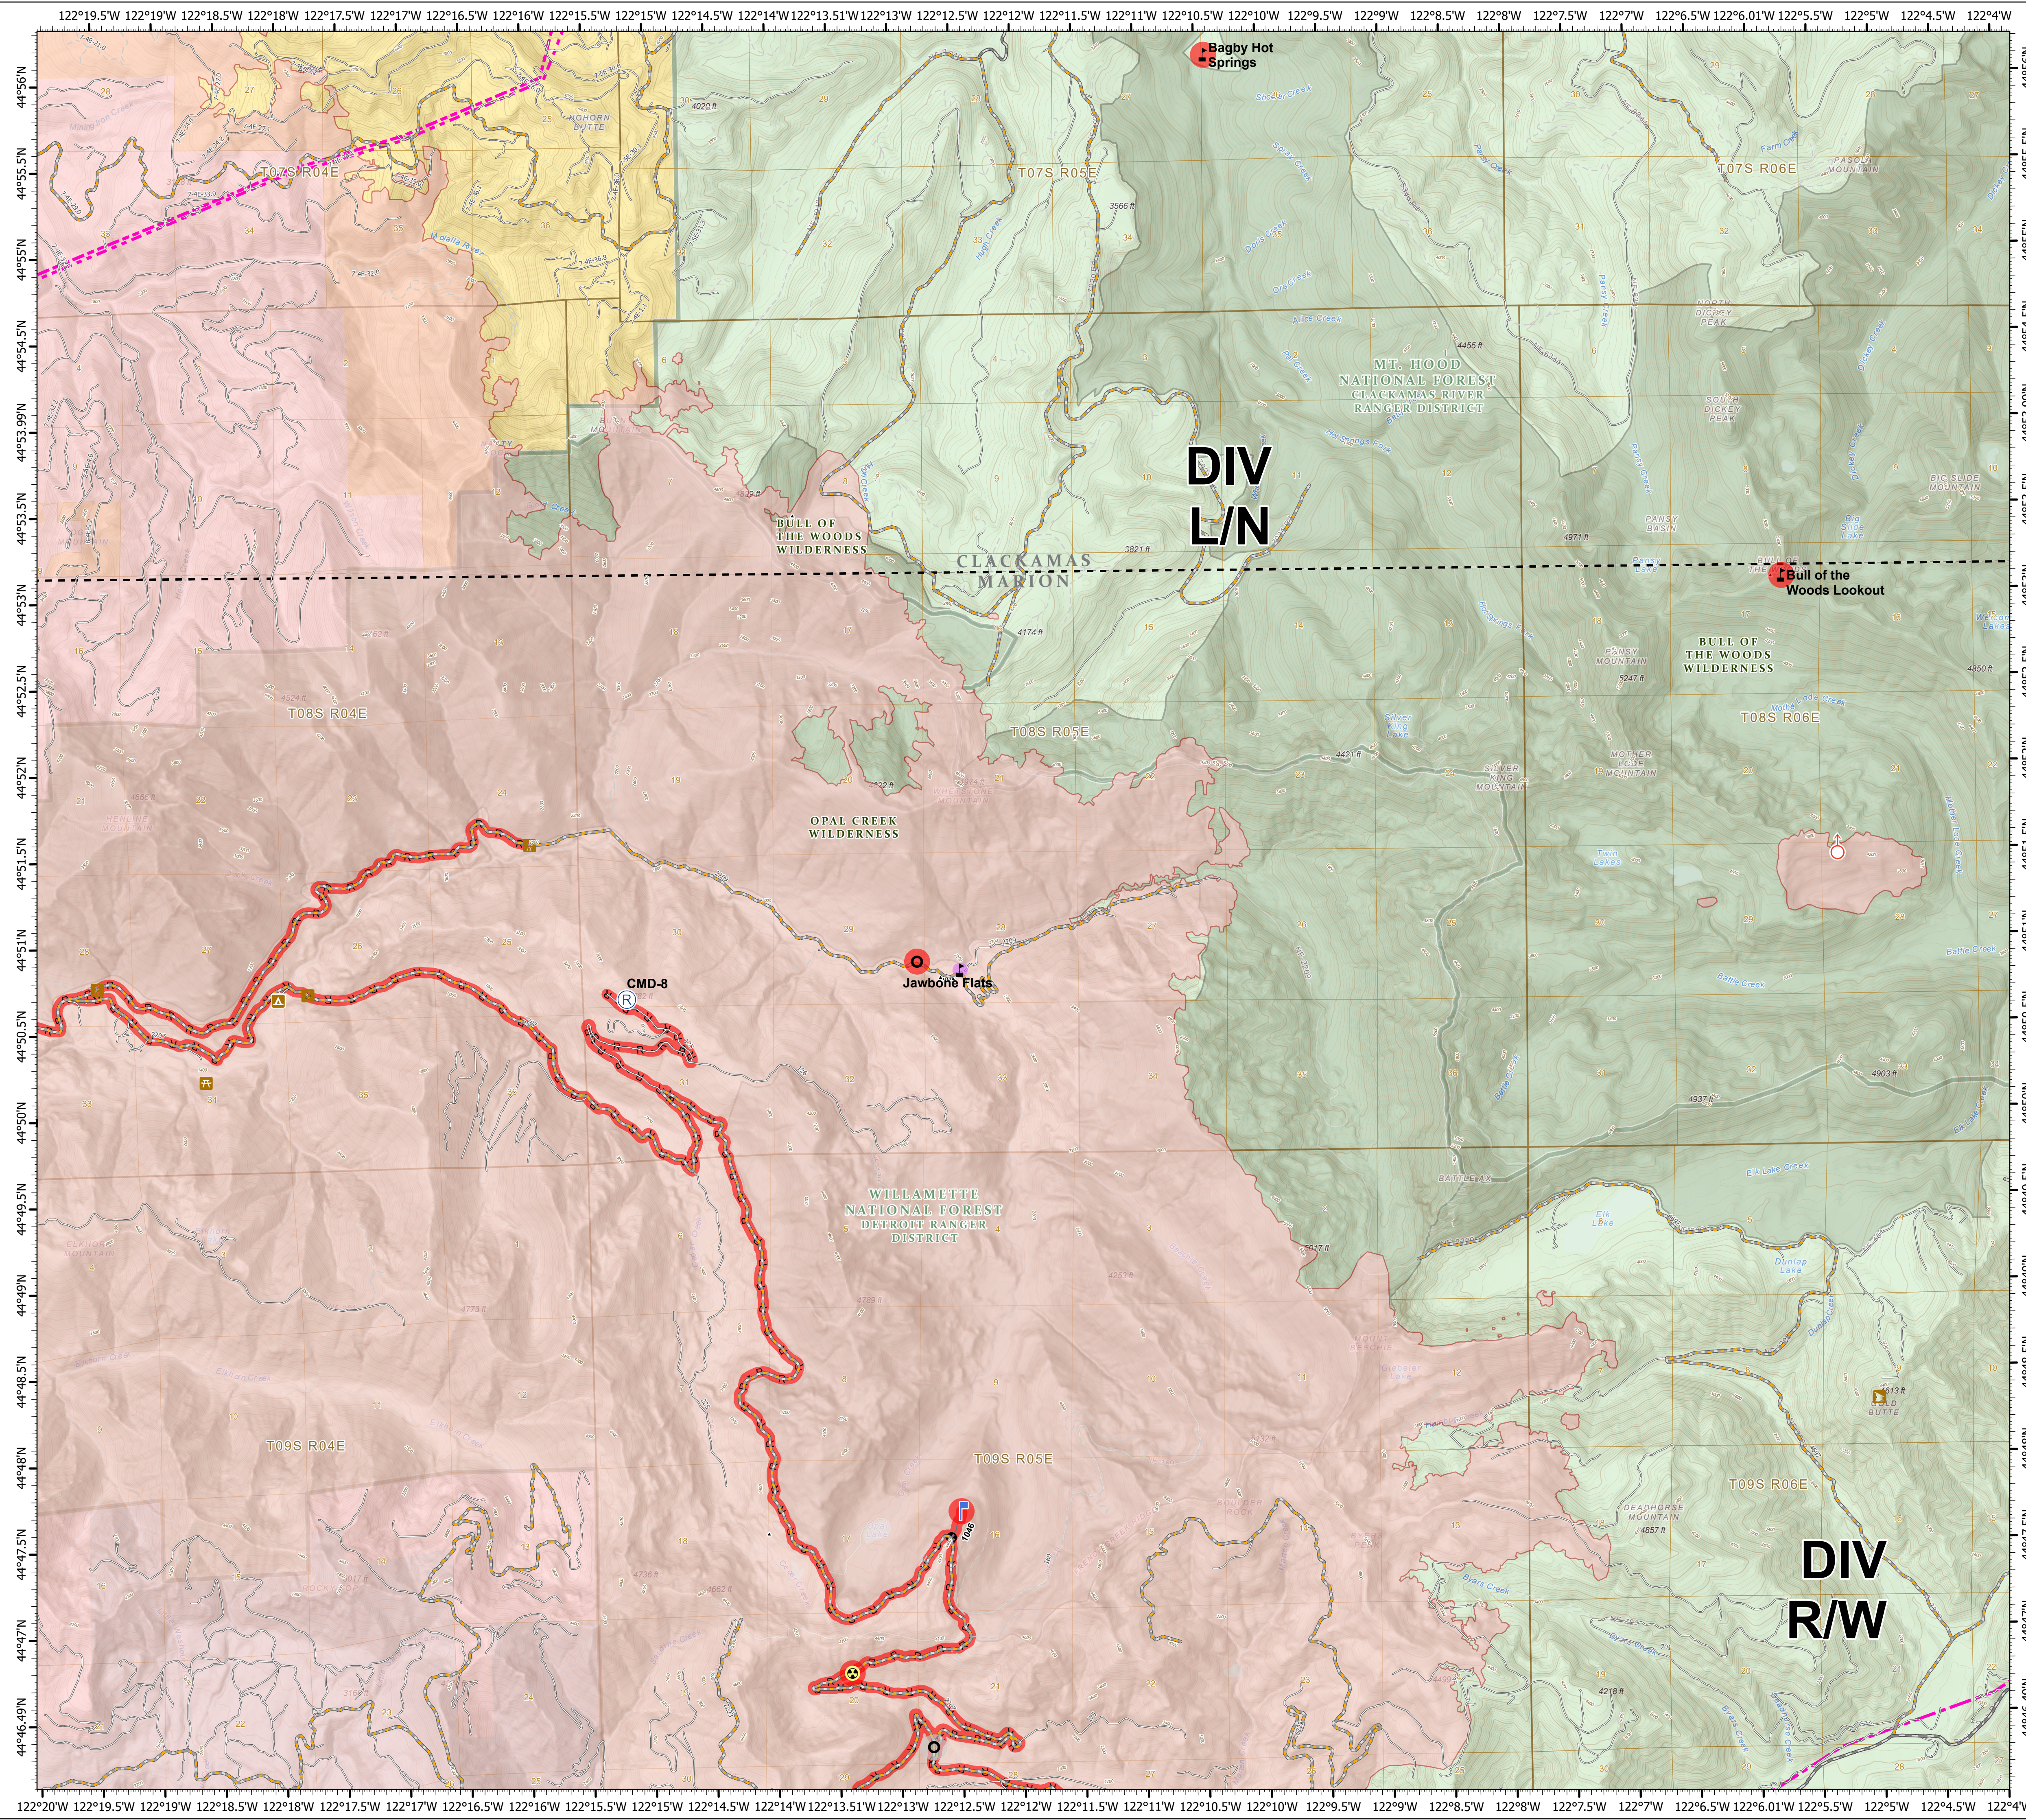
FC Point Type	Repair Status	Repair Comments	Label
Culvert	Other - See Comments	BAER ALERT - FSR 2223, MP 4.32, remove and replace with 34" x 24" culvert.	
Culvert	Repair Needed		
Hazard	Repair Needed	Scaling? Excavator?	
Lookout	Repair Needed		
Repeater	Unknown		CMD-8
Spot Fire	Unknown		
Value at Risk	Repair Needed		Bagby Hot Springs
Value at Risk	Repair Needed		Bull of the Woods Lookout
Value at Risk	Unknown		Jawbone Flats

FC Line Type	Repair Status	Repair Comments	Length Feet
Road as Completed Line	Repair Needed	Road as Line Needed to be Added and Repaired	
Road as Completed Line	Repair Needed	Road as Line Needed to be Added and Repaired	
Road as Completed Line	Repair Needed	Road as Line Needed to be Added and Repaired	
Road as Completed Line	Repair Needed	Road as Line Needed to be Added and Repaired	
Road as Completed Line	Repair Needed	Road as Line Needed to be Added and Repaired	
Road as Completed Line	Repair Needed	Road as Line Needed to be Added and Repaired	
Other	Repair Needed	Cover with brush. Pull flagging	1046
