# Suppression Repair

Beachie Creek  
ORWIF-200299  
Beachie 7

Riverside  
ORMHF-000859

10/08/20  
Page: 14

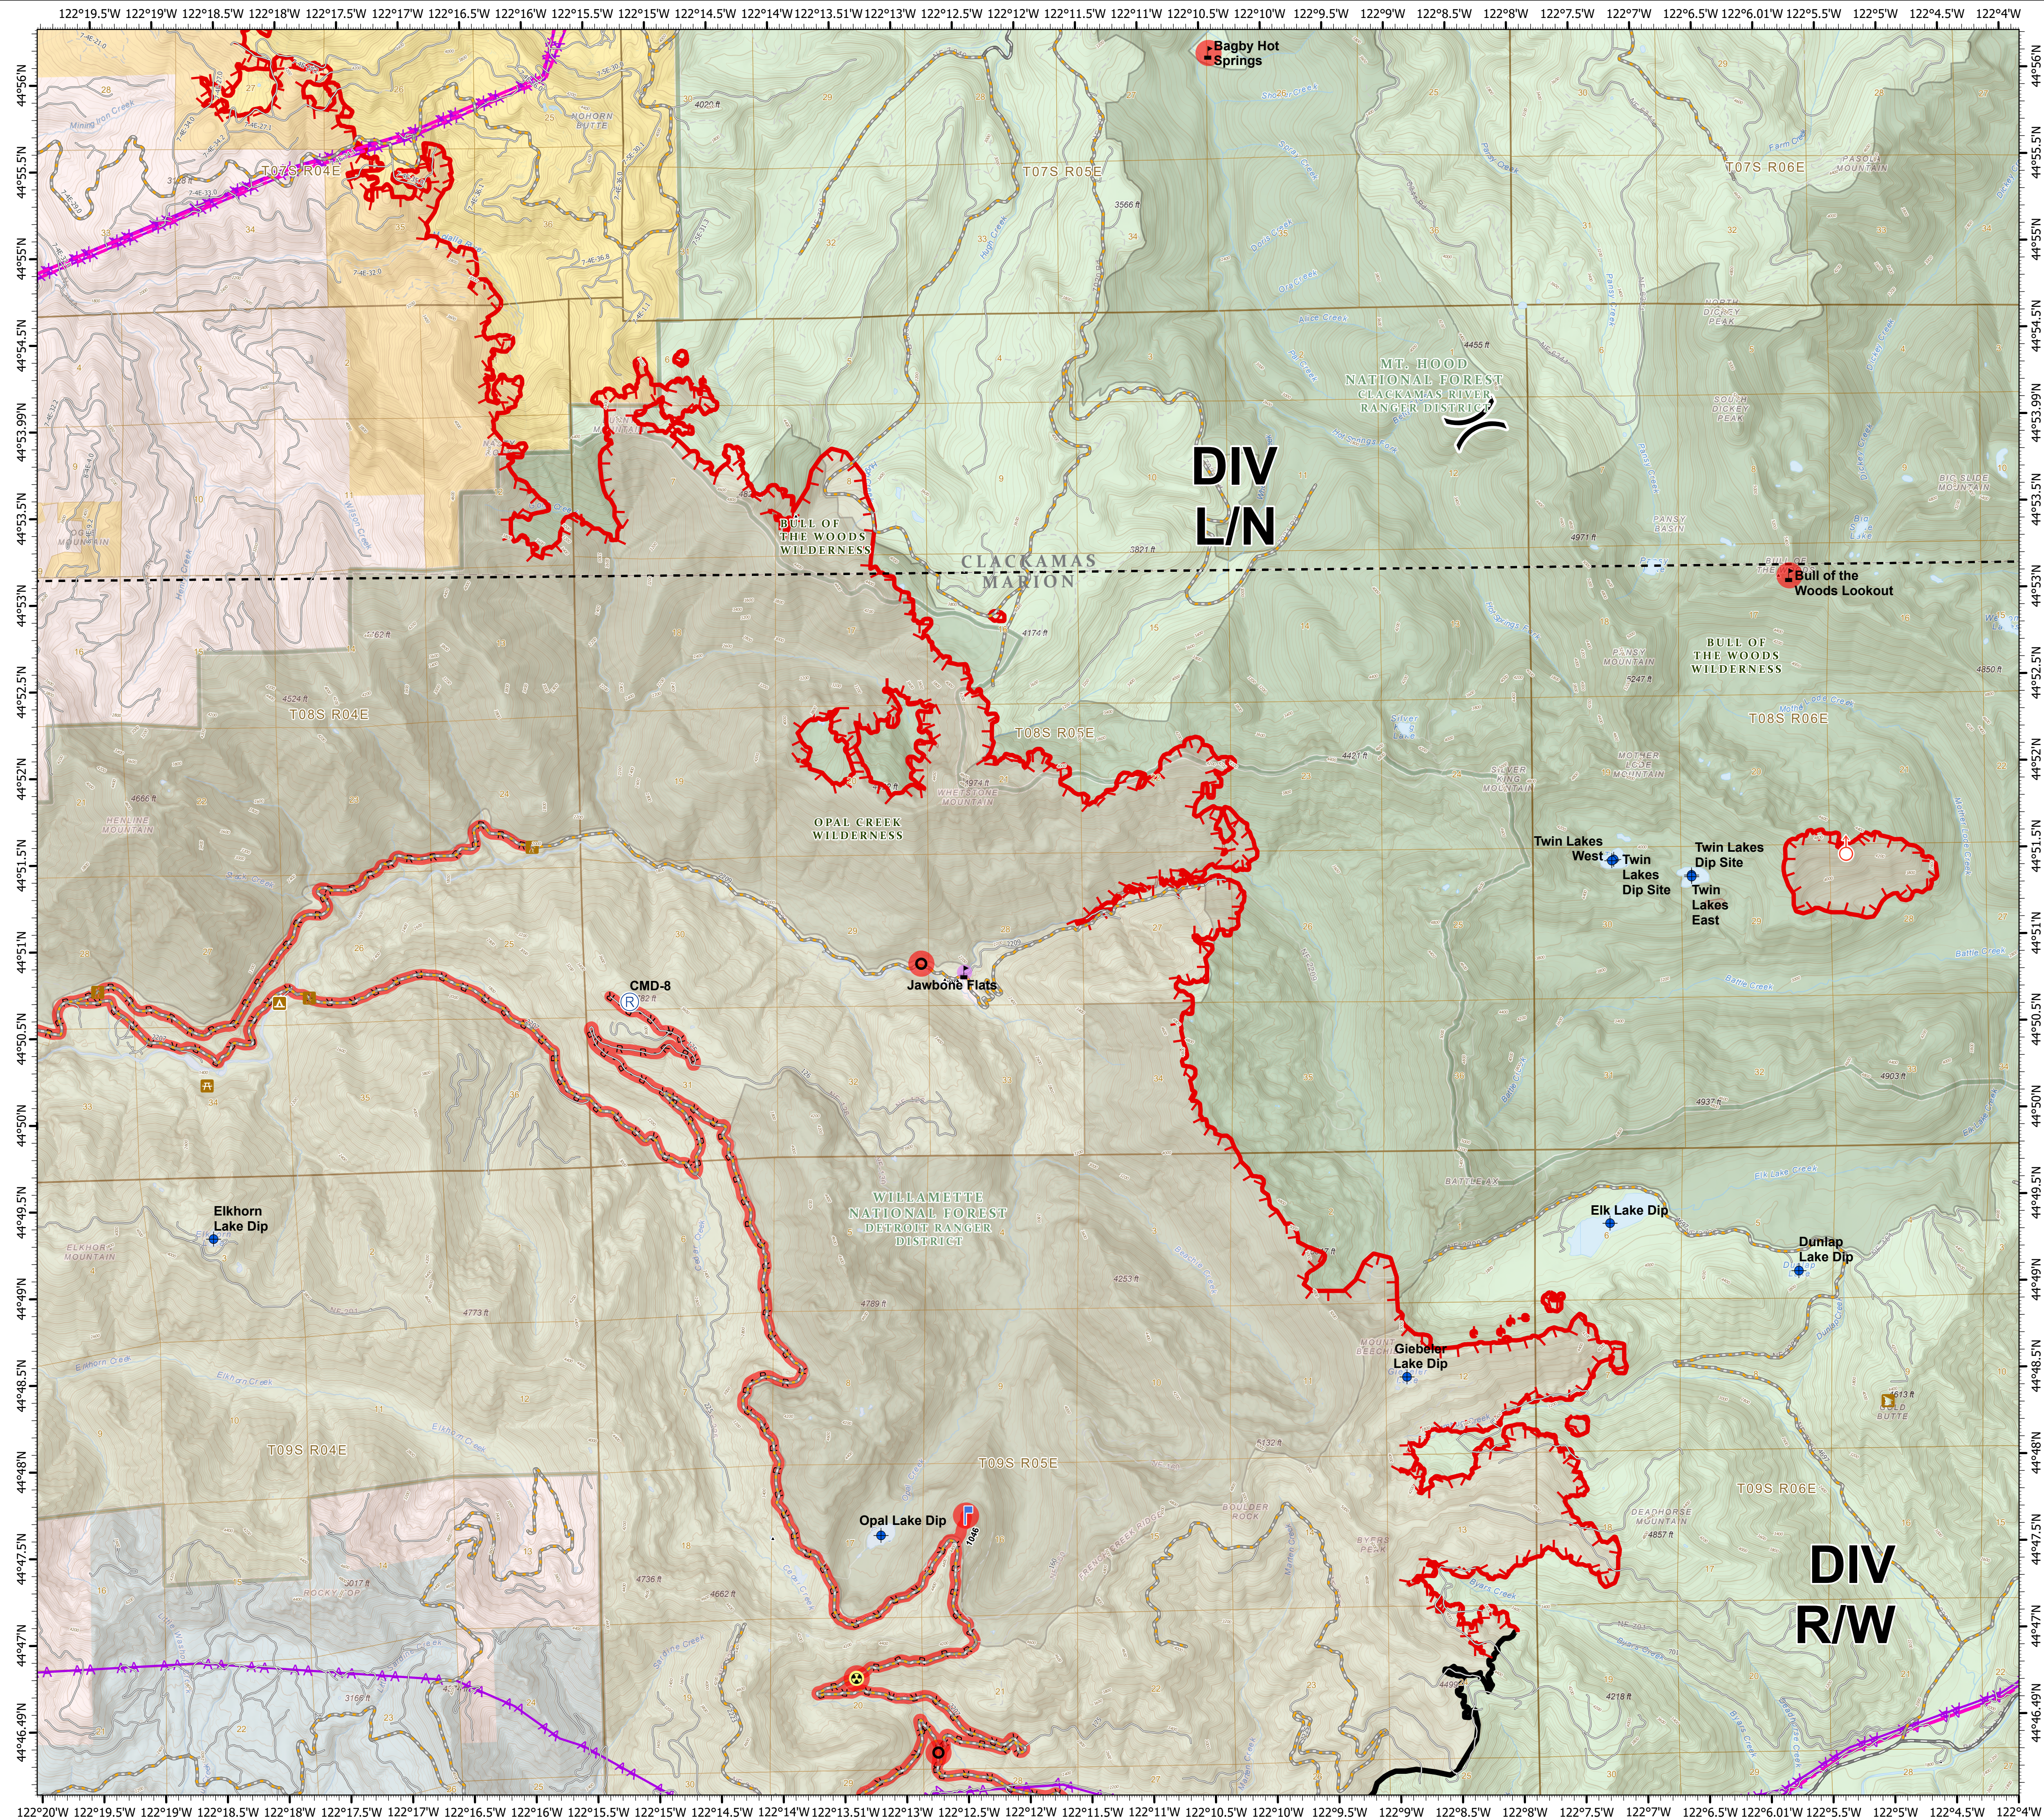
FC Point Type	Repair Status	Repair Comments	Label
Culvert	Repair Needed		
Culvert	Repair Needed	BAER ALERT - FSR 2223, MP 4.32, remove and replace with 36" x 24" culvert.	
Hazard	Repair Needed	Scaling? Excavator?	
Lookout	Repair Needed		
Repeater	Unknown		CMD-8
Spot Fire	Unknown		
Value at Risk	Repair Needed		Bagby Hot Springs
Value at Risk	Repair Needed		Bull of the Woods Lookout
Value at Risk	Unknown		Jawbone Flats

FC Line Type	Repair Status	Repair Comments	Length Feet
Road as Completed Line	Repair Needed	Road as Line Needed to be Added and Repaired	
Road as Completed Line	Repair Needed	Road as Line Needed to be Added and Repaired	
Road as Completed Line	Repair Needed	Road as Line Needed to be Added and Repaired	
Road as Completed Line	Repair Needed	Road as Line Needed to be Added and Repaired	
Road as Completed Line	Repair Needed	Road as Line Needed to be Added and Repaired	
Road as Completed Line	Repair Needed	Road as Line Needed to be Added and Repaired	
Other	Repair Needed	Cover with brush. Pull flagging	1046
