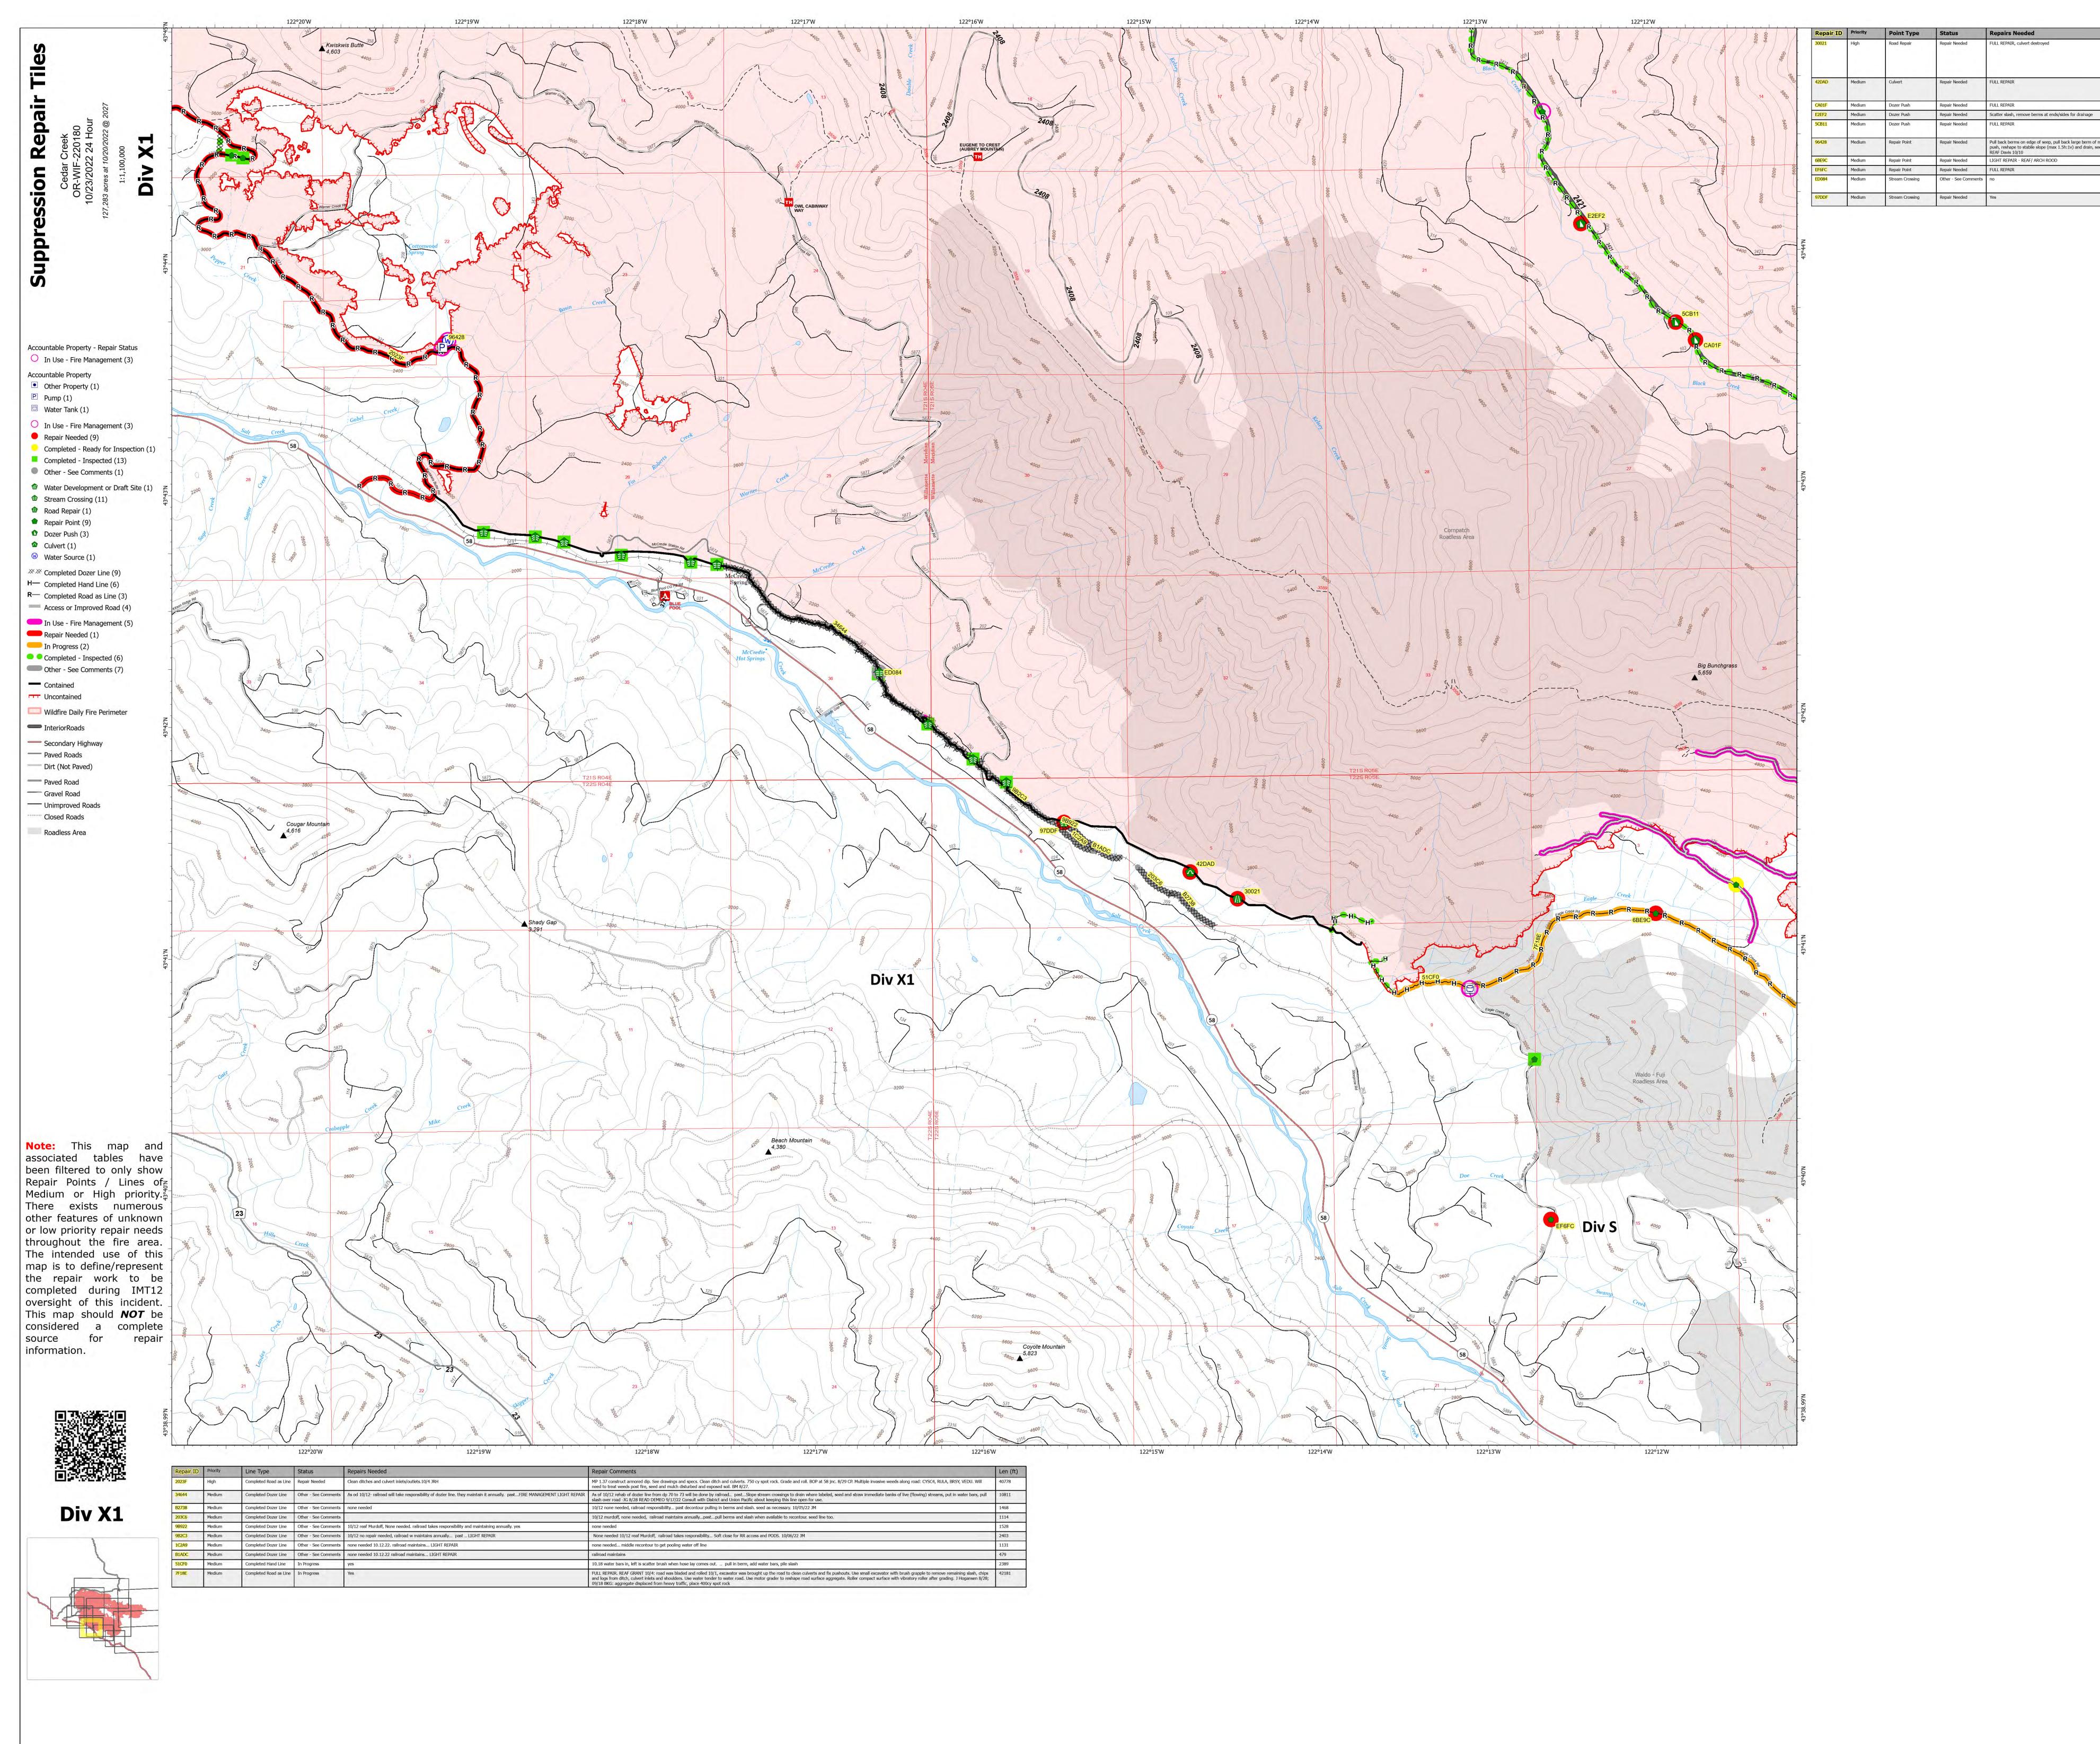
REAF RICHARDSON- 9/22/22. Full replacement of culvert. Fire burned out culvert and now the water from running stream has been diverted. Could lead to watershed and railroad below issues. Full replacement needed. Excavator with 6-way blade to dig new culvert. Compactor needed. // REAF ALLEN 09/27/22 Road to be decommissioned. Culvert will not be replaced. Remove rest of culvert with excavator. Dig out new stream bed. match the slope of stream. Add rock to bottom of new channel. clear any debris

Remove slash and rounds from side of road and channel, particularly south side of road, live class 3 stream) - Geertsen 10/11 / REAF ALLEN 9/25/22 Clear slash and debris from stream bed.

Clear culvert basin, pull out debris from and around culvert, clear ditch of debris- Geertsen 8/30 // REAF ALLEN 09/27/22 Culvert on South side of road has been flagged and labeled. Clear chips and debris away from culvert and out of streambed

pull debris out of channel, pull back debris piles away from outslope and 43° 41.558' N 122° 15.489' W

Edit (8/29 J Hogansen) End haul slash and waste to disposal site. Road is to remain open. Previous note follow - (Use slash and debris on site to return road to pre-fire condition cjb 08/28)

Repair Needed FULL REPAIR

Repair Needed LIGHT REPAIR - REAF/ ARCH ROOD
