# Community Dozer Repair West

# Community Dozer Repair East

## **Community Dozer Repair Standards:**

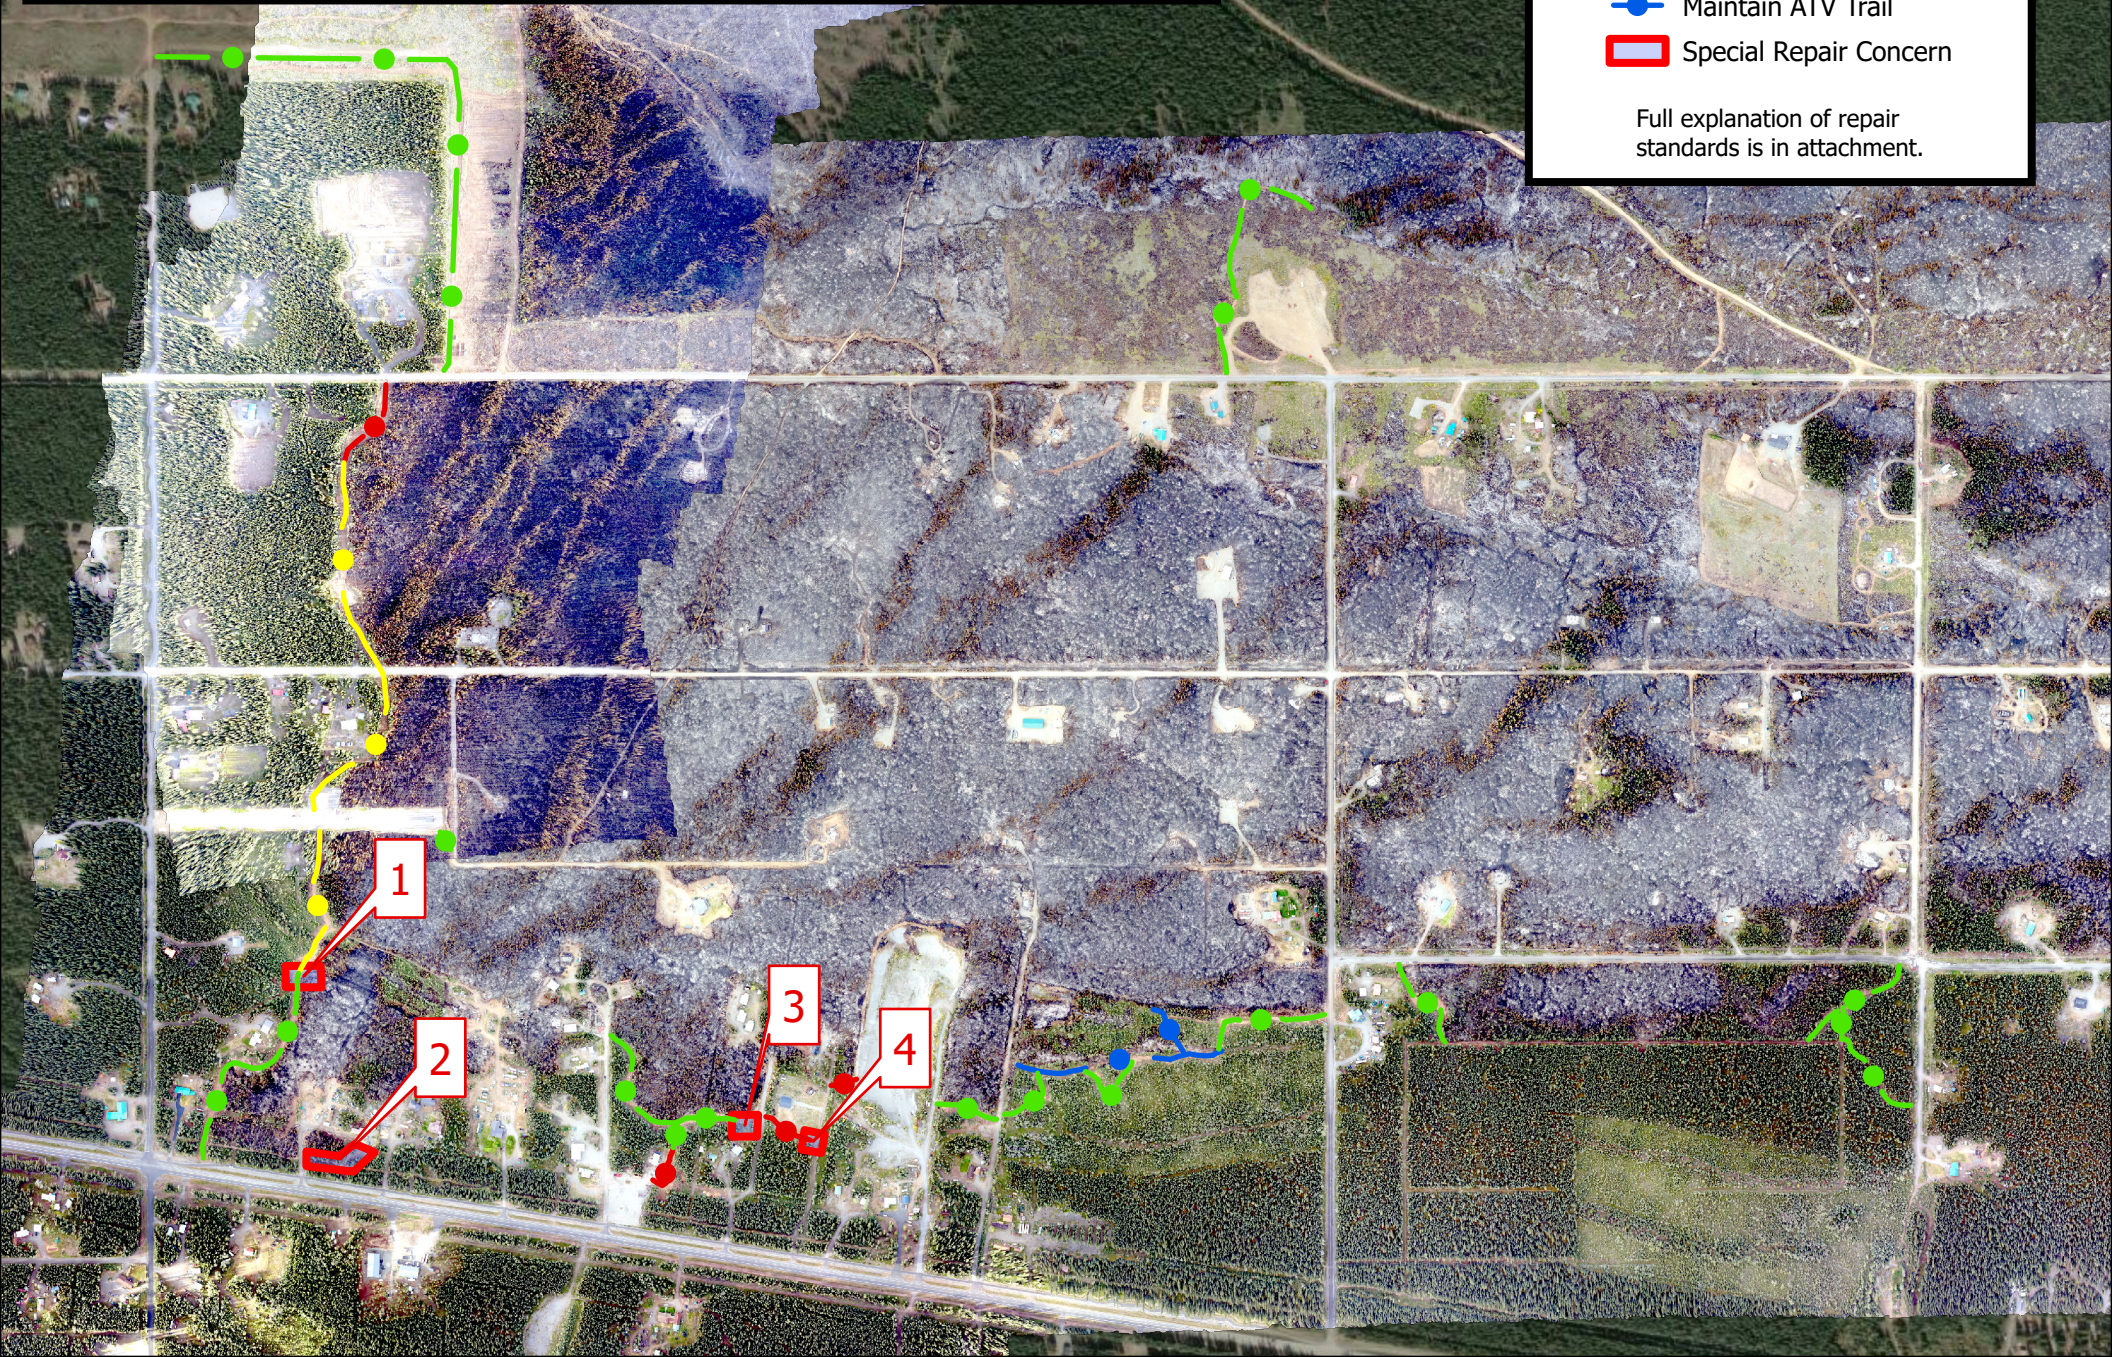
- Full Repair
- Partial Repair
- No Repair Needed
- Maintain ATV Trail
- Special Repair Concern

Full explanation of repair standards is in attachment.

**Full Repair:** Spread berms and slash back over the entire bladed surface, restore natural contour, and block the line to OHV access. Line is closed.

**Partial Repair:** Break down berms and spread material to reduce exposed mineral soil. Tease out and retain firewood-sized material on site to the greatest extent possible.

**No Repair Needed:** Landowner has directed that the line be left as-is. No work required.

**Maintain ATV Trail:** Break down berms and distribute vegetation over the bladed surface, leaving a passable 6-ft ATV trail. Do not block.

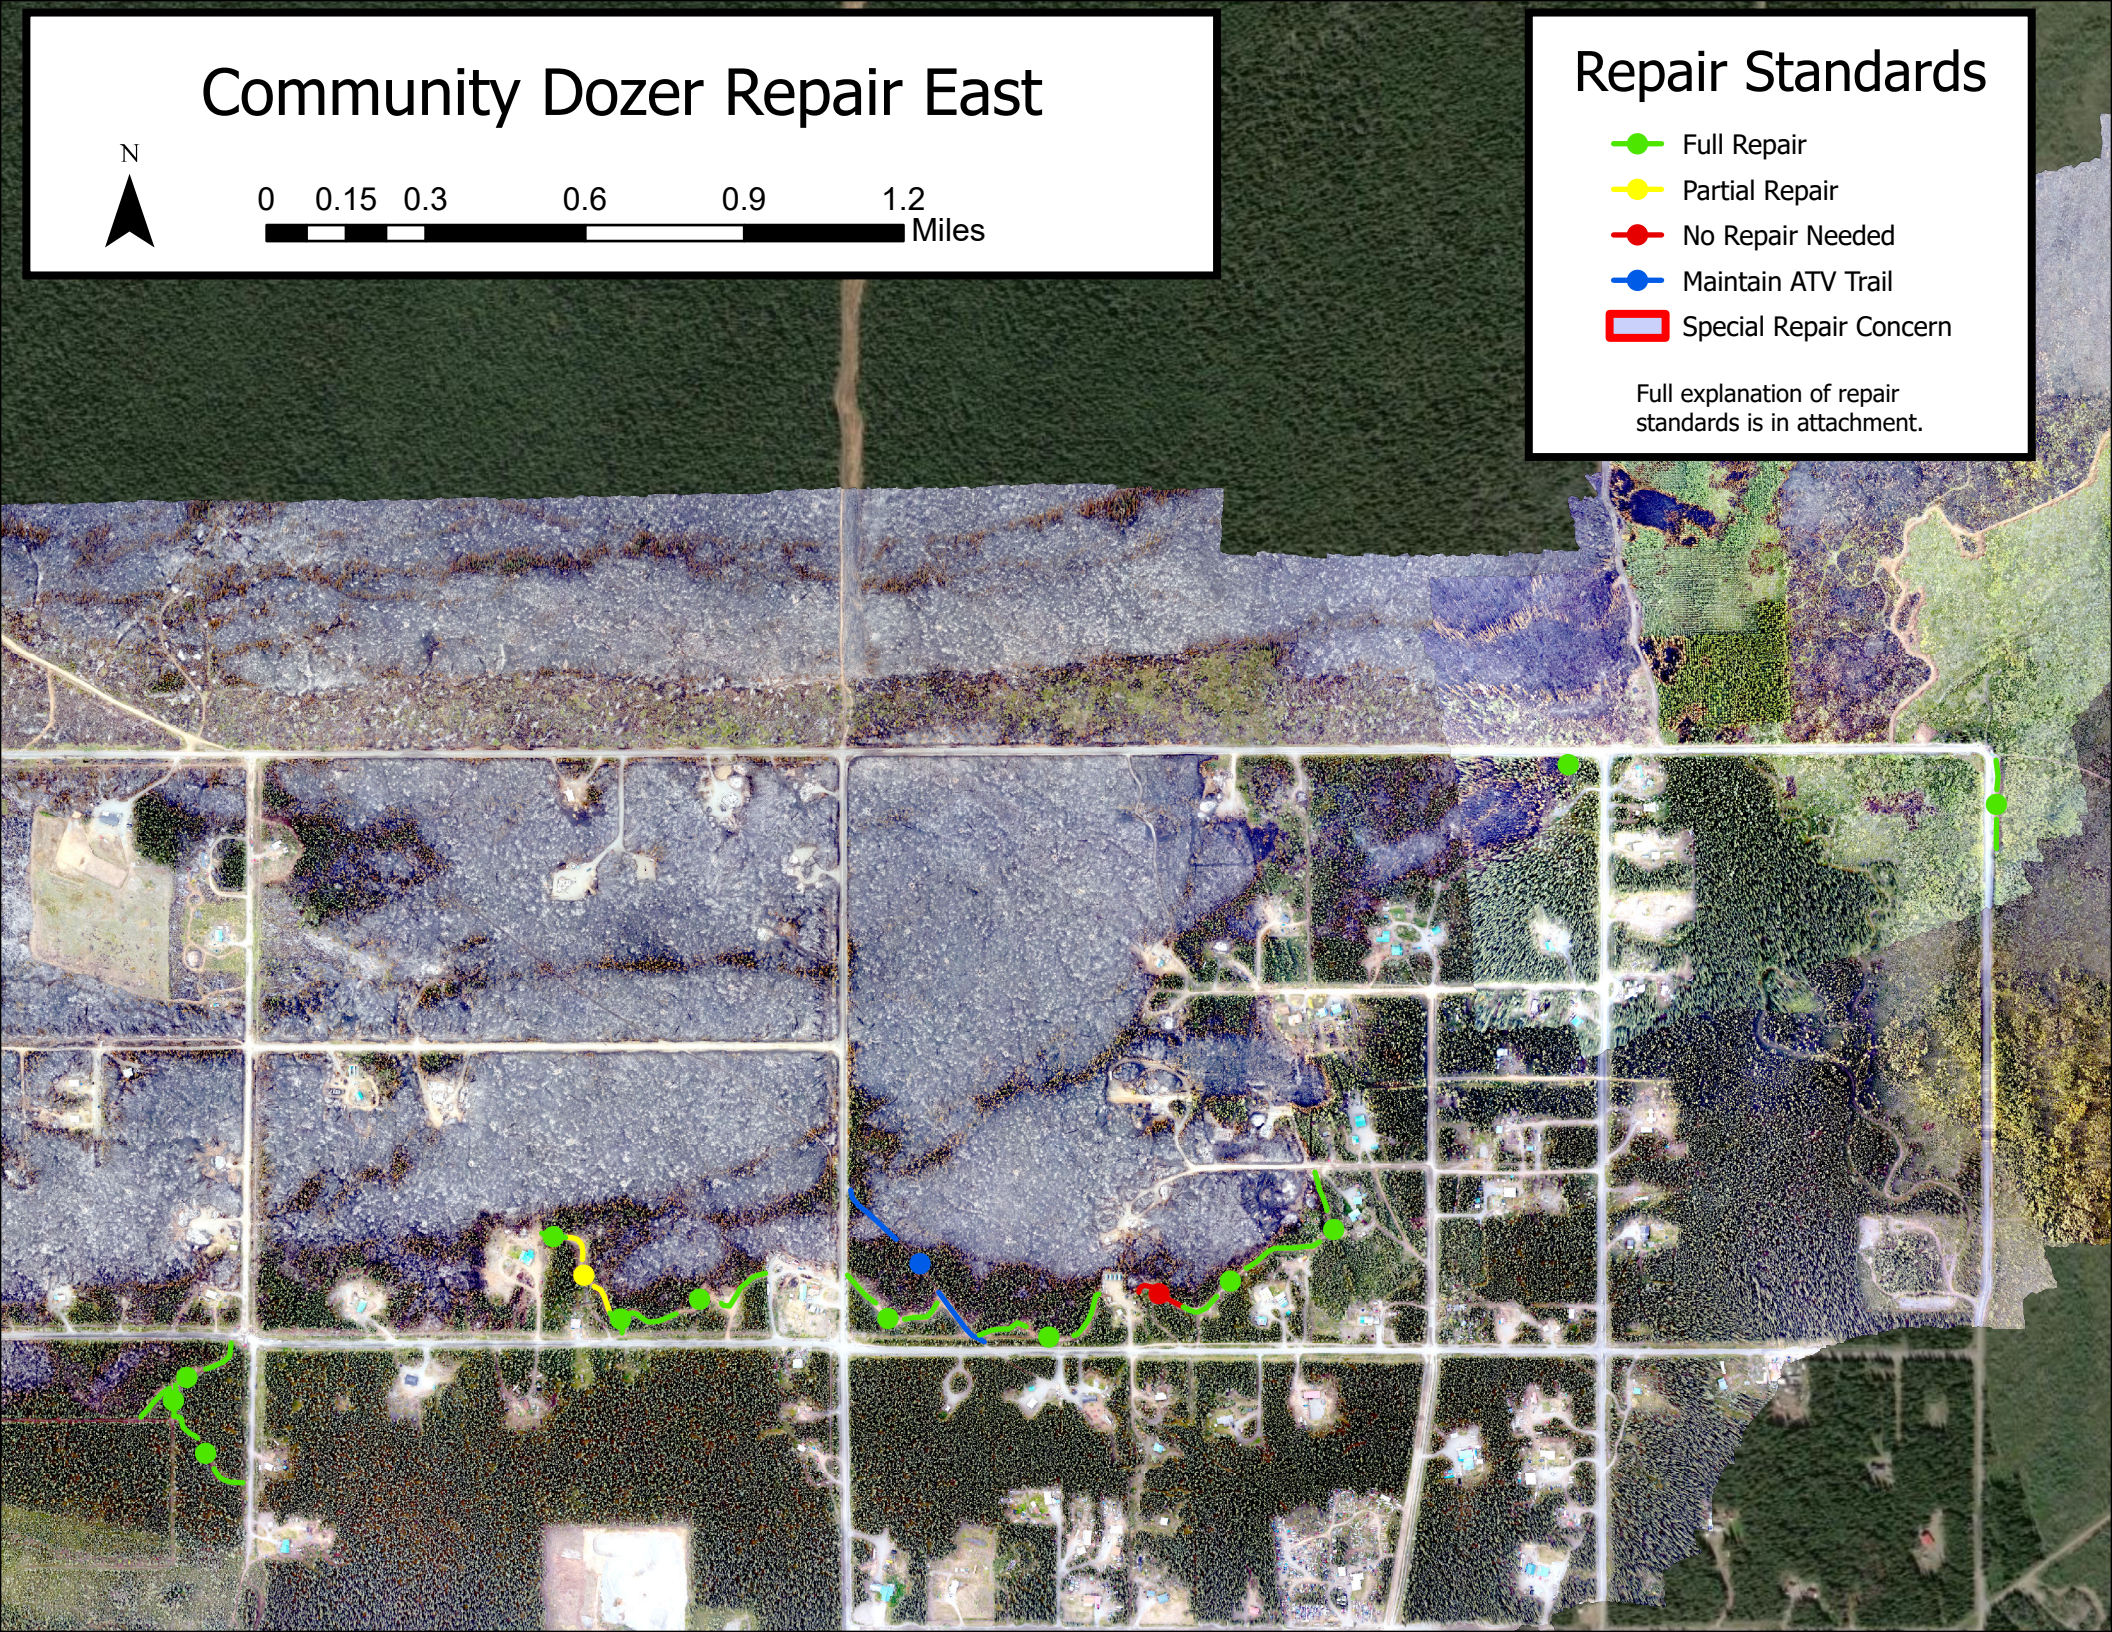
- Full Repair
- Partial Repair
- No Repair Needed
- Maintain ATV Trail
- Special Repair Concern

Full explanation of repair standards is in attachment.

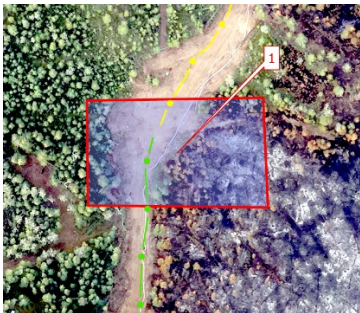
1. Survey Marker in the ground. Cap is missing. Attempt to locate and work around. Do Not Destroy, if possible.

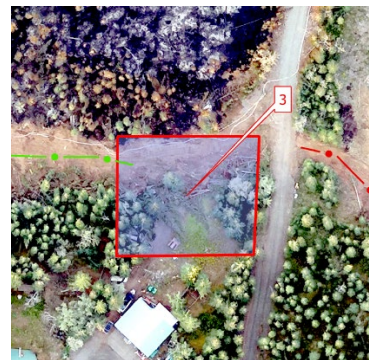
3. Dozed slash blocking preexisting pull-thru access. Reestablish access.

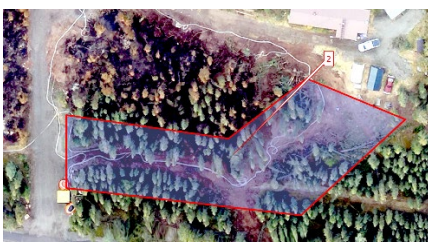
2. Pull slash from unburned forest and consolidate into few large piles for winter burning. Owner hopes to create new driveway over dozer scrape. Spread berms.

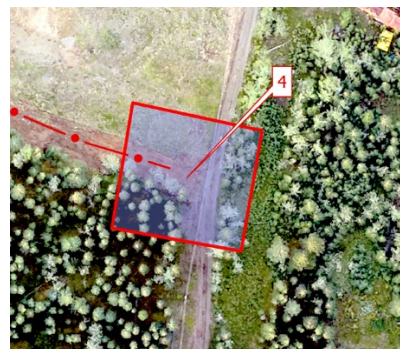
4. Level berm, but retain open dozer line.
