Natchez Fire 2018

Incident Number: OR-RSF-000348

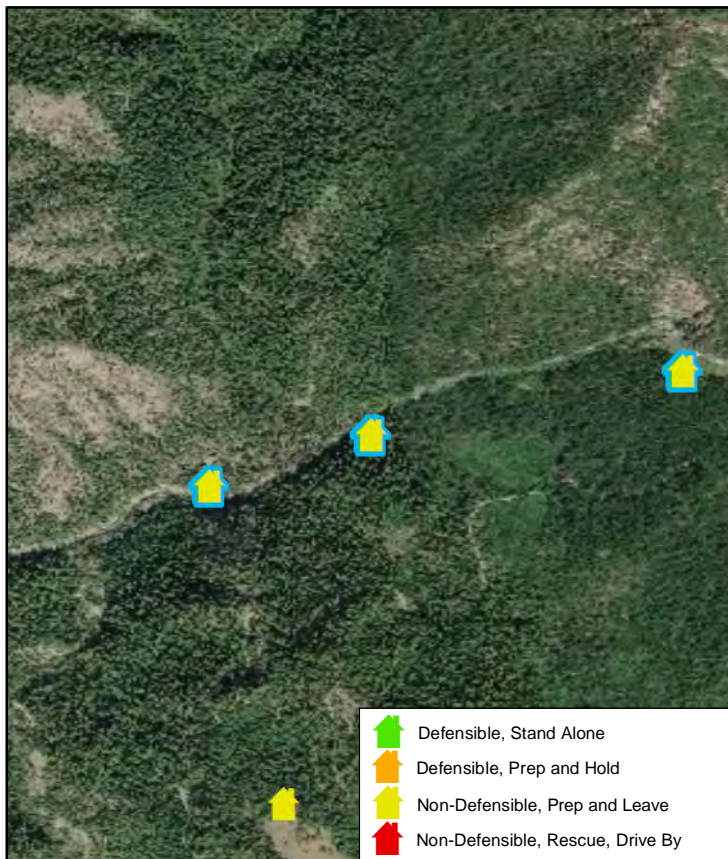
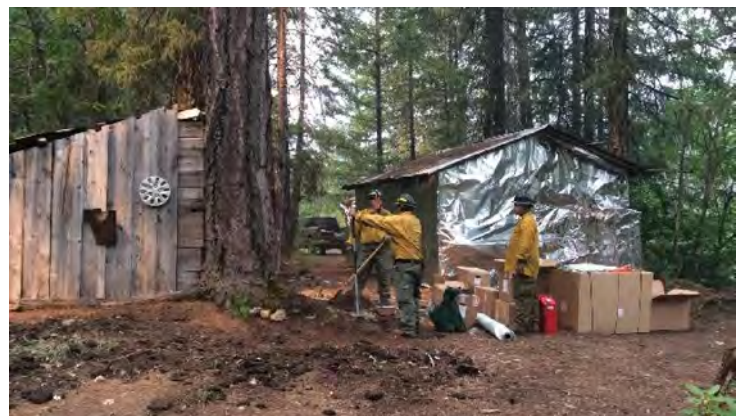
Hazards: Terrain,Fuels,NoTurnAround

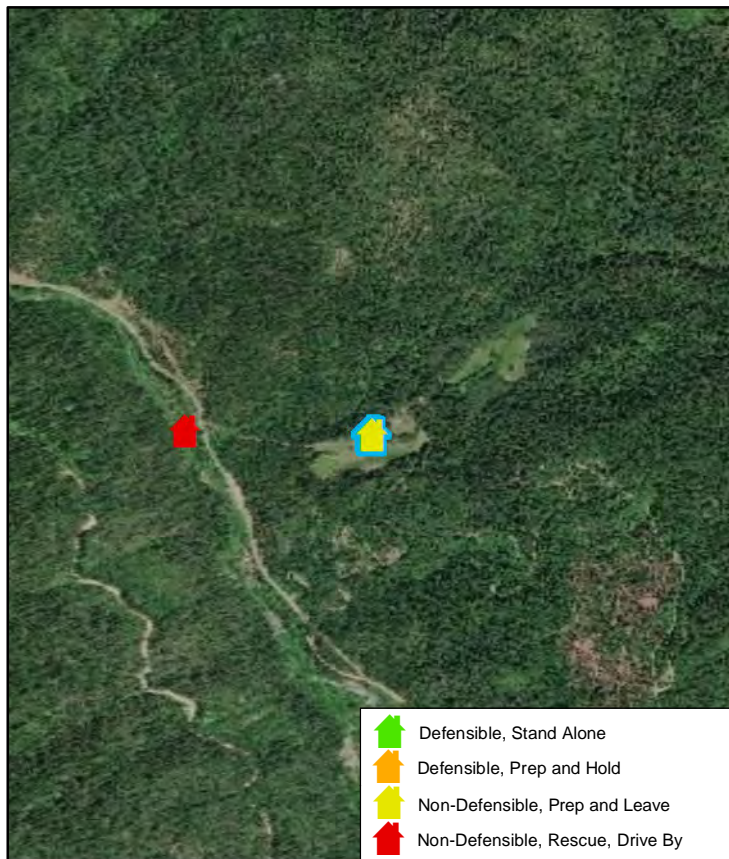
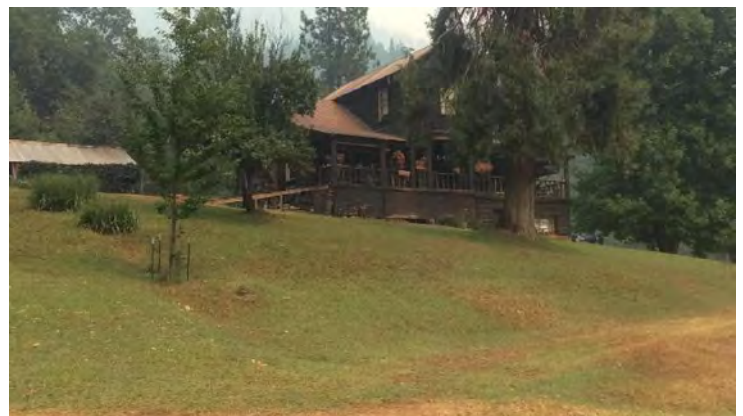
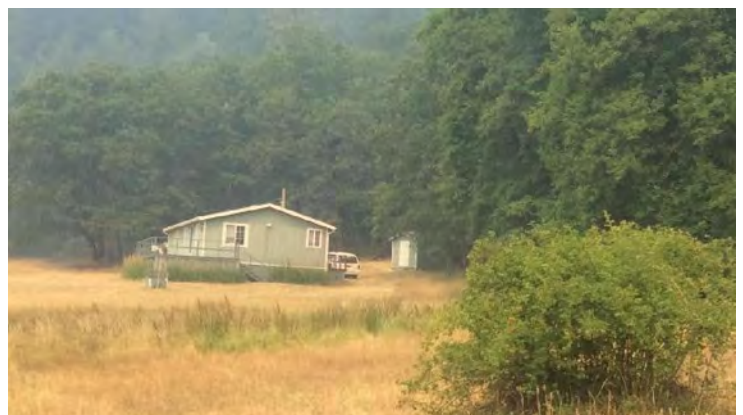
Hazards: **Other**

Hazard Notes: **Access. Narrow heavily timbered road for approximately one third if a mile off of 18N18 Road**

Resources Needed to Protect Structure: **Pump and kit, pumpkin, hose lay, sprinklers, etc.**

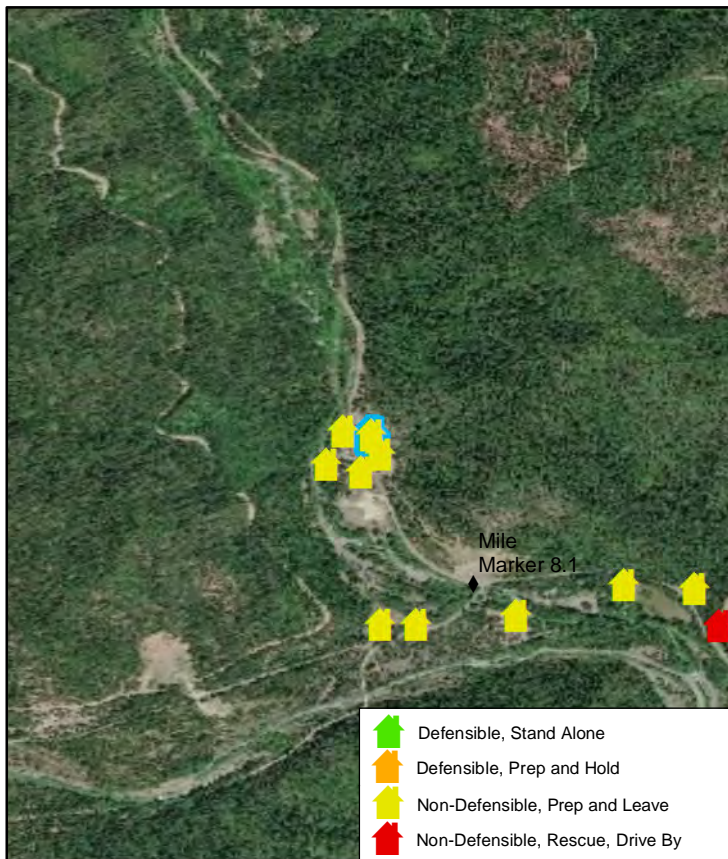
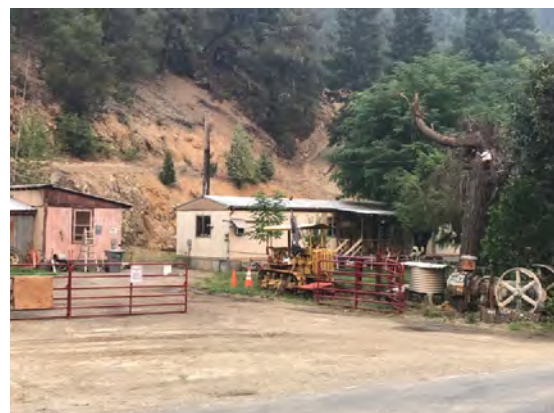
Hazards: **Adjacent to a yard of large earth moving equipment**

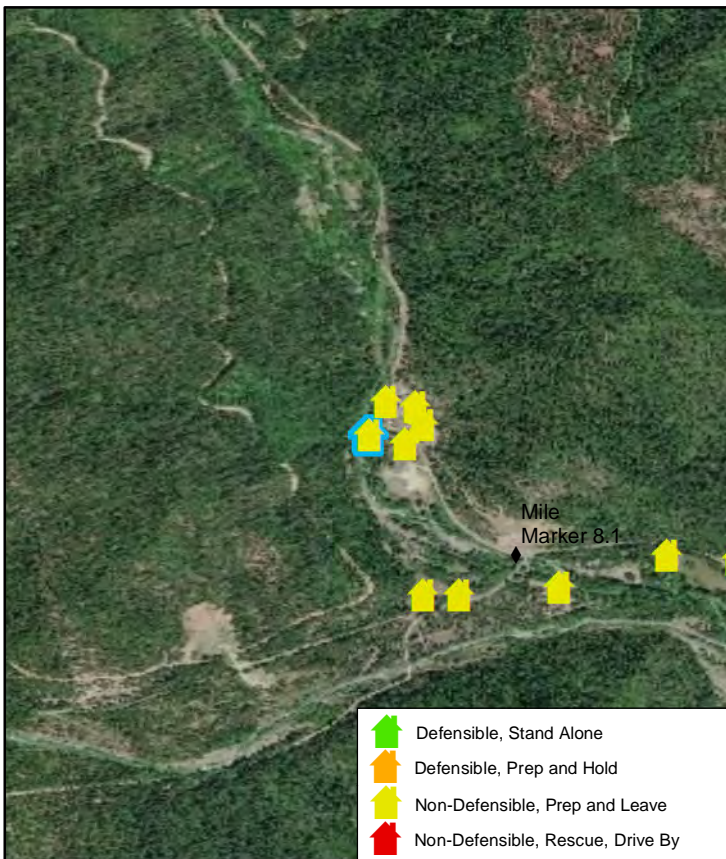
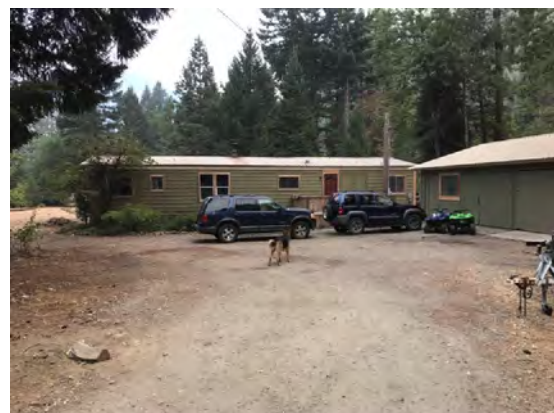
Notes: **Adjacent to a staging area for large earth moving equipment**

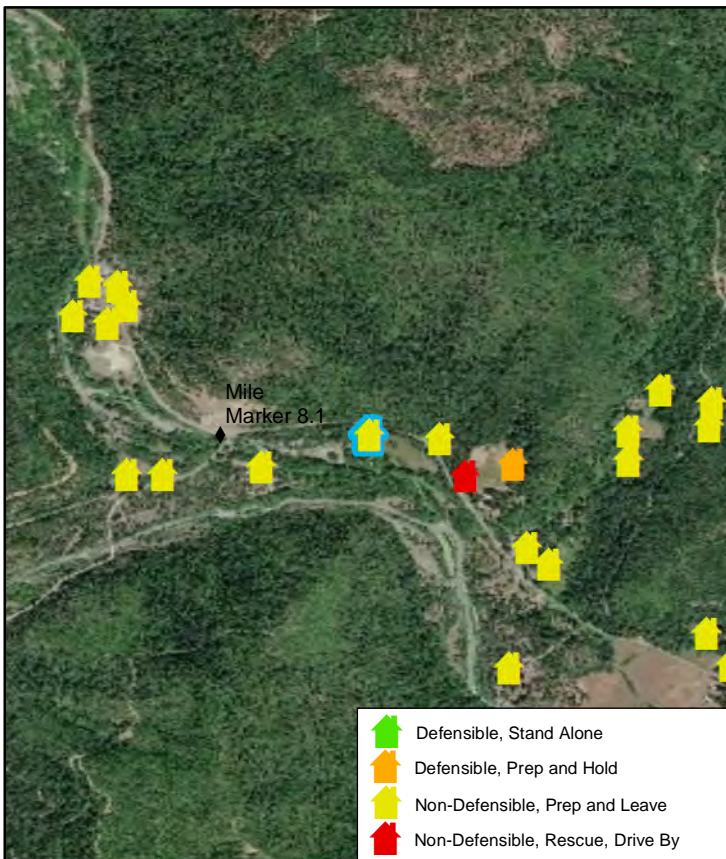
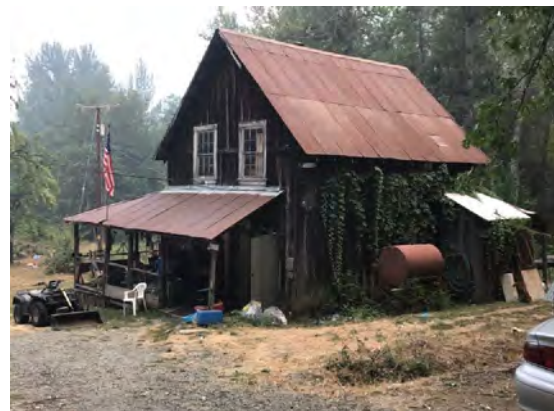
Hazards: **Yard art**

Hazard Notes: **Numerous**

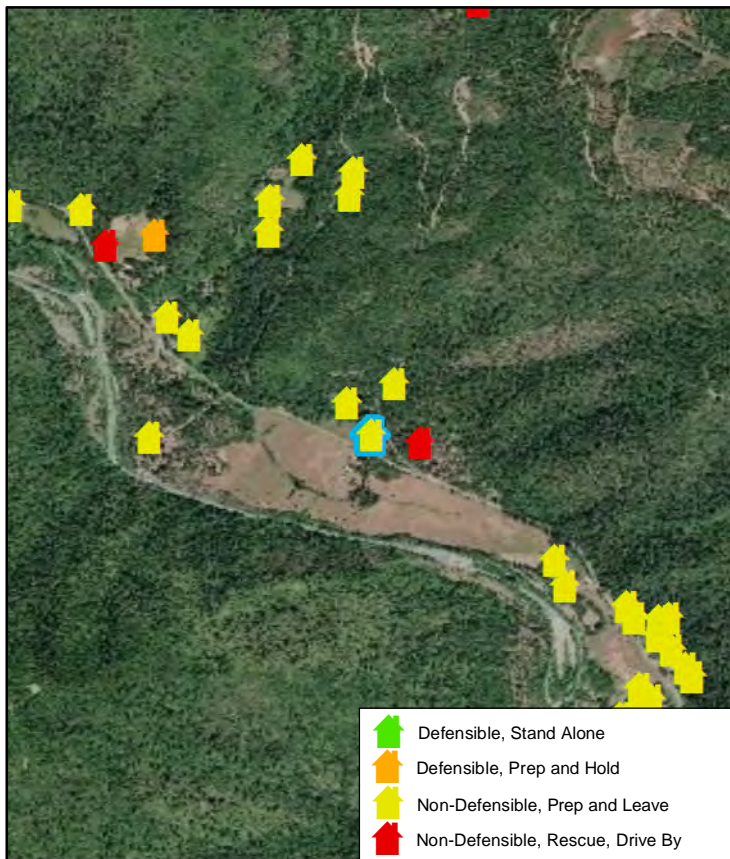
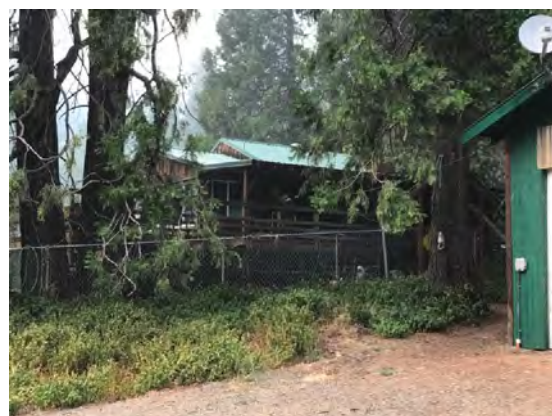
Notes: **Large barn across Hwy 48**

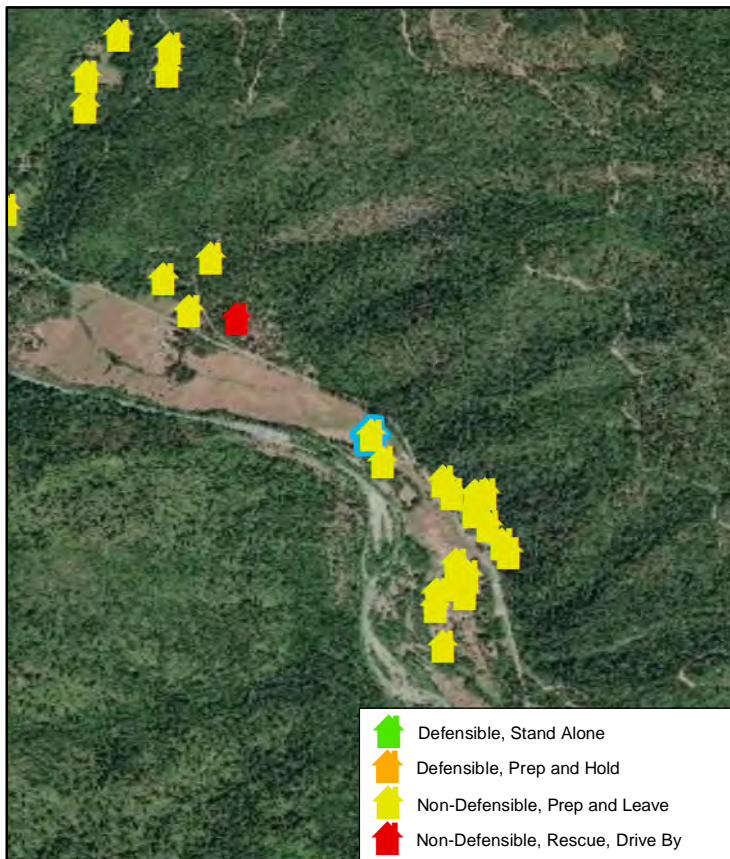
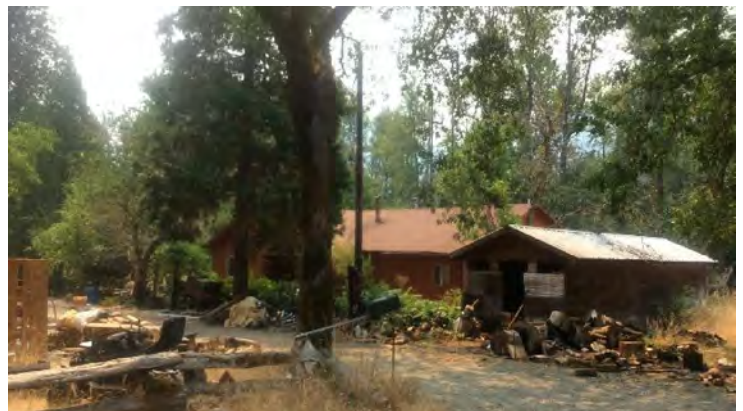
Hazards: **Yard art**

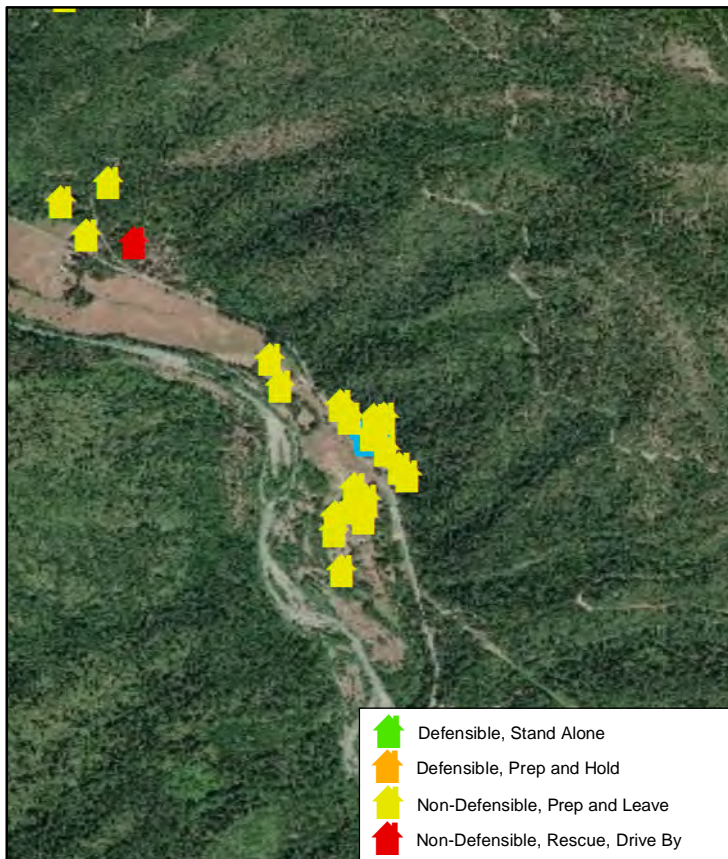
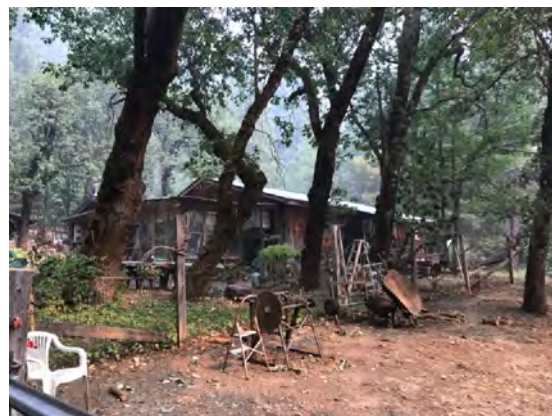
Hazards: **Yard art**

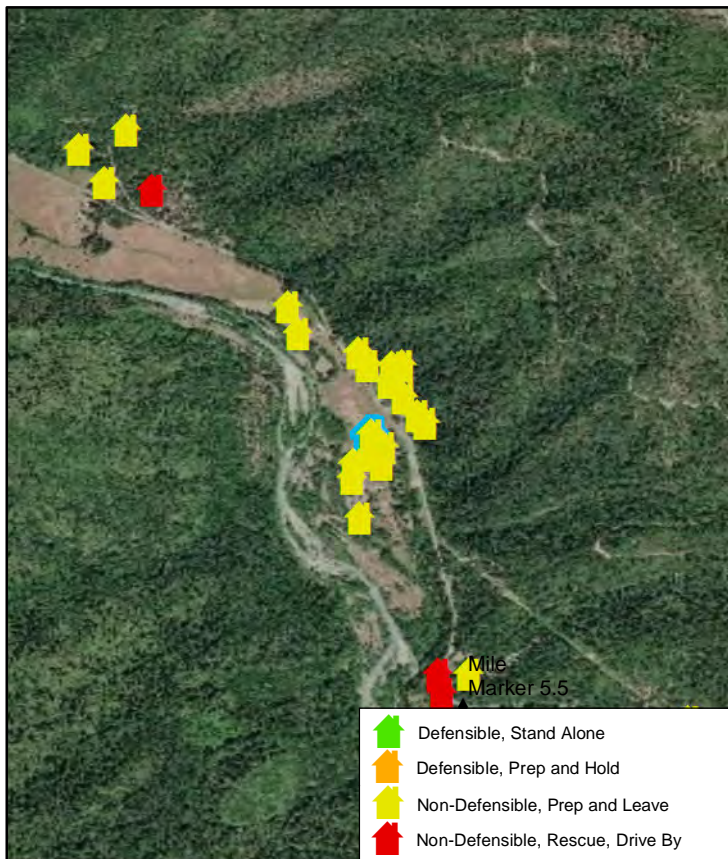
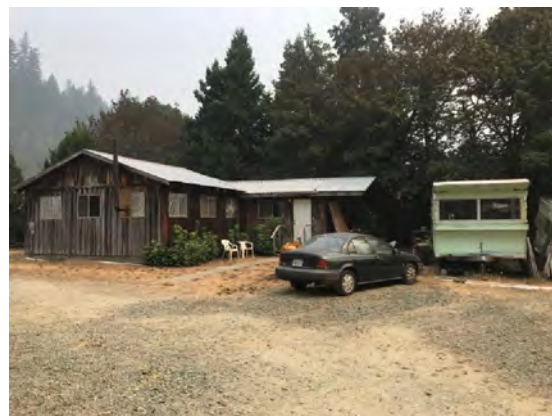
Hazards: **Yard art**

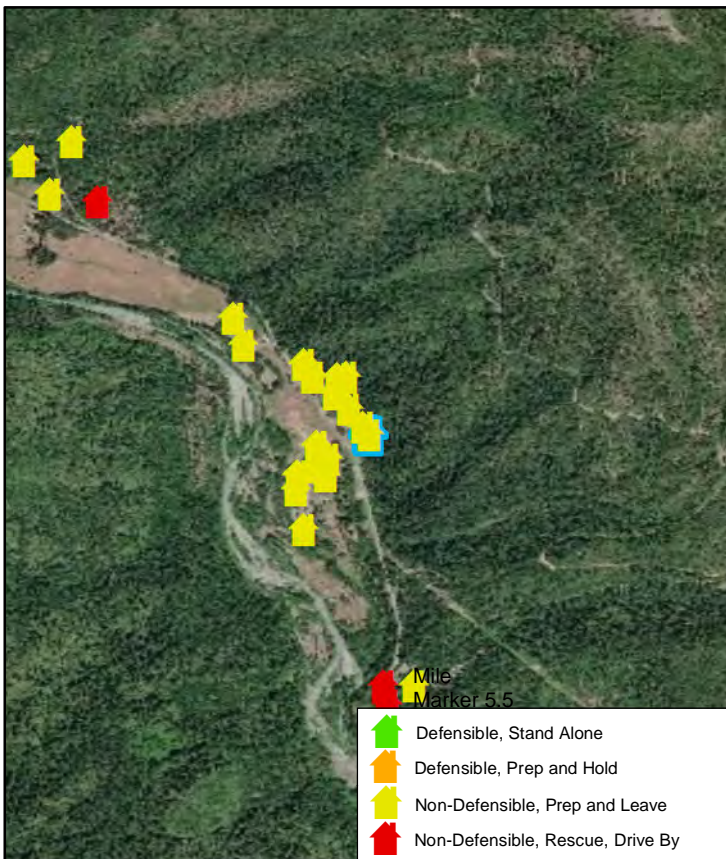
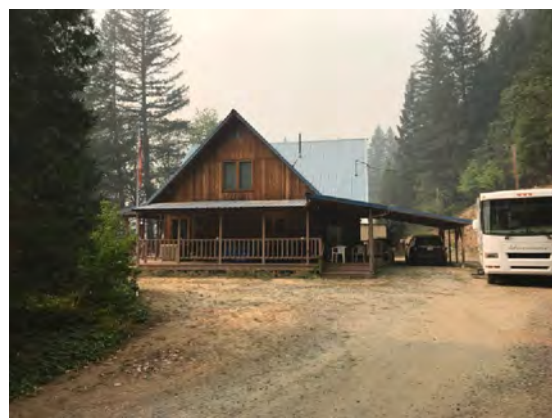
Hazards: **Numerous**

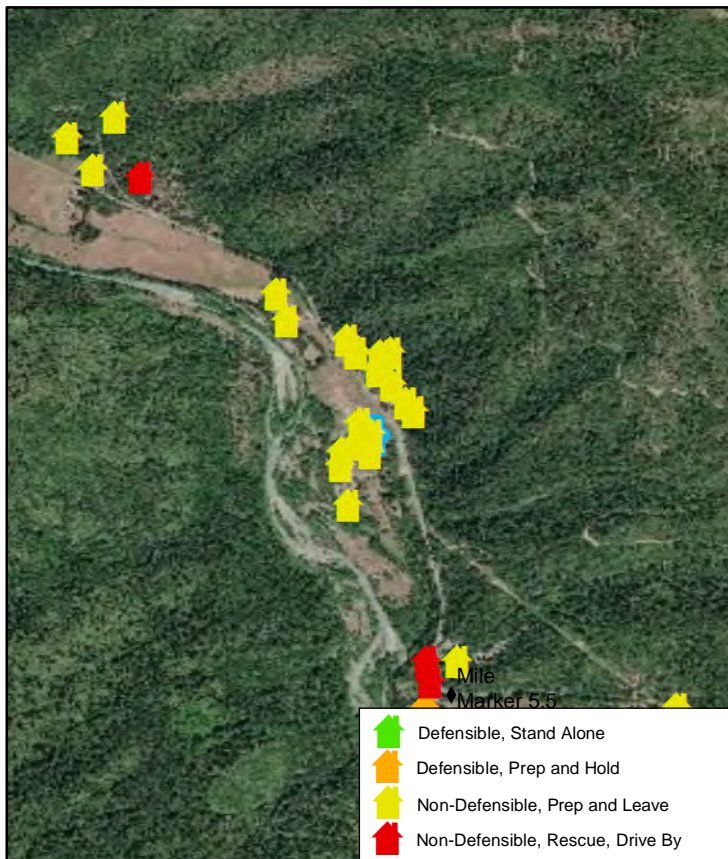
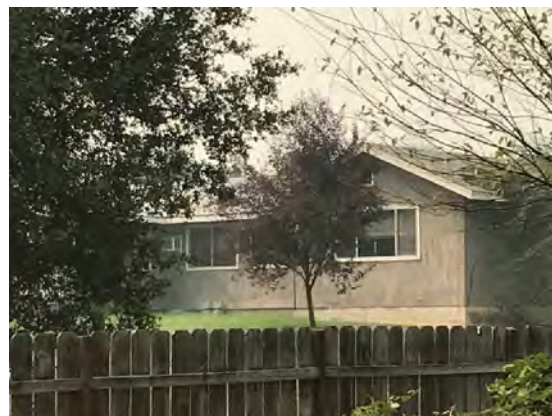
Hazards: Numerous

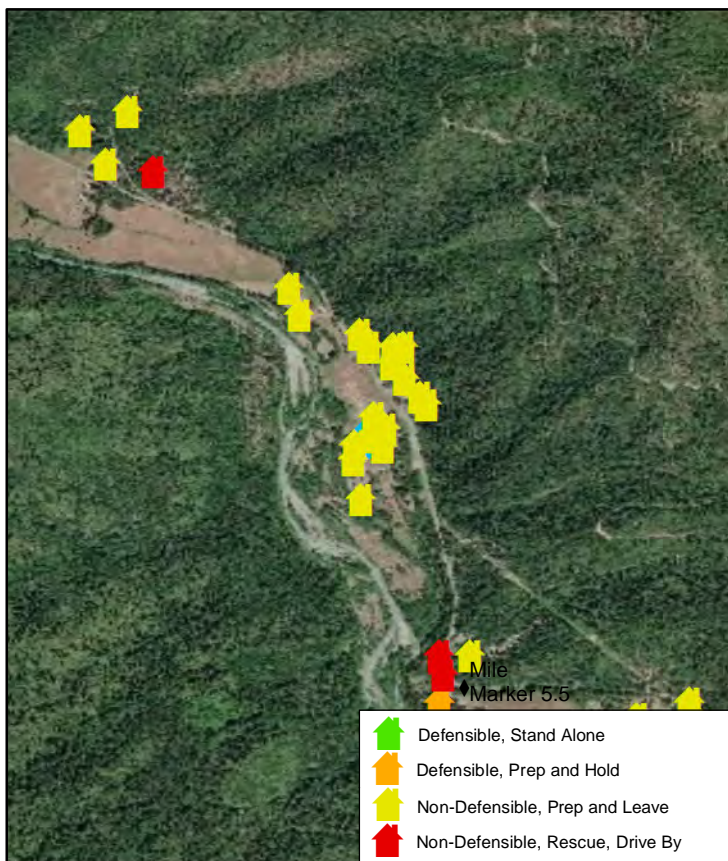
Hazards: **Yard art**

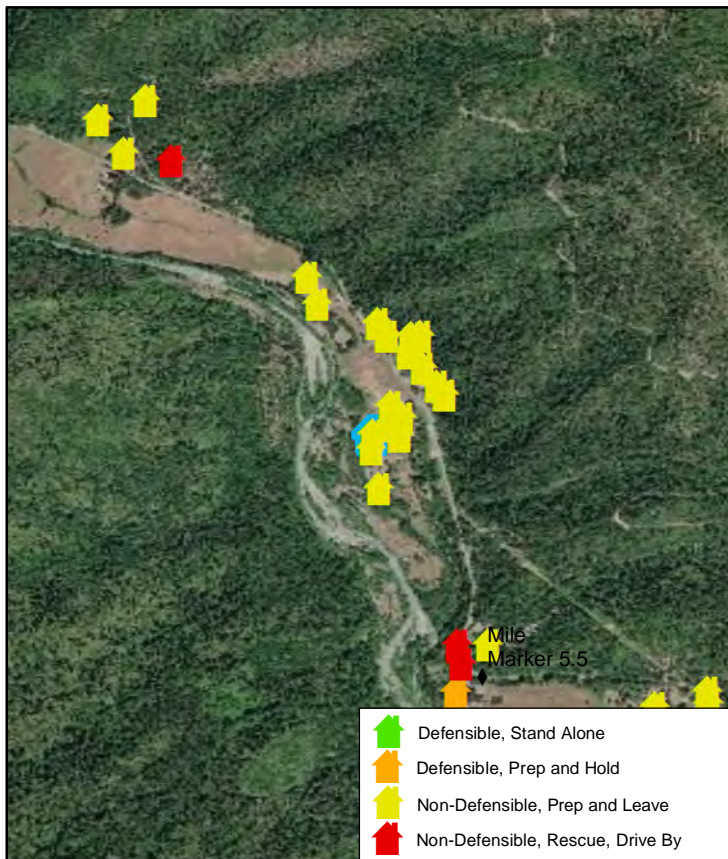
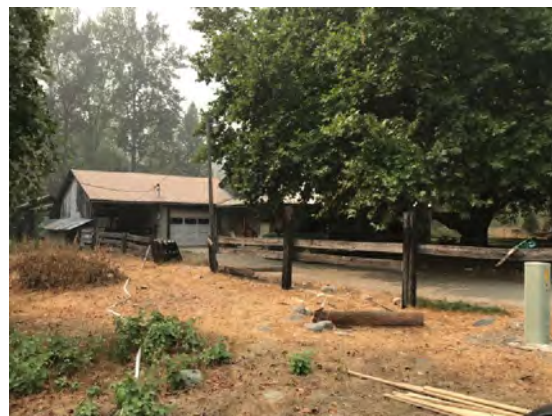
Hazards: Numerous

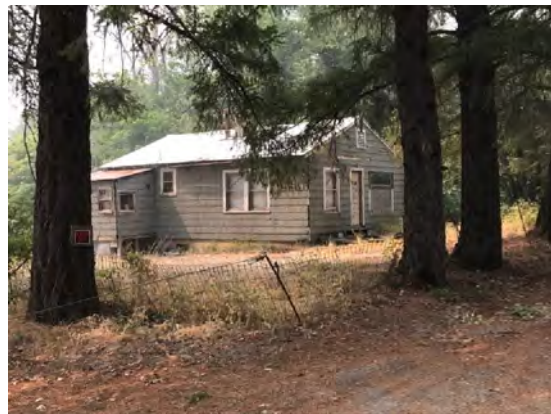
Hazards: **Asbestos siding**

Notes: **Abandoned**

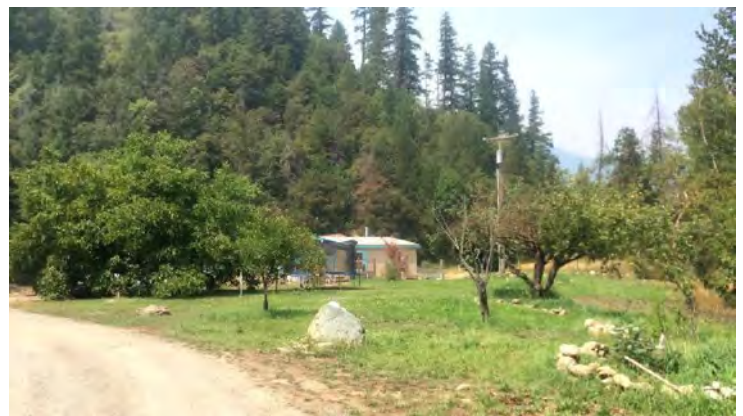
Hazards: **Bridge load limits, Yard art**

Notes: **Bridge is insufficient for engine traffic**

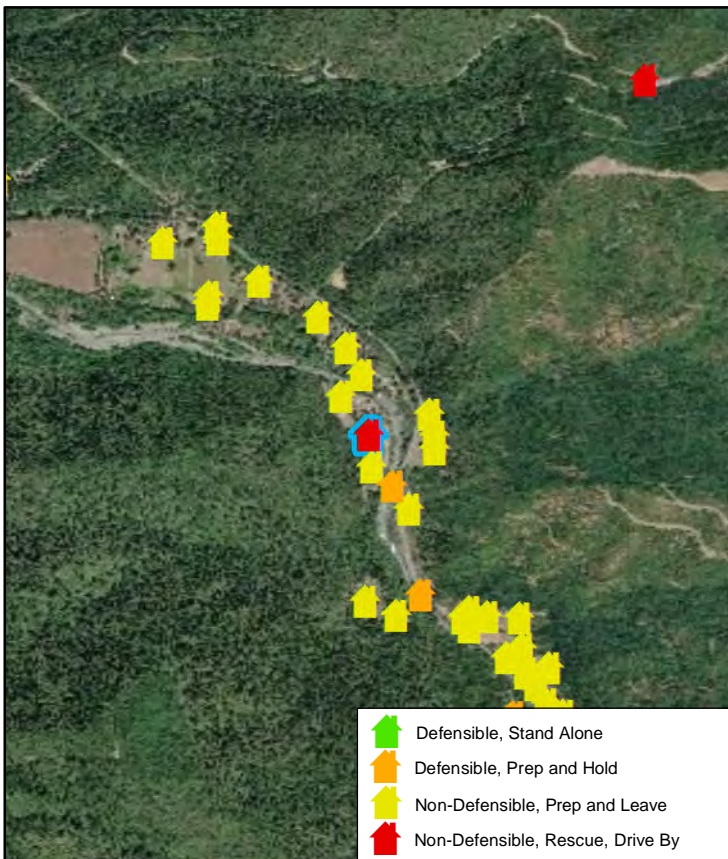
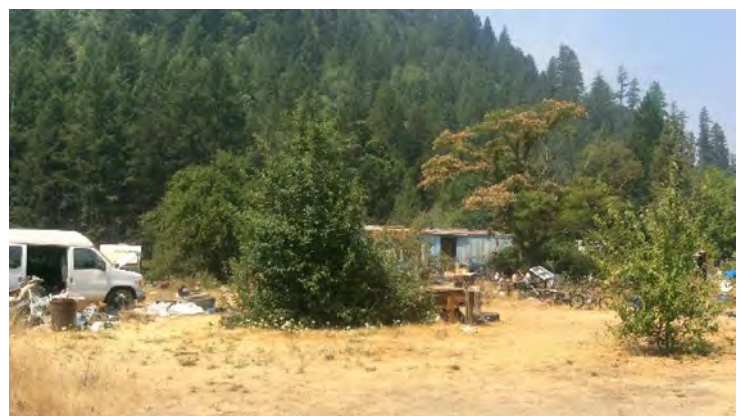
Hazards: **Bridge load limits, yard art**

Hazard Notes: **Excessive amounts of yard art**

Notes: **Bridge is insufficient for engine traffic**

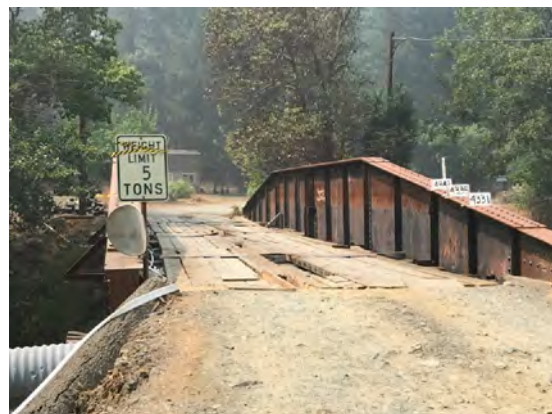
Hazards: **Operator use extreme caution crossing bridge**

Notes: **Bridge is significantly insufficient, pickup only, walk it out first**

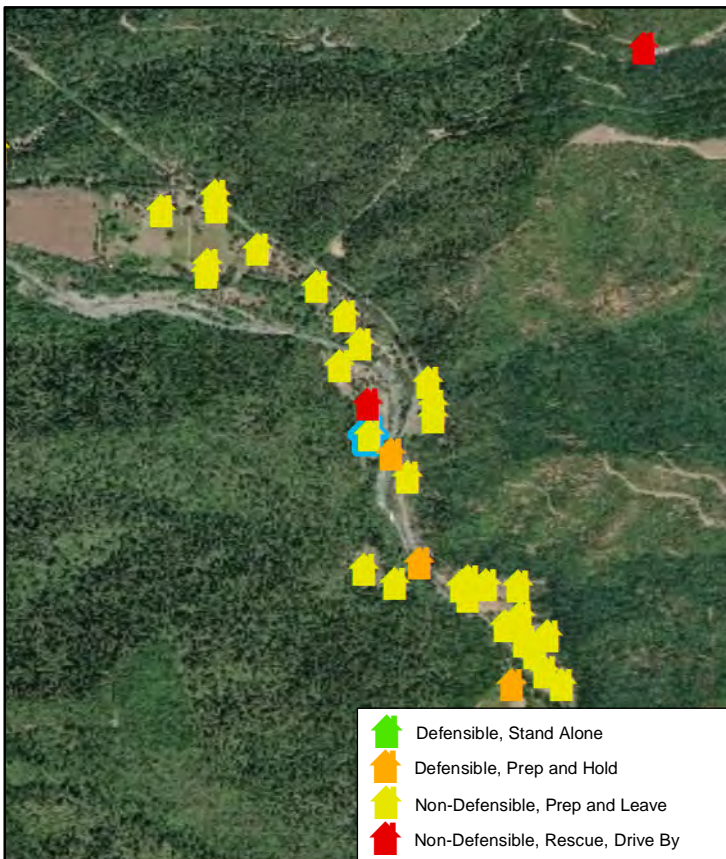
Hazards: **Bridge load limits**

Hazard Notes: **Posted 5 ton bridge load limit, operator use discretion**

Notes: **Bridge is insufficient for engine traffic**

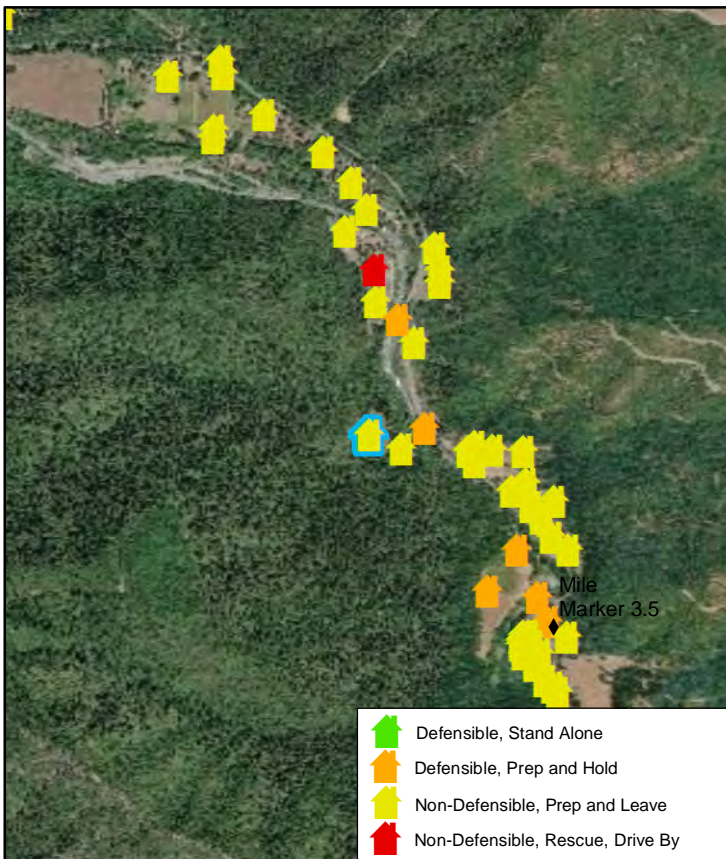
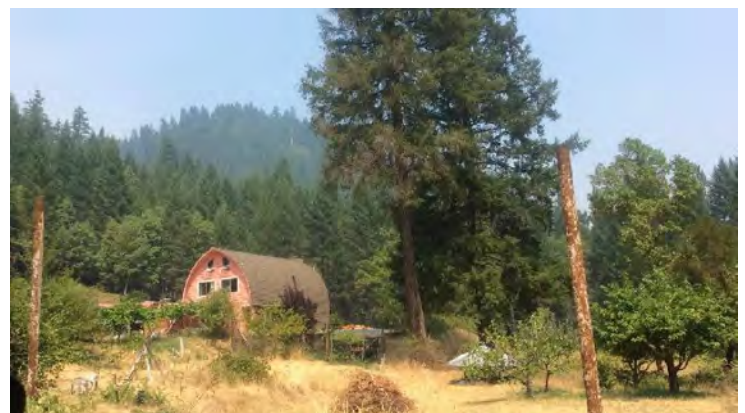
Hazard Notes: **Wooden bridge access from Indian Creek Road- unmarked load limit**

Notes: **Bridge load limitations, pickups only**

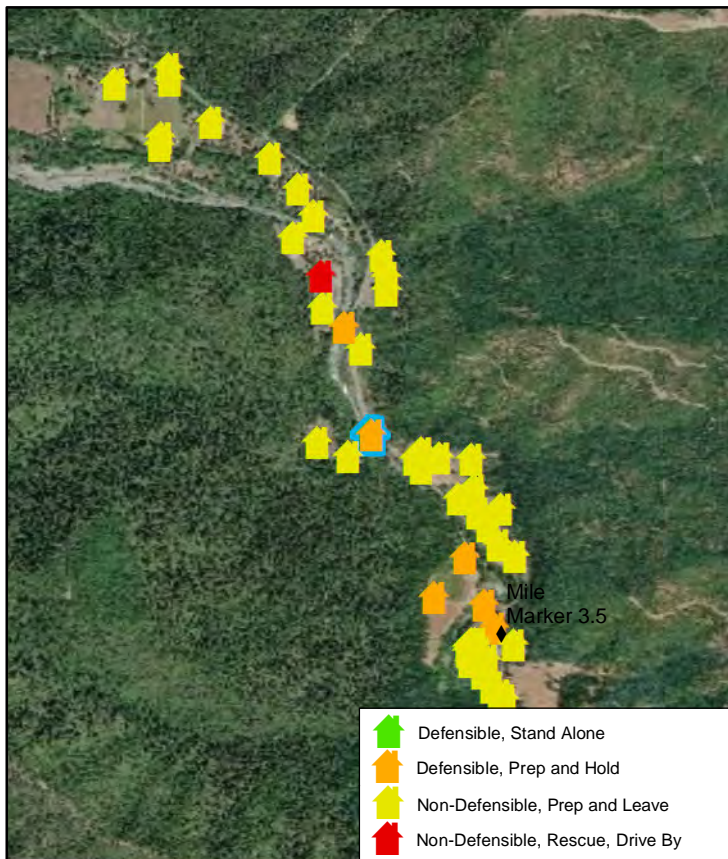
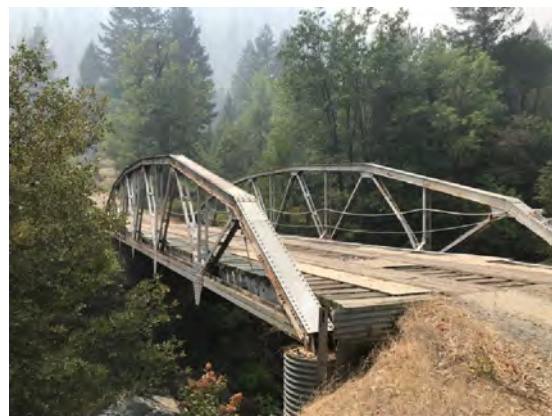
Notes: **This bridge is limited to pickups only, no engines**

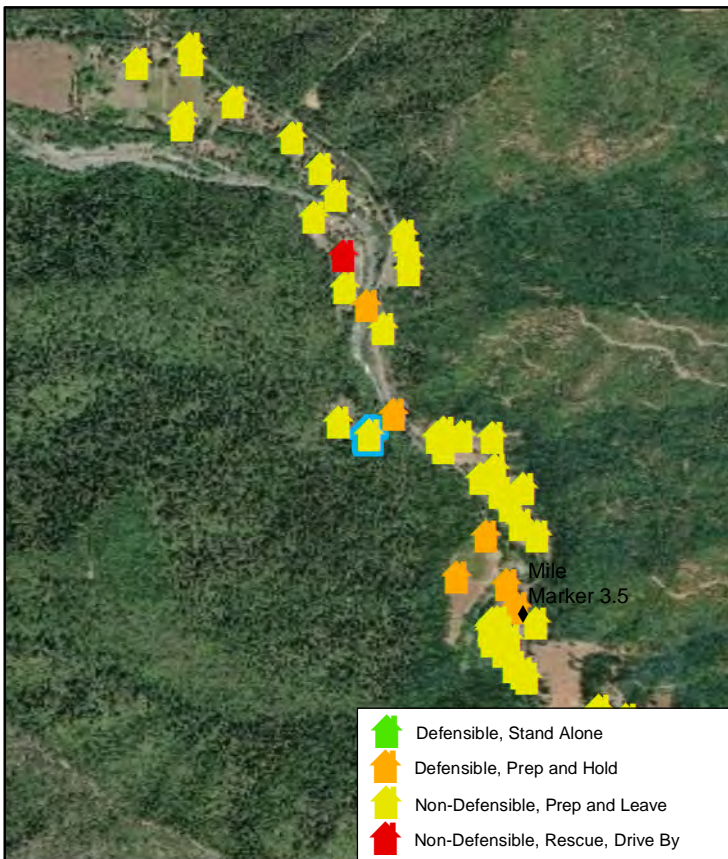
Hazard Notes: **Unmarked load limit on bridge**

Notes: **Bridge load limits, pickups only**

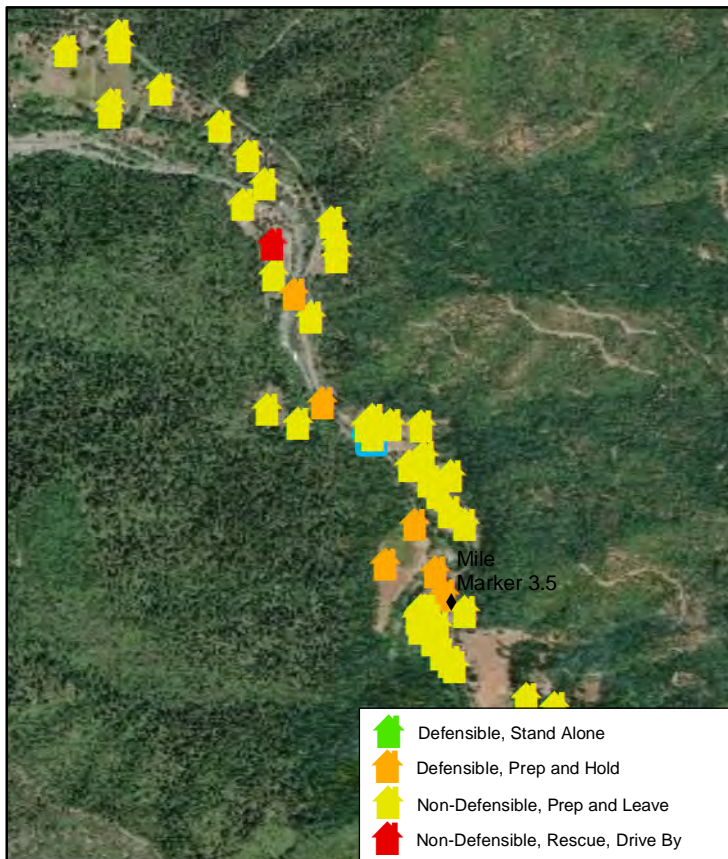
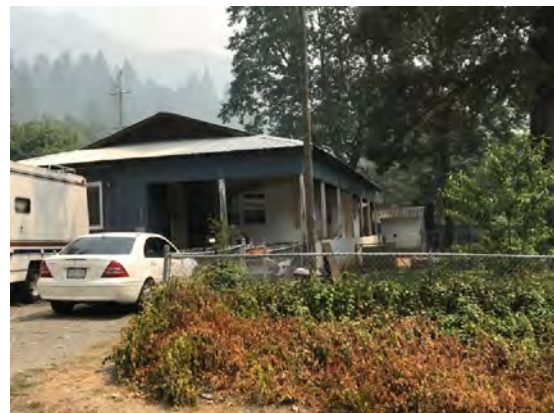
Hazards: **Yard art**

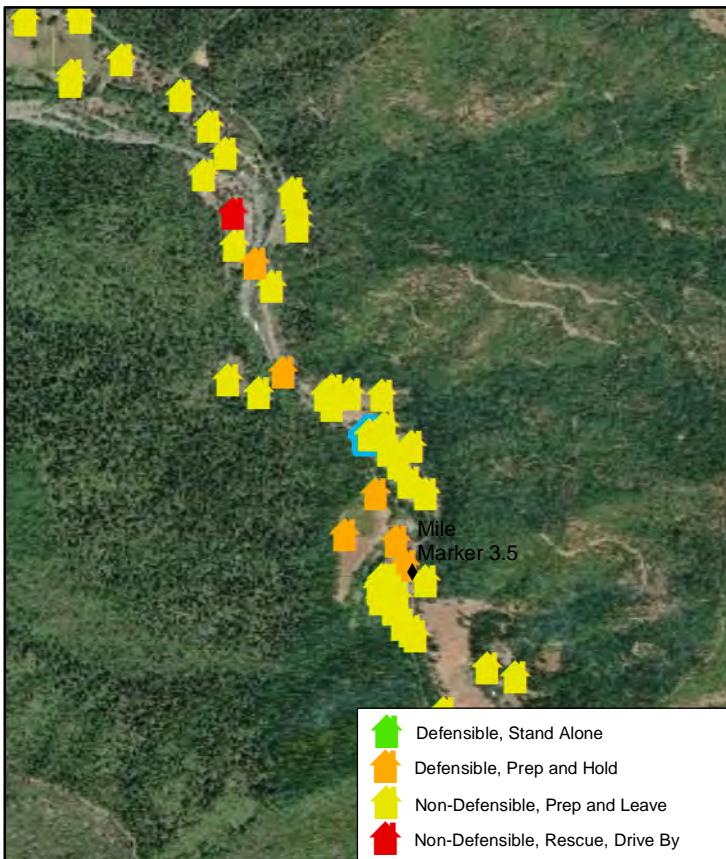
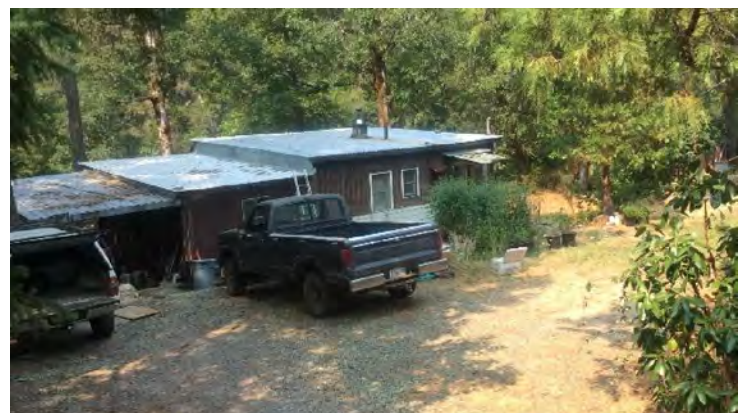
Hazards: **Yard art**

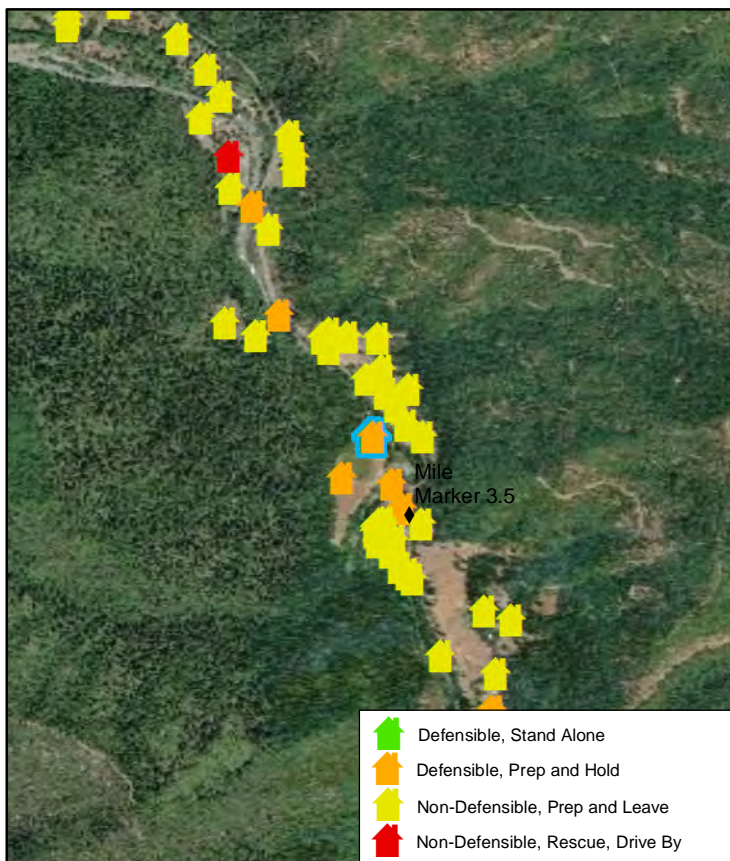
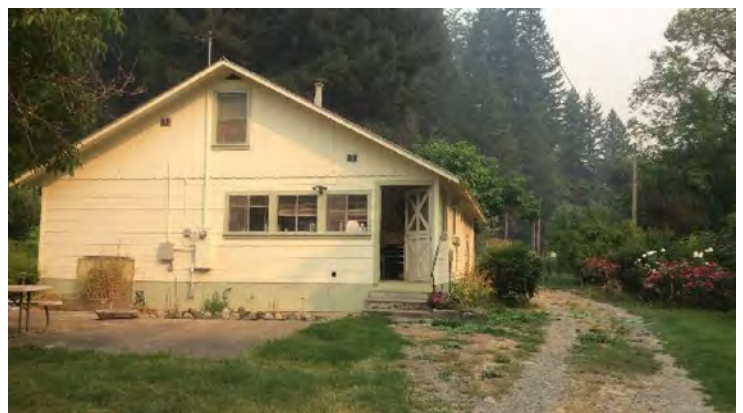
Hazard Notes: **Narrow bridge, Nine Springs bridge, 40,000# load limit**

Notes: **Large wood barn and secondary residence behind main home.**

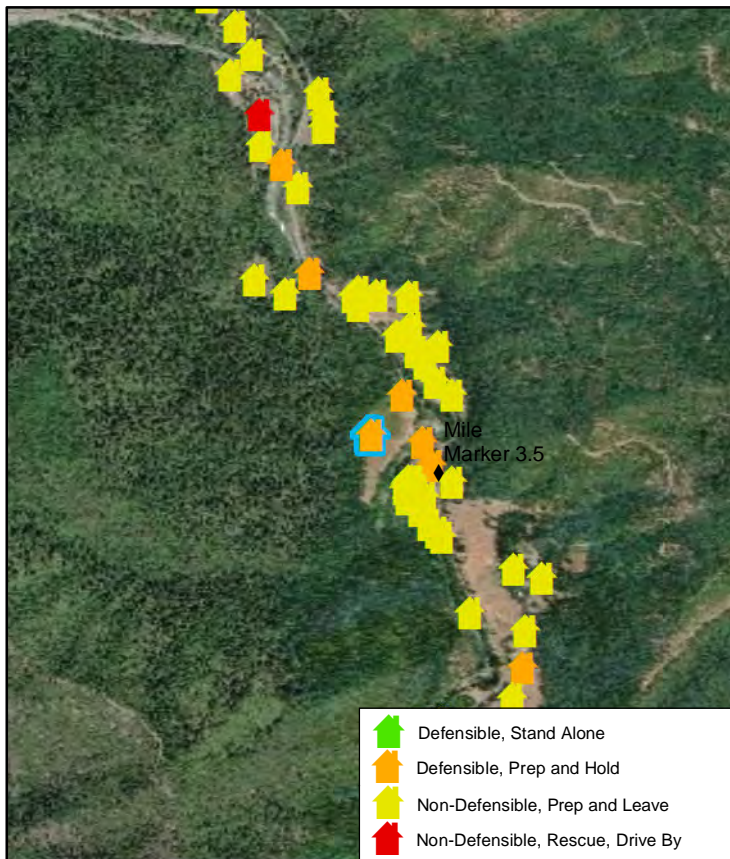
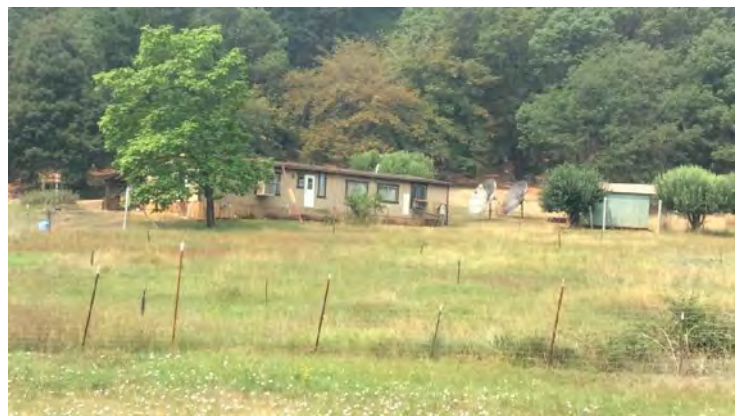
Hazard Notes: **Narrow bridge, Nine Springs bridge, 40,000# load limit**

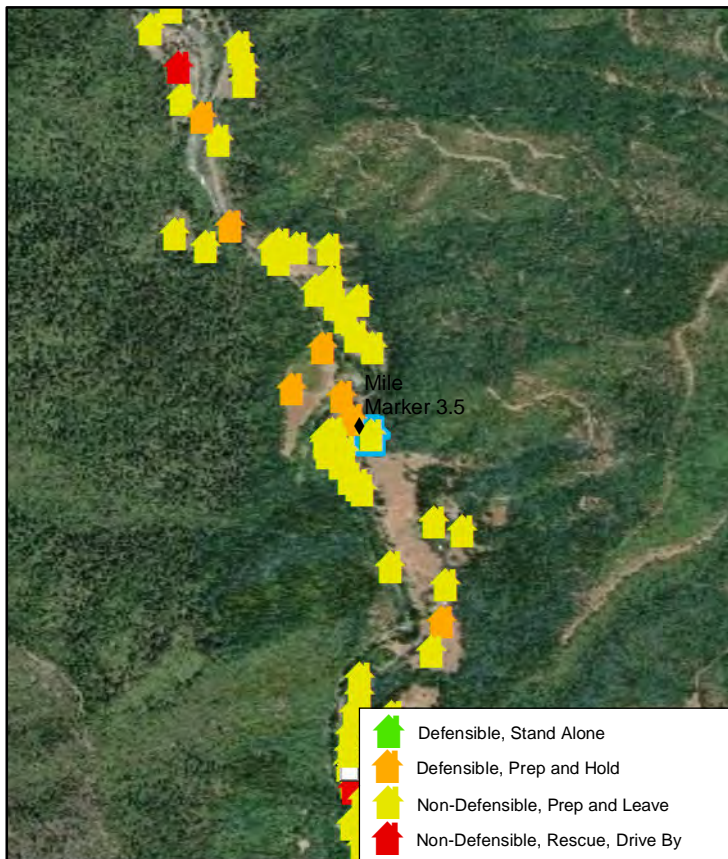
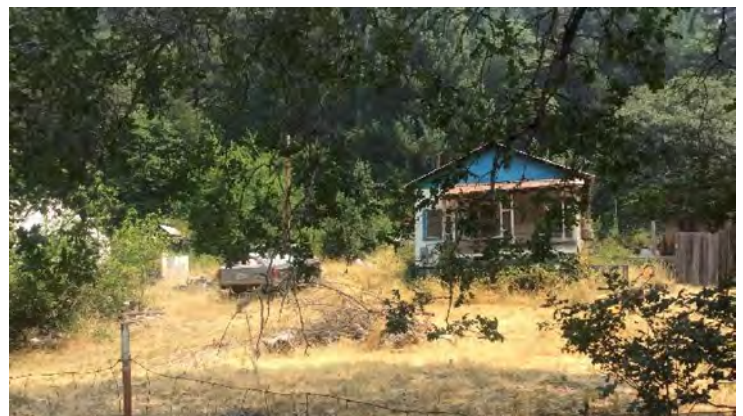
Hazards: **Numerous**

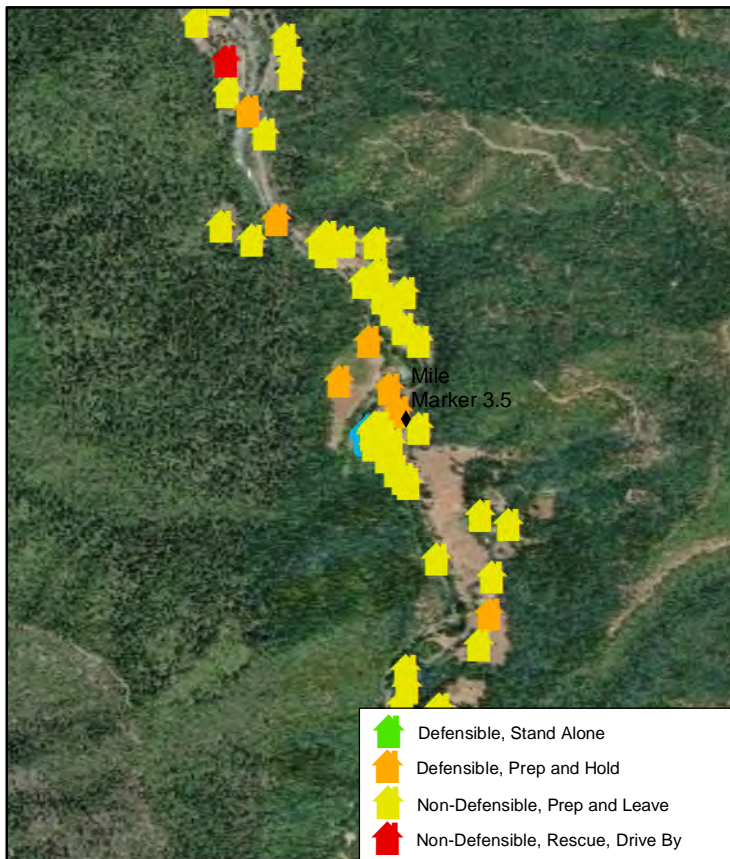
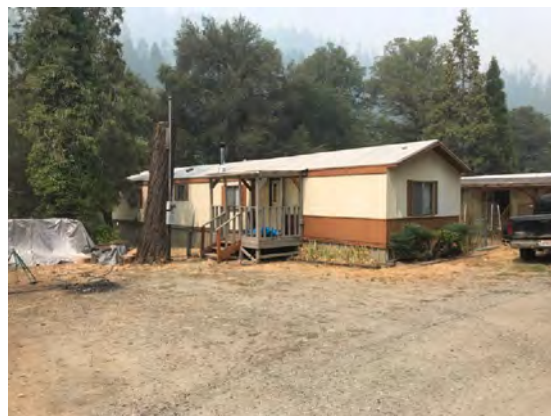
Hazard Notes: **Proximity to other structures**

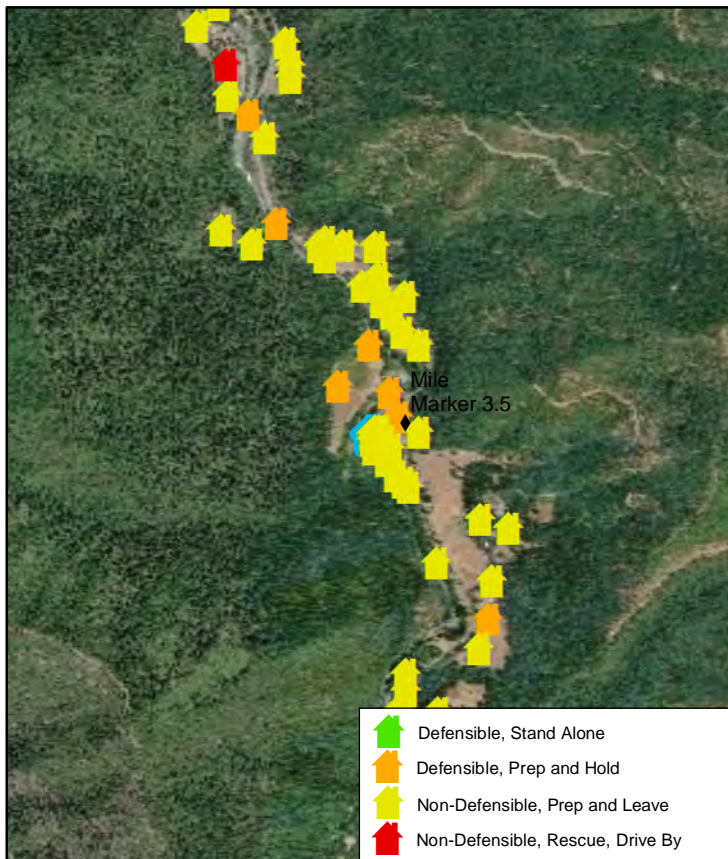
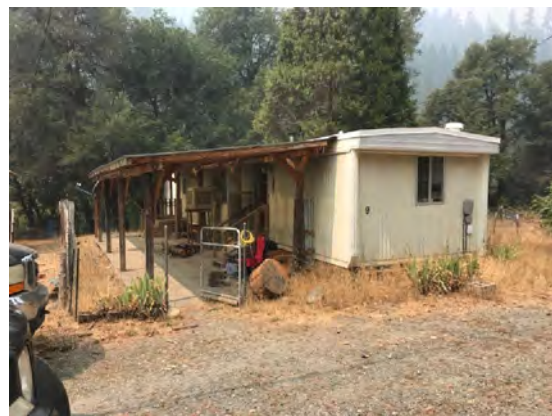
Hazards: **Proximity to other structures**
