Natchez Fire 2018

Incident Number: OR-RSF-000348

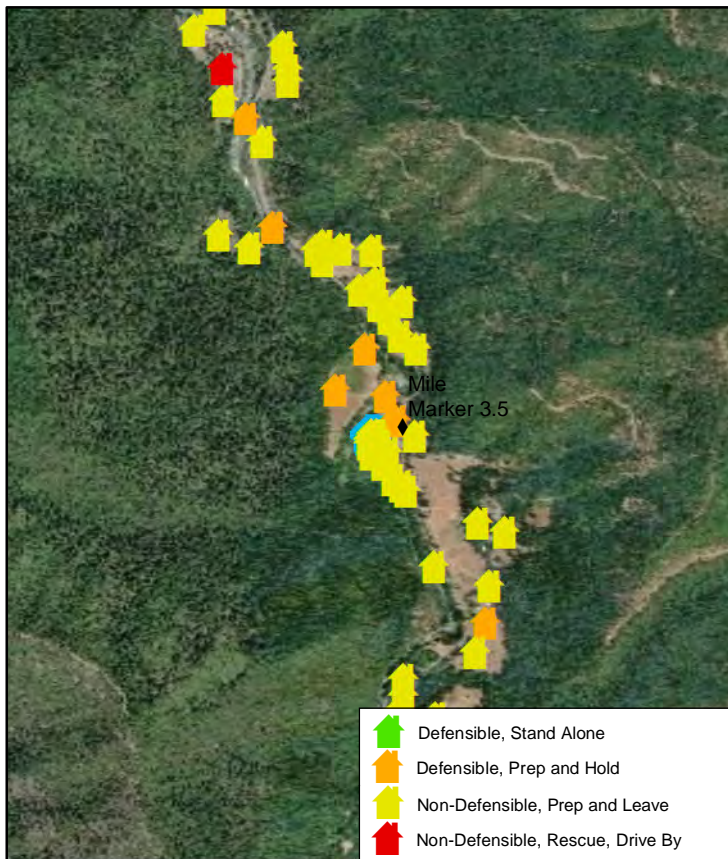
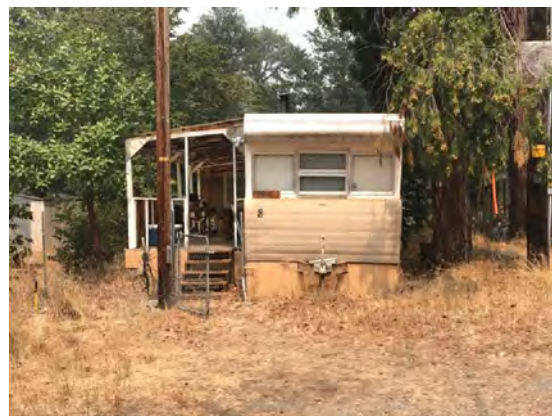
Hazards: **Proximity to other structures**

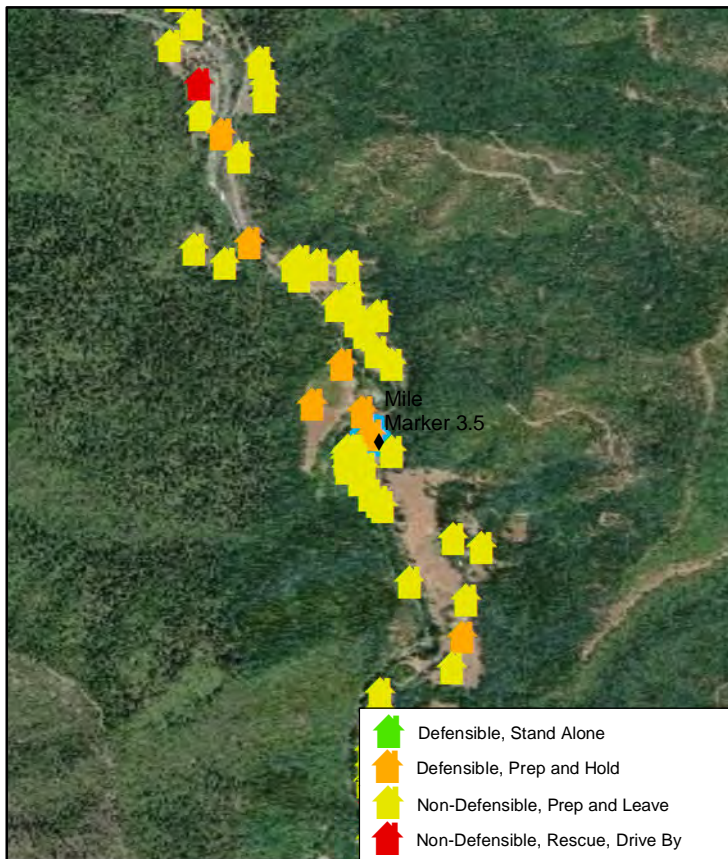
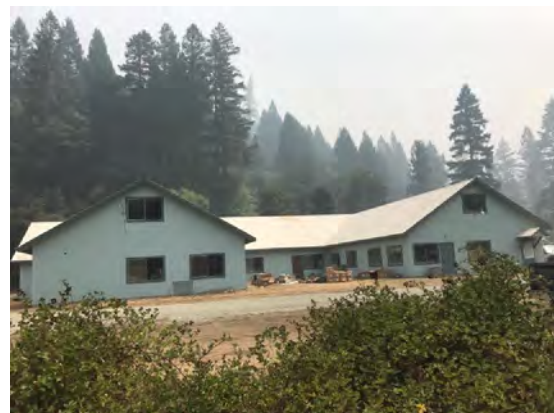
Notes: **Book store and bookbinding shop**

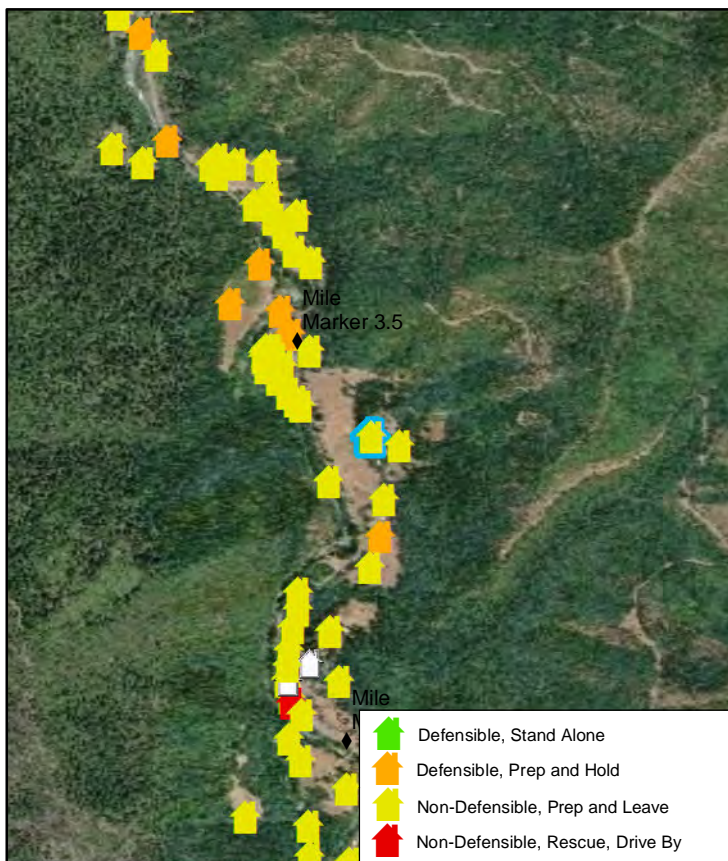
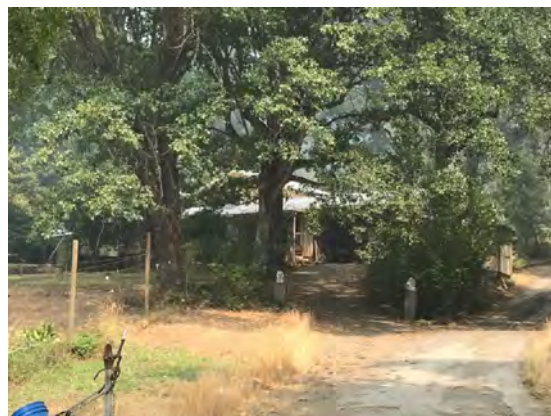
Notes: **Pasture could be used as an area to seek refuge, however access is limited.**

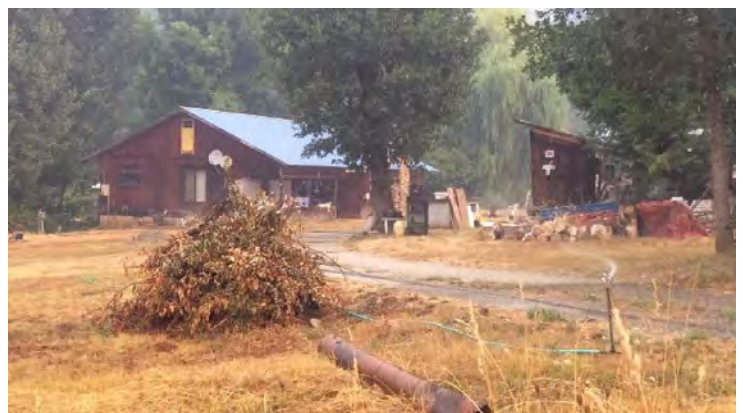
Hazard Notes: 80 lb propane tank.

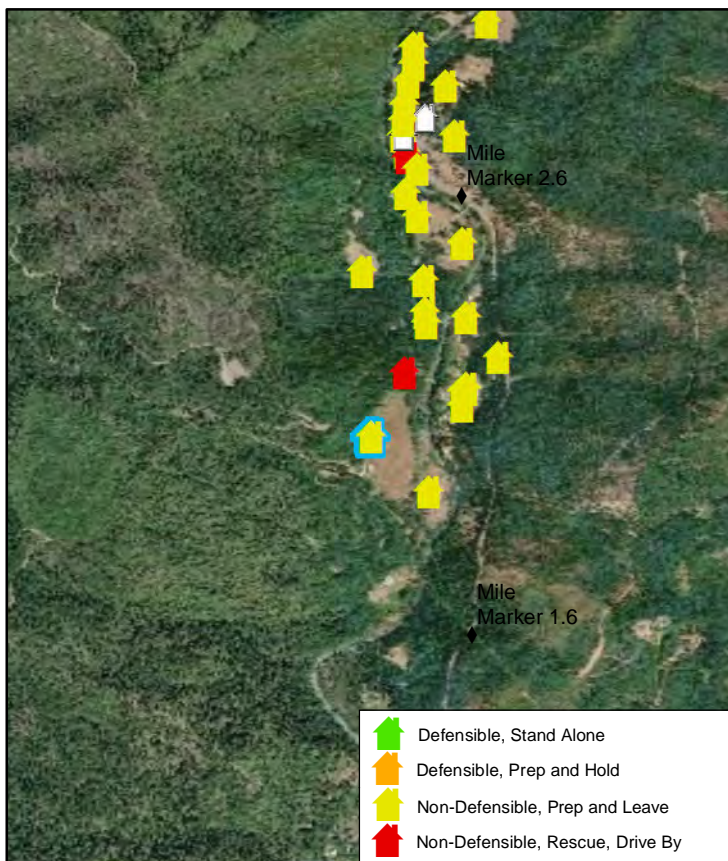
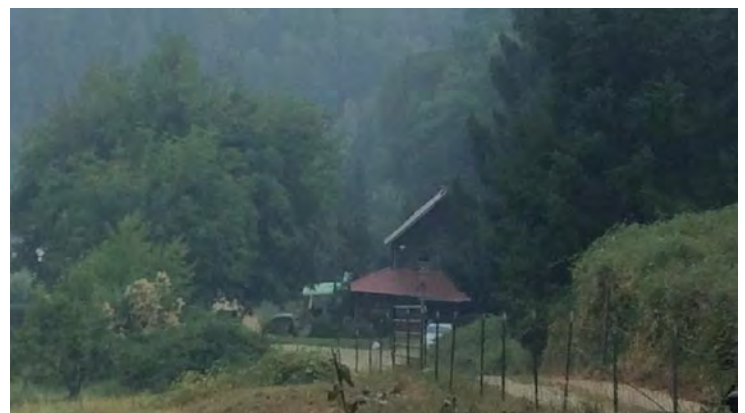
Notes: Two homes on this property

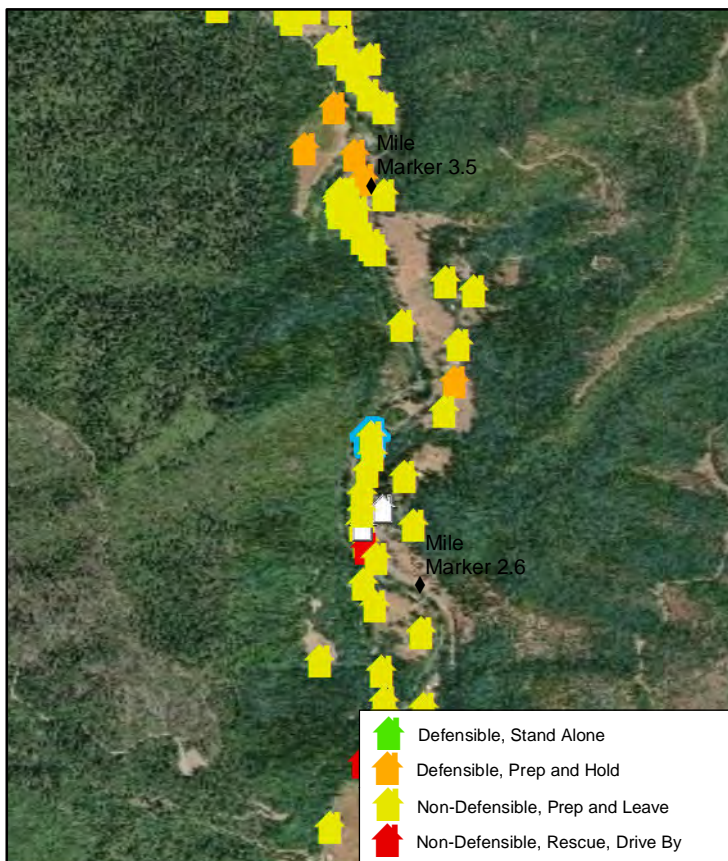
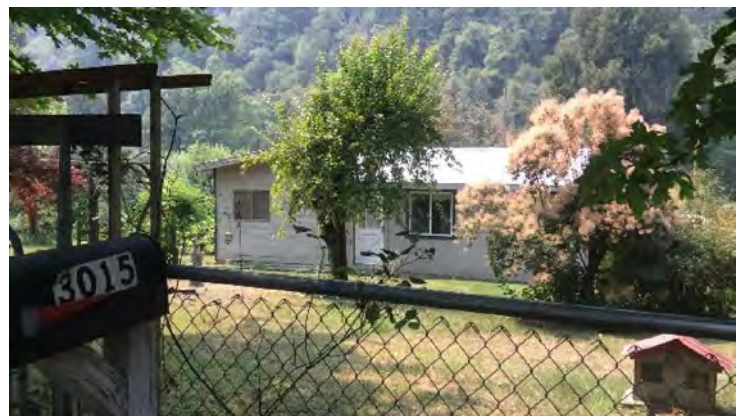
Notes: **3 homes on this property**

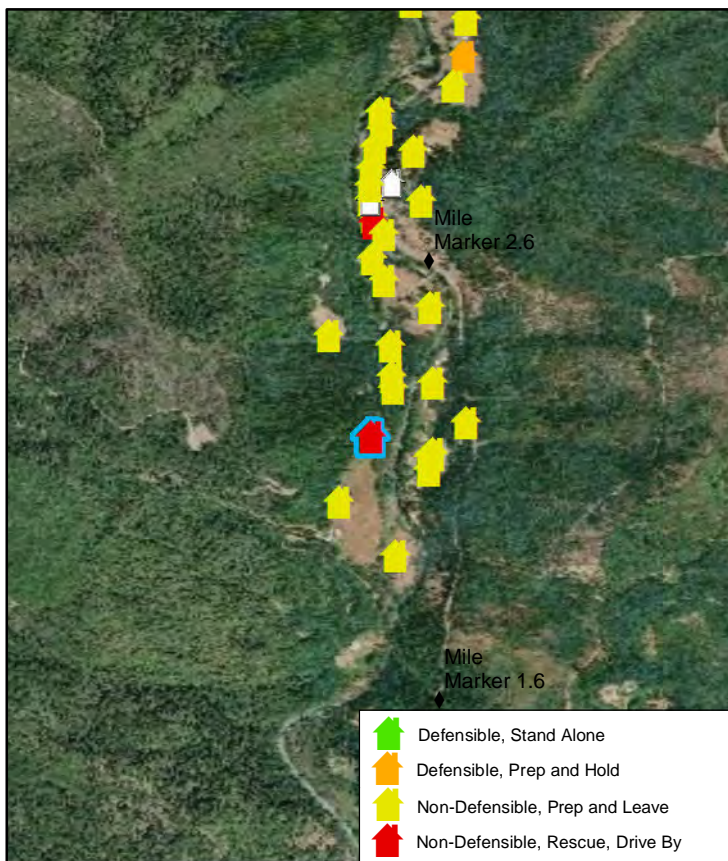
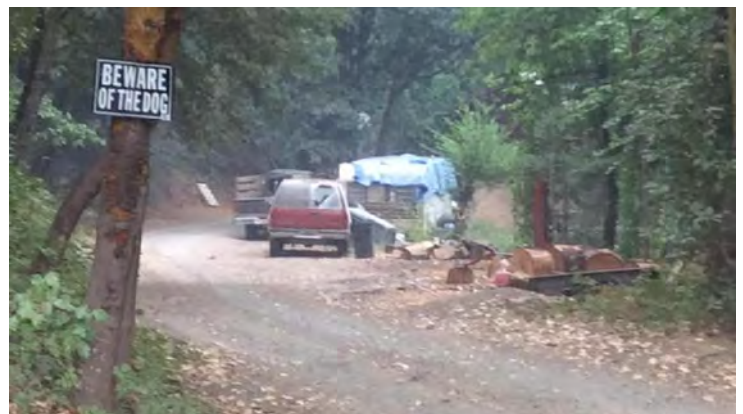
Hazard Notes: **Access. Narrow,heavily timbered driveway.**

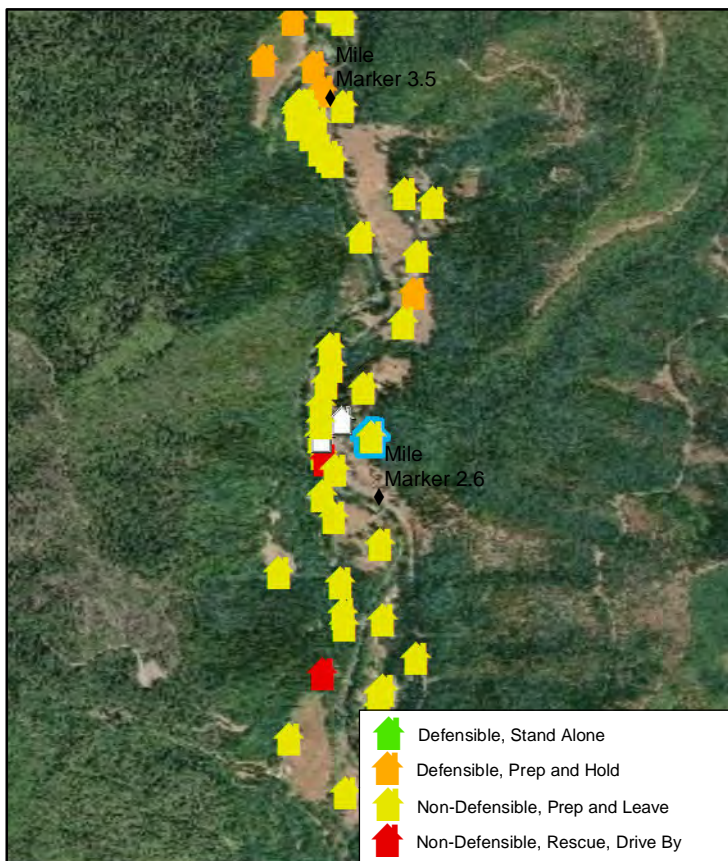
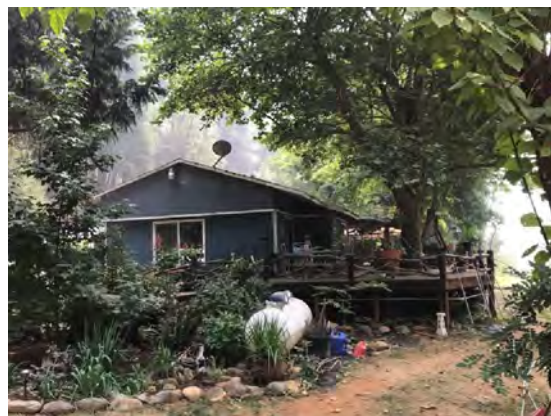
Hazard Notes: **Multiple structures on property**

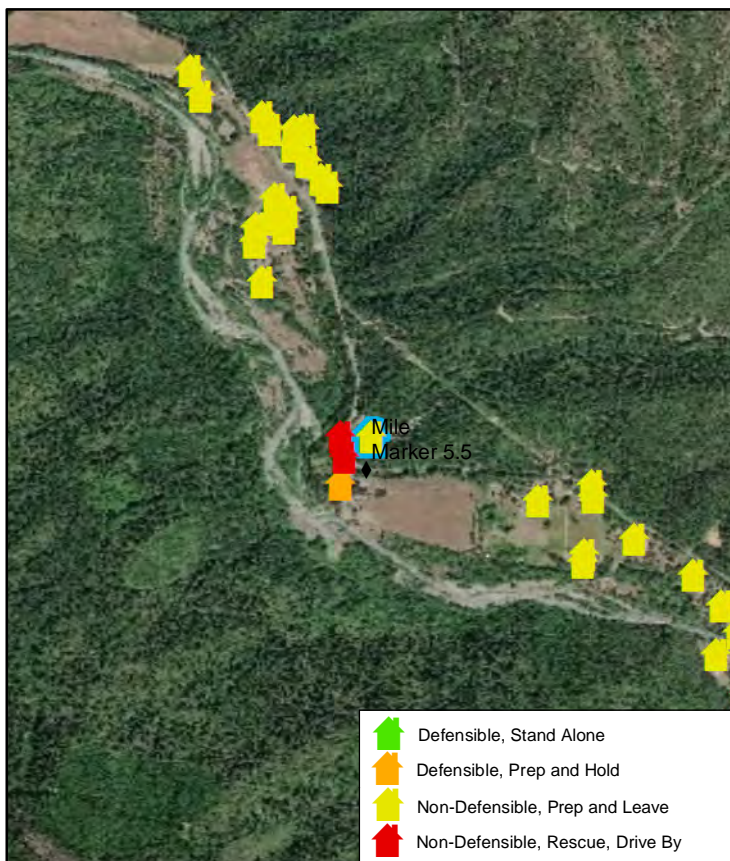
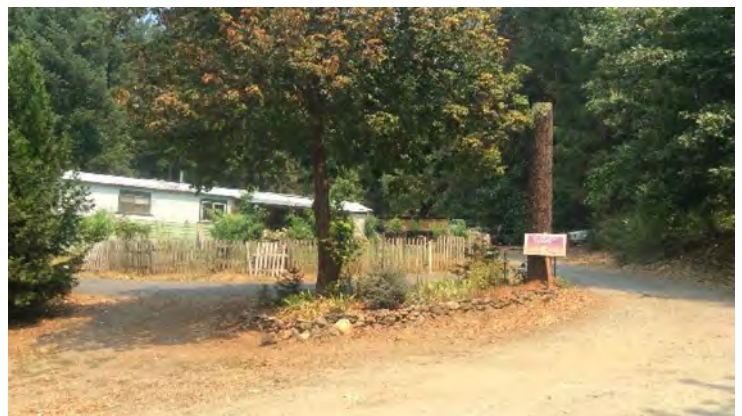
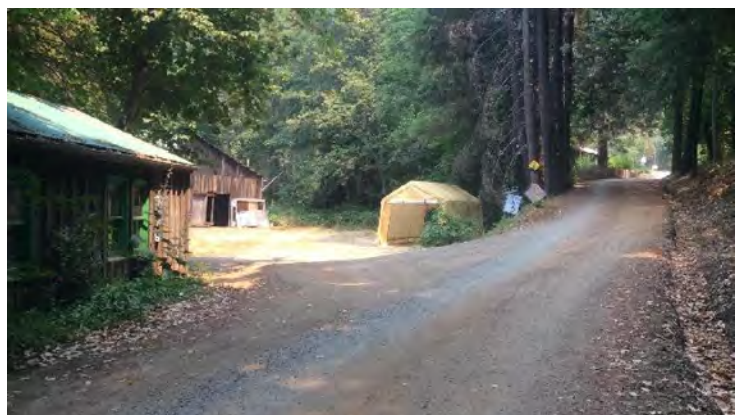
Notes: **There are 8 cabins here on 14 acres that are rented on monthly basis. Owners also live on site.**

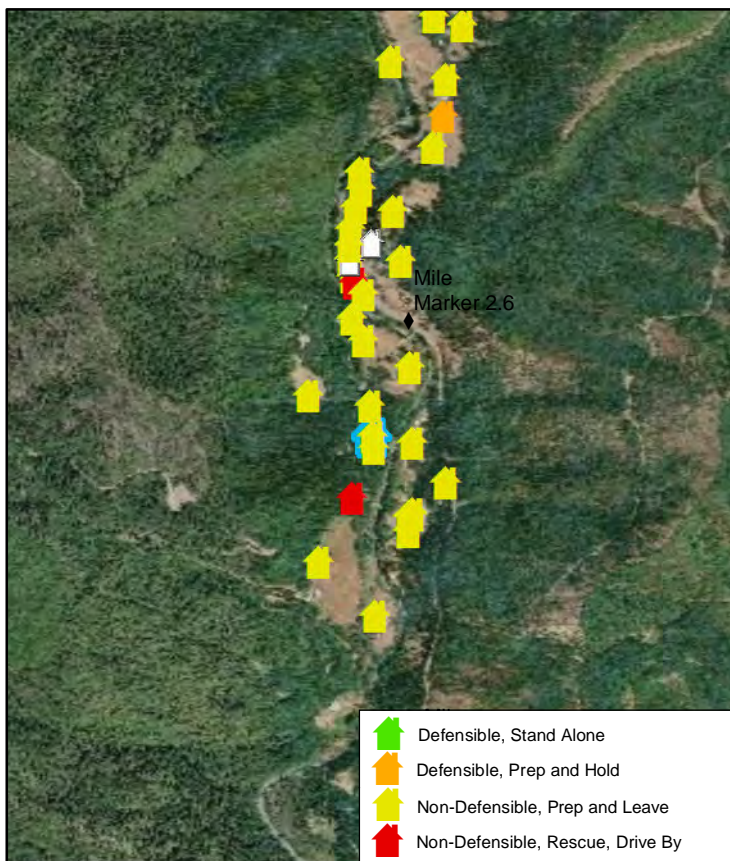
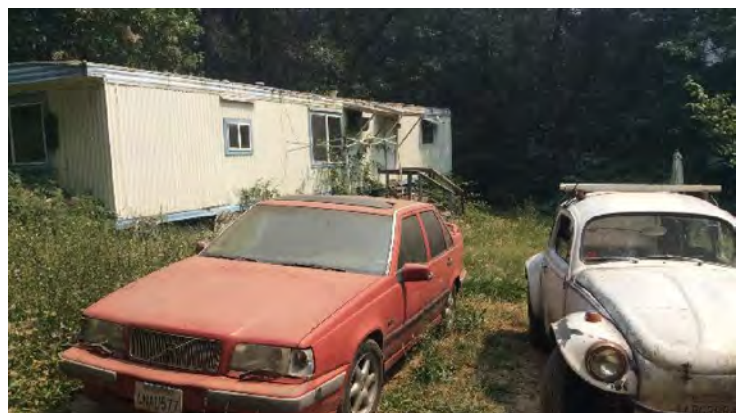
Notes: **Yard art, no electricity**

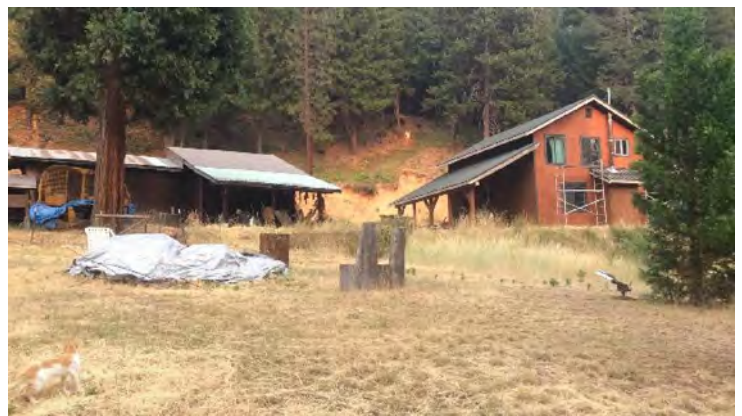
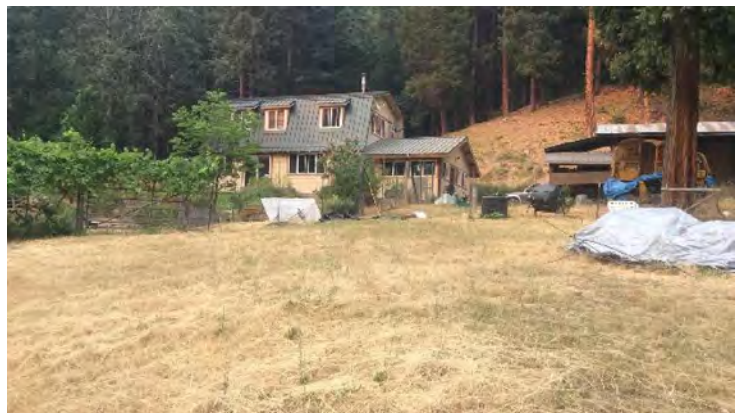
Hazard Notes: **Access. Steep narrow road down into property with heavy timber**

Notes: **Large house with one large shop and shed. Large irrigated grass field in front of house. There is a two thousand gallon well located outside the yard at the end of the grape vines. (There is also a hydrant in the backyard by the end of the bricks. Renters are Patrick and Shuana Mayfield, 707-346-0171 or 707-**

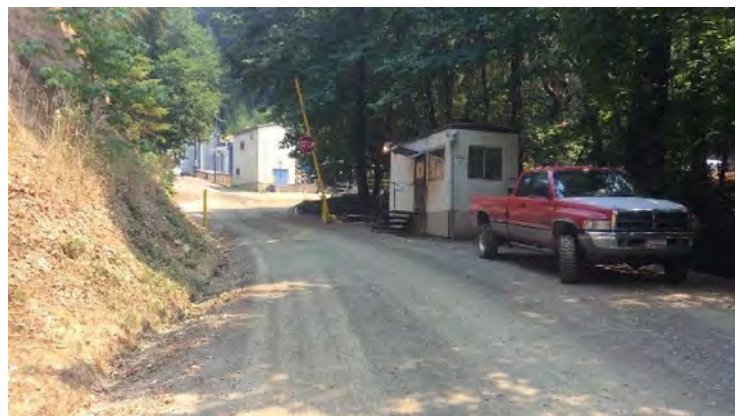
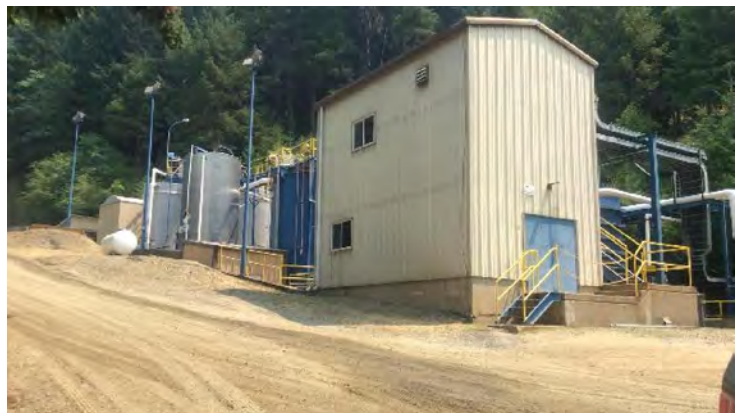
Hazard Notes: **Mining site, sodium chloride tank present in addition to diesel tank. Maybe other hazardous materials associated with mining industry present.**

Notes: **Mobile retardant site is up steep narrow road from mine entrance.**
